Alaska DOT&PF

Pavement Inspection Report Gulkana Airport

Point of Contact	Phone	Email	Date Inspected	Date Published
Mr. Andrew Pavey, Pavement Management Engineer	(907) 269 6213	andrew.pavey@alaska.gov	June 2023	September 2023*

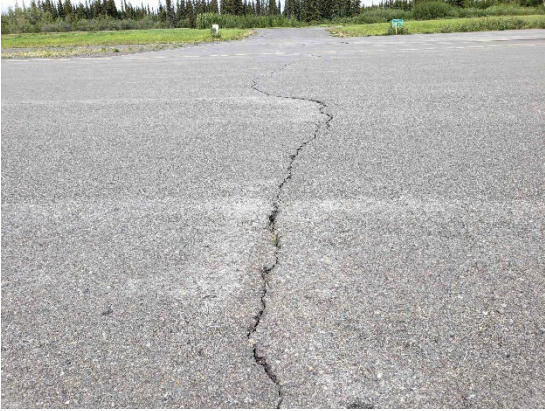
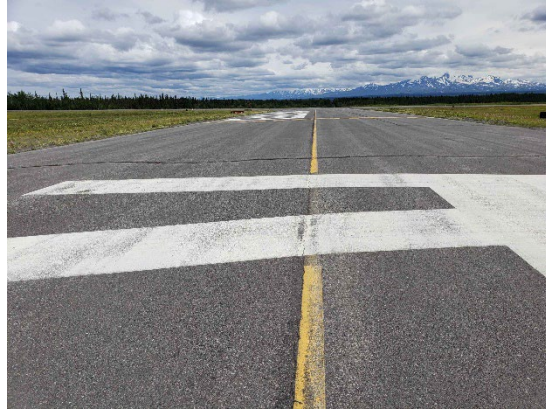
Branch ID	Branch Name	Branch Use	No. of Sections	Area (sf)	Weight Average PCI
0200	Taxiway B	Taxiway	3	154,138	77

Taxiway B is composed of three sections. The two connecting to Runway 33R-15L were constructed in 2007 while the section adjacent to the apron was constructed in 2016. The most common distresses observed are low to medium to high severity longitudinal and transverse cracking, low severity raveling, and low severity weathering. Field observations include wearing of the pavement around longitudinal and transverse cracks from snowplows.

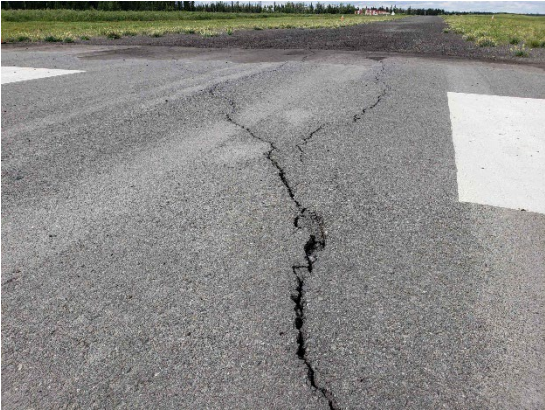
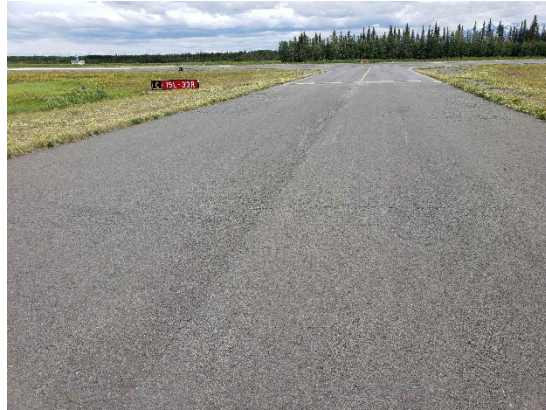
Branch ID	Branch Name	Branch Use	No. of Sections	Area (sf)	Weight Average PCI
0300	Taxiway C	Taxiway	1	34,241	79

Taxiway C was constructed in 2007 and connects runway 33R-15L to the gravel runway 33L-15R. The most common distresses low severity longitudinal and transverse cracking and low severity weathering. Adjacent to the gravel runway is an area with high severity longitudinal and transverse cracking. Field observations include the development of new unsealed cracks.

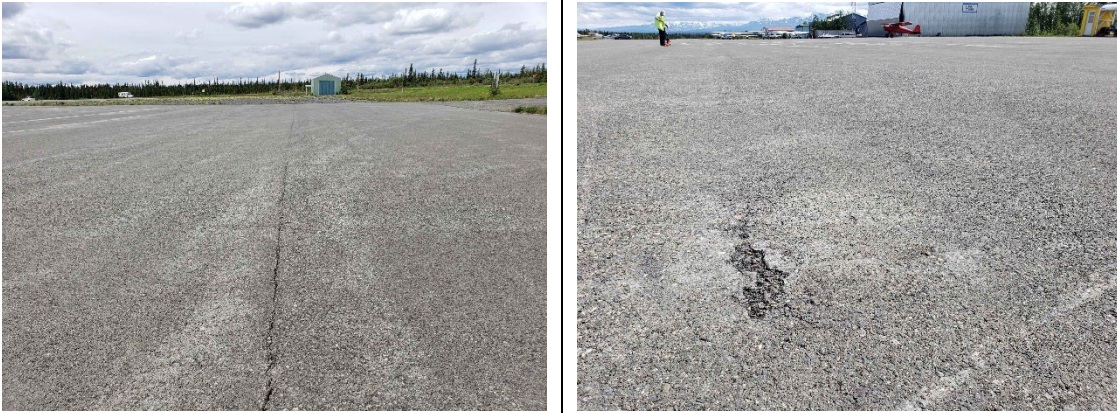
Branch ID	Branch Name	Branch Use	No. of Sections	Area (sf)	Weight Average PCI
4100	General Aviation Apron	Parking Apron	5	213,222	87

The apron was constructed in 2016. Crack seal operations have not been performed on the branch. The most common distresses observed are low to medium severity longitudinal and transverse cracking, low severity weathering and isolated areas of raveling. Field observations include initiation of new unsealed cracks and widening of previously filled cracks.

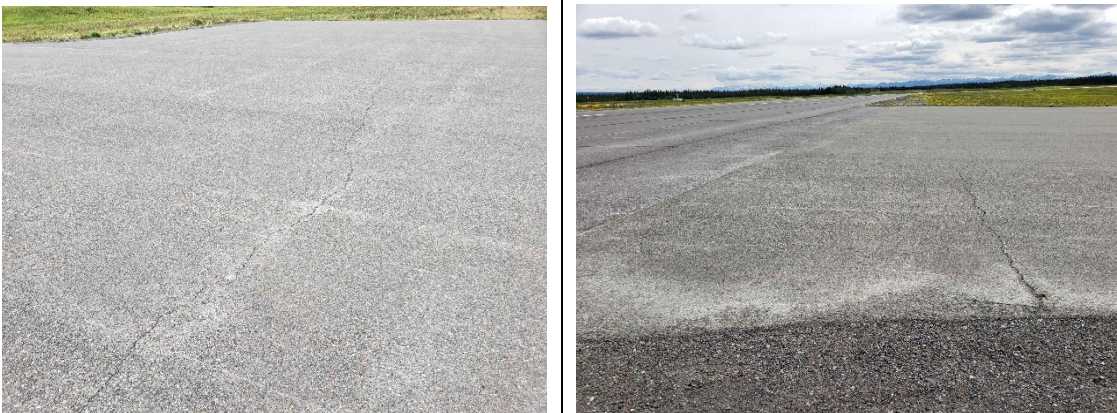
Branch ID	Branch Name	Branch Use	No. of Sections	Area (sf)	Weight Average PCI
4200	Medevac Apron	Parking Apron	4	15,930	86

The Medevac Apron was constructed in 2006. The most common distresses are low severity longitudinal and transverse cracking and low severity weathering. Raveling from snowplows was observed along the pavement edge.

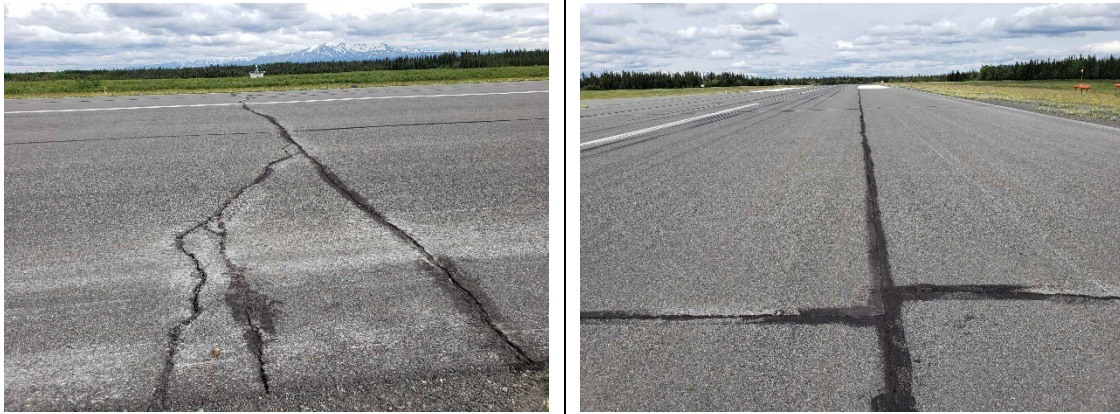
Branch ID	Branch Name	Branch Use	No. of Sections	Area (sf)	Weight Average PCI
6100	Runway 15L/33R	Runway	1	500,000	75

The runway was constructed in 2007, receives crack seal operations approximately every three years and the crack seal needs touched up. The most common distresses are low to medium to high severity longitudinal and transverse cracking, low to medium severity raveling, and low severity weathering. Field observations include widening of previously filled cracks and snowplow damage around transverse cracks from where they heave and catch plows during the winter.

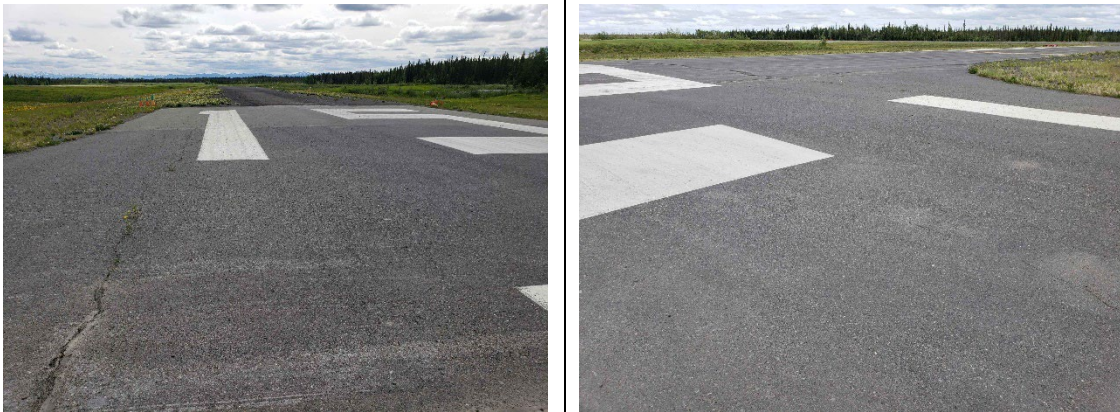
Branch ID	Branch Name	Branch Use	No. of Sections	Area (sf)	Weight Average PCI
6200	Runway 15R/33L	Runway Approach	1	7,421	81

This branch is the approach to gravel runway 15R/33L and was constructed in 2007. The most common distresses observed are low to medium severity longitudinal and transverse cracking and low severity weathering. Field observations include development of new unsealed cracks.
