Alaska DOT&PF

Pavement Inspection Report Haines Airport

Airport Name	IATA	ICAO	Latitude	Longitude	Elevation (ft)
Haines Airport	HNS	PAHN	59° 14' 37.79" N	135° 31' 24.74" W	15.3

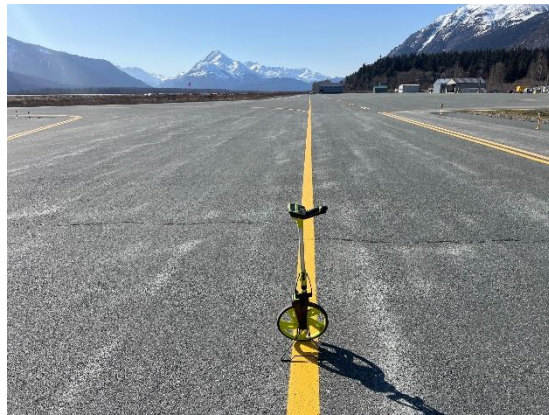
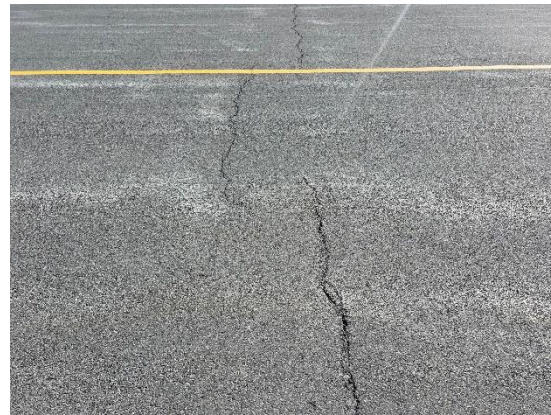
Section 0100-01 (91 PCI), 0100-02 (85 PCI)

Taxiway A consists of three sections, of which Sections 0100-01 and 0100-02 were initially constructed in 1985 and the most recent major work was surface reconstruction in 2018. Crack sealing has not been performed on this section since its reconstruction. The most common distresses observed are low severity longitudinal and transverse cracking and low severity weathering. Field observations include the development of new unfilled cracks and the initial wearing of the asphalt binder and fine aggregate matrix from the pavement surface.

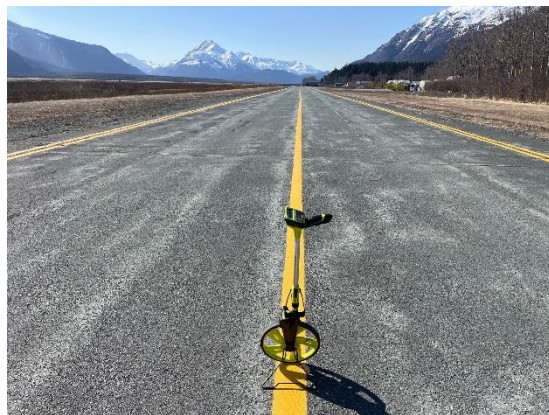
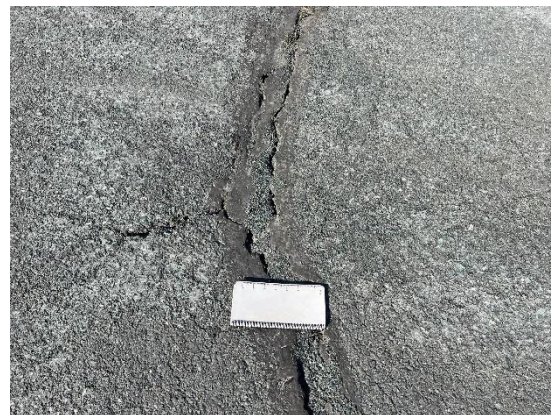
Section 0100-03 (51 PCI)

Taxiway A Section 0100-03 was initially constructed in 1985, and the most recent major work was a thin overlay in 1992. Crack sealing has been performed on this section, but the sealant is beginning to lose its bond to the edges of the pavement. This can lead to significant water infiltration, as well as increased FOD (Foreign Object Debris) potential. The most common distresses observed are low to medium severity alligator cracking, low to high severity longitudinal and transverse cracking, low to medium severity raveling and low to medium severity weathering. Field observations include the development of new unfilled cracks, the widening of previously filled cracks increasing the severity, and the deterioration of the pavements surface leading to large areas of raveling across the taxiway.

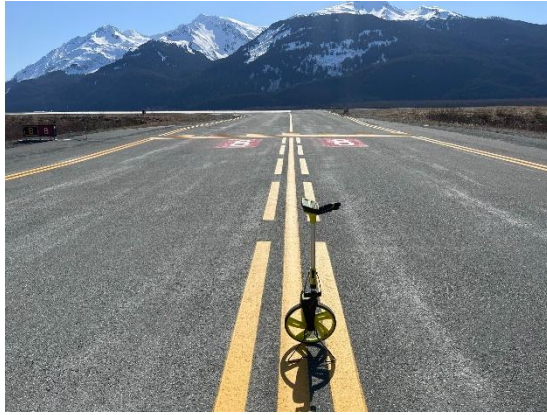
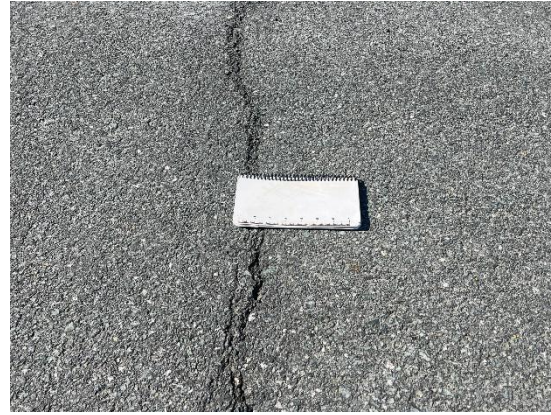
Section 0200-01 (83 PCI)

Taxiway B consists of two sections, of which Section 0200-01 was initially constructed in 1992 and the most recent major work was complete reconstruction in 2018. Crack sealing has not been performed on this section since its reconstruction. The most common distresses observed are low severity longitudinal and transverse cracking, low severity raveling and low severity weathering. Field observations include the development of new unfilled cracks and the initial wearing of the asphalt binder and fine aggregate matrix from the pavement surface.

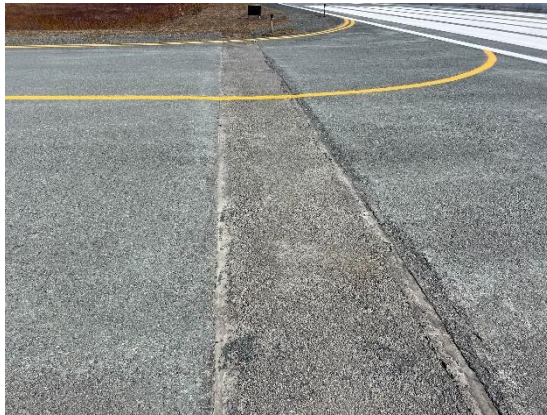
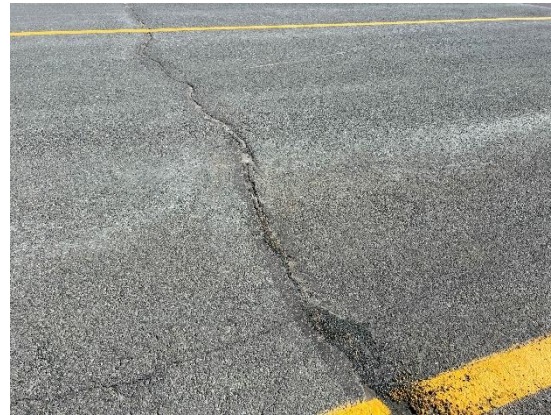
Section 0200-02 (60 PCI)

Taxiway B Section 0200-02 was initially constructed in 1992 and has not received any major work since. Crack sealing has been performed on this section, but the sealant is beginning to lose its bond to the edges of the pavement. This can lead to significant water infiltration, as well as increased FOD potential. The most common distresses observed are low to high severity longitudinal and transverse cracking, medium severity patching, low severity raveling and low to medium severity weathering. Field observations include the development of new unfilled cracks, the widening of previously filled cracks increasing the severity, and the deterioration of the pavement surface leading to large areas of raveling across the taxiway.

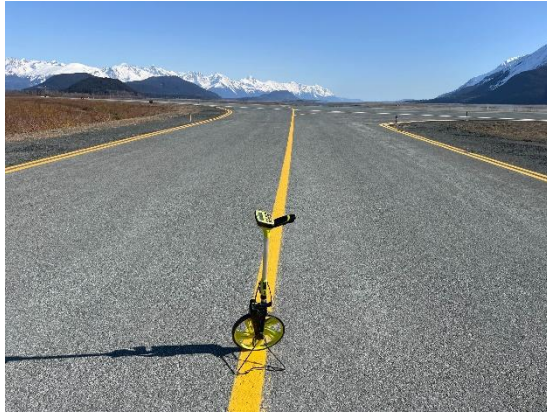
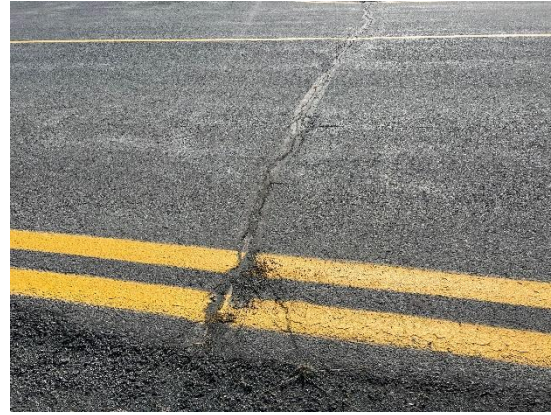
Section 0300-01 (60 PCI)

Taxiway C consists of two sections, of which Section 0300-01 was initially constructed in 1992 and has not received any major work since. Crack sealing has been performed on this section, but the sealant is beginning to lose its bond to the edges of the pavement. This can lead to significant water infiltration, as well as increased FOD potential. The most common distresses observed are low to high severity longitudinal and transverse cracking, low to medium severity raveling and low to medium severity weathering. Field observations include the development of new unfilled cracks, the widening of previously filled cracks increasing the severity, and the deterioration of the pavement surface leading to large areas of raveling across the taxiway.

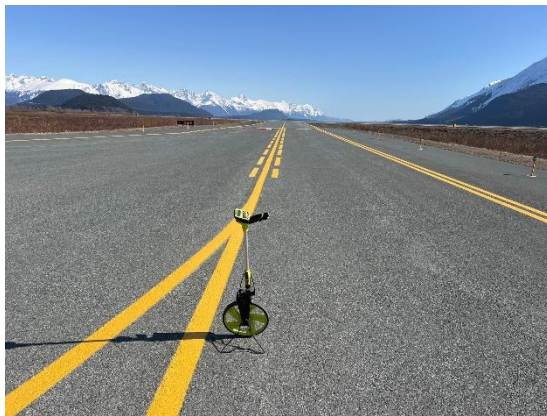
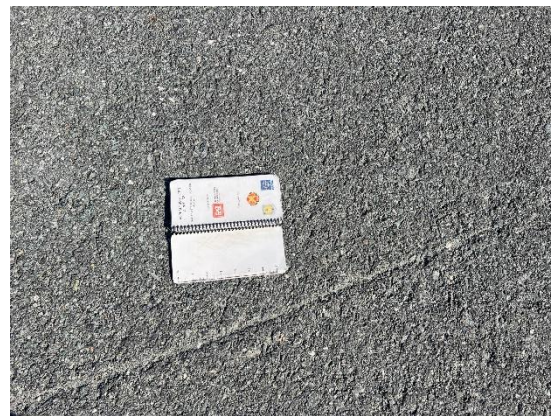
Section 0300-02 (88 PCI)

Taxiway C Section 0300-02 was initially constructed in 1992 and the most recent major work was surface reconstruction in 2018. Crack sealing has not been performed on this section since its reconstruction. The most common distresses observed are low severity longitudinal and transverse cracking, low severity raveling and low severity weathering. Field observations include the development of new unfilled cracks, the occasional mechanical gouge of the asphalt surface and the initial wearing of the asphalt binder and fine aggregate matrix from the pavement surface.

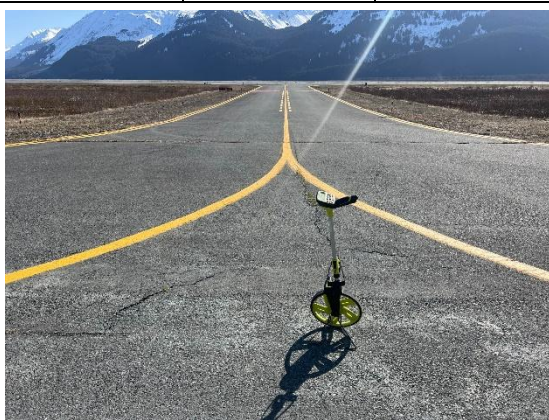
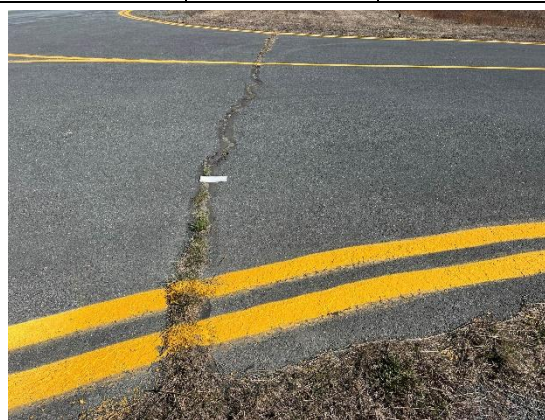
Taxiway D was initially constructed in 1992 and has not received any major work since. Crack sealing has been performed on this section, but the sealant is beginning to lose its bond to the edges of the pavement. This can lead to significant water infiltration, as well as increased FOD potential. The most common distresses observed are low severity depressions, low to high severity longitudinal and transverse cracking, low severity raveling and low severity weathering. Field observations include the development of new unfilled cracks, the widening of previously filled cracks increasing the severity, and the deterioration of the pavements surface leading to large areas of raveling across the taxiway.

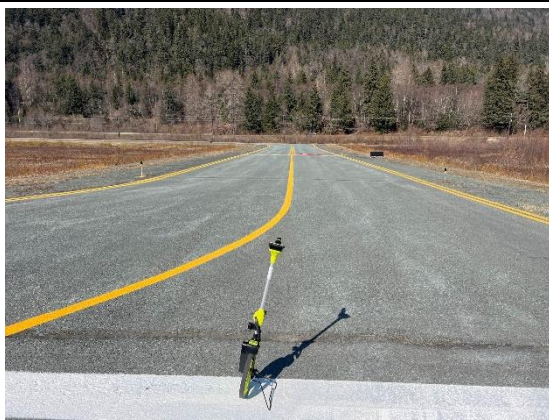
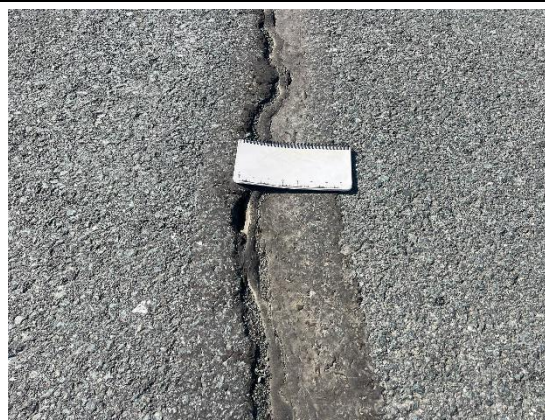
Taxiway E was initially constructed in 1992 and has not received any major work since. Crack sealing has been performed on this section, but the sealant is beginning to lose its bond to the edges of the pavement. This can lead to significant water infiltration, as well as increased FOD potential. The most common distresses observed are low severity depression, low to high severity longitudinal and transverse cracking, low to medium severity raveling and low severity weathering. Field observations include the development of new unfilled cracks, the widening of previously filled cracks increasing the severity, and the deterioration of the pavement surface leading to large areas of raveling across the taxiway.

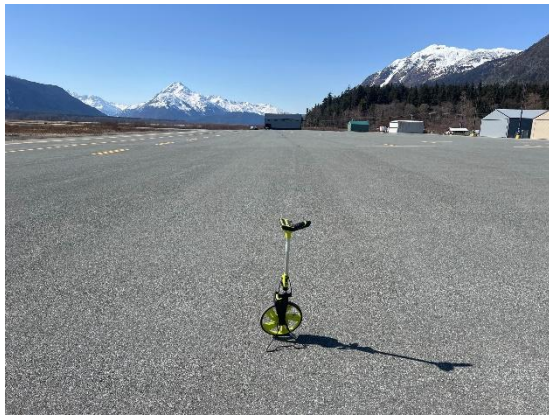
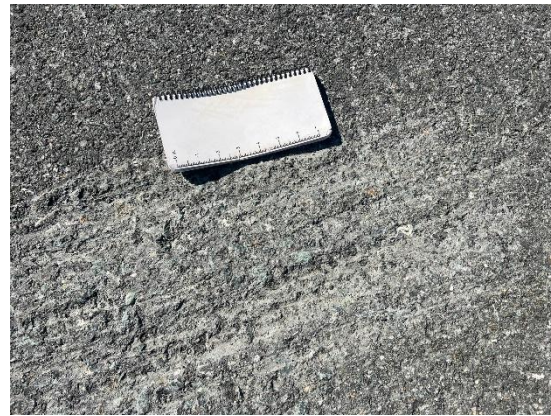
The Main Apron was initially constructed in 1992 and the most recent major work was surface reconstruction in 2018. Crack sealing has not been performed on this section since its reconstruction. The most common distresses observed are low severity longitudinal and transverse cracking, low severity raveling and low severity weathering. Field observations include the development of new unfilled cracks and the initial wearing of the asphalt binder and fine aggregate matrix from the pavement surface.

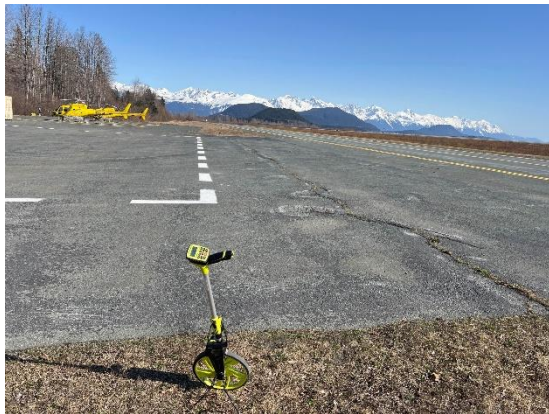
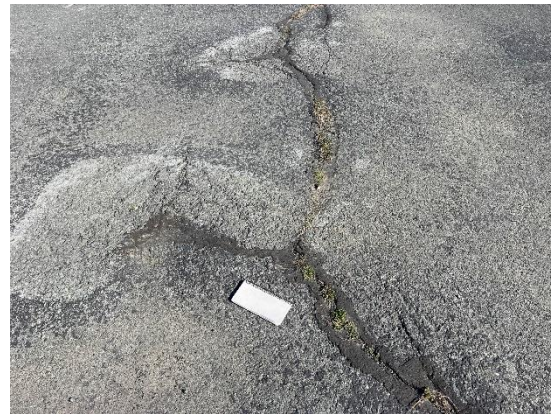
The Helipad was constructed in 1992 and has not received any work since. Crack sealing has been performed on this section but should be replaced. The most common distresses observed are low to medium severity depression, low to high severity longitudinal and transverse cracking, low severity raveling and low severity weathering. Field observations include the development of new unfilled cracks, the widening of previously filled cracks increasing the severity, and the deterioration of the pavements surface leading to large areas of raveling across the apron.

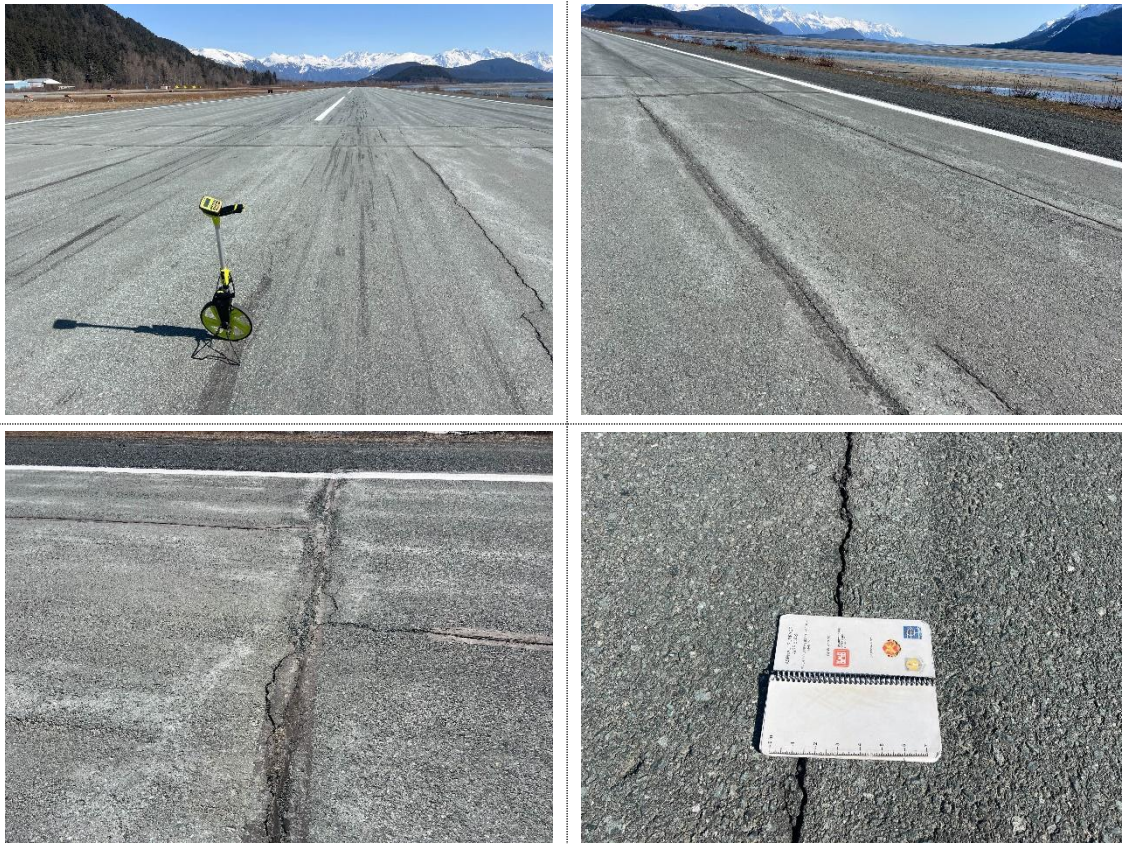
Runway 08/26 was constructed in 1992 and has not received any major work since. Crack sealing has been performed on this section, but the sealant is beginning to lose its bond to the edges of the pavement. This can lead to significant water infiltration, as well as increased FOD potential. The most common distresses observed are low to high severity longitudinal and transverse cracking, low severity raveling, and low to medium severity weathering. Field observations include the development of new unfilled cracks, the longitudinal paving joints the length of the runway continuing to open, the widening of previously filled cracks increasing the severity, and the deterioration of the pavements surface leading to large areas of raveling across the runway.
