# Alaska DOT&PF

## Pavement Inspection Report Healy River Airport

Airport Name	IATA	ICAO	Latitude	Longitude	Elevation (ft)
Healy River Airport	-	PAHV	63° 52' 03" N	148° 58' 08" W	1,263

Point of Contact	Phone	Email	Date Inspected	Date Published
Mr. Andrew Pavey, Pavement Management Engineer	(907) 269 6213	andrew.pavey@alaska.gov	June 2023	September 2023

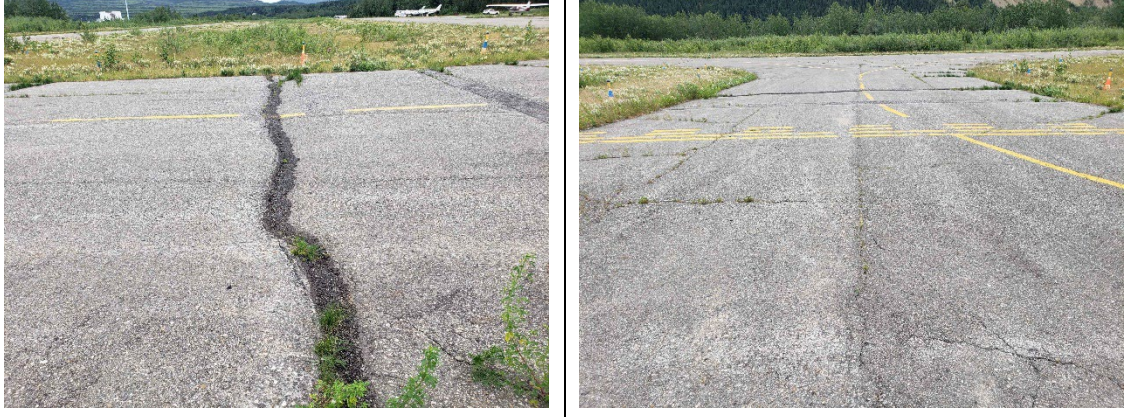
Branch ID	Branch Name	Branch Use	No. of Sections	Area (sf)	Weight Average PCI
0100	Taxiway A	Taxiway	1	5,394	30

Taxiway A was constructed in 1996. The most common distresses observed are low to high severity raveling, low to medium severity weathering, corrugation, low severity patching, low severity block cracking and medium severity longitudinal and transverse cracking.

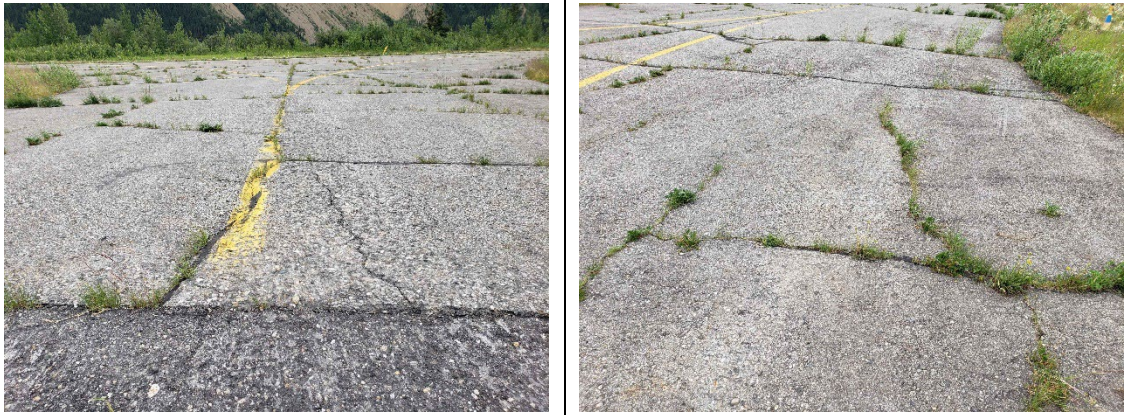
Branch ID	Branch Name	Branch Use	No. of Sections	Area (sf)	Weight Average PCI
0200	Taxiway B	Taxiway	1	6,189	35

Taxiway B was constructed in 1996. Observed distresses are low to medium severity block cracking, low to high severity raveling, low to medium severity weathering and low severity patching. There is a significant amount of vegetation growing through cracking on the branch.

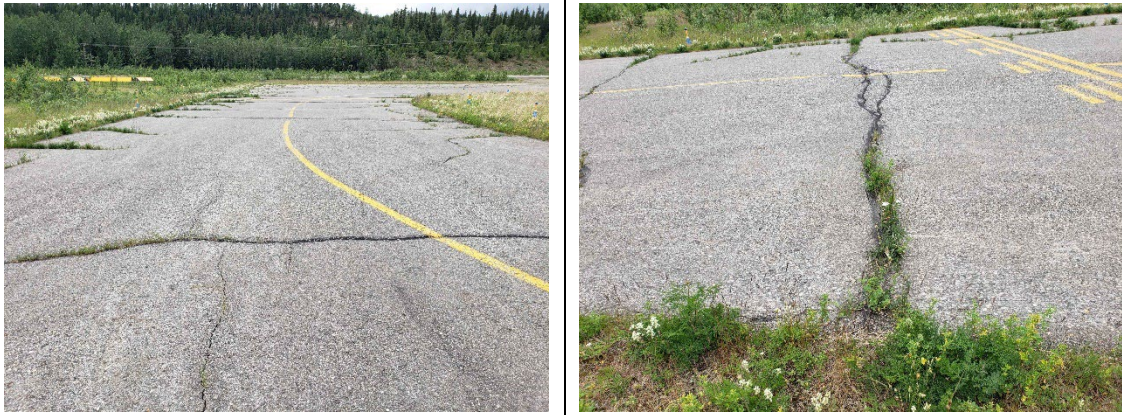
Branch ID	Branch Name	Branch Use	No. of Sections	Area (sf)	Weight Average PCI
0300	Taxiway C	Taxiway	2	17,897	41

Taxiway C was constructed in 1996 and is composed of two sections. The most common distresses observed are low to medium to high severity longitudinal and transverse cracking, low severity weathering and low to high severity raveling. Field observations include significant vegetation growth through cracking.

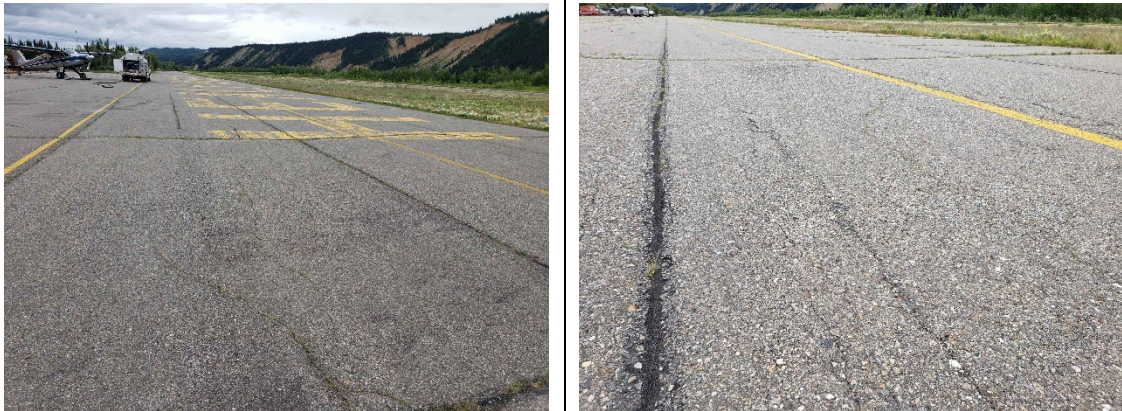
Branch ID	Branch Name	Branch Use	No. of Sections	Area (sf)	Weight Average PCI
0400	Apron Taxilane	Taxiway	1	125,000	47

The taxilane was constructed in 1996. Distresses observed are low to medium severity block cracking, low severity weathering, low severity alligator cracking and low severity raveling.

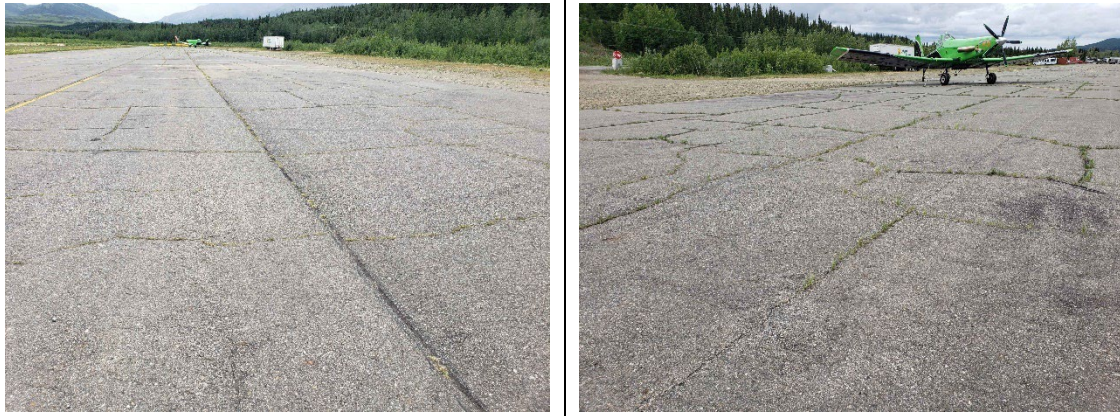
Branch ID	Branch Name	Branch Use	No. of Sections	Area (sf)	Weight Average PCI
4100	South Apron	Parking Apron	1	58,500	42

The apron was constructed in 1996. The most common distresses observed are either low to medium to high severity longitudinal and transverse cracking or block cracking, low severity weathering and low severity raveling. Vegetation is growing through most of the cracks.

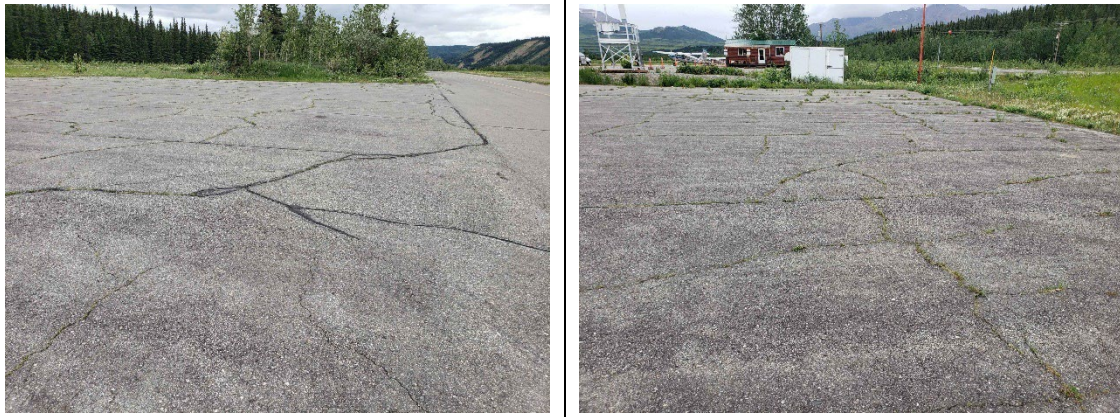
Branch ID	Branch Name	Branch Use	No. of Sections	Area (sf)	Weight Average PCI
4200	Apron #2	Parking Apron	1	18,696	47

This apron was constructed in 1996. The most common distresses observed are low severity block cracking, medium severity longitudinal and transverse cracking, low severity weathering and low to high severity raveling. Vegetation is growing through longitudinal and transverse cracks.

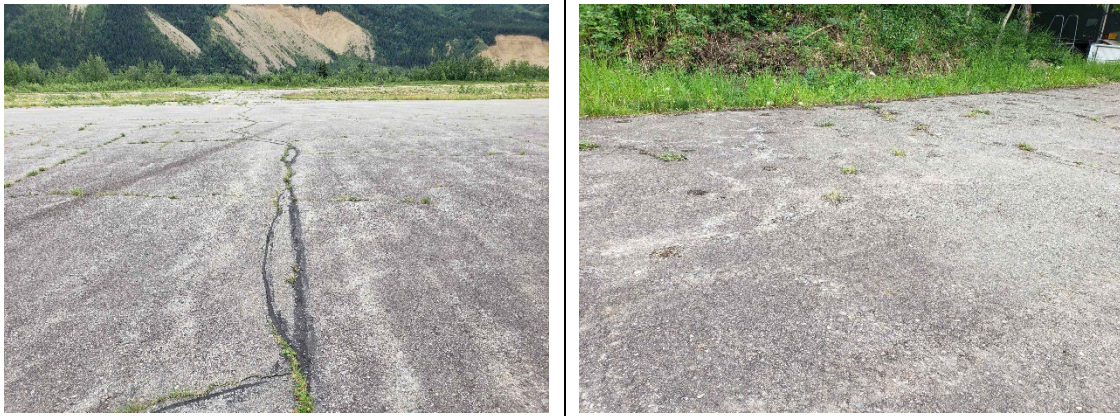
Branch ID	Branch Name	Branch Use	No. of Sections	Area (sf)	Weight Average PCI
4300	Taxiway B Apron	Parking Apron	1	19,722	38

The apron was constructed in 1996. The most common distresses observed are low to medium severity block cracking, high severity longitudinal and transverse cracking, low severity weathering and low to high severity raveling. Field observations include areas where vegetation is growing through cracks or severely raveled areas of the pavement surface.

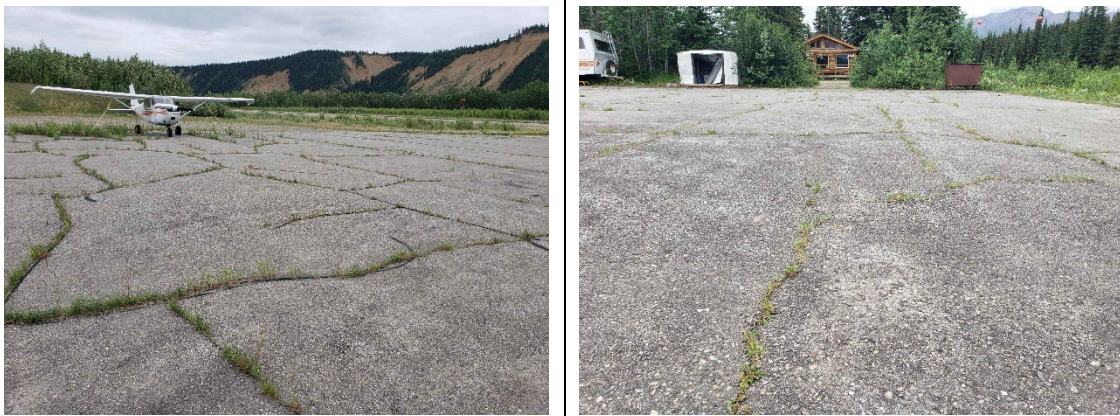
Branch ID	Branch Name	Branch Use	No. of Sections	Area (sf)	Weight Average PCI
4400	North Apron	Parking Apron	2	63,784	39

The apron was constructed in 1996. The most common distresses observed are low to medium to high severity block cracking, low severity weathering and low to high severity raveling. There is significant vegetation growth through cracks on the apron.

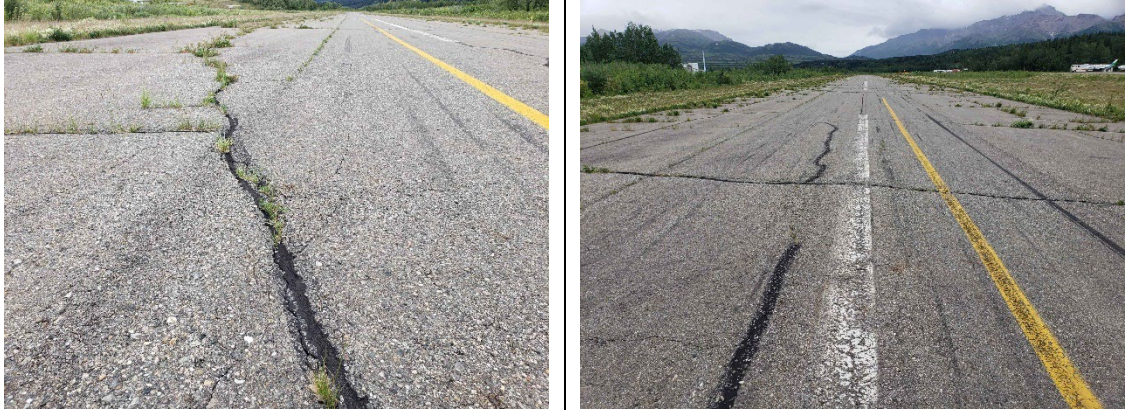
Branch ID	Branch Name	Branch Use	No. of Sections	Area (sf)	Weight Average PCI
6100	Runway 15-33	Runway	1	174,600	39

The runway was constructed in 1996. The most common distresses are low to medium to high severity longitudinal and transverse cracking intermixed with low severity block cracking, low to high severity raveling, and low severity weathering. There are isolated areas of low severity alligator beginning to form. The runway has significant vegetation growth with only the center portion of the runway having vegetation maintained.
