Alaska DOT&PF

Pavement Inspection Report Hoonah Airport

Hoonah Airport

Airport Code: HNH
Site Number: 50321.01*A

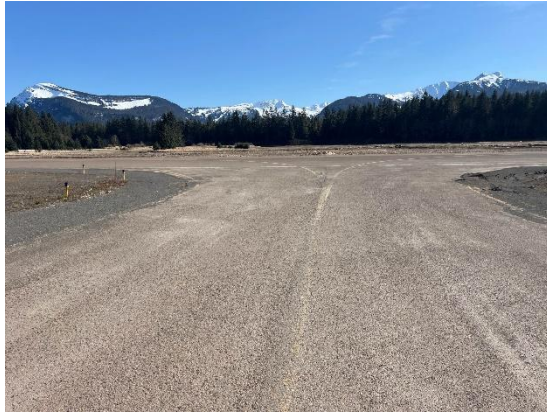
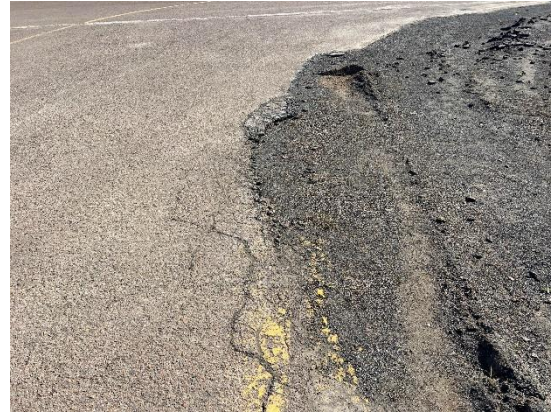
Taxiway A was constructed in 1992 and has not undergone major work since. Occasional crack seal operations have been performed on the branch. The most common distresses are low to medium severity longitudinal and transverse cracking, low to high severity raveling, and low to medium severity weathering. Pavement inspectors observed damage to the pavement edge where the taxiway connects with the runway, leading to the degradation of the pavement surface. Further deterioration of the top layer of asphalt concrete is contributing to an increasing amount and higher severity of raveling and weathering on the taxiway.

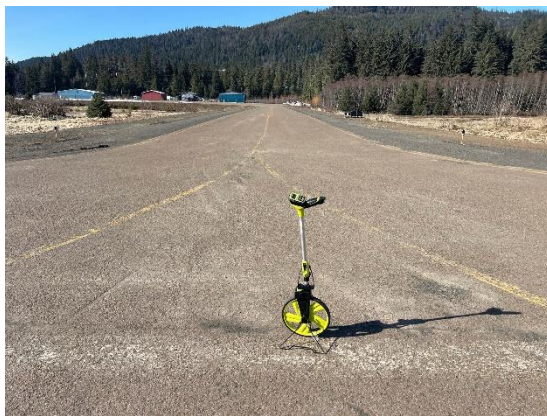
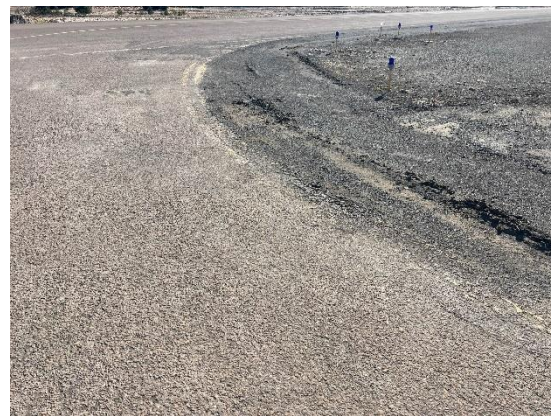
Taxiway B was constructed in 1992 and has not undergone any major work since. Occasional crack seal operations have been performed on the branch. The most common distresses are low to medium severity longitudinal and transverse cracking, low to high severity raveling, and low to medium severity weathering. Pavement inspectors observed damage to the pavement edge where the taxiway connects with the runway, leading to the degradation of the pavement surface. Further deterioration of the top layer of asphalt concrete is contributing to an increasing amount and higher severity of raveling and weathering on the taxiway.

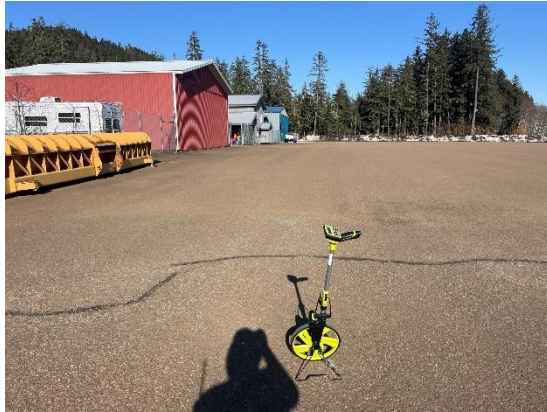
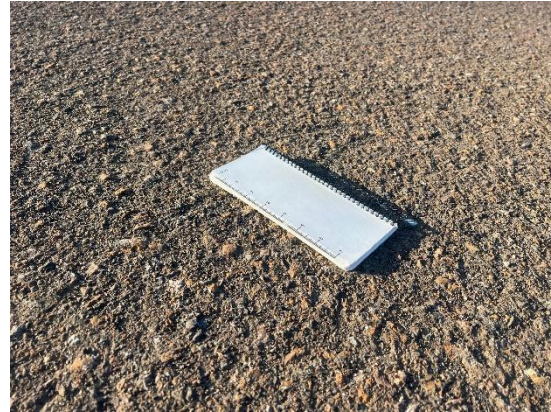
Section 4100-01 (58 PCI)

The Parking Apron consists of two sections, Section 4100-01 and Section 4100-02. Section 4100-01 was initially constructed in 1992 and has not undergone any major work since. Occasional crack seal operations have been performed on the branch. The most common distresses are low to high severity depressions, low to medium severity longitudinal and transverse cracking, low to high severity raveling, and low to medium severity weathering. Inspectors observed the wearing away of the asphalt binder and fine aggregate from the pavement surface, increasing the quantity and severity of raveling and weathering across the parking apron.

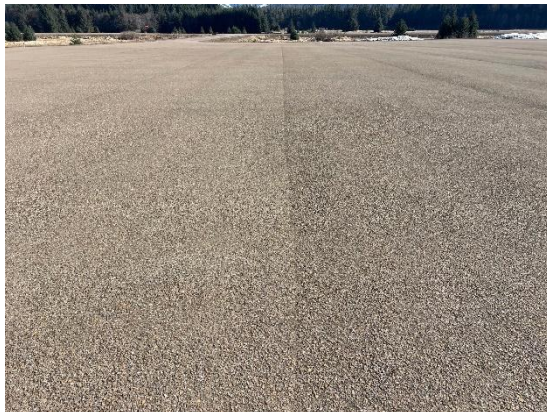
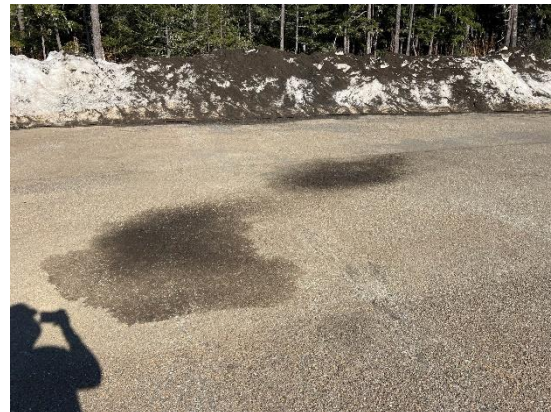
Section 4100-02 (72 PCI)

Section 4100-02 was constructed in 2013 and has not undergone any major work since. Occasional crack seal operations have been performed on the branch. The most common distresses are low to medium severity longitudinal and transverse cracking, oil spillage, low severity raveling, and low to medium severity weathering. Inspectors noted locations of large oil spills and the widespread wearing of the asphalt binder and fine aggregate from the pavement surface, increasing in the quantity and severity of raveling and weathering.

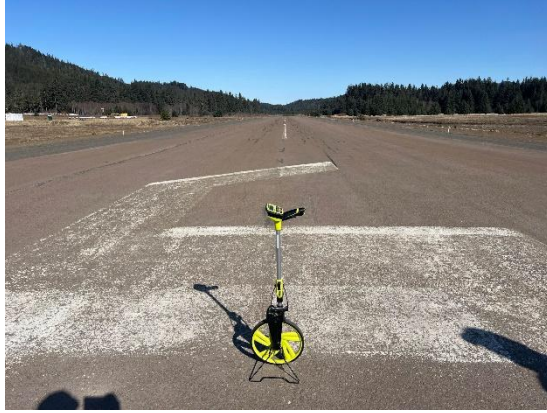
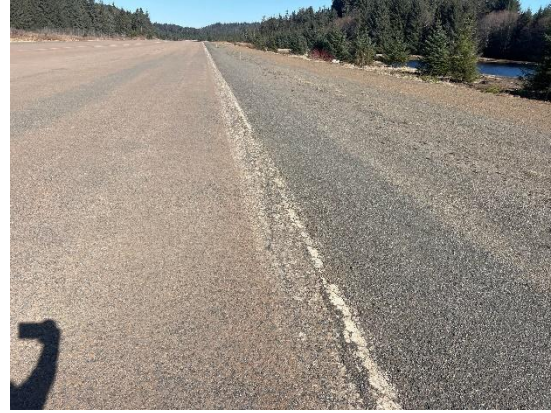
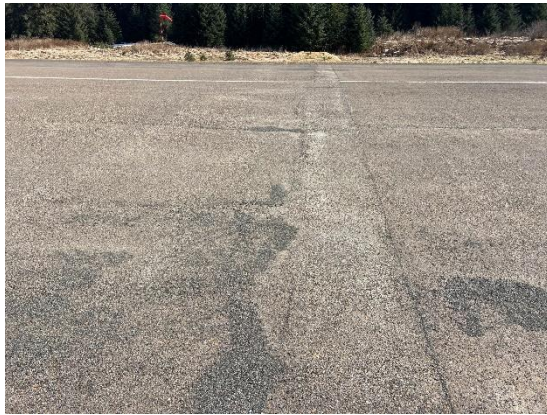
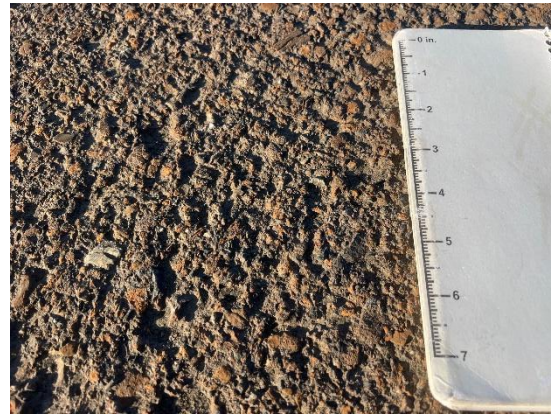
Section 6100-01 (49 PCI), 6100-02 (75 PCI)

Runway 06/24 consists of two sections, Section 6100-01 and Section 6100-02. Section 6100-01 was constructed in 1992 with a total length of 3,000 feet. In 2013, Runway 06/24 was lengthened by an additional 367 feet, with the extension designated Section 6100-02. The runway has not undergone any major work since. Periodic crack seal operations have been performed on the branch since construction. The most common distresses are low severity fatigue cracking, low to medium severity longitudinal and transverse cracking, low to high severity raveling, and low severity weathering. The inspection team observed more advanced wearing of the asphalt binder and fine aggregate from the pavement surface, increasing in the quantity and severity of raveling and weathering on the runway.
