Alaska DOT&PF

Pavement Inspection Report Iliamna Airport

Airport Name	IATA	ICAO	Latitude	Longitude	Elevation (ft)
Iliamna Airport	ILI	PAIL	59° 45' 05.79" N	154° 54' 47.12" W	192

Point of Contact	Phone	Email	Date Inspected	Date Published
Mr. Andrew Pavey, Pavement Management Engineer	(907) 269 6213	andrew.pavey@alaska.gov	October 2022	June 2023

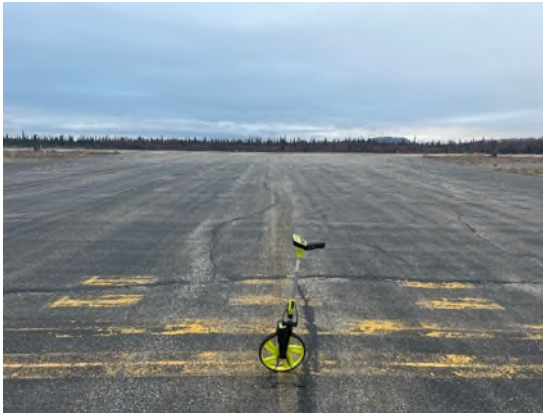
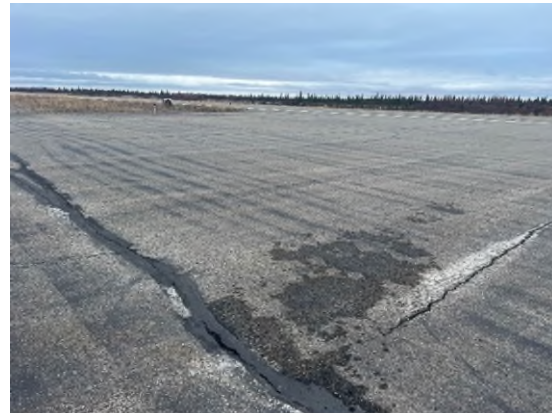
Branch ID	Branch Name	Branch Use	No. of Sections	Area (sf)	Weight Average PCI
0100	Taxiway A	Taxiway	1	29,932	63

Taxiway A was constructed in 2003 and received a sand tar surface treatment in 2015. Annual crack seal operations have been performed on the branch. The most common distresses observed are low to medium severity longitudinal and transverse cracking, low severity raveling, and low severity weathering. Field observations include wearing of the sand tar application due to climate and traffic, creation of new unfilled cracks, and widening of previously filled cracks.

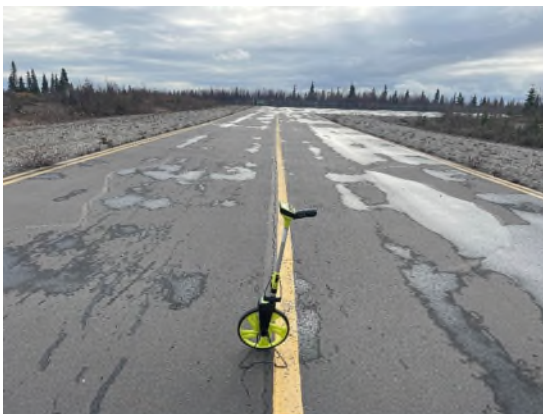
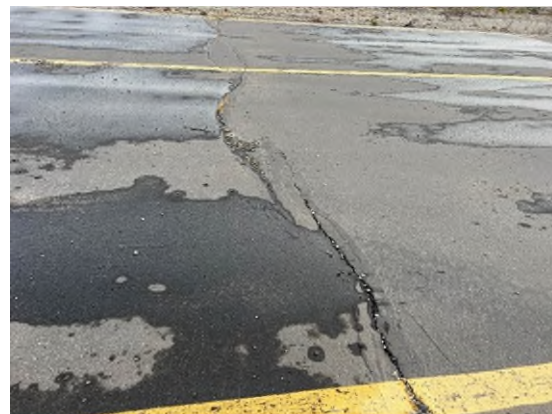
Branch ID	Branch Name	Branch Use	No. of Sections	Area (sf)	Weight Average PCI
0200	Taxiway B	Taxiway	1	18,000	74

Similar to Taxiway A, Taxiway B was constructed in 2003 and received a sand tar surface treatment in 2015. Annual crack seal operations are behind schedule on this branch. The most common distresses observed are low to medium to high severity longitudinal and transverse cracking. Field observations include the development of new unfilled cracks, widening of previously filled cracks, and vegetation growth in the cracks.

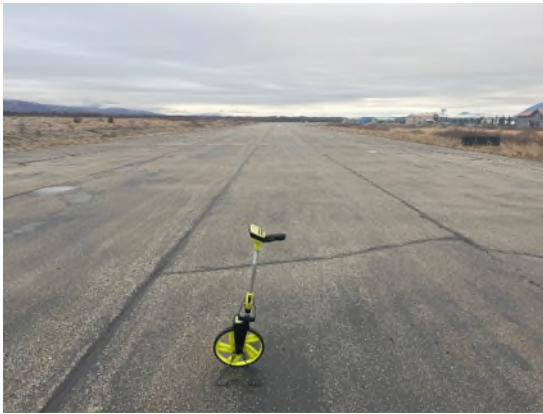
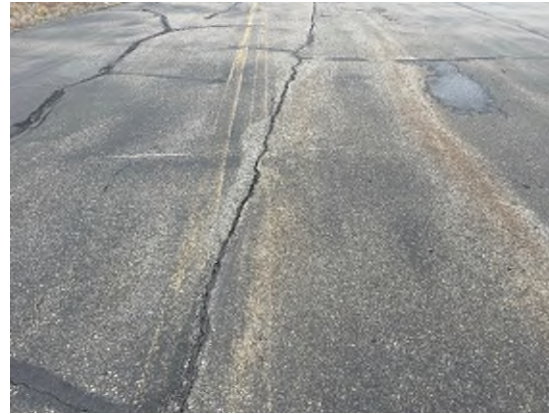
Branch ID	Branch Name	Branch Use	No. of Sections	Area (sf)	Weight Average PCI
0300	Taxiway C	Taxiway	1	79,958	63

Taxiway C was also constructed in 2003 and received a sand tar surface treatment in 2015. Annual crack seal operations have been performed on the branch. The most common distresses observed are low to medium severity longitudinal and transverse cracking, low severity raveling, and low severity weathering. Field observations include wearing of the sand tar application due to climate and traffic, the initiation of new unfilled cracks, and widening of previously filled cracks.

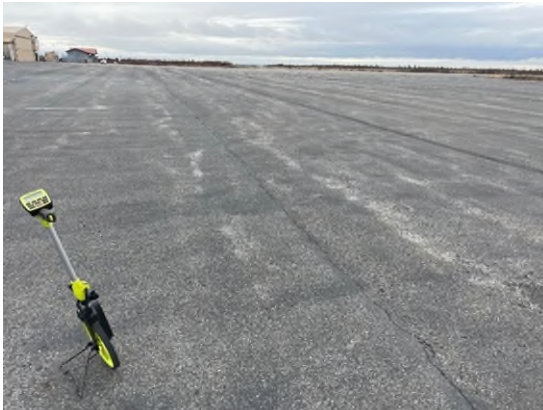
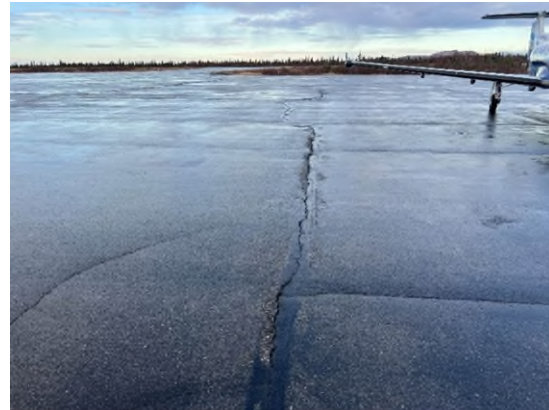
Branch ID	Branch Name	Branch Use	No. of Sections	Area (sf)	Weight Average PCI
4100	East Apron	Parking Apron	4	409,790	71

The East Apron was constructed in 2003 and received a sand tar surface treatment in 2015 except for section 4100-04. Annual crack seal operations have been performed on the branch. The most common distresses observed are low to medium severity longitudinal and transverse cracking, low severity raveling, and low severity weathering. Field observations include wearing of the sand tar application (not as much wear as the taxiways), development of new unfilled cracks, widening of previously filled cracks, and a transverse crack that is starting to widen, causing a localized depression, and creating a smoothness concern.

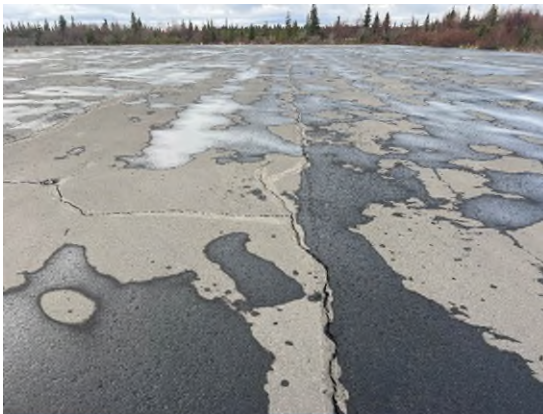
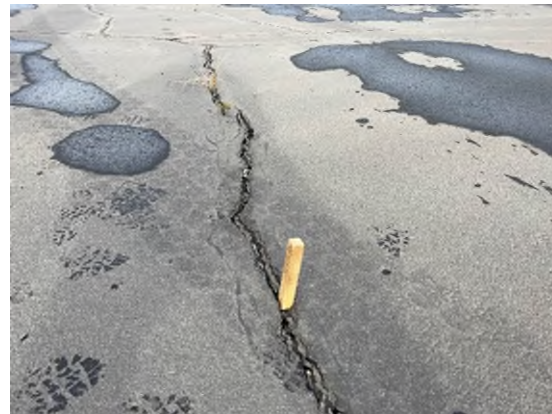
Branch ID	Branch Name	Branch Use	No. of Sections	Area (sf)	Weight Average PCI
4200	West Apron	Parking Apron	1	116,102	62

The West Apron was constructed in 2003 and received a sand tar surface treatment in 2015. Annual crack seal operations are behind schedule on this branch. The most common distresses observed are low to medium to high severity longitudinal and transverse cracking. Field observations include creation of new unfilled cracks, widening of previously filled cracks, and vegetation growth in the cracks.

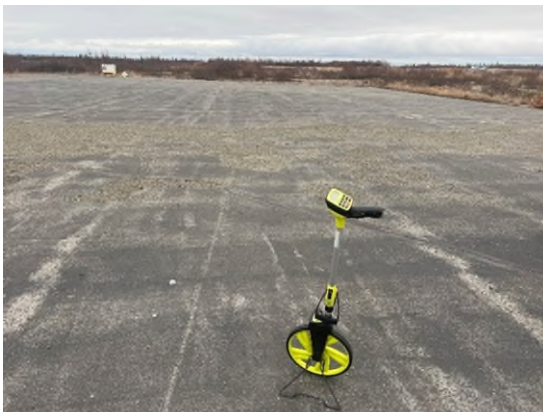
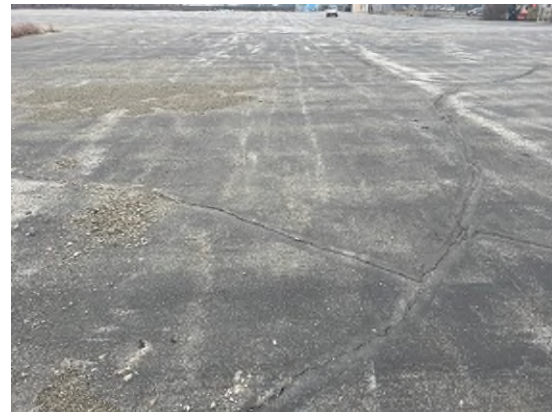
Branch ID	Branch Name	Branch Use	No. of Sections	Area (sf)	Weight Average PCI
5100	Helipad	Helipad	1	24,000	70

The Helipad was constructed in 2003 and received a sand tar surface treatment in 2015. Annual crack seal operations have been performed on the section. The most common distresses observed are low to medium severity longitudinal and transverse cracking, low severity raveling, and low severity weathering. Field observations include wearing of the sand tar application (not as much wear as the taxiways), initiation of new unfilled cracks, and widening of previously filled cracks.

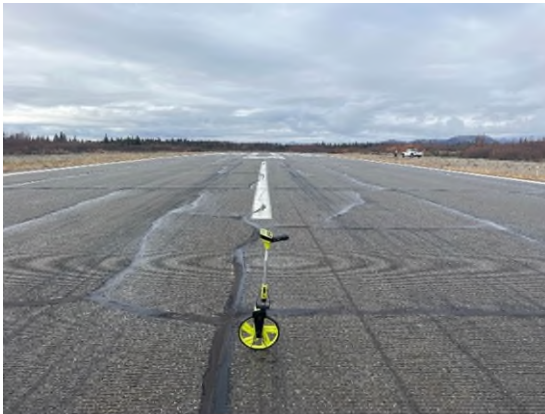
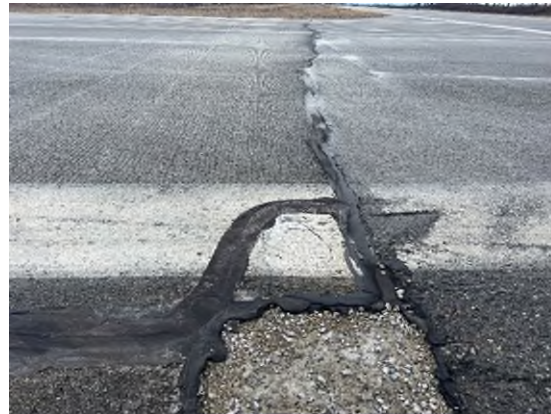
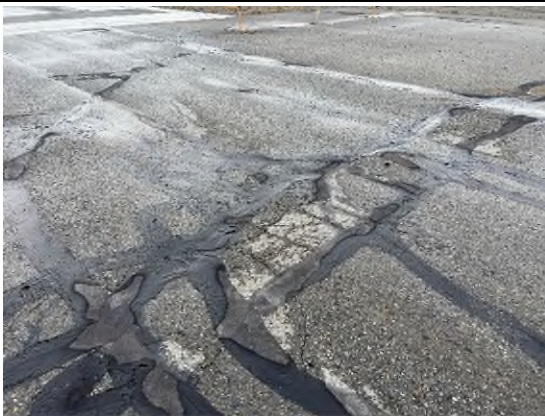
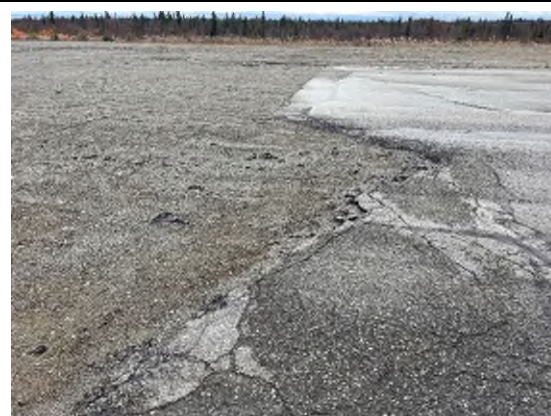
Branch ID	Branch Name	Branch Use	No. of Sections	Area (sf)	Weight Average PCI
6100	Runway 08/26	Runway	3	540,000	60

Runway 08/26 was constructed in 2003. Annual crack seal operations have been performed on the section. The most common distresses observed are low to medium severity longitudinal and transverse cracking, low to medium to high severity raveling, and low severity weathering. Field observations include development of new unfilled cracks, widening of previously filled cracks, areas of increased severity and quantity of raveling, and overruns being damaged by snow plow operations (bottom right photograph).

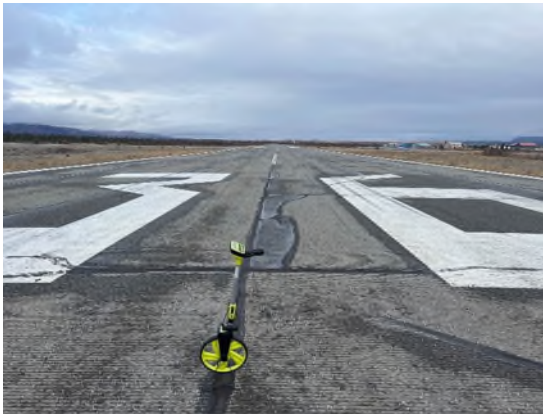
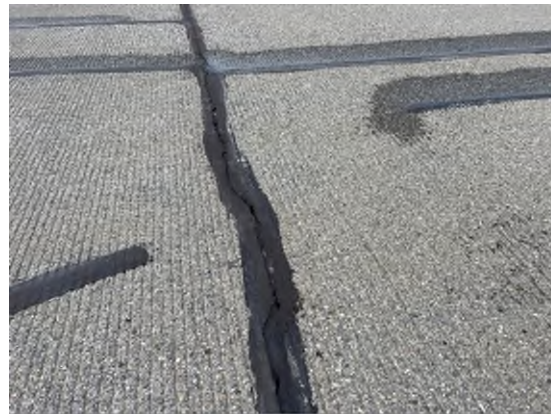
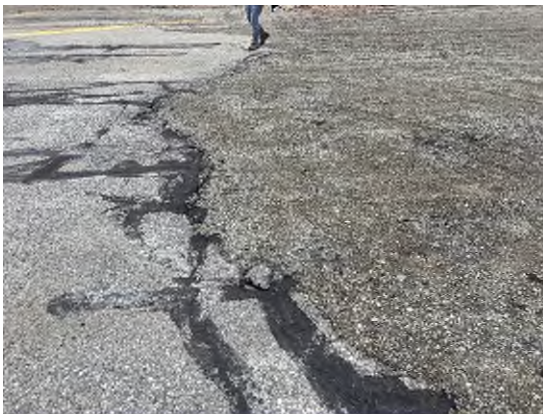
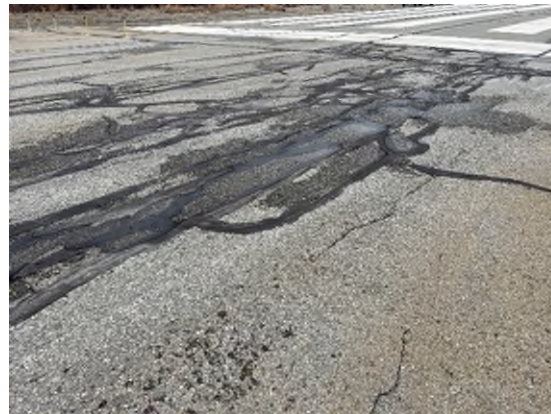
Branch ID	Branch Name	Branch Use	No. of Sections	Area (sf)	Weight Average PCI
6200	Runway 18/36	Runway	4	499,500	62

Runway 18/36 was constructed in 2003. Annual crack seal operations have been performed on the section. The most common distresses observed are low to medium severity longitudinal and transverse cracking, low to medium to high severity raveling, and low severity weathering. Field pavement observations include development of new unfilled cracks, widening of previously filled cracks, and areas of increased severity and quantity of raveling.
