Alaska DOT&PF

Pavement Inspection Report Juneau Airport

Airport Name	IATA	ICAO	Latitude	Longitude	Elevation (ft)
Juneau International Airport	JNU	PAJN	58° 21' 16.96" N	134° 34' 42.49" W	25.0

Point of Contact	Phone	Email	Date Inspected	Date Published
Mr. Andrew Pavey, Pavement Management Engineer	(907) 269 6213	andrew.pavey@alaska.gov	April 2024	April 2025

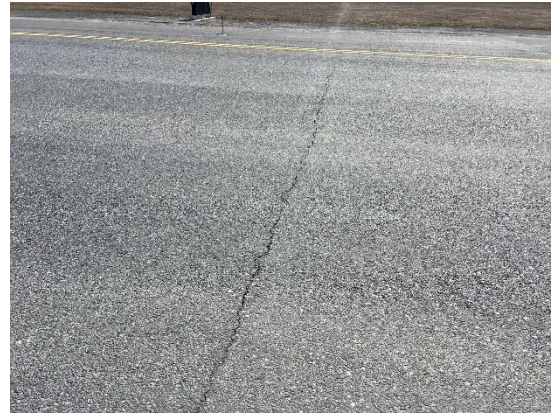
Taxiway A consists of five asphalt concrete (AC) sections, of which Sections 0100-01 through 0100-04 underwent surface rehabilitation in 2020. Crack sealing has not occurred on these sections. The most common distresses are low severity longitudinal and transverse cracking, low severity raveling, and low to medium severity weathering. Field observations indicate new unfilled cracks and initial surface deterioration leading to medium severity weathering and low severity raveling across the taxiway.

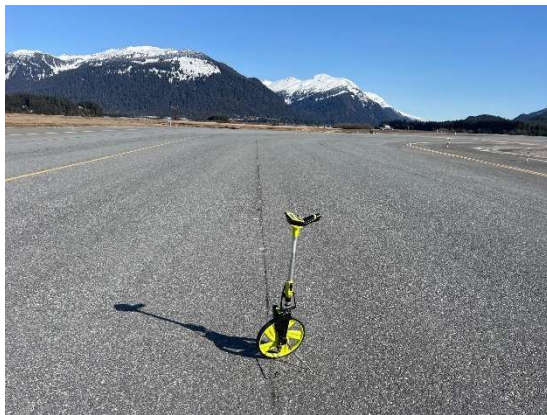
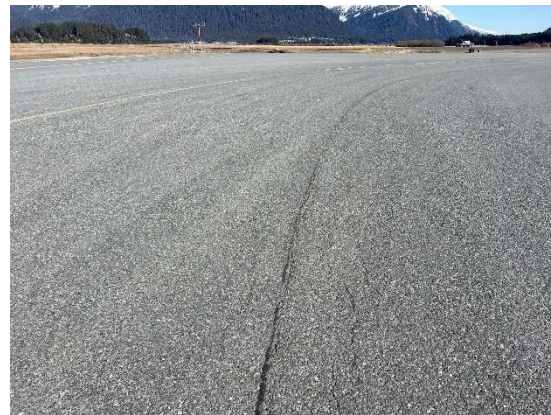
Section 0100-05 (72 PCI)

Taxiway A was extended in 2013, and the extended portion of the taxiway did not undergo the surface rehabilitation applied to the other sections, resulting in the creation of Section 0100-05. Crack sealing has not been performed on this section. The most common distresses are low severity fatigue cracking, low severity longitudinal and transverse cracking, low to medium severity raveling, and low to medium severity weathering. Field observations highlight the development of fatigue cracking along the paving lane joints, particularly in areas where aircraft turning occurs between Taxiway A and Taxiway G.

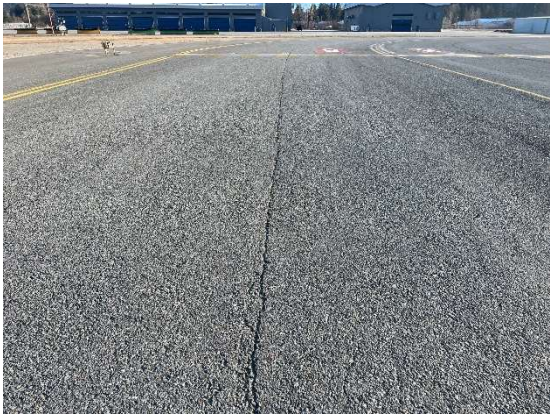
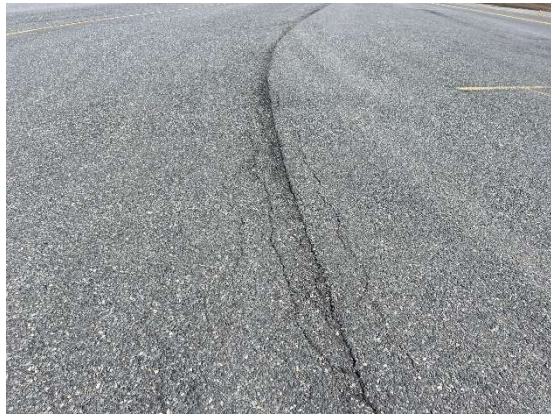
Taxiway B is an AC section that underwent surface rehabilitation in 2013. Crack sealing has not been performed on the branch. The most common distresses are low to medium fatigue cracking, low to medium severity longitudinal and transverse cracking, low to medium severity raveling, and low to medium severity weathering. Field observations highlight the development of fatigue cracking along the paving lane joints, particularly in areas where turning occurs between Taxiway B and Runway 8/26.

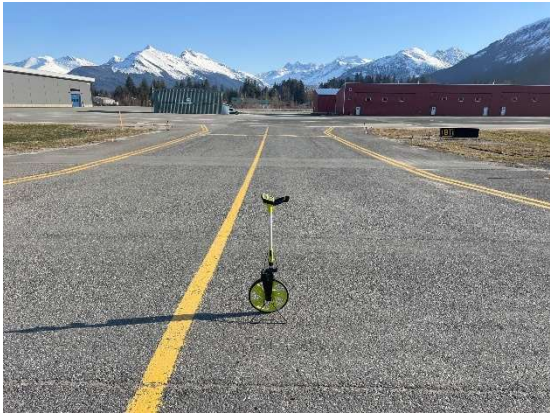
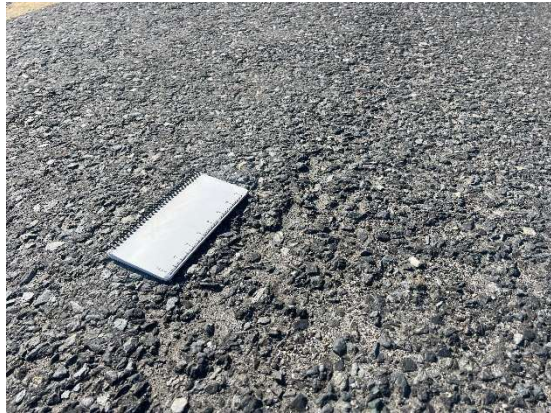
Taxiway B1 was realigned and fully reconstructed in 2016. Crack sealing has not been performed on the branch. The most common distresses are low severity longitudinal and transverse cracking, low severity patching, low to medium severity raveling, and low to medium severity weathering. Field observations indicate the initial deterioration of the AC surface layer has contributed to an increasing quantity and severity of raveling throughout the branch.

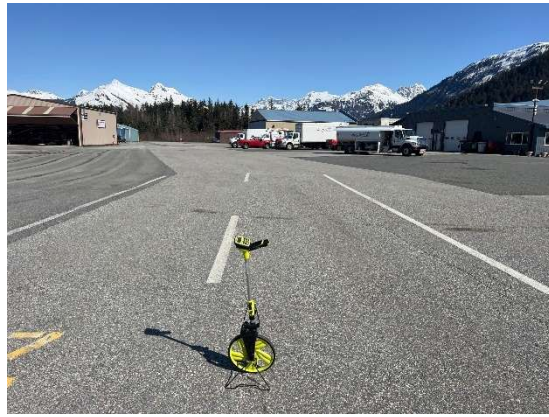
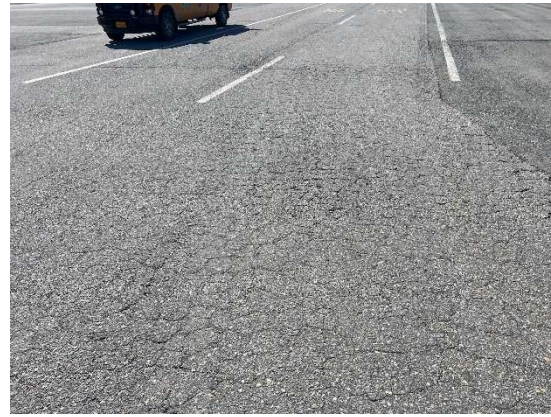
Section 0220-01 (32 PCI)

Taxiway B2 is an AC taxiway that consists of three sections: Sections 0220-01, 0220-02 and 0220-03. Major work has not been completed on Section 0220-01 since its initial construction in 1981. Crack sealing has not been performed on this section. The most common distresses are low to high severity fatigue cracking, low to medium severity longitudinal and transverse cracking, low to medium severity patching, low severity raveling, and low to medium severity weathering. Field observations indicate that the pavement is highly degraded, with widespread load-related distresses visible throughout the taxiway. The extensive fatigue cracking suggests significant structural deterioration.

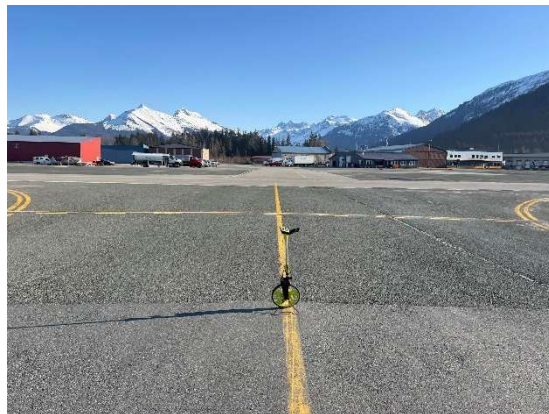
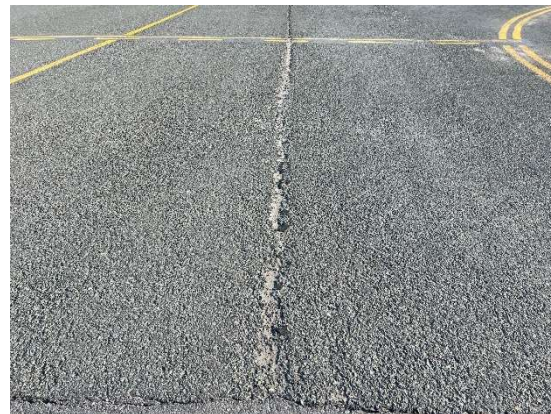
Section 0220-02 (58 PCI)

Major work has not been performed on Section 0220-02 since its initial construction in 2005. Crack sealing has not been performed on this section. The most common distresses are low severity longitudinal and transverse cracking, low to medium severity raveling, and low severity weathering. The pavement surface has deteriorated as characterized by widening of the paving lane joints and the progressive raveling of the coarse aggregate.

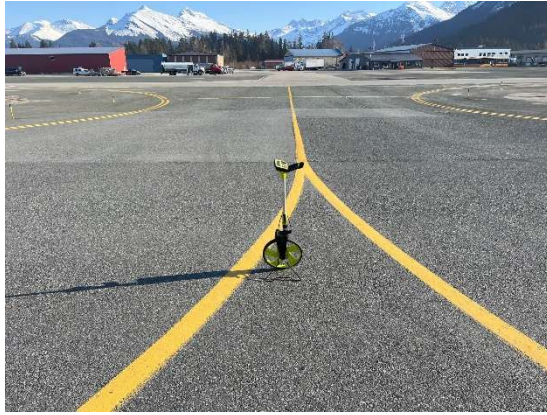
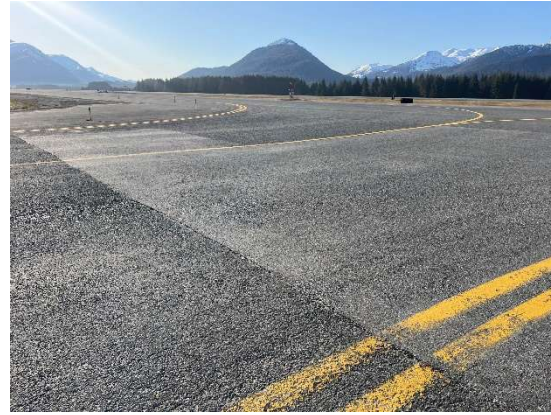
Section 0220-03 (89 PCI)

Surface rehabilitation was accomplished on Taxiway B2 Section 0220-03 in 2020. Crack sealing has not been performed on this section. The most common distresses are low severity longitudinal and transverse cracking, low severity raveling, and low severity weathering. Field observations include new unfilled cracks and initial surface deterioration, leading to localized areas of raveling across the taxiway.

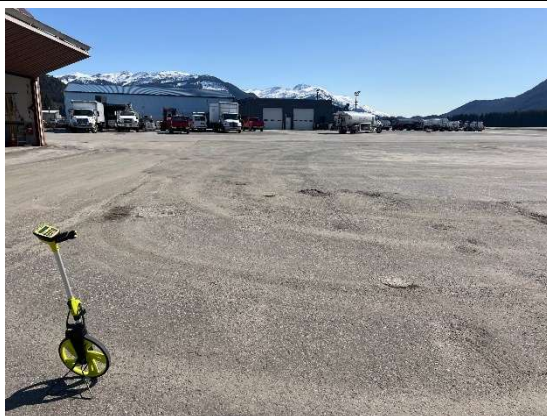
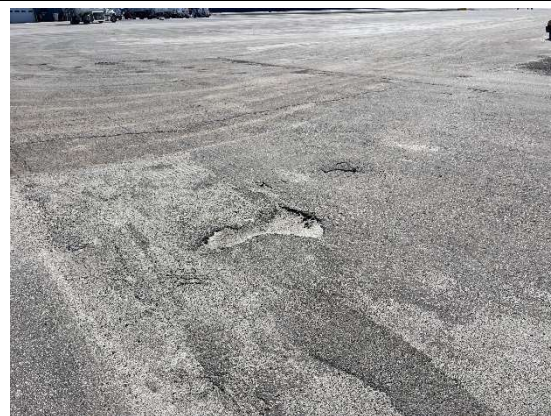
Section 0230-01 (41 PCI)

Taxilane B3 consists of two sections: 0230-01 and 0230-02. Section 0230-01 has not received major work since its initial construction in 2000. Crack sealing has not been performed on this section. The most common distresses are medium to high severity fatigue cracking, medium severity depressions, low severity longitudinal and transverse cracking, low to high severity patching, low to high severity raveling, and low to medium severity weathering. Field observations indicate highly degraded pavement with load-related distress across the taxiway. Additionally, uneven surface conditions and minor depressions have been noted.

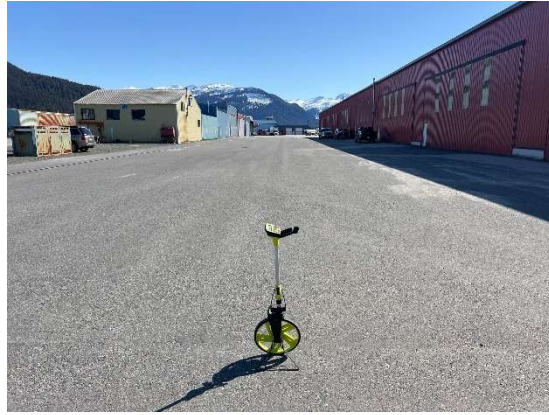
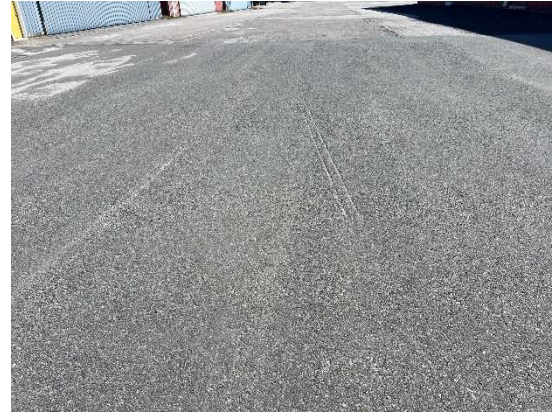
Section 0230-02 (92 PCI)

Taxilane B3 Section 0230-02 was reconstructed in 2020. Crack sealing has not been performed on this section. The most common distress is low severity weathering. Field observations include areas of mechanical damage from snowplow operations.

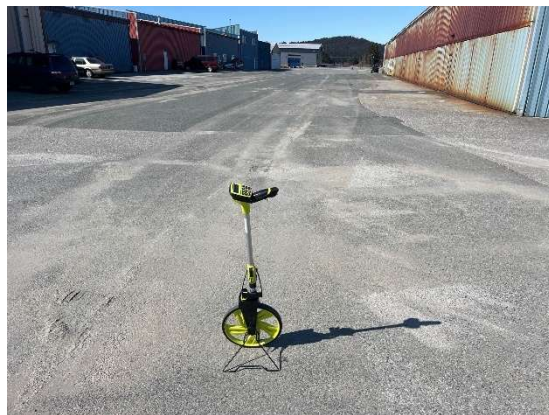
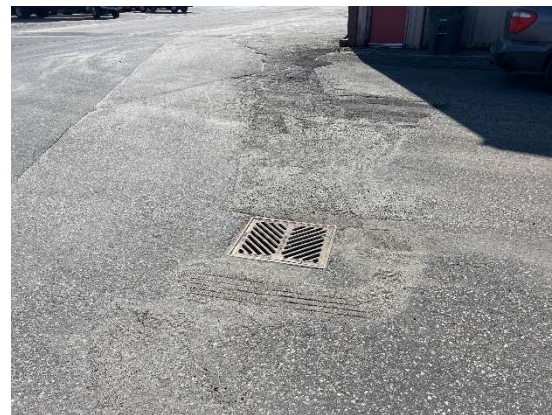
Section 0240-01 (60 PCI)

Taxilane B4 consists of two sections: 0240-01 and 0240-02. Section 0240-01 received surface rehabilitation in 2004. Crack sealing has not been performed on this section. The most common distresses are low severity fatigue cracking, low severity depressions, low to medium severity longitudinal and transverse cracking, low to high severity patching and low to medium severity weathering. Field observations indicate variable patch quality with some patches failing prematurely. In addition, inspectors noted uneven surface conditions and minor depressions.

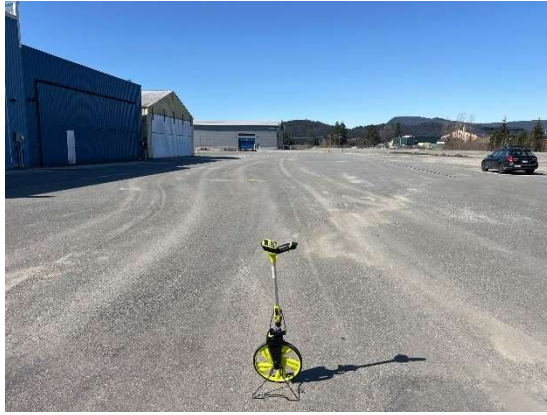
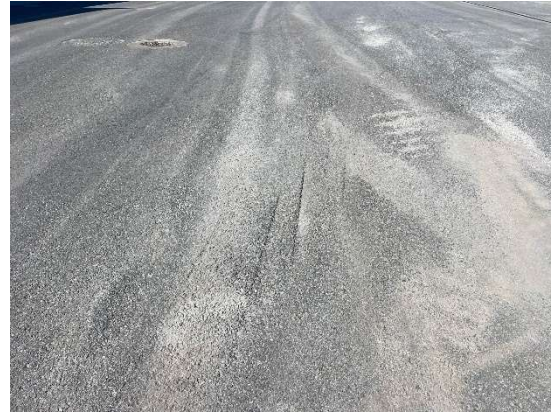
Section 0240-02 (85 PCI)

Taxilane B4 Section 0240-02 was reconstructed in 2020. Crack sealing has not been performed on this section. The most common distresses are low severity raveling and low severity weathering. Field observations include areas of mechanical snowplow damage.

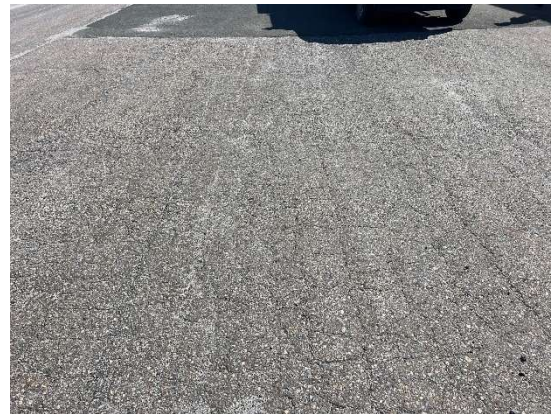
Taxilane B5 received a structural overlay in 1999. Crack sealing has not been performed on the branch. The most common distresses are low to medium severity fatigue cracking, low to high severity longitudinal and transverse cracking, low severity patching, and low to medium severity weathering. Field observations indicate highly degraded pavement with load-related distresses across the taxiway.

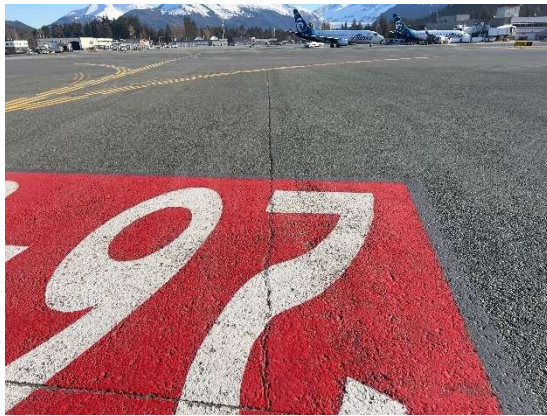
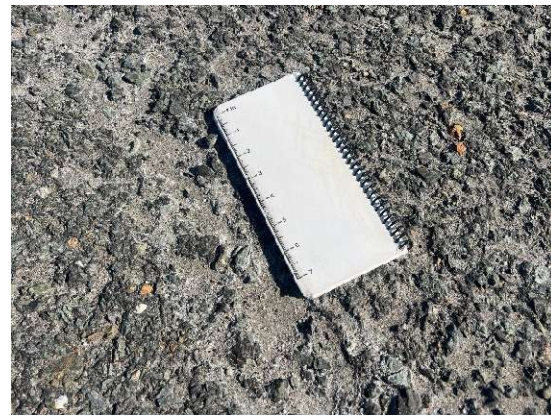
Section 0300-01 (62 PCI)

Taxiway C consists of three sections: 0300-01, 0300-02 and 0300-03. Section 0300-01 is an AC pavement that received a structural overlay in 2004. Crack sealing has not been performed on the section. The most common distresses are low severity fatigue cracking, low to high severity longitudinal and transverse cracking, low severity patching, low to medium severity raveling, and low severity weathering. Field observations indicate significant deterioration of the pavement surface characterized by widening of the paving lane joints and the progressive raveling of coarse aggregate.

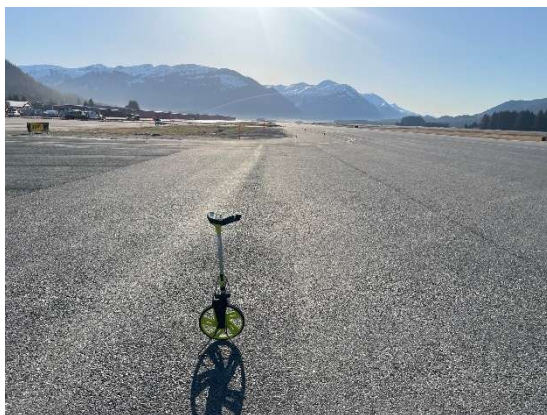
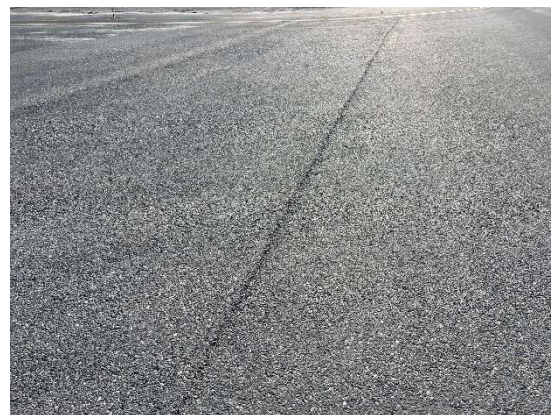
Section 0300-02 (95 PCI)

Taxiway C Section 0300-02 is an AC pavement that received surface rehabilitation in 2020. Crack sealing has not been performed on this section. The most common distresses are low severity raveling and low severity weathering. Field observations include initial surface deterioration which lead to localized areas of raveling and weathering across the taxiway.

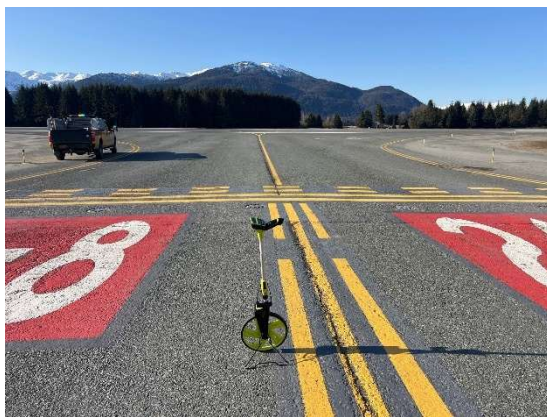
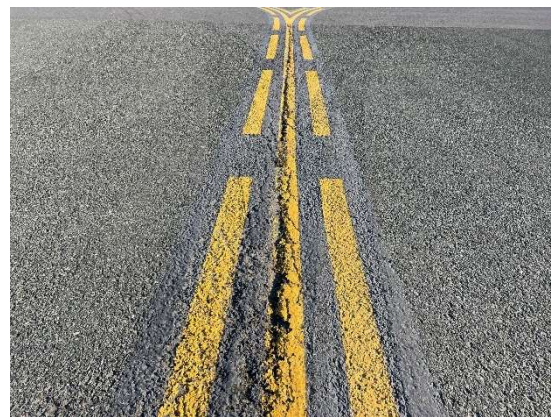
Taxiway D has not received major work since its initial construction in 2005. Crack sealing has not been performed on the branch. The most common distresses are low to medium severity fatigue cracking, low to medium severity longitudinal and transverse cracking, low to medium severity patching, low to high severity raveling, and low to medium severity weathering. Field observations indicate significant deterioration of the pavement surface characterized by widening of the paving lane joints and the progressive raveling of the coarse aggregate.

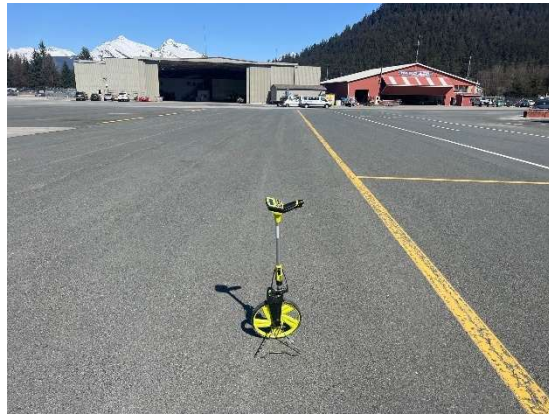
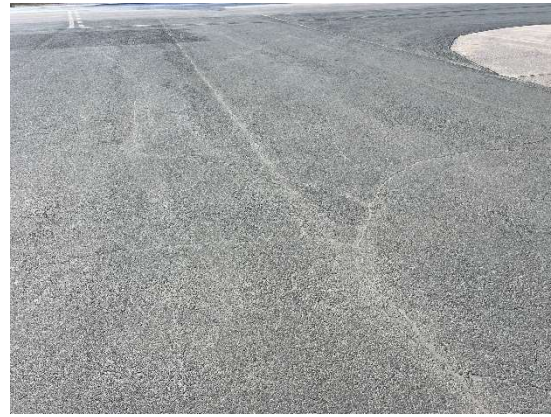
Section 0410-01 (53 PCI)

Taxiway D1 consists of two sections: 0410-01 and 0410-02. Section 0410-01 has not undergone any major work since its initial construction in 1997. Crack sealing has not been performed on this section. The most common distresses are low severity fatigue cracking, low severity block cracking, low to medium severity longitudinal and transverse cracking, low severity raveling, and low to medium severity weathering. Field observations indicate significant deterioration of the pavement surface characterized by widening of the paving lane joints and the progressive raveling of the coarse aggregate.

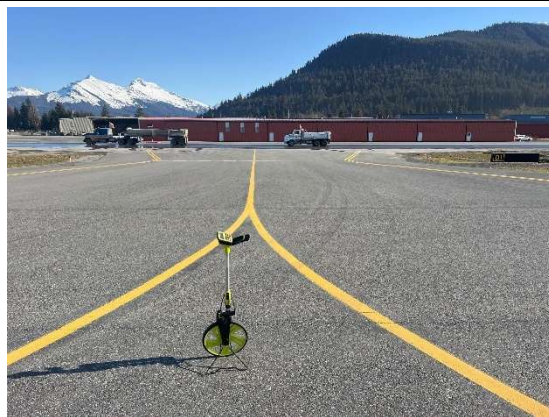
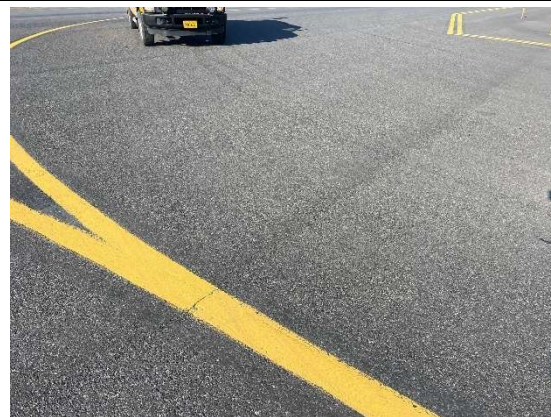
Section 0410-02 (93 PCI)

Taxiway D Section 0410-02 was realigned and completely reconstructed in 2020. Crack sealing has not been performed on the section. The most common distresses are low severity longitudinal and transverse cracking, and low severity weathering. Field observations include new unfilled cracks and initial surface deterioration.

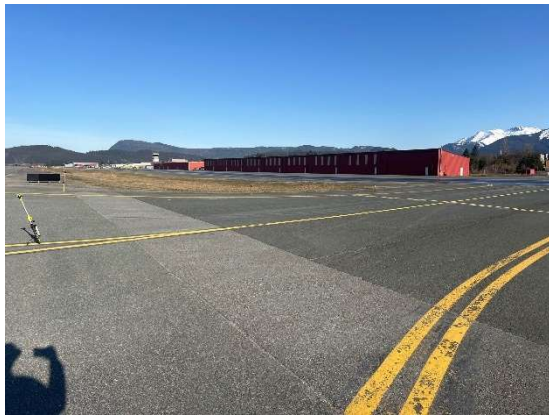
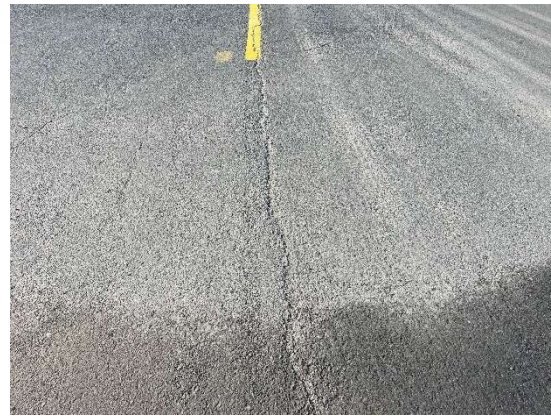
Taxiway D2 has not undergone any major work since its initial construction in 1997. Crack sealing has not been performed on the branch. The most common distresses are low severity fatigue cracking, low to high severity longitudinal and transverse cracking, low severity patching, low severity raveling, and low to medium severity weathering. Field observations indicate significant deterioration of the pavement surface characterized by widening of the paving lane joints and the progressive raveling of the coarse aggregate.

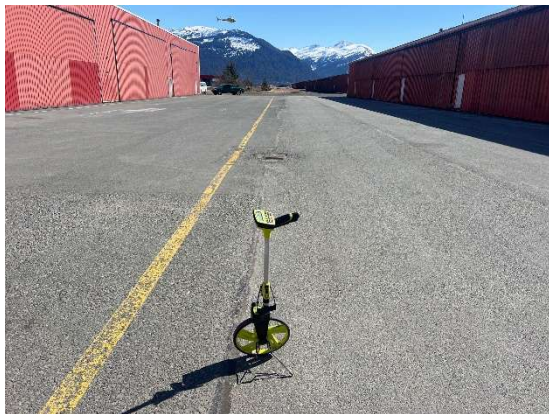
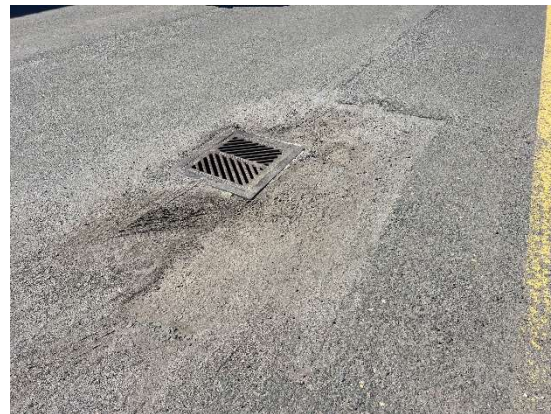
Taxilane D4 has not undergone any major work since its initial construction in 1998. Crack sealing has not been performed on the branch. The most common distresses are low to medium severity longitudinal and transverse cracking, low to high severity patching, low to high severity raveling, and low to medium severity weathering. Field observations indicate patches of variable quality, including some with indications of premature failure.

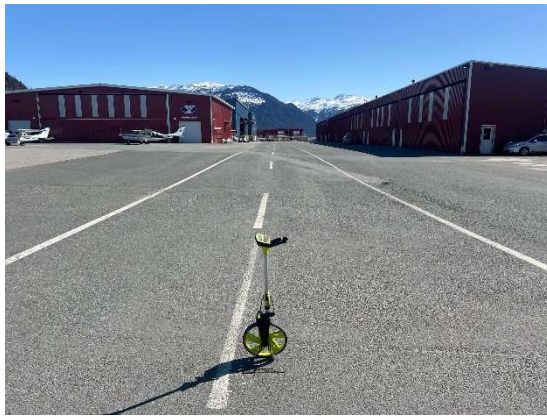
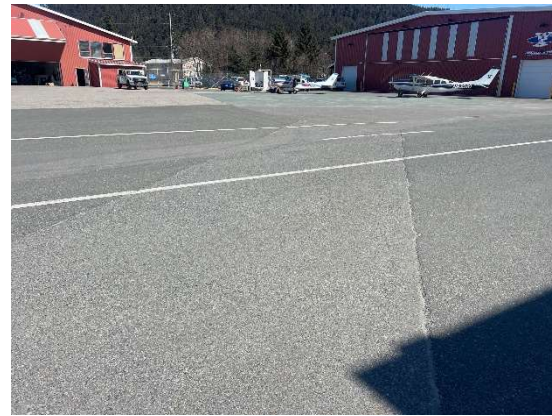
Taxilane D5 has not undergone any major work since its initial construction in 1998. Crack sealing has not been performed on the branch. The most common distresses are low severity patching, low to medium severity raveling, and low to medium severity weathering. Field observations indicate deterioration of the pavement surface characterized by widening of the paving lane joints and the progressive raveling of the coarse aggregate.

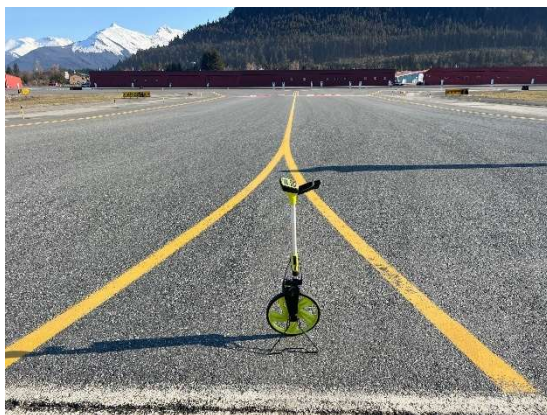
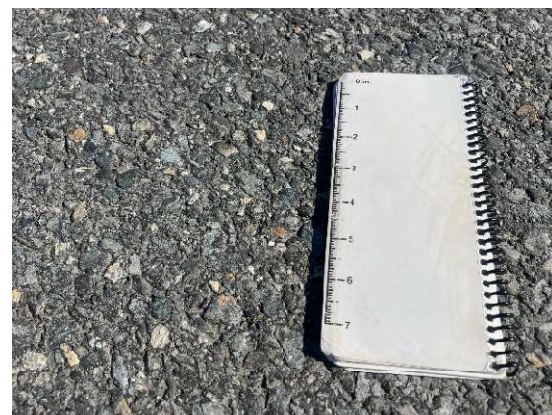
The Taxiway E pavement surface was rehabilitated, along with Taxiway A, in 2020. Crack sealing has not been performed on the branch. The most common distresses are low severity longitudinal and transverse cracking, and low severity weathering. Field observations include new unfilled cracks and initial surface deterioration.

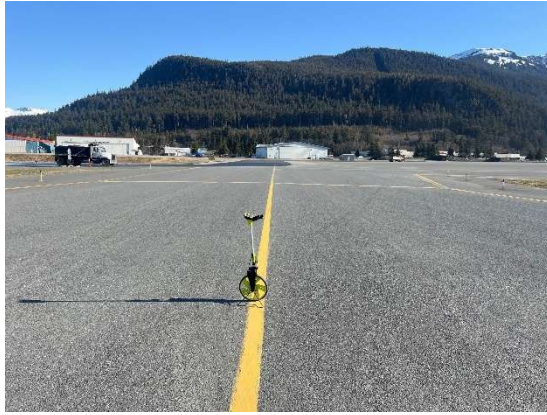
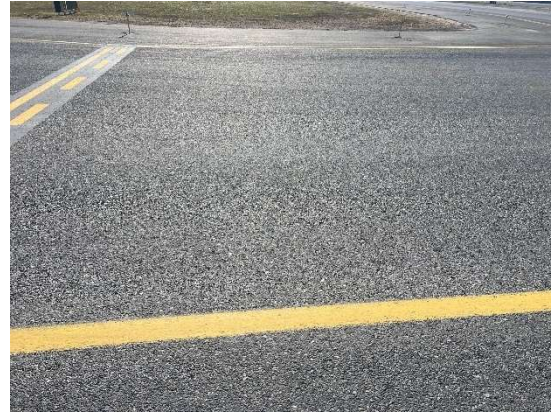
Section 0510-01 (94 PCI)

Taxiway E1 consists of five sections: 0510-01 through 0510-05. The pavement surface of Section 0510-01 was rehabilitated in 2020 along with Taxiway A. Crack sealing has not been performed on this section. The most common distresses are low severity raveling, and low severity weathering. Field observations include initial surface deterioration.

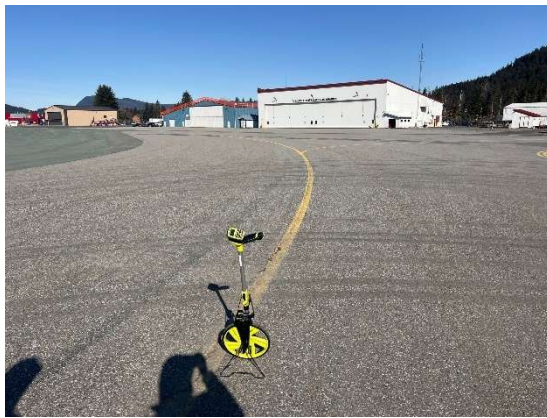
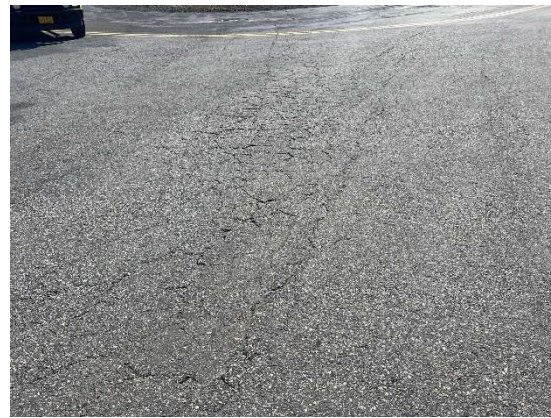
Section 0510-02 (46 PCI), 0510-03 (47 PCI), 0510-05 (54 PCI)

No major work has been performed on Taxiway E1 Sections 0510-02, 0510-03, and 0510-05 since initial construction in 1990. Crack sealing has not been performed on these sections. The most common distresses are low to high severity fatigue cracking, low to medium severity longitudinal and transverse cracking, low to medium severity raveling, and low to medium severity weathering. Field observations indicate highly degraded pavement with a considerable amount of load-related distress across the taxiway.

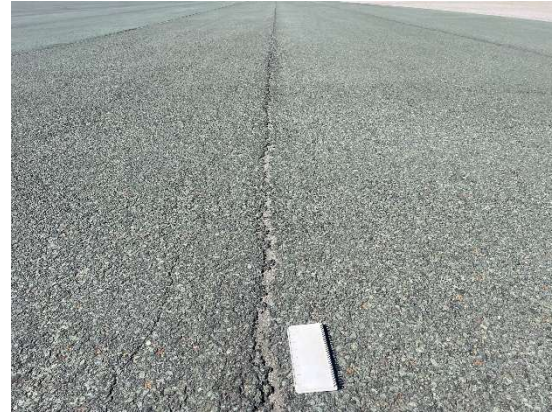
Section 0510-04 (61 PCI)

The pavement surface of Taxiway E1 Section 0510-04 was rehabilitated in 2006. Crack sealing has not been performed on this section. The most common distresses are low to medium severity longitudinal and transverse cracking, low to medium severity raveling, and low to medium severity weathering. Field observations indicate significant deterioration of the pavement surface characterized by widening of the paving lane joints and the progressive raveling of the coarse aggregate.

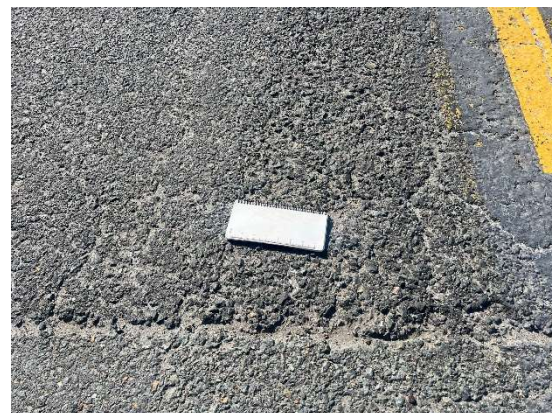
Section 0600-01 (60 PCI)

Taxiway F consists of two sections: 0600-01 and 0600-02. The pavement surface on Section 0600-01 was milled and overlaid in 2004. Crack sealing has not been performed on this section. The most common distresses are low severity fatigue cracking, low to medium severity longitudinal and transverse cracking, low to medium severity raveling, and low to medium severity weathering. Field observations indicate significant deterioration of the pavement surface characterized by widening of the paving lane joints and the progressive raveling of the coarse aggregate.

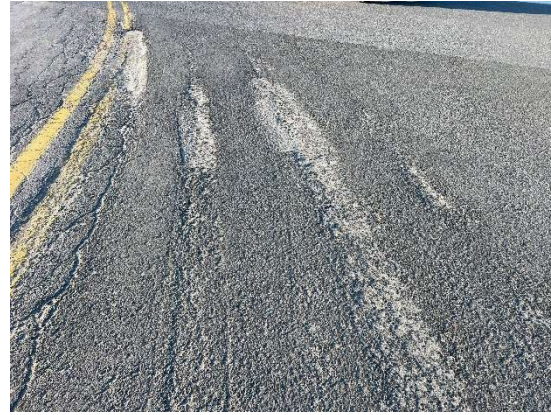
Section 0600-02 (30 PCI)

The Taxiway F Section 0600-02 pavement received a mill and overlay in 1997. Crack sealing has not been performed on this section. The most common distresses are low to high severity fatigue cracking, low severity block cracking, low to medium severity longitudinal and transverse cracking, low to high severity raveling, and low to medium severity weathering. Field observations indicate highly degraded pavement with load-related distress across the taxiway and significant deterioration of the pavement surface characterized by widening of the paving lane joints and the progressive raveling of coarse aggregate.

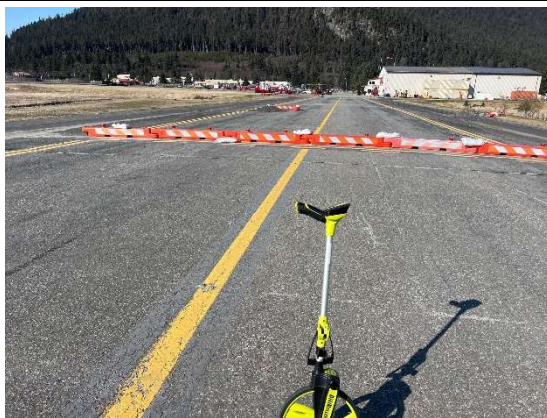
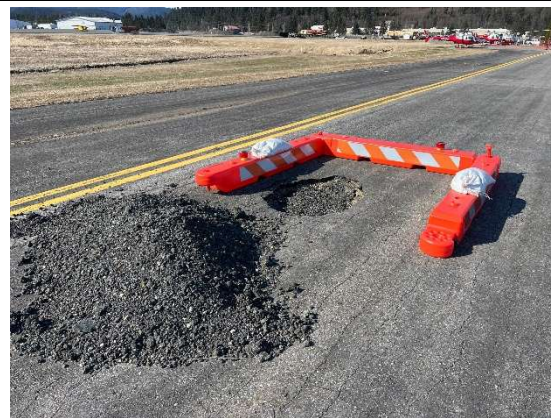
Taxiway F1 has not undergone any major work since its initial construction in 1991. Crack sealing has not been performed on the branch. The taxiway was closed to aircraft operations during the inspection due to a large pothole. The most common distresses are low to high severity fatigue cracking, high severity corrugation, low severity longitudinal and transverse cracking, medium to high severity raveling, and low to medium severity weathering. Field observations indicate highly degraded pavement with a considerable amount of load-related distress across the taxiway.

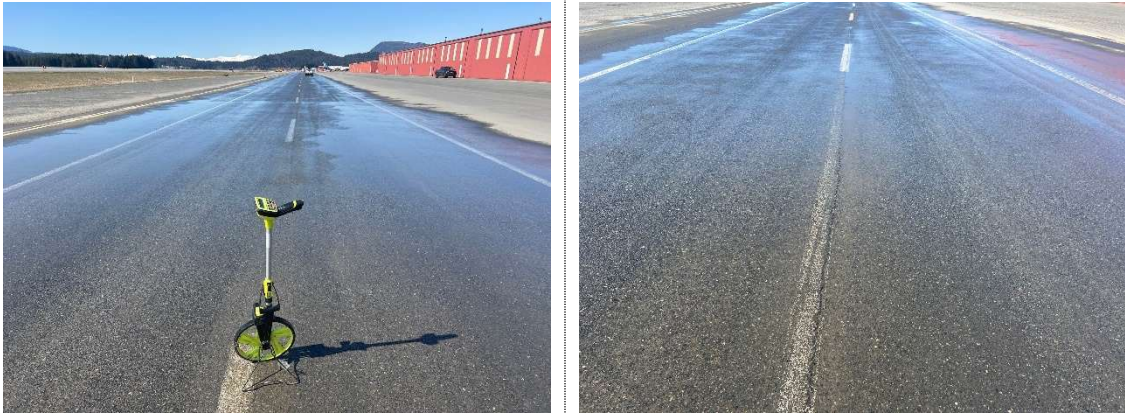
The Taxilane H pavement was completely rehabilitated in 2020. Crack sealing has not been performed on the branch. The most common distresses are low severity longitudinal and transverse cracking, and low severity weathering. Field observations include new unfilled cracks and initial surface deterioration.

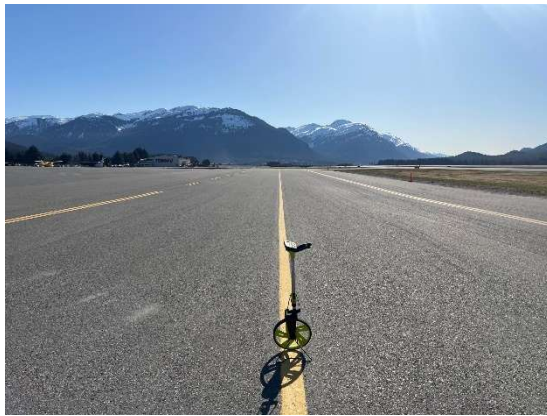
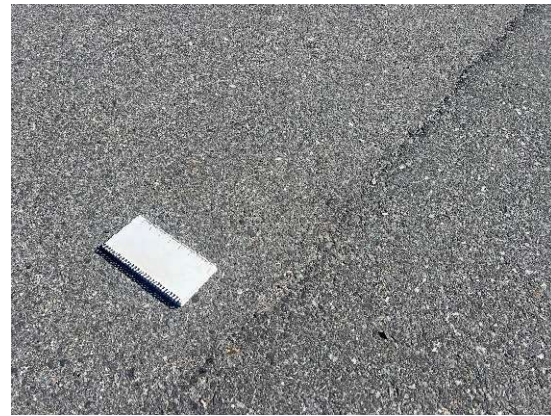
Taxiway H1 has not undergone any major work since its initial construction in 2020. Crack sealing has not been performed on the branch. The most common distress observed is low severity weathering. Field observations include initial surface deterioration.

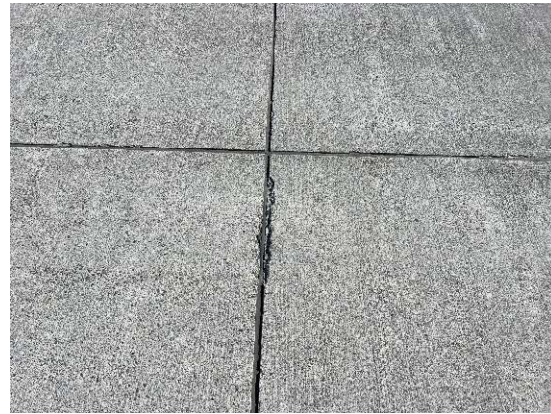
PCC Section 4100-HS4 (82 PCI)

The Terminal Apron Section 4100-HS4 has not undergone any significant work since its initial construction in 2017. The most common distresses are medium severity joint seal damage, low severity joint spalling, and low severity corner spalling. Field observations suggest that initial damage to the joint sealant has progressed, resulting in joint and corner spalls.

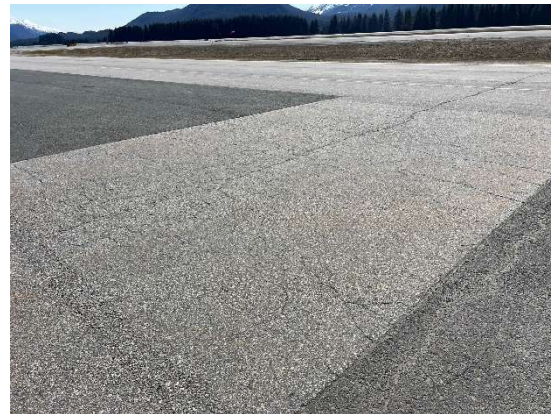
The Large Plane Apron has not undergone any major work since its initial construction in the period 1997 to 1999. Crack sealing has not been performed on the branch. The most common distresses are low severity fatigue cracking, low severity block cracking, low severity depressions, low to medium severity longitudinal and transverse cracking, low to high severity patching, low to high severity raveling, and low to medium severity weathering. Field observations indicate significant deterioration of the pavement surface characterized by widening of the paving lane joints and the progressive raveling of the coarse aggregate.

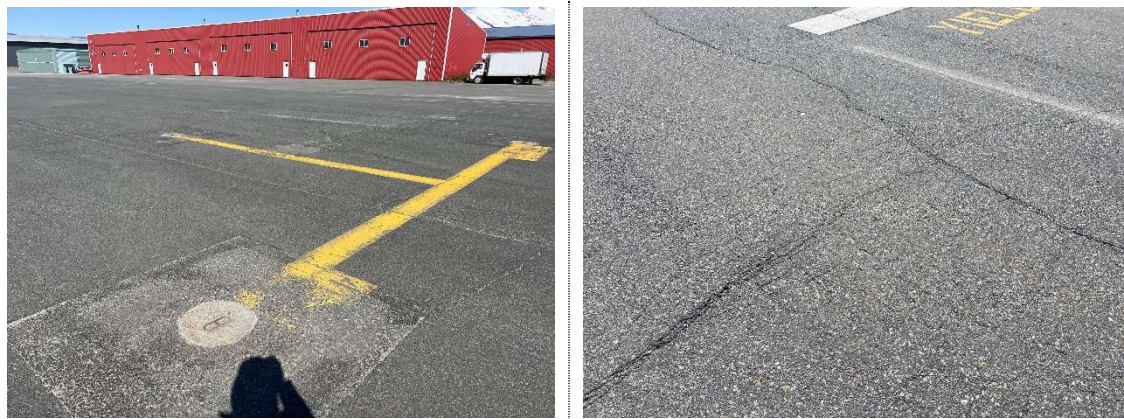
AC Section 4300-01 (59 PCI)

The Small Plane Apron consists of six sections: 4300-01 to 4300-06. Section 4300-01 has not undergone any major work since its initial construction in 1997. Crack sealing has not been performed on this section. The most common distresses are low to medium severity fatigue cracking, low to medium severity longitudinal and transverse cracking, low to medium severity patching, low to high severity raveling, and low to medium severity weathering. Field observations indicate significant deterioration of the pavement surface characterized by widening of the paving lane joints and the progressive raveling of the coarse aggregate.

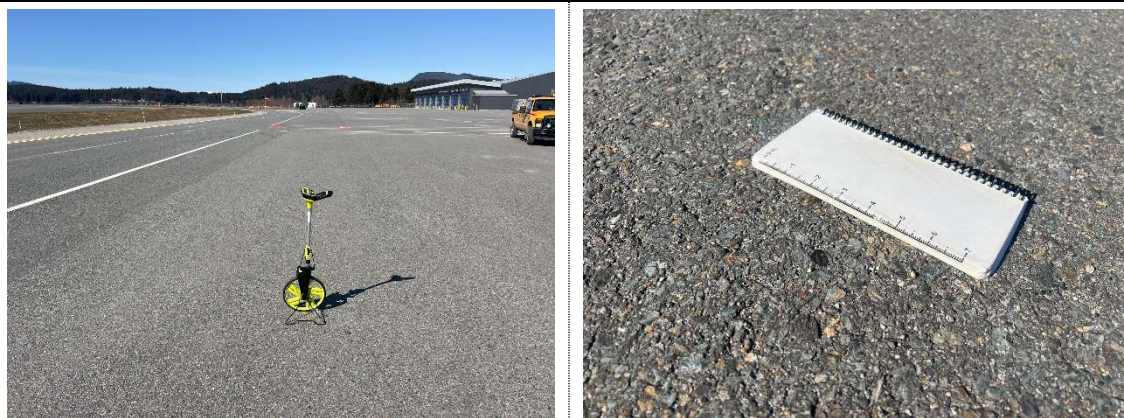
AC Section 4300-02 (92 PCI), 4300-03 (87 PCI), 4300-04 (94 PCI), 4300-05 (89 PCI)

The Small Plane Apron Sections 4300-02 through 4300-05 have not undergone any major work since their initial construction in 2020. Crack sealing has not been performed on these sections. The most common distresses are low severity longitudinal and transverse racking, low severity raveling, and low severity weathering. Field observations include new unfilled cracks and initial surface deterioration.

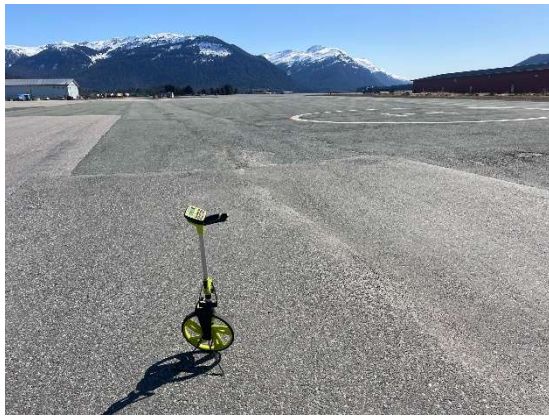
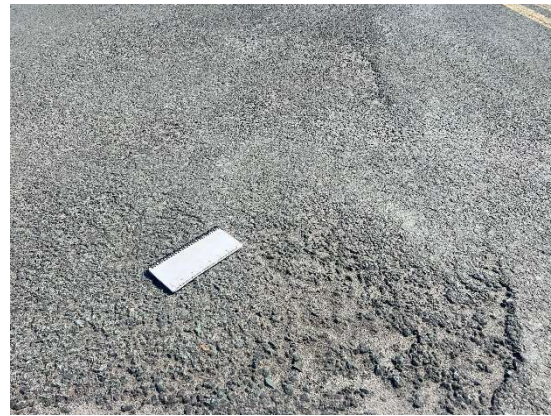
The Apron was constructed in 2006 and has not undergone any major work since that time. Crack sealing has not been performed on the branch. The most common distresses are low to medium severity depressions, low to medium severity longitudinal and transverse cracking, low severity patching, low to high severity raveling, and low to medium severity weathering. Field observations indicate significant deterioration of the pavement surface characterized by widening of the paving lane joints and the progressive raveling of the coarse aggregate.

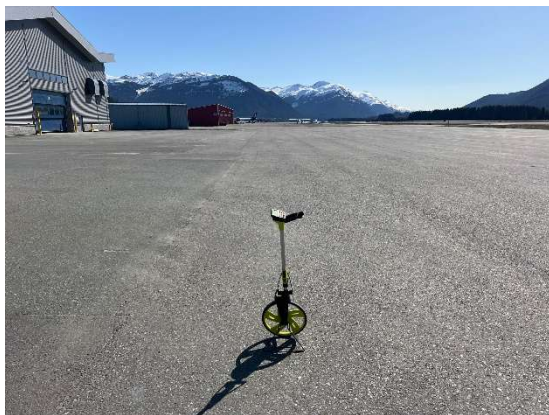
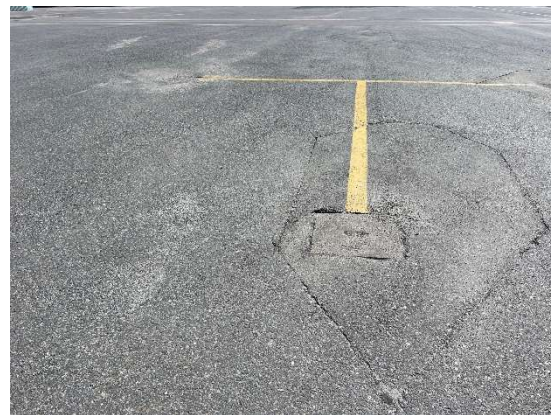
The Northwest Development Apron (NWDA) has not undergone any major work since its initial construction in 2016. Crack sealing has not been performed on the branch. The most common distresses are low severity patching, and low to medium severity weathering. Field observations highlight initial surface deterioration and localized patching around aircraft tie-down anchors.

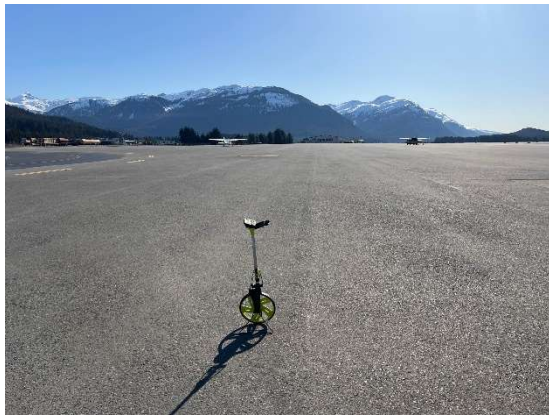
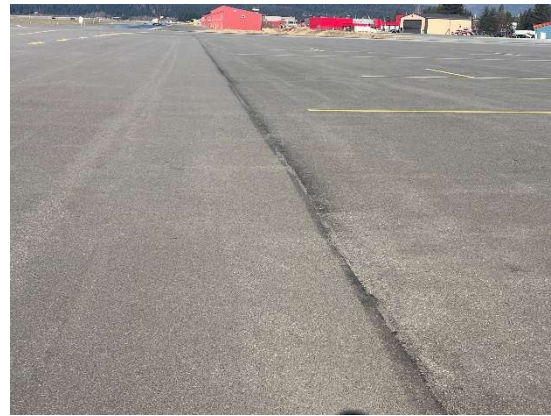
The Northeast Development Apron (NEDA) has not undergone any major work since its initial construction in 2020. Crack sealing has not been performed on the branch. The most common distresses are low severity patching, low severity raveling, and low to medium severity weathering. Field observations indicate initial surface deterioration.

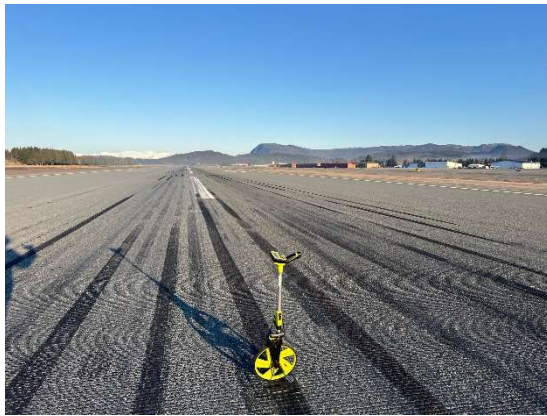
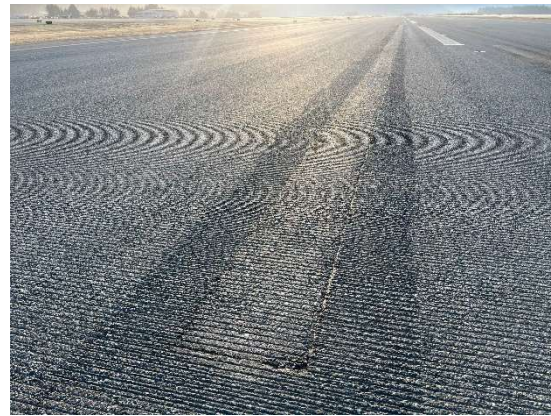
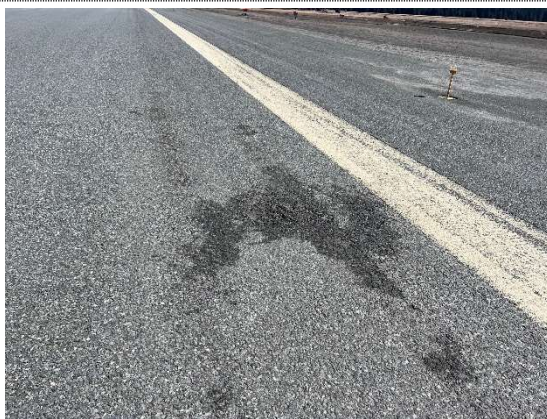
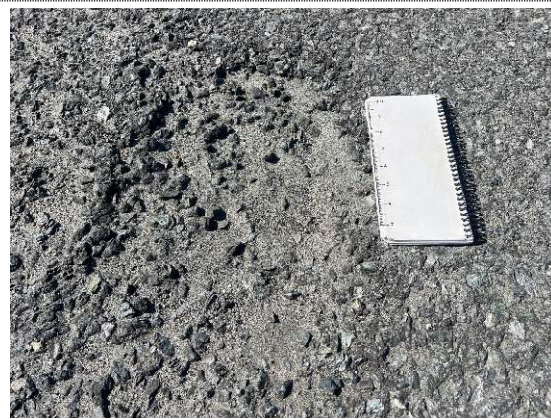
Runway 8/26 received a 3-inch mill and 5-inch overlay in 2015. Crack sealing has not been performed on this branch. The most common distresses are low severity fatigue cracking, low severity longitudinal and transverse cracking, low severity patching, low to high severity raveling, and low to medium severity weathering. Field observations reveal patching concentrated along the keel of the runway near the centerline. (According to airport personnel, the repairs to the runway were caused by repeated propeller strikes that occurred when an aircraft nose gear collapsed.) In addition, areas of the runway surface show signs of raveling where coarse aggregates are detaching from the pavement surface, a potential source of foreign object debris (FOD).
