Alaska DOT&PF

Pavement Inspection Report Kake Airport

Airport Code: AFE
Site Number: 50393.01*A

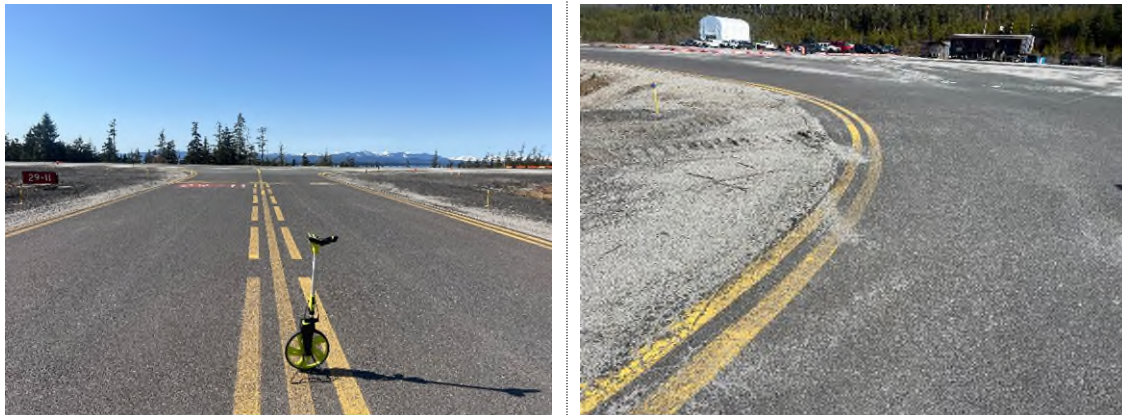
Section 0100-01 (61 PCI)

Taxiway A consists of two sections, Section 0100-01 and Section 0100-02. Section 0100-01 was initially constructed in 1991 and has not received any major work since. Crack seal operations have not been performed on this section. The most common distresses observed are low severity longitudinal and transverse cracking, low severity raveling, and low severity weathering. Field observations include the development of new unfilled cracks and continued wearing of the asphalt binder and fine aggregate matrix from the pavement surface.

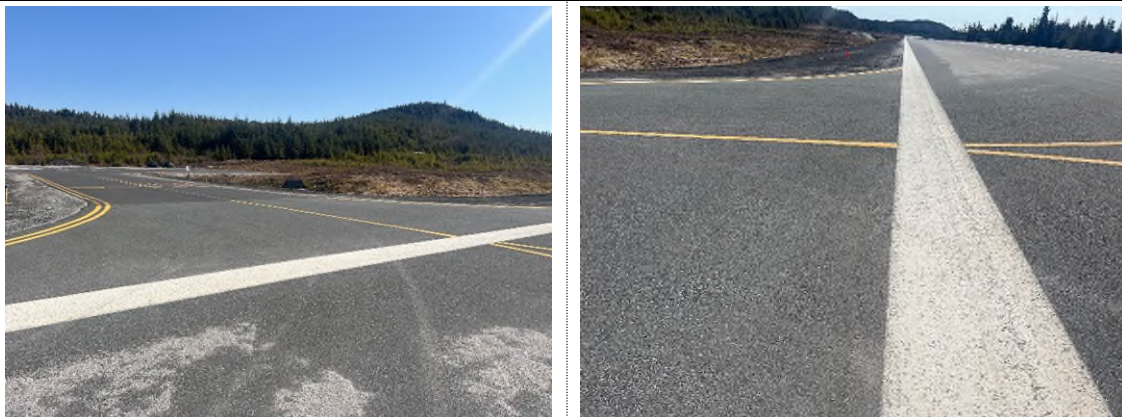
Section 0100-02 (94 PCI)

Taxiway A Section 0100-02 was initially constructed in 1991 and was completely reconstructed in 2018. Crack seal operations have not been performed on this section. The only distress observed was low severity weathering. No additional field observations were documented.

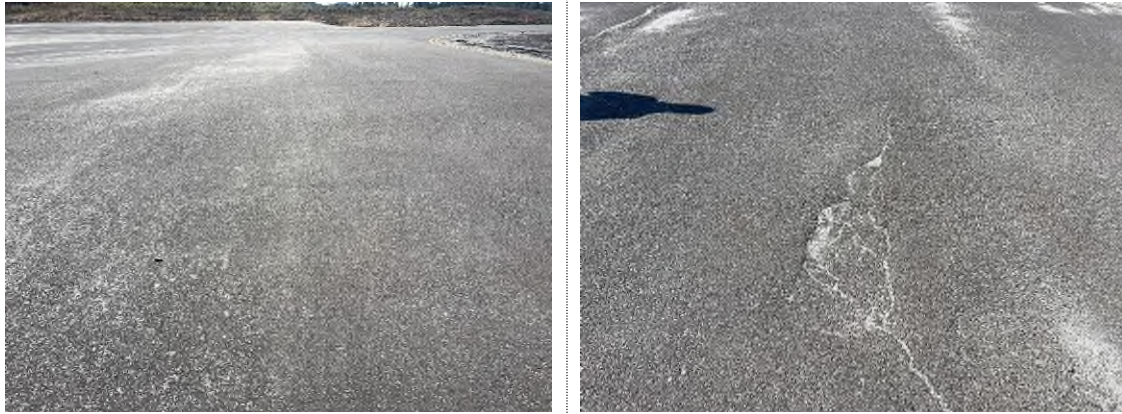
The Apron was constructed in 1991 and has not received any work since. Crack seal operations have not been performed on the Apron. The most common distresses observed are low to medium severity longitudinal and transverse cracking, low to medium severity raveling, and low severity weathering. Field observations include the development of new unfilled cracks, the widening of cracks increasing the severity, and continued wearing of the asphalt binder and fine aggregate matrix from the pavement surface.

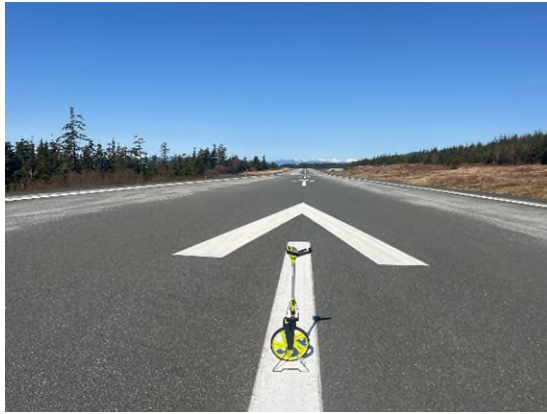
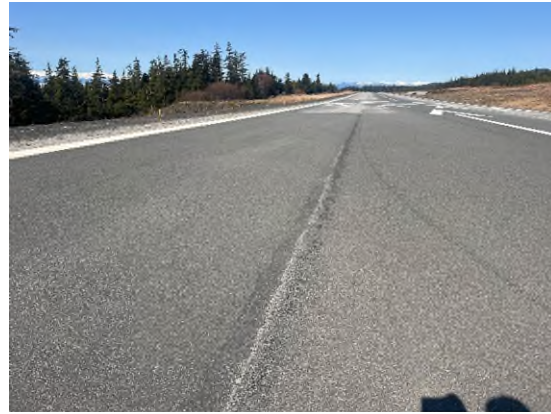
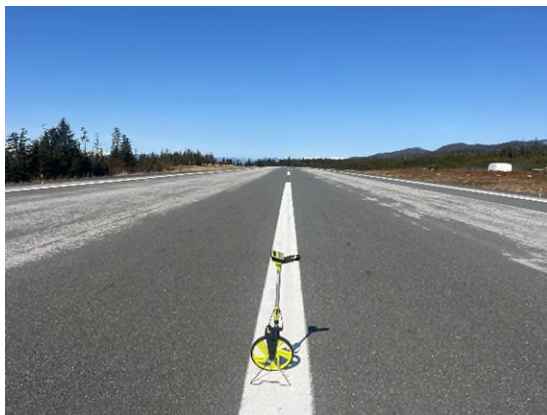
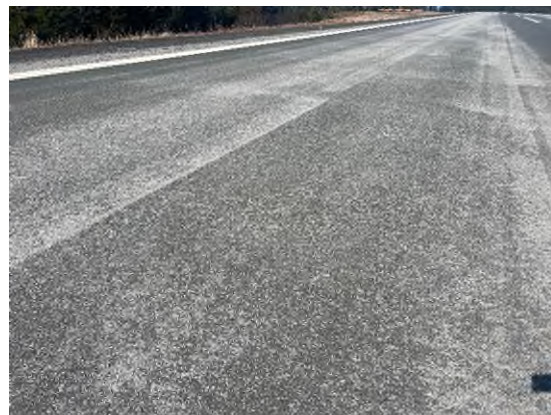
Runway 11/29 was constructed in 1991 and was completely reconstructed in 2018. Crack seal operations have not been performed on Runway 11/29. The only distress observed was low to medium severity weathering. No additional field observations were documented.
