# Alaska DOT&PF

## Pavement Inspection Report Kenai Airport

Airport Name	IATA	ICAO	Latitude	Longitude	Elevation (ft)
Kenai Airport	ENA	PAEN	60° 34' 24" N	151° 14' 41" W	99

Point of Contact	Phone	Email	Date Inspected	Date Published
Mr. Andrew Pavey, Pavement Management Engineer	(907) 269 6213	andrew.pavey@alaska.gov	August 2024	February 2025

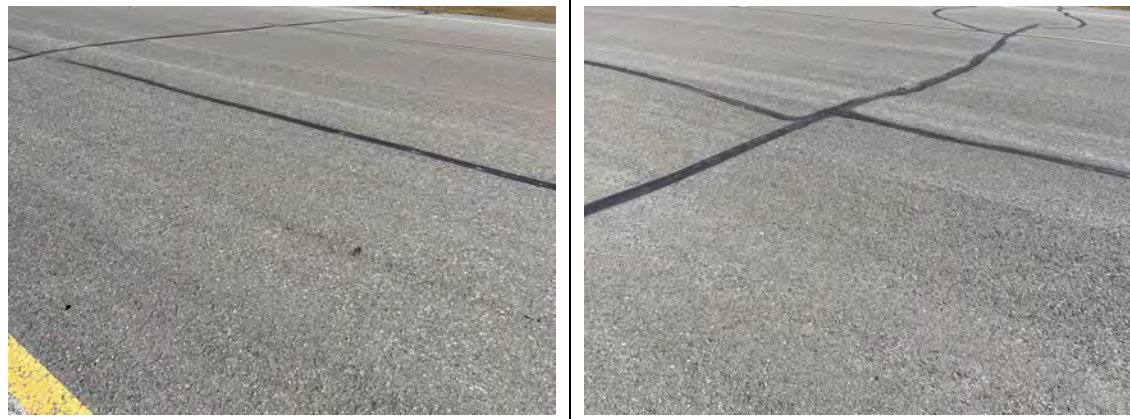
## **Section 100-01 – PCI 72**

Section 100-01 of Taxiway A was last resurfaced in 2006. Predominant distresses include low to medium severity longitudinal and transverse cracking, low severity weathering, and low severity raveling. Other distresses observed are medium severity raveling and weathering.

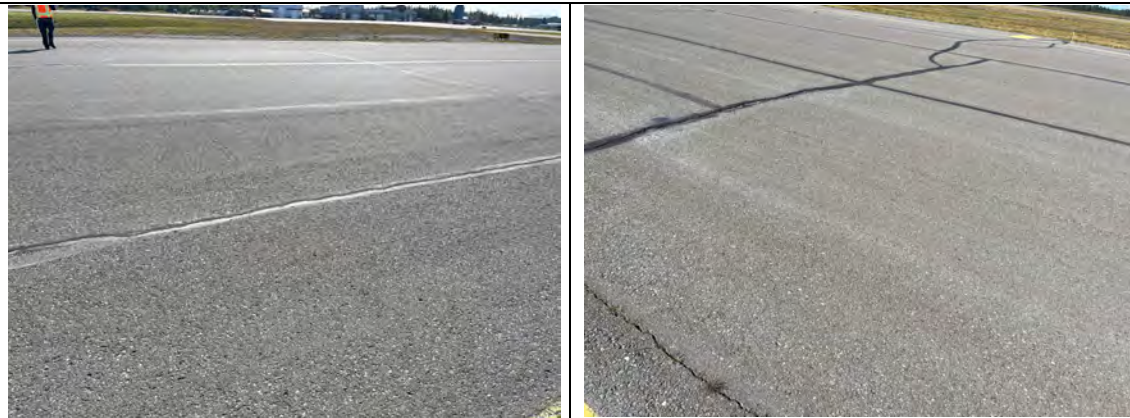
## **Section 100-02 – PCI 67**

The last known resurfacing of the 100-02 portion of Taxiway A was in 1989. Predominant distresses include low to medium severity longitudinal and transverse cracking, low severity weathering, and low severity raveling. Distresses are in higher concentrations than in 100-01.

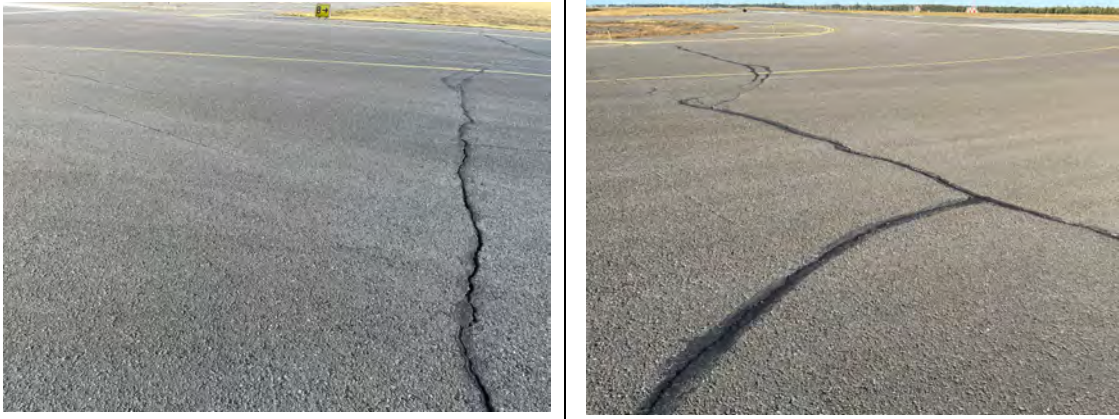
Taxiway B was constructed in 2006. Predominant distresses include low to medium severity longitudinal and transverse cracking, low and medium severity weathering and low severity raveling.

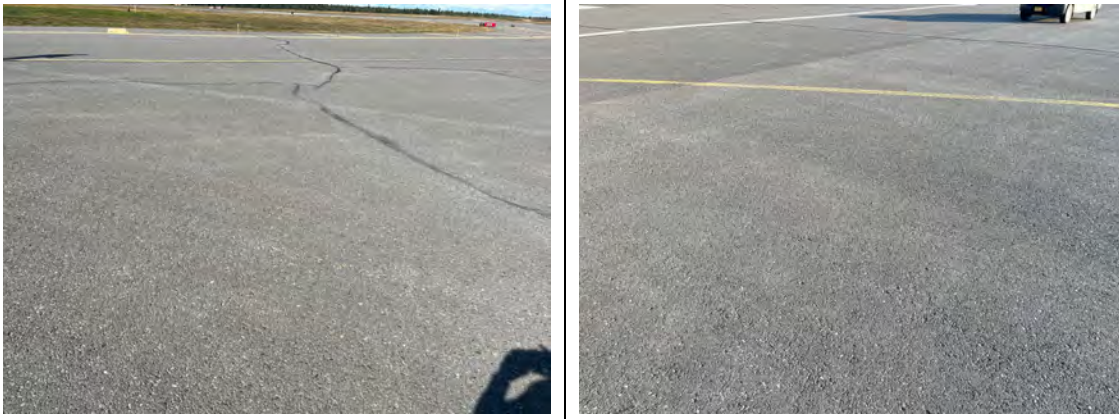
Taxiway C was reconstructed in 2006. Common distresses include low and medium severity longitudinal and transverse cracking, low severity weathering and low severity raveling.

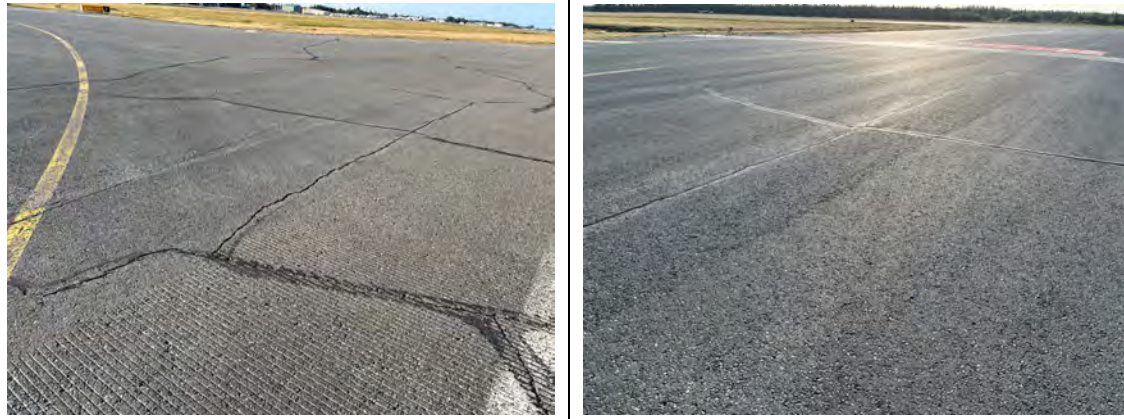
Section 400-01 – PCI 57

Section 400-01 of Taxiway D was constructed in 1971 was resurfaced in 1990 and 2006. Common distresses include low and medium severity longitudinal and transverse cracking, low severity weathering and low severity raveling. Other distresses observed include small areas of high severity cracking and medium severity weathering.

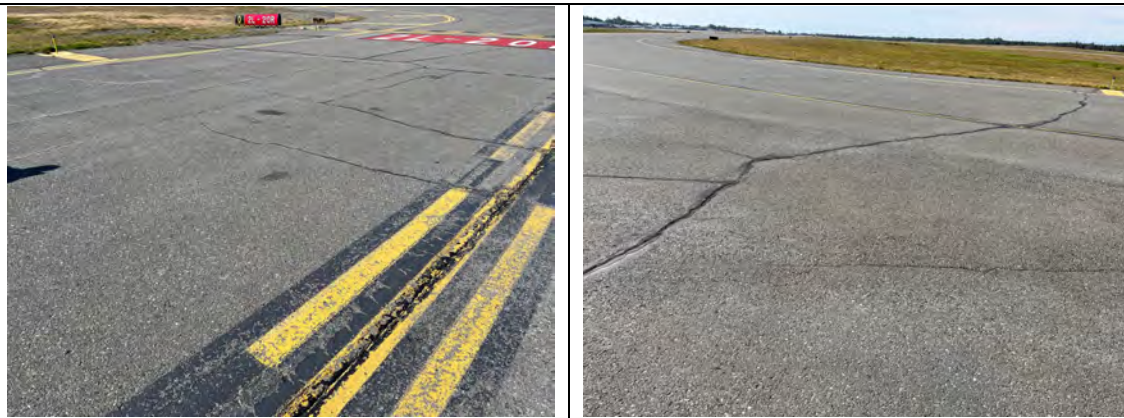
Section 400-02 – PCI 67

Section 400-02 of Taxiway D was constructed in 1971 the last known resurfacing was in 1990. Common distresses include low to medium severity longitudinal and transverse cracking, low severity weathering and small areas of low severity raveling.

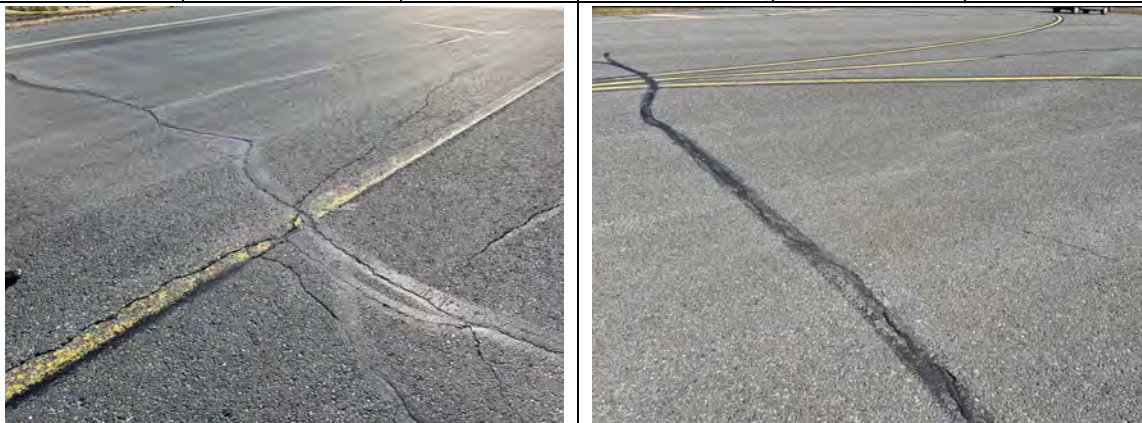
Taxiway E was constructed in 1965 and resurfaced in 1990. Section 500-01 (PCI 64) was last resurfaced in 2006, 500-02 (PCI 67) in 2005, and 500-03 (PCI 71) in 2010. Predominant distresses include low to medium severity longitudinal and transverse cracking, low to medium severity weathering and low severity raveling. Section 500-01 has some small areas with high severity longitudinal and transverse cracking and medium severity raveling.

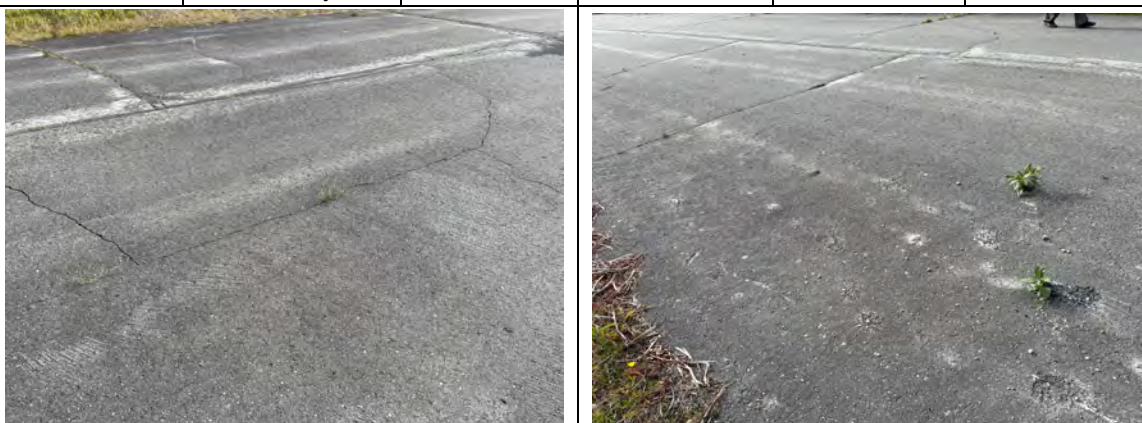
The Basin Access Taxiway was constructed in 1989 and has received no work since. Common distresses include low, medium and high severity longitudinal and transverse cracking, low severity weathering, and low, medium and high severity raveling. Other distresses include low and medium severity alligator cracking, with isolated high severity alligator cracking.

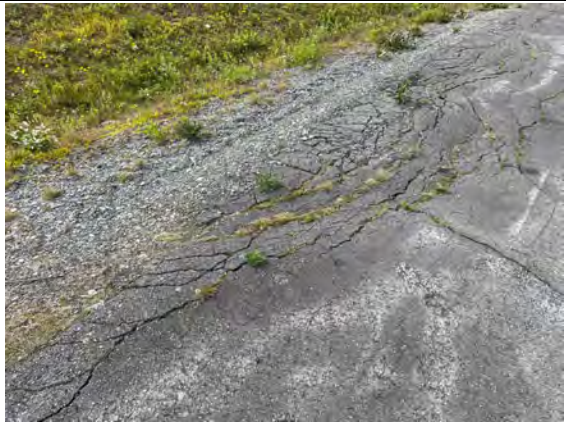
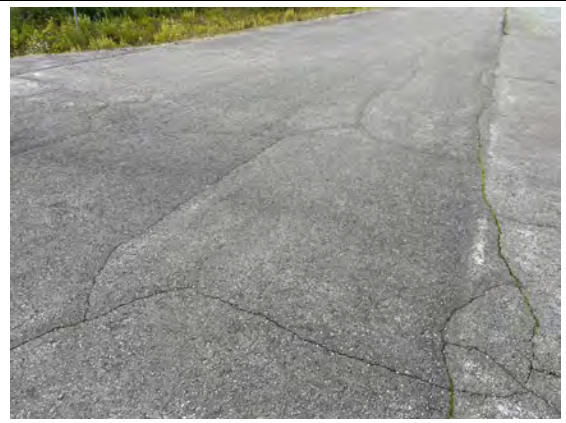
The Basin Taxiway was constructed in 1989 and has received no work since. Common distresses include low to medium severity block cracking, low to medium severity raveling, low to medium severity weathering, and low, medium and high severity alligator cracking. Other distresses observed include high severity depression and severe edge cracking.

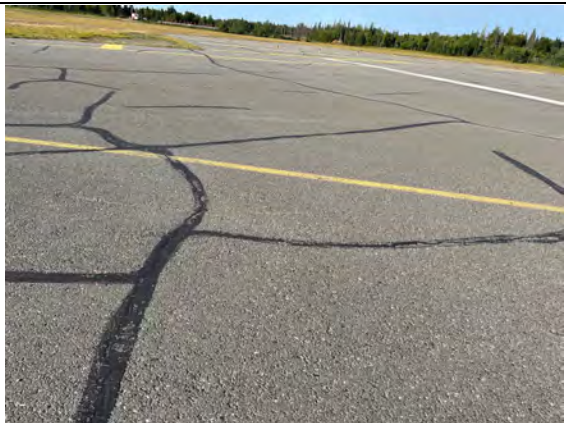
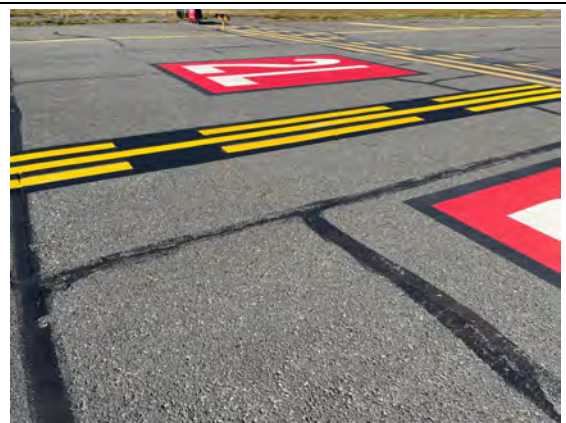
Section 600-01 of Taxiway F was constructed in 1965 and resurfaced in 1989 and 2006. Common distresses include low to medium severity longitudinal and transverse cracking, low to medium severity weathering and low severity raveling. Medium severity raveling was observed at isolated locations.

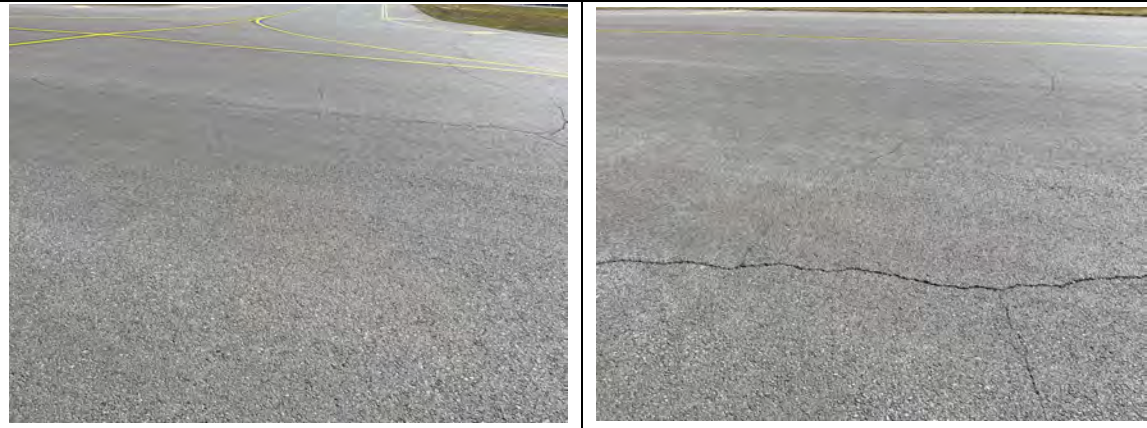
Section 600-02 – PCI 74

Section 600-02 of Taxiway F was constructed in 1965 and resurfaced in 1989, 1994 and 2016. Common distresses include low to medium severity longitudinal and transverse cracking and low severity weathering.

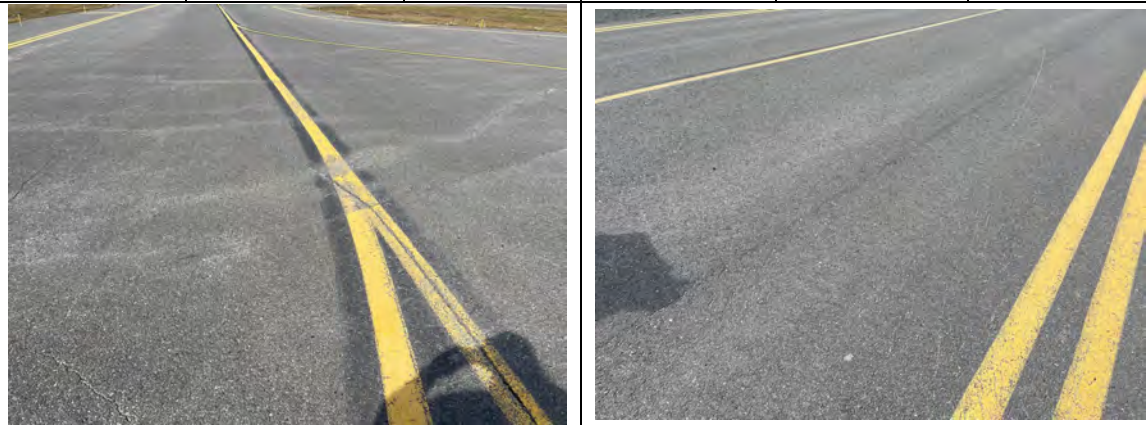
Taxiway G was constructed in 1968 and received resurfacing in 1990 and 2016. Common distresses include low severity longitudinal and transverse cracking and low severity weathering. Small quantities of medium severity longitudinal and transverse cracking and low severity raveling were observed.

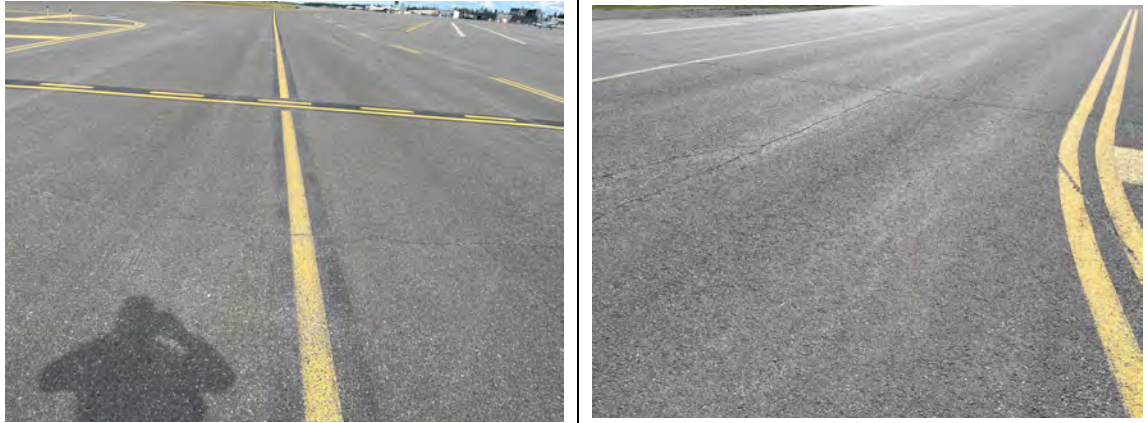
Taxiway H was constructed in 1989 and was resurfaced in 1994 and 2016. Common distresses include low to medium severity longitudinal and transverse cracking, low severity weathering and isolated areas of low severity raveling. A significant number of new longitudinal and transverse cracks were observed this inspection.

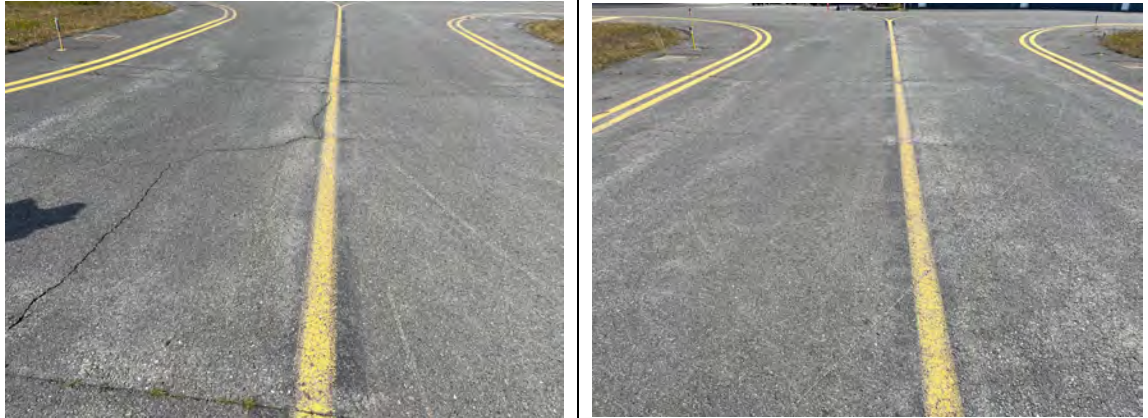
The City Apron Taxiway 1 was constructed in 1989 and resurfaced in 2016. Distresses observed include low to medium severity longitudinal and transverse cracking, low severity weathering and low severity raveling.

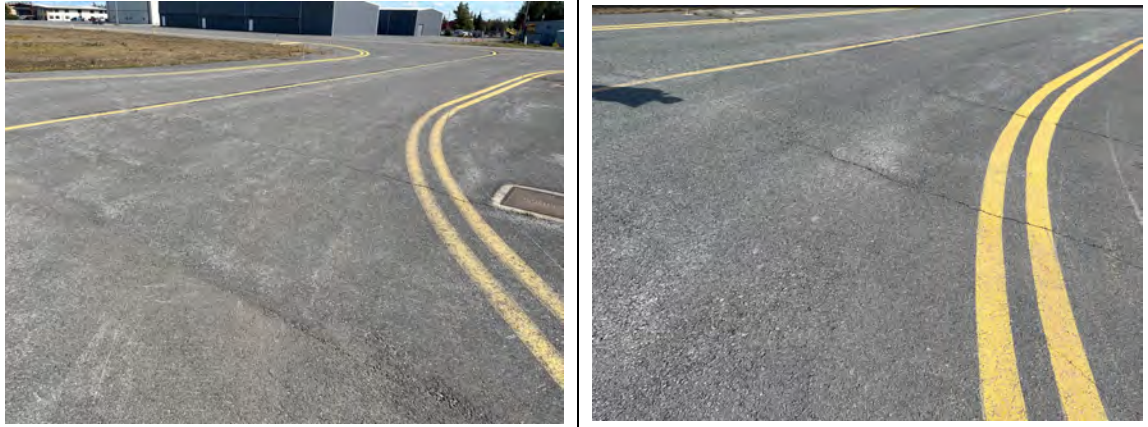
The City Apron Taxiway 2 was constructed in 1989 and resurfaced in 2016. Distresses observed include low to medium severity longitudinal and transverse cracking, low severity weathering and low severity raveling.

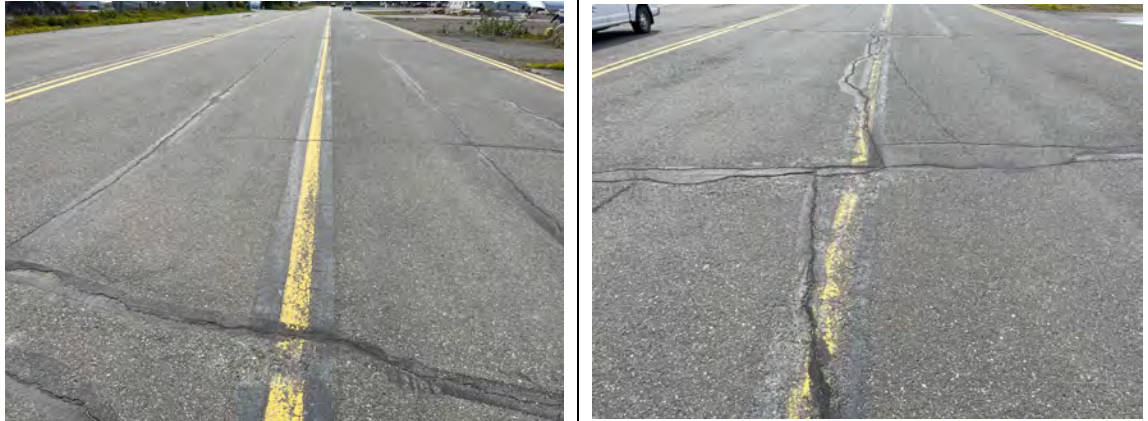
Taxiway J was constructed in 1968 and resurfaced in 1990. Common distresses include low, medium and high severity longitudinal and transverse cracking, low to medium severity raveling and low severity weathering. Other observed distresses are low severity depressions and alligator cracking.

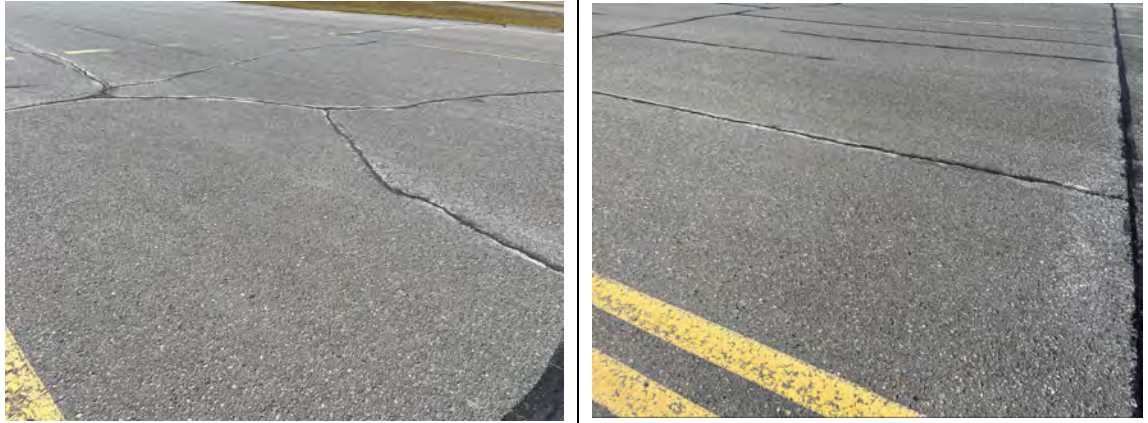
Taxiway K was constructed in 1989. Section 1100-01 was resurfaced in 2006 while 1100-02 was resurfaced in 2010. Common distresses include low, medium and high severity longitudinal and transverse cracking, low severity weathering and low severity raveling. Section 1100-01 includes an area with medium severity swelling at a longitudinal crack with blade damage observed. Section 1100-02 contained one sample with alligator cracking and medium severity weathering occurs over both sections of Taxiway K and.

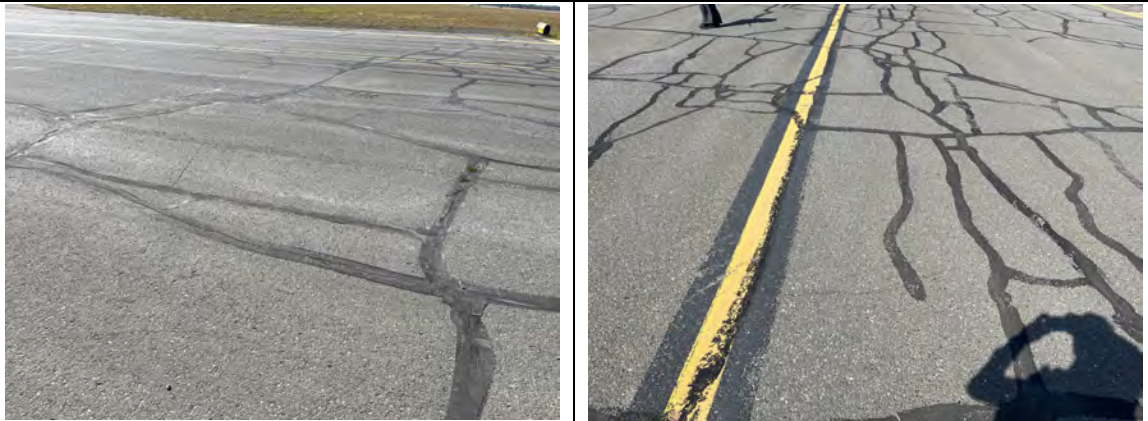
Section 1200-01 of Taxiway L was constructed in 1989 and has received no major work since. It contains low to medium severity block cracking, low severity weathering, and low to medium severity raveling. One small area of alligator cracking was observed.

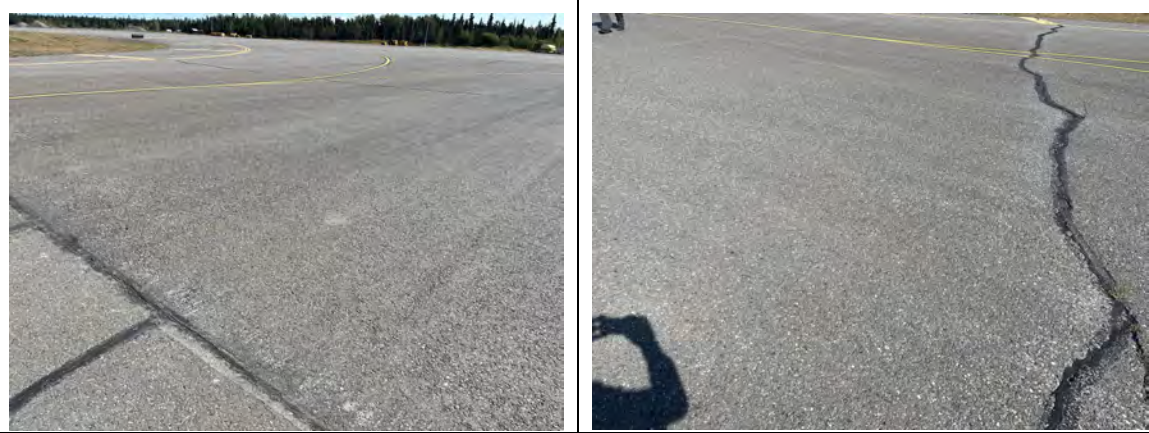
Section 1200-02 – PCI 70

Section 1200-02 of Taxiway L was constructed in 1989 and was reconstructed in 2010. Common distresses are low to medium severity longitudinal and transverse cracking, low severity raveling and low to medium severity weathering.

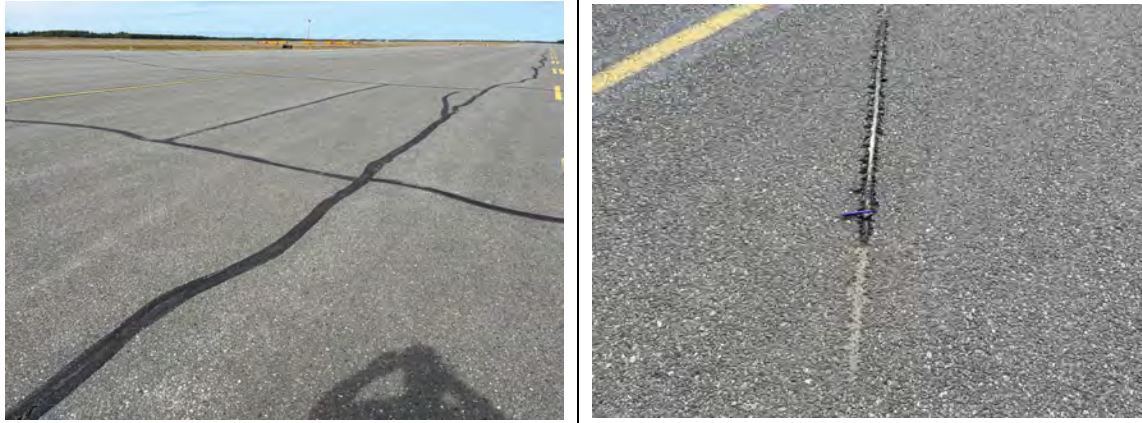
Taxiway J was constructed in 2010 and has received no work since. Common distresses include low severity longitudinal and transverse cracking, and low to medium severity weathering. There are small areas with raveling.

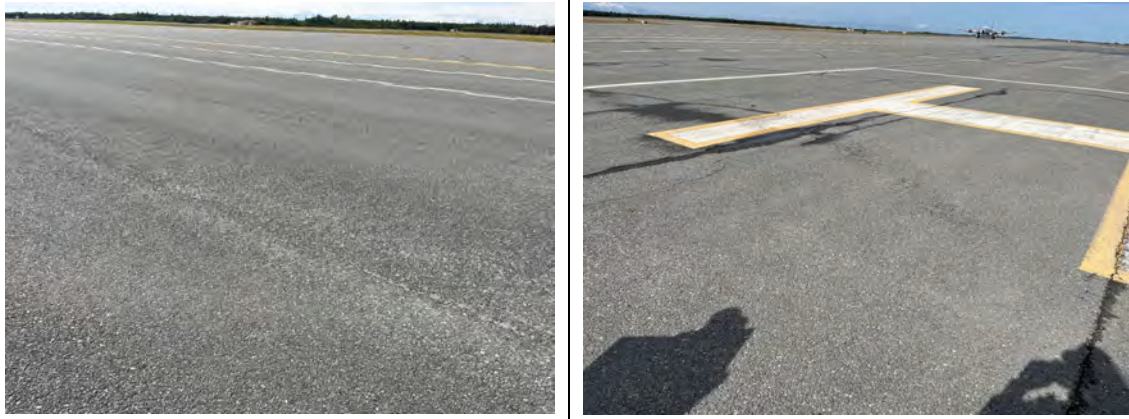
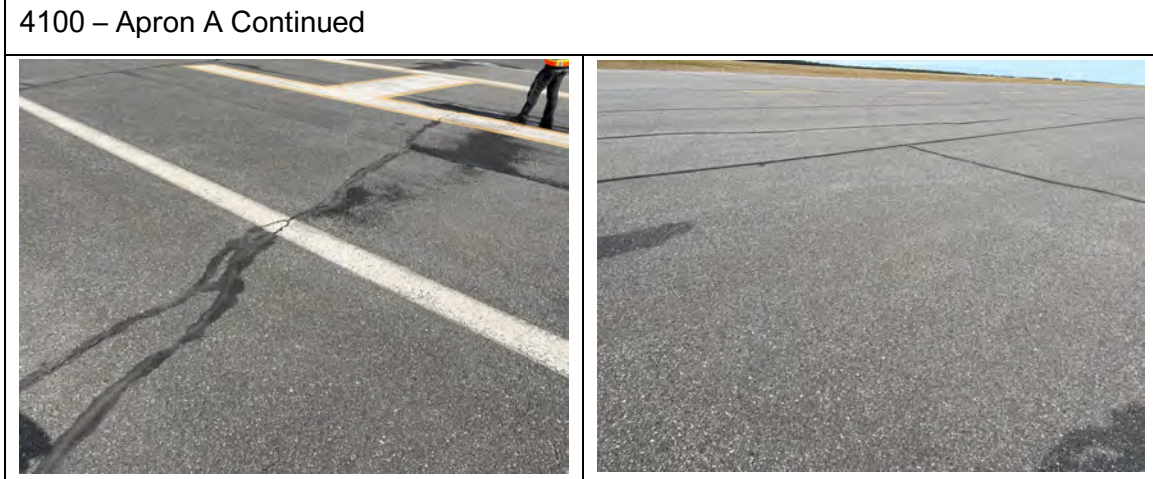
Apron A was constructed in 1965, resurfaced in 1985 and received surface reconstruction in 2010. Common distresses include low to medium severity longitudinal and transverse cracking and low to medium severity weathering.

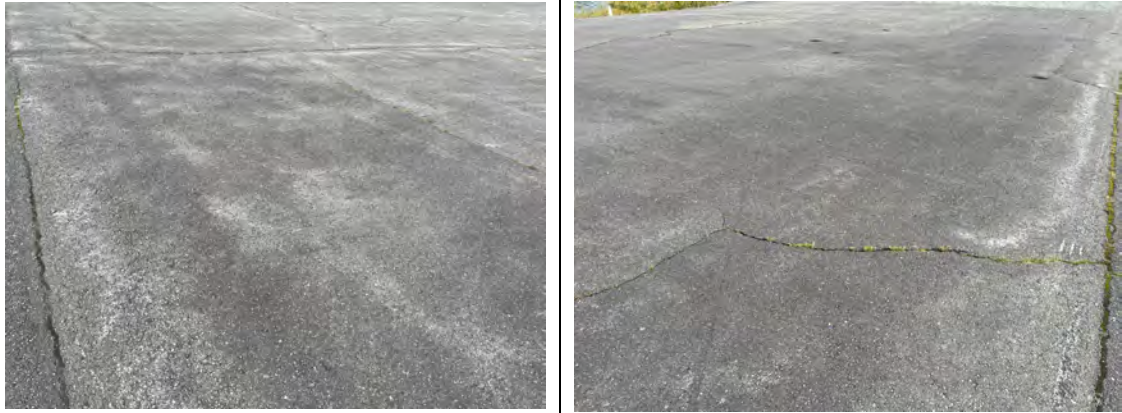
The Basin Ramp was constructed in 1989 and has received no work since. Common distresses include low, medium and high severity longitudinal and transverse cracking, low severity weathering and alligator cracking.

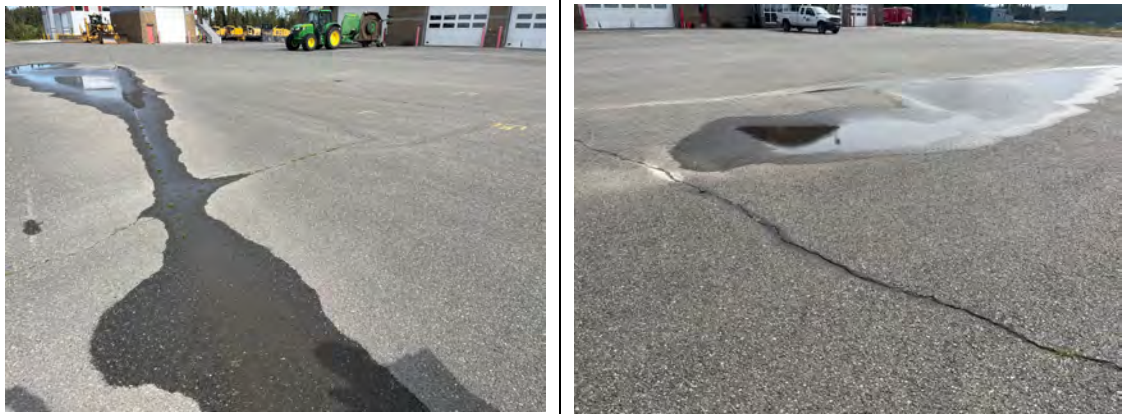
The Operations Building Ramp was constructed in 2002 and resurfaced in 2009. Common distresses include low to medium severity longitudinal and transverse cracking, low severity weathering and raveling, low severity depressions and alligator cracking.

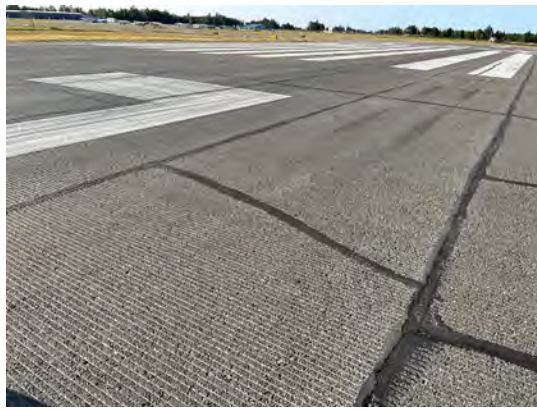
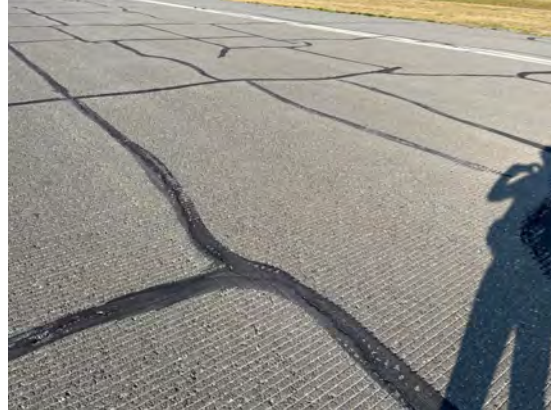
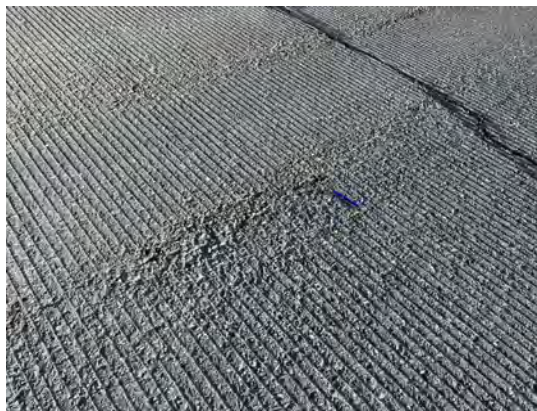
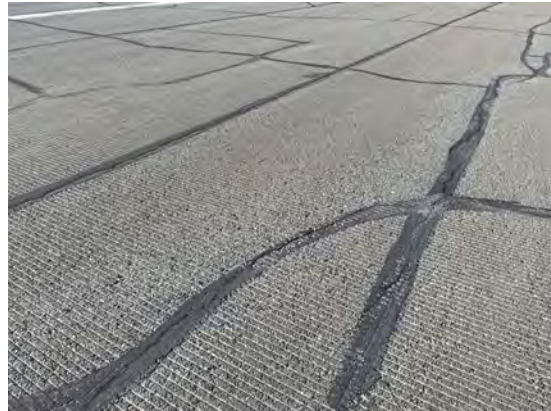
Sections 6100-L, 6100-C and 6100-R – PCI 49

Sections 6100-L, 6100-C and 6100-R were originally constructed in 1965 and have received resurfacing in 1979, 1990 and 2006. Cracking distresses are predominantly low to moderate severity block cracking with intermittent cracks reaching high severity. Moderate and high severity cracks are due to winter plowing operations significantly damaging crack seal allowing FOD potential. Other common distresses include low to moderate severity weathering and raveling.

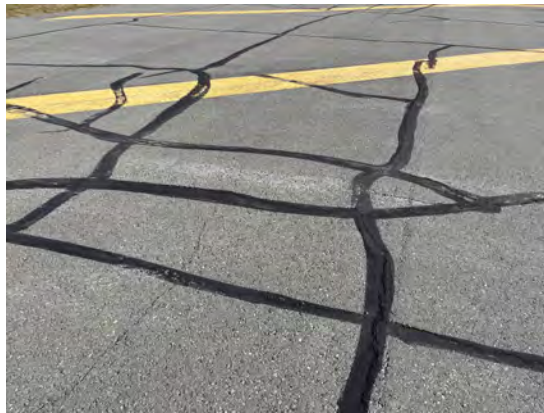
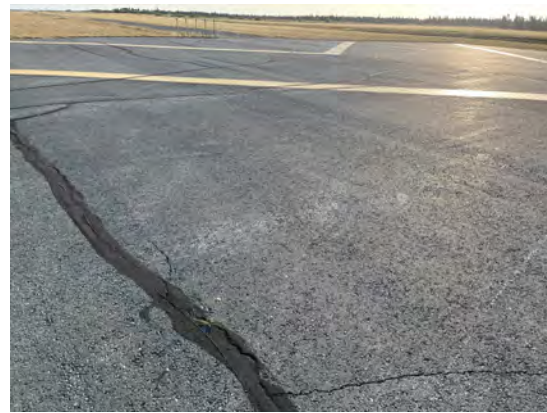
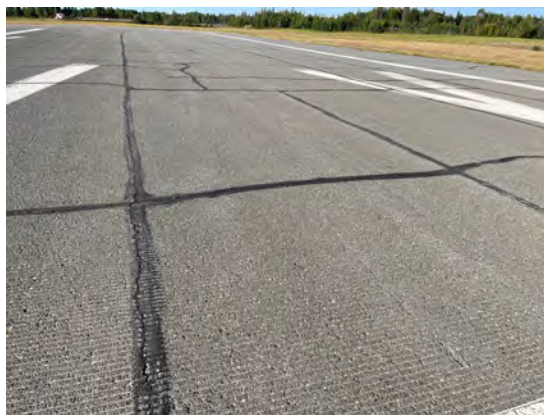
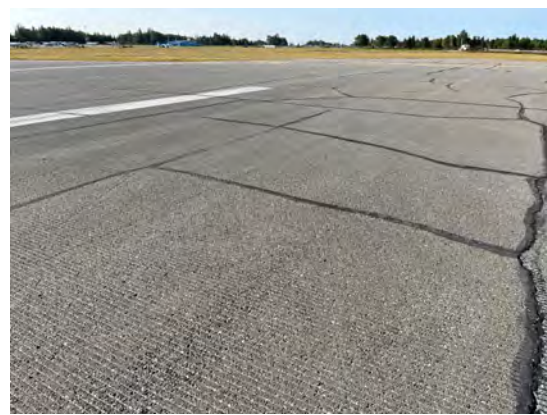
Sections 6100-B, 6100-2 and 6100-3 – PCI 66

Sections 6100-B (PCI 62), 6100-2 (PCI 70) and 6100-3 (67) were constructed in 1990 and resurfaced in 2006. The top two photos are 6100-02 and 6100-03 (blast pads) and bottom two are 6100-B. Common distresses are low to medium severity longitudinal and transverse cracking and low severity weathering. Other distresses include low severity raveling and medium severity weathering.
