## Alaska DOT&PF

# Pavement Inspection Report Ketchikan Airport

Point of Contact	Phone	Email	Date Inspected	Date Published
Mr. Andrew Pavey, Pavement Management Engineer	(907) 269 6213	andrew.pavey@alaska.gov	October 2022	June 2023

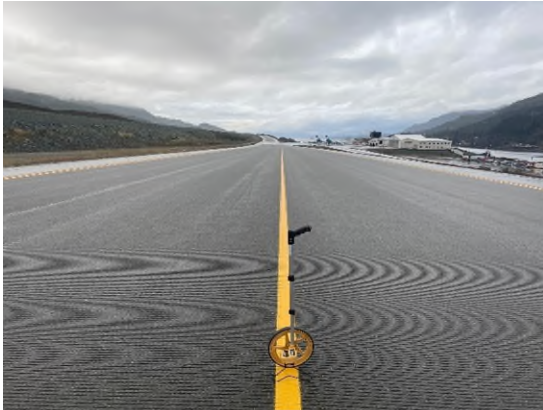
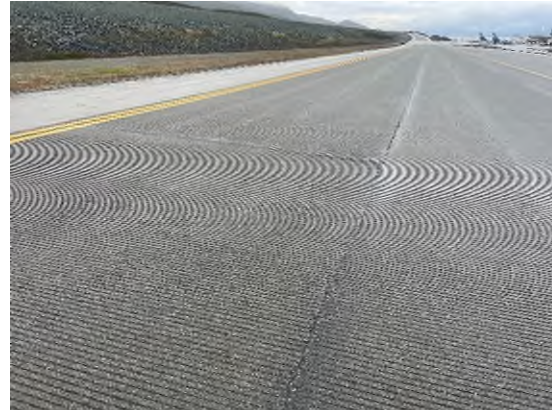
Branch ID	Branch Name	Branch Use	No. of Sections	Area (sf)	Weight Average PCI
0100	Taxiway A	Taxiway	2	238,140	92

Taxiway A was constructed in 1993. The most recent major work on the taxiway was a 2.5-inch AC overlay in 2013. The most common distresses observed are low severity longitudinal and transverse cracking, low severity raveling, and low severity weathering. Field personnel observed degradation of the longitudinal construction joints which is causing longitudinal cracking and raveling to develop.

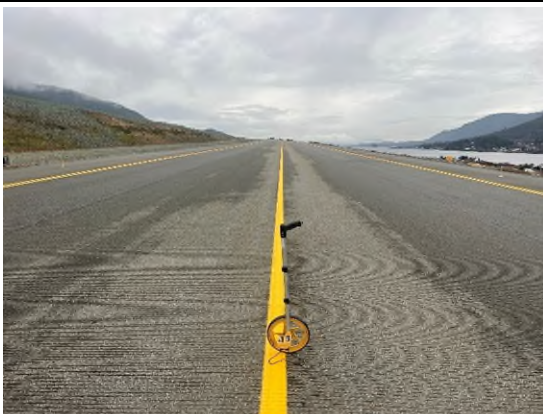
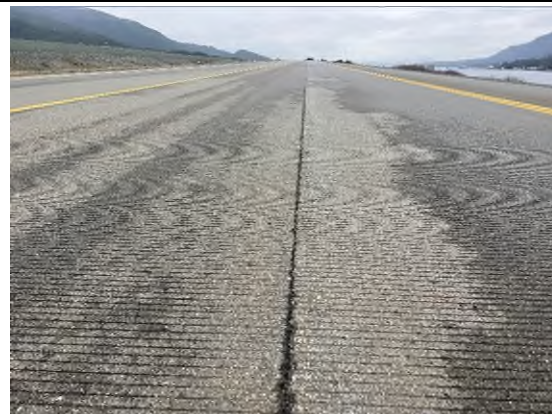
Branch ID	Branch Name	Branch Use	No. of Sections	Area (sf)	Weight Average PCI
0200	Taxiway B	Taxiway	2	200,860	89

Taxiway B was constructed in 2003 and received a 2.5-inch AC overlay in 2013. The most common distresses observed are low to medium severity longitudinal and transverse cracking, low to medium severity raveling, and low severity weathering. Field personnel observed degradation of the longitudinal construction joints which is causing longitudinal cracking and raveling to develop.

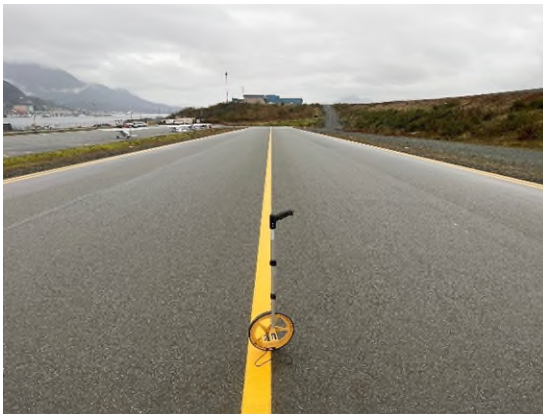
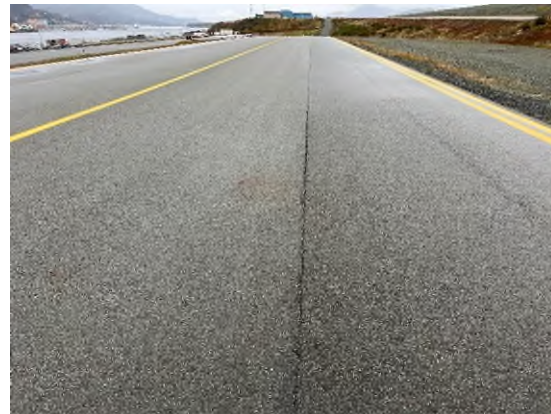
Branch ID	Branch Name	Branch Use	No. of Sections	Area (sf)	Weight Average PCI
0300	Taxiway C	Taxiway	2	61,820	91

Taxiway C was constructed in 1993 and received an AC overlay of variable thickness (2.5 to 3.0 inches) in 2013. The most common distresses observed are low severity longitudinal and transverse cracking, low severity raveling, and low severity weathering. Field personnel observed degradation of the longitudinal construction joints which is causing longitudinal cracking and raveling to develop. This taxiway is intended for use by smaller aircraft, but it often gets used by maintenance vehicles when staff need to access the maintenance building.

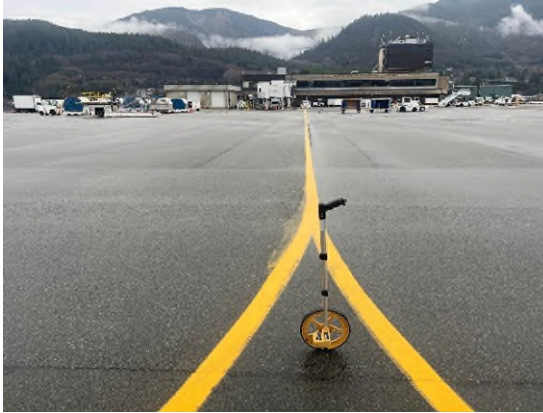
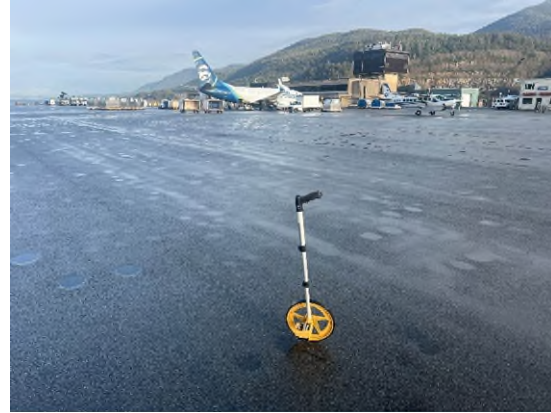
Branch ID	Branch Name	Branch Use	No. of Sections	Area (sf)	Weight Average PCI
4100	Main Apron	Apron	7	392,315	88
<b>AC Sections 4100-01 / 4100-03 / 4100-04 / 4100-05 / 4100-06 / 4100-07</b>

The main apron consists of seven sections, six of which are AC and one is PCC. The six AC sections were constructed in 1993 and these sections received a variable thickness AC overlay (2.0 to 2.5-inch) in 2013. The most common distresses observed are low severity longitudinal and transverse cracking, low severity raveling, and low severity depression. Field personnel observed degradation of the longitudinal construction joints which is causing longitudinal cracking and raveling to develop. Furthermore, widespread dimpling was observed across Section 4100-7 apron creating areas of ponding water. The depth of ponded water in most dimples was measured to be less than ½-inch, and so it was not recorded (per ASTM D5340). However, the large quantity of individual dimpling across section 4100-07 is noteworthy.

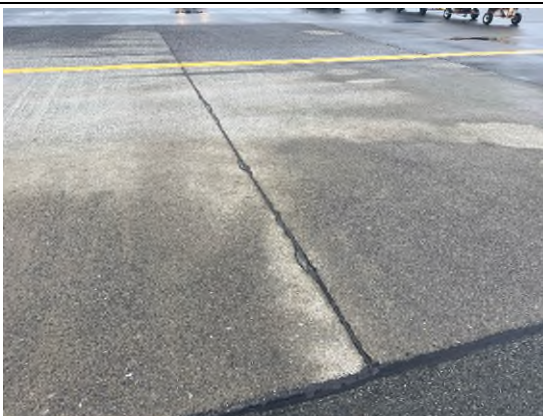
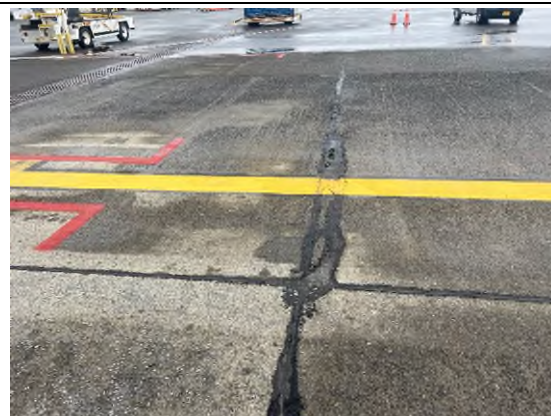
**PCC Section 4100-02: Hardstand 702 (78 PCI) Hardstand 704 (20 PCI)**

The single PCC section on the apron consists of two separate hardstands that were constructed in 1988. There has not been any major work since. Hardstand 702 is the smaller of the two with a PCI of 78. The most common distresses observed on Hardstand 702 are low severity joint and corner spalling, low severity scaling, and medium severity joint seal damage. Hardstand 704 is the larger of the two and has a PCI of 20. The most common distresses observed are medium to high severity joint spalling, medium to high severity scaling, and medium severity joint seal damage. Hardstand 704 has a PCI of 20 in which the ASTM categorizes as **serious**. The numerous high severity distresses observed are consistent with a 35 year old concrete section.

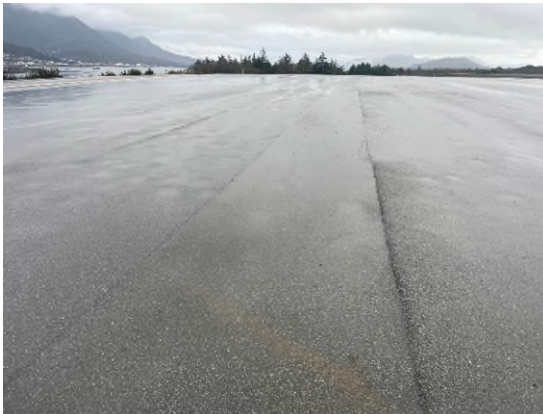
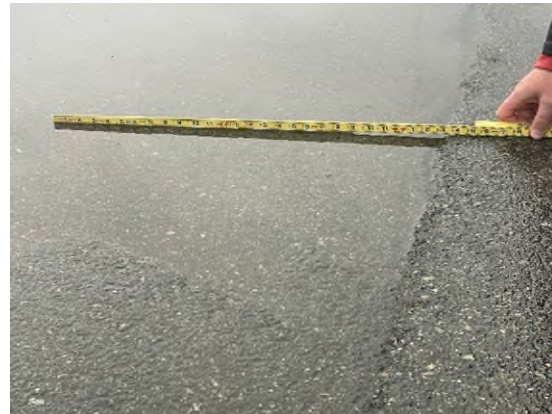
Branch ID	Branch Name	Branch Use	No. of Sections	Area (sf)	Weight Average PCI
4200	Holding Apron	Apron	2	76,240	86

The holding apron was constructed in 1993. The most recent major work conducted on this branch was a 2.5-inch overlay in 2013. The most common distresses observed are low severity longitudinal and transverse cracking, low severity raveling, and low severity weathering. Field personnel observed degradation of the longitudinal construction joints which is causing longitudinal cracking and raveling to develop. Furthermore, dimples were observed across the apron leading to areas of standing water.

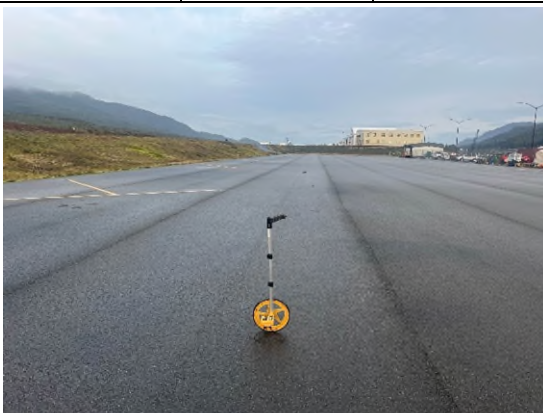
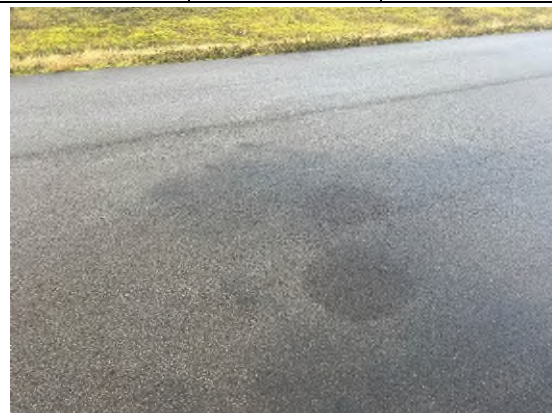
Branch ID	Branch Name	Branch Use	No. of Sections	Area (sf)	Weight Average PCI
4300	General Aviation Apron	Apron	1	127,090	93

The general aviation apron was constructed in 1970 and was most recently received a 3.0-inch overlay in 2013. The most common distresses observed are low severity longitudinal and transverse cracking, low severity raveling, and oil spillage. Field personnel observed degradation of the longitudinal construction joints, which is causing longitudinal cracking and raveling. Areas of oil spillage were also observed.

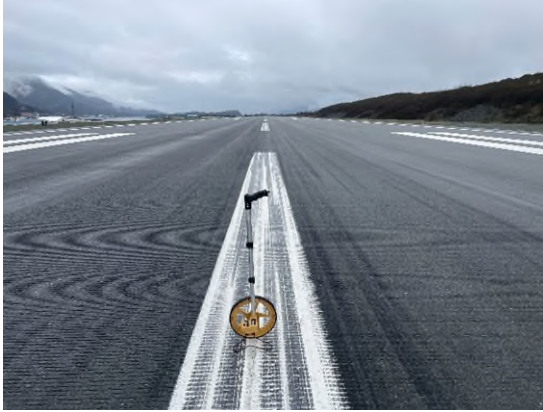
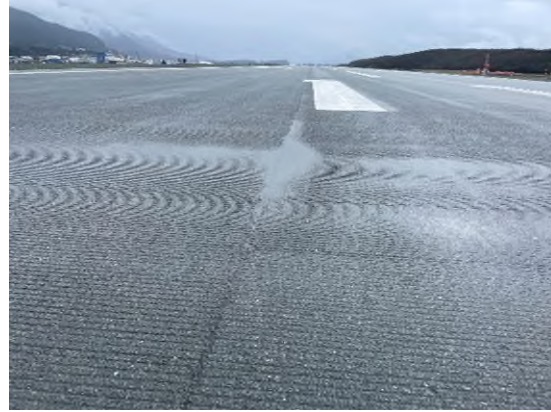
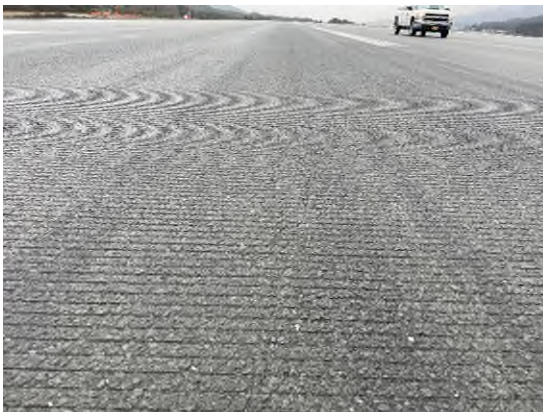
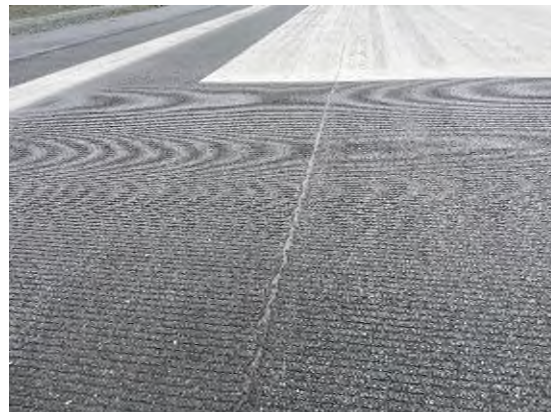
Branch ID	Branch Name	Branch Use	No. of Sections	Area (sf)	Weight Average PCI
6100	Runway 11/29	Runway	5	1,267,500	66

Runway 11/29 was constructed in 1988. It was then reconstructed in 2008. The most common distresses observed are low to medium severity longitudinal and transverse cracking, low to medium severity raveling, and low severity weathering. Field personnel observed degradation of the longitudinal construction joints which is causing longitudinal cracking and raveling to develop. Maintenance staff report that ice domes along the longitudinal construction joints during winter due to the presence of shallow groundwater below the pavement. The formation of ice domes along the longitudinal joints presents a potential runway friction hazard, one which maintenance staff has expressed difficulty mitigating.
