Alaska DOT&PF

Pavement Inspection Report King Salmon Airport

Point of Contact	Phone	Email	Date Inspected	Date Published
Mr. Andrew Pavey, Pavement Management Engineer	(907) 269 6213	andrew.pavey@alaska.gov	April 2024	February 2025

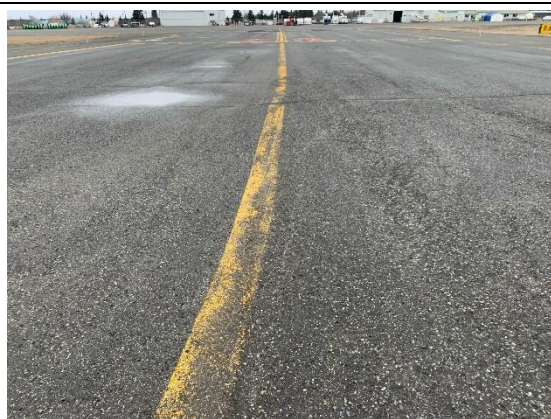
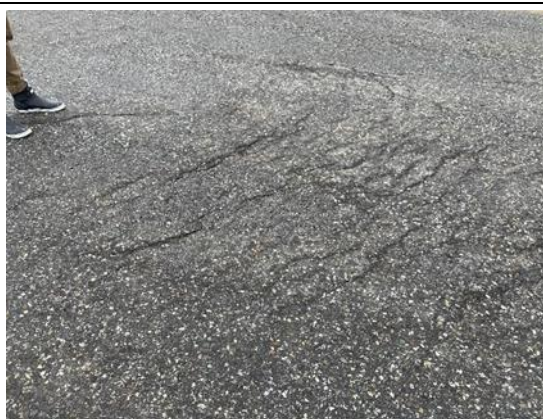
Section 0100-01 (60 PCI)

Taxiway A consists of two sections that were initially constructed in 1989. Section 0100-01 was reconstructed in 2009 and the most recent major work was a 2-inch-thick overlay in 2018. Occasional crack seal operations have been performed on the branch, but the sealant is failing. The most common distresses observed are low severity depressions, low to medium severity longitudinal and transverse cracking, slippage cracking, low severity raveling, and low severity weathering. Field observations of slippage cracking indicate that there is a poor bond between the top lift and the underlying hot mix asphalt (HMA). This bond failure may be due to improper compaction, aging of the materials, or inadequate tack coat application, leading to the relative movement of the layers under traffic loads.

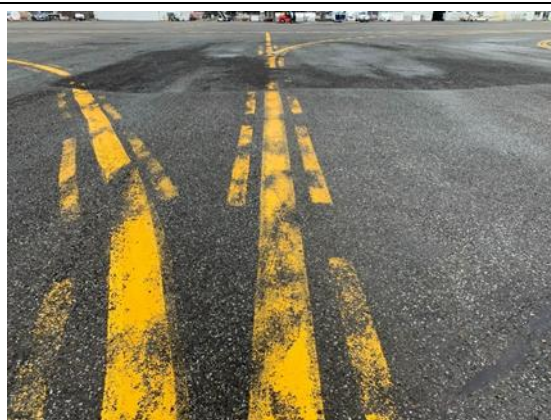
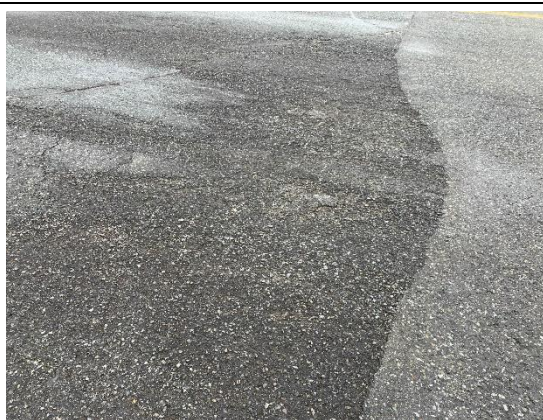
Section 0100-02 (52 PCI)

Section 0100-02 was initially constructed in 1989 and received a 4-inch-thick overlay in 2009. Occasional crack seal operations have been performed on the branch, but the sealant is failing. The most common distresses observed are low to medium severity longitudinal and transverse cracking, low to high severity raveling, and low severity weathering. Field observations include further deterioration of the top layer of HMA which is contributing to higher quantity and severity raveling throughout the branch. The location of high severity raveling pictured above appears to occur along a paving joint.

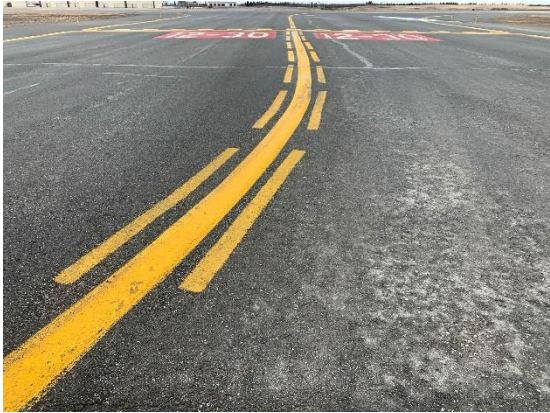
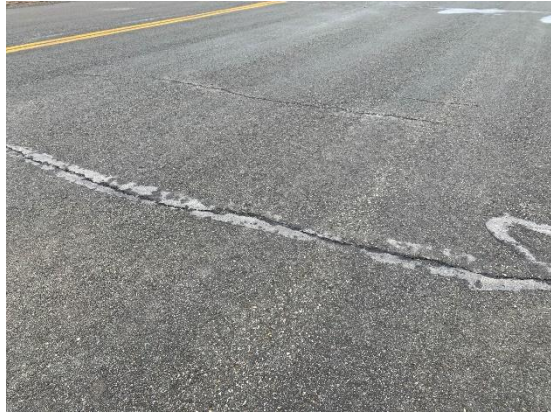
Branch ID	Branch Name	Branch Use	No. of Sections	Area (sf)	Weighted Average PCI
0200	Taxiway B	Taxiway	1	29,142	74

Taxiway B was initially constructed in 1989, was reconstructed in 2009, and received a 2-inch overlay in 2018. Occasional crack seal operations have been performed on the branch. The most common distresses observed are low severity longitudinal and transverse cracking, low severity raveling, and low severity weathering. Field observations noted further deterioration of the top layer of HMA which is contributing to higher quantity of raveling throughout the branch.

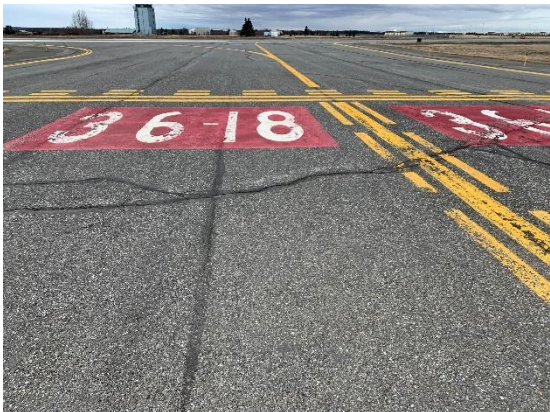
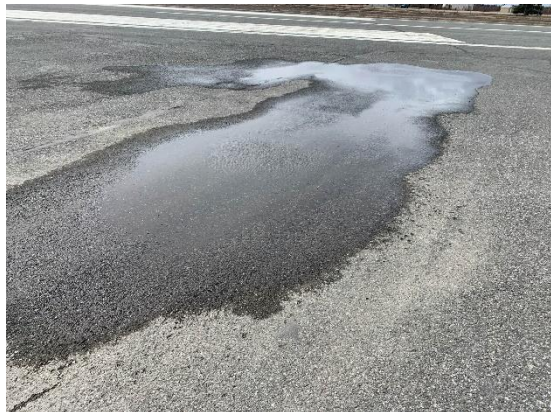
Branch ID	Branch Name	Branch Use	No. of Sections	Area (sf)	Weighted Average PCI
0300	Taxiway C	Taxiway	2	224,788	71

Taxiway C consists of two sections, 0300-01 and 0300-02, which were initially constructed in 1985 and 1972, respectively. Both sections were reconstructed in 2009 and have not received any major work since. Occasional crack seal operations have been performed on the branch. The most common distresses observed are low severity depressions, low severity longitudinal and transverse cracking, low severity raveling, and low severity weathering. Field observations include sealed cracks and numerous depressions holding water which are accelerating the raveling of the pavement.

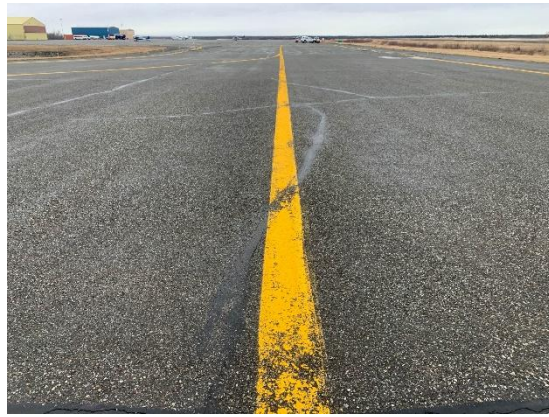
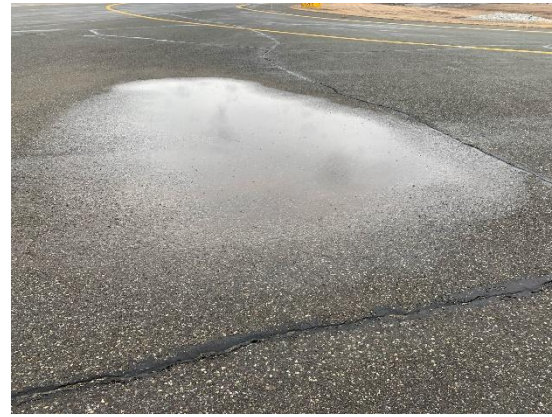
Section 0400-01 (67 PCI)

Taxiway D consists of two sections that were both initially constructed in 1986. Section 0400-01 was reconstructed in 2009 and received a sand-tar surface treatment in 2014. Occasional crack seal operations have been performed on the branch. The most common distresses observed are low severity depressions, low to medium severity longitudinal and transverse cracking, low severity raveling, and low severity weathering. Field observations include sealed cracks and numerous depressions holding water, which are accelerating the raveling of the pavement.

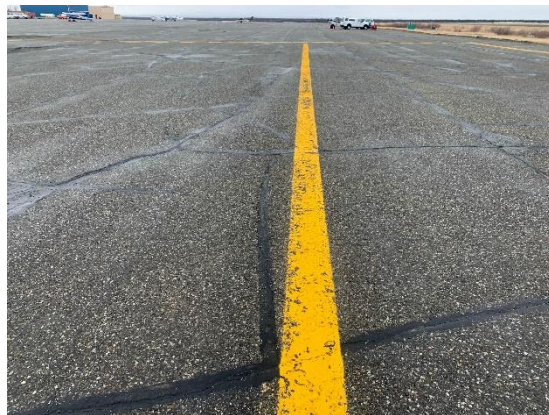
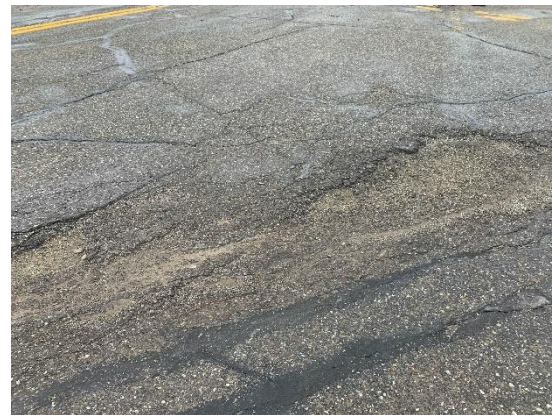
Section 0400-02 (34 PCI)

Section 0400-02 was initially constructed in 1986 and received a sand-tar surface treatment in 2014. Occasional crack seal operations have been performed on the branch, though the pavement is in very poor condition. The most common distresses observed are medium severity alligator cracking, low severity block cracking, medium to high severity longitudinal and transverse cracking, low to high severity raveling, and low severity weathering. Field observations include a rapidly degrading pavement that is fully block cracked in addition to other distresses.

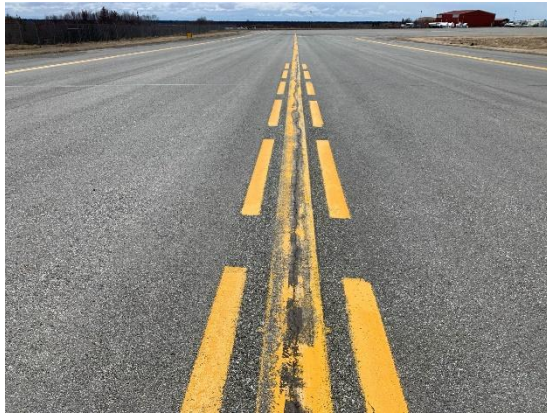
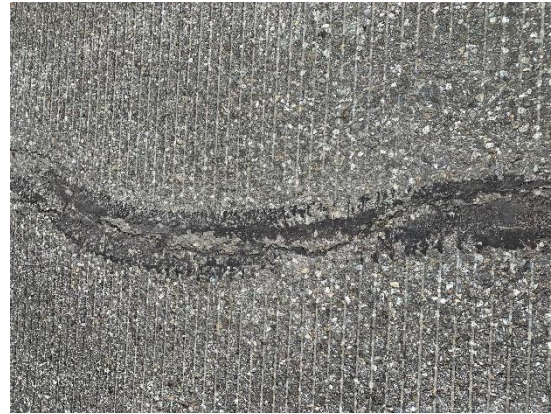
Branch ID	Branch Name	Branch Use	No. of Sections	Area (sf)	Weighted Average PCI
0500	Taxiway E	Taxiway	1	52,343	81

Taxiway E was initially constructed in 1972 and was reconstructed in 2009. The most recent major work was a 2-inch-thick overlay in 2018. Occasional crack seal operations have been performed on the branch. The most common distresses observed are low severity longitudinal and transverse cracking, low severity raveling, and low severity weathering. Field observations include sealed cracks, the pavement surface beginning to weather, and localized areas of raveling.

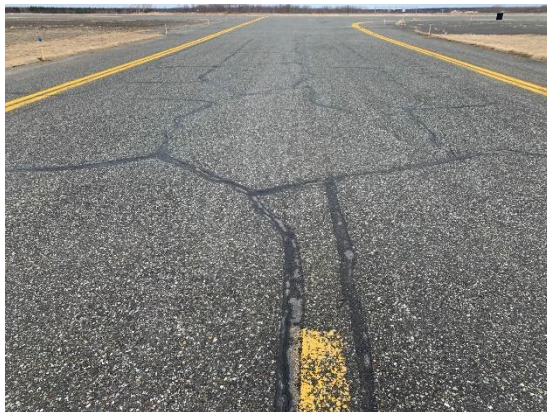
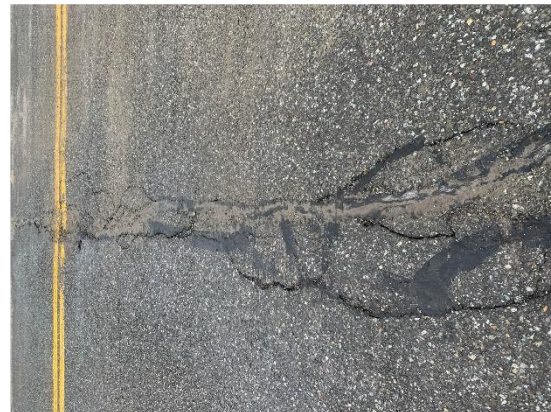
Branch ID	Branch Name	Branch Use	No. of Sections	Area (sf)	Weighted Average PCI
0700	Taxiway G	Taxiway	1	11,777	55

Taxiway G was constructed in 2008 and has not received any major work since. Occasional crack seal operations have been performed on the branch. The most common distresses observed are low severity block cracking, low severity longitudinal and transverse cracking, low severity raveling, and low severity weathering. Field observations noted two high-severity transverse cracks near Runway 18/36. Although these cracks have been sealed, they remain a high-severity distress despite the sealant. Additionally, the sealant is showing signs of deterioration, which may allow for further water infiltration and subsequent damage.

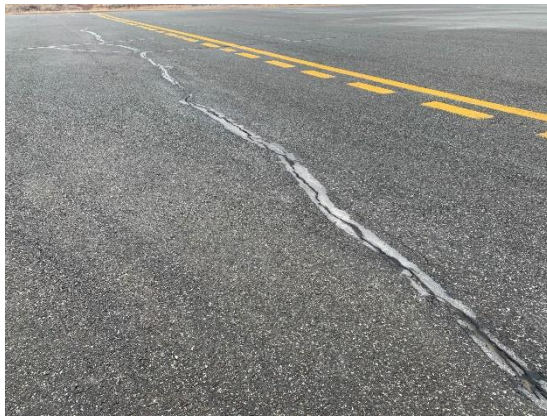
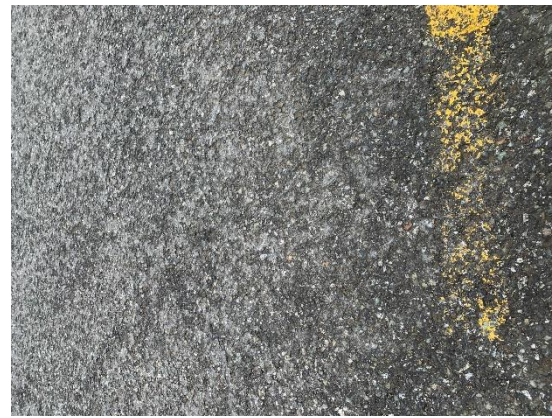
Branch ID	Branch Name	Branch Use	No. of Sections	Area (sf)	Weighted Average PCI
0900	West Apron Taxilane	Taxiway	1	42,967	72

The West Apron Taxilane was initially constructed in 1991 and was reconstructed in 2009. Occasional crack seal operations have been performed on the branch. The most common distresses observed are low to medium severity longitudinal and transverse cracking, low severity raveling, and low severity weathering. Field observations include a weathered and raveled pavement that has old crack sealant which is beginning to fail.

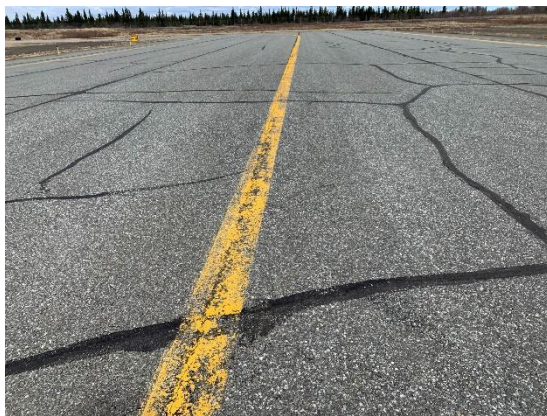
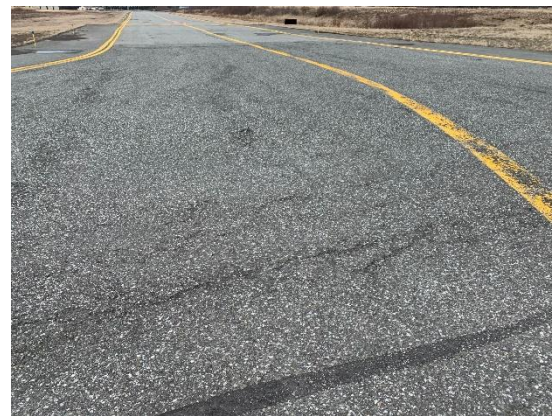
Branch ID	Branch Name	Branch Use	No. of Sections	Area (sf)	Weighted Average PCI
1400	Taxiway N	Taxiway	1	40,501	64

Taxiway N was initially constructed in 1950 and was reconstructed in 2008. Occasional crack seal operations have been performed on the branch. The most common distresses observed are low severity block cracking, low severity longitudinal and transverse cracking, low to medium severity raveling, and low severity weathering. Field observations include localized spots of medium to high severity cracking and medium severity raveling, all near the military taxiway.

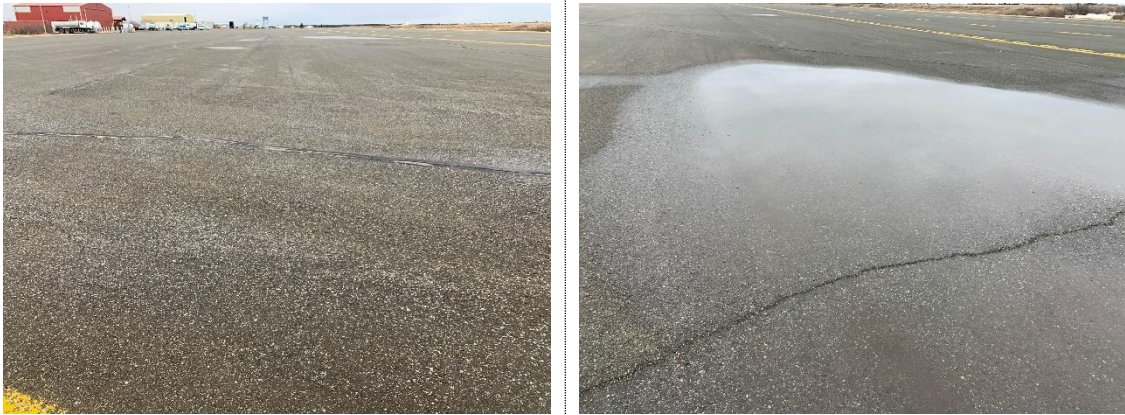
Branch ID	Branch Name	Branch Use	No. of Sections	Area (sf)	Weighted Average PCI
4100	East Apron	Apron	1	183,407	68

The East Apron was constructed in 1972 and was reconstructed in 2009. The most common distresses observed are low to medium severity depressions, low to medium severity longitudinal and transverse cracking, low severity raveling, and low severity weathering. Field observations include standing water within depressions and the presence of some old crack sealant, although numerous cracks remain unsealed.

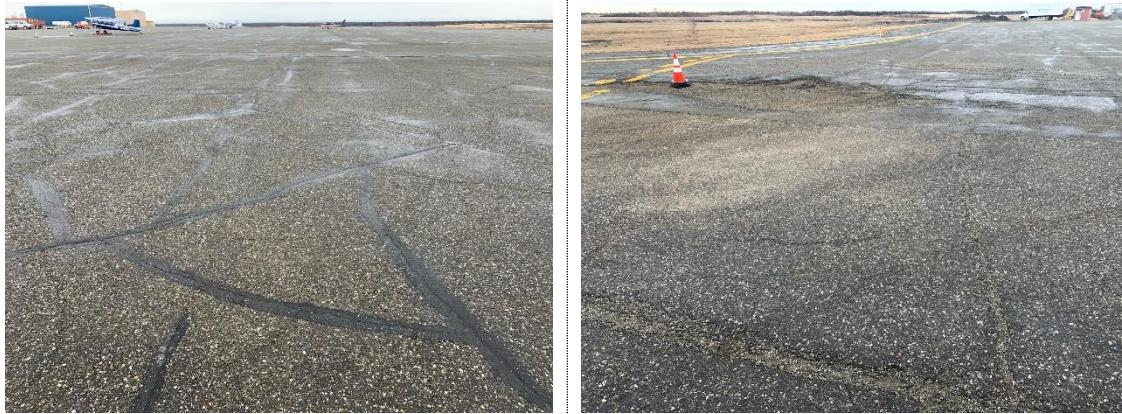
Section 4300-01 (47 PCI)

The Southeast Ramp consists of two sections that were both initially constructed in 1986. Section 4300-01 (269,195 sq ft) received a sand-tar surface treatment in 2014. Occasional crack seal operations have been performed on the branch, but the sealant is failing. The most common distresses observed are low to medium severity block cracking, low severity raveling, and low severity weathering. Field observations include a highly block cracked apron with localized spots of high severity cracking, high severity patching, and high severity raveling.

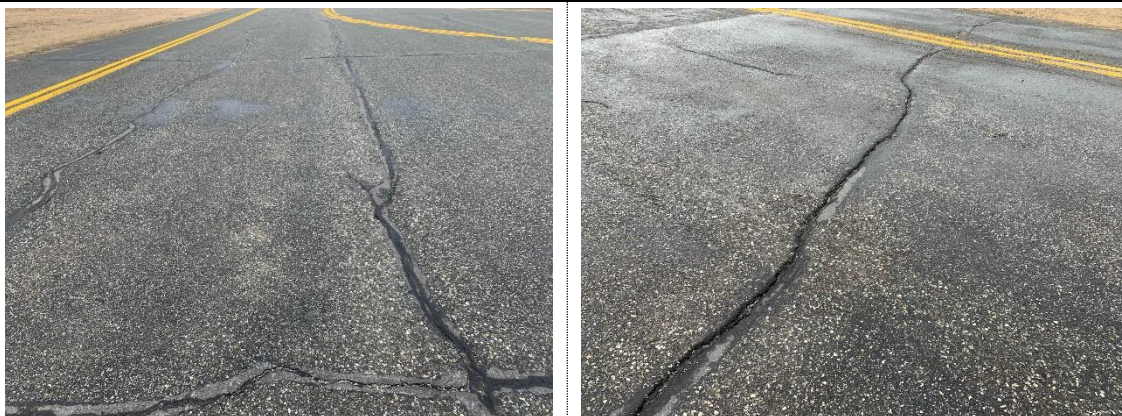
Section 4300-02 (70 PCI)

Section 4300-02 (29,159 sq ft) was initially constructed in 1986 and was reconstructed in 2009. Occasional crack seal operations have been performed on the branch. The most common distresses observed are low to medium severity longitudinal and transverse cracking, low severity raveling, and low severity weathering. Field observations include numerous sealed longitudinal and transverse cracks in which some of the sealant is beginning to fail.

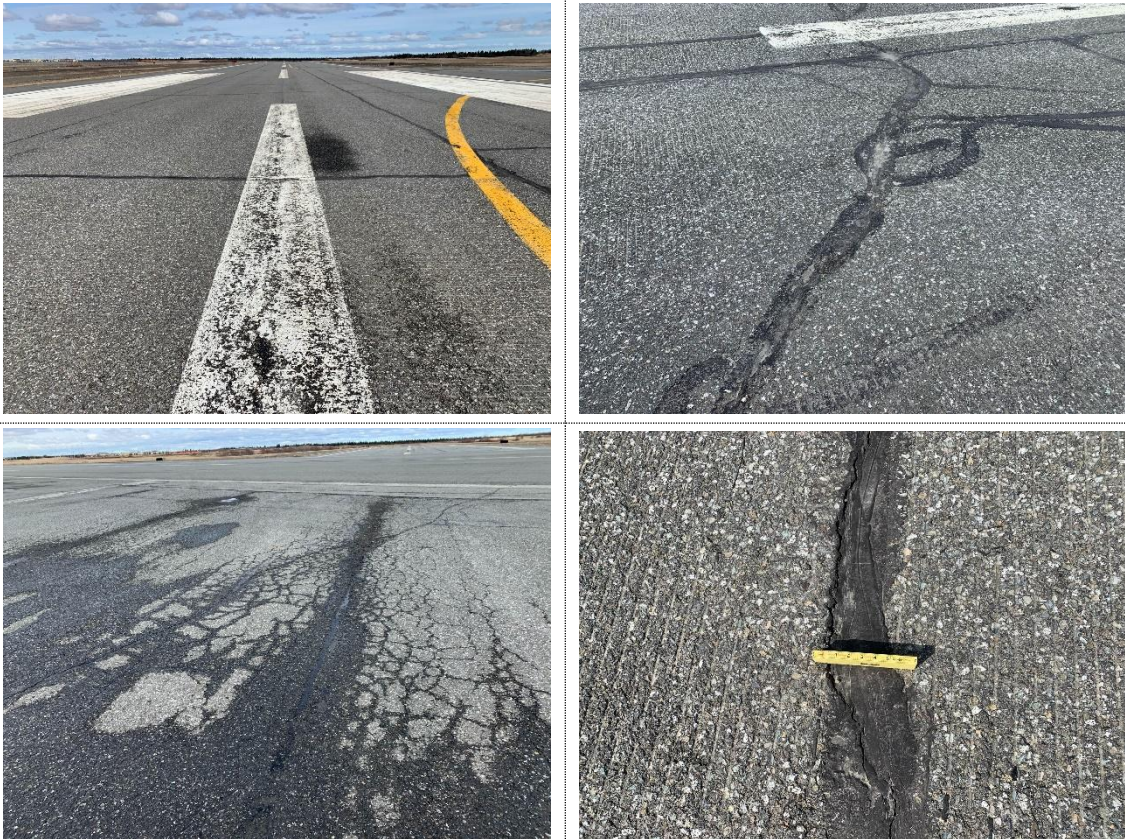
Branch ID	Branch Name	Branch Use	No. of Sections	Area (sf)	Weighted Average PCI
6200	Runway 18/36	Runway	4	444,000	65

Runway 18/36 was initially constructed in 1991 and was reconstructed in 2008. Occasional crack seal operations have been performed on the runway. The most common distresses observed are low to medium severity longitudinal and transverse cracking, low severity raveling, and low severity weathering. Field observations include an additional sample unit being recorded at the south side of the intersection with Runway 12/30. The distresses observed include medium to high severity alligator cracking, medium severity depression, medium severity shoving, and medium to high severity raveling.
