Alaska DOT&PF

Pavement Inspection Report Klawock Airport

Airport Name	IATA	ICAO	Latitude	Longitude	Elevation (ft)
Klawock Airport	AKW	PAKW	55° 34'45.2"N	133° 4'33.6"W	79.7

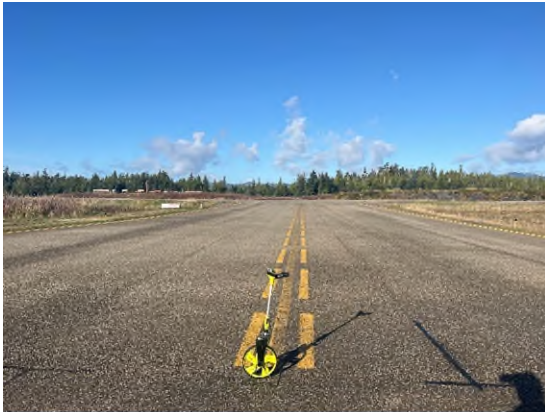
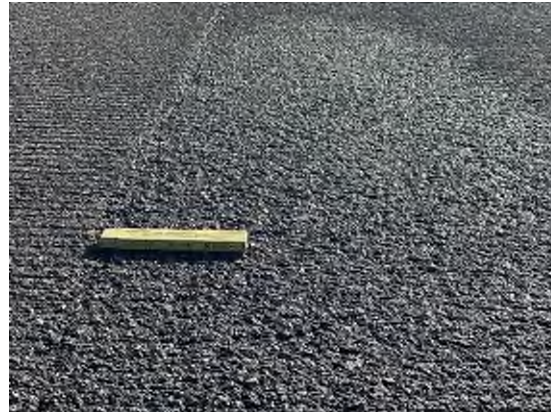
Branch ID	Branch Name	Branch Use	No. of Sections	Area (sf)	Weight Average PCI
0200	Taxiway B	Taxiway	1	26,000	70

Taxiway B was constructed in 1988 and was reconstructed in 2008. The most common distresses observed are low severity longitudinal and transverse cracking, low to medium severity raveling, and low to medium severity weathering. Our field personnel observed an increased loss of fine aggregate (weathering), which is exposing the coarse aggregate and in some areas the removal of the coarse aggregate altogether (raveling).

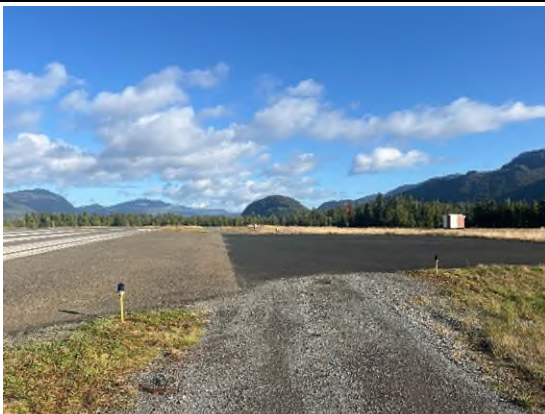
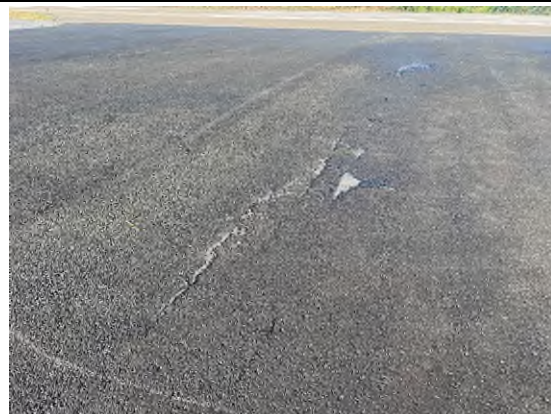
Branch ID	Branch Name	Branch Use	No. of Sections	Area (sf)	Weight Average PCI
0300	Taxiway C	Taxiway	1	10,900	73

Taxiway C was constructed in 1988. In 2018, the taxiway received a 2-inch overlay. The most common distresses observed are low to medium to high severity raveling, low severity weathering, and bleeding. The weathering and raveling are significant for a 4-year old pavement (at the time of inspection). Also noted were a considerable area of bleeding, which is caused by problems with the asphalt concrete mix properties, such as excessive asphalt binder and/or low air voids.

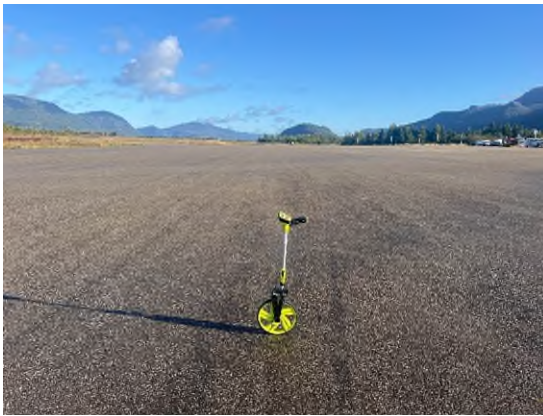
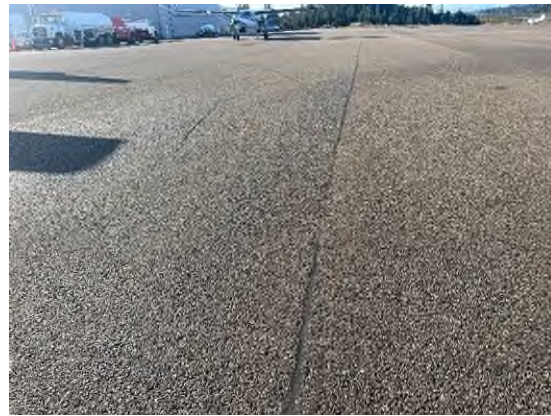
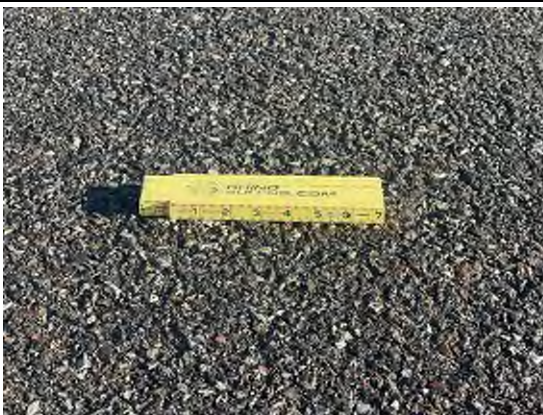
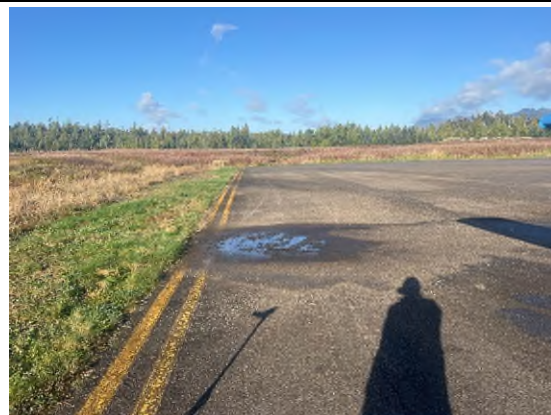
Branch ID	Branch Name	Branch Use	No. of Sections	Area (sf)	Weight Average PCI
4100	Apron	Apron	1	360,000	71

The aircraft parking apron was constructed in 1988 and was reconstructed in 2008. The most common distresses observed are low severity longitudinal and transverse cracking, low to medium to high severity raveling, and low to medium severity weathering. Our field personnel observed an increased loss of fine aggregate (weathering), which is exposing the coarse aggregate and in some areas the removal of the coarse aggregate altogether (raveling). Areas of mechanical damage appears to be causing the high severity raveling. Along the southwest edge of the apron, our field personnel observed a large depression which is retaining water (see photo above). Repair of this area of the parking apron is needed to correct the grade and create positive drainage off the pavement surface.

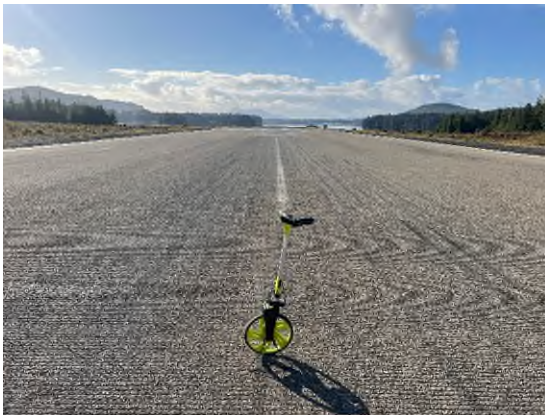
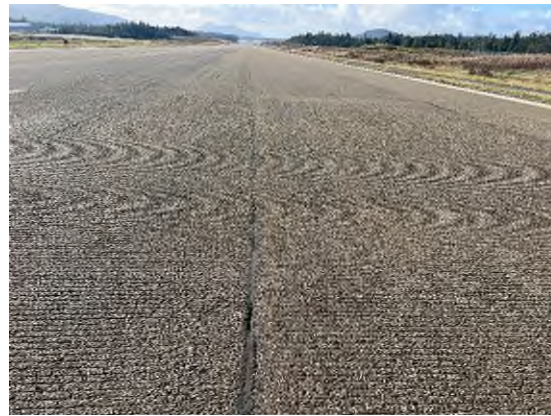
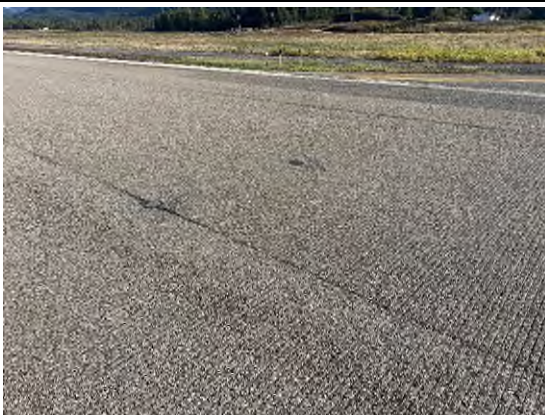
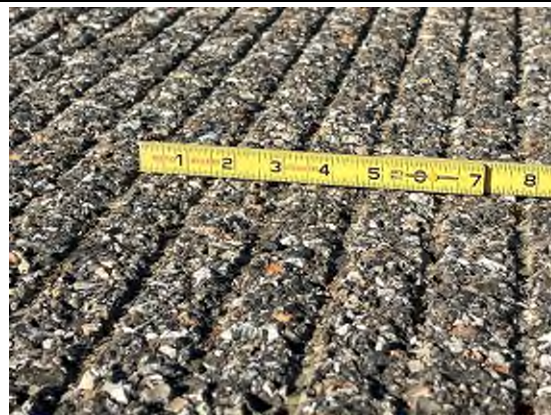
Branch ID	Branch Name	Branch Use	No. of Sections	Area (sf)	Weight Average PCI
6100	Runway 02/20	Runway	2	500,000	75

Runway 02/20 was constructed in 1988 and reconstructed in 2008. The most common distresses observed are low severity longitudinal and transverse cracking, low to medium severity raveling, and low to medium severity weathering. We observed the loss of the fine aggregate along the longitudinal construction joints which is exposing the coarse aggregate (weathering) and in some areas the removal of the coarse aggregate altogether (raveling).
