Alaska DOT&PF

Pavement Inspection Report Kodiak Airport

Airport Name	IATA	ICAO	Latitude	Longitude	Elevation (ft)
Kodiak Airport	ADQ	PADQ	57° 44' 59.258" N	152° 29' 38.197" W	78.7

Point of Contact	Phone	Email	Date Inspected	Date Published
Mr. Andrew Pavey, Pavement Management Engineer	(907) 269 6213	andrew.pavey@alaska.gov	May 2023	September 2023

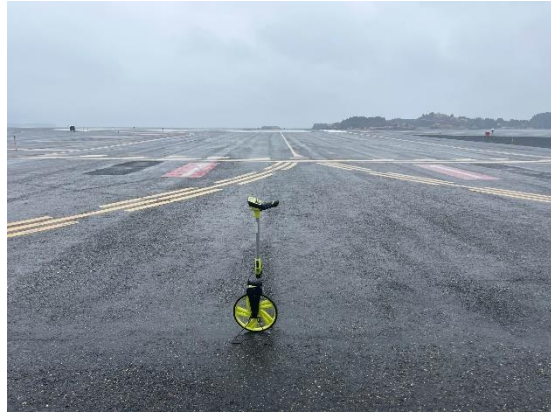
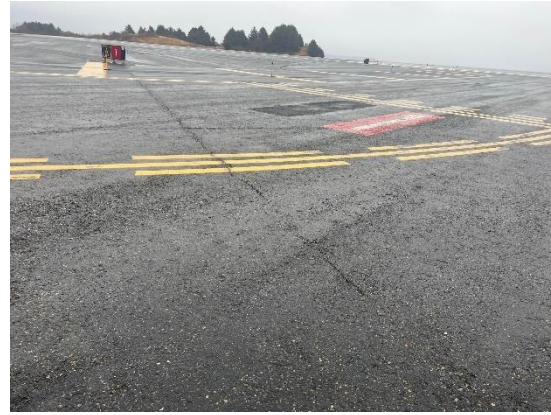
Branch ID	Branch Name	Branch Use	No. of Sections	Area (sf)	Weighted Average PCI
0100	Taxiway A	Taxiway	1	18,490	73

Taxiway A was initially constructed in 1995 and was reconstructed and reconfigured in 2012. Crack seal operations have not been performed on the branch. The most common distresses observed are low to medium severity longitudinal and transverse cracking, low to medium severity raveling, and low severity weathering. Field observations include wearing of the pavements surface leading to isolated areas of raveling and the creation of new unfilled cracks. Paint removal accounts for the increased quantities of raveling.

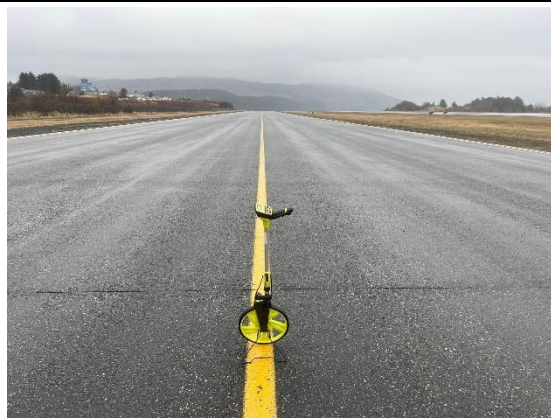
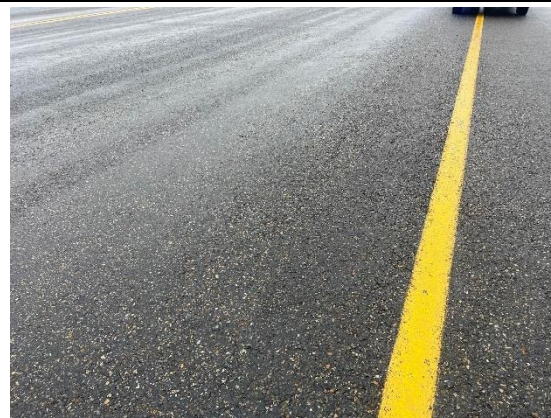
Branch ID	Branch Name	Branch Use	No. of Sections	Area (sf)	Weighted Average PCI
0200	Taxiway B	Taxiway	1	232,165	84

Taxiway B was initially constructed in 1942 as concrete and the most recent major work was a surface reconstruction in 2012. Crack seal operations have not been performed on the branch. The most common distresses observed are low severity longitudinal and transverse cracking, low to medium severity raveling, and low severity weathering. Field observations include wearing of the pavements surface which contributes to the weathering, and the creation of new unfilled cracks.

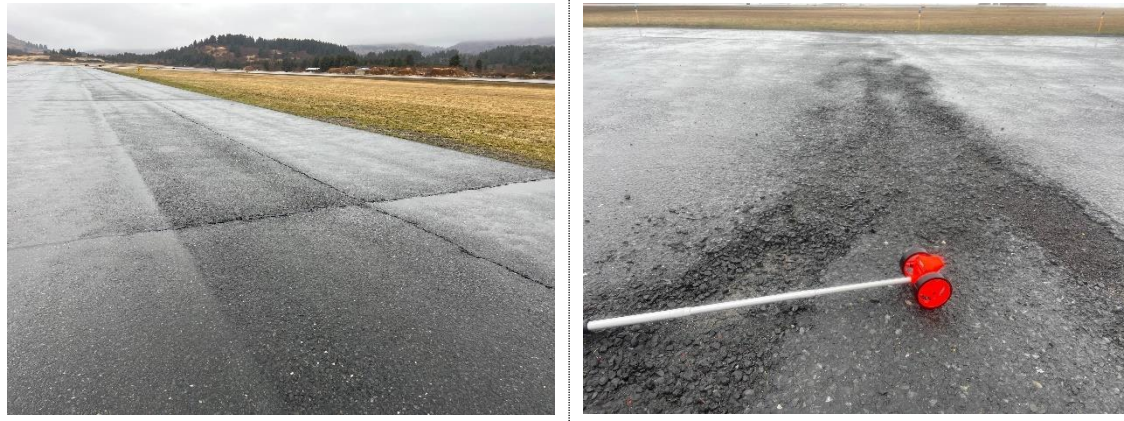
Section 0300-01 (56 PCI)

Taxiway C consists of 2 sections, of which section 0300-01 B was initially constructed in 1942 as concrete and the most recent major work was a 2-inch overlay in 2001. Annual crack seal operations have been performed on this section but should be replaced. The most common distresses observed are low to medium to high severity joint reflective cracking, low to medium severity longitudinal and transverse cracking, low to medium severity raveling, and low to medium severity weathering. Field observations include the development of new unfilled cracks, the widening of joint reflective cracking, and the deterioration of the pavements surface leading to large areas of raveling across the taxiway.

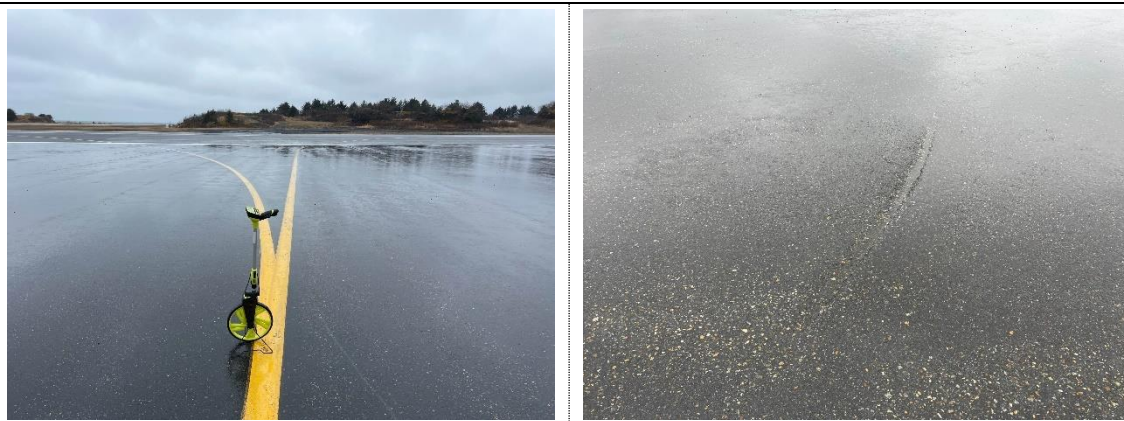
Section 0300-02 (85 PCI)

Taxiway C section 0300-02 was initially constructed in 1990 and received surface reconstruction in 2015. Crack seal operations have not been performed on this section. The most common distresses observed are low to medium severity raveling and low severity weathering. Field observations include the pavements surface beginning to weather and a few mechanical gouges from snowplow activities.

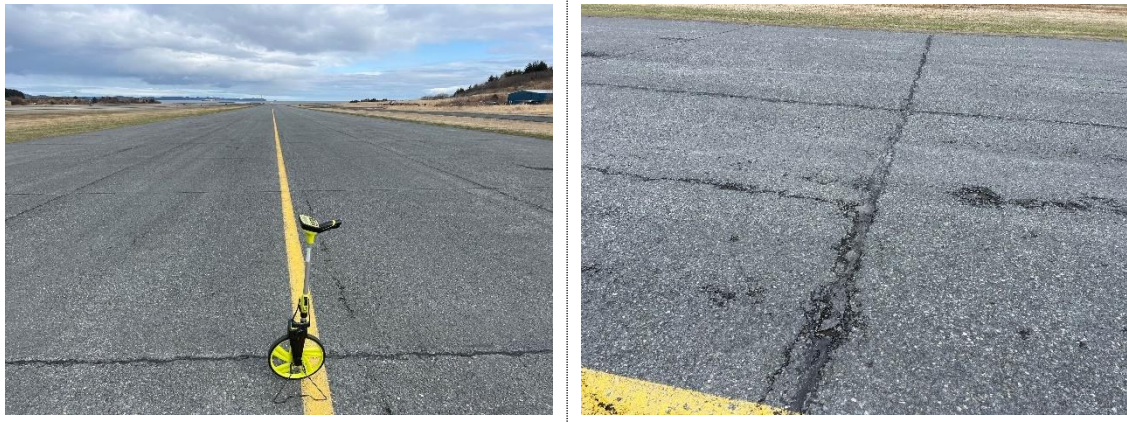
Branch ID	Branch Name	Branch Use	No. of Sections	Area (sf)	Weighted Average PCI
0400	Taxiway D	Taxiway	1	297,693	56

Taxiway D was initially constructed in 1942 as concrete and the most recent major work was a 2-inch overlay in 2001. Annual crack seal operations have been performed on the branch but should be replaced. The most common distresses observed are low to medium to high severity joint reflective cracking, low to medium severity longitudinal and transverse cracking, low to medium severity raveling, and low to medium severity weathering. Field observations include the development of new unfilled cracks and the widening of joint reflective cracking.

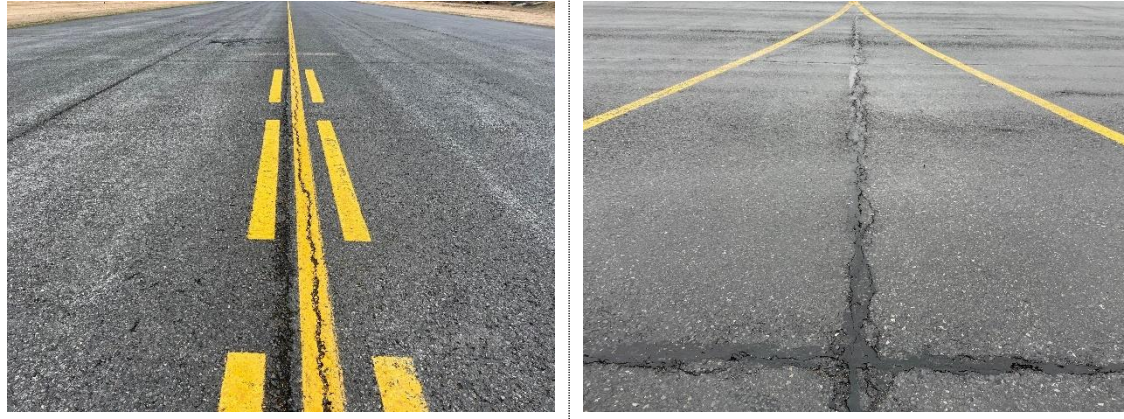
Section 0500-01 (50 PCI), 0500-02 (54 PCI)

Taxiway E consists of 3 sections, of which sections 0500-01 and 0500-02 B was initially constructed in 1942 as concrete and the most recent major work was a 2-inch overlay in 2001. Annual crack seal operations have been performed on these sections but should be replaced. The most common distresses observed are low to medium to high severity joint reflective cracking, low to medium severity longitudinal and transverse cracking, low to medium severity raveling, and low to medium severity weathering. Field observations include the development of new unfilled cracks and the widening of joint reflective cracking.

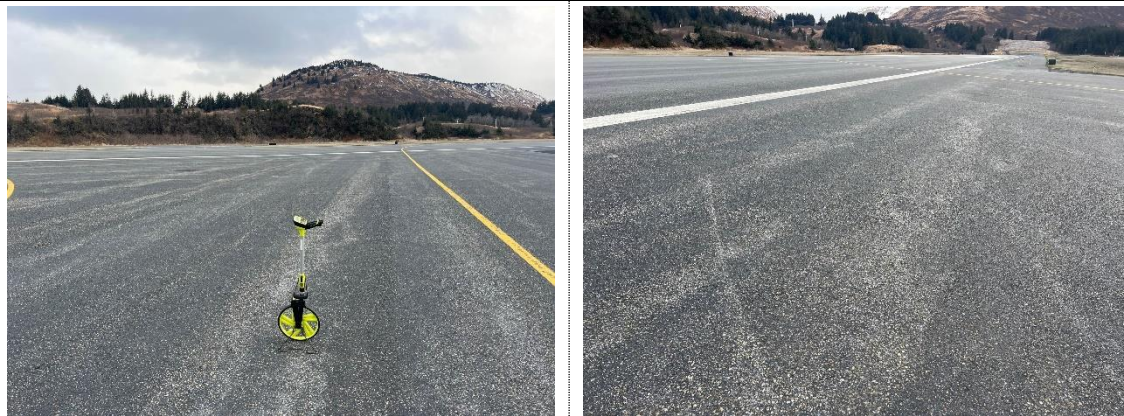
Section 0500-01A (88 PCI)

Taxiway E section 0500-01A has the same history as sections 01 and 02 but underwent an additional surface reconstruction concurrently with runway 08/26 in 2012. Crack seal operations have not been performed on this section. The most common distresses observed are low to medium severity raveling, and low to medium severity weathering. Field observations include the pavements surface beginning to weather and localized areas of raveling.

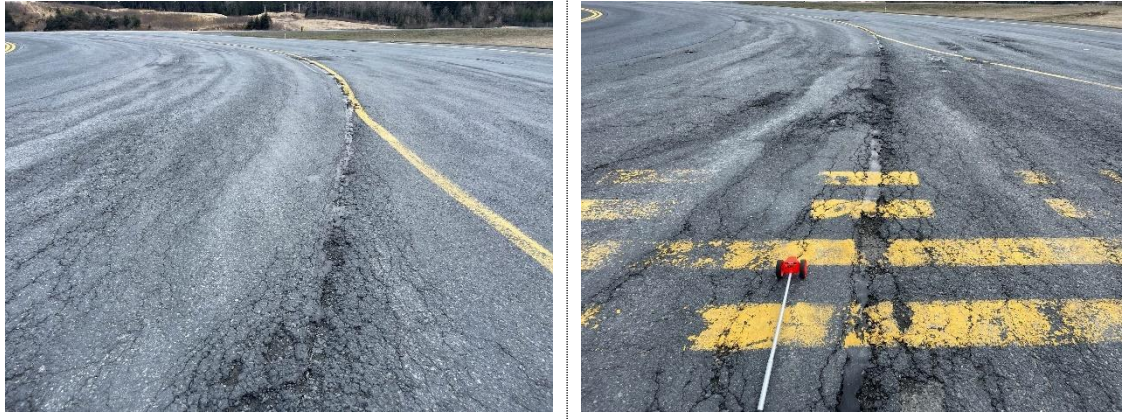
Section 0600-01 (52 PCI), 0600-02 (16 PCI)

Taxiway F consists of 3 sections, of which sections 0600-01 and 0600-02 were initially constructed in 1975, section 0600-01 underwent a surface reconstruction in 2001 while section 0600-02 underwent a surface reconstruction in 2008. Annual crack seal operations have been performed on these sections, but major repairs are needed. The most common distresses observed are low to high severity alligator cracking, low to high severity joint reflective cracking, low to high severity longitudinal and transverse cracking, low to high severity raveling, and low to medium severity weathering. Field observations include a rapidly degrading pavement caused by multiple distresses of all severities. Major repairs are needed to fix this major taxiway that connects the terminal apron to runway 08/26.

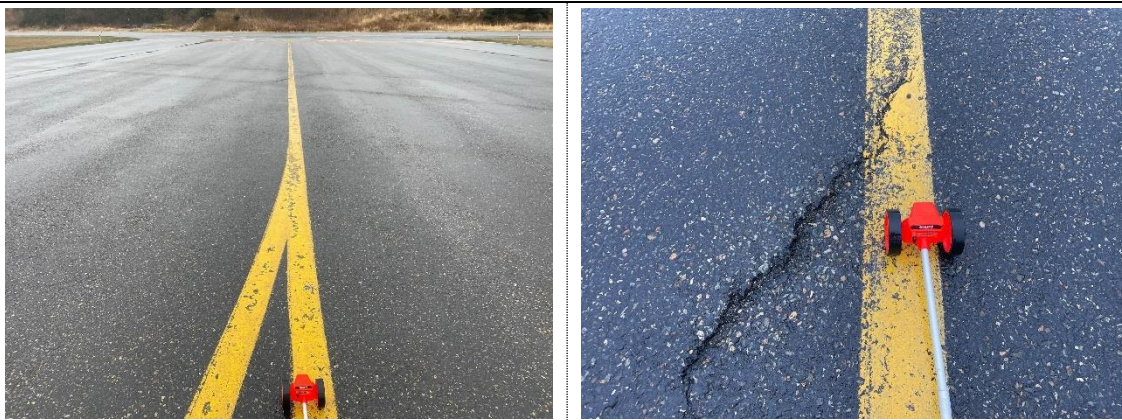
Section 0600-03 (87 PCI)

Taxiway F section 0600-03 was initially constructed in 2012 and has not received any major work since. Section 0600-03 connects runway 08/26 with taxiway D. Crack seal operations have not been performed on this section. The most common distresses observed are low to medium severity raveling, and low severity weathering. Field observations include the pavements surface beginning to weather and a few cracks starting to develop.

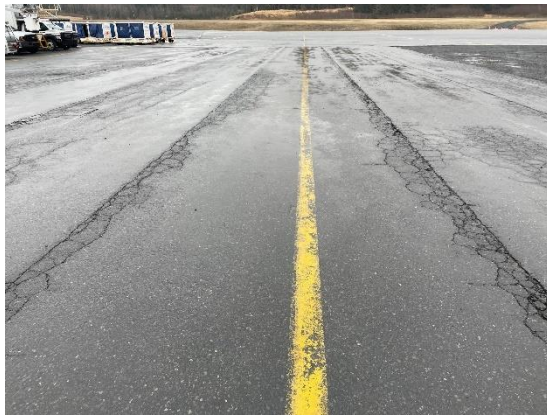
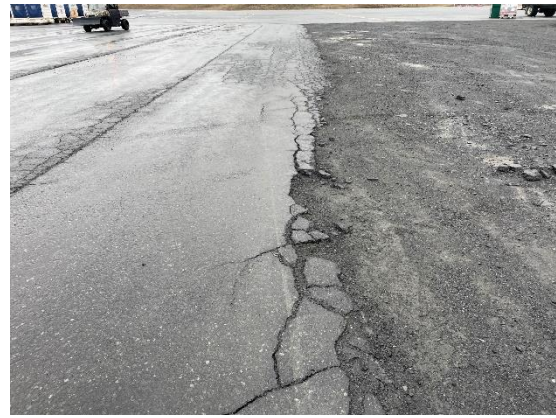
Branch ID	Branch Name	Branch Use	No. of Sections	Area (sf)	Weighted Average PCI
0700	GA Taxiway	Taxiway	1	26,750	20

The general aviation taxiway was initially constructed in 1984 and received a 2-inch overlay in 1993. Crack seal operations have not been performed on this branch. The most common distresses observed are low to medium to high severity alligator cracking, low to medium severity longitudinal and transverse cracking low to medium to high severity raveling, and low severity weathering. Field observations include a highly degraded edge of pavement where loss of asphalt is extensive, as well as the paving joints deteriorating to the point that alligator cracking is spreading across the length of the taxiway.

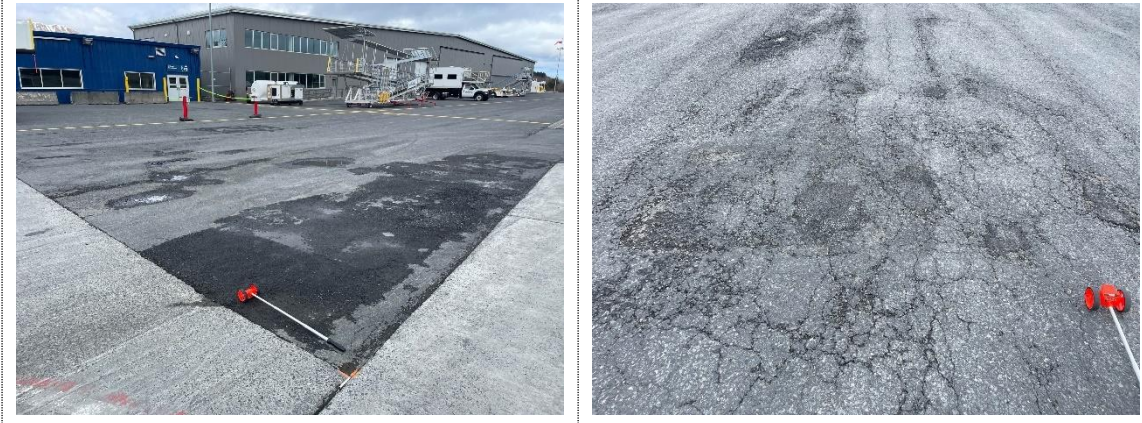
Branch ID	Branch Name	Branch Use	No. of Sections	Area (sf)	Weighted Average PCI
4100	Terminal Apron	Apron	4	521,014	39
AC Sections 4100-01A (33PCI), 4100-01B (56 PCI), 4100-01C (42 PCI)

The terminal apron consists of 4 sections, of which 3 are AC and 1 is PCC. The AC sections 4100-01A and 4100-01B were initially constructed in 1975 and the most recent major work was a surface reconstruction in 2001. Section 4100-01C was initially constructed in 1984 and has not received work since. The most common distresses observed are low to medium severity alligator cracking, low to medium severity longitudinal and transverse cracking, low to medium to high severity patching, low to medium to high severity raveling, and low to medium severity weathering. Field observations include attempts to patch a rapidly degrading pavement, these patches are deteriorating just as quickly as the pavement surrounding them. Major repairs are needed, especially around the concrete hardstands.

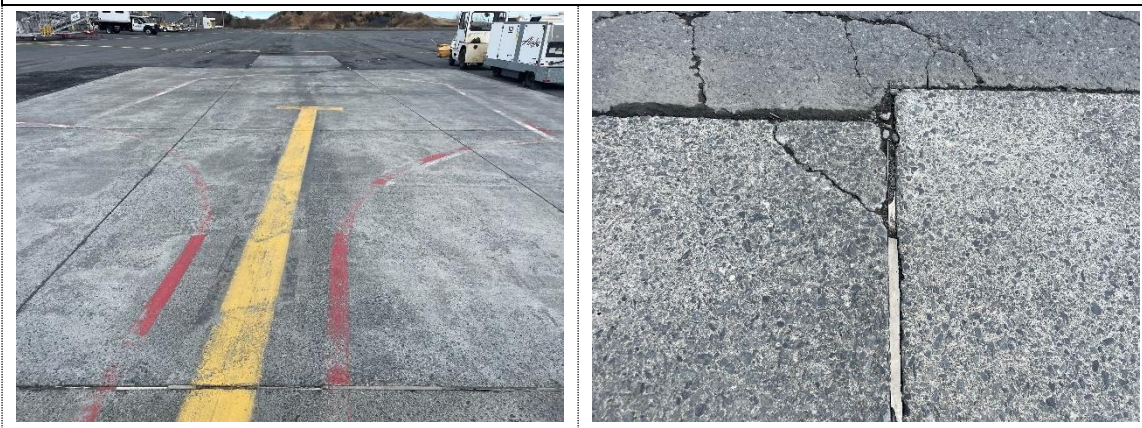
PCC Section 4100-HS (73 PCI)

The PCC section 4100-HS consists of two hardstands that were initially constructed in 2001 and there has not been any major work since. The most common distresses observed are low to medium severity joint and corner spalling, low severity scaling, and high severity joint seal damage. Field observations show that the concrete has several spalls across both hardstands and the joint sealant needs replaced.

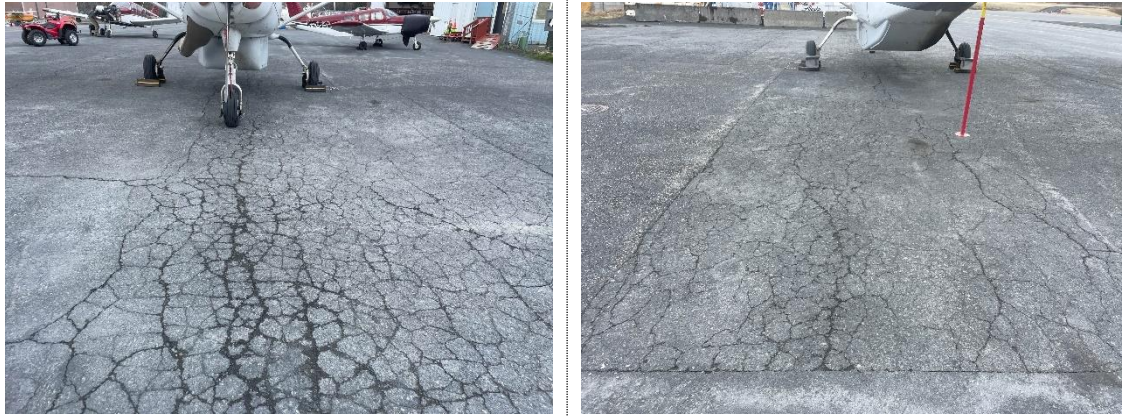
Section 4110-01 (26PCI)

The Pen Air apron consists of 2 sections, of which section 4110-01 was initially constructed in 1994 and has not received major work since. Crack seal operations have not been performed on this section. The most common distresses observed are medium to high severity alligator cracking, medium severity block cracking, low to medium to high severity longitudinal and transverse cracking, low to medium severity raveling, and low to medium severity weathering. Field observations include the degradation of the pavement furthering the development of the alligator cracking into a large network.

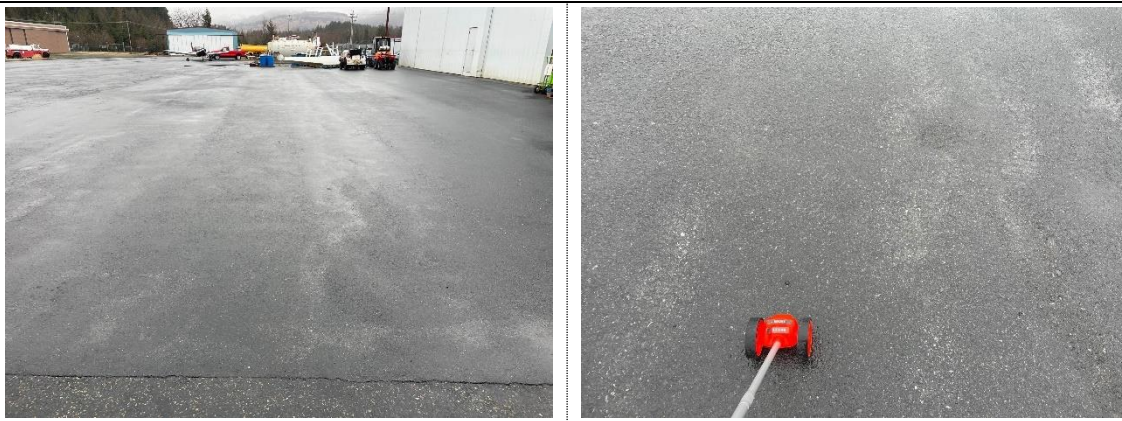
Section 4110-02 (100 PCI)

Pen Air apron 4110-02 was also initially constructed in 1994 but received major work in 2022. No distresses were recorded during the inspection. Field observations noted a new pavement surface with no recordable distresses.

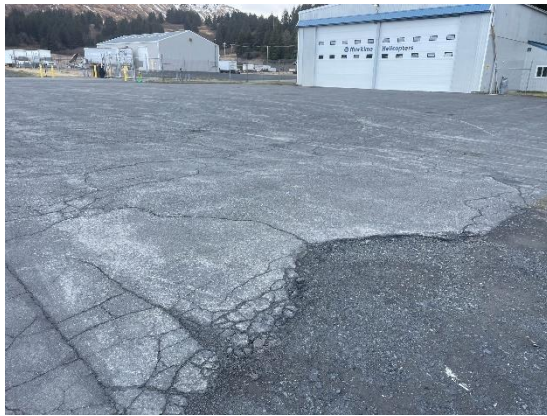
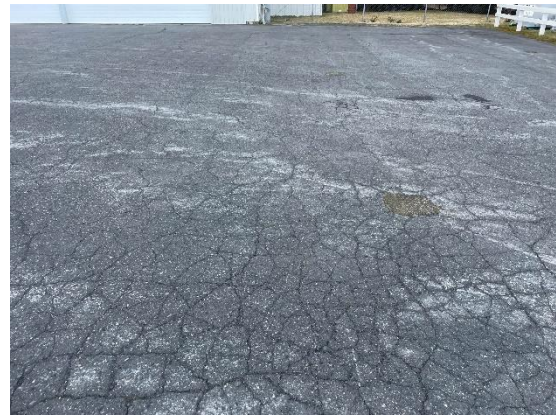
Branch ID	Branch Name	Branch Use	No. of Sections	Area (sf)	Weighted Average PCI
4120	Silver Bay Apron	Apron	1	13,520	19

The Silver Bay apron was initially constructed in 1994 and has not received major work since. Crack seal operations have not been performed on this branch. The most common distresses observed are medium severity alligator cracking, medium severity block cracking, low to medium severity longitudinal and transverse cracking, low to medium to high severity raveling, and low severity weathering. Field observations include a highly degraded edge of pavement where loss of asphalt is extensive, and degradation of the pavement furthering the development of the alligator cracking into a large network.

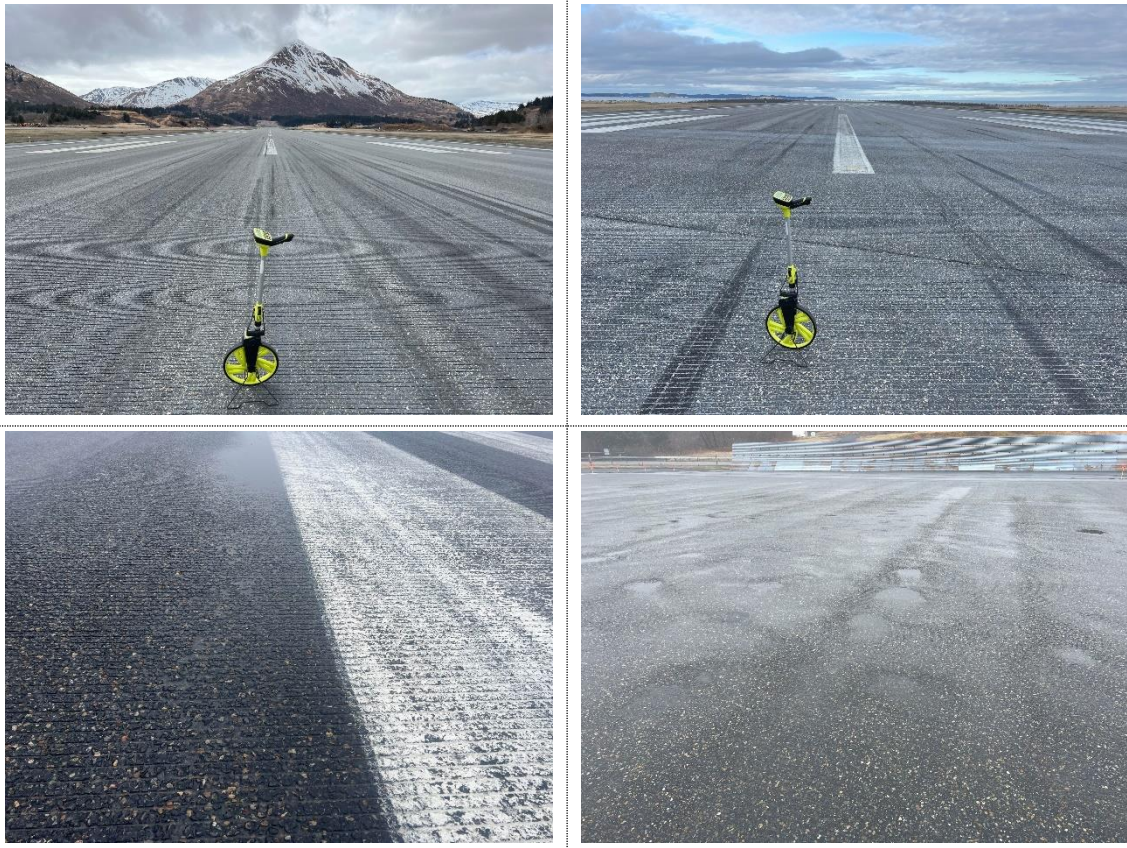
Branch ID	Branch Name	Branch Use	No. of Sections	Area (sf)	Weighted Average PCI
6100	Runway 08/26	Runway	4	1,198,500	79

Runway 08/26 consists of 5 sections, of which sections 6100-01, 6100-02, and 6100-03 were initially constructed in 1990 and underwent a surface reconstruction in 2012. Section 6100-04 (overrun) was constructed in 2014 and extends the runway into the bay area. Crack seal operations have not been performed on the section but are recommended at the intersections of the runways. The most common distresses observed are low severity depression, low to medium severity longitudinal and transverse cracking, low to medium severity raveling, and low to medium severity weathering. Field observations include development of new unfilled cracks at the intersections of the runways, dimpling of the pavement on the 08 end of the runway, and depressions along some of the joints resulting in areas of standing water.

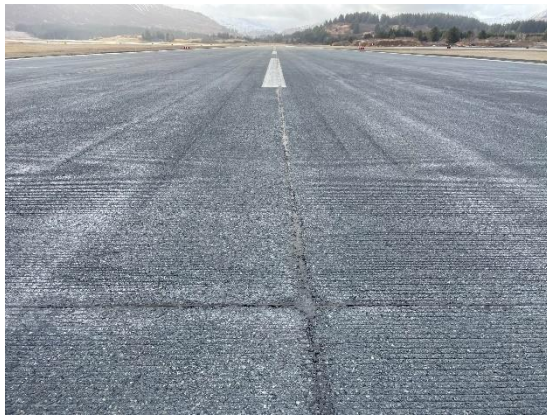
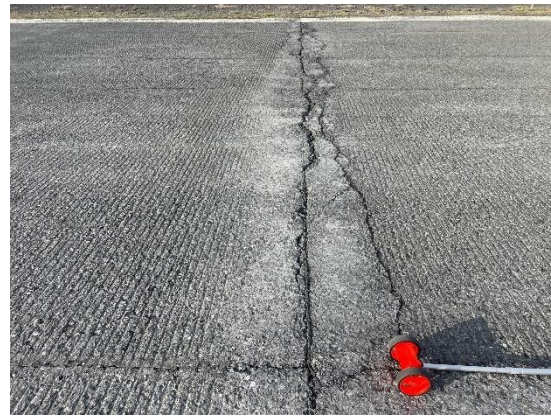
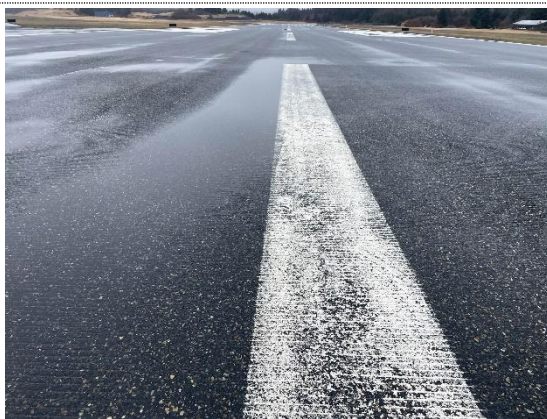
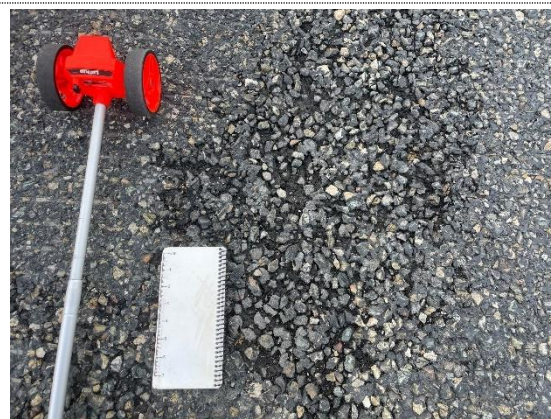
Branch ID	Branch Name	Branch Use	No. of Sections	Area (sf)	Weighted Average PCI
6200	Runway 11/29	Runway	7	828,834	63

Runway 11/29 consists of 7 sections, of which sections 6200-01 through 6200-06 were initially constructed in 1978 and underwent a surface reconstruction in 2001. Section 6200-07 (runway intersections) has the same history but received another surface reconstruction in 2012 to coincide with work being done to runways 08/26 and 01/19. Crack seal operations have not been performed on the section but are recommended at the intersections of the runways. The most common distresses observed are low severity depression, low to medium severity joint reflective cracking, low to medium severity longitudinal and transverse cracking, low to medium severity raveling, and low to medium to high severity weathering. Field observations include the development of new unfilled cracks and the widening of joint reflective cracking, PCC slabs from initial construction buckling and showing through to the top layer of the asphalt, and depressions along some of the joints resulting in areas of standing water.

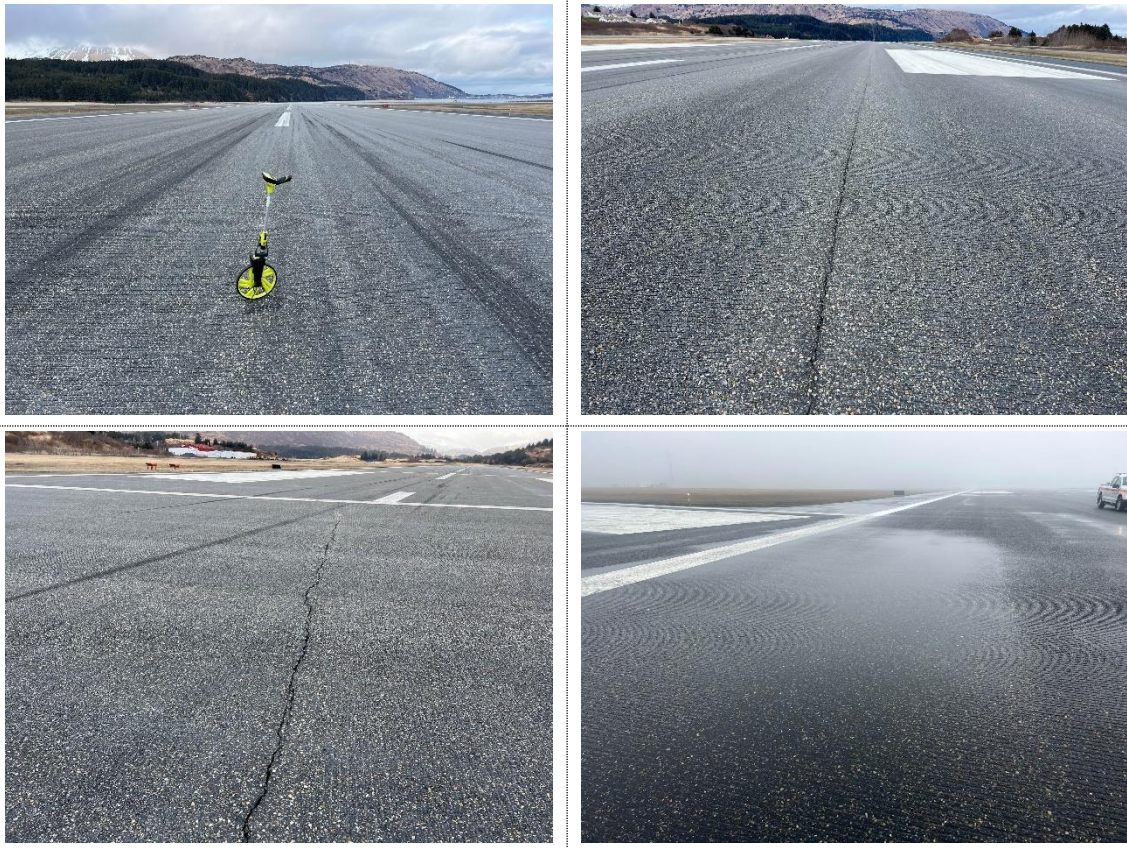
Branch ID	Branch Name	Branch Use	No. of Sections	Area (sf)	Weighted Average PCI
6300	Runway 01/19	Runway	6	808,972	82

Runway 01/19 consists of 7 sections, of which sections 6300-01 through 6300-05 were initially constructed in 1991 and underwent a surface reconstruction in 2012. Section 6300-07 (overrun) was newly constructed in 2012 and extends the runway into the bay area. Crack seal operations have not been performed on the section but are recommended at the intersections of the runways. The most common distresses observed are low severity depression, low to medium severity longitudinal and transverse cracking, low to medium severity raveling, and low to medium severity weathering. Field observations include development of new unfilled cracks at the intersections of the runways, a few paving joints beginning to open, and depressions along the length of the runway resulting in areas of standing water.
