## Alaska DOT&PF

# Pavement Inspection Report Kotzebue Airport

Airport Name	IATA	ICAO	Latitude	Longitude	Elevation (ft)
Ralph Wein Memorial Airport	OTZ	PAOT	66° 53' 5.3" N	162° 35' 53.3" W	15.4

Point of Contact	Phone	Email	Date Inspected	Date Published
Mr. Andrew Pavey, Pavement Management Engineer	(907) 269 6213	andrew.pavey@alaska.gov	July 2024	December 2024

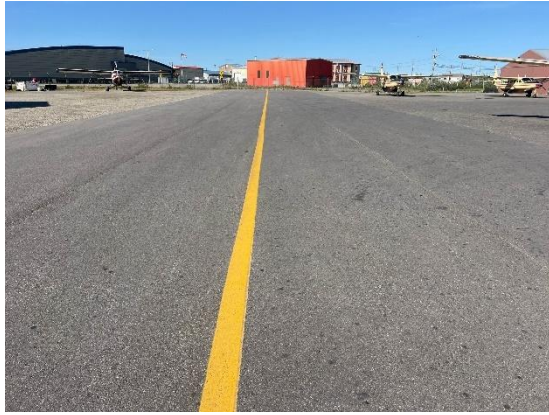
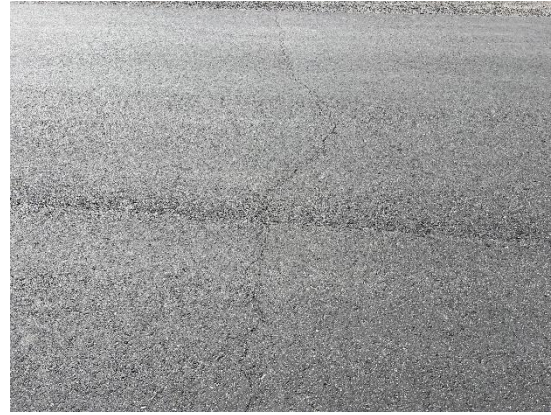
Branch ID	Branch Name	Branch Use	No. of Sections	Area (sf)	Weighted Average PCI
0100	Taxiway A	Taxiway	1	20,000	94

Taxiway A was initially constructed in 1994, the most recent major work was complete reconstruction in 2022. Crack seal operations have not yet been performed on the branch. The most common distresses observed are low severity longitudinal and transverse cracking, low severity raveling, and low severity weathering. Field observations include the initial wearing of the pavement surface and the development of cracking along the taxiway.

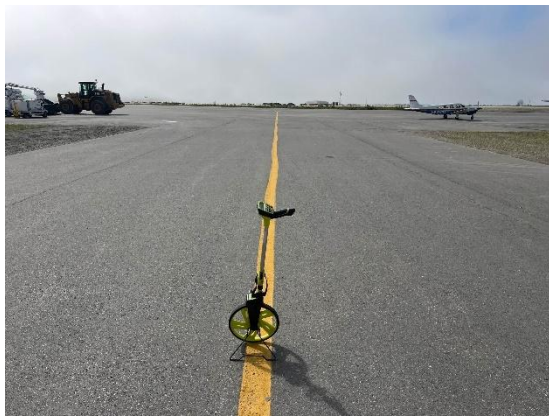
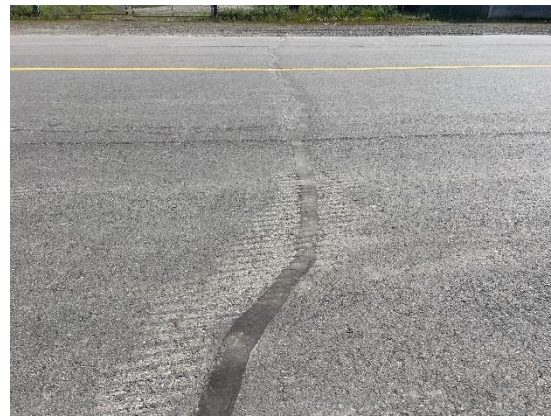
Branch ID	Branch Name	Branch Use	No. of Sections	Area (sf)	Weighted Average PCI
0200	Taxiway B	Taxiway	1	20,000	94

Taxiway B was initially constructed in 1994, the most recent major work was complete reconstruction in 2022. Crack seal operations have been performed on the branch. The most common distresses observed are low severity longitudinal and transverse cracking, low severity raveling, and low severity weathering. Field observations include the initial wearing of the pavement surface and the development of cracking along the taxiway.

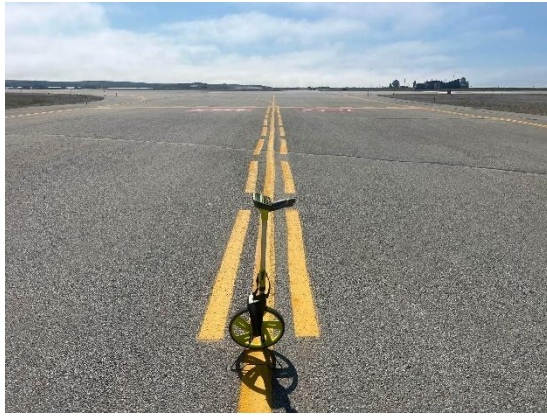
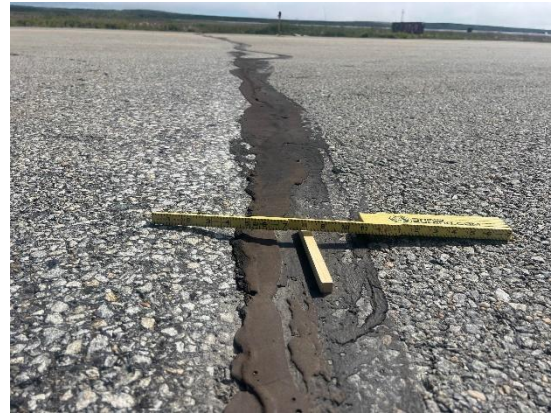
Branch ID	Branch Name	Branch Use	No. of Sections	Area (sf)	Weighted Average PCI
0300	Taxiway C	Taxiway	2	38,958	88

Taxiway C was initially constructed in 1975, the most recent major work was complete reconstruction in 2016 which realigned the taxiway to be perpendicular to the runway. Occasional crack seal operations have been performed on the branch. The most common distresses observed are low to medium severity longitudinal and transverse cracking, low severity raveling, and low severity weathering. Field observations include sealed transverse cracks that are starting to widen and depress increasing the distresses severity.

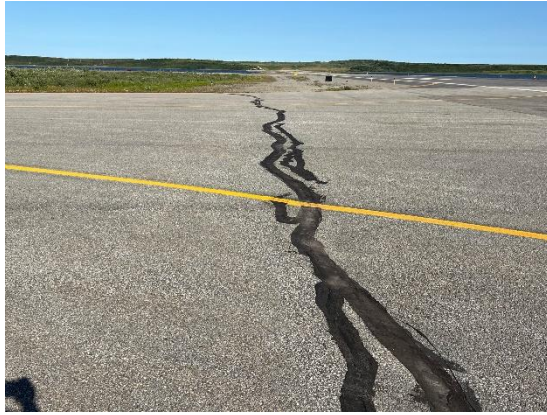
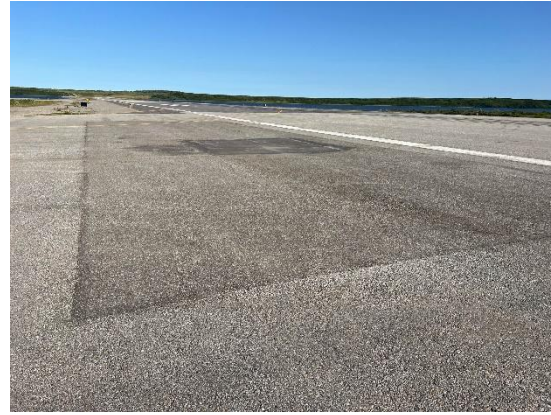
#### Section 0400-01 (82 PCI)

Taxiway D Section 0400-01 was initially constructed in 1975 then received a surface reconstruction along with the runway in 2011. The most common distresses observed are low to medium severity depressions, low to medium severity longitudinal and transverse cracking, low severity patching, and low to medium severity weathering. Field observations include the development of depressions across the taxiway as well as a patched area that is beginning to depress and hold water again.

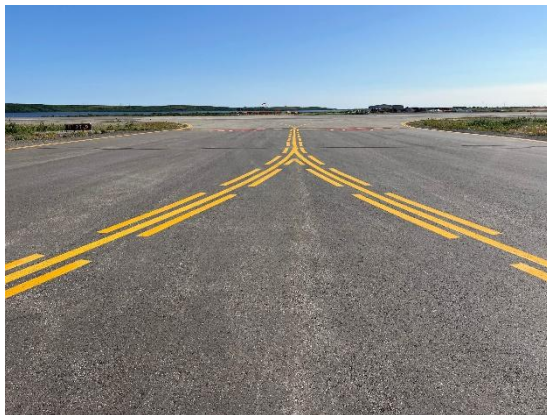
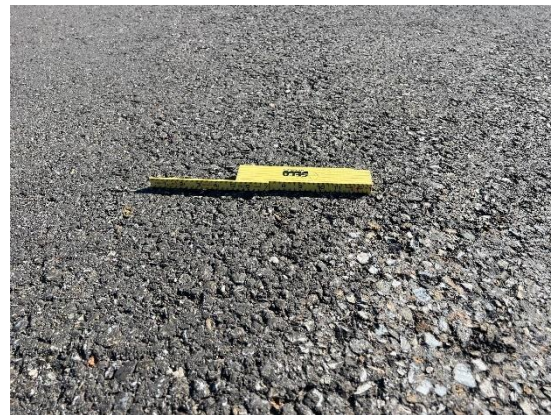
#### Section 0400-02 (91 PCI)

Taxiway D Section 0400-02 was initially constructed in 1975, the most recent major work was complete reconstruction in 2022. Crack seal operations have been performed on the section. The most common distresses observed are low severity longitudinal and transverse cracking, low severity raveling, and low severity weathering. Field observations include the initial wearing of the pavement surface and the development of cracking along the taxiway.

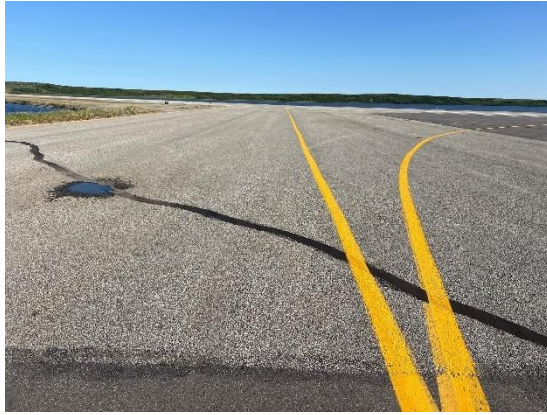
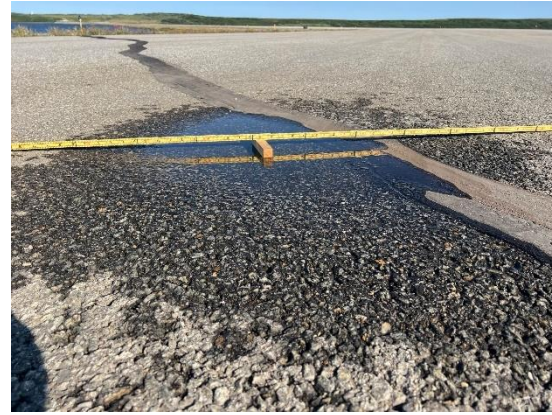
#### Section 0500-01 (83 PCI)

Taxiway E Section 0500-01 was initially constructed in 1985 then received a surface reconstruction along with the runway in 2011. The most common distresses observed are low severity depressions, low to medium severity longitudinal and transverse cracking, low severity raveling, and low to medium severity weathering. Field observations include the development of depressions across the taxiway as well as the pavements surface beginning to deteriorate leading to higher quantities and severities of raveling and weathering.

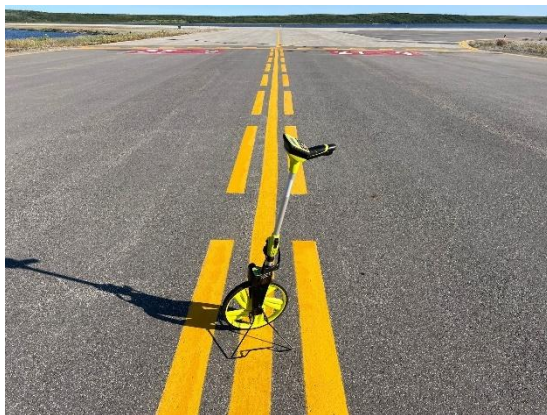
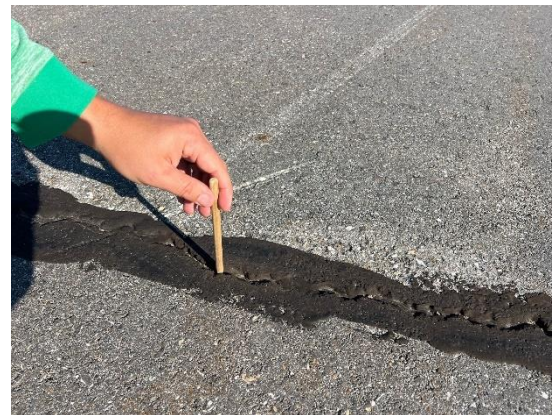
#### Section 0500-02 (92 PCI)

Taxiway E Section 0500-02 was initially constructed in 1985, the most recent major work was complete reconstruction in 2022. Crack seal operations have been performed on the section. The most common distresses observed are low to medium severity longitudinal and transverse cracking, and low severity weathering. Field observations include the development of new unfilled cracks as well as the widening of previously sealed cracks increasing the severity.

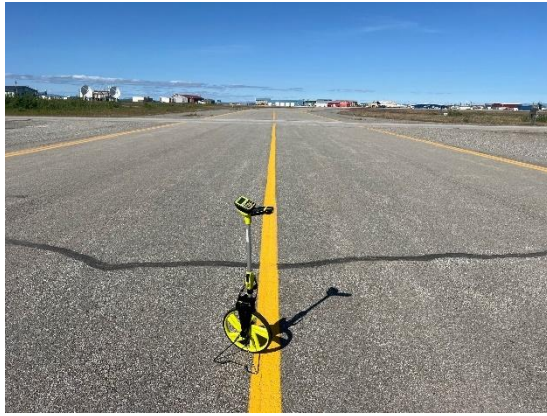
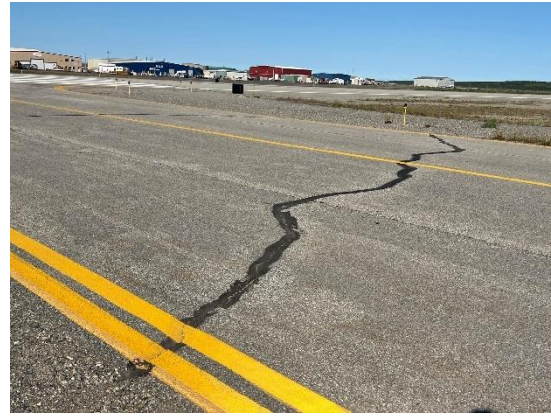
Branch ID	Branch Name	Branch Use	No. of Sections	Area (sf)	Weighted Average PCI
0600	Taxiway F	Taxiway	2	72,684	86

Taxiway F was initially constructed in 1975, both sections were reconstructed in 2013 and then section 0600-01 was realigned in 2016 to directly match up with Taxiway C across the runway. Occasional crack seal operations have been performed on the branch. The most common distresses observed are low medium severity longitudinal and transverse cracking, low to medium severity raveling, and low to medium severity weathering. Field observations include sealed transverse cracks that are starting to widen and depress increasing the distresses severity.

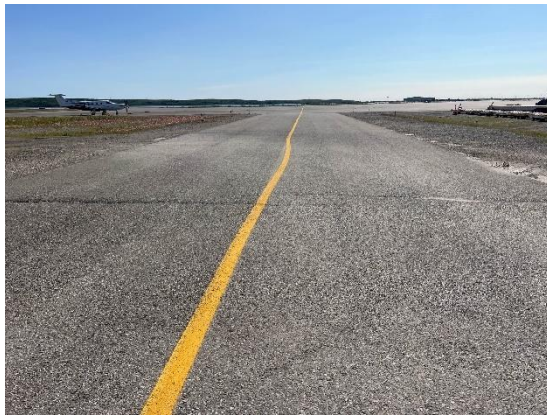
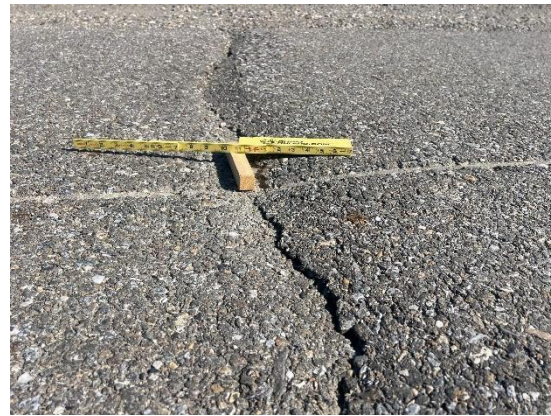
Branch ID	Branch Name	Branch Use	No. of Sections	Area (sf)	Weighted Average PCI
0700	Taxiway H	Taxiway	1	7,590	84

Taxiway H was constructed in 2017 and has not received any major work since. Crack seal operations have not been performed on the branch. The most common distresses observed are low to medium severity longitudinal and transverse cracking, low severity raveling, and low severity weathering. Field observations include sealed transverse cracks that are starting to widen and depress increasing the distresses severity.

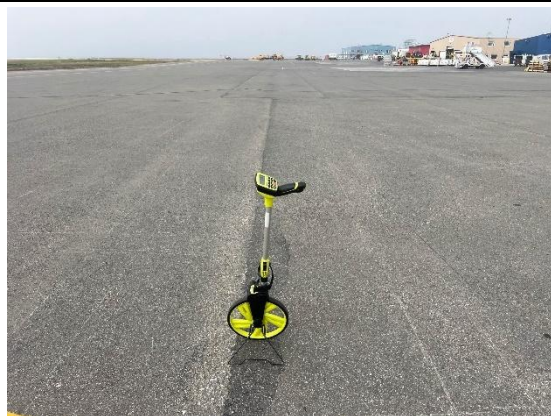
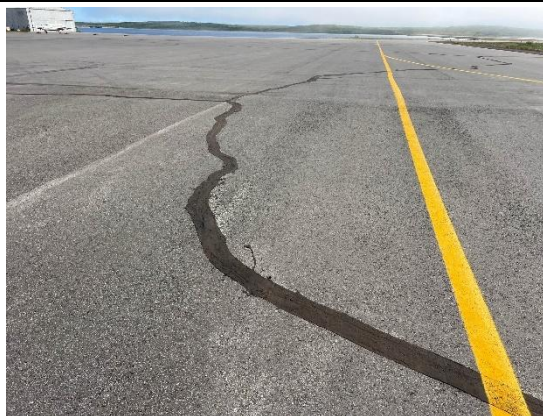
**AC Sections 4100-01 (93 PCI), 4100-02 (94 PCI)**

The Main Apron Section 4100-01 was initially constructed in 1975 while AC section 4100-02 was initially constructed in 1985. Both sections were completely reconstructed in 2022 receiving 6" of foamed asphalt stabilized base course and 4" of new HMA. Crack seal operations have been performed on the branch. The most common distresses observed are low to severity longitudinal and transverse cracking, oil spillage, low to medium severity raveling, and low severity weathering. Field observations include the initial wearing of the pavement surface and the development of cracking across the apron.

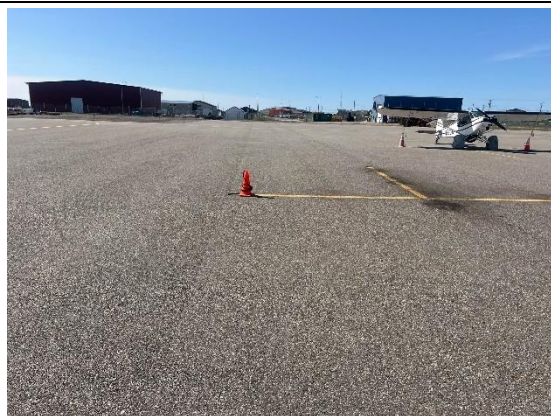
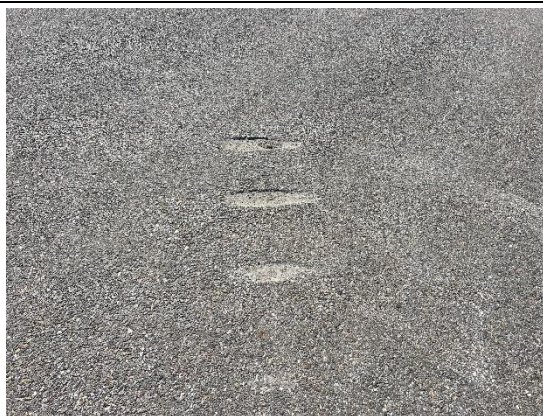
**AC Section 4100-03 (92 PCI)**

The Main Apron Section 4100-03 was constructed in 2017 and has not received any major work since. Crack seal operations have not yet been performed on the branch. The most common distresses observed are oil spillage, medium to high severity raveling, and low severity weathering. Field observations include the initial wearing of the pavement surface, large areas of oil spillage beginning to soften the asphalt surface, and gouges in the asphalt due to propeller strikes, snow plow operations, etc.

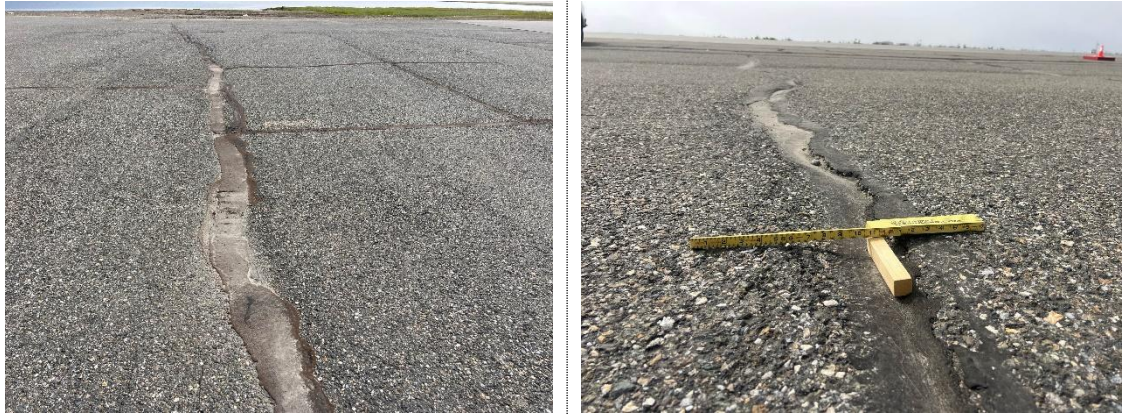
**AC Section 4100-04 (55 PCI)**

The Main Apron Section 4100-04 was initially constructed in 1985 then received a thin overlay in 2011. Occasional crack seal operations have been performed on the branch. The most common distresses observed are low severity block cracking, low severity depressions, low to high severity longitudinal and transverse cracking, low severity raveling, and low to medium severity weathering. Field observations include further deterioration of the pavements surface leading to higher quantities and severities of raveling and weathering. The longitudinal and transverse cracks are expanding also increasing the quantities and severities.

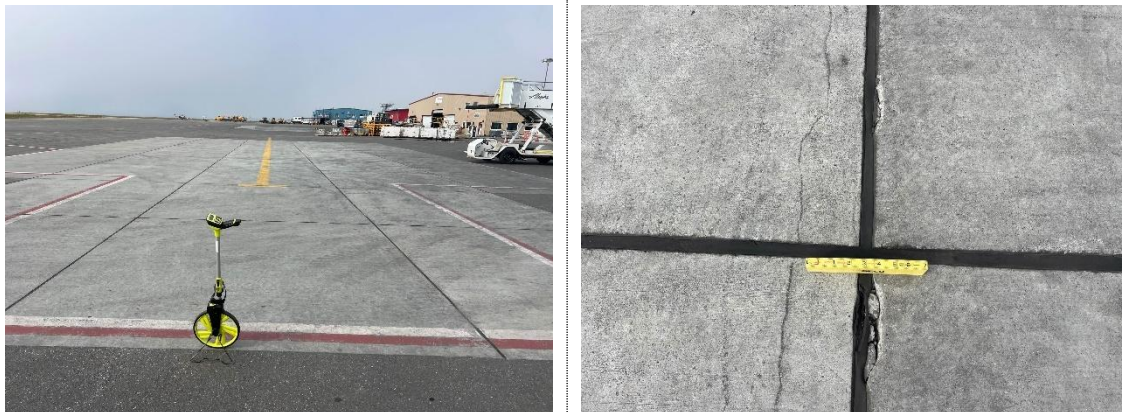
**PCC Section 4100-05 (97 PCI), 4100-06 (93 PCI)**

The Main Apron PCC hardstands, Sections 4100-05 and 4100-06, were constructed in 2022 and have not received any major work since. The most common distresses observed are low severity joint seal damage, low to medium severity joint spall, and low severity corner spall. Field observations include minor damage to the joint seal and a few spalls on both hardstands.

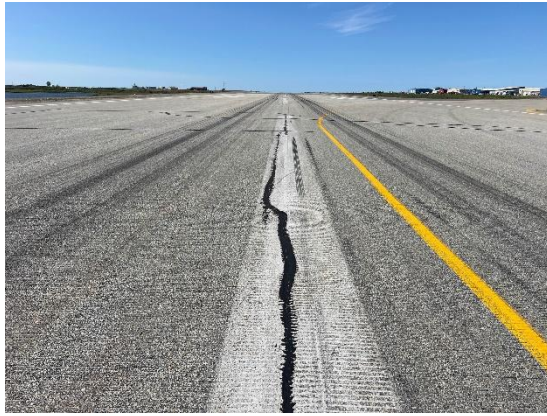
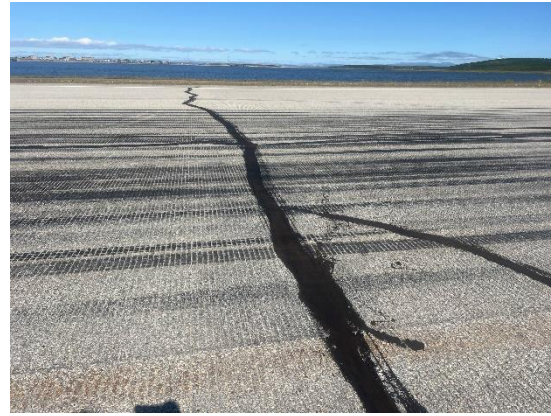
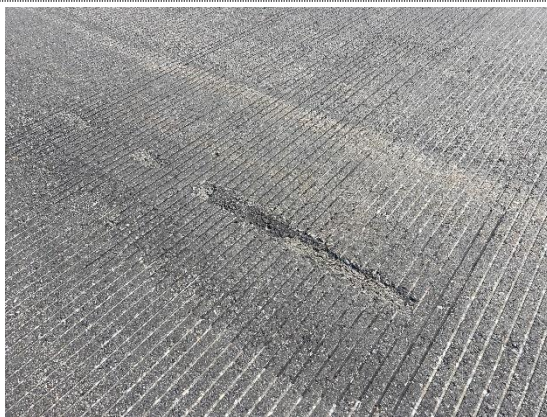
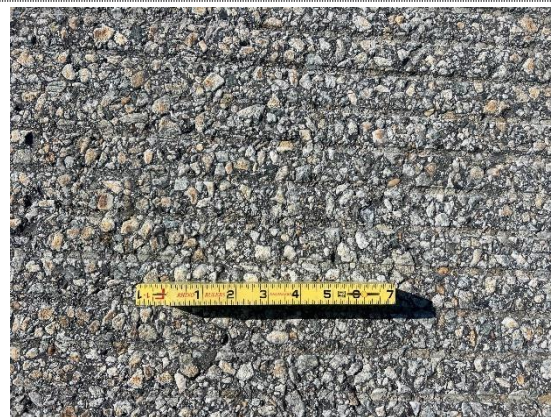
Branch ID	Branch Name	Branch Use	No. of Sections	Area (sf)	Weighted Average PCI
6100	Runway 09/27	Runway	7	962,500	85

Runway 09/27 was initially constructed in 1975 and underwent a surface reconstruction in 2011. Regular crack seal operations have been performed on the branch. The most common distresses observed are low severity depressions, low severity longitudinal and transverse cracking, low severity patching, low to high severity raveling, and low to medium severity weathering. Field observations include further deterioration of the top layer of asphalt, contributing to higher quantity and severity of raveling and weathering. There have been settlement issues causing depressions across the runway, some of the larger areas of concern were repaired as part of the Runway Settlement Repair Project NFAPT00650 (Runway full width between Taxiway D and Taxiway E).
