Alaska DOT&PF

Pavement Inspection Report McGrath Airport

Airport Name	IATA	ICAO	Latitude	Longitude	Elevation (ft)
McGrath Airport	MCG	PAMC	62° 57' 10.0221" N	155° 36' 25.373" W	342.7

Point of Contact	Phone	Email	Date Inspected	Date Published
Mr. Andrew Pavey, Pavement Management Engineer	(907) 269 6213	andrew.pavey@alaska.gov	July 2023	February 2024

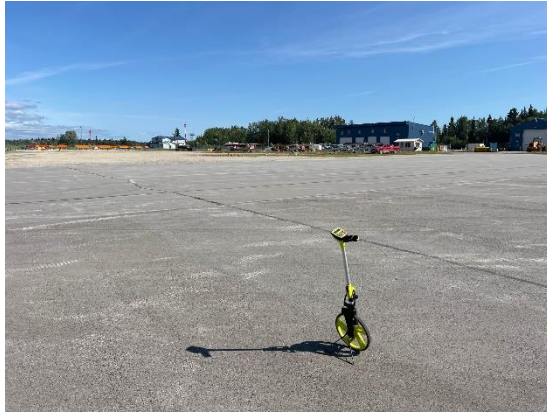
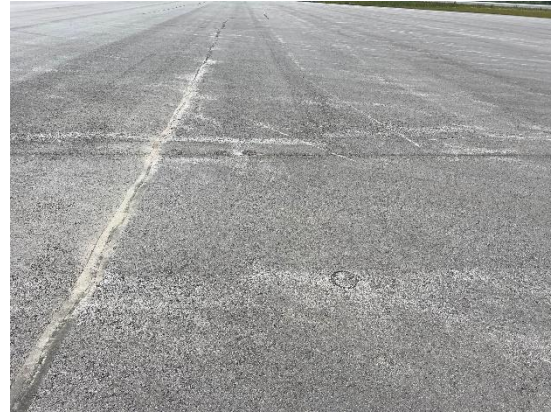
Branch ID	Branch Name	Branch Use	No. of Sections	Area (sf)	Weighted Average PCI
0100	Taxiway A	Taxiway	1	62,730	93

Taxiway A was constructed in 2001 and reconstructed in 2022 with 4" HMA and 8" foamed asphalt treated base. Annual crack seal operations have been performed on the branch. The most common distresses observed are low severity bleeding and low severity longitudinal and transverse cracking. Field observations include the application of crack seal on the paving joints which can cause large quantities of cracking to be recorded for a pavement that is only one year old.

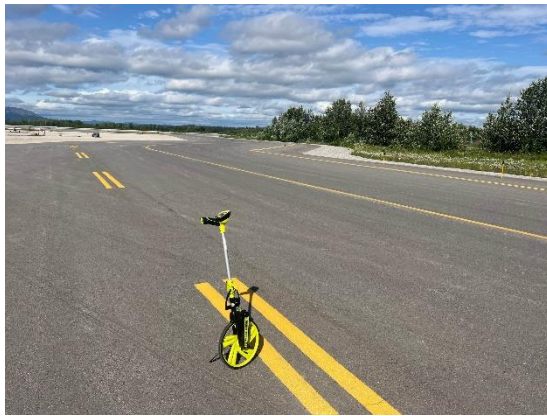
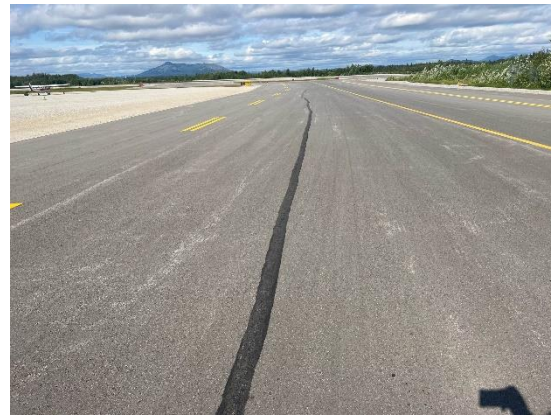
Branch ID	Branch Name	Branch Use	No. of Sections	Area (sf)	Weighted Average PCI
0200	Taxiway B	Taxiway	1	101,990	96

Taxiway B was constructed in 2007 and reconstructed in 2022 with 4" HMA and 8" foamed asphalt treated base. Annual crack seal operations have been performed on the branch. The most common distresses observed are low severity longitudinal and transverse cracking and low severity patching. Field observations include several transverse cracks beginning to reflect through the overlay and the application of crack seal on the paving joints which can cause large quantities of cracking to be recorded for a pavement that is only one year old.

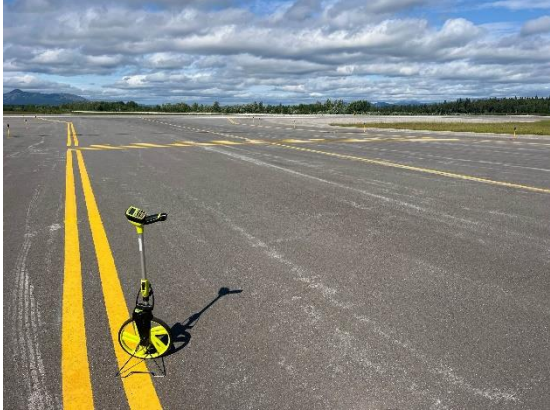
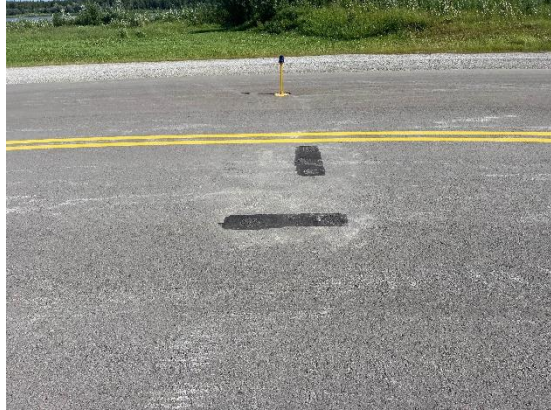
Branch ID	Branch Name	Branch Use	No. of Sections	Area (sf)	Weighted Average PCI
0400	Taxiway D	Taxiway	1	57,852	95

Taxiway D was constructed in 2001 and reconstructed (including realignment) in 2022 with 4" HMA and 8" foamed asphalt treated base. Annual crack seal operations have been performed on the branch. The most common distresses observed are low severity longitudinal and transverse cracking and low severity patching. Field observations include several transverse cracks beginning to reflect through the overlay and patching for the core samples that were taken from the section.

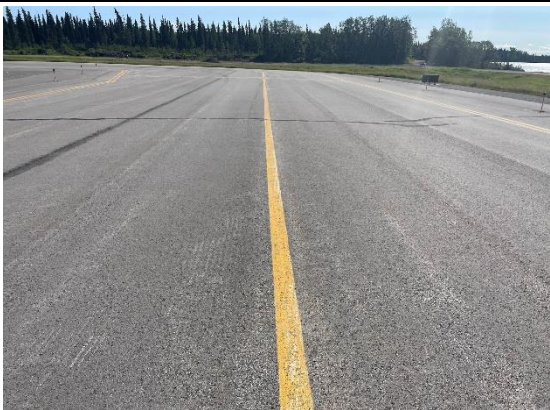
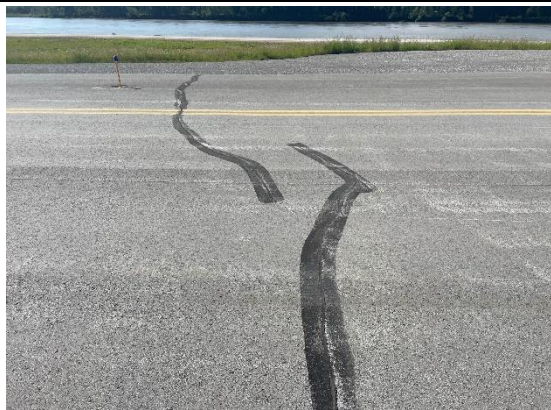
Branch ID	Branch Name	Branch Use	No. of Sections	Area (sf)	Weighted Average PCI
0800	Taxiway H	Taxiway	1	50,513	96

Taxiway H (formerly Taxiway C) was constructed in 2001 and reconstructed in 2022 with 4" HMA and 8" foamed asphalt treated base. Annual crack seal operations have been performed on the branch. The most common distresses observed are low severity longitudinal and transverse cracking. Field observations include several transverse cracks beginning to reflect through the overlay and the application of crack seal on the paving joints which can cause large quantities of cracking to be recorded for a pavement that is only one year old.

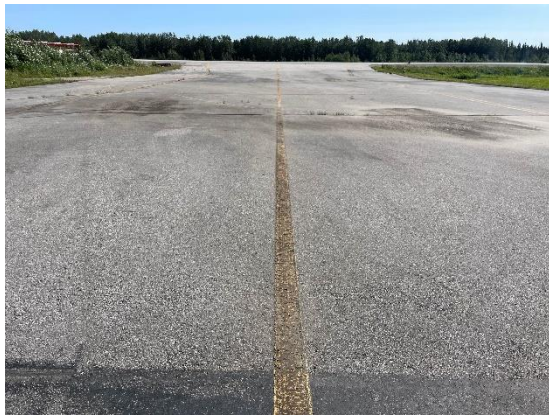
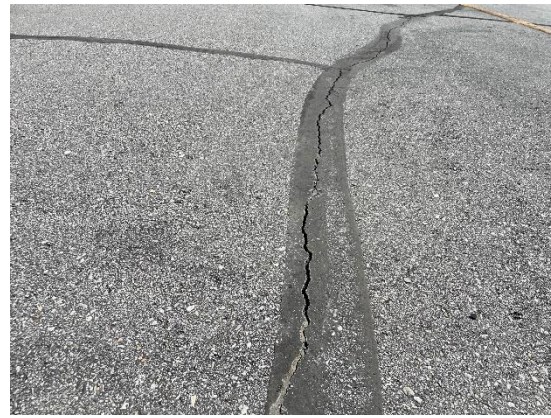
Branch ID	Branch Name	Branch Use	No. of Sections	Area (sf)	Weighted Average PCI
0900	Taxiway I	Taxiway	2	47,251	74

Taxiway I was constructed in 1976 and received a 4-in overlay in 2001. Annual crack seal operations have been performed on the branch. The most common distresses observed are low severity depression, low to medium severity longitudinal and transverse cracking, low severity raveling, and low severity weathering. Field observations include low spots where dirt and sand has collected as well as standing water after a rainstorm. Also, the cracks are starting to open back up and could use another round of sealant.

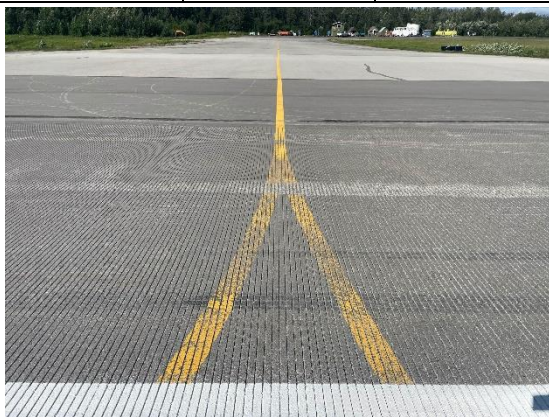
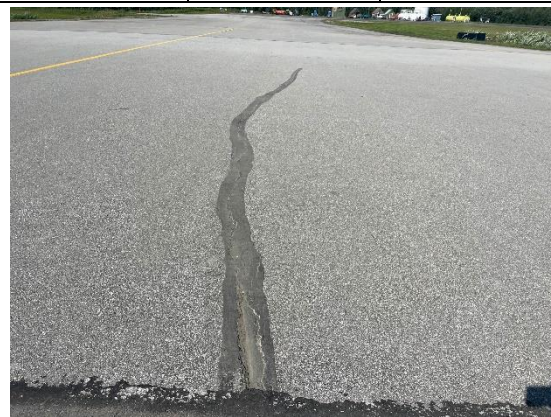
Branch ID	Branch Name	Branch Use	No. of Sections	Area (sf)	Weighted Average PCI
1000	Taxiway J	Taxiway	2	46,289	85

Taxiway J was constructed in 1976 and received a 4-in overlay in 2001. Annual crack seal operations have been performed on the branch. The most common distresses observed are low severity depression, low severity longitudinal and transverse cracking, low severity raveling, and low severity weathering. Field observations include areas of standing water across the taxiway. Also, the cracks are starting to open back up and could use another round of sealant.

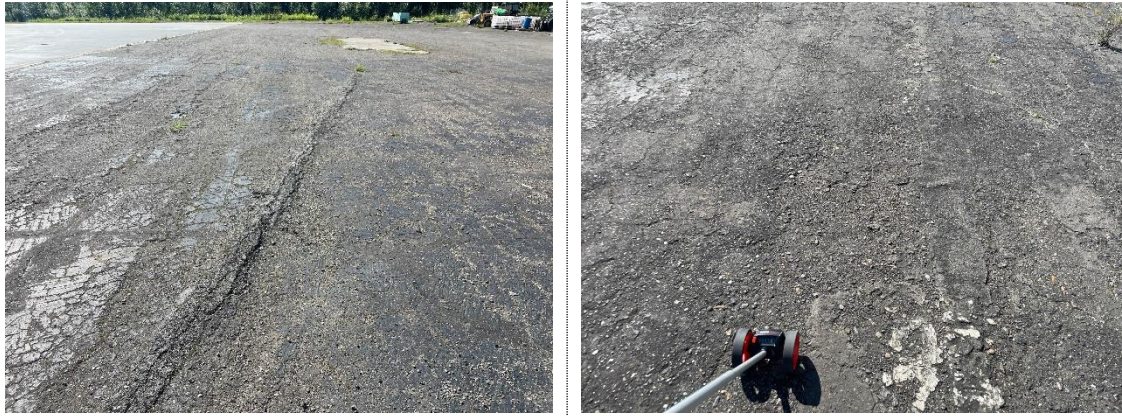
AC Section 4200-01 (4 PCI)

Section 4200-01 of the Retardant Ramp was constructed in 1966 and has not received any major work since. Annual crack seal operations have not been performed on the section. The most common distresses observed are medium severity alligator cracking, high severity block cracking, and medium to high severity raveling. Field observations include a pavement surface that is completely deteriorating away and there is significant FOD potential.

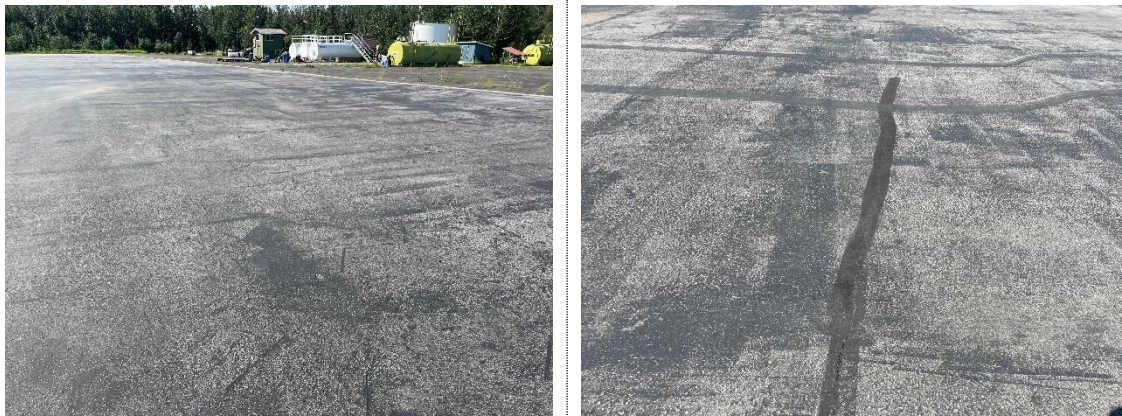
AC Section 4200-02 (89 PCI)

Section 4200-02 of the Retardant Ramp was constructed in 1976 and received a 3-in overlay in 2001. Annual crack seal operations have been performed on the branch. The most common distresses observed are low severity depression, low severity longitudinal and transverse cracking, and low severity weathering. Field observations include wearing of the coal tar treatment leading to the initial loss of the fine aggregate matrix.

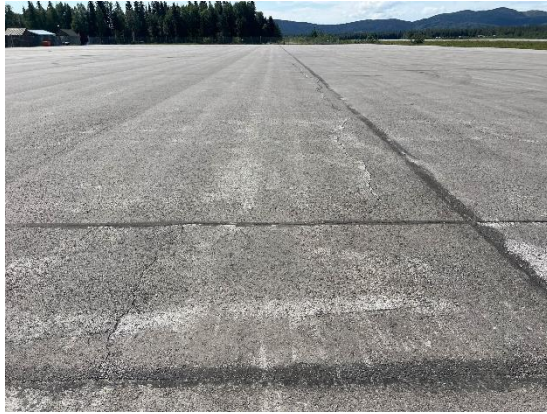
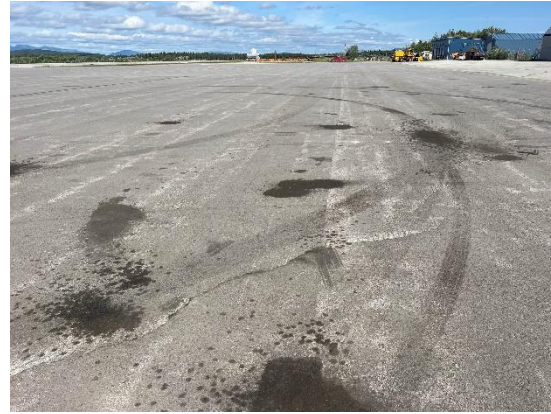
AC Section 4300-01 (91 PCI)

Section 4300-01 of the East Ramp was constructed in 2001 and reconstructed in 2022 with 4" HMA and 8" foamed asphalt treated base. Annual crack seal operations have been performed on the branch. The most common distresses observed are low severity bleeding, low severity longitudinal and transverse cracking, and low severity oil spillage. Field observations include several transverse cracks beginning to reflect through the overlay and the application of crack seal on the paving joints which can cause large quantities of cracking to be recorded for a pavement that is only one year old. Also, large quantities of oil spillage can be seen across the apron.

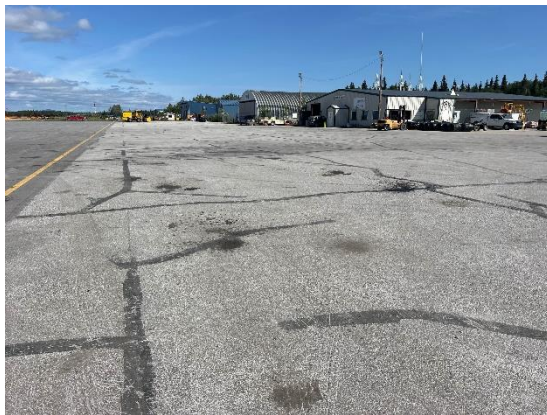
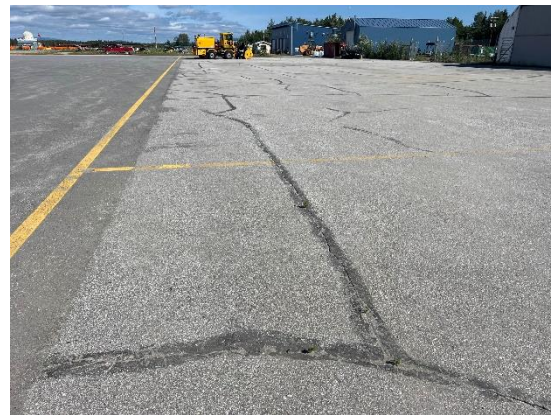
AC Section 4300-02 (63 PCI)

East Ramp Section 4300-02 was constructed in 2001 but was not reconstructed in 2022. Annual crack seal operations have been performed on the branch. The most common distresses observed are low severity block cracking, low to medium severity longitudinal and transverse cracking, low severity oil spillage, low severity raveling, and low severity weathering. Field observations include new cracking, an increase severity of existing cracks, and the loss of the fine aggregate from the pavement surface.

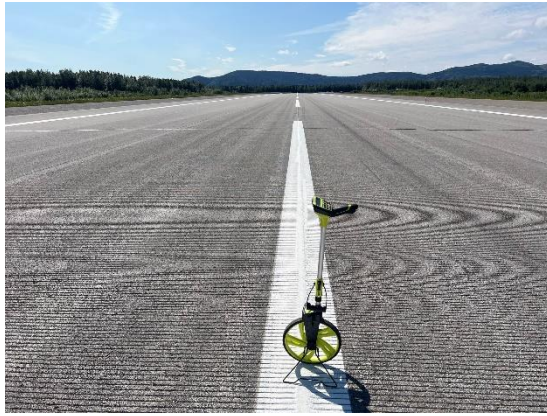
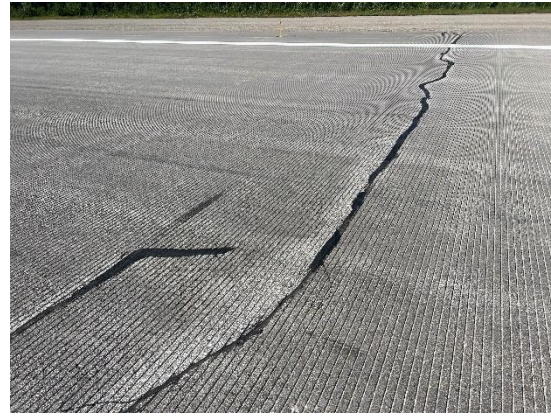
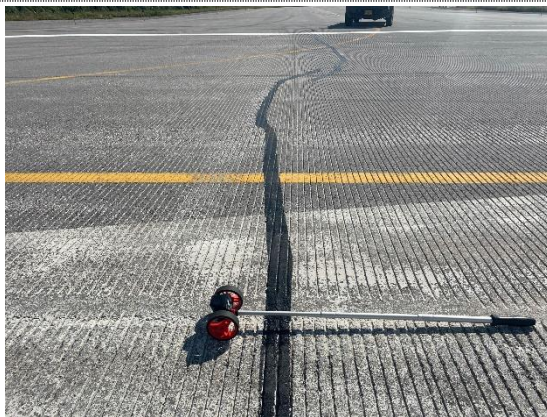
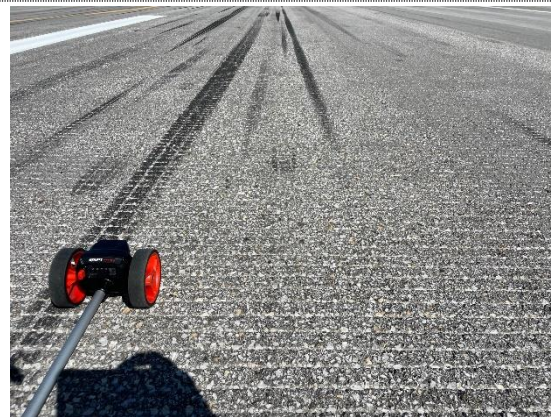
Branch ID	Branch Name	Branch Use	No. of Sections	Area (sf)	Weighted Average PCI
6100	Runway 16/34	Runway	1	592,500	95

Runway 16/34 was initially constructed in 1976, underwent complete reconstruction in 2001, and again was reconstructed in 2022 with 4" HMA and 8" foamed asphalt treated base. Annual crack seal operations have been performed on the branch since construction. The most common distresses observed are low severity longitudinal and transverse cracking. Field observations include several transverse cracks beginning to reflect through the overlay.
