# Alaska DOT&PF

## Pavement Inspection Report Merrill Field Airport

Airport Name	IATA	ICAO	Latitude	Longitude	Elevation (ft)
Merrill Field Airport	MRI	PAMR	61° 12' 48.77" N	149° 50' 40.95" W	143.1

Point of Contact	Phone	Email	Date Inspected	Date Published
Mr. Andrew Pavey, Pavement Management Engineer	(907) 269 6213	andrew.pavey@alaska.gov	July 2024	August 2025

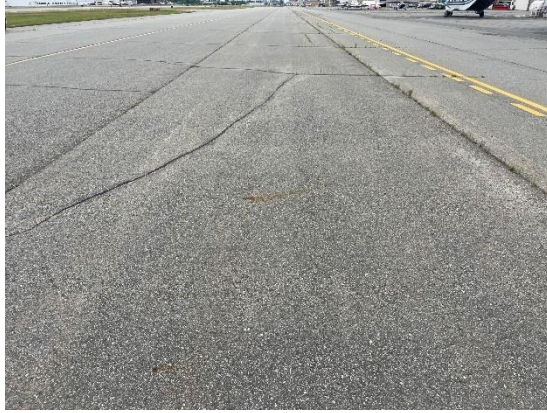
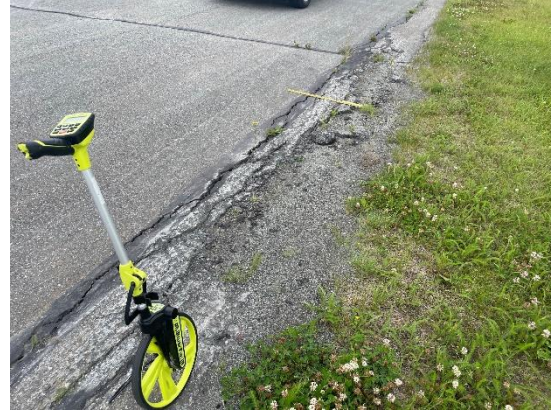
Taxiway A consists of three sections, of which Section 0100-01 has not undergone any major work since its initial construction in 1997. The pavement surface of Sections 0100-02 and 0100-03 were rehabilitated in 2003. Occasional crack seal operations have been performed on the branch. The most common distresses are low to high severity longitudinal and transverse cracking, low to high severity raveling, and low severity weathering. A significant amount of low and medium severity cracking exists, although many cracks have been sealed. Some high severity cracking was observed. Some of the medium and high severity cracks exhibit localized raveling. Coarse aggregate particles will continue to dislodge from the asphalt concrete (AC) surface at these and similar locations.

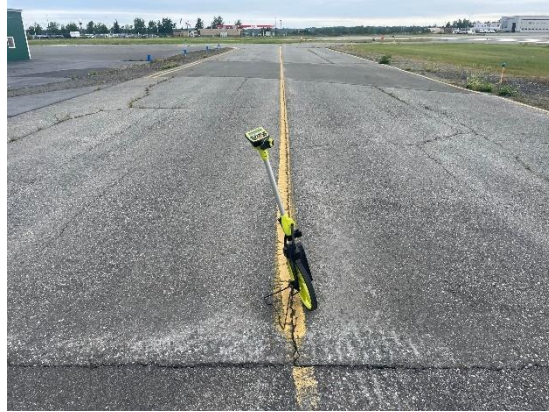
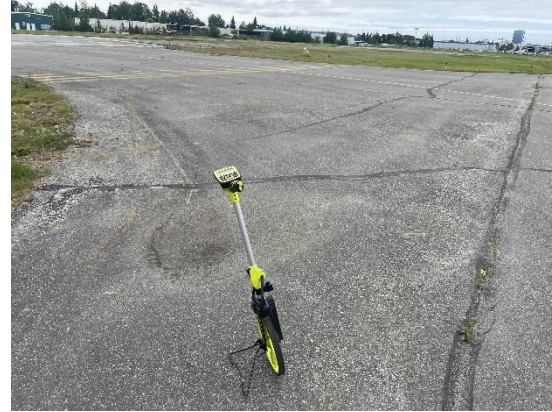
**Section 0200-01 (63 PCI), 0200-02 (69 PCI), 0200-03 (56 PCI)**

Taxiway B consists of five sections, Sections 0200-01 through 0200-05. The pavement surface of Section 0200-01 was rehabilitated in 2003. Sections 0200-02 and 0200-03 have not undergone any major work since their initial construction in 1998 and 1996, respectively. Occasional crack seal operations have been performed on these sections. The most common distresses are low to medium severity longitudinal and transverse cracking, low severity raveling, and low severity weathering. Pavement inspectors observed vegetation growing in cracks, even many that have been sealed, indicating that water is infiltrating the cracks.

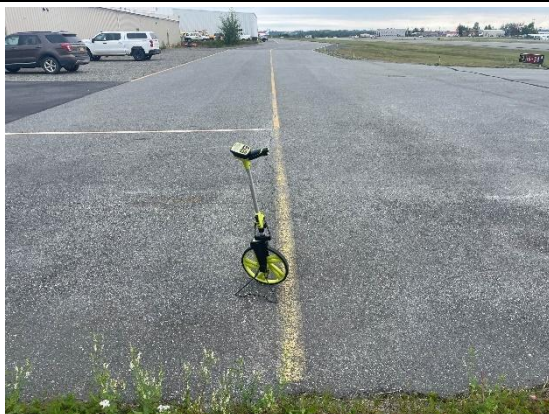
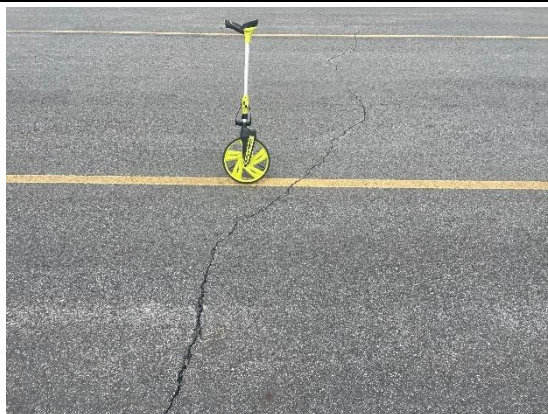
**Section 0200-04 (79 PCI), 0200-05 (80 PCI)**

Taxiway B Sections 0200-04 and 0200-05 have not undergone any major work since their initial construction in 2006 and 2017, respectively. Crack seal operations have not been performed on these sections. The most common distresses are low to medium severity longitudinal and transverse cracking, low severity raveling, and low severity weathering. Unsealed longitudinal and transverse cracks have the potential to allow vegetative growth similar to the remainder of Taxiway B.

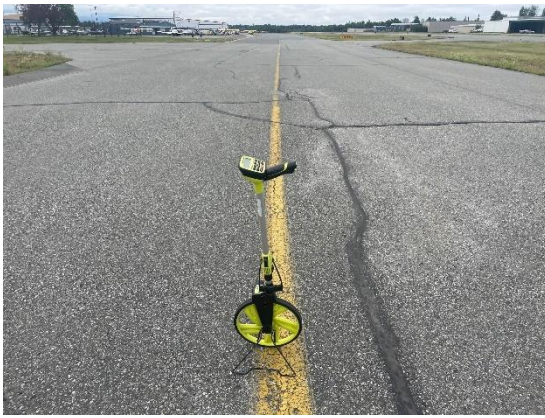
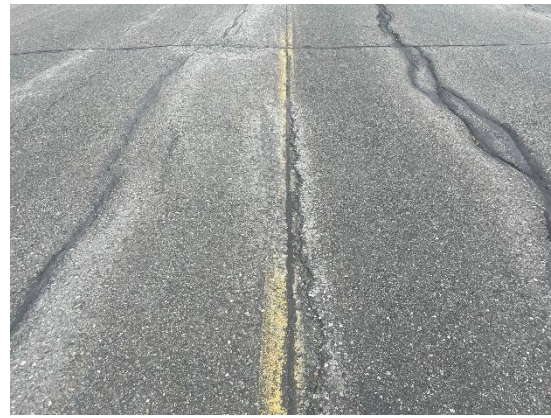
Taxiway C consists of three sections, Sections 0300-01 to 0300-03. The pavement surfaces of these sections were rehabilitated in 2002, 1999, and 2003, respectively. Occasional crack seal operations have been performed on the branch. The most common distresses are low to medium severity longitudinal and transverse cracking, low severity raveling, and low severity weathering. Most cracks are sealed well, although localized regions of raveling along unsealed cracks exist.

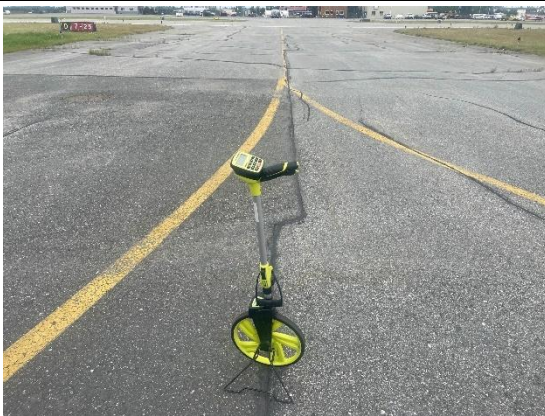
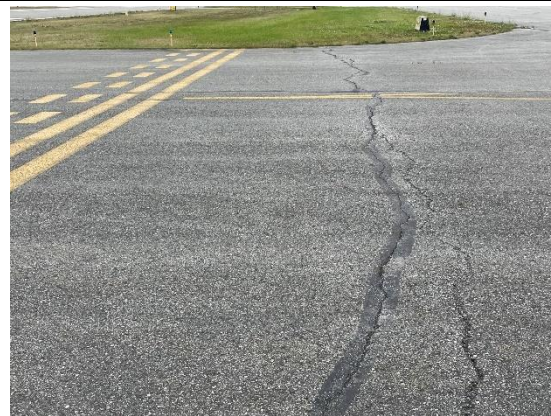
Taxiway D consists of three sections, Sections 0400-01a, 0400-01b and 0400-02. The pavement surfaces of Sections 0400-01a and 0400-01b were rehabilitated in 1999, while Section 0400-02 received a surface rehabilitation in 2003. Occasional crack seal operations have been performed on the branch. The most common distresses are low to high severity longitudinal and transverse cracking, low severity raveling, and low severity weathering. Cracks mostly contain sealant although vegetation is protruding from some cracks of medium and high severity.

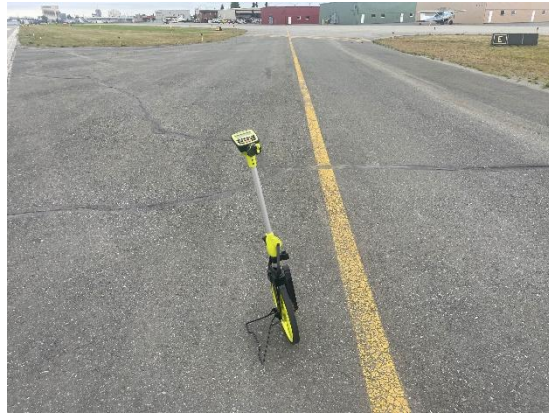
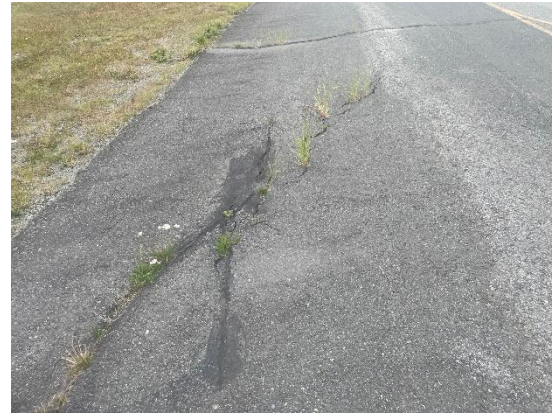
Taxiway E was realigned and fully reconstructed in 2001 and consists of three sections, Section 0500-01a, 0500-01b, and 0500-02. The pavement surface of Section 0500-01b was rehabilitated in 2008. No work has been performed on Section 0500-01a and 0500-02 since they were constructed. Crack sealing has occasionally been performed on the branch. The most common distresses are low to high severity longitudinal and transverse cracking, low severity raveling, and low severity weathering. Medium and high severity cracks allow water to infiltrate and vegetation to grow through the cracks. Inspectors observed a crack at the connection to Taxiway N has swelled up, allowing the AC surface to be raveled, likely from snowplow operations.

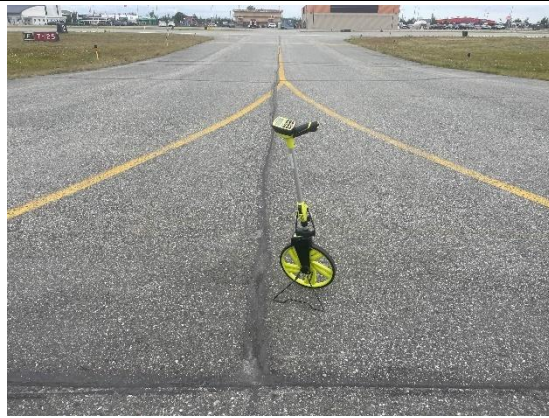
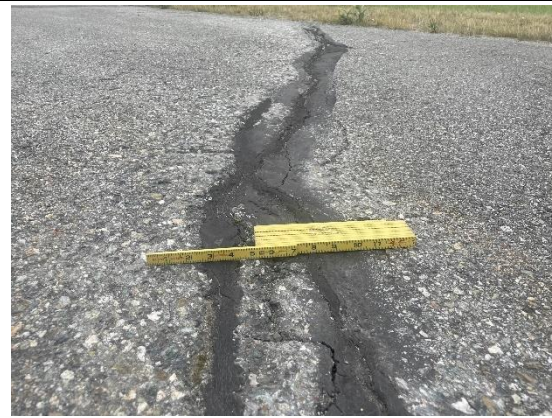
The three sections of Taxiway F, Section 0600-01a, 0600-01b, and 0600-02, were realigned and reconstructed of AC in 2001. The pavement surface of Section 0600-01b was subsequently rehabilitated in 2008. Crack sealing has occasionally been performed on the branch. The most common distresses are low to medium severity longitudinal and transverse cracking, low severity raveling, and low severity weathering. Inspectors observed cracks were mostly sealed, although stretches of raveling exist along some cracks.

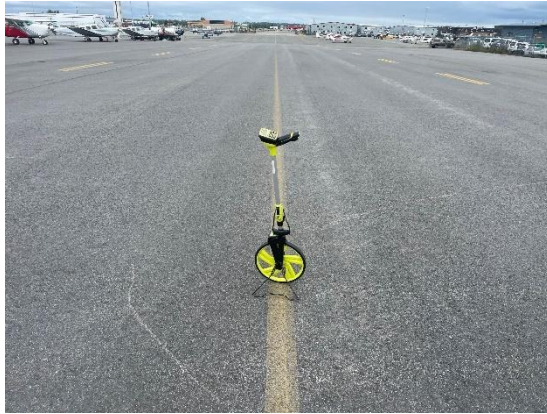
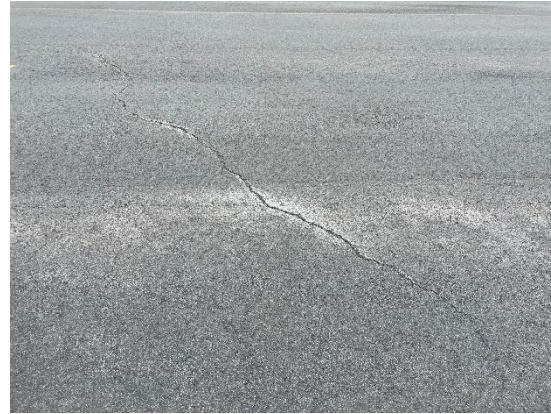
**Section 0700-01 (93 PCI)**

Taxiway G consists of four sections, Sections 0700-01 to 0700-04. Section 0700-01 was completely reconstructed in 2018. Crack sealing has not been performed on section 0700-01. The most common distresses are low to medium severity longitudinal and transverse cracking and low severity weathering. New unfilled cracks have formed and exhibit initial surface deterioration.

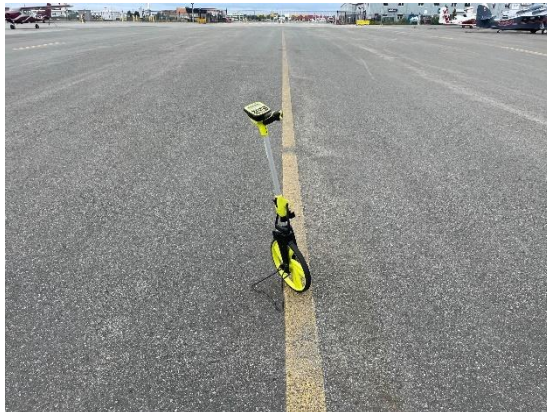
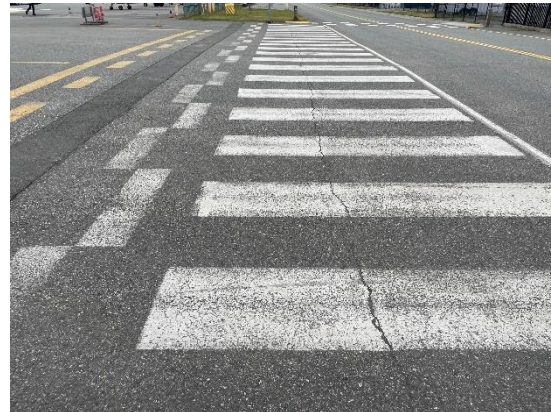
**Section 0700-02 (80 PCI), 0700-03 (75 PCI)**

Taxiway G Sections 0700-02 and 0700-03 were completely reconstructed in 2012 and 2009, respectively. Crack sealing has only been performed on Section 0700-03 north of the access road that crosses the section. The most common distresses are low to medium severity longitudinal and transverse cracking, low severity patching, and low severity weathering. Multiple transverse cracks are developing across the width of the taxiway that remain unsealed. In addition, inspectors noted a full-width patch south of the access road on Section 0700-03.

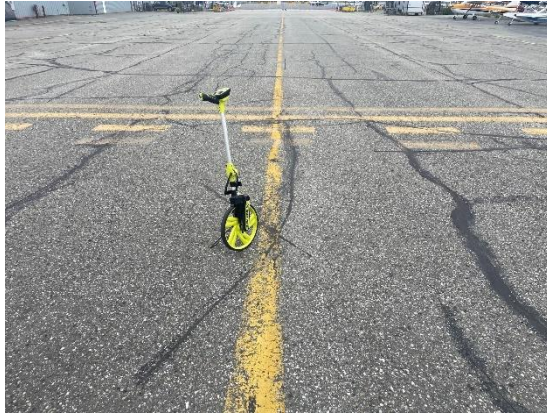
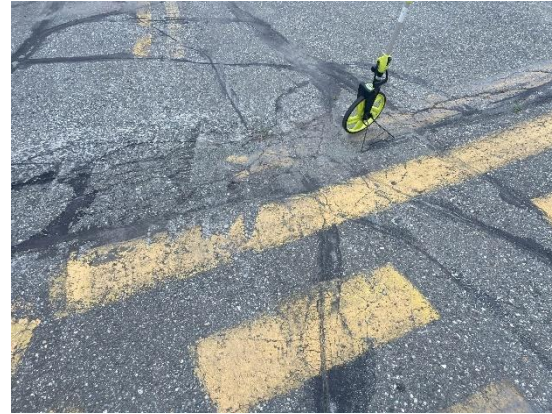
**Section 0700-04 (27 PCI)**

No major work has been performed on Taxiway G Section 0700-04 since its initial construction in 1980. Crack sealing has occasionally been performed on the section. The most common distresses are low to medium severity fatigue cracking, low severity block cracking, medium severity longitudinal and transverse cracking, low severity raveling, and low severity weathering. The pavement surface of this section is highly degraded with a large quantity of load-related distresses throughout.

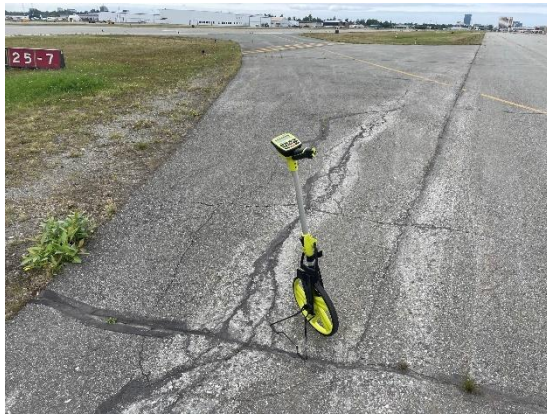
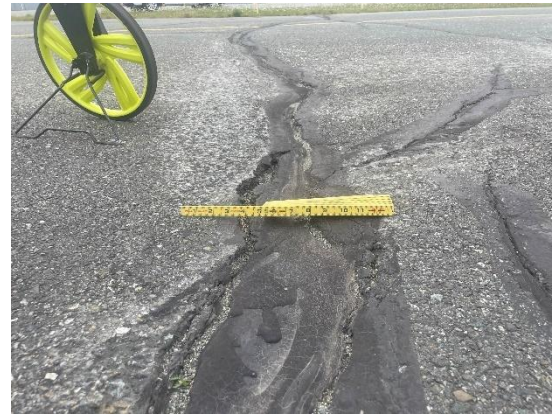
Taxiway H was realigned and fully reconstructed in 2001 and consists of three sections, Section 0800-01a, 0800-01b, and 0800-02. Major work has been performed only on Section 0800-01b, which received a surface rehabilitation in 2008. Occasional crack seal operations have been performed on the branch. The most common distresses are low to high severity longitudinal and transverse cracking, low severity raveling, and low severity weathering. Pavement inspectors observed that cracks are mostly sealed with some vegetation noted. In addition, inspectors noted raveling around a raised crack at the connection to Taxiway A, likely from snowplow operations.

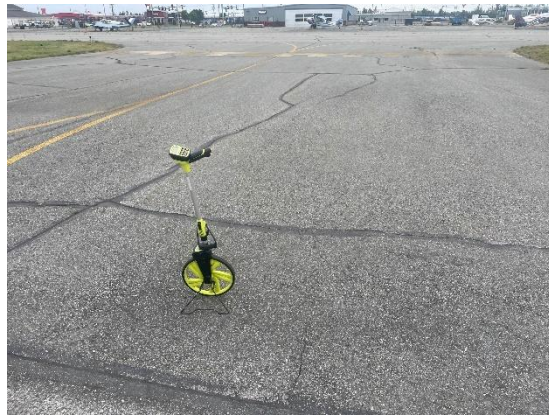
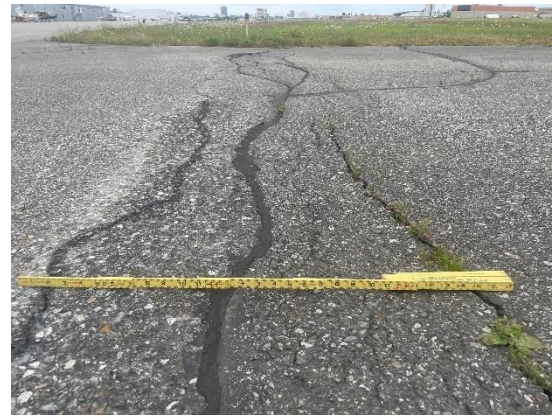
Taxiway J consists of three sections, Sections 1000-01a, 1000-01b and 1000-02. Sections 1000-01a and 1000-01b were most recently rehabilitated in 1999 while Section 1000-02 was rehabilitated in 2003. Crack sealing has occasionally been performed on the branch. The most common distresses are low to medium severity longitudinal and transverse cracking, low severity raveling, and low severity weathering. Cracks are mostly sealed with some areas of raveling noted. Inspectors noted a swelled crack that is raveling near the connection to Taxiway N parallel to the taxiway, likely from snowplow maintenance.

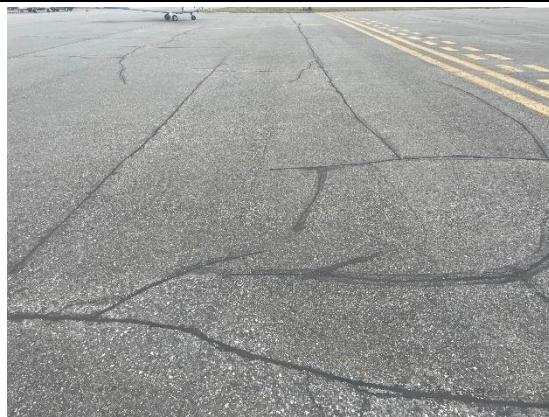
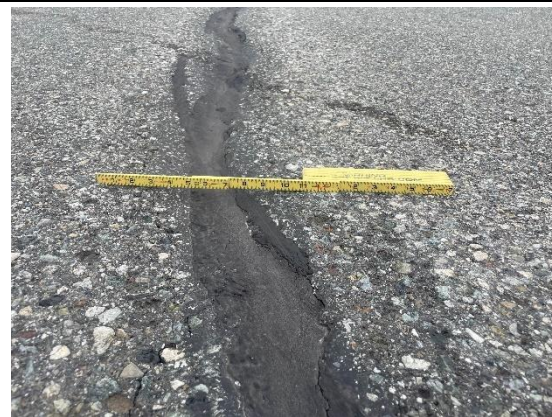
Taxiway K consists of Sections 1100-01 and 1100-02, both of which were constructed of AC in 1978. The pavement surface of Section 1100-01 was rehabilitated in 1999, while that of Section 1100-02 was rehabilitated in 2003. Crack sealing has occasionally been performed on the branch. The most common distresses are low to medium severity longitudinal and transverse cracking, low severity raveling, and low severity weathering. Inspectors observed that cracks are mostly sealed, although localized areas of raveling exist along some cracks.

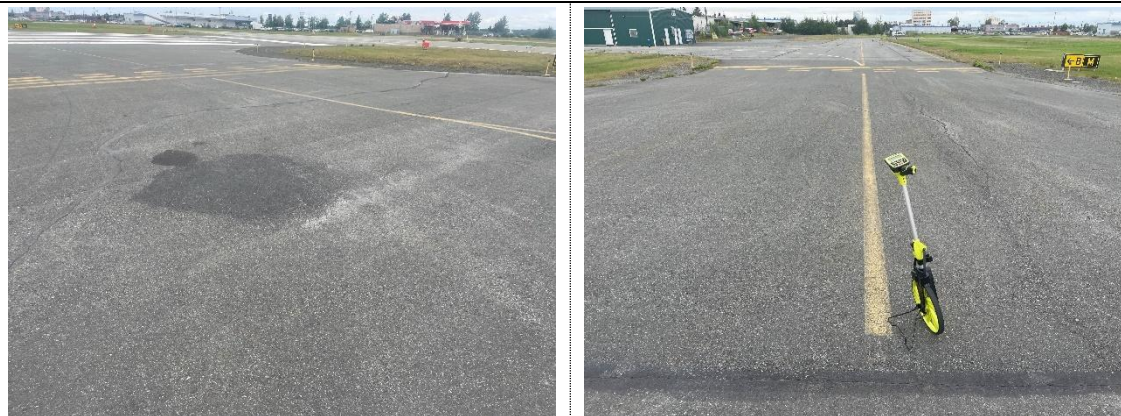
**Section 1300-01 (72 PCI), 1300-02a (81 PCI)**

Taxiway M consists of four sections, Sections 1300-01, 1300-02a, 1300-02b and 1300-03. Sections 1300-01 and 1300-02a received a mill and overlay in 2010 and since that time, crack sealing has occasionally been performed on these sections. The most common distresses are low to medium severity longitudinal and transverse cracking, low severity patching, and low severity weathering. The pavement on these sections exhibits both filled and unfilled cracks, along with a notable oil spill on Section 1300-01 near the hold-short line for Runway 16/34.

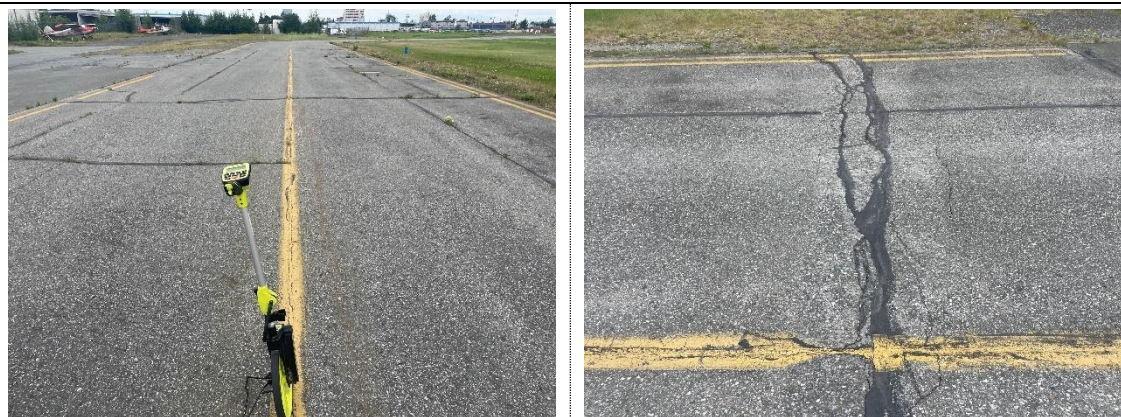
**Section 1300-02b (57 PCI), 1300-03 (67 PCI)**

No major work has been performed on Taxiway M Sections 1300-02b and 1300-03 since their initial construction in 1996 and 1997, respectively. Crack sealing has occasionally been performed on these sections. The most common distresses are low to medium severity longitudinal and transverse cracking, low severity raveling, and low severity weathering. Considerable cracking exists, but most cracks are sealed. Stretches of raveling exist along some cracks, with vegetation protruding through the crack sealant in many instances. Inspectors observed a medium severity depression on Section 1300-02b west of its connection to Taxiway B.

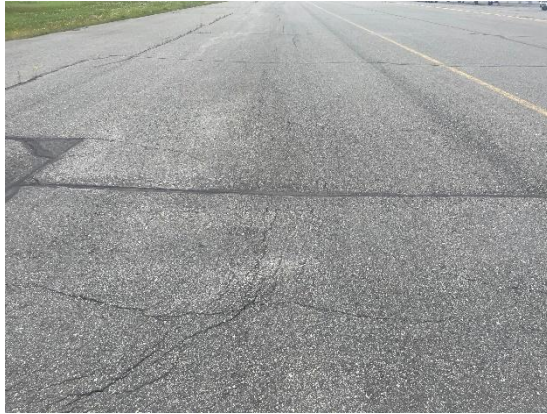
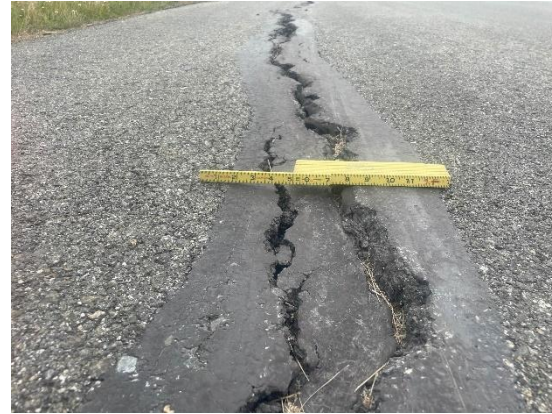
**Section 1400-01 (66 PCI), 1400-02 (72 PCI)**

Taxiway N consists of three sections, Sections 1400-01 to 1400-03, which were constructed in 1978. The pavement surfaces of Sections 1400-01 and 1400-02 were rehabilitated in 1999. Crack sealing has occasionally been performed on these two sections. The most common distresses are low severity fatigue cracking, low to high severity longitudinal and transverse cracking, low severity patching, low to medium severity raveling, and low severity weathering. The fatigue cracks and longitudinal and transverse cracks are mostly sealed with localized areas of raveling along some cracks. High severity cracks exist with the most significant on Section 1400-01 Additional Sample Unit 26A east of Taxiway E.

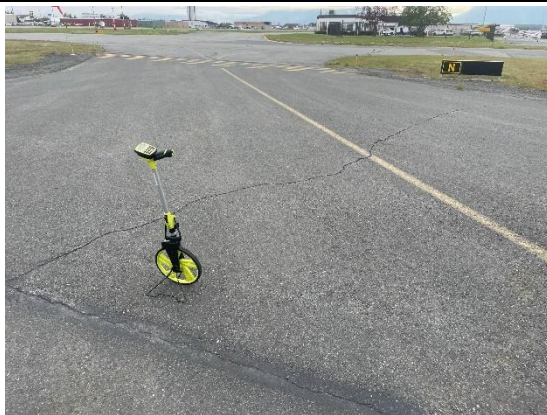
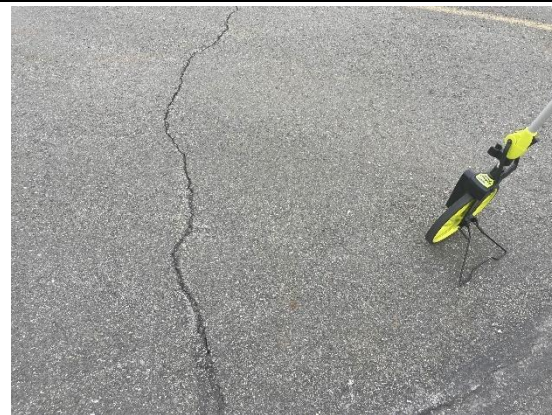
**Section 1400-03 (85 PCI)**

Taxiway N Section 1400-03 was milled and overlaid in 2010. Crack sealing has not been performed on the section. The most common distresses are low to medium longitudinal and transverse cracking and low severity weathering. Pavement inspectors observed an unfilled crack that spans the width of the taxiway.

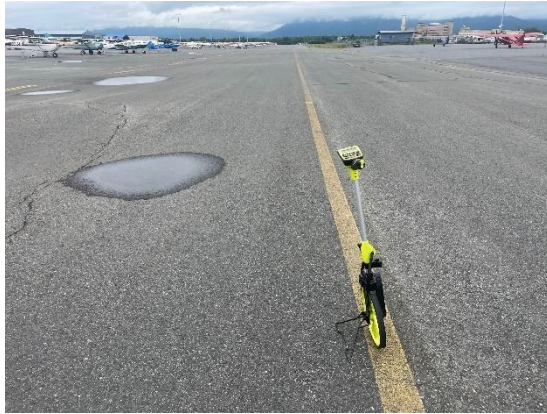
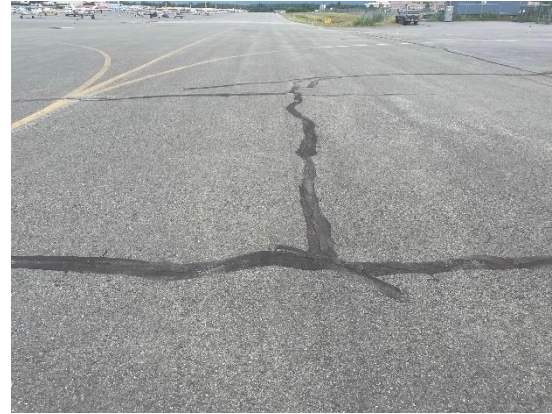
**Section 1700-01 (81 PCI), 1700-05 (90 PCI), 1700-06 (93 PCI)**

Taxiway Q consists of seven sections, Sections 1700-01, 1700-01a, and 1700-02 through 1700-06. Sections 1700-01, 1700-05 and 1700-06 were completely reconstructed in 2012, 2018, and 2017, respectively. Crack sealing has occasionally been performed on these sections. The most common distresses are low to medium severity longitudinal and transverse cracking, and low severity weathering. Low severity depressions were observed along Section 1700-05. In addition, numerous low severity depressions were noted on Section 1700-01 Additional Sample Unit 17A, west of Taxiway G.

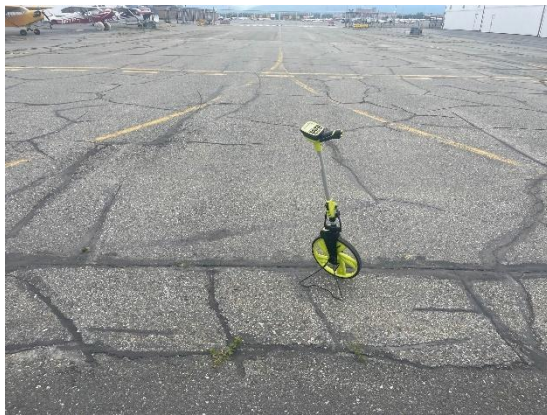
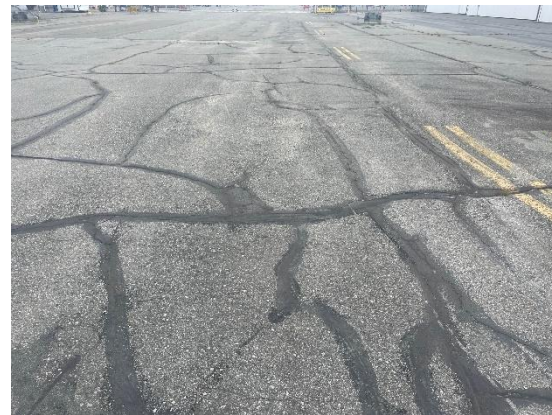
**Section 1700-01a (45 PCI)**

Taxiway Q Section 1700-01a has not undergone any major work since its initial construction in 1997. Crack sealing has occasionally been performed on the section. The most common distresses are low to medium severity block cracking, low severity raveling, and medium severity weathering. The pavement is fully block cracked and although it has been sealed well, the AC surface is highly degraded, with some coarse aggregate particles dislodged.

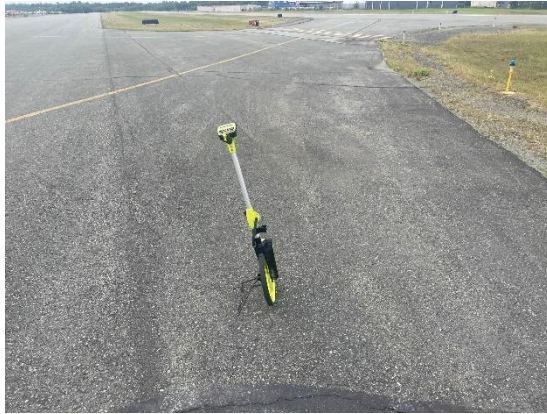
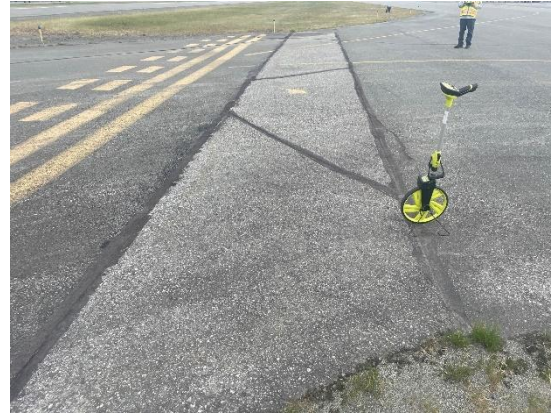
**Section 1700-02 (75 PCI)**

The Taxiway Q Section 1700-02 pavement surface was rehabilitated in 2002. Crack sealing has occasionally been performed on the section. The most common distresses are low severity longitudinal and transverse cracking, low severity patching, and low severity weathering. Inspectors noted that cracks span the section, including a full-width patch with sealed cracks.

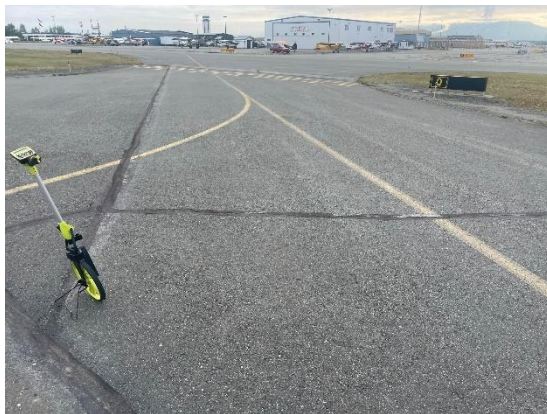
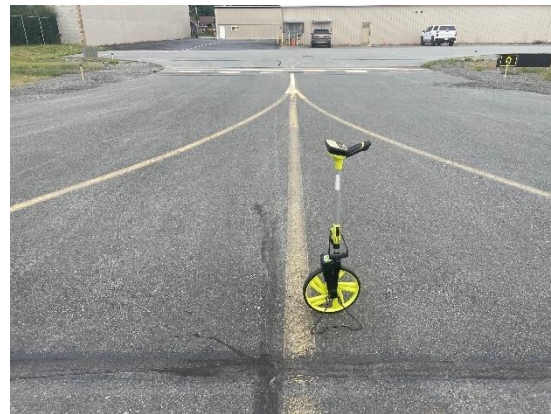
**Section 1700-03 (85 PCI), 1700-04 (79 PCI)**

Taxiway Q Section 1700-03 lies to the east of the runway. It was constructed in 1978 and was subsequently milled and overlaid in 2010. Section 1700-04, which lies to the west of the runway, was newly constructed in 2010. Crack sealing has occasionally been performed on these sections. The most common distresses are low severity longitudinal and transverse cracking, low severity patching, and low severity weathering. Pavement inspectors noted that cracks are mostly sealed with some new cracks developing.

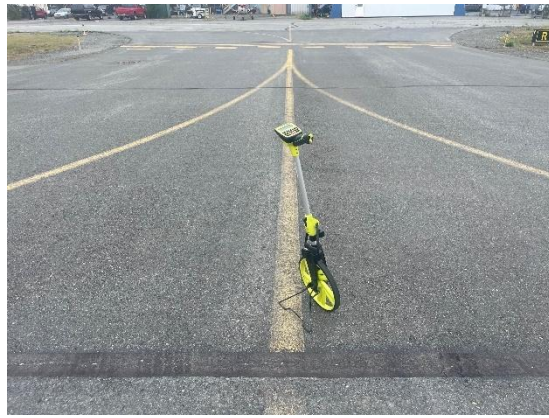
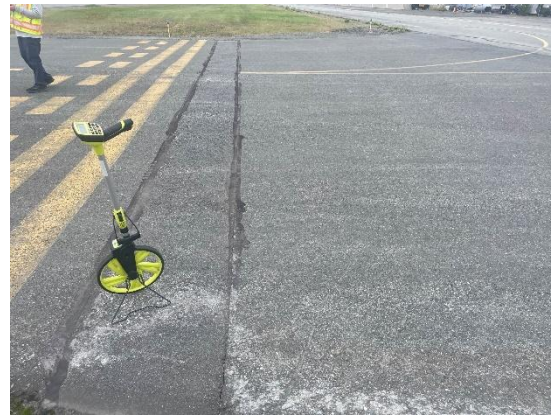
Taxiway R was newly constructed in 2010 concurrent with the Runway 16/34 mill and overlay project. Occasional crack seal operations have been performed on the branch. The most common distresses are low severity longitudinal and transverse cracking, low severity patching, low severity raveling, and low severity weathering. Full-width sealed cracks and a full-width patch were observed by inspectors.

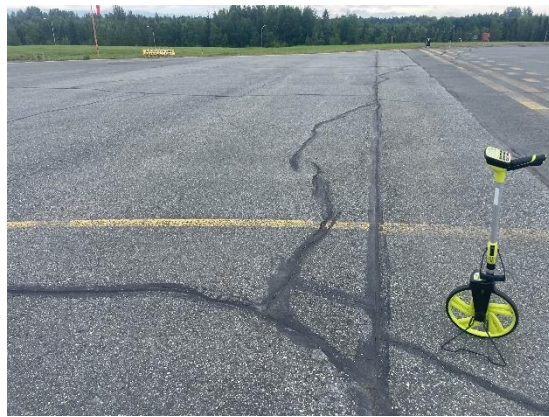
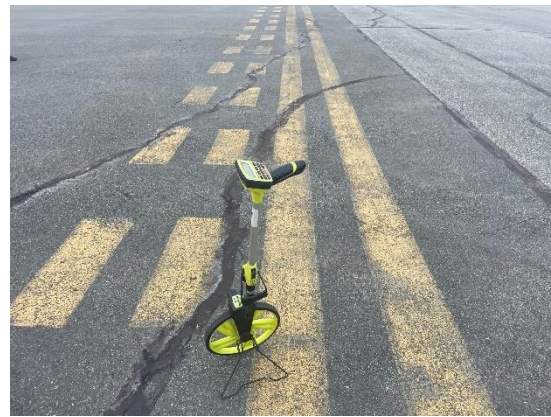
Taxiway S consists of three sections, Sections 1900-01 to 1900-03, which were constructed in 1998. Sections 1900-01 and 1900-02 received a mill and overlay in 2010. Section 1900-03 was reconstructed in 2002. Occasional crack seal operations have been performed on the branch. The most common distresses are low to medium severity longitudinal and transverse cracking, low severity patching, low severity raveling, and low severity weathering. Pavement inspectors observed that cracks are mostly sealed well, though vegetation is protruding through the sealant in areas of Section 1900-02 west of the runway.

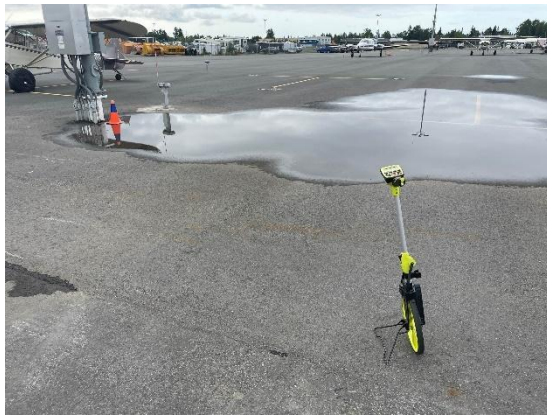
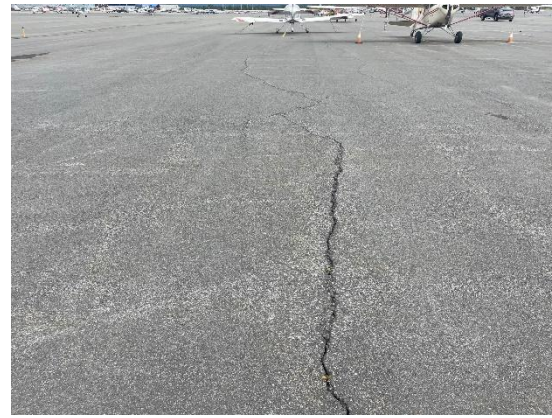
The Taxiway G Apron consists of two sections, Sections 4100-01 and 4100-02. Section 4100-01 was completely reconstructed in 2019 while Section 4100-02 was reconstructed in 2020. Crack seal operations have not been performed on the branch. The most common distresses are low severity depression, low severity longitudinal and transverse cracking, oil spillage, and low severity weathering. Unsealed cracks are developing in addition to numerous depressions and oil spills from the long-term storage of aircraft. However, the significant number of depressions on Section 4100-02 Additional Sample Unit 807A suggests a potential long-term consolidation of the underlying layers, which include a former landfill.

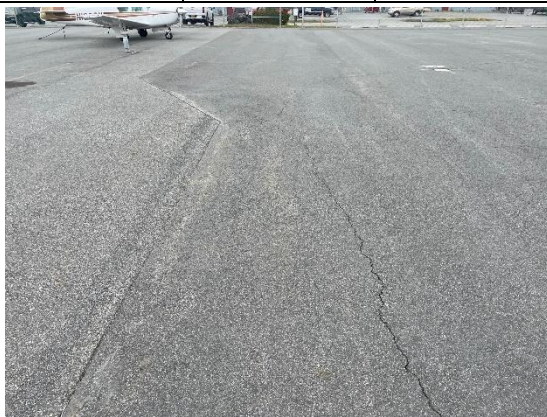
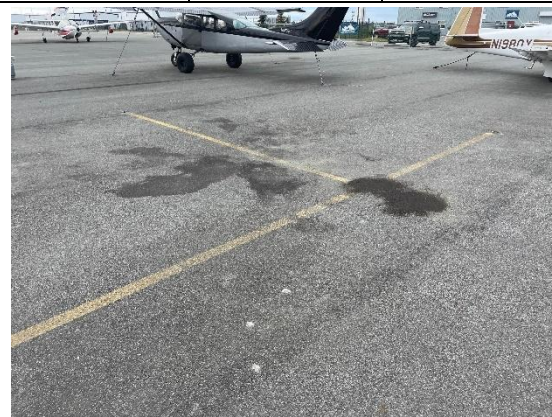
The Taxiway Q Apron was completely reconstructed in 2018. Crack sealing has not been performed on the branch. The most common distresses are low to medium severity longitudinal and transverse cracking, oil spillage, and low severity weathering. Pavement inspectors observed the development of cracks and numerous oil spills from the long-term storage of aircraft.

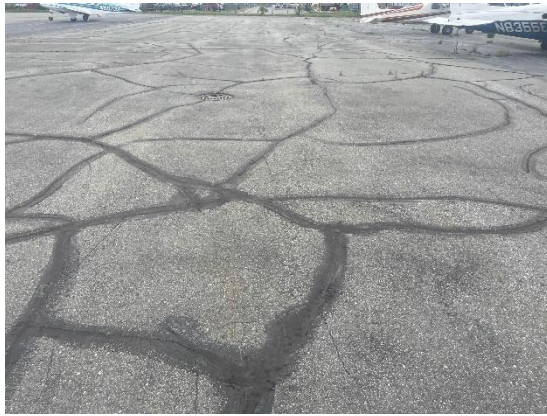
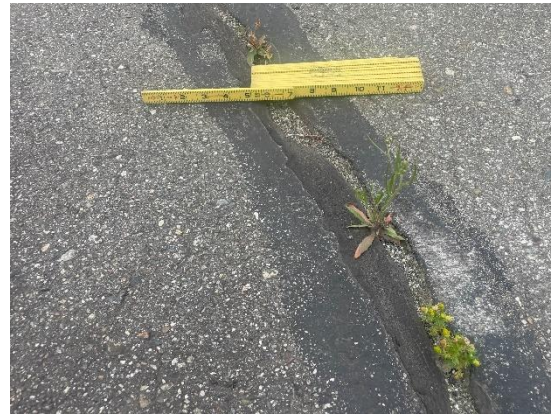
No major work has been performed on Transient Apron 1 since its initial construction in 1978. Crack sealing has occasionally been performed on the branch. The most common distresses are low to medium severity block cracking, low to medium severity longitudinal and transverse cracking, oil spillage, low severity raveling, and low severity weathering. Inspectors noted that while the pavement is cracked, most cracks have been sealed. Vegetation is protruding through the sealant in many instances.

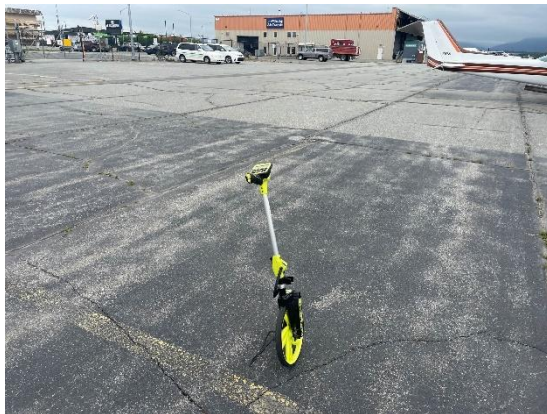
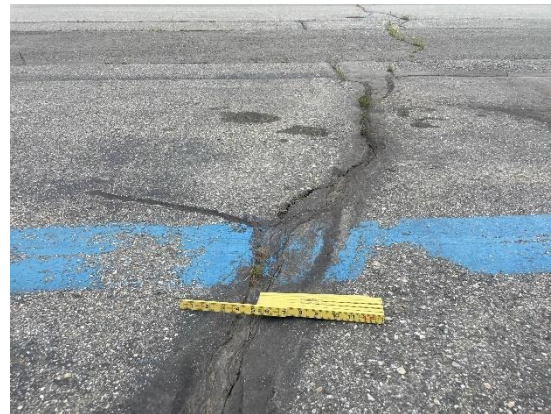
Originally constructed in 1978, no major work has been performed on the Tower Apron. Crack sealing has occasionally been performed on the branch. The most common distresses are low to medium severity longitudinal and transverse cracking, low severity patching, and low severity weathering. Inspectors observed that the pavement is generally degraded and cracked and that patches exist on all inspected sample units.

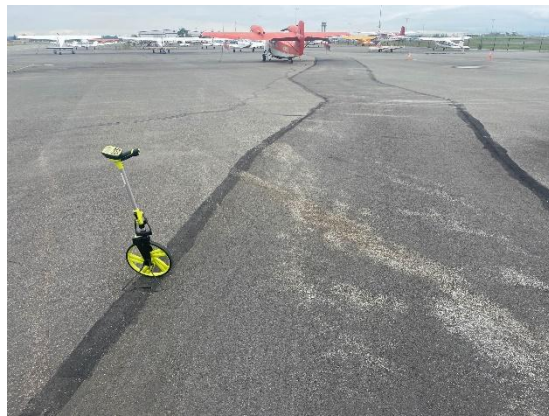
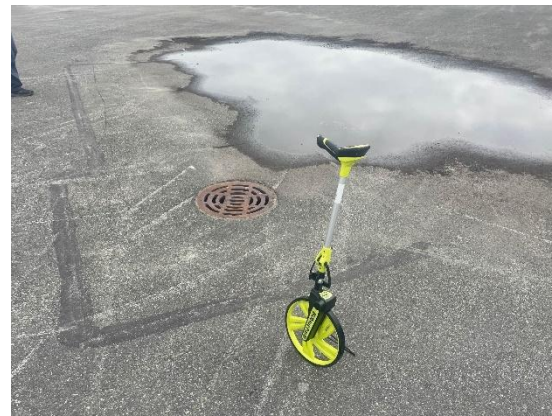
The Taxiway S Apron was constructed in 1978 and the pavement surface was most recently rehabilitated in 2010. Crack sealing has occasionally been performed on the branch. The most common distresses are low severity depression, low to medium severity longitudinal and transverse cracking, oil spillage, low severity patching, and low severity weathering. Inspectors observed an array of distresses on the pavement surface, including numerous patches, depressions and oil spills. Sealed and unsealed cracks exist on the branch, including some that are raveling.

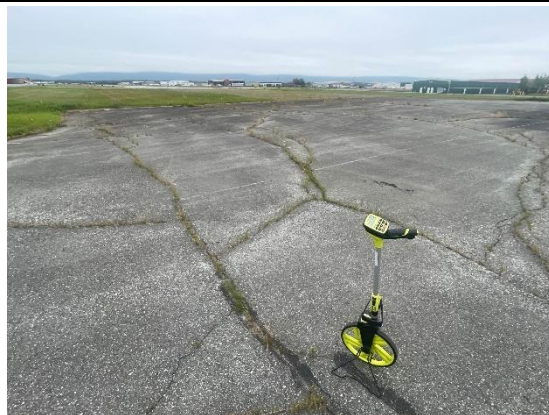
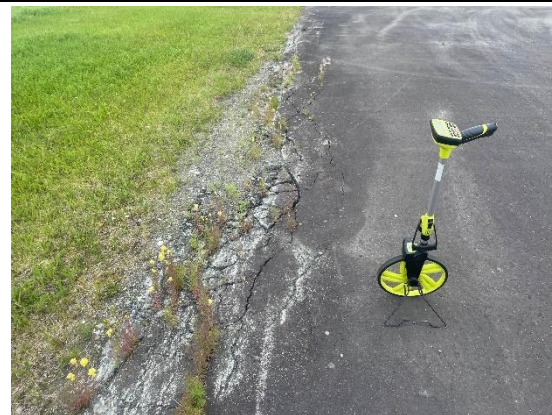
The Compass Rose Apron has not undergone any major work since its initial construction in 1997. Crack sealing has occasionally been performed on the branch. The most common distresses are low to high severity longitudinal and transverse cracking, low to high severity raveling, and low severity weathering. This pavement is degraded and vegetation has grown through most cracks. Furthermore, the pavement edge on the perimeter of the apron is cracked in numerous locations.

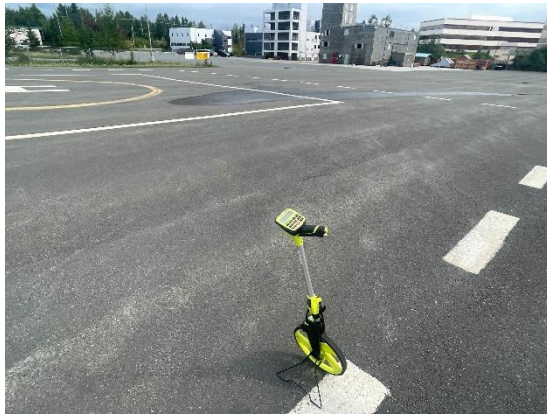
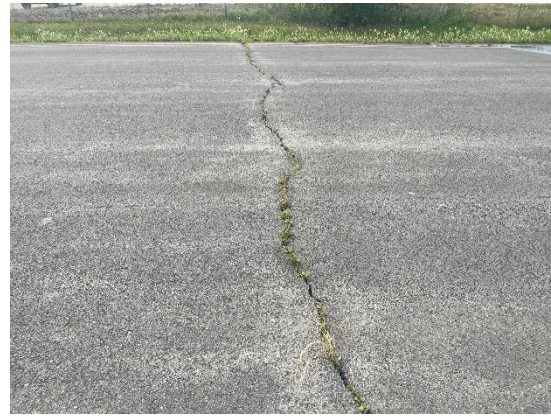
The Medivac Helipad Apron was completely reconstructed in 2013. Crack sealing has not been performed on the branch. The most common distresses observed are low severity depression, low to medium severity longitudinal and transverse cracking, and low severity weathering. Cracks are developing, which have not yet been sealed. Pavement inspectors noted depressions capable of holding water, particularly on Section 5100-01 Additional Sample Unit 100A, where a medium severity depression was observed.

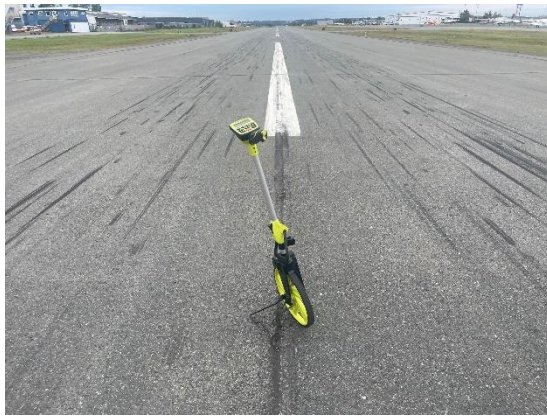
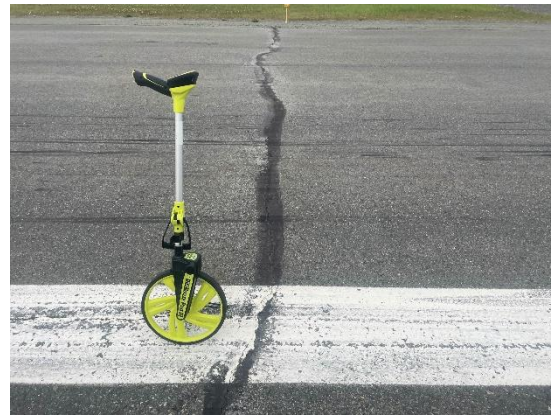
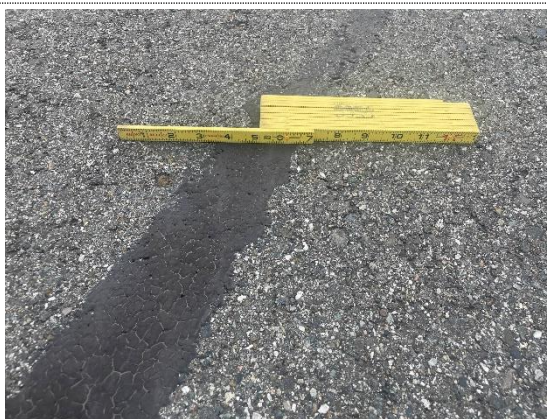
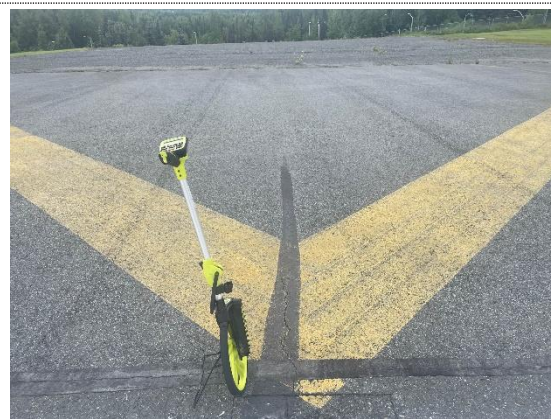
Runway 16/34 was originally constructed in 1980 and was most recently milled and overlaid in 2010. Crack sealing has occasionally been performed on the branch. The most common distresses are low severity longitudinal and transverse cracking and low severity weathering. Pavement inspectors observed numerous full-width transverse sealed cracks.

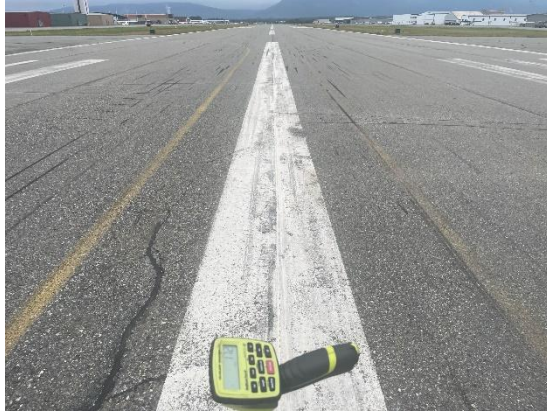
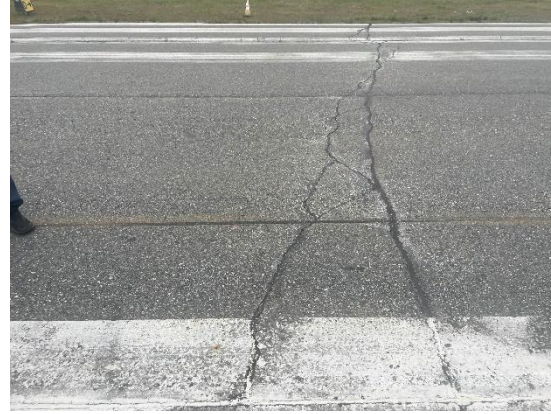
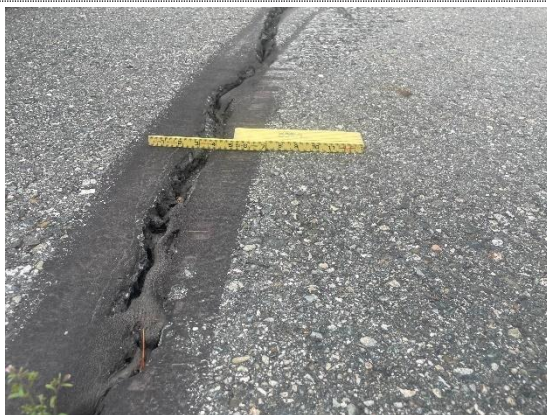
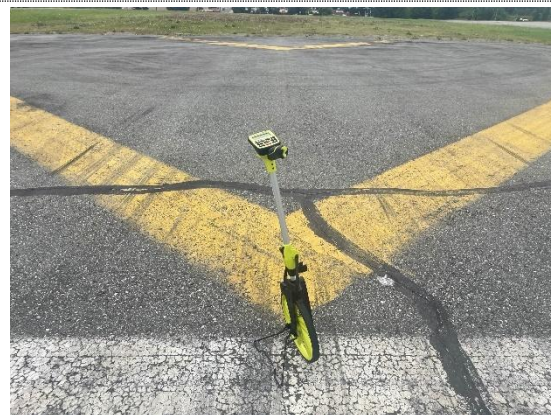
Runway 07/25 consists of three sections, Section 6200-01 to 6200-03. Section 6200-01 is the 4,000-ft long runway, which was originally constructed in 1980 and was rehabilitated 2005. Sections 6200-02 and 6200-03 are the runway overruns, which were constructed in 2005. Crack sealing has occasionally been performed on the branch. The most common distresses are low to medium severity longitudinal and transverse cracking, low severity raveling, and low severity weathering. Inspectors noted that while many cracks have been sealed, the sealant is depressed or otherwise failing, resulting in a medium severity rating. They also observed low severity raveling along the runway, which is the loss of coarse aggregate particles and a potential source of FOD on the pavement surface. At the time of the writing of this report in July 2025, RW 07/25 is currently being rehabilitated.
