Alaska DOT&PF

Pavement Inspection Report Nome Airport

Point of Contact	Phone	Email	Date Inspected	Date Published
Mr. Andrew Pavey, Pavement Management Engineer	(907) 269 6213	andrew.pavey@alaska.gov	July 2024	August 2025

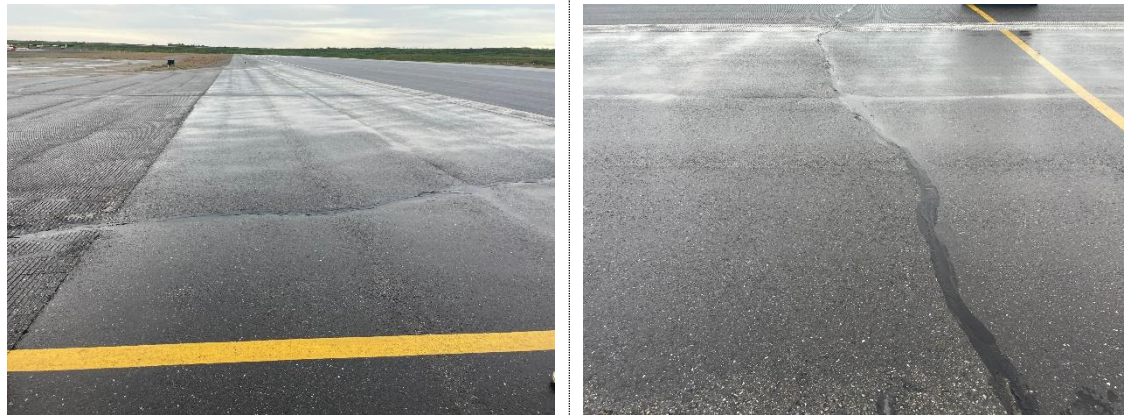
Section 0500-00 (90 PCI)

Taxiway E was initially constructed in 1971 and consists of four sections. The most recent major work was rehabilitation in 2022, concurrent with the foamed asphalt stabilized base project performed on Runway 3/21. Crack sealing has been performed annually on the branch. The most common distress is low severity longitudinal and transverse cracking. Field observations include the start of reflective cracking through the recent overlay.

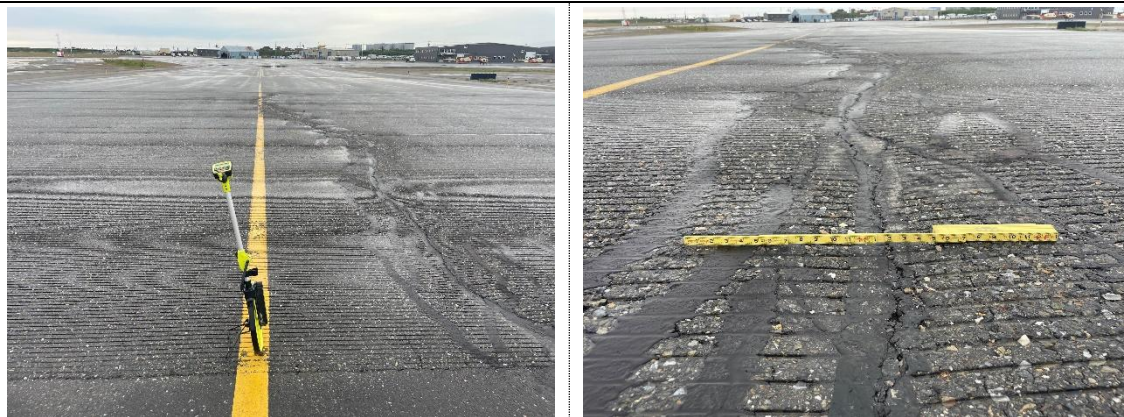
Section 0500-01 (63 PCI)

The most recent major work on Taxiway E Section 0500-01 was a circa 2008 surface rehabilitation. Crack sealing has been performed annually on the branch. The most common distresses are low severity depressions, low to medium severity longitudinal and transverse cracking, low severity raveling, and low severity weathering. Field observation indicates cracks beginning to depress, increasing the severity of the cracking distress. In addition, the maximum depth of the observed depressions is between ½ to 1 inch, a low severity depression for taxiways.

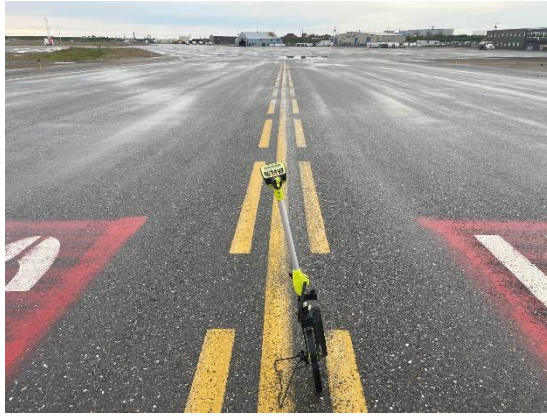
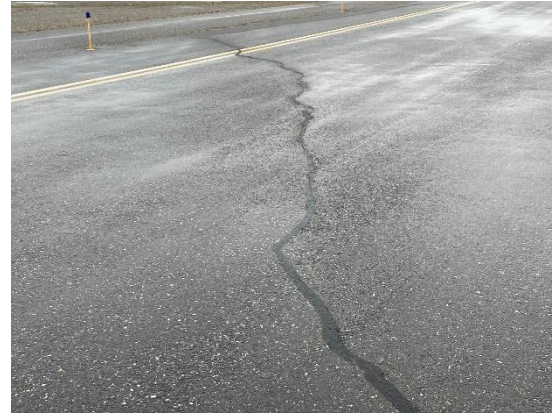
Section 0500-02 (82 PCI)

Taxiway E Section 0500-02 was reconstructed in 2015. Crack sealing has been performed annually on the branch. The most common distresses are low severity depressions, low to medium severity longitudinal and transverse cracking, and low severity raveling. Field observations indicate cracks beginning to depress, increasing the severity of the cracking distress. Moreover, localized areas of raveling can be observed adjacent to the paving lane joints.

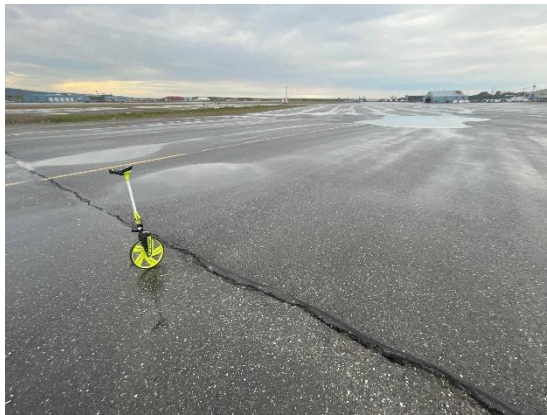
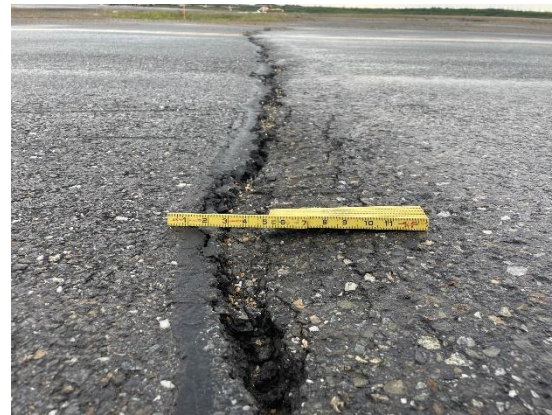
Section 0500-03 (55 PCI)

Section 0500-03 of Taxiway E was also reconstructed in 2015. Crack sealing has been performed annually on the branch. The most common distresses are low severity depressions, low to high severity longitudinal and transverse cracking, and low severity raveling. Field observations indicate a high severity transverse crack spanning the entire width of the taxiway, which is depressed and is allowing water infiltration.

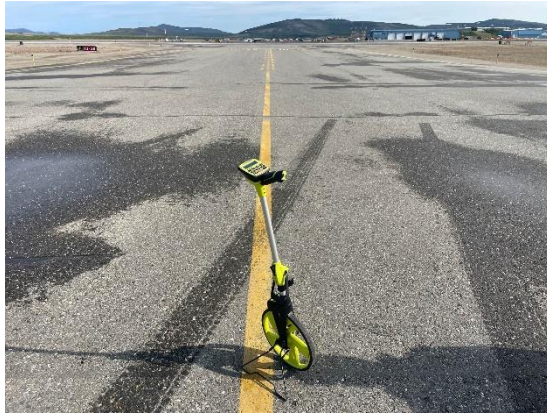
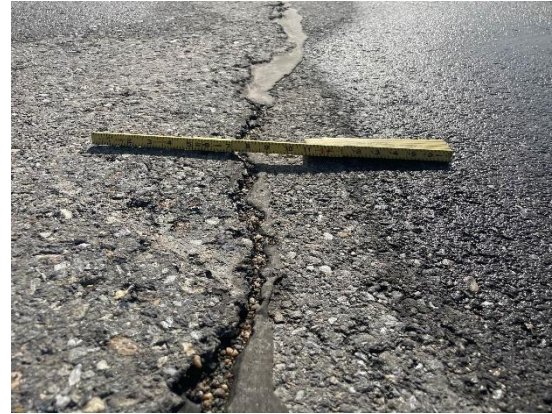
Section 0600-01 (73 PCI)

Taxiway F was initially constructed in 1971 and consists of two sections. Section 0600-01 was reconstructed in 2015. Crack sealing has been performed annually on the branch. The most common distresses are low severity depressions, low to high severity longitudinal and transverse cracking, low severity raveling, and low severity weathering. Field observations indicate cracks beginning to depress, increasing the severity of the cracking distress. In addition, the maximum depth of the observed depressions is between ½ to 1 inch, defined as low severity depressions for taxiways.

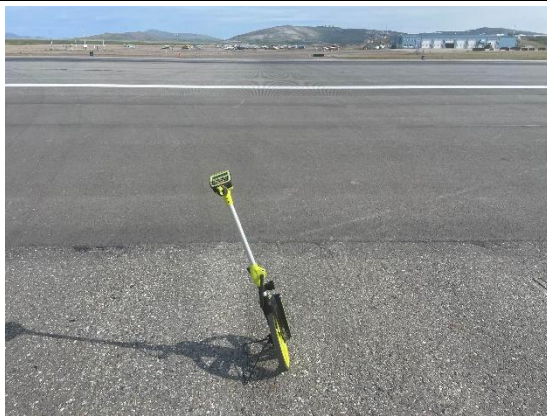
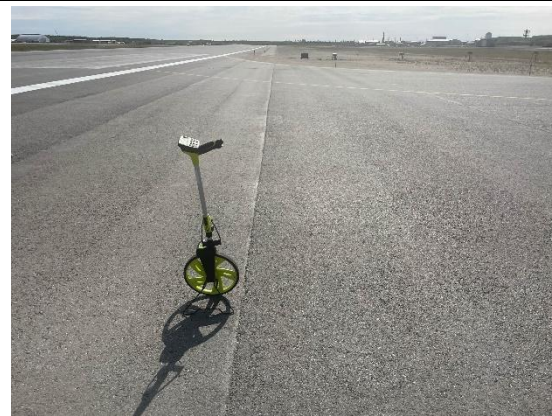
Section 0600-02 (100 PCI)

Taxiway F Section 0600-02 underwent major rehabilitation in 2023, concurrent with the foamed asphalt stabilized base project performed on Runway 10/28. Crack sealing has been performed annually on the branch. Pavement inspectors observed no distresses on this section.

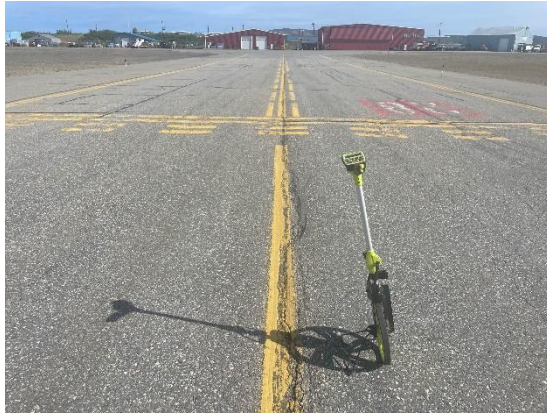
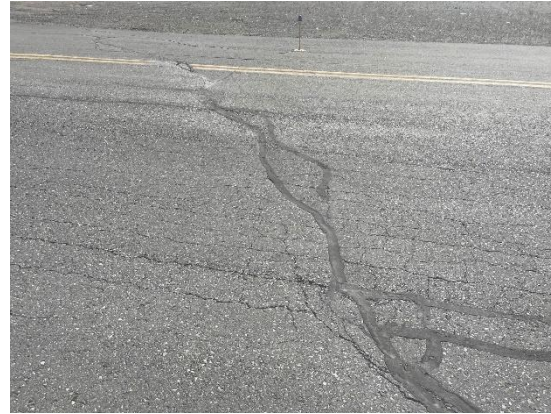
Section 0700-01 (19 PCI)

Taxiway G was initially constructed in 2002 and consists of two sections. Section 0700-01 has not received any major work since. Annual crack seal operations have been performed on the branch. The most common distresses are low to medium severity fatigue cracking, low to high severity longitudinal and transverse cracking, low severity raveling, and low severity weathering. Field observations included a considerable amount of fatigue cracking parallel to the wheel paths, indicating a lack of structural capacity.

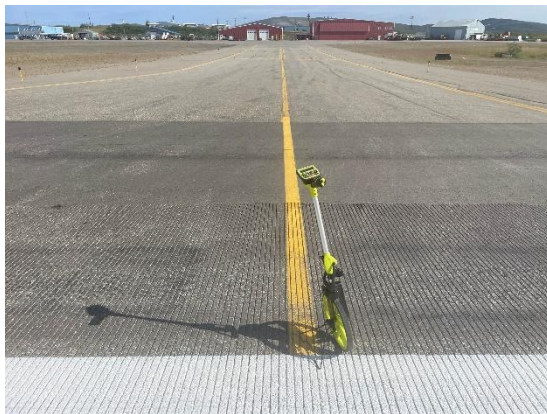
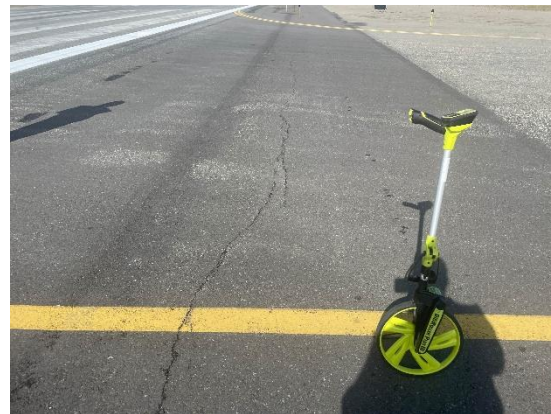
Section 0700-02 (92 PCI)

Taxiway G Section 0700-02 underwent major rehabilitation in 2023, concurrent with the foamed asphalt stabilized base project performed on Runway 10/28. Crack sealing has been performed annually on the branch. The most common distress is low severity longitudinal and transverse cracking. Field observations include the initiation of reflective cracking through the recent overlay.

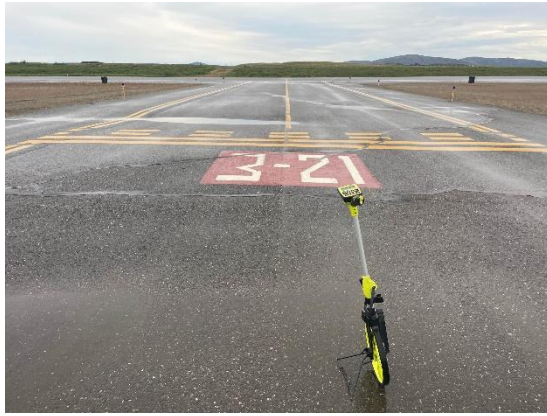
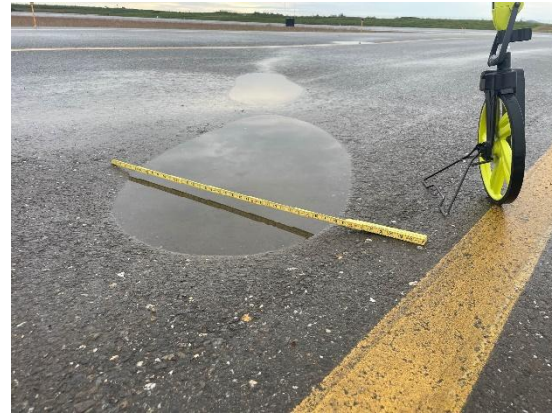
Taxiway H was constructed in 1993 and received a mill and overlay in 2015. Crack sealing has been performed annually on the branch. The most common distresses are medium to high severity depressions, low severity longitudinal and transverse cracking, and low severity weathering. Pavement inspectors observed two large high-severity depressions and Maintenance and Operations personnel indicated the taxiway was closed to aircraft operations. The cause of any structural weakness of the taxiway pavement is not possible to determine from a visual survey. An additional geotechnical investigation is required to identify the underlying cause of the depressions.

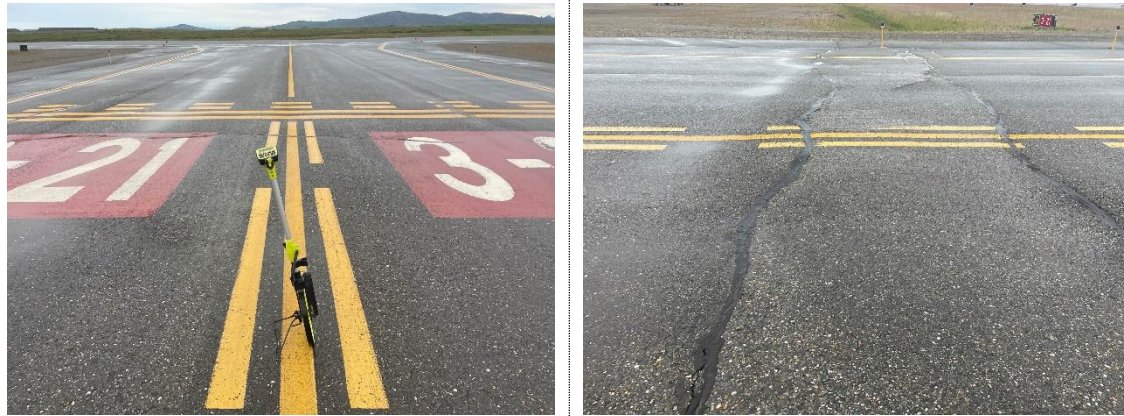
Section 1000-01 (86 PCI)

Taxiway J was initially constructed in 1989 and consists of two sections, Section 1000-01 and Section 1000-02. Section 1000-01 received surface rehabilitation in 2008. Crack sealing has been performed annually on the branch. The most common distresses are low severity depressions, low to medium severity longitudinal and transverse cracking, and low severity weathering. Field observations indicate medium severity transverse cracks spanning the width of the taxiway. The existing crack seal exhibits deterioration, as reflected in its medium severity classification, with partial re-opening observed along previously treated cracks.

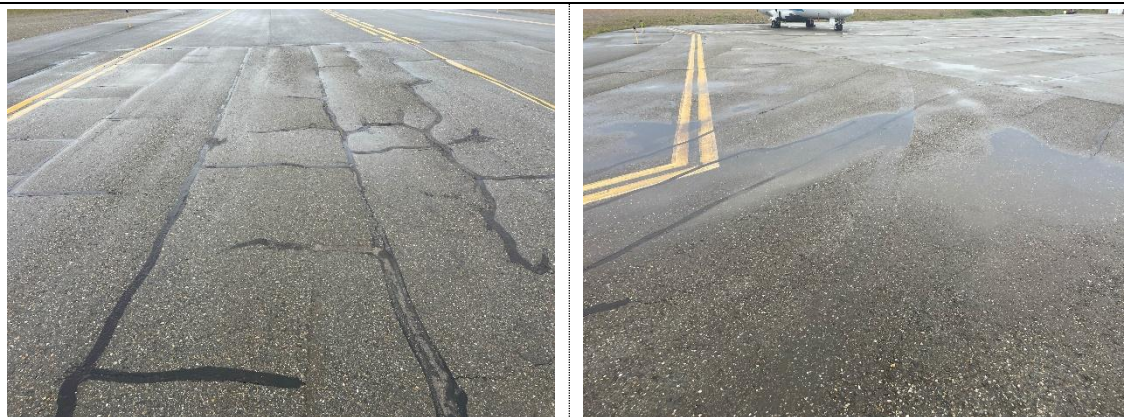
Section 1000-02 (54 PCI)

Taxiway J Section 1000-02 has not received any major work since its initial construction. Crack sealing has been performed annually on the branch. The most common distresses are low severity block cracking, low severity depressions, low to medium severity longitudinal and transverse cracking, low severity raveling, and low severity weathering. Pavement inspectors noted that cracks are becoming interconnected and that the area of block cracking appears to be expanding.

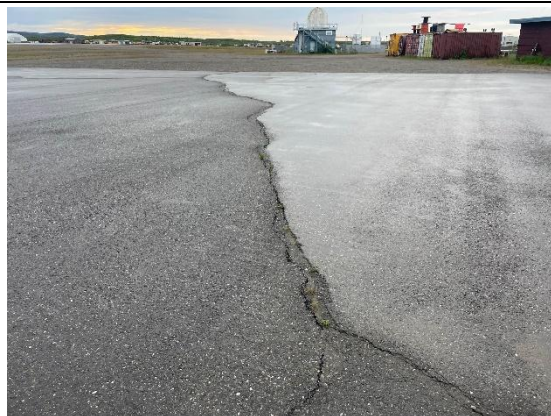
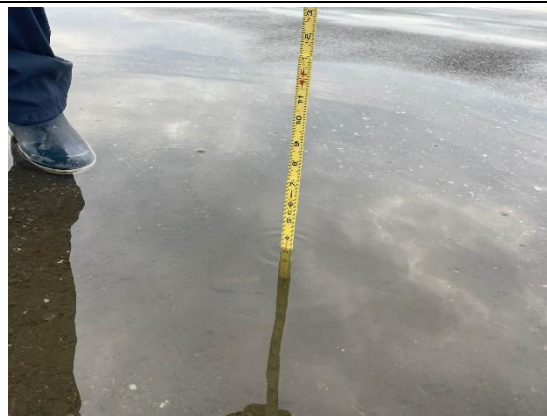
Section 4100-01 (84 PCI), 4100-02 (79 PCI), 4100-04 (80 PCI), 4100-05 (78 PCI)

The Main Apron consists of seven sections which were constructed in 1971 and expanded further in 1984 and 1998. Sections 01, 02, 04, and 05 received major rehabilitation work in 2015. Crack sealing has been performed occasionally on this branch. The most common distresses are low to medium severity depressions, low to medium severity longitudinal and transverse cracking, low to medium severity raveling, and low severity weathering. Field observations include standing water filling depressions on the apron.

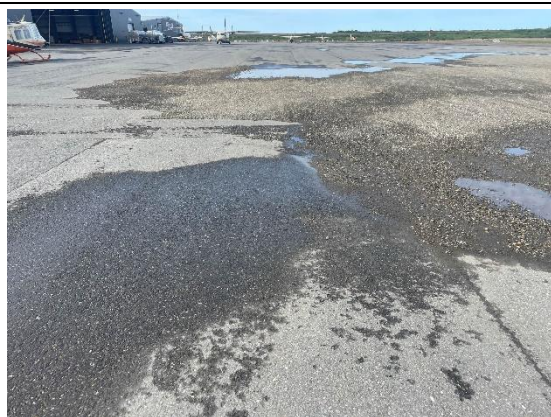
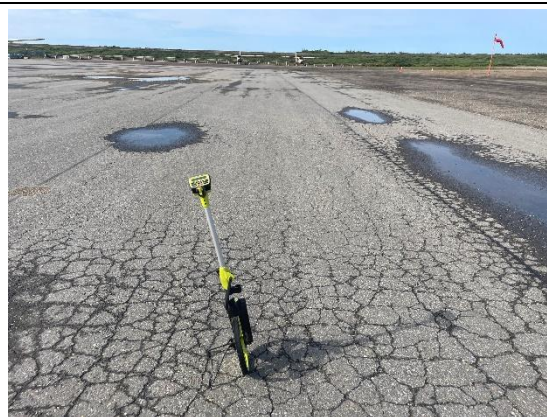
Section 4100-03 (41 PCI)

The Main Apron Section 4100-03 was constructed in 1998 and has not received any major work since. The most common distresses are medium severity fatigue cracking, low to high severity depressions, low to high severity longitudinal and transverse cracking, oil spillage, high severity patching, low severity raveling, and low to medium severity weathering. Airport maintenance personnel have temporarily filled several large high-severity depressions with loose material to allow aircraft operations to continue on the parking apron. An additional geotechnical investigation is required to identify the underlying cause of the depressions. Pavement inspectors also noted extensive medium-severity fatigue cracking on the section, which is indicative of another mode of structural failure due to fatigue of the asphalt concrete layer.

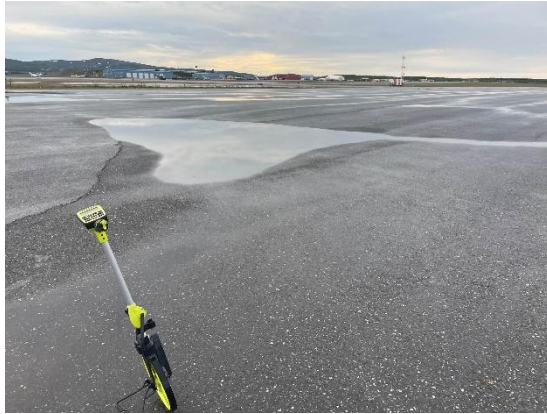
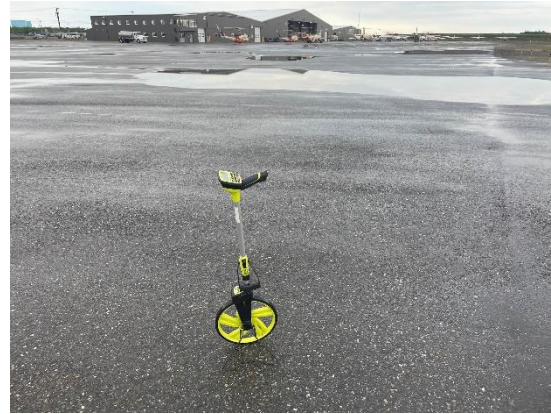
Section 4100-06 (55 PCI)

Main Apron Section 4100-06 was constructed in 1971 and has been rehabilitated in 2002 and again in 2015. The most common distresses are low to high severity depressions, low to medium severity longitudinal and transverse cracking, and low severity raveling. Pavement inspectors observed aircraft operators taking measures to avoid several large high-severity depressions on the parking apron. High-severity depressions indicate a significant loss of support.

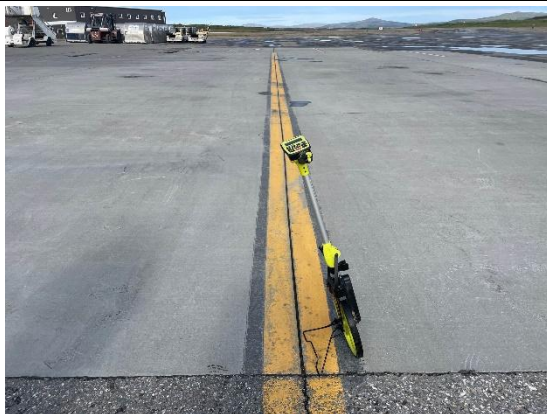
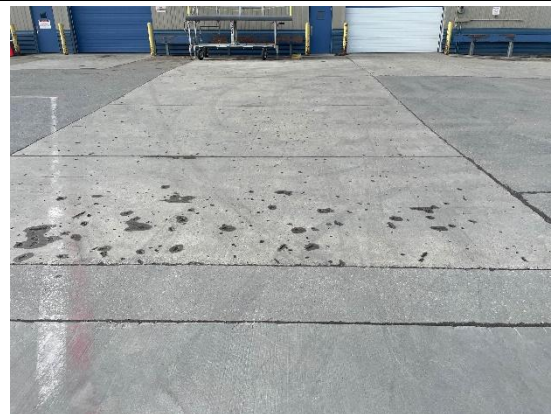
PCC Section 4100-07 (83 PCI)

PCC Section 4100-07 of the Main Apron was initially constructed in 2001 and was completely reconstructed in 2019. The most common distresses are low severity joint seal damage and low to medium severity joint spalling. Pavement inspectors note that longitudinal and transverse joints are becoming worn.

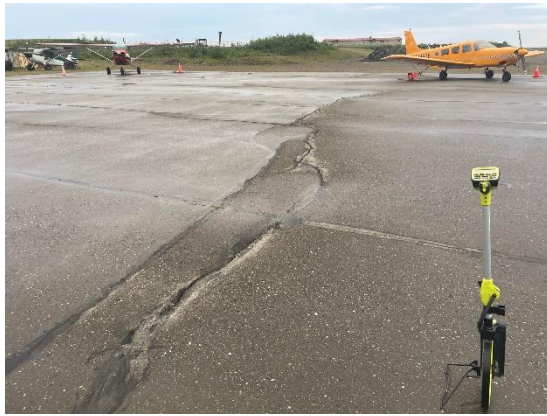
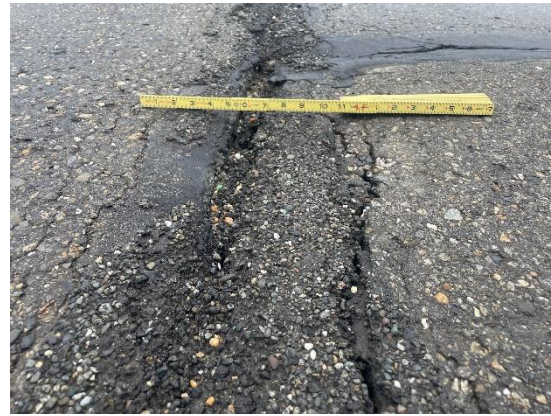
The Alaska Air National Guard Apron was initially constructed in 1989 and has not received any work since. Crack sealing operations have been performed occasionally on the branch. The most common distresses are low severity block cracking, low to medium severity longitudinal and transverse cracking, and high severity patching. Airport maintenance personnel have attempted to patch a high-severity crack, but the crack remains badly deteriorated, leading to poor ride quality and the potential to generate FOD.

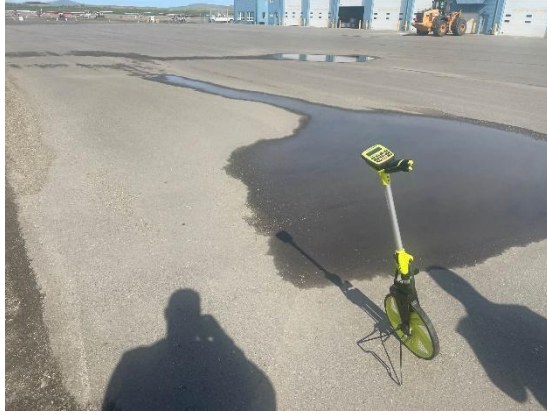
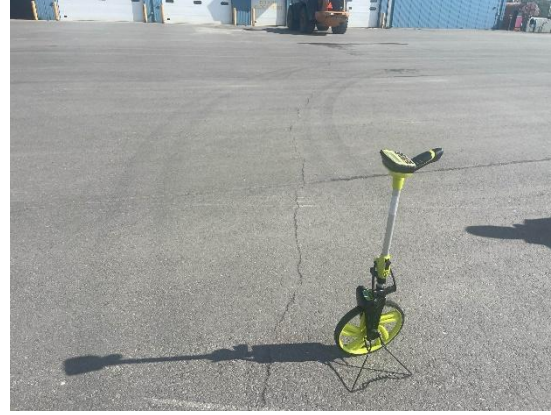
Section 4300-01 (90 PCI)

The North Ramp consists of two sections, Section 4300-01 and Section 4300-02. Section 4300-01 was initially constructed in 1998, expanded in 2008 and rehabilitated in 2022. Crack sealing has been performed on this section. The most common distresses are medium severity depressions and low severity longitudinal and transverse cracking. Pavement inspectors observed standing water in depressions across the parking apron. They also observed that cracking is beginning to develop throughout the section, which would benefit from crack sealing.

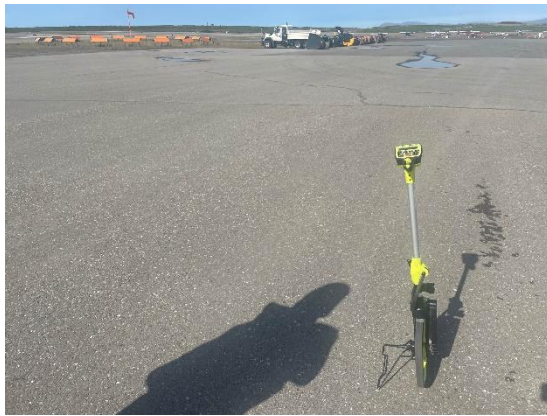
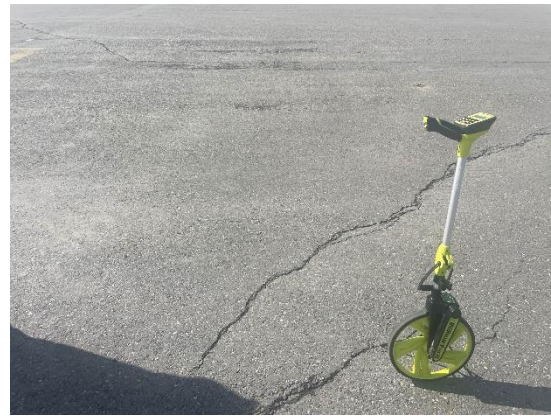
PCC Section 4300-02 (73 PCI)

The North Ramp Section 4300-02 was constructed in 1998 and received major rehabilitation in 2015. The most common distresses are low severity depressions, low to medium severity longitudinal and transverse cracking, oil spillage, low to high severity raveling, and low severity weathering. Standing water was observed in depressions on the parking apron. In addition, widespread cracking is beginning to develop and the section would benefit from crack sealing.

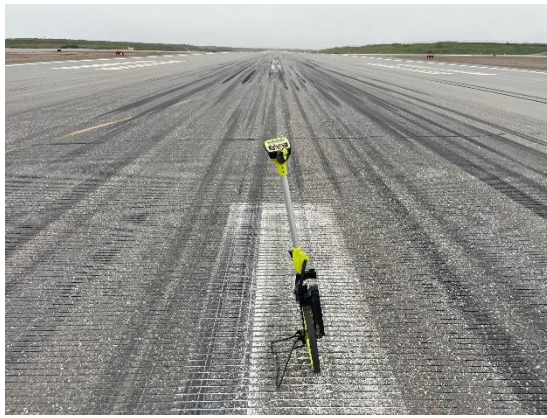
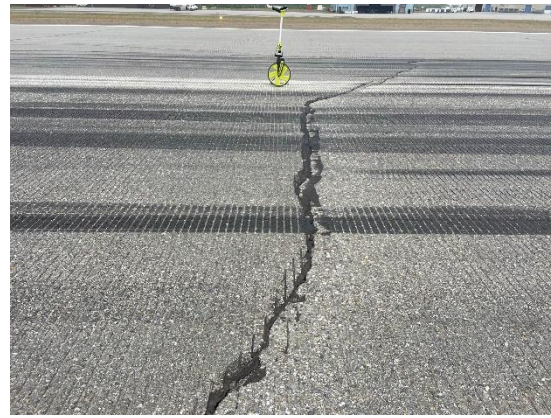
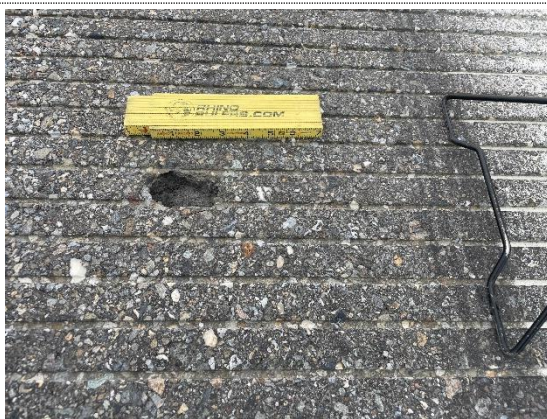
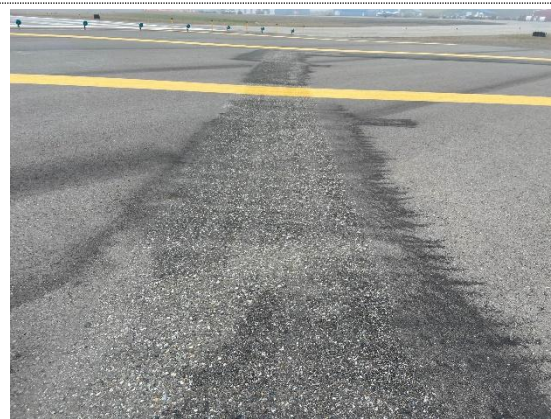
Runway 10/28 was initially constructed in 1971 and has undergone several rehabilitation projects over the years. The most recent major work involved a foamed asphalt stabilized base rehabilitation in 2023. Crack sealing has been performed annually on the branch. The most common distresses are low to medium severity longitudinal and transverse cracking and low severity raveling. Reflective cracking is beginning to develop in the recent overlay. In addition, a significant amount of raveling was observed on the blast pad, apparently due to the removal of paint markings.

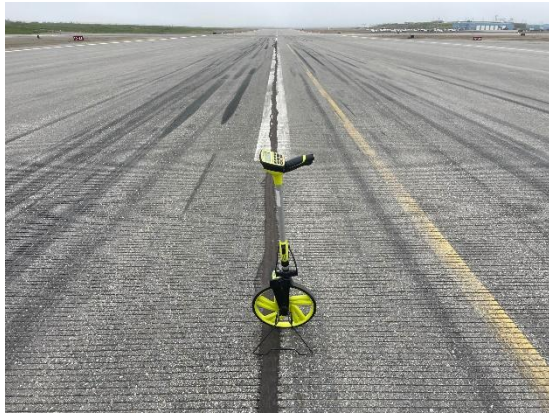
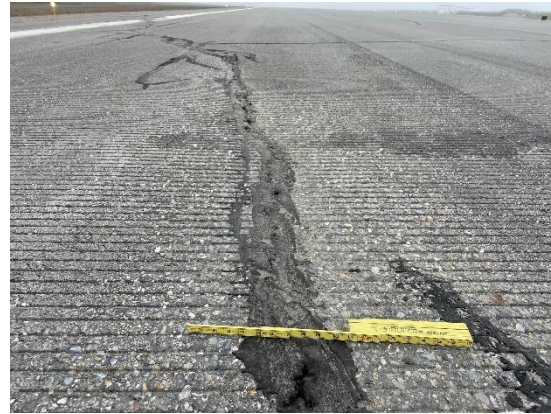
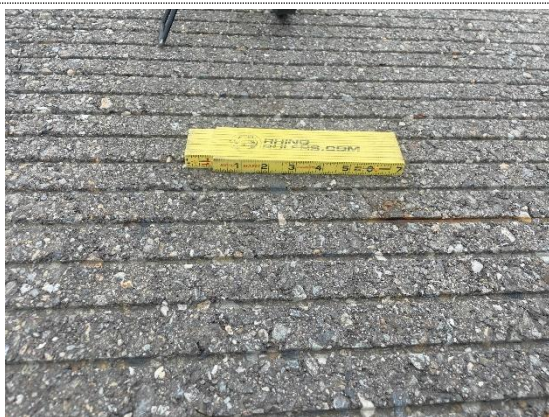
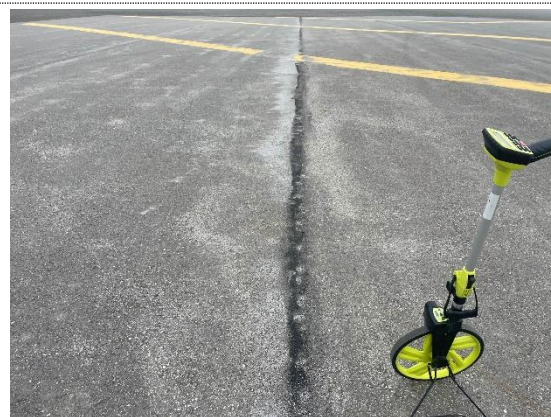
Runway 03/21 was initially constructed in 1971 and has undergone several rehabilitation projects over the years. The most recent major work involved a foamed asphalt stabilized base rehabilitation in 2022. Crack sealing has been performed annually on the branch. The most common distresses are low to medium severity longitudinal and transverse cracking, low severity raveling, and low severity weathering. Inspectors noted the development of reflective cracking through the recent asphalt concrete overlay.
