Alaska DOT&PF

Pavement Inspection Report Petersburg Airport

Airport Name	IATA	ICAO	Latitude	Longitude	Elevation (ft)
Petersburg Airport	PSG	PAPG	56° 48'5.3"N	132° 56'46.4"W	113.2

Point of Contact	Phone	Email	Date Inspected	Date Published
Mr. Andrew Pavey, Pavement Management Engineer	(907) 269 6213	andrew.pavey@alaska.gov	October 2022	October 2023

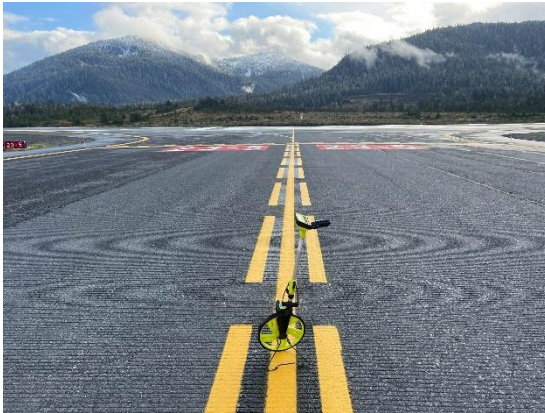
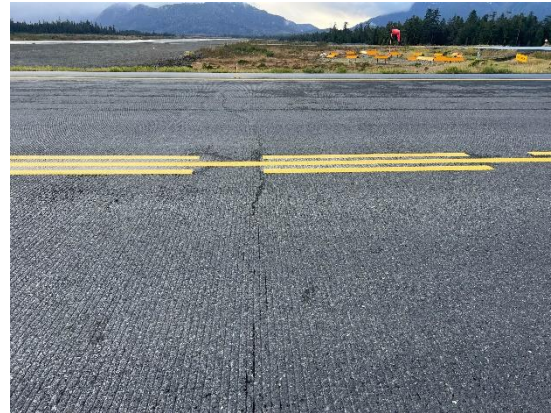
Branch ID	Branch Name	Branch Use	No. of Sections	Area (sf)	Weight Average PCI
0100	Taxiway A	Taxiway	1	53,430	76

Taxiway A was initially constructed in 1981 and its most recent major work was a mill and overlay of 6" in 2014. The most common distresses observed are low severity longitudinal and transverse cracking, low severity raveling, and low severity weathering. In field observations include the degradation of the paving joints causing longitudinal cracking and raveling to develop.

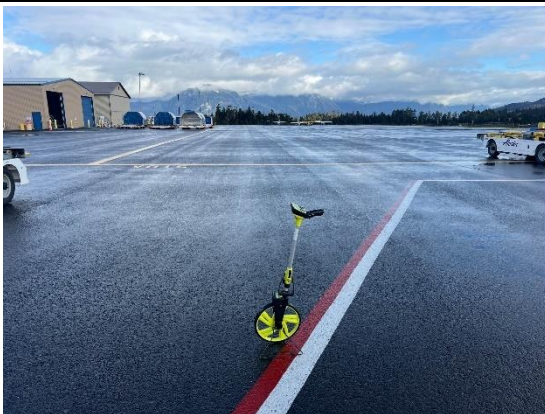
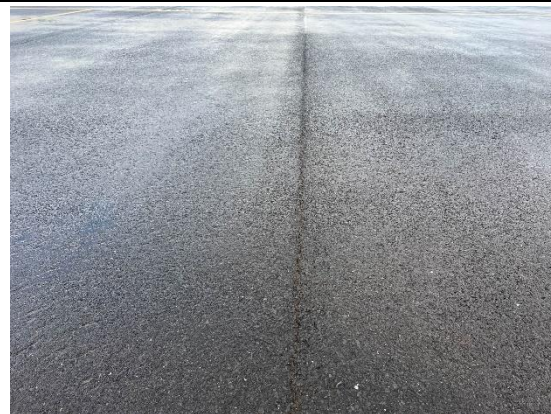
Sections 4100-01 (94 PCI) / 4100-02 (90 PCI) / 4100-03 (88 PCI)

Sections 02 and 03 of the aprons were initially constructed in 1981 while section 01 was initially constructed in 1996. All three sections' most recent major work was a mill and overlay of 6" in 2014. The most common distresses observed are low severity longitudinal and transverse cracking, small quantities of low severity raveling, and low severity weathering. In field observations include the degradation of the paving joints causing longitudinal cracking and raveling to develop.

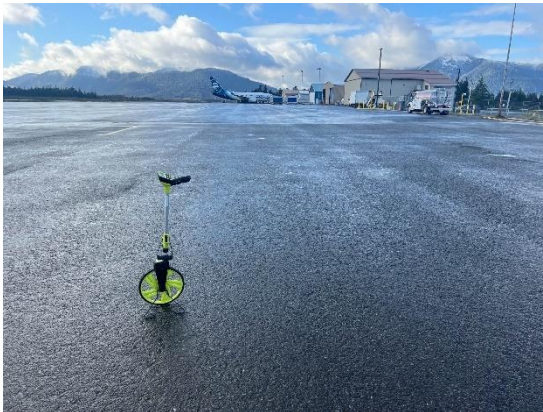
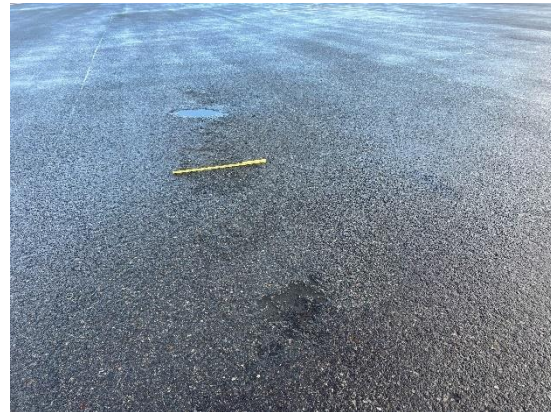
Section 4100-04 (61 PCI)

Section 04 of the apron was initially constructed in 2004 and has had no major work since. The most common distresses observed are low severity longitudinal and transverse cracking, large quantities of low to high severity raveling, and low severity weathering. In field observations include an increased loss of the fine aggregate which is exposing the coarse aggregate and in some areas the removal of the coarse aggregate altogether.

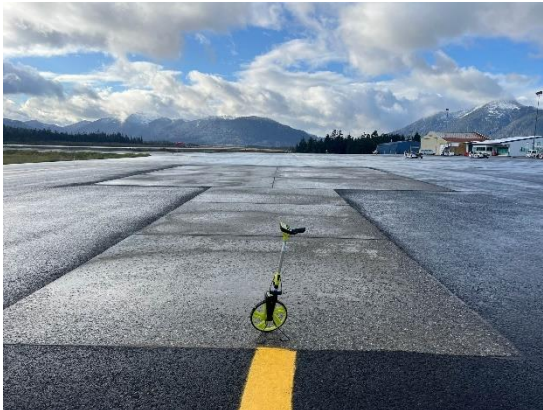
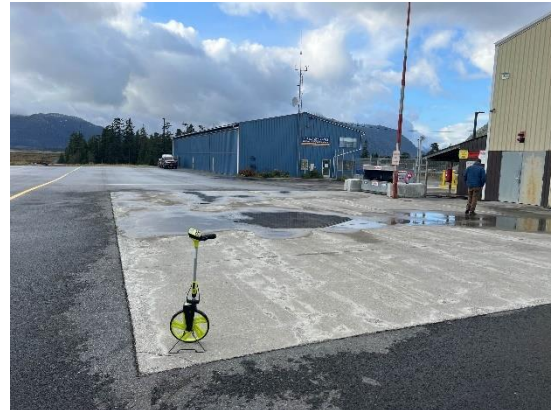
Sections 4100-05 (63 PCI) / 4100-06 (83 PCI) / 4100-07 (78 PCI)

Sections 05/06/07 of the apron are concrete (PCC). Sections 05 and 07 were built in 2004 and section 06 was built in 1987. The most common distresses observed are low severity joint and corner spalling, low to medium severity scaling, and low to medium severity joint seal damage. In field observations include section 06 that was built in 1987 is showing its age with all slabs affected by scaling due to environmental factors. The sections that were built in 2004 have grading and drainage issues where water will collect and pool. In the winter the water will freeze which maintenance crews have difficulty removing.

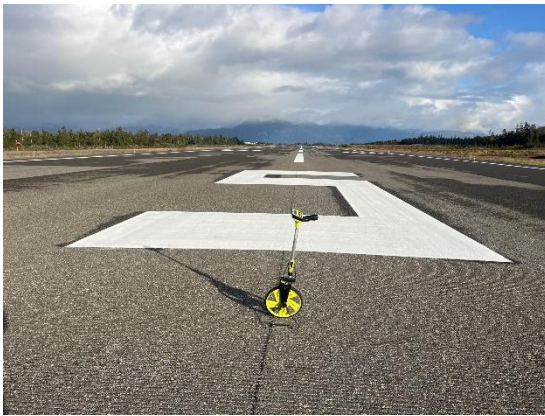
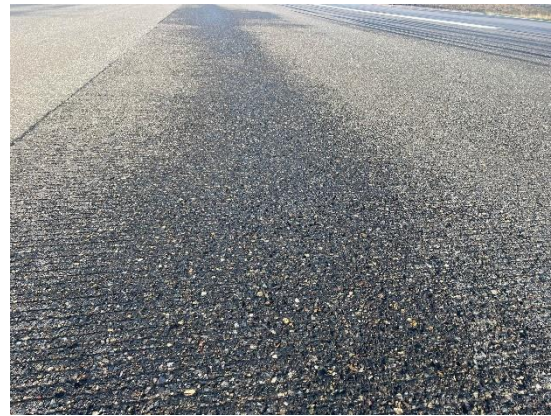
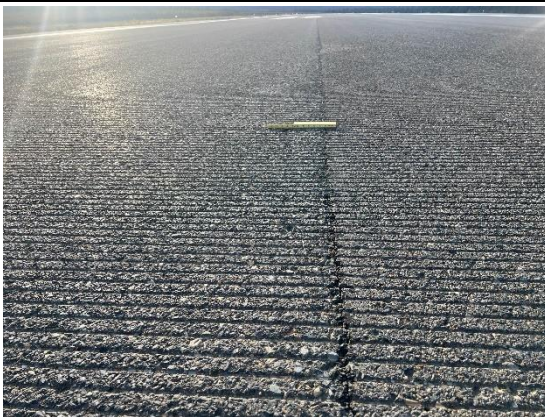
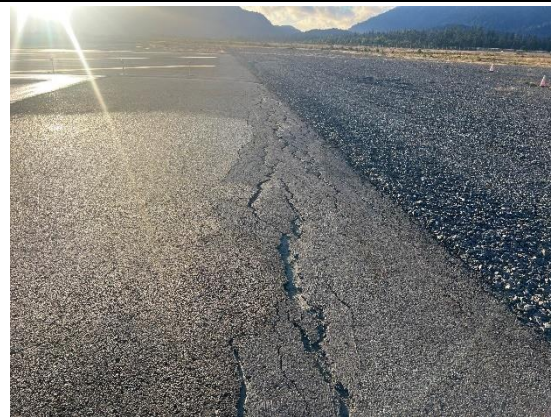
Branch ID	Branch Name	Branch Use	No. of Sections	Area (sf)	Weight Average PCI
6100	Runway 5/23	Runway	8	1,040,000	68

Runway 5/23 was initially constructed in 1981 with a runway length of 6,000 ft. In 2009 it was expanded another 400 ft giving it a total length of 6,400 ft. The most recent major work was an overlay of 4" in 2010. The most common distresses observed are low severity longitudinal and transverse cracking, low to medium severity raveling, and low severity weathering. In field observations include an increased loss of the fine aggregate which is exposing the coarse aggregate and, in some areas, leading to raveling. On the northern side of the 05 (southwest) end of the runway the edge of the pavement is sinking and cracking (bottom right photograph). This is due to snowplow operations reaching the end of the runway and pushing heavy loads onto the edges. In addition, maintenance staff mentioned that the Runway Safety Area (RSA) is sinking in areas and work is needed to keep the slopes consistent.
