# Alaska DOT&PF

## Pavement Inspection Report Point Hope Airport

Airport Name	IATA	ICAO	Latitude	Longitude	Elevation (ft)
Point Hope	PHO	PAPO	68° 20' 55.58" N	166° 47' 57.34" W	18.3

Point of Contact	Phone	Email	Date Inspected	Date Published
Mr. Andrew Pavey, Pavement Management Engineer	(907) 269 6213	andrew.pavey@alaska.gov	July 2024	December 2024

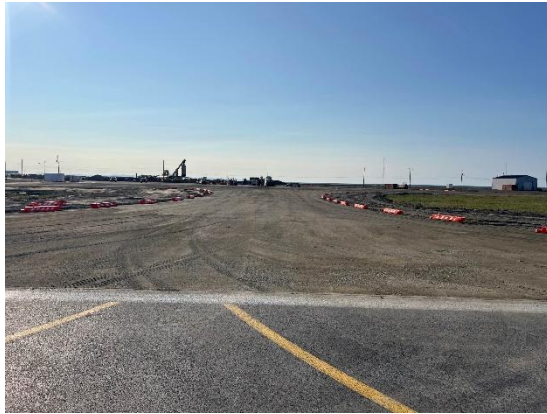
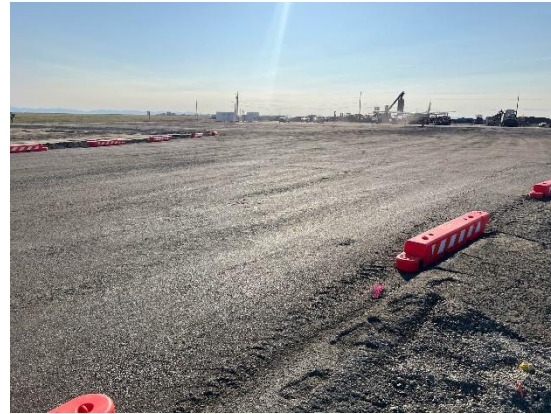
Taxiway A was first constructed in 1993 and was under construction during the 2024 inspection due to a runway realignment project. The project includes removal of the existing asphalt pavement and placing 4" of P-401 HMA on top of 6" of P-209 CABC. Construction was ongoing during the inspection, as paving operations on the taxiway had yet to commence. However, the project will be finished by the end of the 2024 construction season.

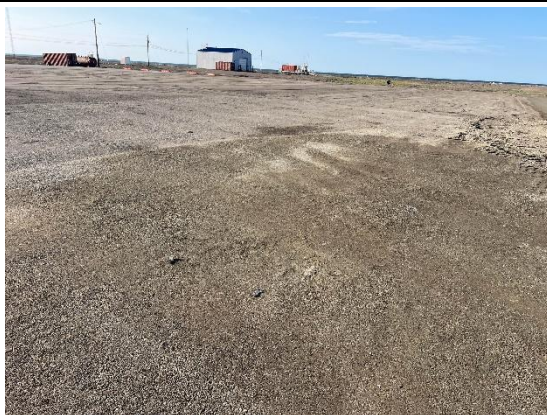
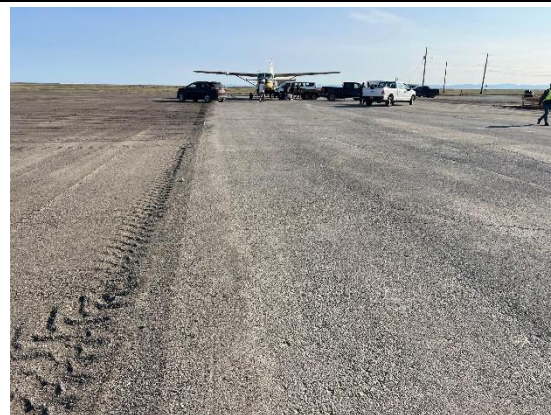
The Point Hope Apron was first constructed in 1993 and was under construction during the 2024 inspection due to a runway realignment project. The project includes removal of the existing asphalt pavement and placing 4" of P-401 HMA on top of 6" of P-209 CABC. Construction was ongoing during the inspection, as paving operations on the apron had yet to commence. However, the project will be finished by the end of the 2024 construction season.

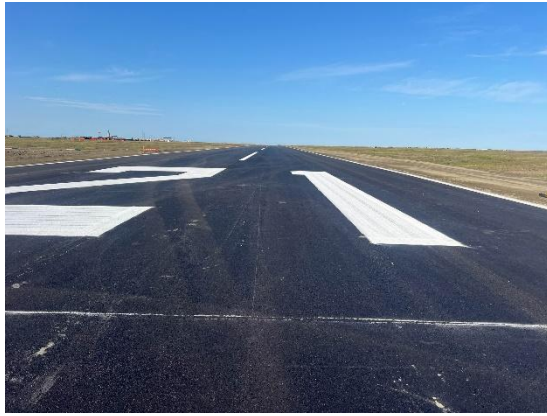
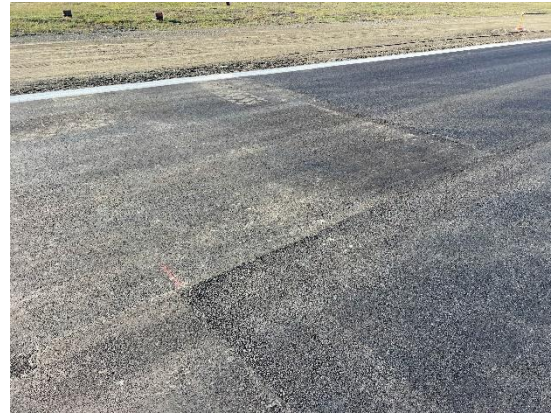
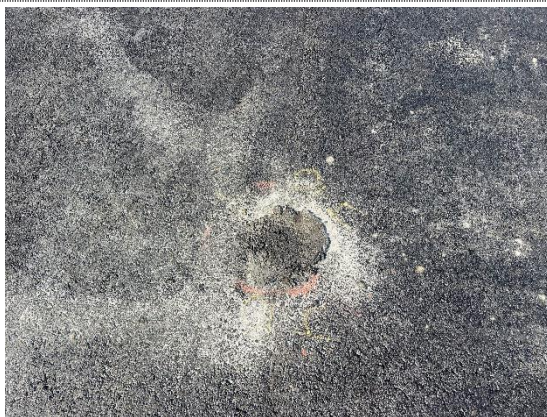
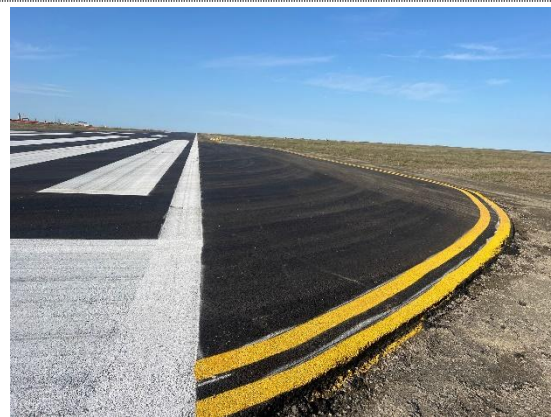
Runway 03/21 was first constructed in 1993 and was under construction during the 2024 inspection due to a runway realignment project. The project includes removal of the existing asphalt pavement and placing 4" of P-401 HMA on top of 6" of P-209 CABC. Construction was ongoing during the inspection. However, paving operations on the runway had been completed and the inspection was able to be performed. Field observations note the presence of patched in place core holes that are between low and medium severity. Also, there were areas of asphalt segregation around the paving joints that look to have occurred during placement. No distress was recorded but will be re-evaluated during the next inspection.
