Alaska DOT&PF

Pavement Inspection Report Saint George Airport

Airport Name	IATA	ICAO	Latitude	Longitude	Elevation (ft)
Saint George Airport	PBV	PAPB	56° 34' 38.5" N	169° 39' 49.4" W	127.9

Point of Contact	Phone	Email	Date Inspected	Date Published
Mr. Andrew Pavey, Pavement Management Engineer	(907) 269 6213	andrew.pavey@alaska.gov	May 2023	September 2023

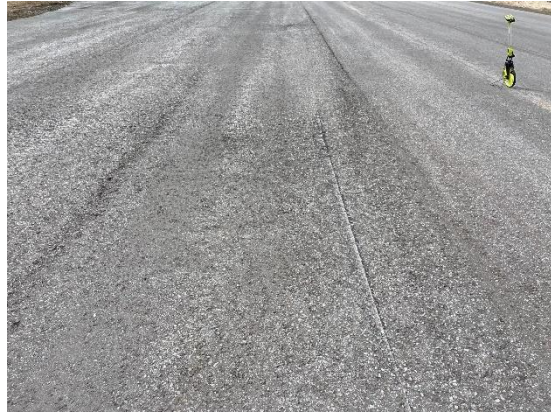
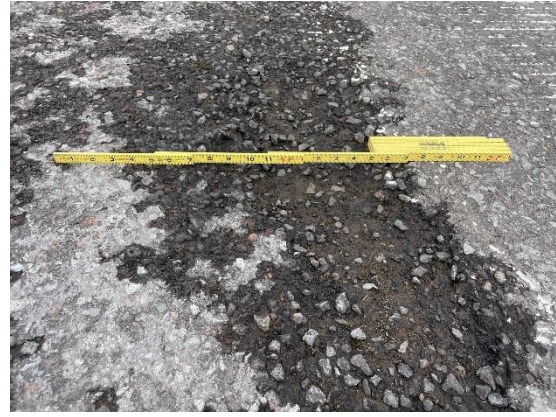
Branch ID	Branch Name	Branch Use	No. of Sections	Area (sf)	Weighted Average PCI
0100	Taxiway A	Taxiway	1	39,500	80

Taxiway A was constructed in 2006 and has not received any major work since. Crack seal operations have not been performed on the branch. The most common distresses observed are low to medium severity longitudinal and transverse cracking, low severity raveling, and low severity weathering. Field observations include wearing of the pavement surface due to climate, the development of new unfilled cracks, and localized areas of medium and high raveling near the paving joints.

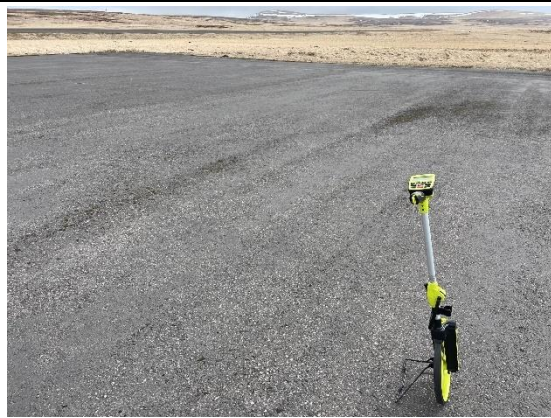
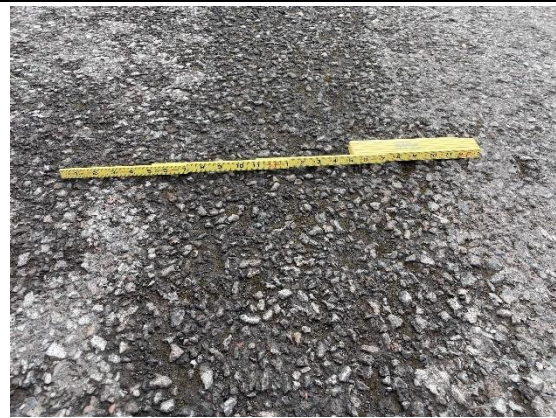
Branch ID	Branch Name	Branch Use	No. of Sections	Area (sf)	Weighted Average PCI
4100	Apron	Apron	1	146,150	86

Like Taxiway A, the Apron was constructed in 2006 and has not received any major work since. Crack seal operations have not been performed on the branch. The most common distresses observed are low severity longitudinal and transverse cracking, low to medium severity raveling, and low severity weathering. Field observations include wearing of the pavements surface due to climate, the development of new unfilled cracks, and localized areas of medium and high raveling spread throughout the branch.

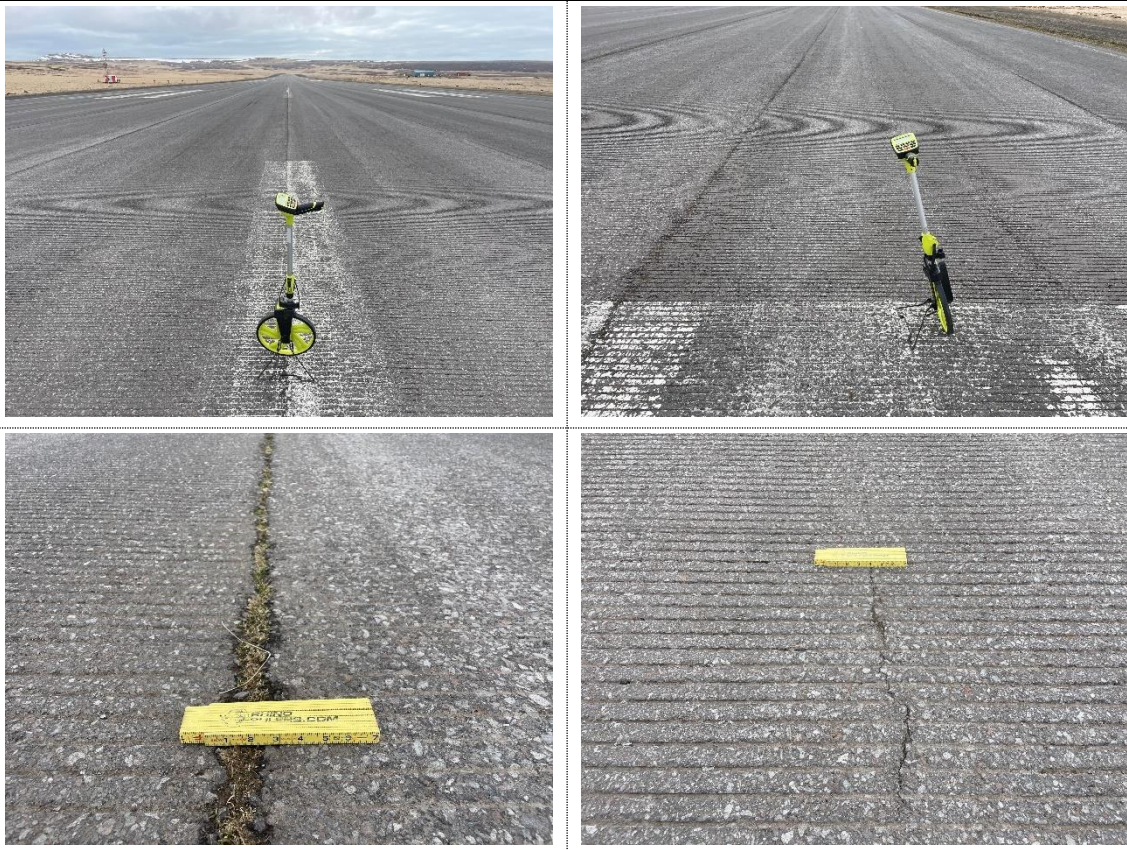
Branch ID	Branch Name	Branch Use	No. of Sections	Area (sf)	Weighted Average PCI
6100	Runway 11/29	Runway	3	747,000	83

Runway 11/29 was constructed in 2006 and has not received any major work since. Crack seal operations have not been performed on the section. The most common distresses observed are low to medium severity longitudinal and transverse cracking, low to medium severity raveling, and low severity weathering. Field pavement observations include deterioration of the paving joints leading to higher severity longitudinal cracking as well as raveling, and vegetation growth inside the paving joints.
