# Alaska DOT&PF

## Pavement Inspection Report Saint Paul Airport

Airport Name	IATA	ICAO	Latitude	Longitude	Elevation (ft)
Saint Paul Airport	SNP	PASN	57° 9' 58.7" N	170° 13' 21.2" W	66.4

Point of Contact	Phone	Email	Date Inspected	Date Published
Mr. Andrew Pavey, Pavement Management Engineer	(907) 269 6213	andrew.pavey@alaska.gov	May 2023	September 2023

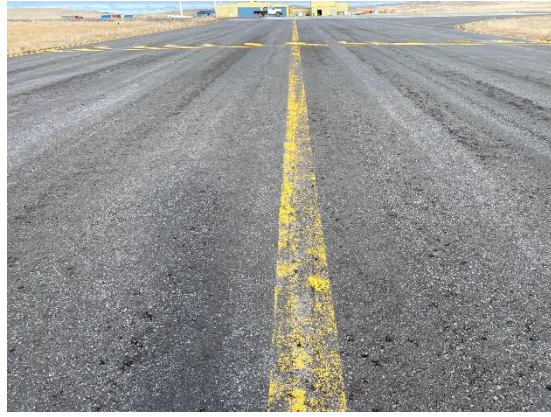
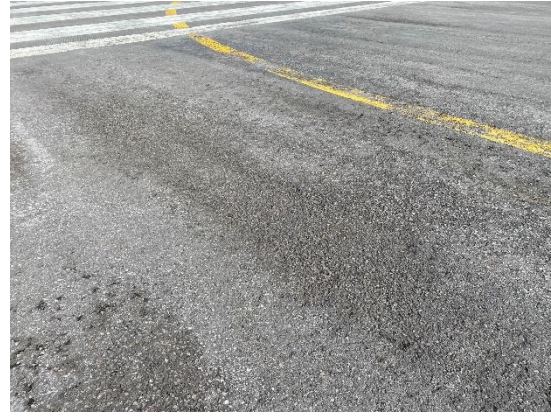
Branch ID	Branch Name	Branch Use	No. of Sections	Area (sf)	Weighted Average PCI
0100	Taxiway A	Taxiway	1	40,820	80

Taxiway A was constructed in 2005 and has not received any major work since. Crack seal operations have not been performed on the branch. The most common distresses observed are low to medium severity raveling, and low severity weathering. Field observations include wearing of the pavements surface concentrated at the paving joints, and localized areas of raveling.

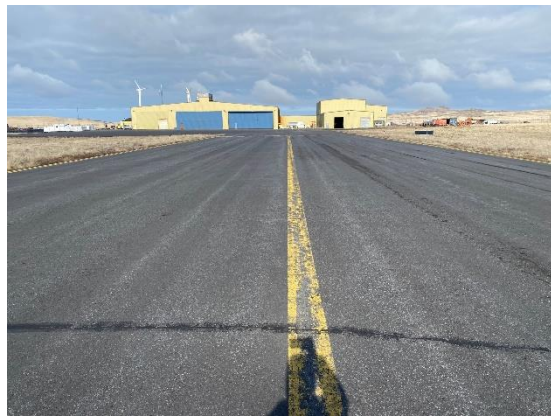
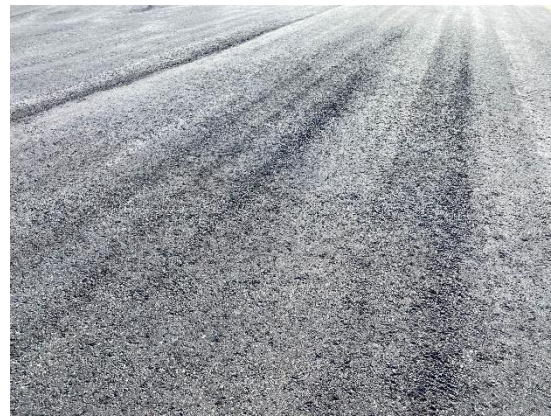
Branch ID	Branch Name	Branch Use	No. of Sections	Area (sf)	Weighted Average PCI
0200	Taxiway B	Taxiway	1	40,930	82

Like Taxiway A, Taxiway B was constructed in 2005 and has not received any major work since. Annual crack seal operations have been performed on the branch. The most common distresses observed are low severity longitudinal and transverse cracking, low to medium severity raveling, and low severity weathering. Field observations include wearing of the pavements surface concentrated at the paving joints, and localized areas of raveling.

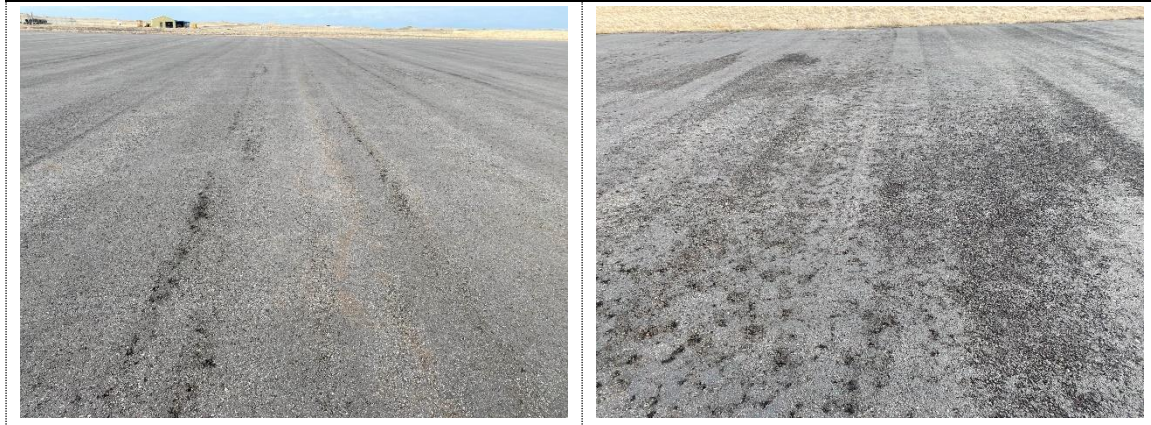
**AC Section 4100-01 (82 PCI)**

The Apron consists of 2 sections, of which 1 is AC and 1 is PCC. The AC section was constructed in 2005 and has not received any major work since. Crack seal operations have not been performed on the branch. The most common distresses observed are low to medium severity raveling, and low severity weathering. Field observations include the degradation of the paving joints causing raveling to develop as well as localized areas of raveling across the apron.

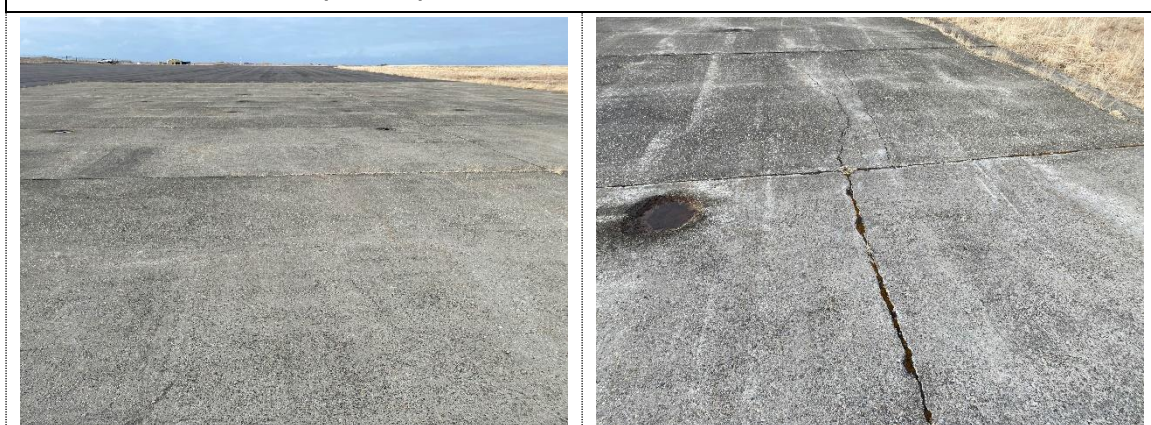
**PCC Section 4100-02 (26 PCI)**

The PCC section consists of a single hardstand constructed in 2005 and has not received major work since. The most common distresses observed are low to medium to high severity linear cracking, and high severity joint seal damage. Field observations show that 8 out of the 14 total slabs have a linear crack of various severities. Also, the joint sealant is failing as vegetation can be seen between the sealant and the concrete.

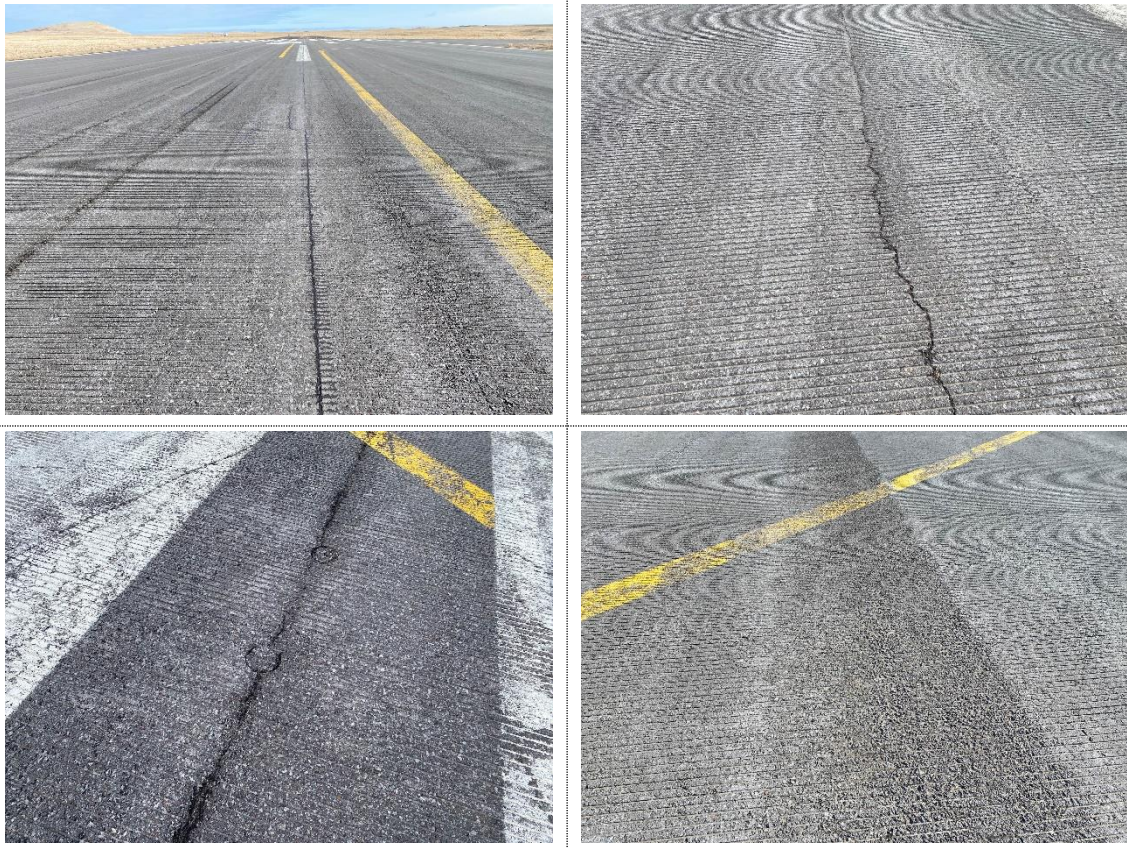
Branch ID	Branch Name	Branch Use	No. of Sections	Area (sf)	Weighted Average PCI
6100	Runway 18/36	Runway	4	1,003,600	85

Runway 18/36 was constructed in 2005 and has not received any major work since. Annual crack seal operations have been performed, but the runway would benefit from another application. The most common distresses observed are low to medium severity longitudinal and transverse cracking, low to medium severity raveling, and low severity weathering. Field observations include development of new unfilled cracks, widening of previously filled cracks, and localized areas of increased severity and quantity of raveling throughout.
