Alaska DOT&PF

Pavement Inspection Report Sand Point Airport

Airport Name	IATA	ICAO	Latitude	Longitude	Elevation (ft)
Sand Point Airport	SDP	PASD	55° 18' 49.303" N	160° 31' 17.129" W	23.6

Point of Contact	Phone	Email	Date Inspected	Date Published
Mr. Andrew Pavey, Pavement Management Engineer	(907) 269 6213	andrew.pavey@alaska.gov	May 2023	August 2023

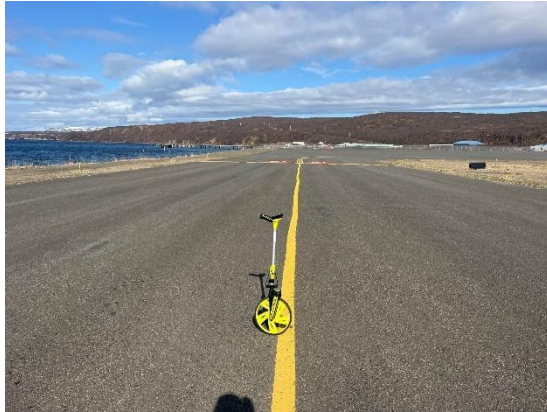
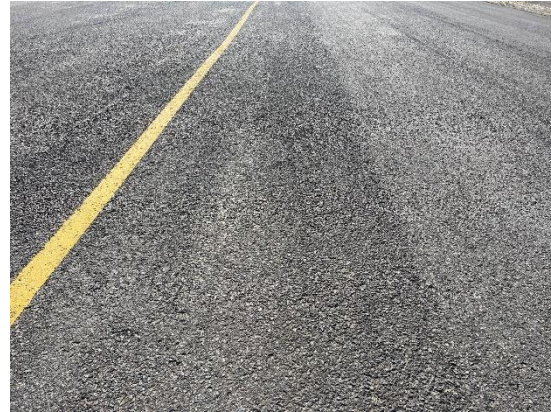
Branch ID	Branch Name	Branch Use	No. of Sections	Area (sf)	Weighted Average PCI
0100	Taxiway A	Taxiway	1	23,400	78

Taxiway A was reconstructed in 2006 and received a rejuvenating surface seal in 2014. Crack seal operations have not been performed on the branch. The most common distresses observed are bleeding, low to medium severity raveling, and low to medium severity weathering. Field observations include an increased loss of fine aggregate which caused higher severity weathering and localized areas of raveling.

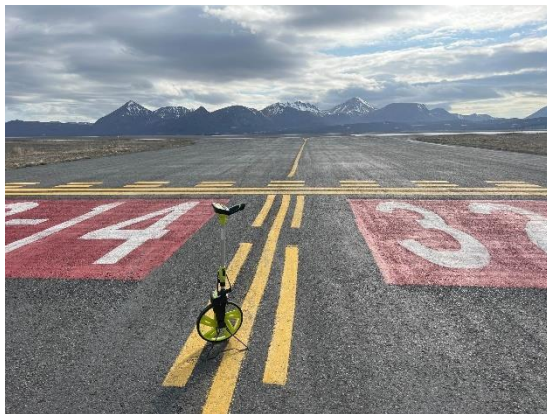
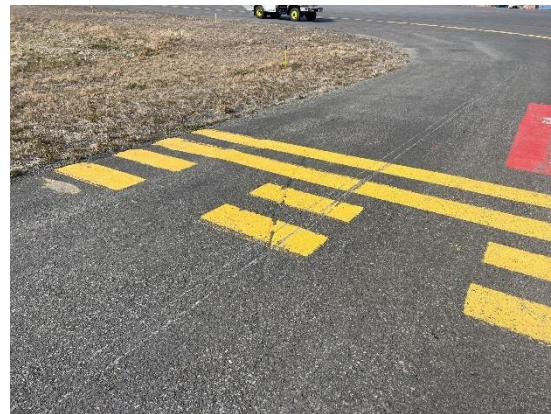
Branch ID	Branch Name	Branch Use	No. of Sections	Area (sf)	Weighted Average PCI
0200	Taxiway B	Taxiway	1	23,450	83

Like Taxiway A, Taxiway B was reconstructed in 2006 and received a rejuvenating surface seal in 2014. Crack seal operations have not been performed on the branch. The most common distresses observed are low to medium to high severity raveling, and low to medium severity weathering. Field observations include wearing the rejuvenation application and an increased loss of fine aggregate which caused the increased severity in weathering and localized areas of raveling. Also, damage from snowplows was seen on multiple samples.

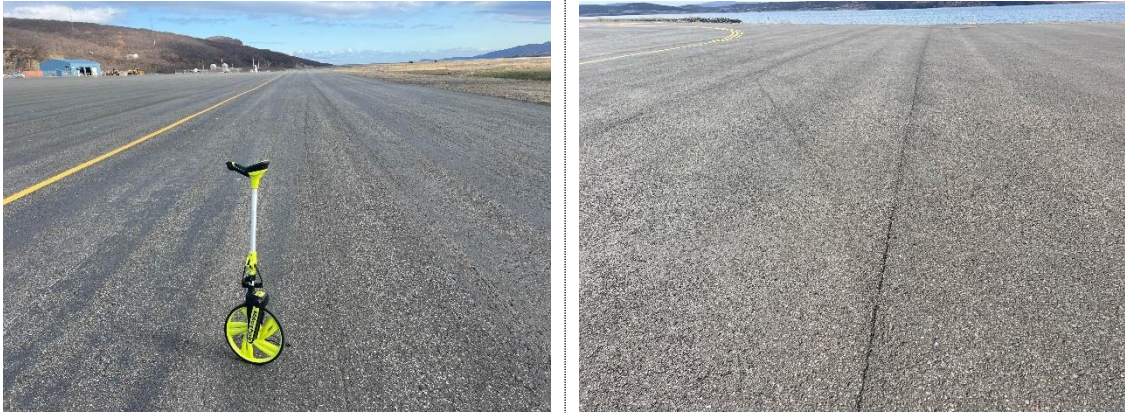
Branch ID	Branch Name	Branch Use	No. of Sections	Area (sf)	Weighted Average PCI
0300	Taxiway C	Taxiway	1	106,400	75

Like Taxiway A and B, Taxiway C was reconstructed in 2006 and received a rejuvenating surface seal in 2014. Crack seal operations have not been performed on the branch. The most common distresses observed are low severity longitudinal and transverse cracking, low to medium severity raveling, and low to medium severity weathering. Field observations include a paving joint beginning to open creating space for water to infiltrate below the asphalt, wearing of the rejuvenation application, and an increased loss of fine aggregate which has caused the increased severity in weathering.

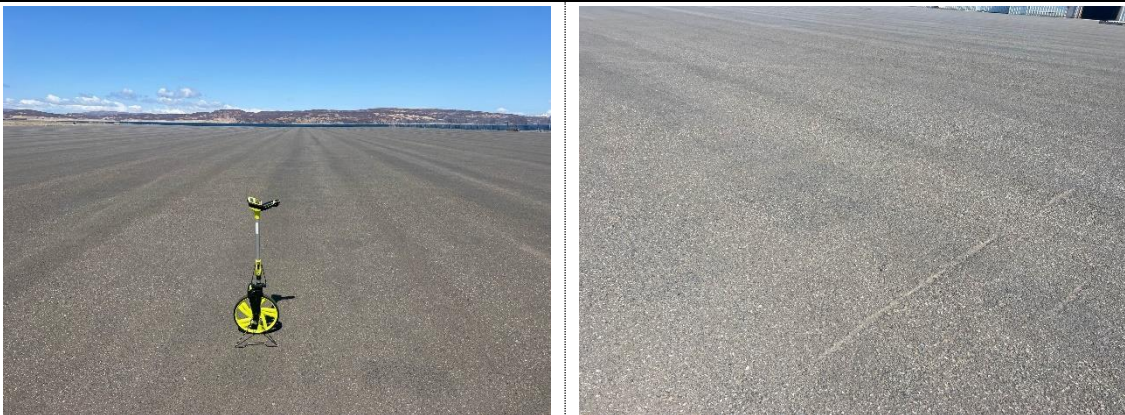
Branch ID	Branch Name	Branch Use	No. of Sections	Area (sf)	Weighted Average PCI
4100	Apron	Apron	1	427,400	85

Like the Taxiways, the Apron was also reconstructed in 2006 and received a rejuvenating surface seal in 2014. Crack seal operations have not been performed on the branch. The most common distresses observed are oil spillage, low to medium to high severity raveling, and low to medium severity weathering. Field observations include areas of oil spillage across the apron, wearing of the rejuvenation application, and an increased loss of fine aggregate which has caused the increased severity in weathering as well as localized areas of raveling. Also, damage from snowplows was seen on multiple samples.

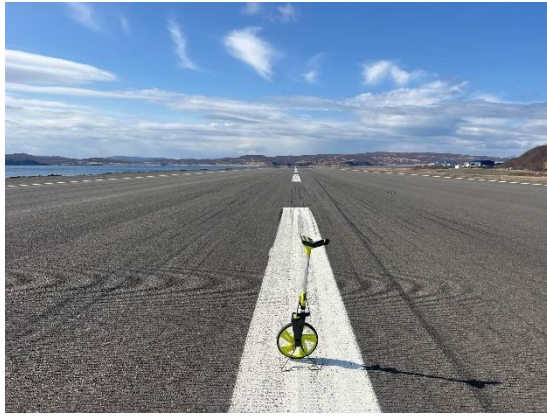
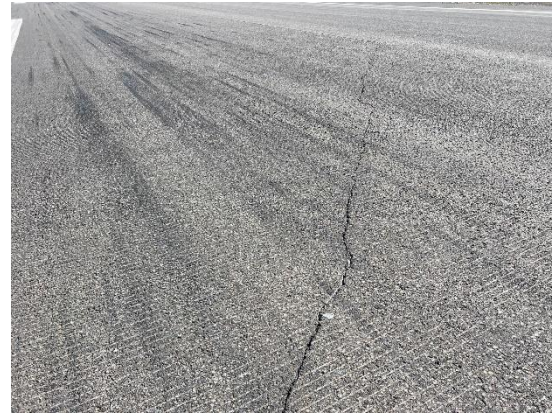
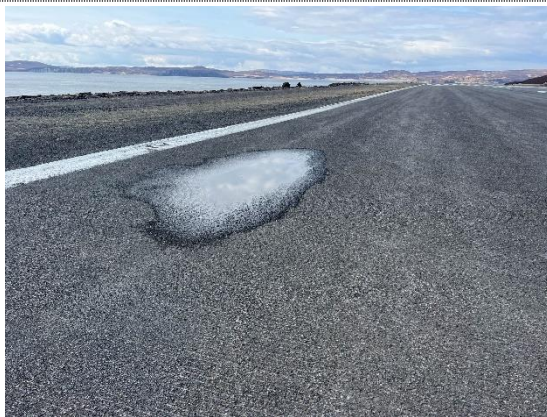
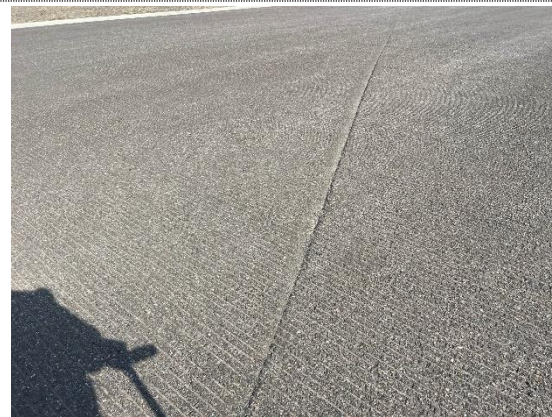
Branch ID	Branch Name	Branch Use	No. of Sections	Area (sf)	Weighted Average PCI
6100	Runway 14/32	Runway	8	782,700	82

Runway 14/32 was reconstructed in 2006. Crack seal operations have not been performed on the branch. The most common distresses observed are low to medium severity longitudinal and transverse cracking, low to medium to high severity raveling, and low to medium severity weathering. Field observations include the creation of a transverse cracking across the keel of the runway and a localized depression causing standing water on the edge of the runway. Also, damage from snowplows was seen on multiple samples across the runway.
