Alaska DOT&PF

Pavement Inspection Report Seward Airport

Seward Airport
Airport Code: SWD

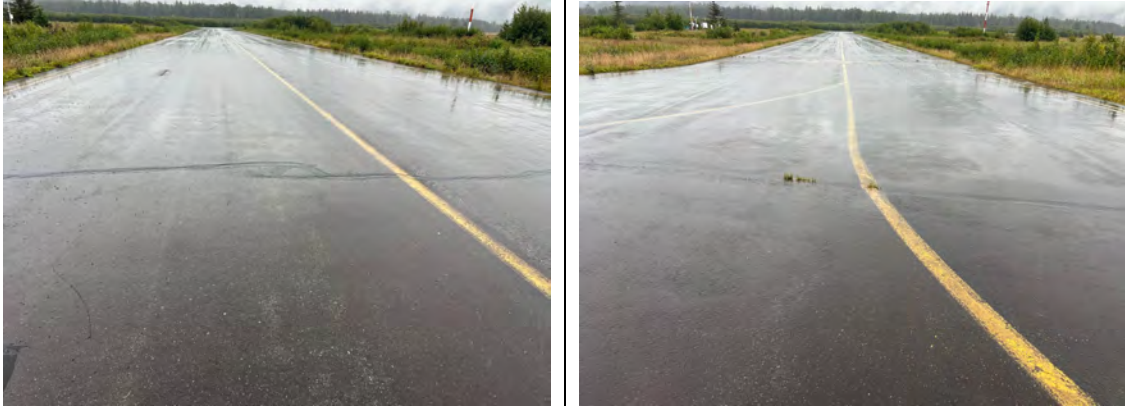
Branch ID	Branch Name	Branch Use	No. of Sections	Area (sf)	Weight Average PCI
0100	Taxiway A	Taxiway	2	46,211	85

Taxiway A was originally constructed in 1970 and was reconstructed after flood damage in 2007. Section 100-02 (photo to the top right) appeared to receive some additional work after the 2007 repair, potentially 2017, although no construction records can be found to verify. Common distresses include low severity longitudinal and transverse cracking, and low severity weathering.

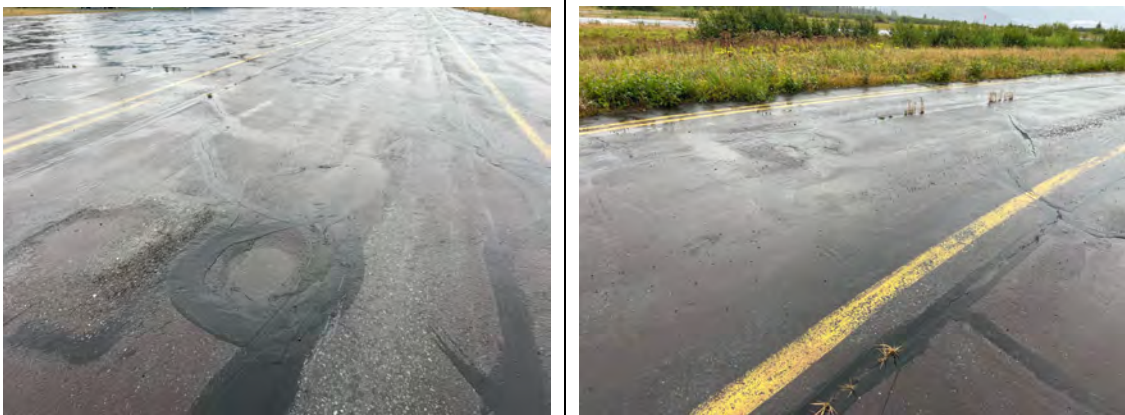
Branch ID	Branch Name	Branch Use	No. of Sections	Area (sf)	Weight Average PCI
0200	Taxiway B	Taxiway	3	109,467	48
Sections 200-01 and 200-02 – PCI 39

Sections 200-01 and 200-02 of Taxiway B were constructed in 1975 and resurfaced in 1983. Common distresses include low to medium severity longitudinal and transverse cracking, low severity weathering, and low to medium severity raveling. Other distresses observed include depressions, alligator cracking, rutting and swelling of varying severities.

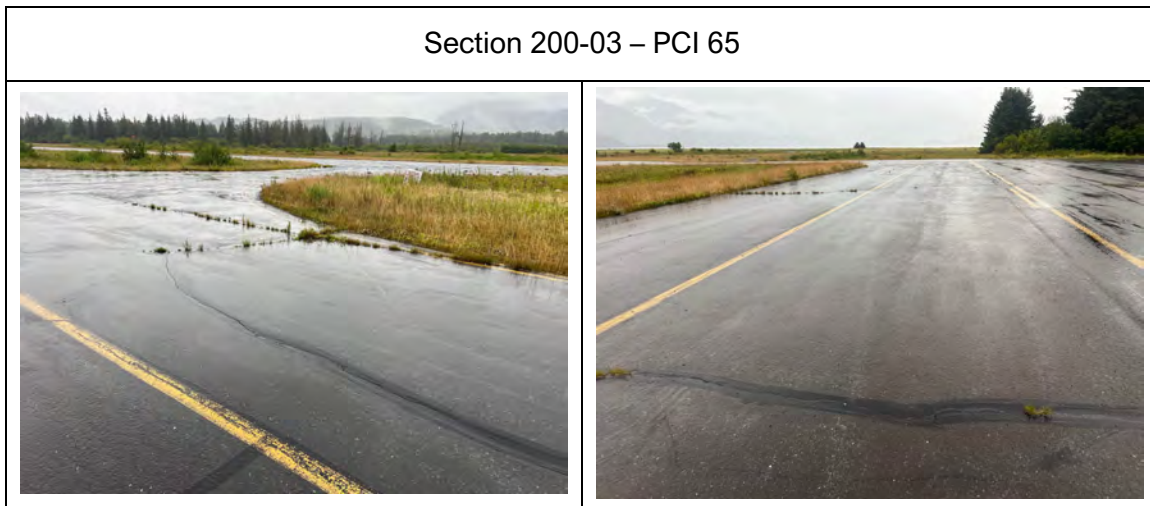
Section 200-03 was constructed in 1991 as part of the apron expansion project. Common distresses include low to medium severity longitudinal and transverse cracking, low severity weathering, and low severity raveling.

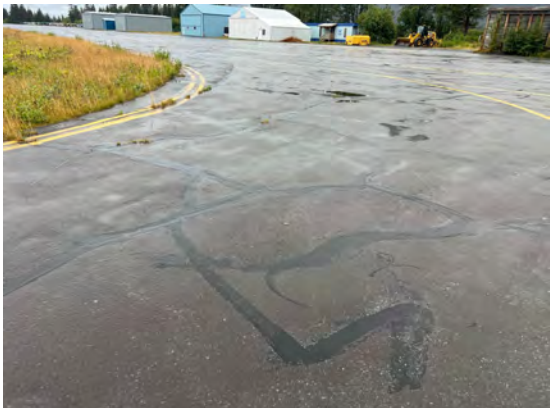
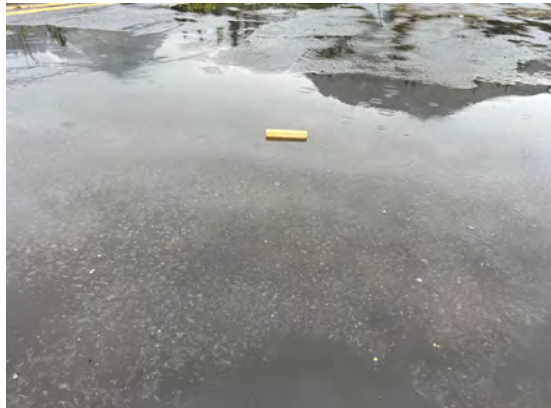
Branch ID	Branch Name	Branch Use	No. of Sections	Area (sf)	Weight Average PCI
0300	Taxiway C	Taxiway	1	7,804	44

Taxiway C was constructed in 1975 and was resurfaced in 1983. Common distresses include low severity longitudinal and transverse cracking, low severity weathering and low to medium severity raveling. Other observed distresses include low severity depressions and low severity alligator cracking.

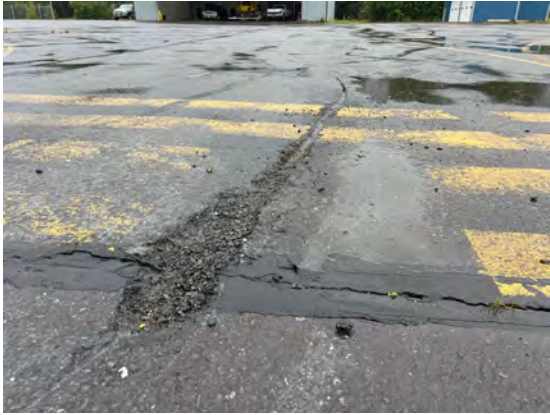
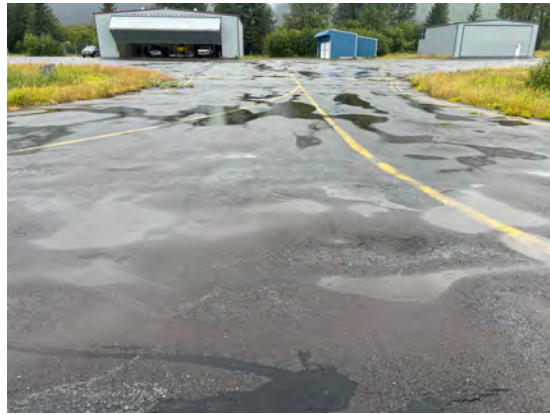
Branch ID	Branch Name	Branch Use	No. of Sections	Area (sf)	Weight Average PCI
0400	Taxiway D	Taxiway	1	8,372	52

Taxiway D was constructed in 1975 and resurfaced in 1983. Common distresses are low to medium severity longitudinal and transverse cracking, low severity weathering, and low severity raveling. Other distresses include low to medium severity swelling, low severity alligator cracking, low to medium severity depressions, and one area of high severity raveling from equipment damage.

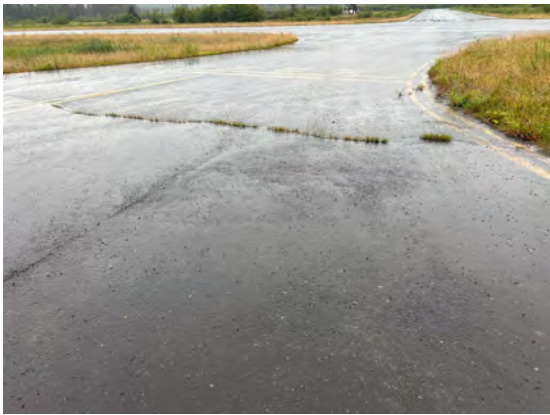
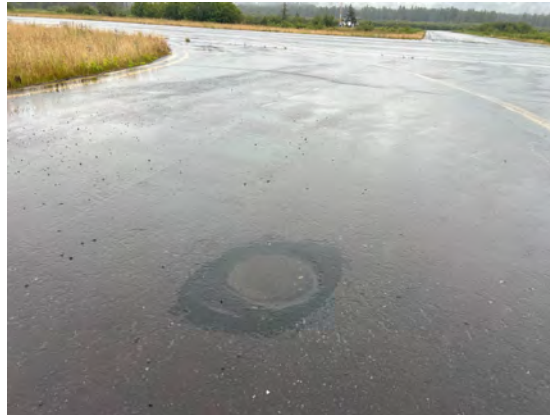
Branch ID	Branch Name	Branch Use	No. of Sections	Area (sf)	Weight Average PCI
0500	Taxiway E	Taxiway	1	7,622	56

Taxiway E was constructed in 1992 and has received no work since. Common distresses on the taxiway are low to medium severity longitudinal and transverse cracking, low severity weathering and low to medium severity raveling.

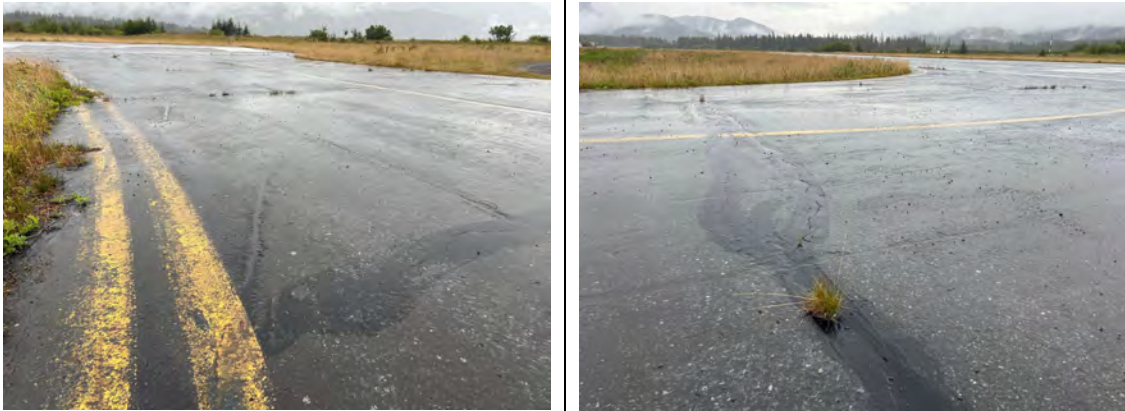
Branch ID	Branch Name	Branch Use	No. of Sections	Area (sf)	Weight Average PCI
0600	Taxiway F	Taxiway	1	6,267	60

Taxiway F was constructed in 1992 and has received no work since. The primary distresses are low to medium severity longitudinal and transverse cracking, low severity weathering and low severity raveling.

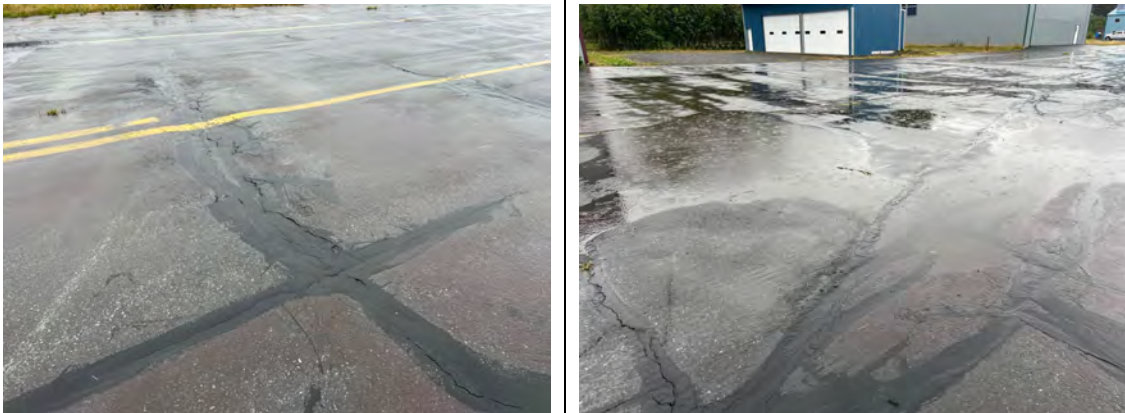
Branch ID	Branch Name	Branch Use	No. of Sections	Area (sf)	Weight Average PCI
4100	Operations Apron	Apron	1	169,430	50

The Operations Apron was constructed in 1975 and resurfaced in 1983. Common distresses are low to medium severity longitudinal and transverse cracking, low severity weathering and low severity raveling. Other observed distresses include low severity depressions, low severity alligator cracking, low severity swelling and medium severity raveling.

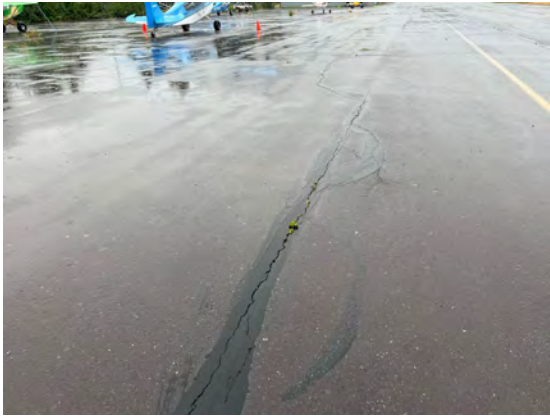
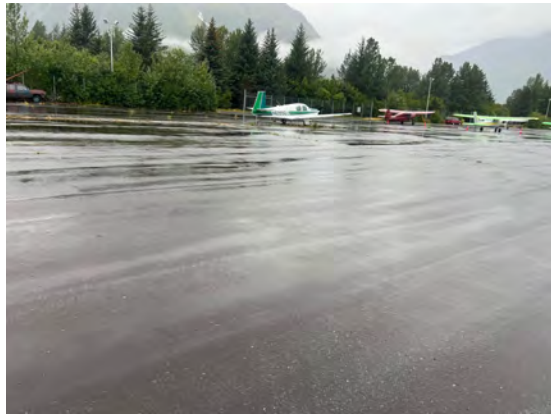
Branch ID	Branch Name	Branch Use	No. of Sections	Area (sf)	Weight Average PCI
4200	Parking Apron	Apron	1	195,802	69

The Parking Apron was constructed in 1992 and has received no work since. Predominant distresses are low to medium severity longitudinal and transverse cracking, low severity weathering and low severity raveling.

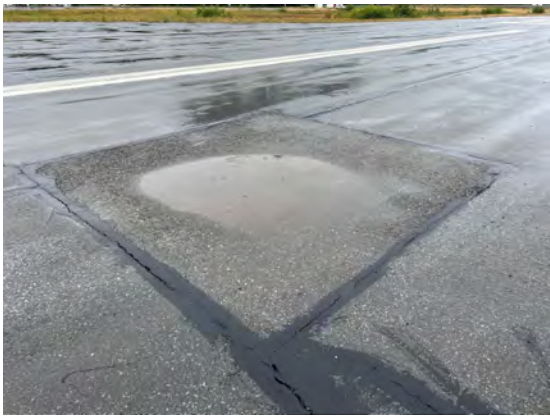
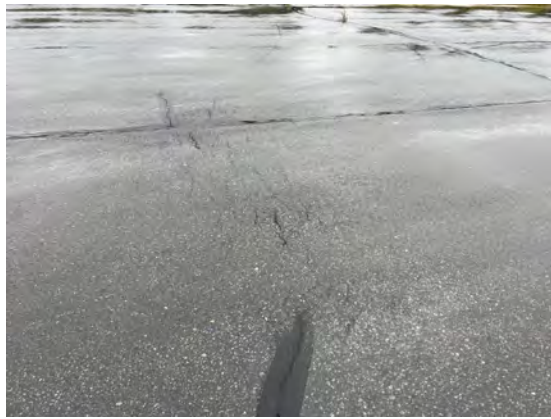
Branch ID	Branch Name	Branch Use	No. of Sections	Area (sf)	Weight Average PCI
6100	13/31	Runway	3	469,804	56

Runway 13/31 received a repair by the Corp of Engineers in 1964, reconstructed in 1975 and was resurfaced in 1983. Common distresses include low to medium longitudinal and transverse cracking, low severity weathering, low to medium severity raveling and patching. Section 6100-02 is in worse condition than other sections of the runway and contains depressions and alligator cracking.

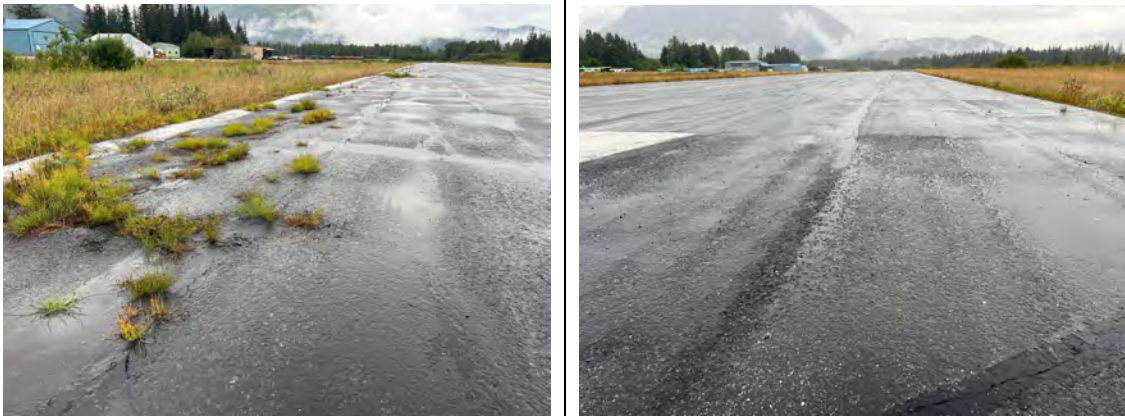
Branch ID	Branch Name	Branch Use	No. of Sections	Area (sf)	Weight Average PCI
6200	16/34	Runway	1	183,862	46

Runway 16/34 was constructed in 1975 and resurfaced in 1983. Common distresses are low to medium severity longitudinal and transverse cracking, low to medium severity raveling, and low severity weathering. Other observed distresses include medium severity patching, low severity depressions, low severity alligator cracking, and low to medium severity swelling.
