Alaska DOT&PF

Pavement Inspection Report Sitka Airport

Airport Name	IATA	ICAO	Latitude	Longitude	Elevation (ft)
Sitka Airport	SIT	PASI	57° 2.81'N	135° 21.66'W	26.5

Point of Contact	Phone	Email	Date Inspected	Date Published
Mr. Andrew Pavey, Pavement Management Engineer	(907) 269 6213	andrew.pavey@alaska.gov	October 2022	October 2023

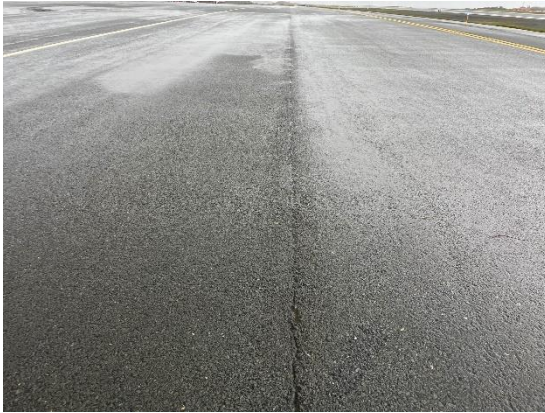
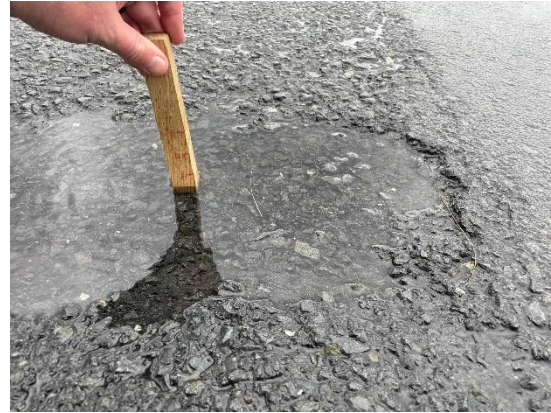
Taxiway A was constructed in 1983 and reconstructed with four inches of AC in 2000. Section 2 received a 1.5-inch mill and overlay in 2008. Section 01 has a PCI of 53 while Section 2 has a PCI of 77. The most common distresses observed are low severity alligator cracking, low severity longitudinal and transverse cracking, low to medium to high severity raveling, and low severity weathering. Field personnel observed the degradation of the longitudinal joints, causing cracking and raveling. We also observed the development of alligator cracking on the taxiway where it joins Runway 11-29.

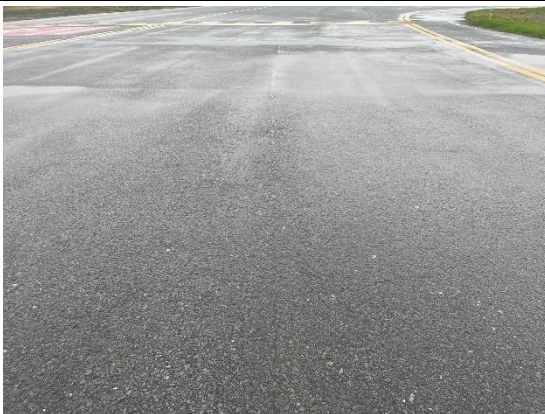
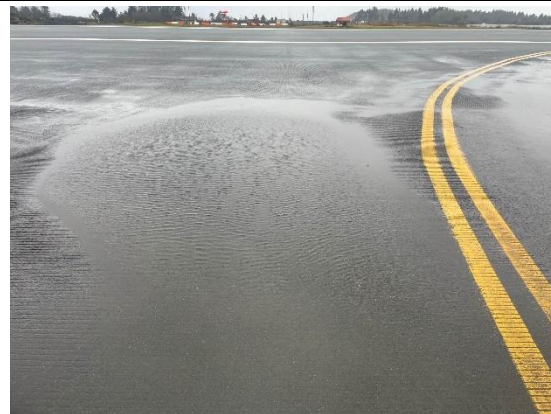
Taxiway B was constructed in 1983 and received a 2-inch overlay in 2000. Section 1 received a 3.5-inch overlay in 2012 and has a PCI of 88. Section 2 has a PCI of 62. The most common distresses observed are low severity alligator cracking, low to medium severity depression, low severity longitudinal and transverse cracking, low to medium to high severity raveling, and low severity weathering. Degradation of the longitudinal joints is causing cracking and raveling. We observed alligator cracking in one sample unit on the taxiway. Large depressions with standing water were observed on the south end of the taxiway near the shoulder.

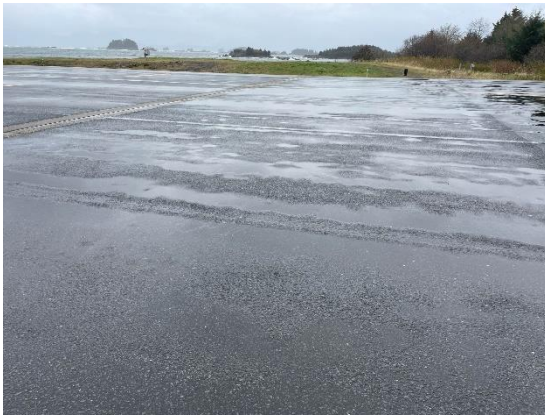
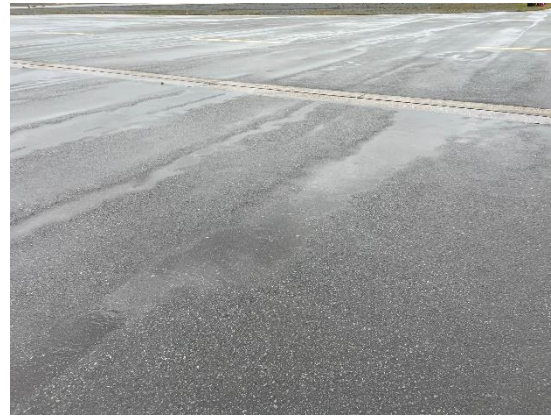
The Coast Guard Taxiway was constructed in 2000 and has not received any major work since. The most common distresses observed are low severity depression, low severity longitudinal and transverse cracking, low to medium severity raveling, and low severity weathering. Field observations include the development of widespread dimpling across the taxiway leading to areas of standing water. Most of the dimples contained less than ½-inch of standing water and thus the distress was not recorded (per ASTM D5340).

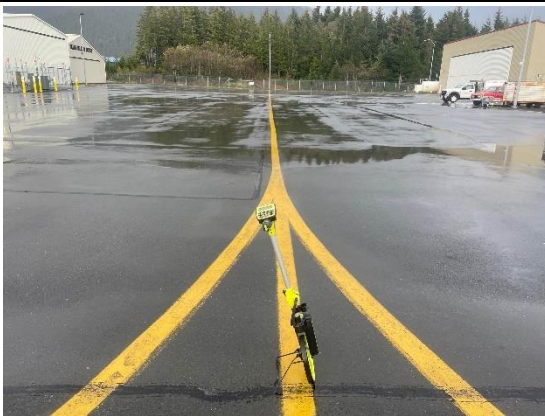
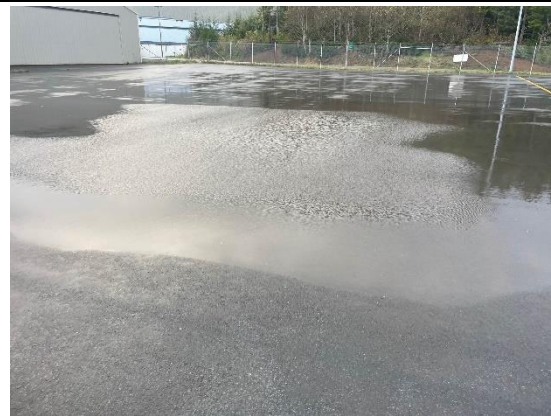
The Northwest Taxi Lane was constructed in 2002 and has not received any major work since. The most common distresses observed are low to medium severity depression, low severity longitudinal and transverse cracking, and low severity raveling. Field observations include the degradation of the paving joints causing longitudinal cracking and raveling. In addition, we observed a number of large areas of depressions, as evidenced by significant areas of standing water.

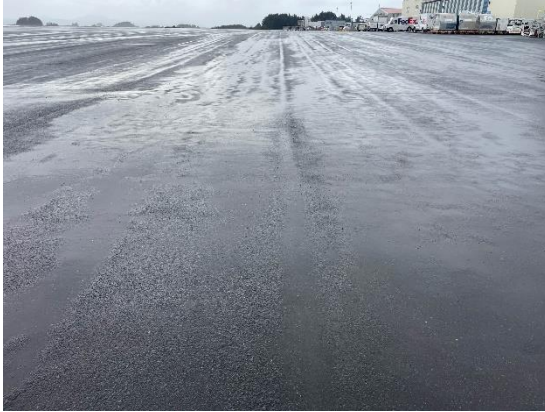
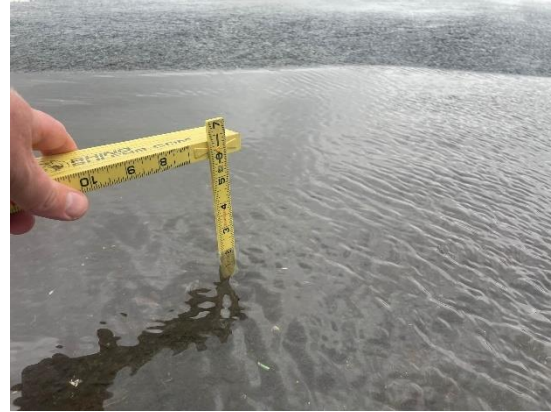
The main apron consists of six sections, three constructed of AC and three constructed of PCC. The three AC sections were constructed in 1983 received a 2-inch overlay in 2000. The most common distresses observed are low severity depression, low severity longitudinal and transverse cracking, low to medium severity raveling, and low severity weathering. Degradation of the paving joints is causing longitudinal cracking and raveling to develop. Widespread dimpling was observed across the apron, leading to large areas of standing water. Standing water was measured to be less than ½-inch deep, thus the distress was not recorded (per ASTM D5340).

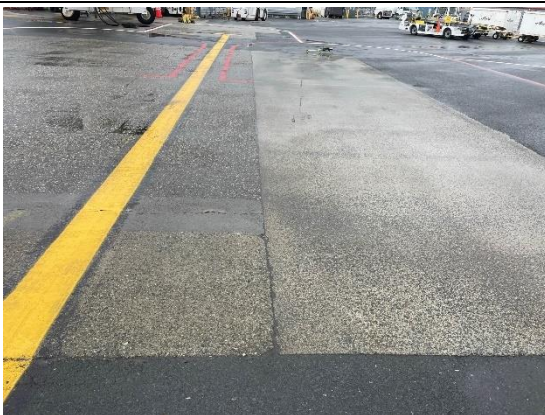
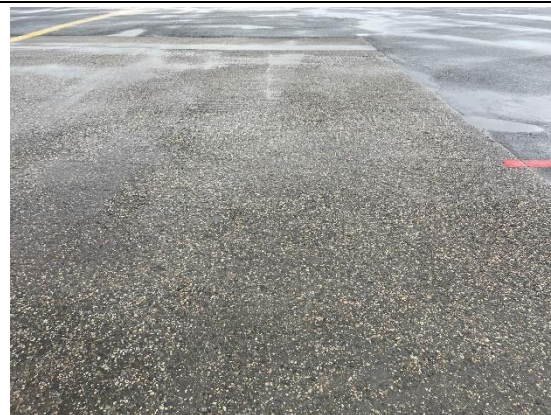
The three PCC sections consist of three separate hardstands. Section 4 was constructed in 1983 and Sections 5 and 6 were constructed in 2012. No major work has been conducted on these PCC sections. The most common distresses observed are medium to high severity joint and corner spalling, low to high severity scaling, and high severity joint seal damage. The concrete is showing its age at nearly 40 years old with numerous high severity distresses.

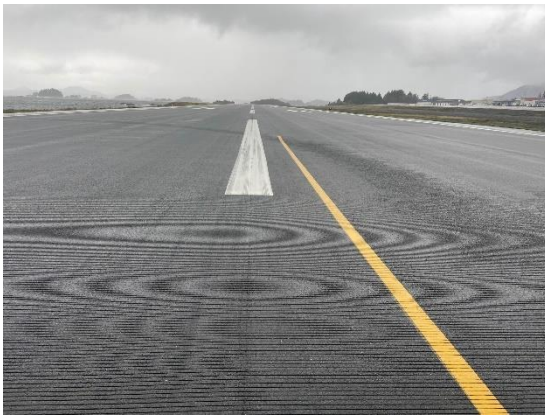
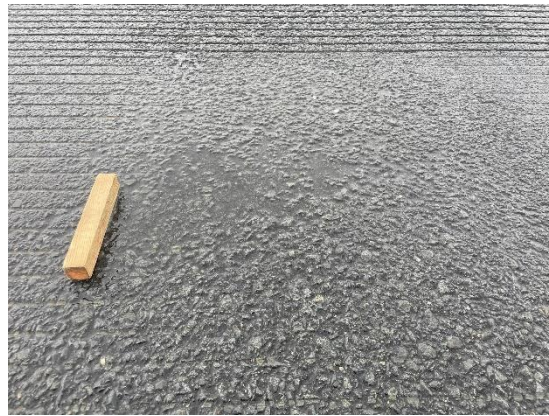
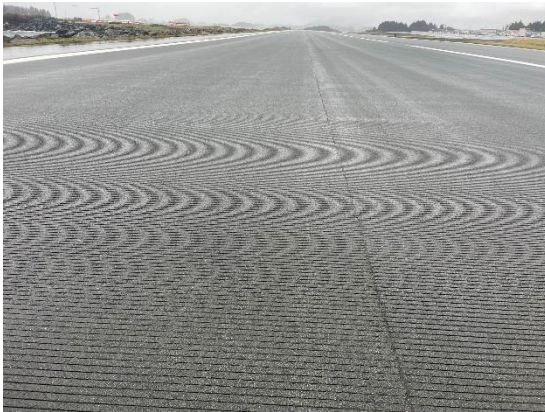
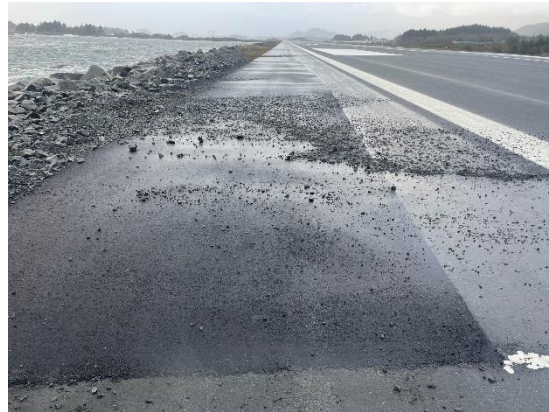
Runway 11/29 was constructed in 1984 at a length of 6,500 ft. In 2011 the runway was lengthened to 6,800 ft. The most recent rehabilitation was a thin overlay in 2012. The most common distresses observed are low severity longitudinal and transverse cracking, low to medium severity raveling, and low severity weathering. We observed an increased loss of the fine aggregate which is exposing the coarse aggregate (weathering). In some areas the distress has progressed to the loss of coarse aggregate (raveling). The west side of the runway has been damaged by waves resulting from the deterioration of the sea wall. Patching has been performed to mitigate the wave damage.
