## Alaska DOT&PF

# Pavement Inspection Report Skagway Airport

Airport Name	IATA	ICAO	Latitude	Longitude	Elevation (ft)
Skagway Airport	SGY	PAGY	59° 27' 36.72" N	135° 19' 00.69" W	59

Point of Contact	Phone	Email	Date Inspected	Date Published
Mr. Andrew Pavey, Pavement Management Engineer	(907) 269 6213	andrew.pavey@alaska.gov	April 2024	August 2025

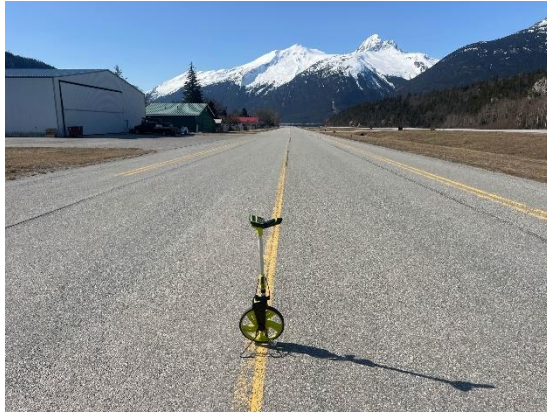
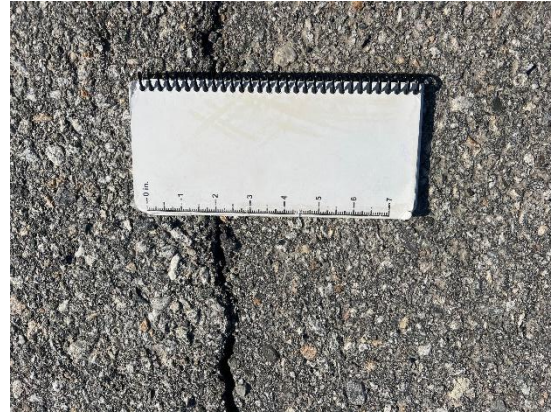
Branch ID	Branch Name	Branch Use	No. of Sections	Area (sf)	Weighted Average PCI
0100	Taxiway A	Taxiway	2	168,655	64

Taxiway A was constructed in 2000 and has not received major work since. Occasional crack seal operations have been performed on the branch but could be touched up. The most common distresses observed are low to medium severity longitudinal and transverse cracking, low to medium severity raveling and low to medium severity weathering. Field observations include the development of new unfilled cracks, the widening of previously filled cracks along the paving joints increasing the severity, and the deterioration of the pavement surface leading to large areas of raveling across the taxiway.

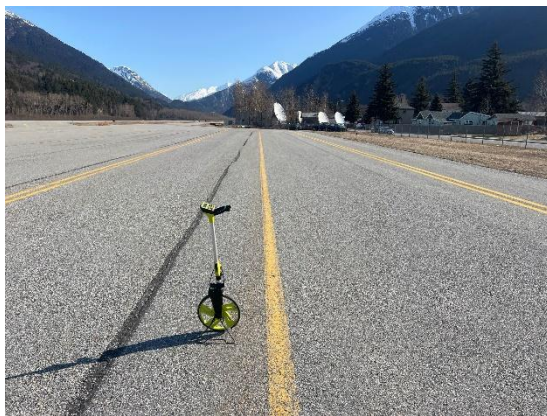
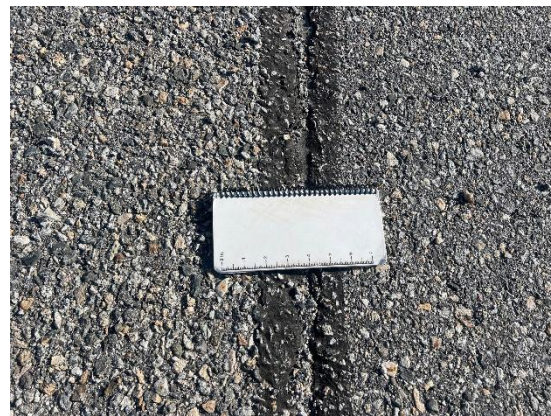
Branch ID	Branch Name	Branch Use	No. of Sections	Area (sf)	Weighted Average PCI
0150	Taxiway A1	Taxiway	1	27,050	67

Like Taxiway A, Taxiway A1 was constructed in 2000 and has not received major work since. Occasional crack seal operations have been performed on the branch but could be touched up. The most common distresses observed are low to medium severity longitudinal and transverse cracking, low to medium severity raveling and low to medium severity weathering. Field observations include the development of new unfilled cracks, the widening of previously filled cracks along the paving joints increasing the severity, and the deterioration of the pavement surface leading to large areas of raveling across the taxiway.

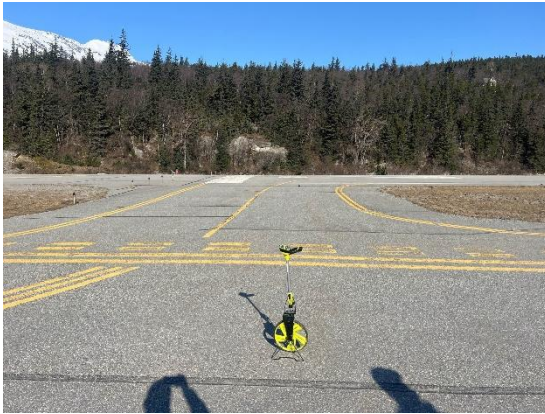
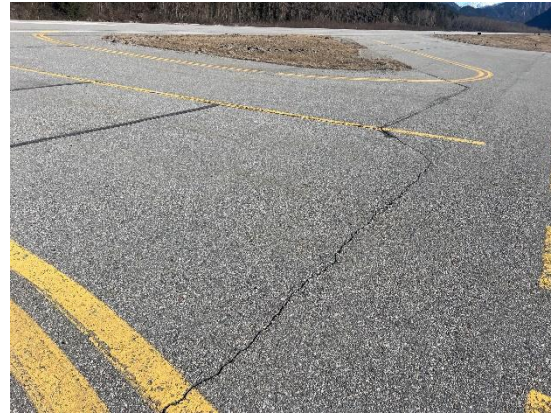
Branch ID	Branch Name	Branch Use	No. of Sections	Area (sf)	Weighted Average PCI
0200	Taxiway B	Taxiway	1	4,282	65

Taxiway B was constructed in 2000 and has not received major work since. Occasional crack seal operations have been performed on the branch but could be touched up. The most common distresses observed are low to medium severity longitudinal and transverse cracking, low severity raveling and low to medium severity weathering. Field observations include the development of new unfilled transverse cracks, the widening of previously filled cracks increasing the severity, and the deterioration of the pavement surface leading to large areas of raveling across the taxiway.

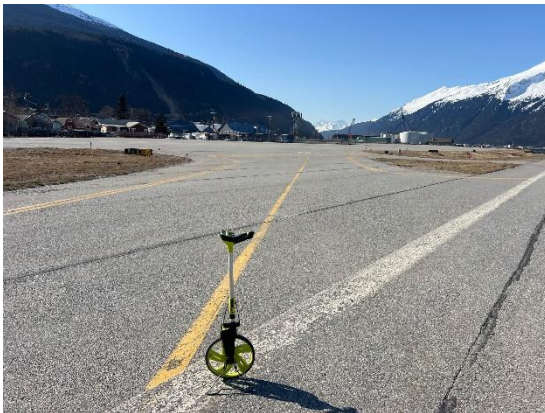
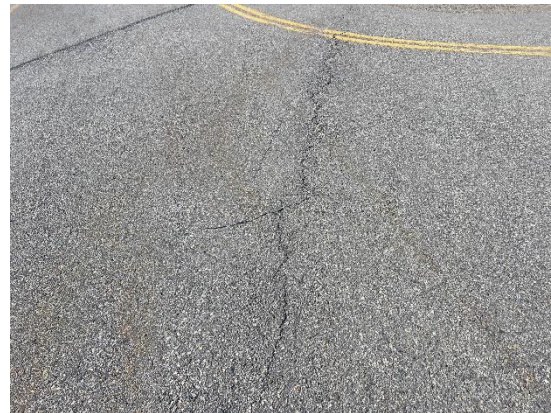
Branch ID	Branch Name	Branch Use	No. of Sections	Area (sf)	Weighted Average PCI
0210	Taxiway B1	Taxiway	1	9,793	65

Like Taxiway B, Taxiway B1 was constructed in 2000 and has not received major work since. Occasional crack seal operations have been performed on the branch but could be touched up. The most common distresses observed are low to medium severity longitudinal and transverse cracking, low severity raveling and low to medium severity weathering. Field observations include the development of new unfilled cracks, the widening of previously filled cracks along the paving joints increasing the severity, and the deterioration of the pavement surface leading to large areas of raveling across the taxiway.

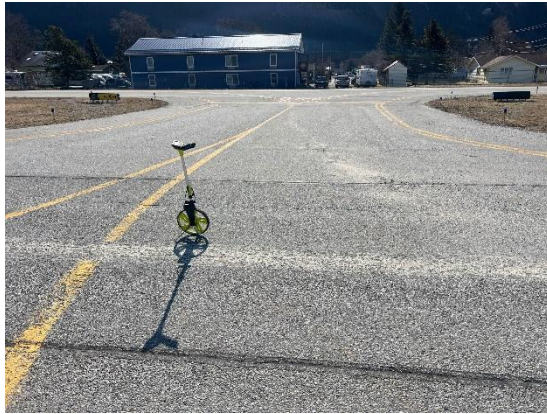
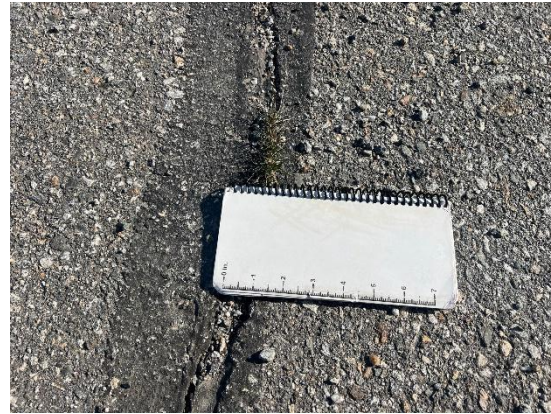
Branch ID	Branch Name	Branch Use	No. of Sections	Area (sf)	Weighted Average PCI
0300	Taxiway C	Taxiway	1	5,250	64

Taxiway C was constructed in 2000 and has not received major work since. Occasional crack seal operations have been performed on the branch but could be touched up. The most common distresses observed are low to medium severity longitudinal and transverse cracking, low to medium severity raveling and low to medium severity weathering. Field observations include the development of new unfilled transverse cracks, the widening of previously filled cracks increasing the severity, and the deterioration of the pavement surface leading to large areas of raveling across the taxiway.

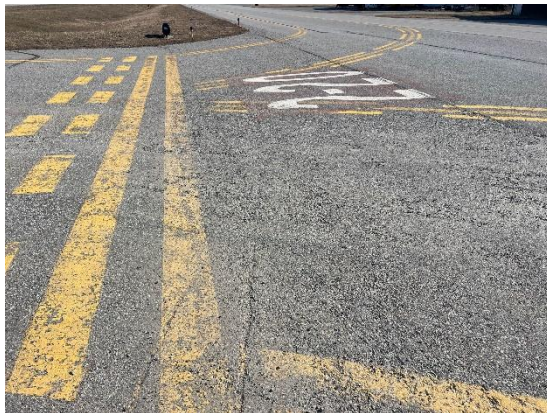
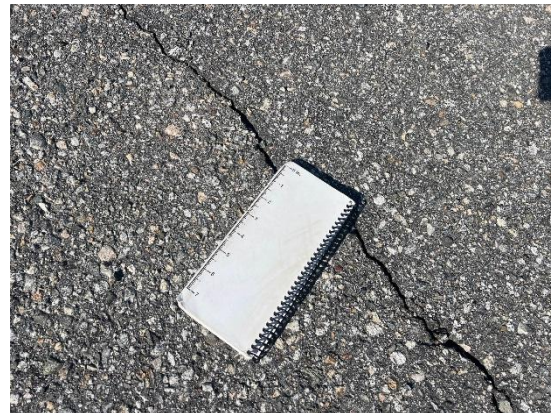
Branch ID	Branch Name	Branch Use	No. of Sections	Area (sf)	Weighted Average PCI
0400	Taxiway D	Taxiway	1	5,112	61

Taxiway D was constructed in 2000 and has not received major work since. Occasional crack seal operations have been performed on the branch but could be touched up. The most common distresses observed are low severity depression, low to medium severity longitudinal and transverse cracking, low to medium severity raveling and low to medium severity weathering. Field observations include areas where standing water is possible, the development of new unfilled transverse cracks, the widening of previously filled cracks increasing the severity, and the deterioration of the pavement surface leading to large areas of raveling across the taxiway.

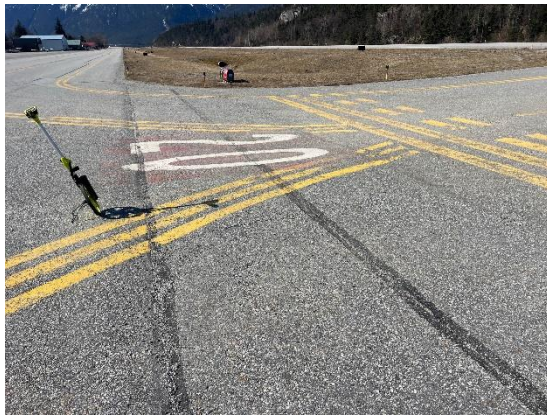
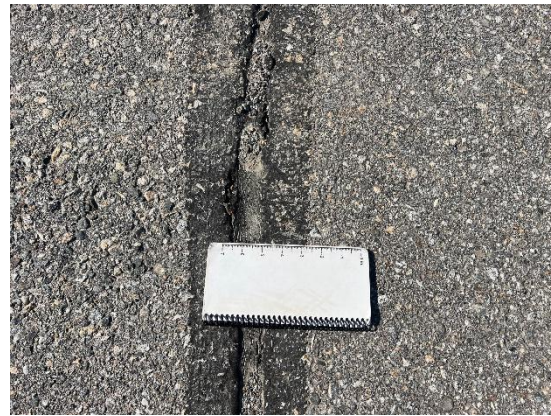
Branch ID	Branch Name	Branch Use	No. of Sections	Area (sf)	Weighted Average PCI
0500	Taxiway E	Taxiway	1	4,682	58

Taxiway E was constructed in 2000 and has not received major work since. Occasional crack seal operations have been performed on the branch but could be touched up. The most common distresses observed are low to high severity longitudinal and transverse cracking, low to medium severity raveling and low to medium severity weathering. Field observations include the development of new unfilled transverse cracks, the widening of previously filled cracks increasing the severity, and the deterioration of the pavement surface leading to large areas of raveling across the taxiway.

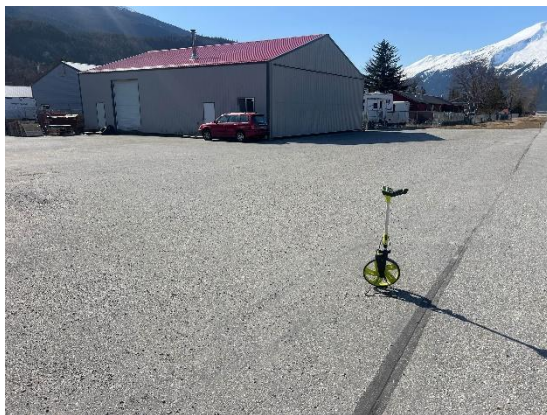
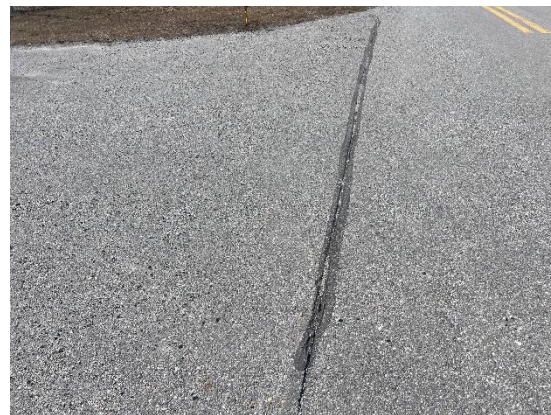
Branch ID	Branch Name	Branch Use	No. of Sections	Area (sf)	Weighted Average PCI
0600	Fuel TW	Taxiway	1	8,422	66

The fuel taxiway was constructed in 2000 and has not received major work since. Occasional crack seal operations have been performed on the branch but could be touched up. The most common distresses observed are low to medium severity longitudinal and transverse cracking, low severity raveling and low to medium severity weathering. Field observations include the development of new unfilled cracks, the widening of previously filled cracks increasing the severity, and the deterioration of the pavement surface leading to large areas of raveling across the taxiway.

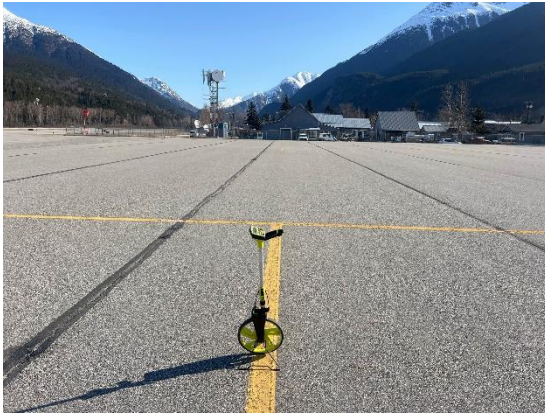
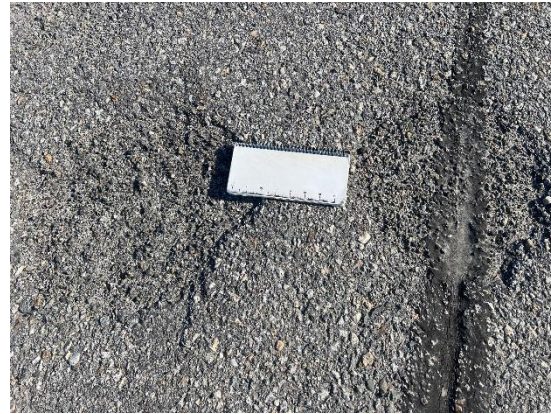
Branch ID	Branch Name	Branch Use	No. of Sections	Area (sf)	Weighted Average PCI
4100	South Apron	Apron	1	320,309	64

The south apron was constructed in 2000 and has not received any work since. Occasional crack seal operations have been performed on the branch but could be touched up. The most common distresses observed are low to medium severity longitudinal and transverse cracking, low to high severity raveling and low to medium severity weathering. Field observations include the development of new unfilled cracks, the widening of previously filled cracks along the paving joints increasing the severity, and the deterioration of the pavement surface leading to large areas of raveling across the apron.

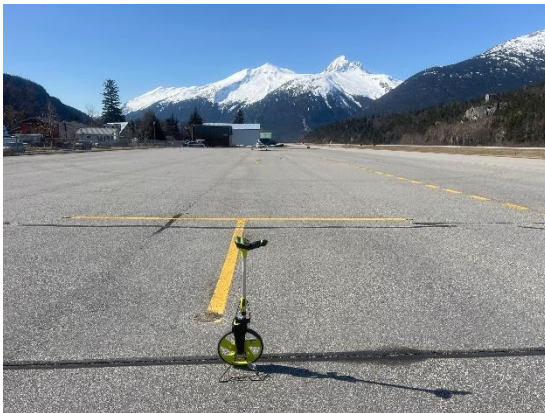
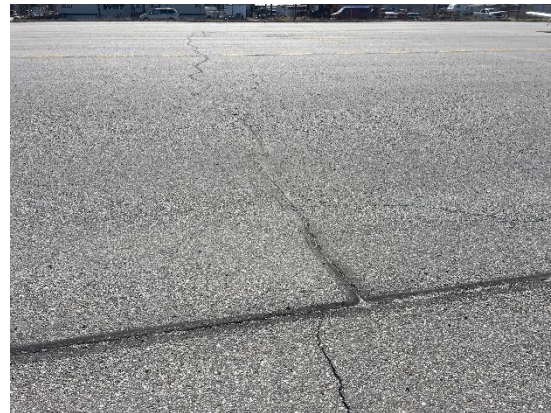
Branch ID	Branch Name	Branch Use	No. of Sections	Area (sf)	Weighted Average PCI
4200	North Apron	Apron	1	121,651	67

The north apron was constructed in 2001 and has not received any work since. Occasional crack seal operations have been performed on the branch but could be touched up. The most common distresses observed are low to medium severity longitudinal and transverse cracking, low to medium severity raveling and low to medium severity weathering. Field observations include the development of new unfilled cracks, the widening of previously filled cracks along the paving joints increasing the severity, and the deterioration of the pavement surface leading to large areas of raveling across the apron.

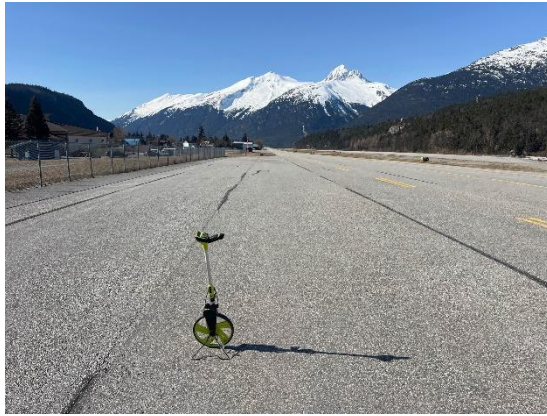
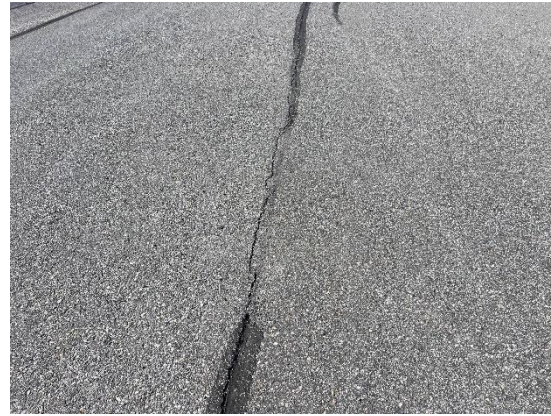
Branch ID	Branch Name	Branch Use	No. of Sections	Area (sf)	Weighted Average PCI
4300	Far North Apron	Apron	1	17,228	59

The apron was constructed in 2001 and has not received any work since. Occasional crack seal operations have been performed on the branch but could be touched up. The most common distresses observed are low to medium severity longitudinal and transverse cracking, low to medium severity raveling and low to medium severity weathering. Field observations include the development of new unfilled cracks, the widening of previously filled cracks along the paving joints increasing the severity, and the deterioration of the pavement surface leading to large areas of raveling across the apron.

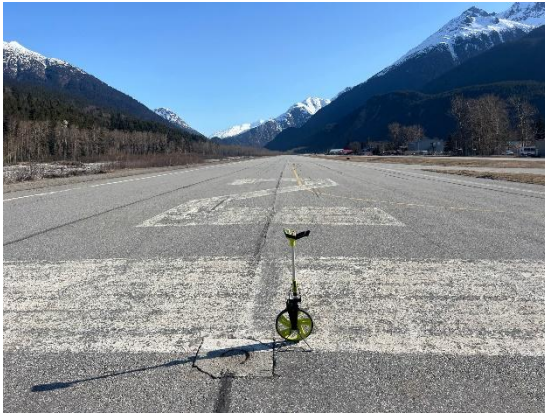
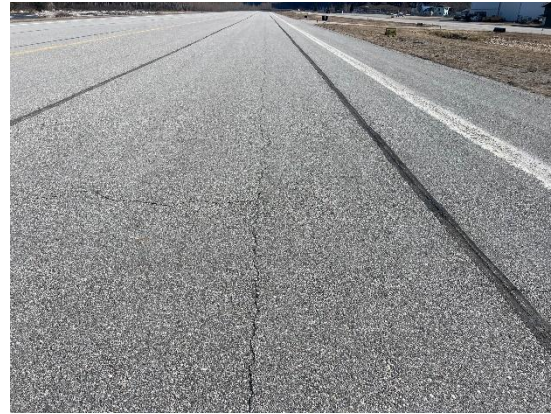
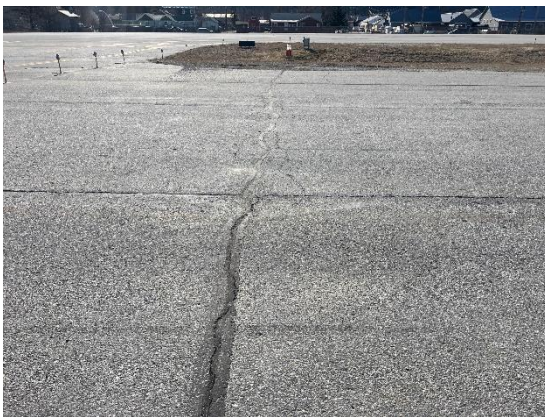
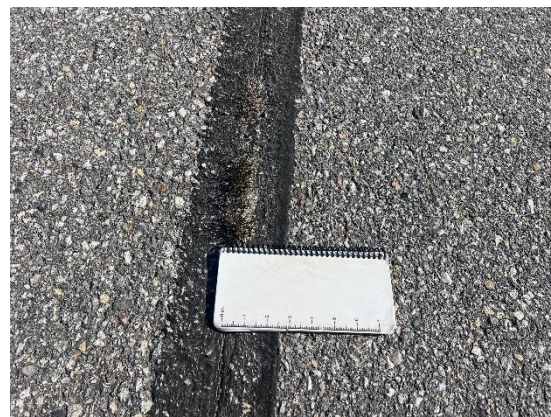
Branch ID	Branch Name	Branch Use	No. of Sections	Area (sf)	Weighted Average PCI
6100	Runway 02/20	Runway	3	311,250	63

Runway 02/20 was initially constructed in 1990 and the most recent major work was complete reconstruction in 2000. Occasional crack seal operations have been performed on the branch since construction. The most common distresses observed are low to medium severity longitudinal and transverse cracking, low to medium severity raveling and low to medium severity weathering. Field observations include further deterioration of the top layer of asphalt concrete, contributing to a higher quantity and severity of raveling throughout the branch. Efforts have been made to seal areas of high raveling, but the sealant is failing.
