# Pavement Inspection Report Unalakleet Airport

Airport Name	IATA	ICAO	Latitude	Longitude	Elevation (ft)
Unalakleet Airport	UNK	PAUN	63° 53' 18.6" N	160° 47' 56.8" W	25.7

Point of Contact	Phone	Email	Date Inspected	Date Published
Mr. Andrew Pavey, Pavement Management Engineer	(907) 269 6213	andrew.pavey@alaska.gov	July 2024	July 2025

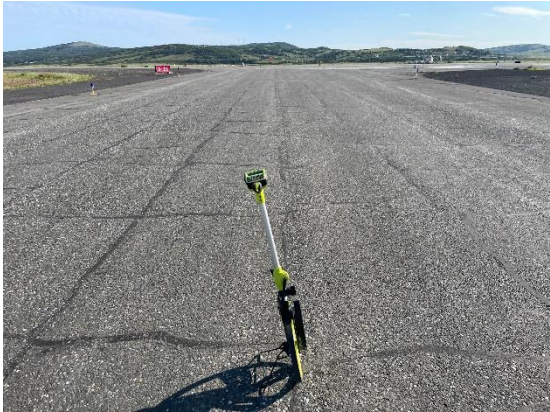
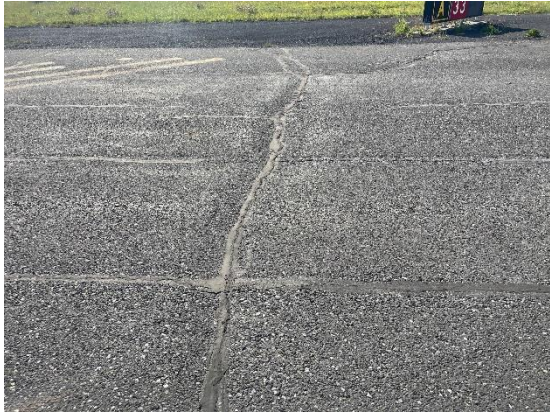
Branch ID	Branch Name	Branch Use	No. of Sections	Area (sf)	Weighted Average PCI
0100	Taxiway A	Taxiway	1	21,875	60

Taxiway A was constructed in 2009 and has not received major work since. Annual crack seal operations have been performed on the branch. The most common distresses observed are low severity block cracking, low severity longitudinal and transverse cracking, and low severity weathering. Field observations include further development of cracks becoming interconnected, leading to a larger quantity of block cracking.

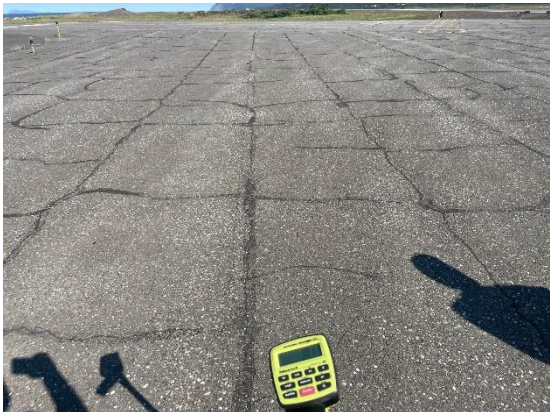
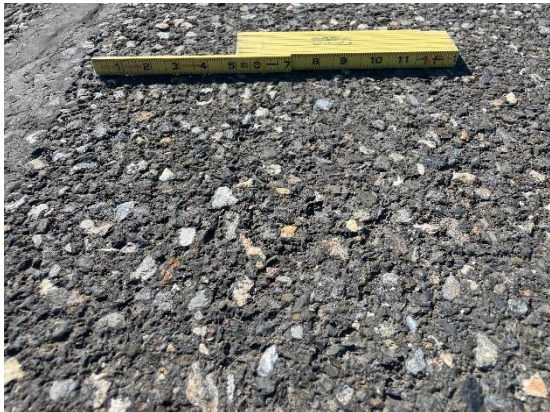
Branch ID	Branch Name	Branch Use	No. of Sections	Area (sf)	Weighted Average PCI
0200	Taxiway B	Taxiway	1	17,236	61

Taxiway B was constructed in 2009 and has not received major work since. Annual crack seal operations have been performed on the branch. The most common distresses observed are low severity block cracking, low severity longitudinal and transverse cracking, and low severity weathering. Field observations include continued development of cracks becoming interconnected, leading to a larger quantity of block cracking.

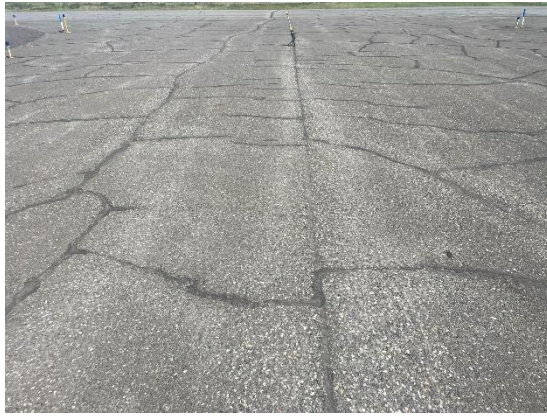
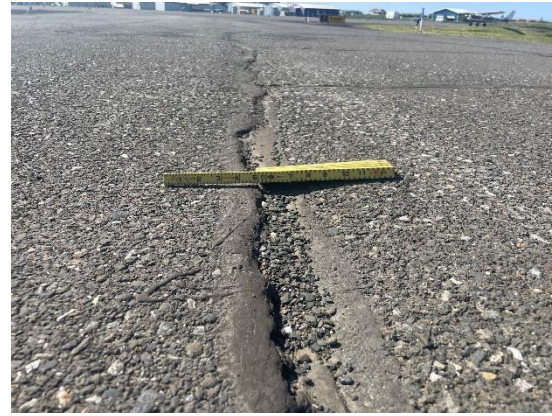
Branch ID	Branch Name	Branch Use	No. of Sections	Area (sf)	Weighted Average PCI
0300	Taxiway C	Taxiway	1	15,191	56

Taxiway C was constructed in 2009 and has not received major work since. Annual crack seal operations have been performed on the branch. The most common distresses observed are low severity block cracking, low to medium severity longitudinal and transverse cracking, and low severity weathering. Field observations include further development of cracks becoming interconnected, leading to larger quantities of block cracking. Additionally, some cracks are beginning to depress, increasing the severity level of the distress.

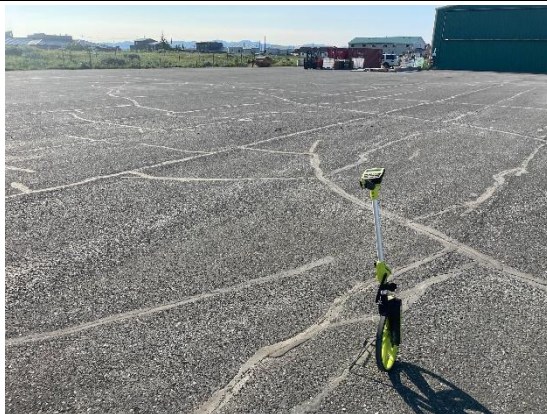
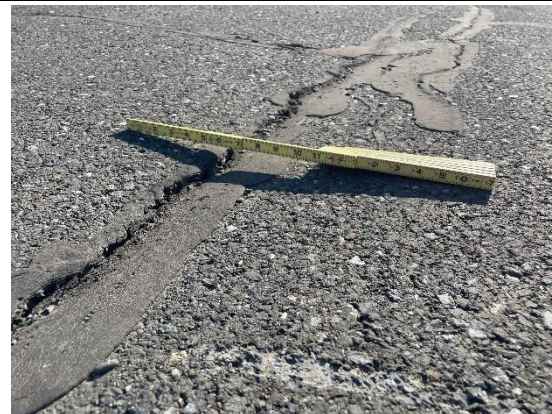
Branch ID	Branch Name	Branch Use	No. of Sections	Area (sf)	Weighted Average PCI
4100	Main Apron	Apron	1	292,474	64

The Main Apron was constructed in 2009 and has not received major work since. Annual crack seal operations have been performed on the branch. The most common distresses observed are low to medium severity longitudinal and transverse cracking, oil spillage, and low severity weathering. Field observations indicate that the cracking is continuing to degrade, with cracks increasing in both width and depth across the apron. This has led to higher severity distresses.

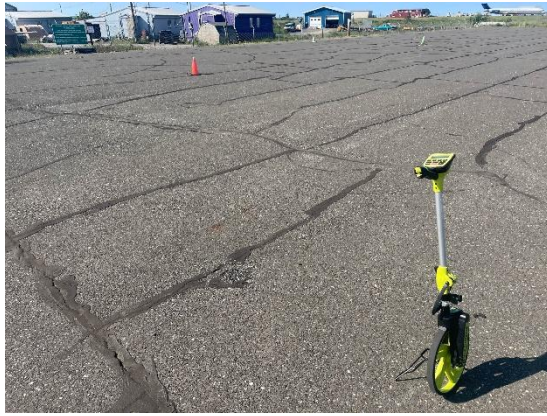
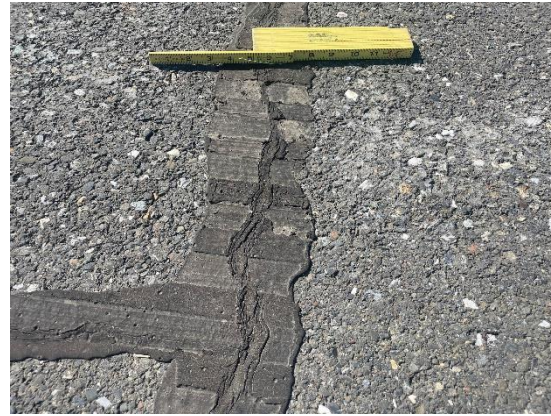
Branch ID	Branch Name	Branch Use	No. of Sections	Area (sf)	Weighted Average PCI
4200	GA Apron	Apron	1	65,000	54

The GA Apron was constructed in 2009 and has not received major work since. Annual crack seal operations have been performed on the branch. The most common distresses observed are low to medium severity block cracking, low to medium severity longitudinal and transverse cracking, oil spillage, and low severity weathering. Field observations include further development of cracks becoming interconnected, leading to a larger quantity of block cracking. Additionally, some cracks are beginning to depress, increasing the severity level of the distress.

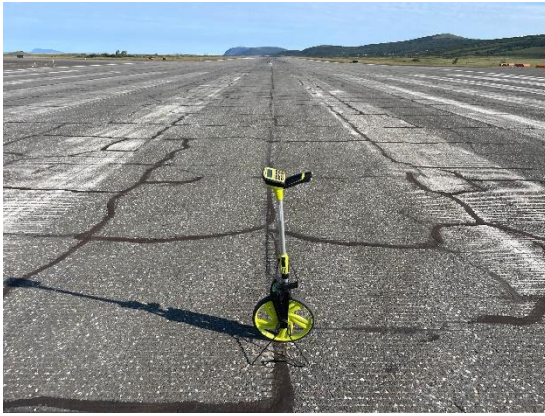
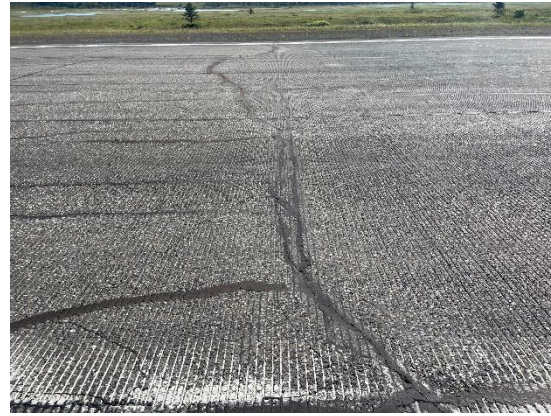
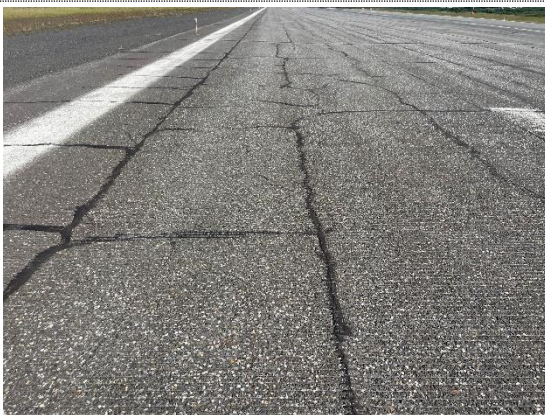
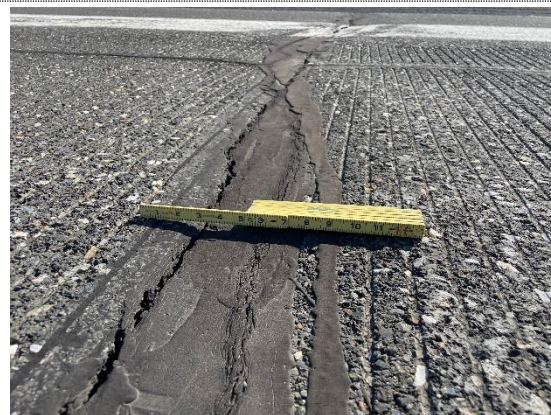
Branch ID	Branch Name	Branch Use	No. of Sections	Area (sf)	Weighted Average PCI
6100	Runway 15/33	Runway	2	925,000	57

Runway 15/33 was constructed in 2009 and has not received major work since. Annual crack seal operations have been performed on the branch. The most common distresses observed are low severity block cracking, low to medium severity longitudinal and transverse cracking, low severity raveling, and low severity weathering. Field observations include further development of cracks becoming interconnected, leading to a larger quantity of block cracking. Additionally, some cracks are beginning to depress, increasing the severity level of the distress.

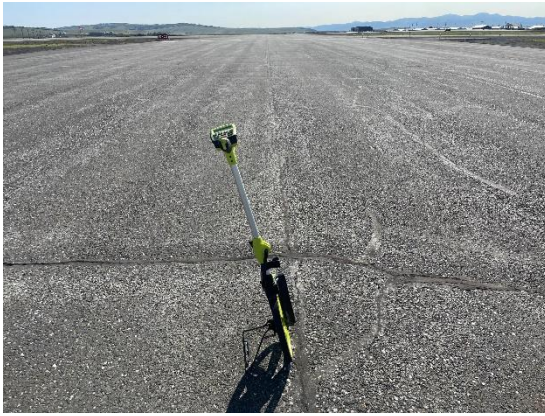
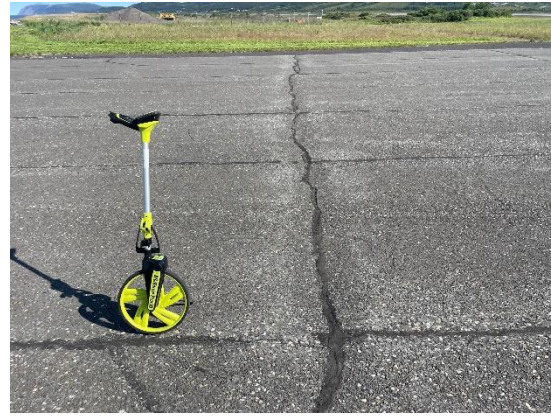
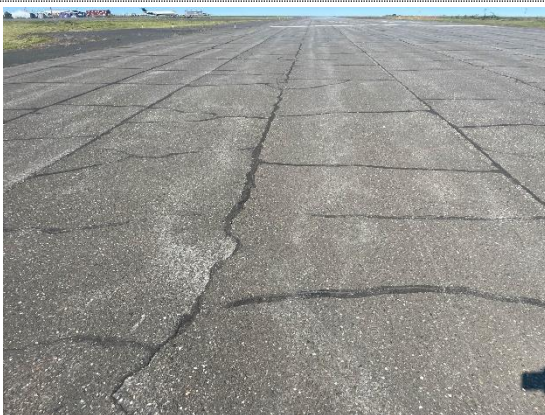
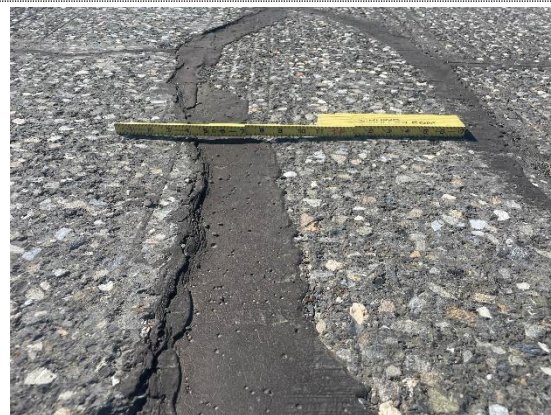
Branch ID	Branch Name	Branch Use	No. of Sections	Area (sf)	Weighted Average PCI
6200	Runway 08/26	Runway	3	172,173	57

Runway 08/26 was constructed in 2009 and has not received major work since. Annual crack seal operations have been performed on the branch. The most common distresses observed are low severity block cracking, low to medium severity longitudinal and transverse cracking, low severity raveling, and low severity weathering. Field observations include further development of cracks becoming interconnected, leading to a larger quantity of block cracking. Additionally, some cracks are beginning to depress, increasing the severity level of the distress.
