## Alaska DOT&PF

# Pavement Inspection Report Unalaska Airport

Airport Name	IATA	ICAO	Latitude	Longitude	Elevation (ft)
Unalaska Airport	DUT	PADU	53° 53' 56.2" N	166° 32' 42.1" W	23.3

Point of Contact	Phone	Email	Date Inspected	Date Published
Mr. Andrew Pavey, Pavement Management Engineer	(907) 269 6213	andrew.pavey@alaska.gov	June 2024	June 2025

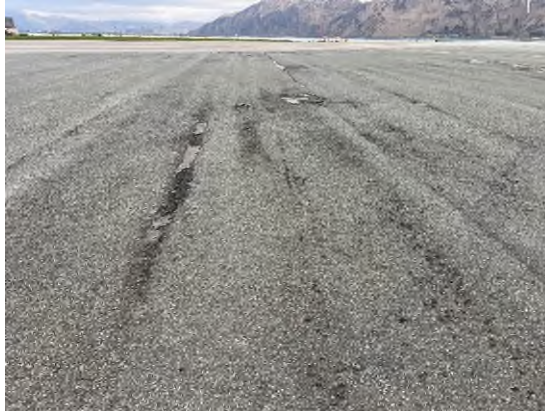
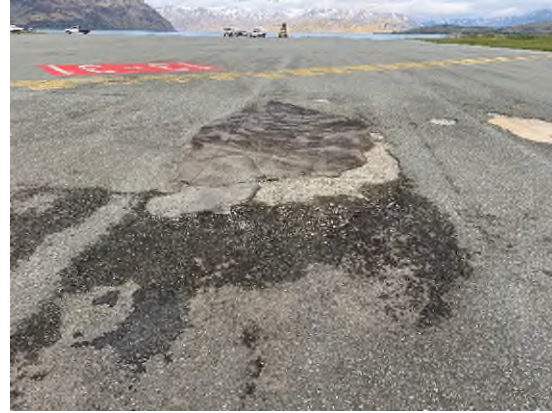
Taxiway A was originally built in 1943 using portland cement concrete (PCC). Over the years, it has undergone asphalt concrete (AC) surface rehabilitations, with the most recent rehabilitation taking place in 1998. These rehabilitations have resulted in a surface categorized as asphalt over portland cement (APC). Crack seal operations have not been performed on the branch. The most common distresses observed are low to medium severity depressions, low to high severity longitudinal and transverse cracking, medium to high severity patching, low to high severity raveling, and medium severity weathering. Field observations indicate a heavily deteriorated pavement surface, characterized by extensive medium and high severity distresses across the taxiway. Large quantities of these distresses are present, highlighting the need for maintenance and rehabilitation to prevent further degradation of the pavement structure. Additionally, the prevalence of raveling suggests significant surface material loss, which can further compromise pavement integrity and functionality.

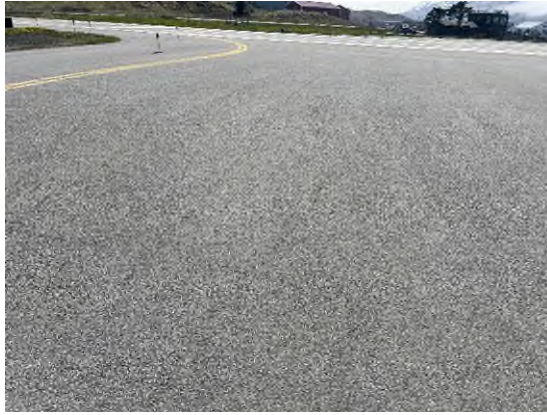
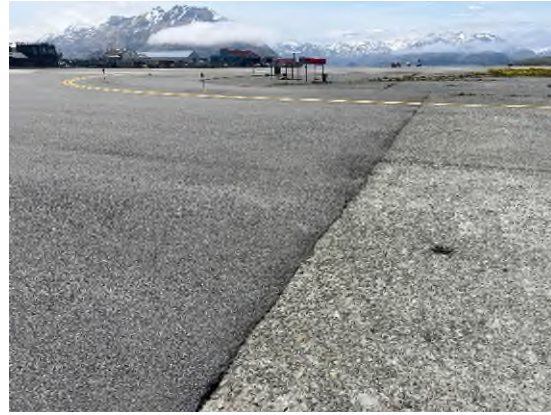
**APC Section 0200-01 (90 PCI)**

Taxiway B is comprised of two sections, Section 0200-01 and Section 0200-02. APC Section 0200-01 was originally constructed in 1943 using PCC and has undergone multiple AC surface rehabilitations over the years, with the most recent occurring in 2014. Crack seal operations have not been performed on the section. The most common distress observed is low to medium severity weathering. Field observations include initial deterioration to the top layer of AC.

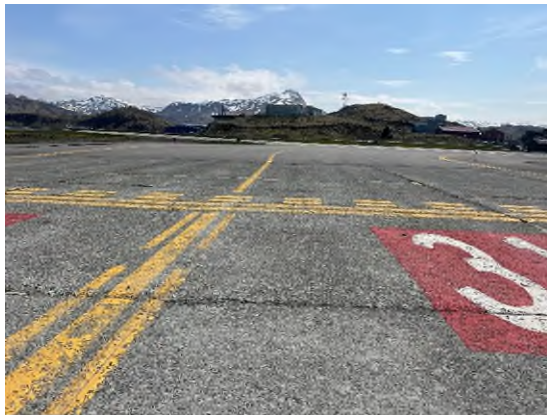
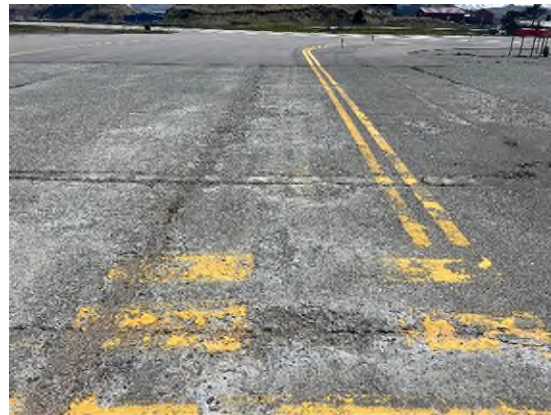
**PCC Section 0200-02 (0 PCI)**

Taxiway B Section 0200-02 was constructed in 1943 and has not received any major work since. Crack and joint seal operations have not been performed on the section. The most common distresses observed are high severity joint seal damage, low to high small and large severity patching, high severity scaling, and high severity joint and corner spalling. Field observations include wearing of the surface of the PCC leading to high severity scaling, and vegetation growth in every joint leading to the high severity joint seal damage. Overall, the pavement surface is heavily deteriorated, with extensive high-severity distresses evident throughout the taxiway. This section remains the original PCC and has exceeded its original service life.

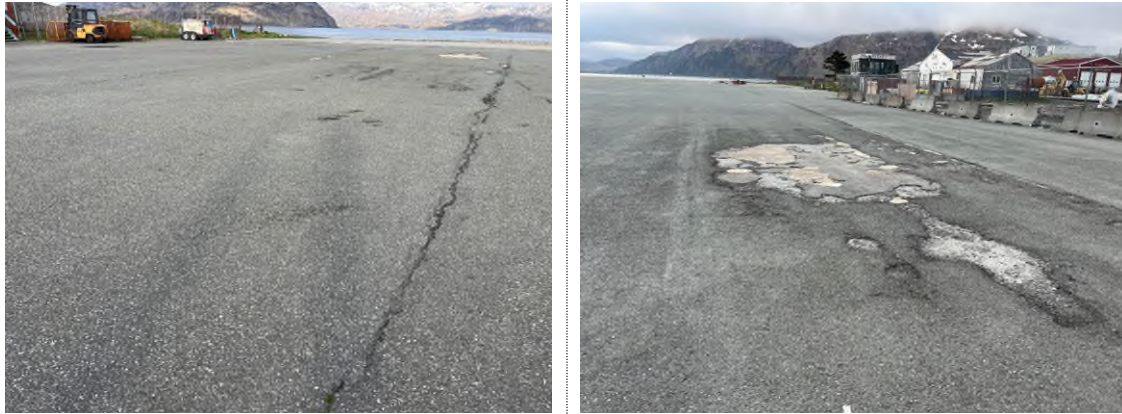
**APC Section 4100-01 (23 PCI)**

The Terminal Apron is comprised of two sections, Section 4100-01 and Section 4100-02. APC Section 4100-01 was originally constructed in 1943 using PCC and has received multiple AC surface rehabilitations, most recently in 1998. Crack seal operations have not been performed on the section. The most common distresses observed are low to medium severity depressions, low to medium severity longitudinal and transverse cracking, high severity patching, low to high severity raveling, and high severity weathering. Field observations indicate a heavily deteriorated pavement surface, characterized by extensive medium and high severity distresses across the taxiway. Large quantities of these distresses are present, highlighting the need for maintenance and rehabilitation to prevent further degradation of the pavement structure. In addition, the prevalence of raveling suggests significant surface material loss, which can further compromise the pavement integrity and functionality.

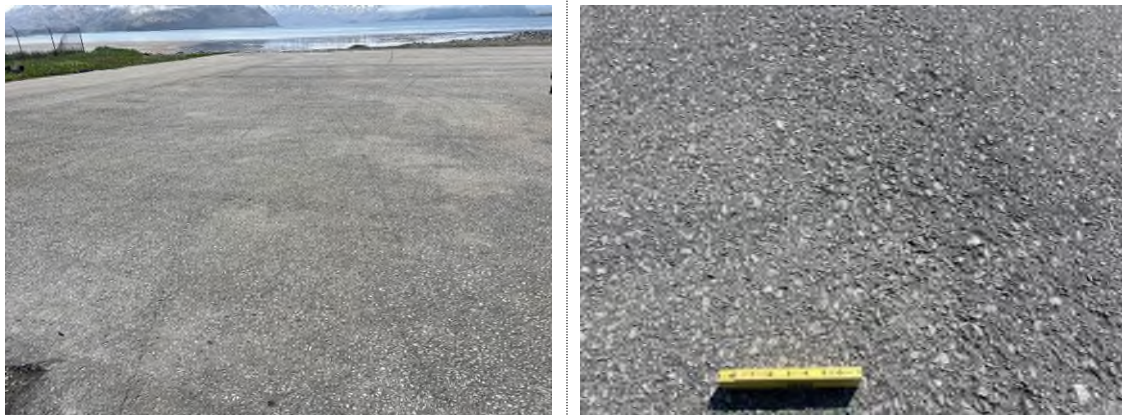
**AC Section 4100-02 (57 PCI)**

Terminal Apron Section 4100-02 was constructed in 2003 and has not received any major work since. Crack seal operations have not been performed on the section. The most common distresses observed are low severity longitudinal and transverse cracking, oil spillage, low to medium severity raveling, and low to medium severity weathering. Field observations include continued deterioration to the top layer of AC, leading to increased loss of the fine and coarse aggregates across the apron.

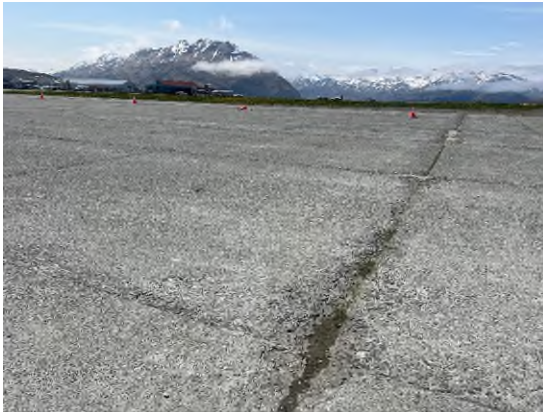
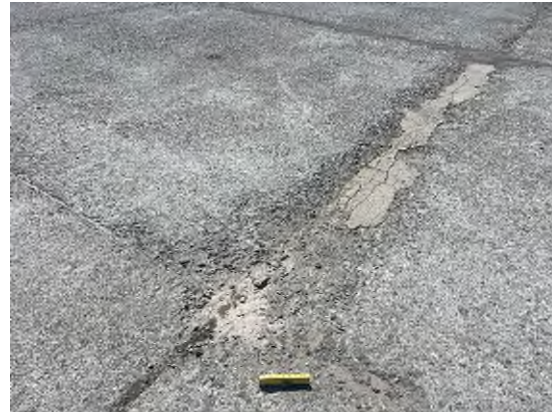
The Hangar Apron was constructed in 1943 and has not received any major work since. The most common distresses observed are high severity corner breaks, high severity linear cracks, high severity joint seal damage, high severity small and large patching, high severity scaling, and high severity joint and corner spalling. Field observations include wearing of the surface of the concrete leading to high severity scaling, and vegetation growth in every joint leading to the high severity joint seal damage. Overall, the pavement surface is heavily deteriorated, with extensive high-severity distresses evident throughout the apron. This section remains the original PCC and has exceeded its original service life.

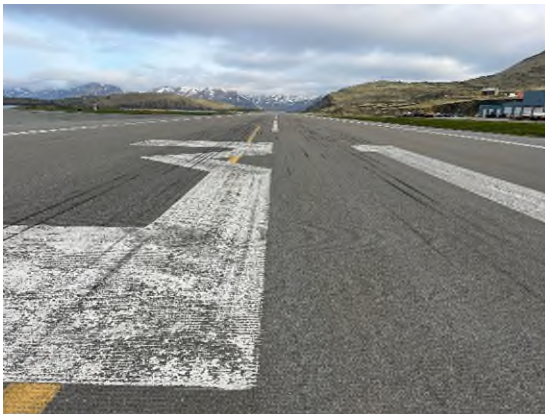
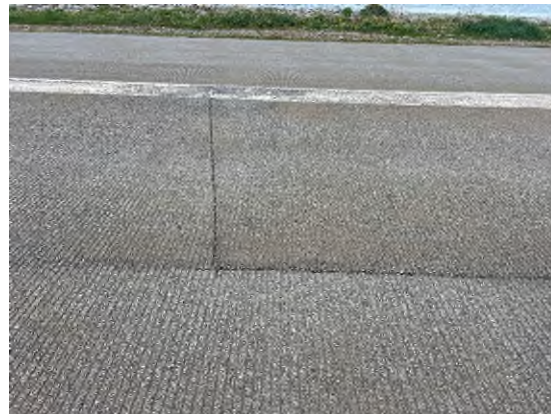
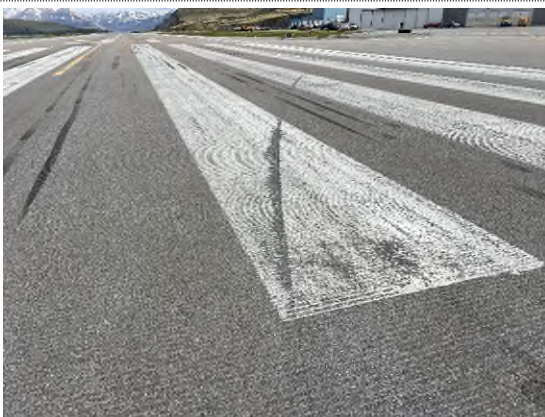
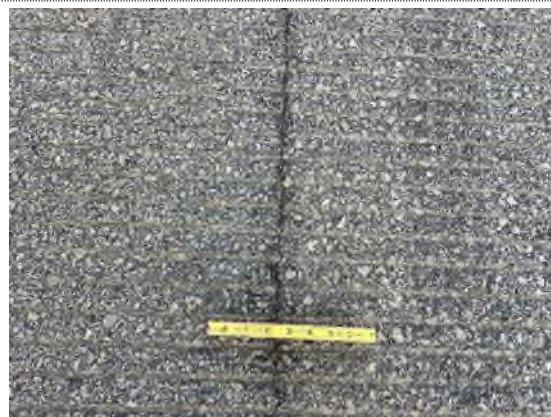
Runway 13/31 was originally constructed in 1943 of PCC and has undergone multiple AC surface rehabilitations over the years, with the most recent occurring in 2014. Crack seal operations have not been performed on the section. The most common distresses observed are low to medium severity longitudinal and transverse cracking, low to medium severity raveling, and low to medium severity weathering. Field observations indicate a gradual increase in weathering and raveling, leading to some loss of both fine and coarse aggregate across the runway. Additionally, the inspection noted several mechanical gouges to the AC surface. These gouges are classified as high-severity raveling, which significantly impacts the overall runway condition rating.
