Alaska DOT&PF

Pavement Inspection Report Valdez Airport

Airport Name	IATA	ICAO	Latitude	Longitude	Elevation (ft)
Valdez Airport	VDZ	PAVD	61° 08' 02" N	146° 14' 54" W	128

Point of Contact	Phone	Email	Date Inspected	Date Published
Mr. Andrew Pavey, Pavement Management Engineer	(907) 269 6213	andrew.pavey@alaska.gov	September 2025	September 2025

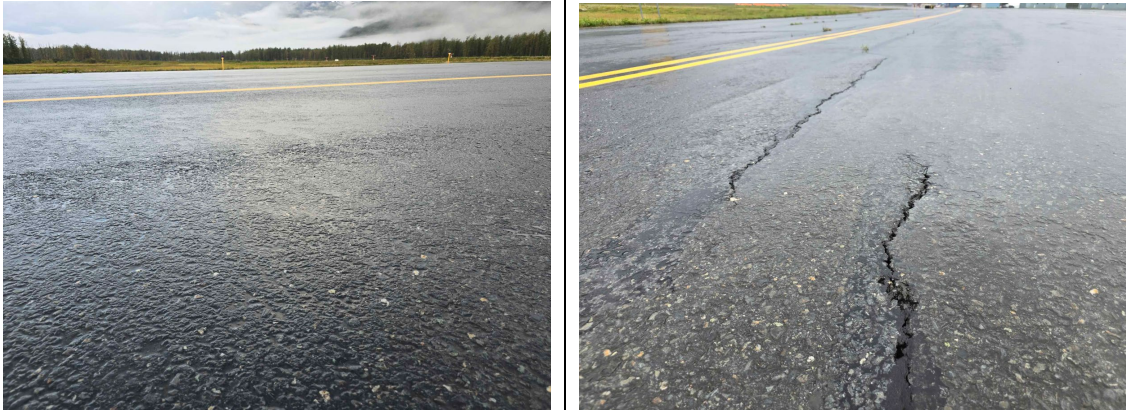
Branch ID	Branch Name	Branch Use	No. of Sections	Area (sf)	Weight Average PCI
0100	Taxiway A	Taxiway	3	526,000	73

Taxiway A consists of three sections, being 100-01, 100-02, and 100-03. 100-01 was constructed in 1981 and resurfaced in 2006, while sections 100-02 and 100-03 were constructed in 2006. Common distresses are low to medium severity longitudinal and transverse cracking and low to medium severity weathering. Areas of low severity raveling are observed, and there are small, isolated areas of moderate severity raveling.

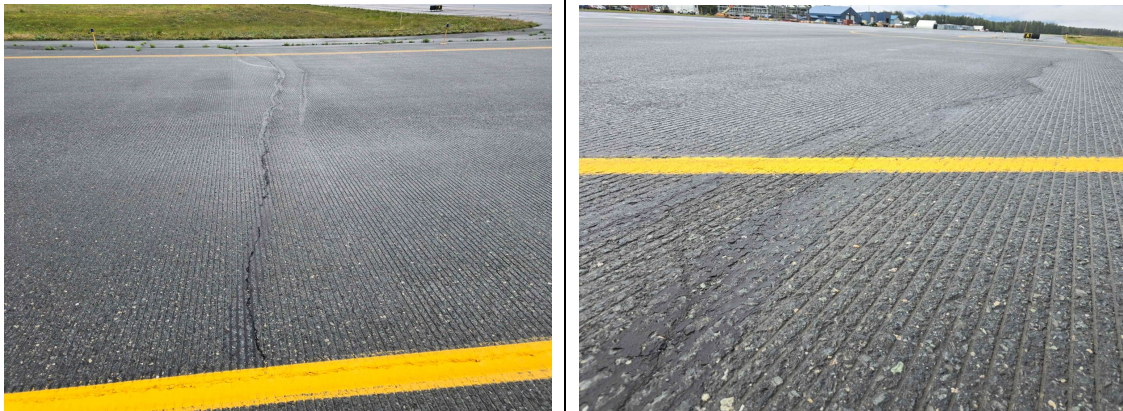
Branch ID	Branch Name	Branch Use	No. of Sections	Area (sf)	Weight Average PCI
0300	Taxiway C	Taxiway	1	70,075	68

Taxiway C was constructed in 1981 and resurfaced in 2006. Observed distresses are low to medium severity severity longitudinal and transverse cracking, low to medium severity weathering, and low severity raveling.

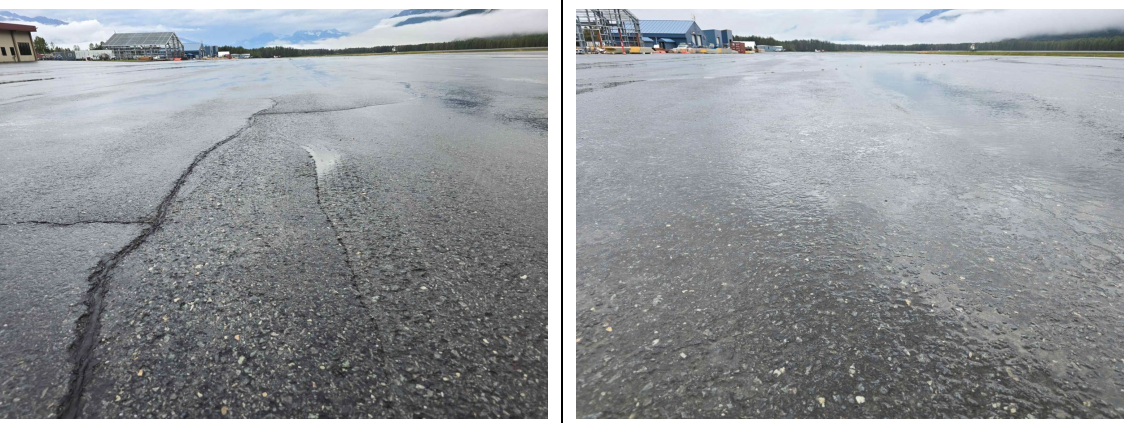
Branch ID	Branch Name	Branch Use	No. of Sections	Area (sf)	Weight Average PCI
4100	Terminal Apron	Parking Apron	1	96,600	69

The Terminal Apron was originally constructed in 1981 and was resurfaced in 2006. Commonly observed distresses are low to medium severity longitudinal and transverse cracking, low to medium severity weathering and low severity raveling. There are isolated areas of medium severity raveling.

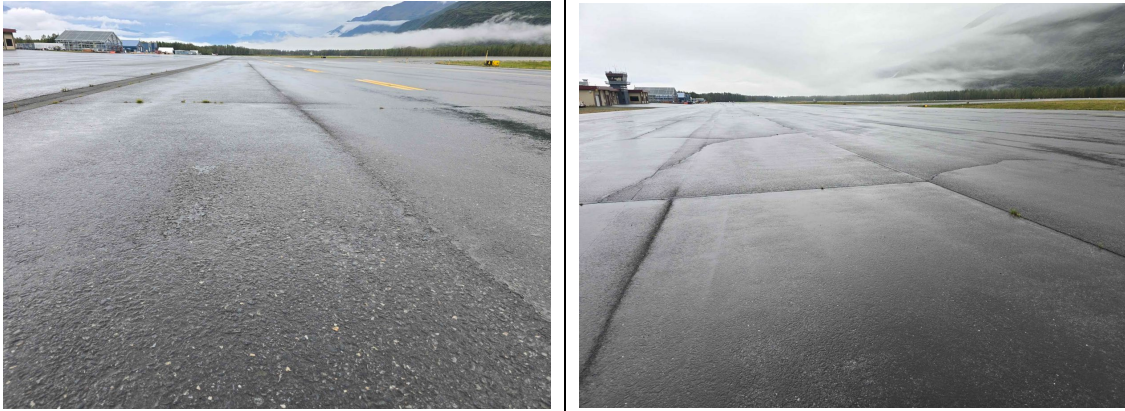
Branch ID	Branch Name	Branch Use	No. of Sections	Area (sf)	Weight Average PCI
4200	East Apron	Parking Apron	1	168,160	66

The East Apron was constructed in 1974 and resurfaced in 2006. Observed distresses are low to medium severity longitudinal and transverse cracking, low severity weathering and low severity raveling. There are scattered areas of medium severity weathering and medium severity raveling across the apron.

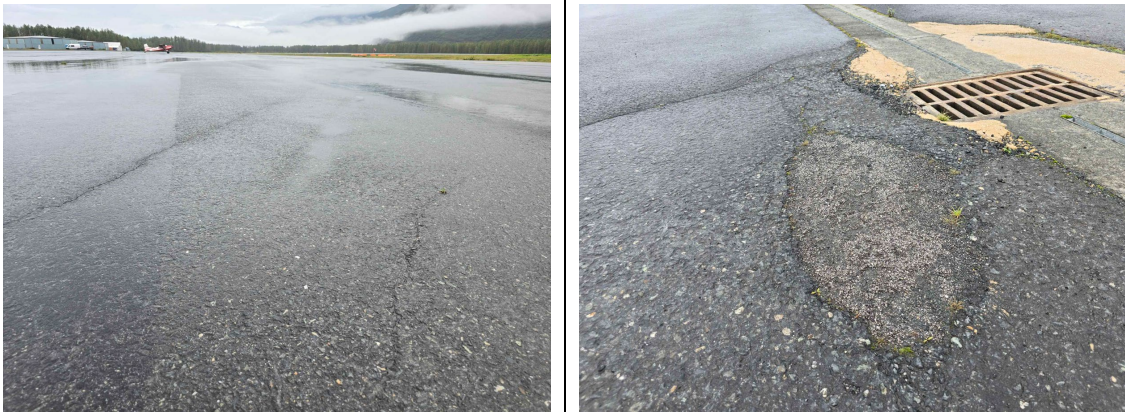
Branch ID	Branch Name	Branch Use	No. of Sections	Area (sf)	Weight Average PCI
4300	West Apron	Parking Apron	2	475,950	75
4300-01 – PCI 60

The West Apron consists of two sections. The first section, 4300-01, was constructed in 1981 and resurfaced in 2006. Observed distresses are low to medium severity longitudinal and transverse cracking, low to medium severity weathering and low severity raveling. There are scattered areas of medium severity raveling, with an area of high severity raveling and patching around the drain pictured above.

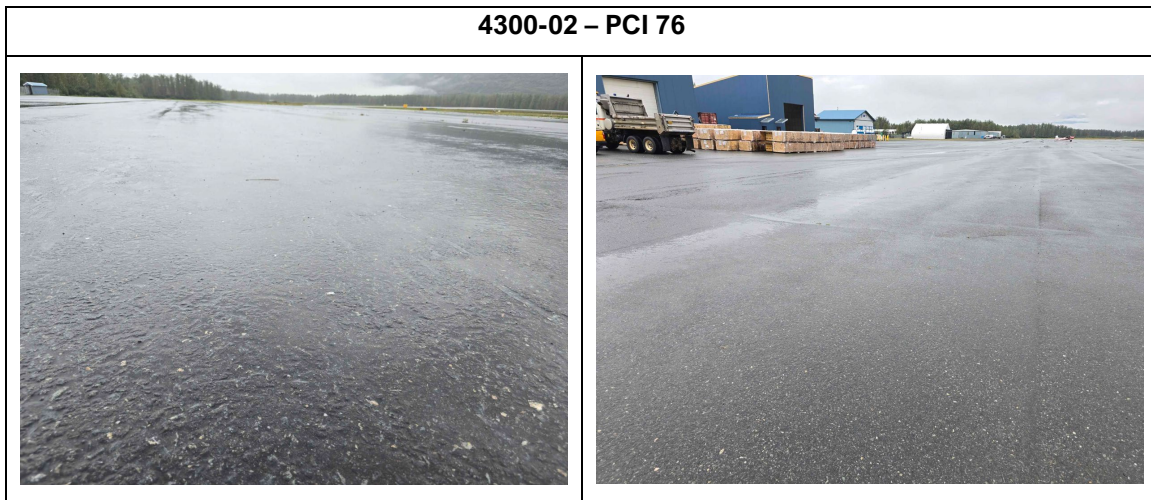
The second section of the West Apron is 4300-02, which was constructed in 1976 and resurfaced in 2006. Observed distresses are low severity longitudinal and transverse cracking, low to medium severity weathering and low severity raveling. There are scattered areas of medium severity raveling from snowplow damage.

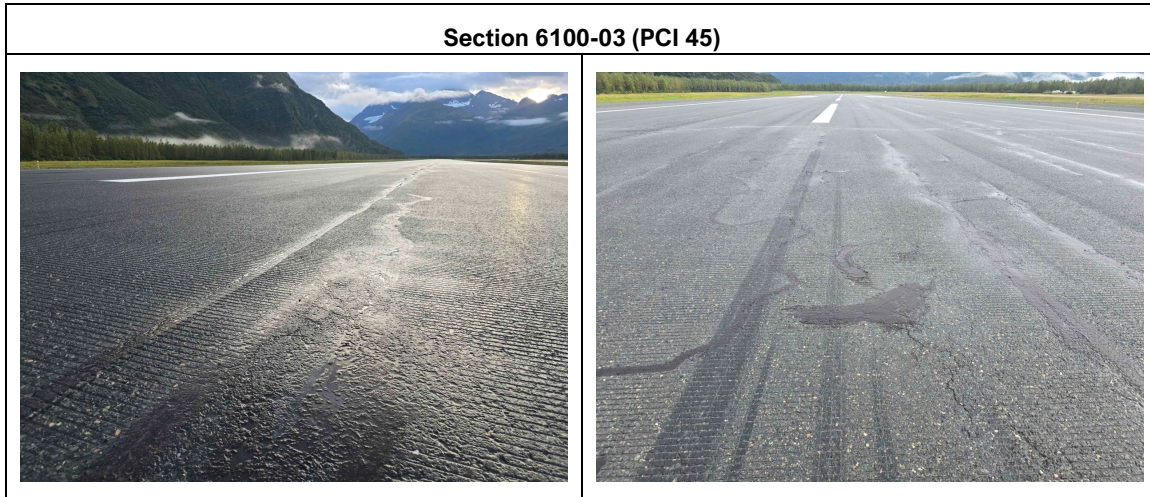
Runway 06-24 was constructed in 1981 and resurfaced in 2006. It is split into three sections, with 6100-03 the 50' on centerline. This section has the most severe distresses of the three sections. The primary distresses in section 6100-03 are low to medium severity weathering, low, medium and high severity longitudinal and transverse cracking, low, medium and high severity raveling. There are also areas of areas of alligator cracking observed along this section of the runway, although most have been covered with crack seal.

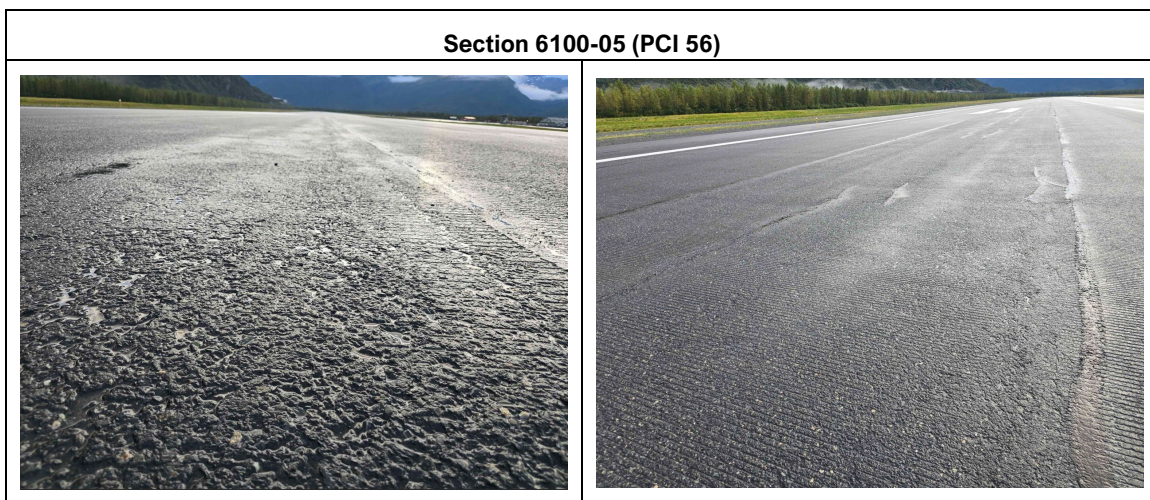
Runway 06-24 was constructed in 1981 and resurfaced in 2006. It is split into three sections, with 6100-05 the right 50'. The primary distresses 6100-05 are low to medium severity weathering, low to medium severity longitudinal and transverse cracking, and low, medium and high severity raveling.
