Alaska DOT&PF

Pavement Inspection Report Wasilla Airport

Airport Name	IATA	ICAO	Latitude	Longitude	Elevation (ft)
Wasilla Airport	IYS	PAWS	61° 34' 19.15" N	149° 32' 22.4" W	353.5

Point of Contact	Phone	Email	Date Inspected	Date Published
Mr. Andrew Pavey, Pavement Management Engineer	(907) 269 6213	andrew.pavey@alaska.gov	July 2024	February 2025

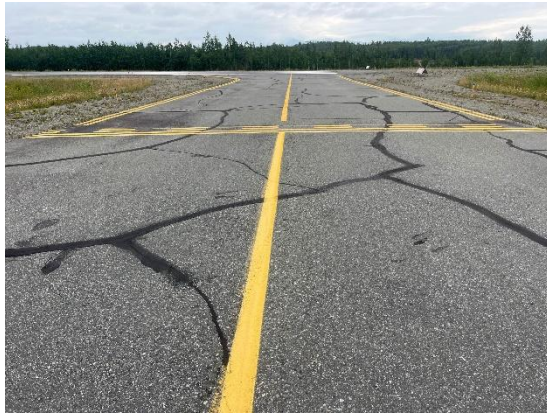
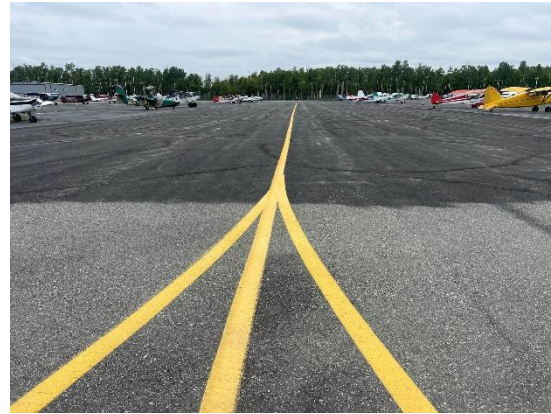
Branch ID	Branch Name	Branch Use	No. of Sections	Area (sf)	Weighted Average PCI
0100	Taxilane A	Taxiway	2	41,010	70

Taxilane A was initially constructed in 2000 and has not received major work since. A surface treatment was applied in 2022 to the majority of section 0100-02 but was not applied to section 0100-01. Occasional crack sealing operations have been performed on the branch. The most common distresses observed include low severity block cracking, low to high severity longitudinal and transverse cracking, low to medium severity raveling, and low to medium severity weathering. Field observations note the continued deterioration of cracks, causing the sealant to detach and allowing vegetation growth. This leads to higher severity distresses, increased water infiltration, and an accelerated rate of deterioration.

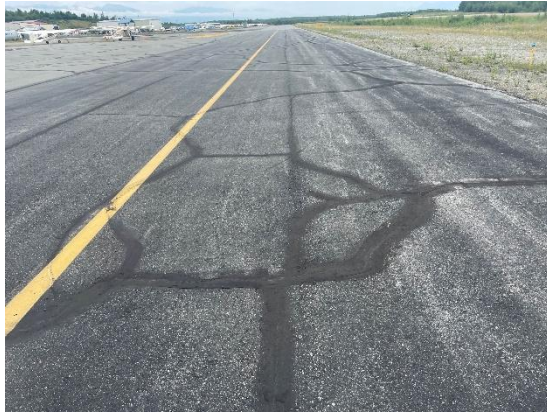
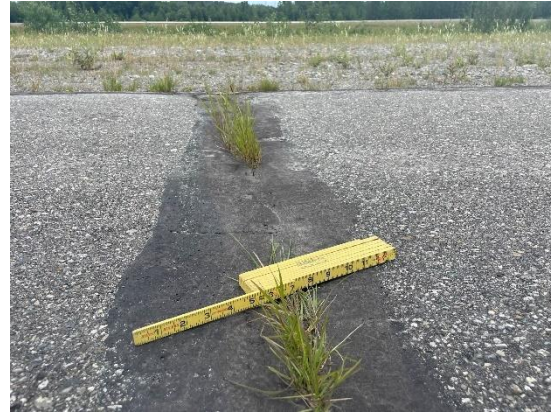
Section 0200-01 (61 PCI), 0200-02 (67 PCI)

Taxiway B sections 0200-01 and 0200-02 were initially constructed in 2000 and have not received any major work since. A surface treatment was applied in 2022 to a majority of section 0200-01 and a portion of section 0200-02. Occasional crack sealing operations have been performed on the branch. The most common distresses observed include low to medium severity longitudinal and transverse cracking, low severity raveling, and low severity weathering. Field observations note the continued deterioration of cracks, causing the sealant to detach and allowing vegetation growth. This leads to higher severity distresses, increased water infiltration, and an accelerated rate of deterioration.

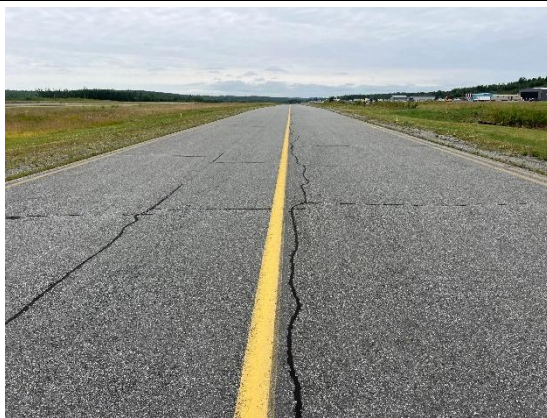
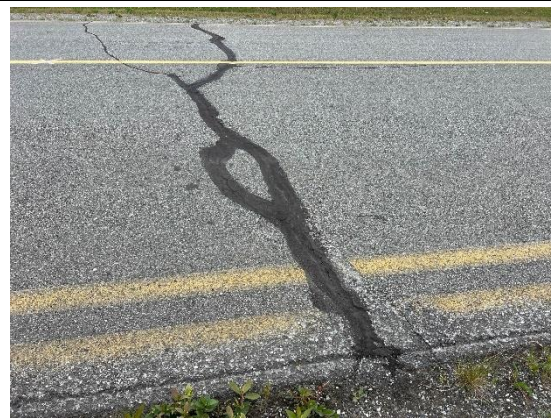
Section 0200-03 (77 PCI)

Taxiway B section 0200-03 was initially constructed in 2006 and has not received any major work since. Occasional crack seal operations have been performed on the branch. The most common distresses observed include low to medium severity longitudinal and transverse cracking, low severity raveling, and low severity weathering. Field observations note the continued deterioration of cracks, causing the sealant to detach and allowing vegetation growth. This leads to higher severity distresses, increased water infiltration, and an accelerated rate of deterioration.

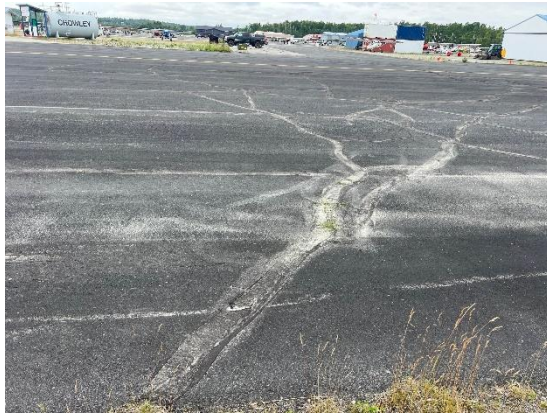
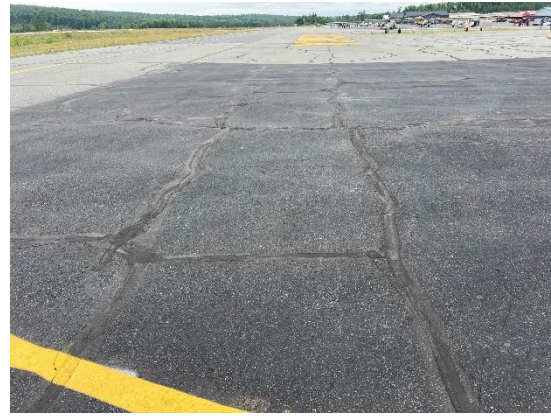
Branch ID	Branch Name	Branch Use	No. of Sections	Area (sf)	Weighted Average PCI
0300	Taxilane C	Taxiway	1	88,400	69

Taxilane C was initially constructed in 2000 and has not received major work since. A surface treatment was applied in 2023 to the entire section. Occasional crack sealing operations have been performed on the branch. The most common distresses observed include low severity block cracking, low to medium severity longitudinal and transverse cracking, and low severity raveling. Field observations note the continued deterioration of cracks, causing the sealant to detach and allowing vegetation growth. This leads to higher severity distresses, increased water infiltration, and an accelerated rate of deterioration.

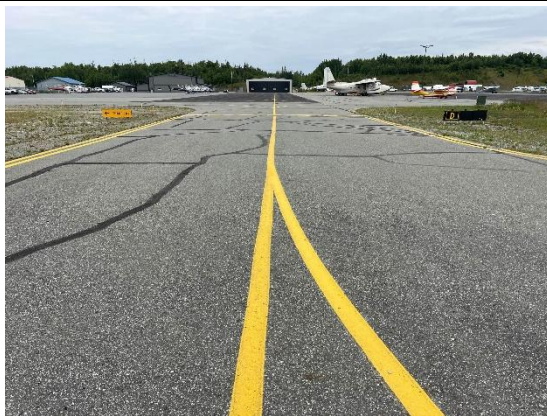
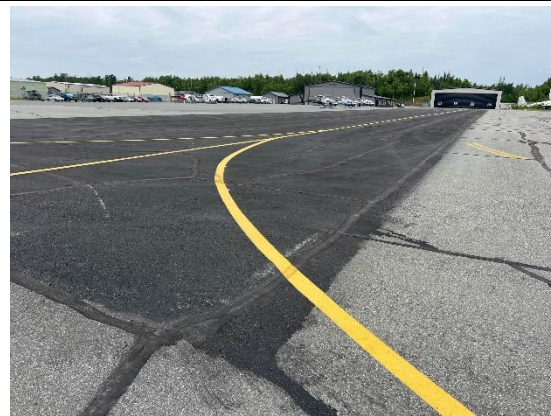
Branch ID	Branch Name	Branch Use	No. of Sections	Area (sf)	Weighted Average PCI
0400	Taxiway D	Taxiway	1	61,452	69

Taxiway D was initially constructed in 2000 and has not received major work since. A surface treatment was applied in 2023 to the majority of the section. Occasional crack sealing operations have been performed on the branch. The most common distresses observed include low severity block cracking, low severity depression, low to medium severity longitudinal and transverse cracking, low severity raveling, and low severity weathering. Field observations note the continued deterioration of cracks, causing the sealant to detach and allowing vegetation growth. This leads to higher severity distresses, increased water infiltration, and an accelerated rate of deterioration.

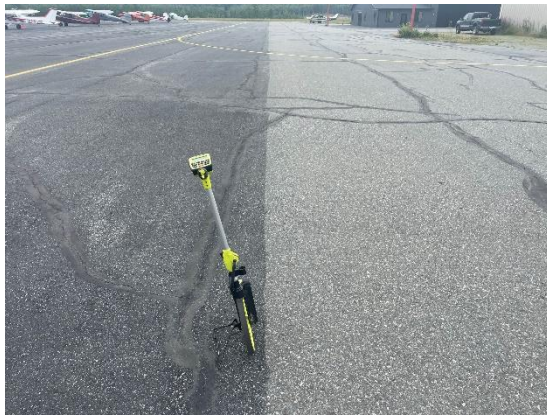
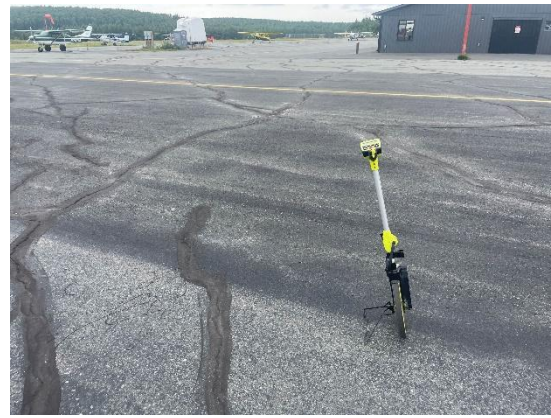
Branch ID	Branch Name	Branch Use	No. of Sections	Area (sf)	Weighted Average PCI
0600	Taxilane F	Taxiway	1	70,000	54

Taxilane F was initially constructed in 2000 and has not received major work since. A surface treatment was applied in 2022 to approximately half of the section. Occasional crack sealing operations have been performed on the branch. The most common distresses observed include low to medium severity block cracking, low to medium severity longitudinal and transverse cracking, oil spillage, low severity raveling, and low severity weathering. Field observations note the continued deterioration of cracks, causing the sealant to detach and allowing vegetation growth. This leads to higher severity distresses, increased water infiltration, and an accelerated rate of deterioration.

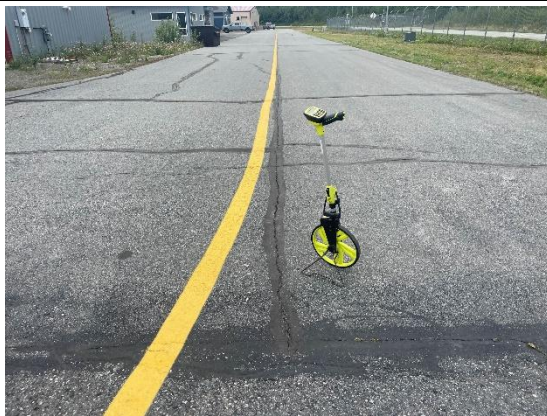
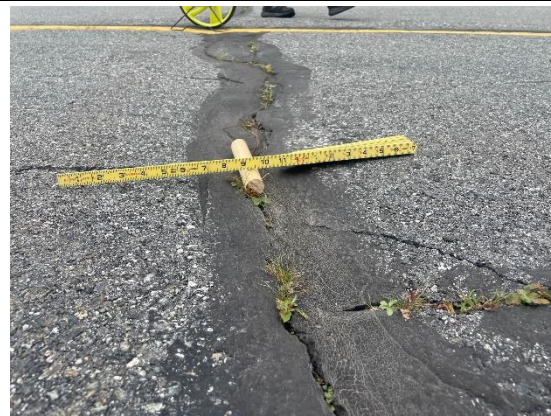
Branch ID	Branch Name	Branch Use	No. of Sections	Area (sf)	Weighted Average PCI
0810	Hanger Access Lane 1	Taxiway	1	20,518	58

Hanger Access Lane 1 was initially constructed in 2004 and has not received major work since. Occasional crack sealing operations have been performed on the branch. The most common distresses observed include low to high severity longitudinal and transverse cracking, low severity patching, low severity raveling, and low severity weathering. Field observations note the continued deterioration of cracks, causing the sealant to detach and allowing vegetation growth. This leads to higher severity distresses, increased water infiltration, and an accelerated rate of deterioration. A few of the transverse cracks are beginning to sag, creating a ride quality issue.

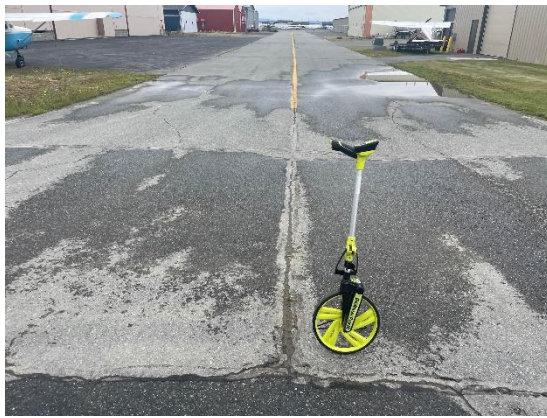
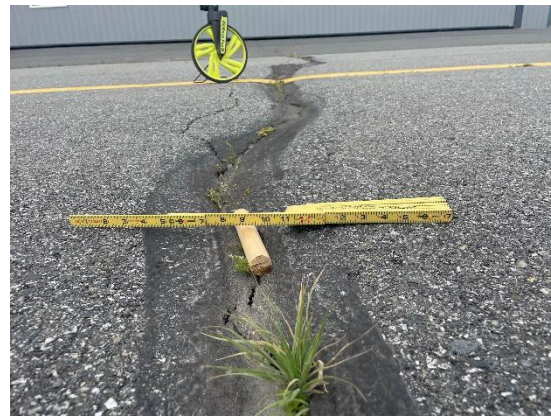
Branch ID	Branch Name	Branch Use	No. of Sections	Area (sf)	Weighted Average PCI
0820	Hanger Access Lane 2	Taxiway	1	24,297	63

Hanger Access Lane 2 was initially constructed in 2004 and has not received major work since. Occasional crack sealing operations have been performed on the branch. The most common distresses observed include low severity depression, low to high severity longitudinal and transverse cracking, low severity patching, and low severity weathering. Field observations note the continued deterioration of cracks, causing the sealant to detach and allowing vegetation growth. This leads to higher severity distresses, increased water infiltration, and an accelerated rate of deterioration. A few of the transverse cracks are beginning to sag, creating a ride quality issue.

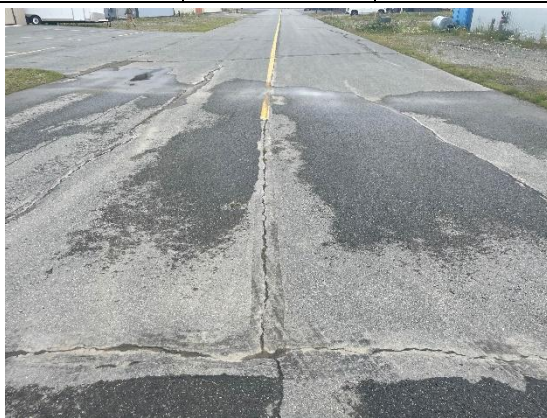
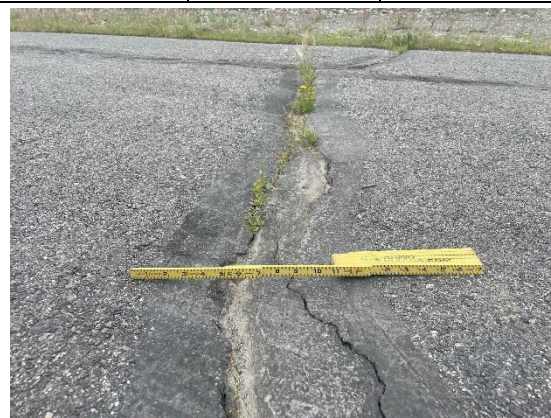
Branch ID	Branch Name	Branch Use	No. of Sections	Area (sf)	Weighted Average PCI
0830	Hanger Access Lane 3	Taxiway	1	23,896	64

Hanger Access Lane 3 was initially constructed in 2004 and has not received major work since. Occasional crack sealing operations have been performed on the branch. The most common distresses observed include low to high severity longitudinal and transverse cracking, low severity patching, low severity raveling, and low severity weathering. Field observations note the continued deterioration of cracks, causing the sealant to detach and allowing vegetation growth. This leads to higher severity distresses, increased water infiltration, and an accelerated rate of deterioration. A few of the transverse cracks are beginning to sag, creating a ride quality issue.

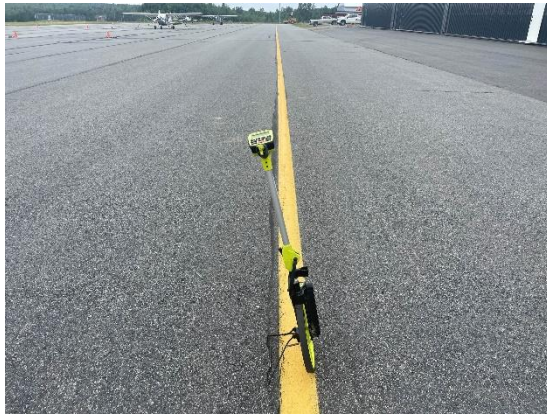
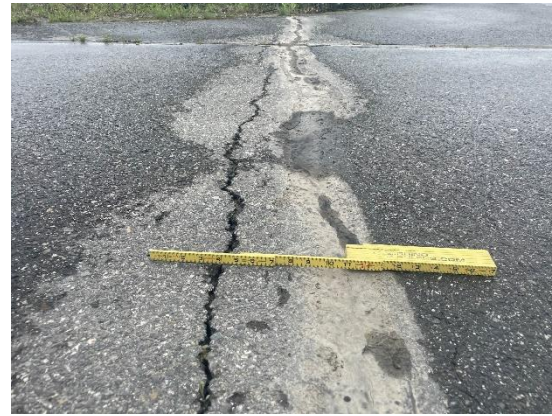
Branch ID	Branch Name	Branch Use	No. of Sections	Area (sf)	Weighted Average PCI
0840	Hanger Access Lane 4	Taxiway	1	23,203	75

Hanger Access Lane 4 was initially constructed in 2004 and has not received major work since. Occasional crack sealing operations have been performed on the branch. The most common distresses observed include low to medium severity longitudinal and transverse cracking, low severity raveling, and low severity weathering. Field observations note the continued deterioration of cracks, causing the sealant to detach and allowing vegetation growth. This leads to higher severity distresses, increased water infiltration, and an accelerated rate of deterioration.

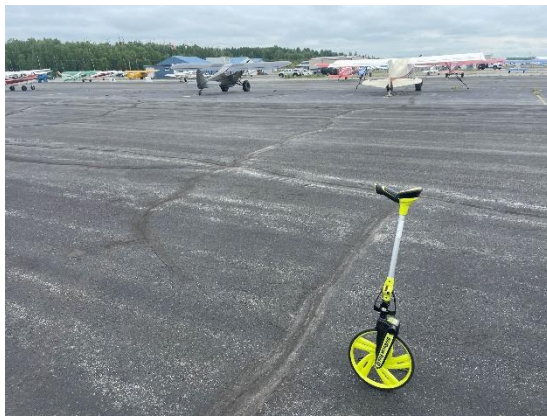
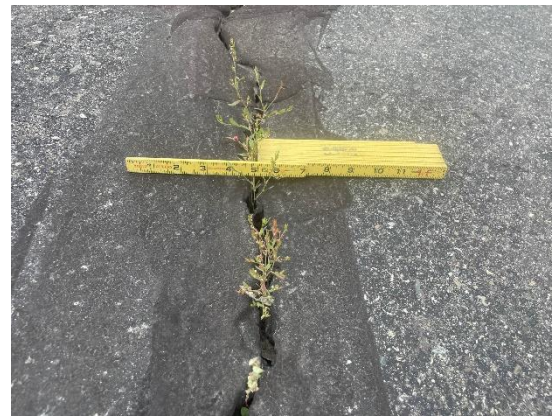
Branch ID	Branch Name	Branch Use	No. of Sections	Area (sf)	Weighted Average PCI
4100	Aircraft Parking Apron	Apron	2	338,100	70

The Aircraft Parking Apron was initially constructed in 2000 and has not received major work since. A surface treatment was applied in 2022 to approximately half of both sections of the apron. Occasional crack sealing operations have been performed on the branch. The most common distresses observed include low severity depression, low to medium severity longitudinal and transverse cracking, oil spillage, low to medium severity raveling, and low severity weathering. Field observations note the continued deterioration of cracks, causing the sealant to detach and allowing vegetation growth. This leads to higher severity distresses, increased water infiltration, and an accelerated rate of deterioration.

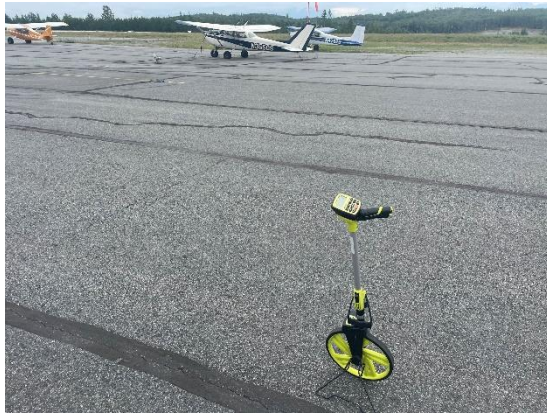
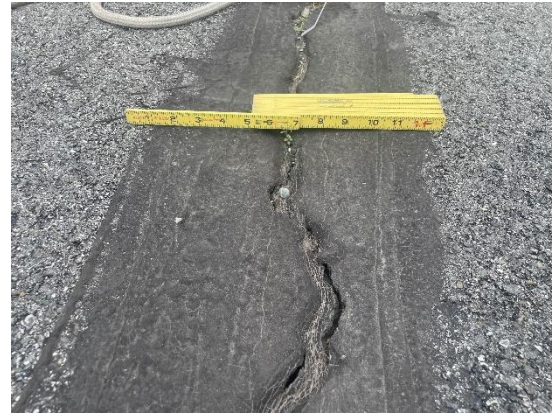
Branch ID	Branch Name	Branch Use	No. of Sections	Area (sf)	Weighted Average PCI
4200	Hanger Apron	Apron	1	74,400	57

The Hanger Apron was initially constructed in 2004 and has not received major work since. Occasional crack sealing operations have been performed on the branch. The most common distresses observed include low to medium severity longitudinal and transverse cracking, oil spillage, low severity patching, low severity raveling, and low severity weathering. Field observations note the continued deterioration of cracks, causing the sealant to detach and allowing vegetation growth. This leads to higher severity distresses, increased water infiltration, and an accelerated rate of deterioration.

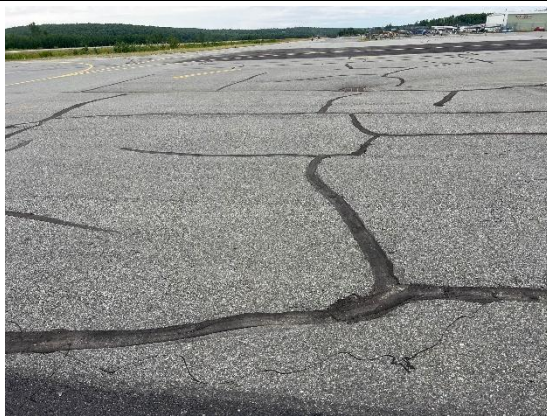
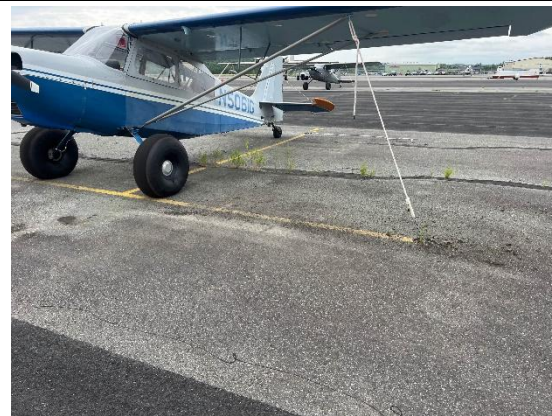
Section 4300-01 (73 PCI), 4300-02 (70 PCI)

The GA Apron section 4300-01 and 4300-02 were initially constructed in 2006 and have not received major work since. A surface treatment was applied in 2023 to approximately half of section 4300-01 and was not applied to section 4300-02. Occasional crack sealing operations have been performed on the branch. The most common distresses observed include low severity block cracking, low to medium severity longitudinal and transverse cracking, oil spillage, and low severity weathering. Field observations note the continued deterioration of cracks, causing the sealant to detach and allowing vegetation growth. This leads to higher severity distresses, increased water infiltration, and an accelerated rate of deterioration.

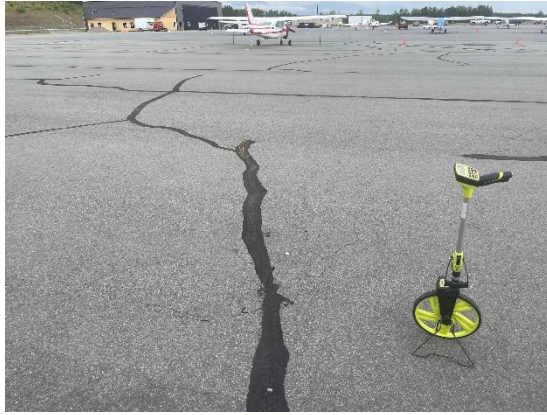
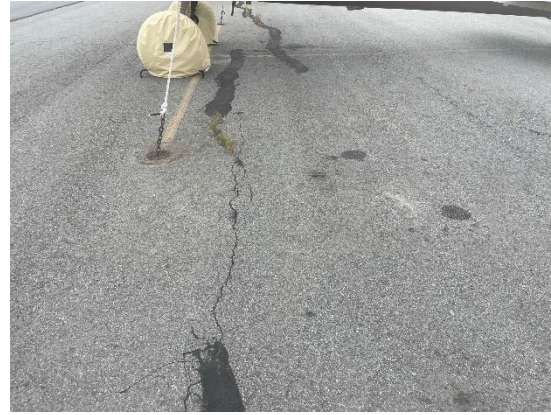
Section 4300-03 (77 PCI)

The GA Apron section 4300-03 was initially constructed in 2006 and has not received major work since. Occasional crack sealing operations have been performed on the branch. The most common distresses observed include low to medium severity longitudinal and transverse cracking, oil spillage, low severity raveling, and low severity weathering. Field observations note the continued deterioration of cracks, causing the sealant to detach and allowing vegetation growth. This leads to higher severity distresses, increased water infiltration, and an accelerated rate of deterioration.

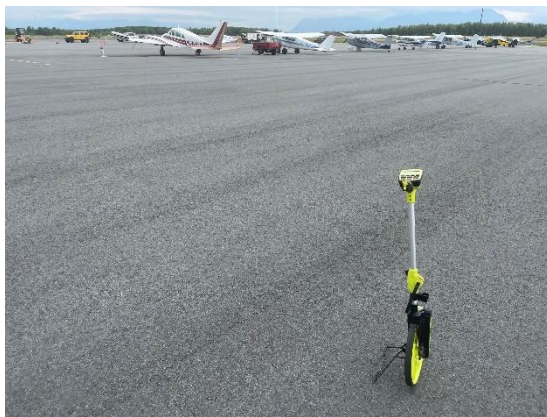
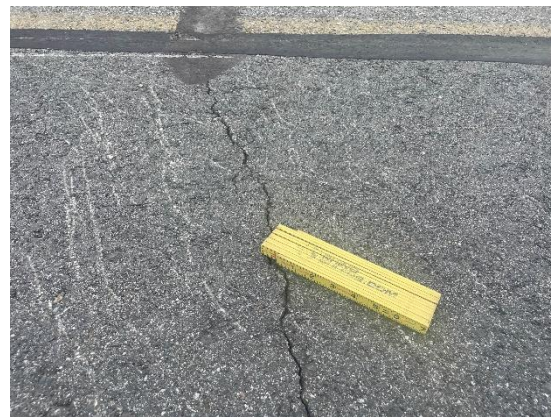
Section 4300-04 (94 PCI)

The GA Apron section 4300-04 was initially constructed in 2020 and has not received major work since. Occasional crack sealing operations have been performed on the branch. The most common distresses observed include low severity longitudinal and transverse cracking and oil spillage. Field observations note the initial development of cracking across the section and the first sightings of oil spillage.

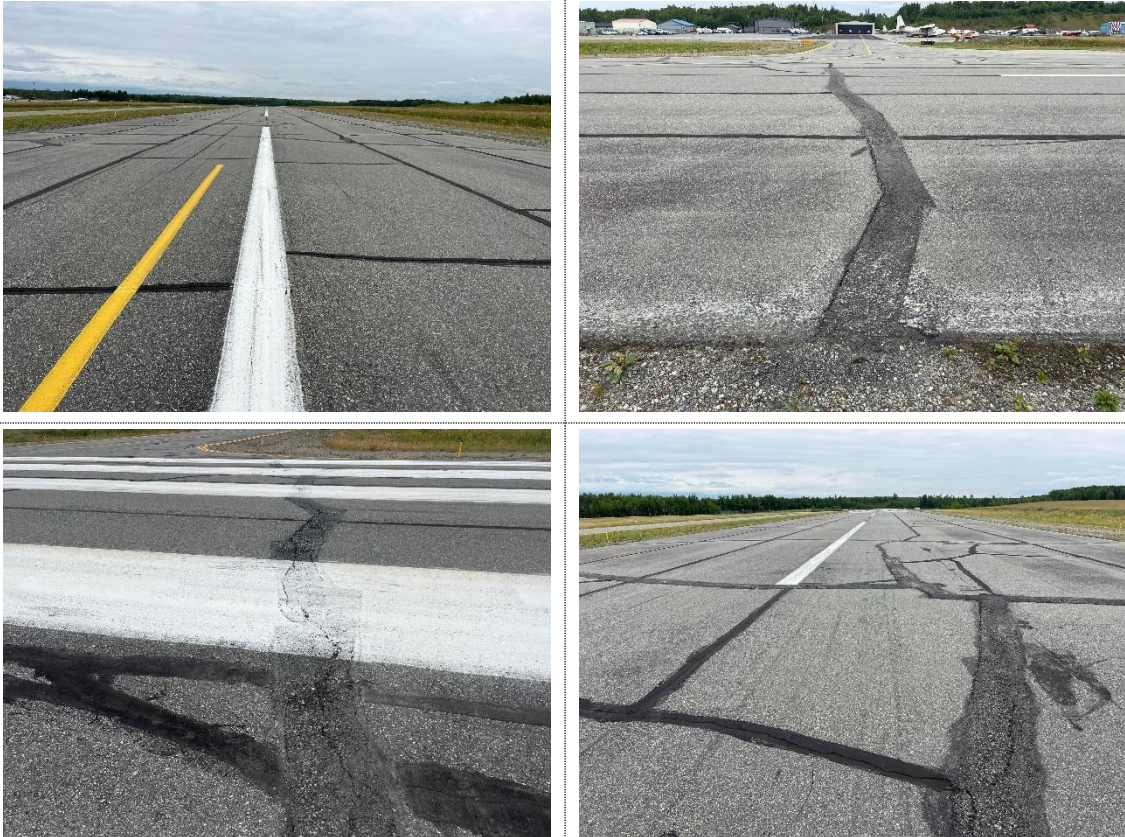
Branch ID	Branch Name	Branch Use	No. of Sections	Area (sf)	Weighted Average PCI
6100	Runway 04/22	Runway	1	277,500	63

Runway 04/22 was initially constructed in 2000 and has not received any major work since. In 2021, localized maintenance and repair was performed to address large cracks developing across the runway. The work included milling cracks to a depth of two inches and a width of 12 inches. This involved grinding down the top layer of AC around the cracks to create a clean, smooth surface for repair. By removing the deteriorated material, the milling ensures better adhesion of the new materials and prevents further deterioration. After milling, sand or grout was placed into the milled cracks, followed by the application of a tack coat to enhance the bond between the old and new AC layers. Periodic crack sealing operations have been performed on the branch. The most common distresses observed are low to medium severity longitudinal and transverse cracking, low to medium severity patching, low severity raveling, and low severity weathering. Field observations note the placement of patches across the runway, correcting high severity longitudinal and transverse cracking recorded during the 2020 inspection. These patches are stabilizing the PCI, preventing further water infiltration, and avoiding a high rate of deterioration.
