Alaska DOT&PF

Pavement Inspection Report Wrangell Airport

Airport Code: WRG
Site Number: 50905.2*A

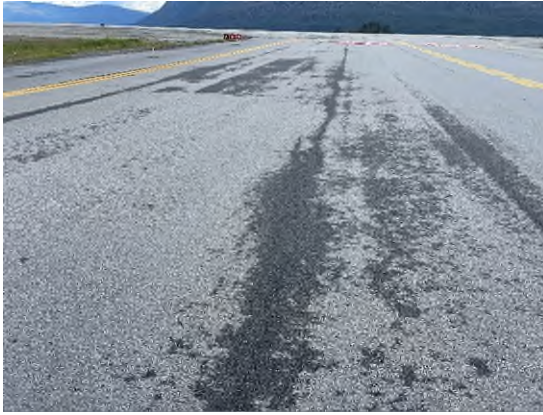
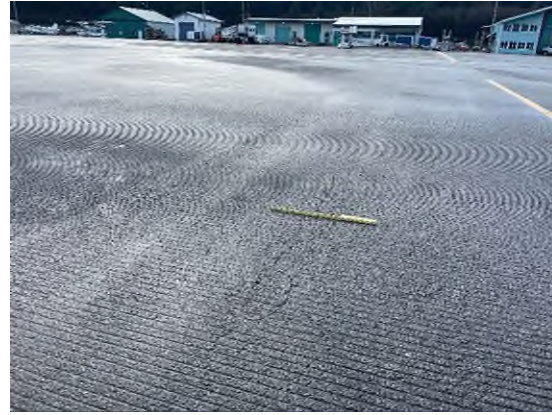
Branch ID	Branch Name	Branch Use	No. of Sections	Area (sf)	Weight Average PCI
0100	Taxiway A	Taxiway	3	59,553	65

Taxiway A was initially constructed in 1981 and received a 2-inch overlay in 2015. The most common distresses observed are low severity alligator cracking, low to medium severity longitudinal and transverse cracking, low to medium severity raveling, and low severity weathering. Degradation of the paving joints is causing longitudinal cracking and raveling. In addition, we observed the development of alligator cracking in the wheel paths of the taxiway. Historical PCI results show that alligator cracking was recorded prior to the placement of the overlay in 2015, which means that structural weakness exists at the stabilized base layer and it is reflecting through the overlay.

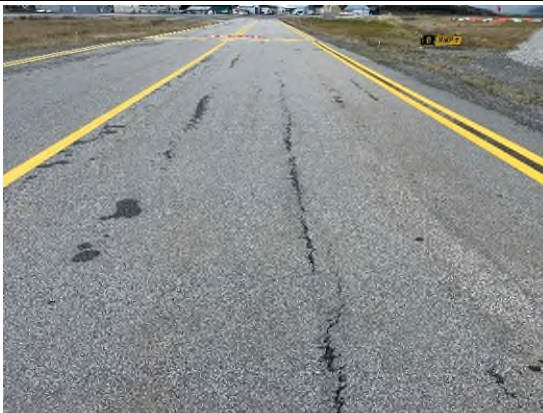
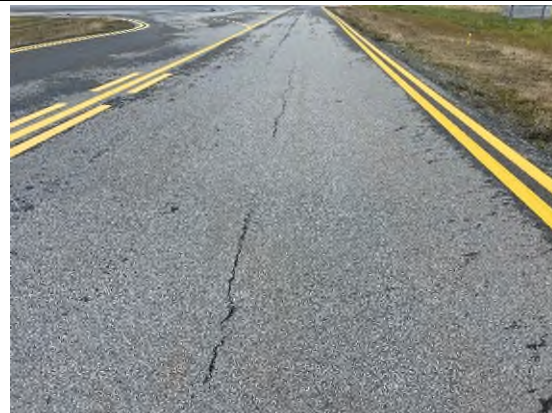
Branch ID	Branch Name	Branch Use	No. of Sections	Area (sf)	Weight Average PCI
0200	Taxiway B	Taxiway	2	42,771	86

Taxiway B was initially constructed in 1997 and its most recent major work was a 2-inch asphalt concrete overlay in 2015. The most common distresses observed are low severity longitudinal and transverse cracking, low severity raveling, and low severity weathering. Field observations include the degradation of the paving joints which is causing longitudinal cracking and raveling.

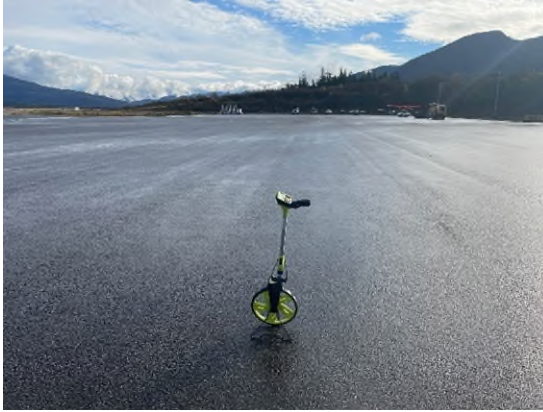
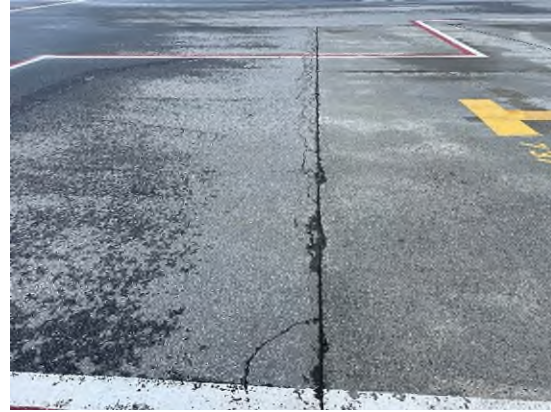
Branch ID	Branch Name	Branch Use	No. of Sections	Area (sf)	Weight Average PCI
4100	Main Apron	Apron	2	275,953	88
AC Section 4100-01 (88 PCI)

The main apron consists of two sections—one AC section and one PCC section. The AC section was initially constructed in 1997 and then received a 2-inch AC overlay in 2015. The most common distresses observed are low severity longitudinal and transverse cracking, low to medium severity raveling, and low severity weathering. While onsite it was observed that the paving joints are degraded, which is leading to the development of longitudinal cracking and raveling. Field personnel noted the initiation of cracking along the AC-PCC transitions.

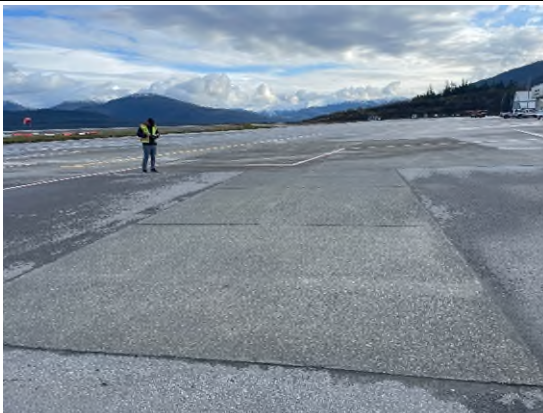
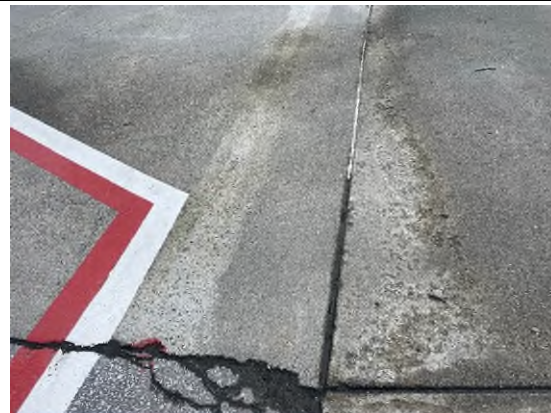
PCC Section 4100-02 (79 PCI)

The PCC section consists of a single hardstand constructed in 1997. No major work has occurred since that time. The most common distresses observed are low severity joint and corner spalling, low severity scaling, and medium severity joint seal damage. Field observations indicate that the concrete has several spalls across the hardstand and the joint sealant is failing in areas.

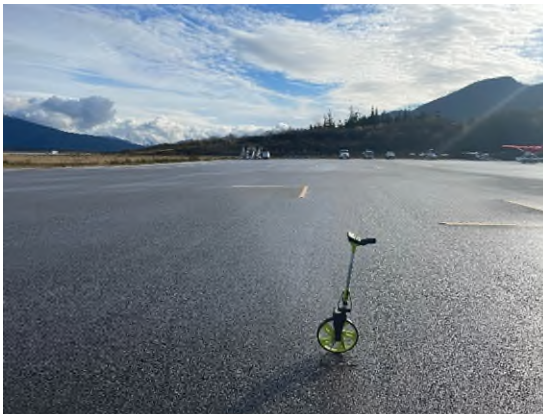
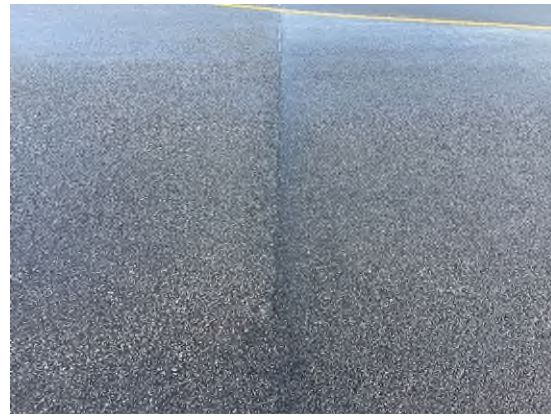
Branch ID	Branch Name	Branch Use	No. of Sections	Area (sf)	Weight Average PCI
4200	GA Parking Apron	Apron	1	93,000	93

The general aviation parking apron was constructed in 1997 and received a 2-inch overlay in 2015. The most common distresses observed are low severity longitudinal and transverse cracking, low to high severity raveling, and oil spillage. Field personnel noted that the longitudinal paving lane joints are degraded, which is causing longitudinal cracking and raveling to develop.

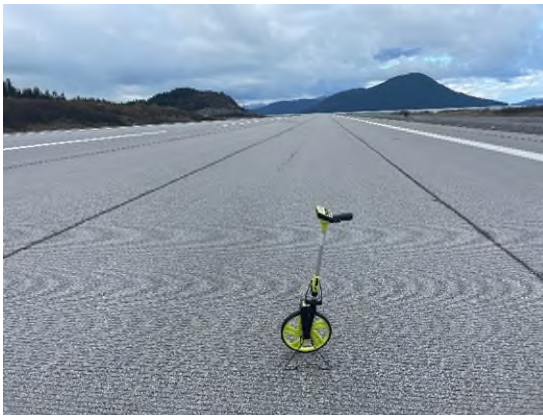
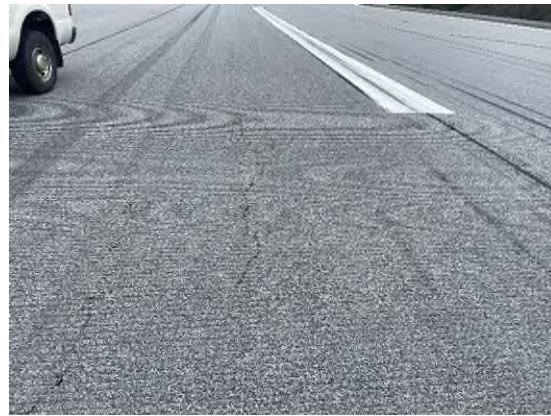
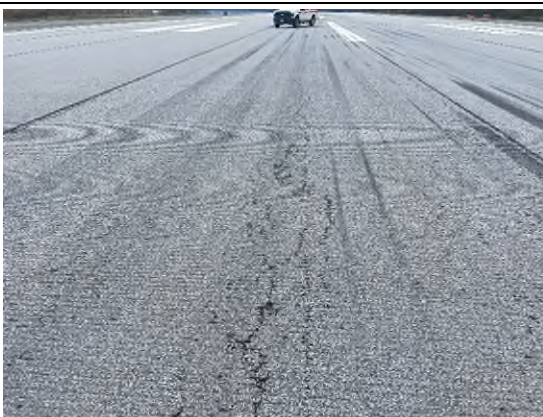
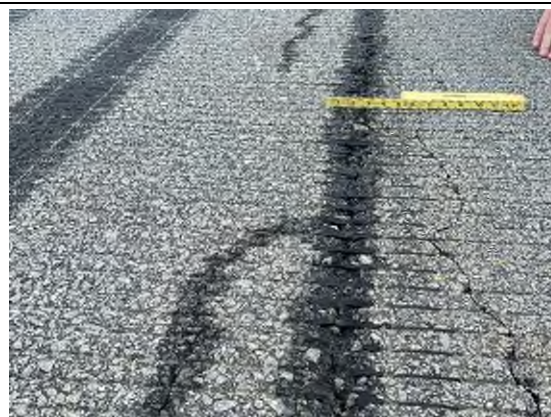
Branch ID	Branch Name	Branch Use	No. of Sections	Area (sf)	Weight Average PCI
6100	Runway 10/28	Runway	6	1,010,000	74

Runway 10/28 was constructed in 1981. The most recent major work was a 3-inch thick AC mill/overlay in 2007. The most common distresses observed are low severity alligator cracking, low to medium severity longitudinal and transverse cracking, low to medium severity raveling, and low severity weathering. Our field personnel observed that the longitudinal joints are degrading, which is causing longitudinal cracking and raveling. Also, alligator cracking is developing in the runway keel in the aircraft wheel paths. Historical PCI records report that alligator cracking existed prior to the AC mill/overlay in 2007, indicating that structural weakness exists in layers below the surface layer.
