GAMBELL AIRPORT

Alaska Airport Pavement Inspection Report

Published September 2014

2014 Pavement Inspection Results

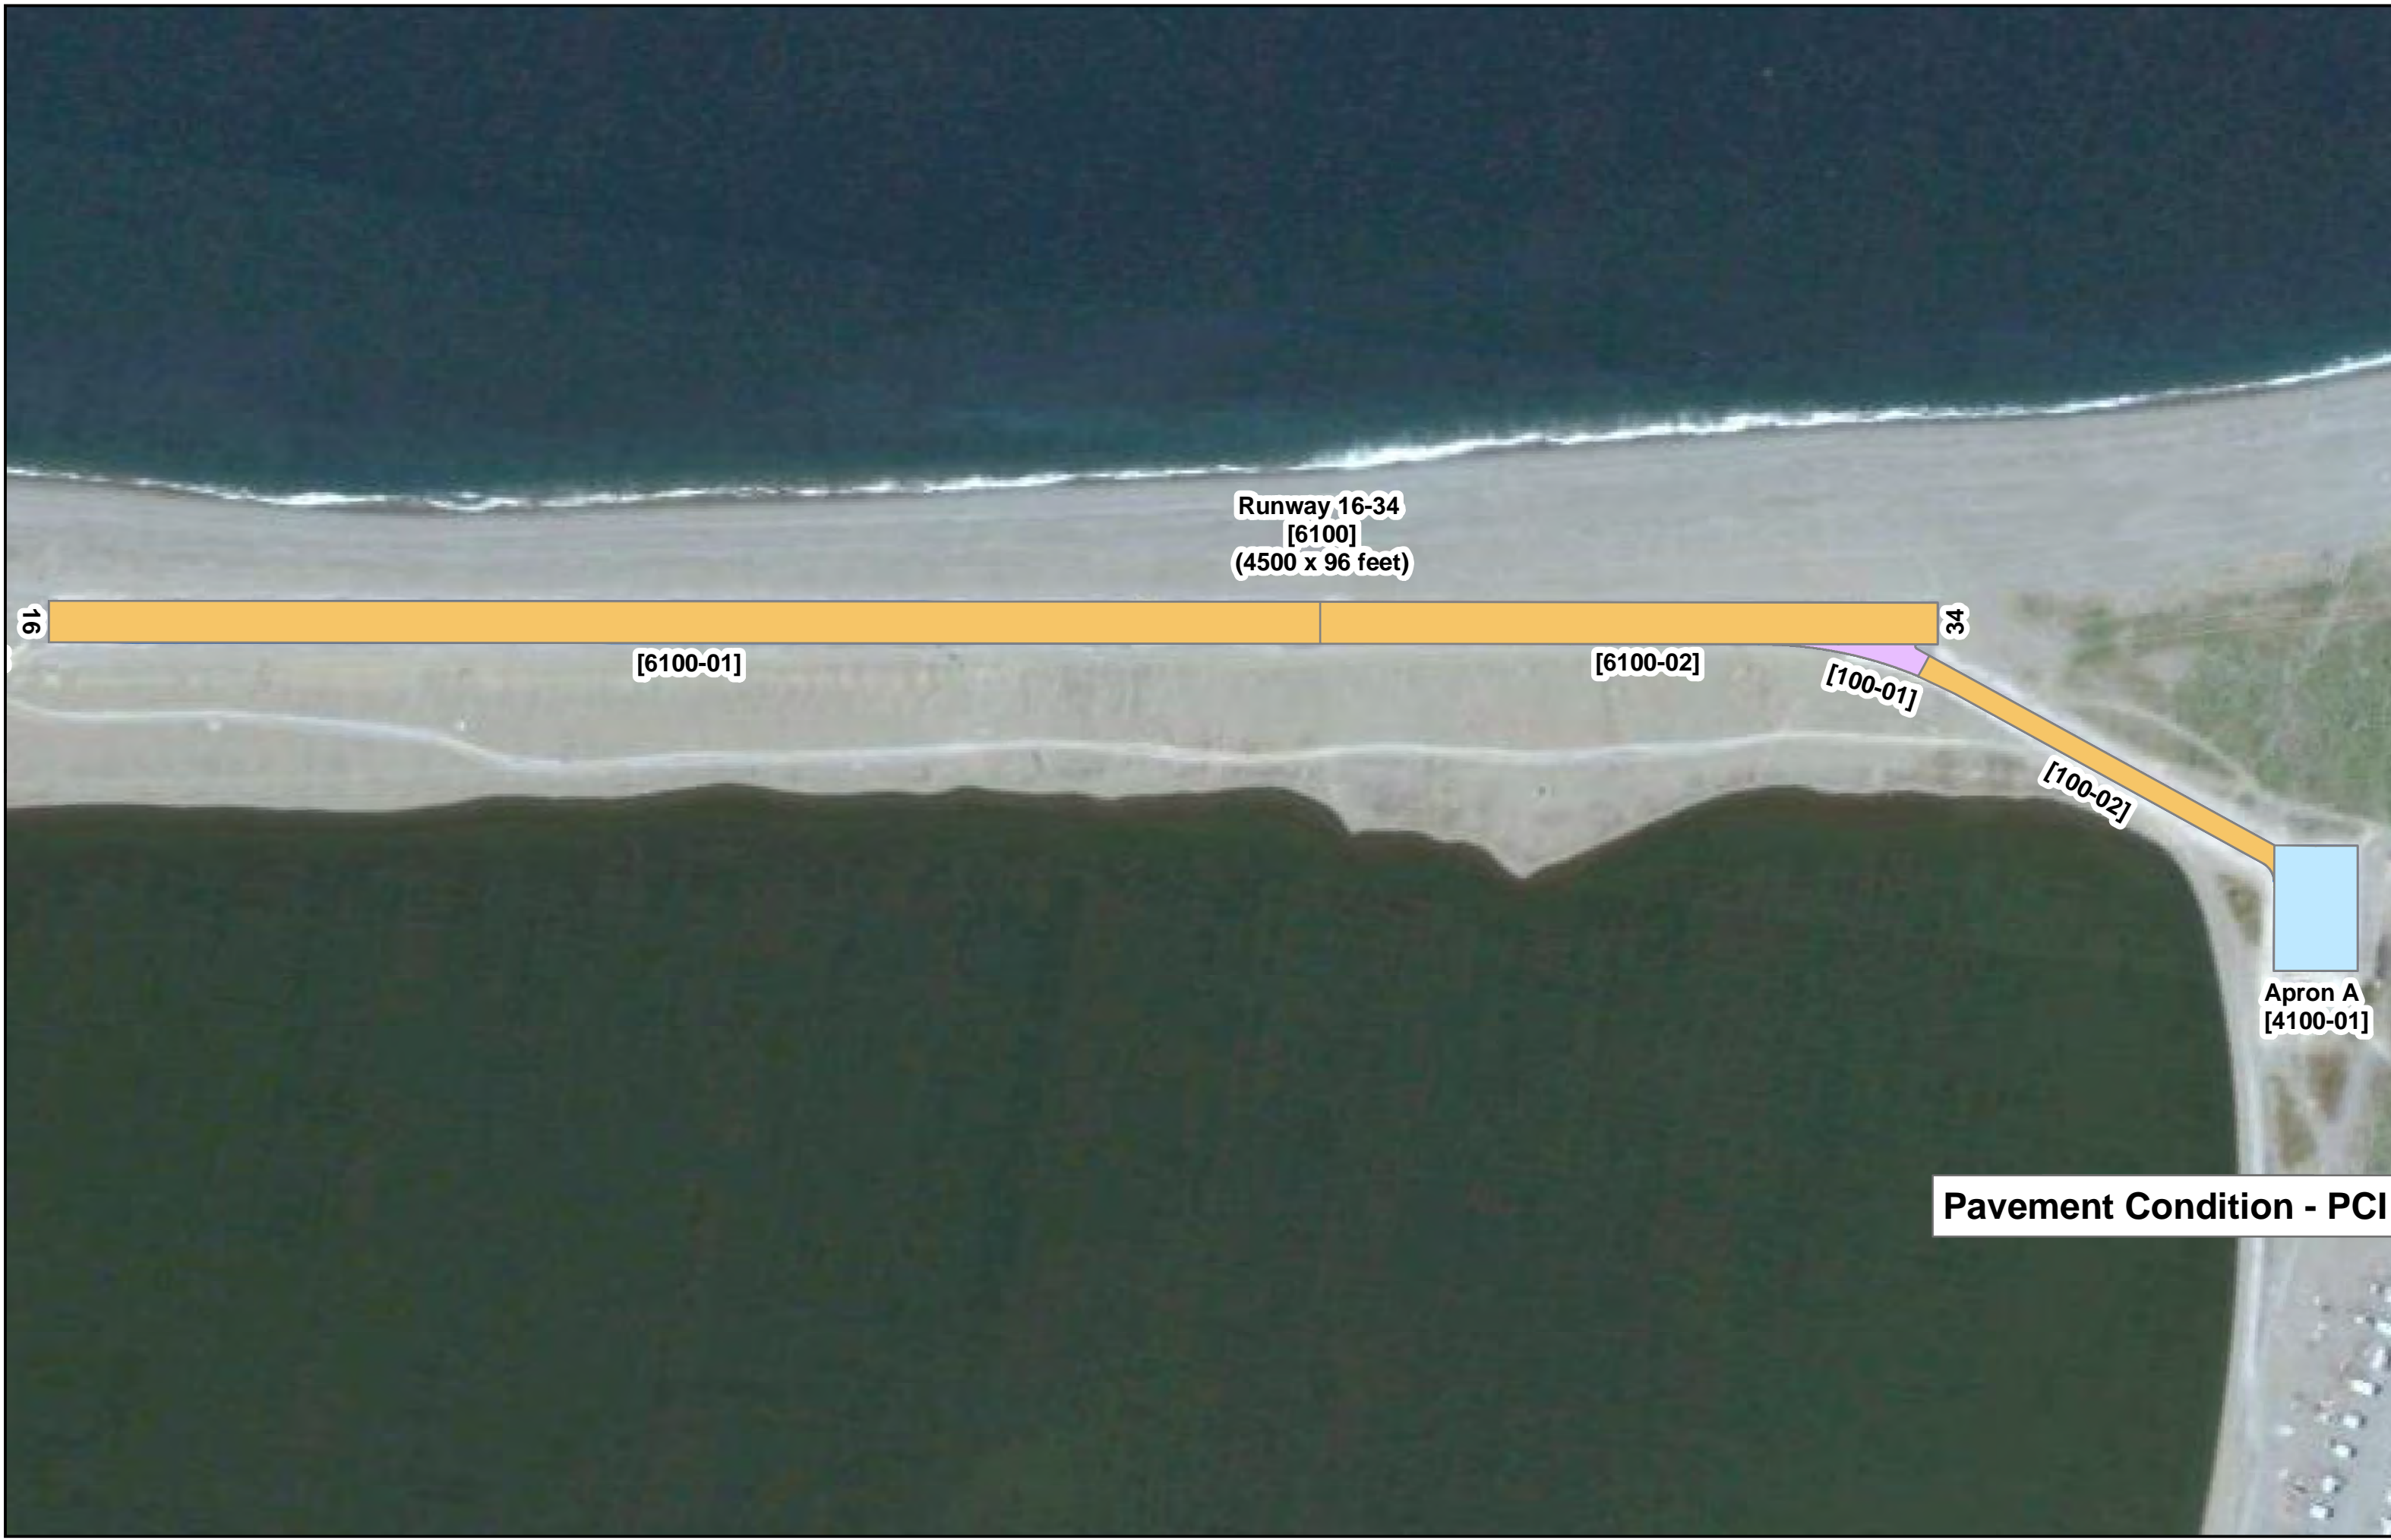
Pavement Condition - PCI
