Vegetated Riprap Survey of Highways in Southcentral and Interior Alaska

Alaska Department of Transportation and Public Facilities

**Andrew Nolen
Agronomist**

**Alaska Department of Transportation
Statewide Research Office
3132 Channel Drive
Juneau, AK 99801-7898**

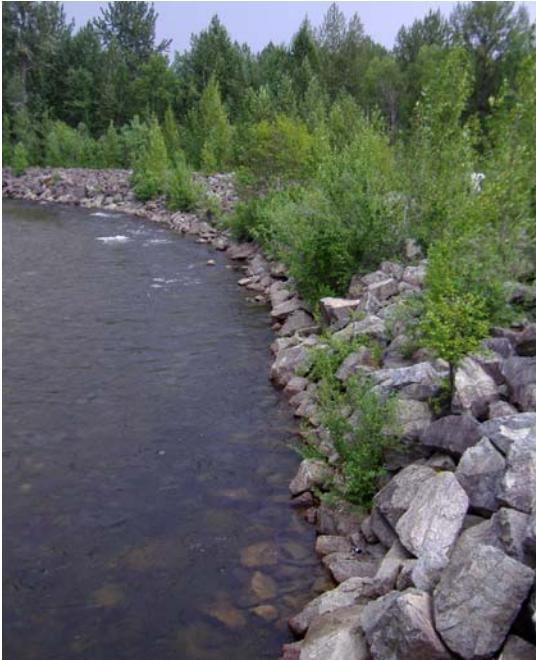
Photo 1 - Montana Creek (Parks Hwy)

Photos 1 and 2 illustrate a stream's OHW level by the lowest vegetated elevation level line along the stream bank.

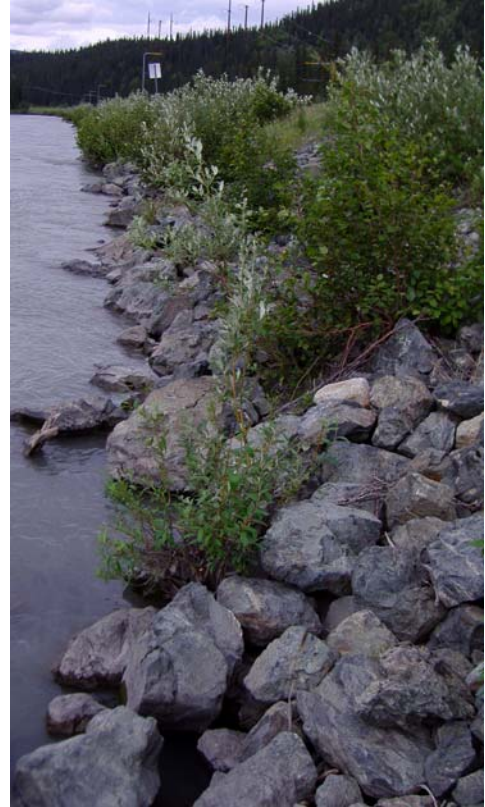
Photo 3 - Nenana River (Parks Hwy)

A bench or ledge might be implemented in an area where the bank toe warrants heavy protection. It was found that this configuration enabled sedimentation during higher flows on a grade that allowed the existing fines to retain moisture. This design may be desirable for a stream location that experiences potentially aggressive ice forces and/or periodic flows that would pose a threat to lightly armored bank toes. The toe can be armored with riprap and a step can be constructed at the approximate OHW level to prevent frequent inundation effects while allowing some overflow and sedimentation. Although this condition focuses on growth only on the surface of the ledge, overhanging vegetation can develop while the stream bank toe is protected with riprap.

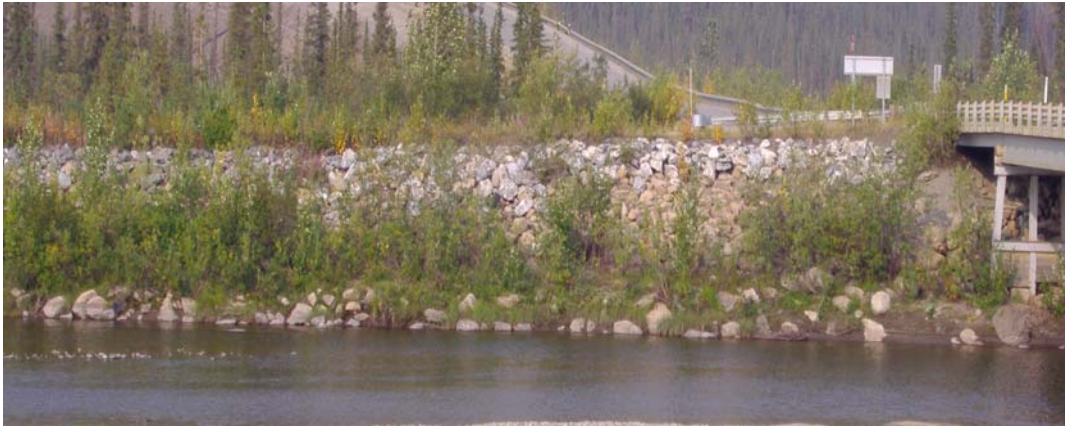
Photo 5 - South Fork Koyukuk River (Dalton Hwy)

Toe protection should be considered for this structure. **Photo 5** illustrates stabilizing toe protection while **Photo 6** illustrates evidence of bank erosion that may eventually eliminate the vegetated buffer zone.

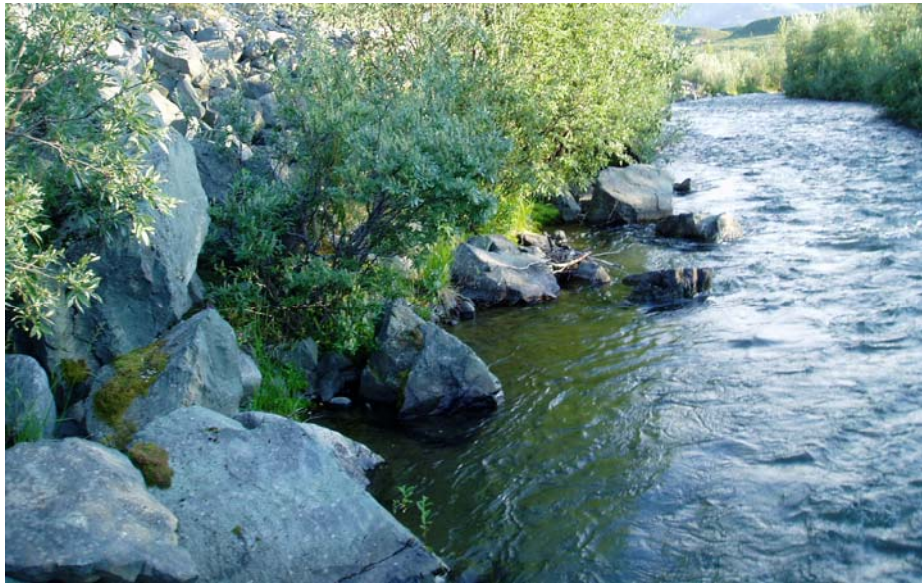
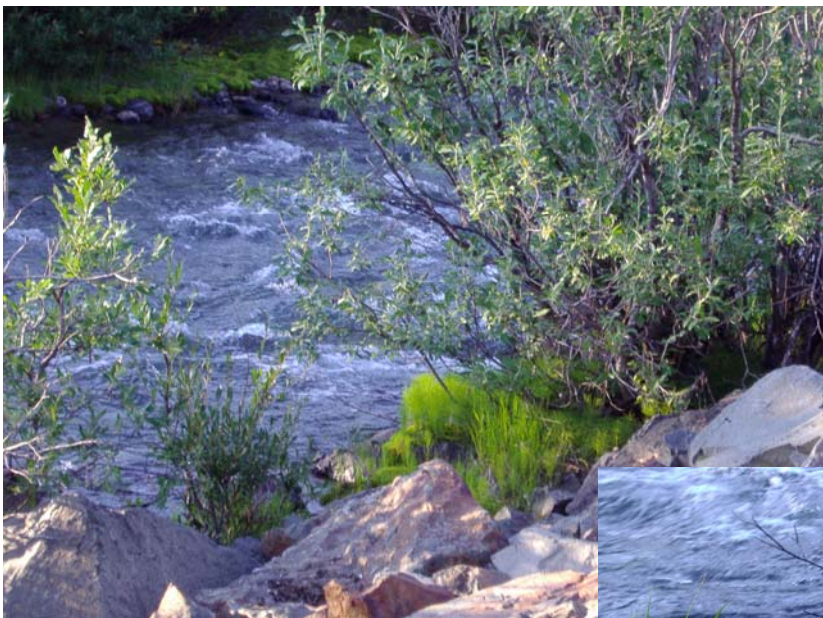
Figure 10 – In-Stream Structures;
Gulkana River (Richardson Hwy)

The in-stream structures noted during this study were naturally placed during the stream's ongoing process of equilibrating. In some cases, singular or clusters of 2 – 4 toe rocks were naturally resituated within 1 - 2 feet of the bank toe. Consequently, the backwater effect of the migrated rock(s) position(s) provided a pool area above (immediately upstream) the rock(s). In addition, the stream's thalweg was influenced away from the bank. The bank apparently self repaired with more rock at its toe and no erosion had taken place. Vegetation present in these areas was near the normal water surface level and overhanging the water surface.

As illustrated in the sites observed with this configuration (**Photos 7 and 8, Figure 10**), rock diameter of the toe protection and the migrated in-stream structures is relatively large.

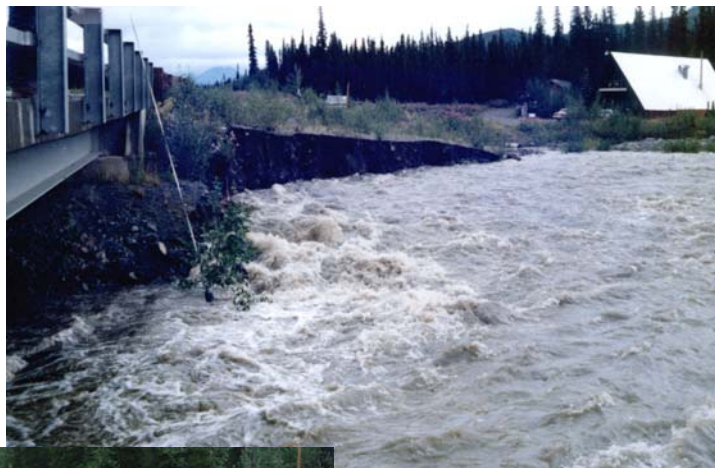
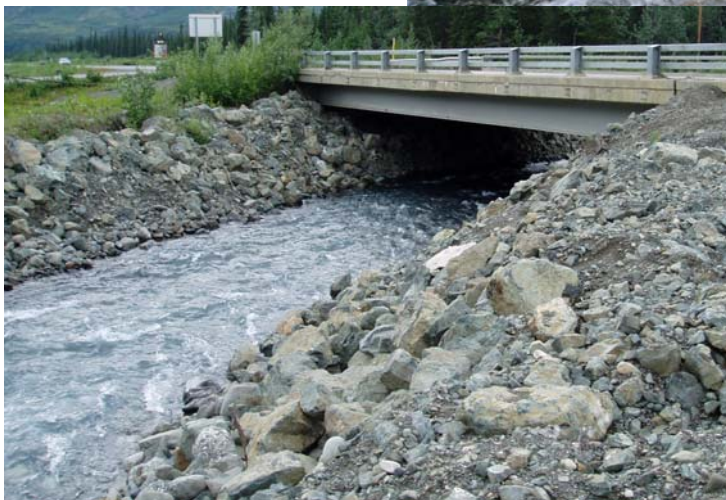
Figure 11 – Frequent Inundation;
Carlo Creek (Parks Hwy)

Historically, the site illustrated in **Figure 11** experiences periodic flooding which may demand emergency repair. The flooding and subsequent bank repair prevent vegetative stability.

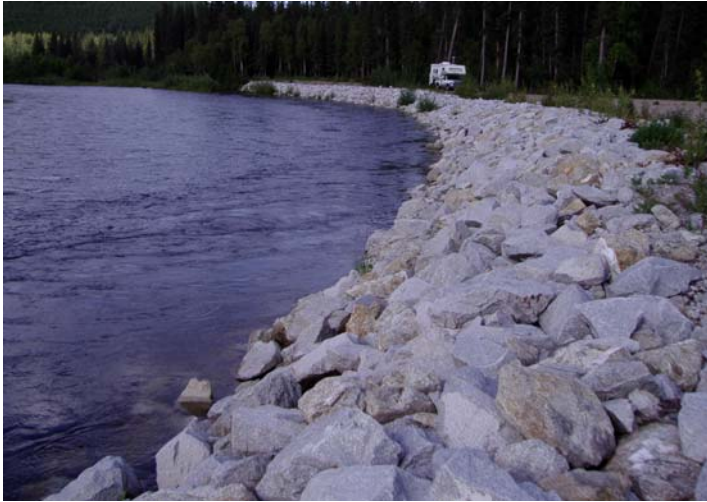
**Photo 9 - North Fork Chena River
(Chena Hot Springs Rd)**

A stream channel is characteristically deeper at its outside bends and shallower at its inside bends or points of inflection. Consequently, flow and average velocity is higher at the outside bend of a stream cross section than at the inflection point. Often, while equilibrating itself during discharge fluctuations, a stream's inside bend accretes with fine alluvial material and channel flow moves closer to the outside bend. The channel bed's thalweg shifts until it impinges on the outside bend bank with greater shear forces, higher average velocity, and the capacity to carry coarser material. The lower discharge energy on the stream's inside bend results in finer material deposition where stream sediment transport capacity is lower. As illustrated in **Photos 9 and 10**, outside bends maintain little to no vegetation

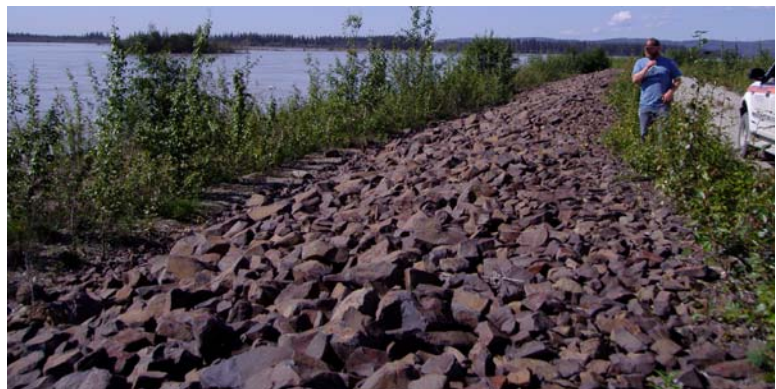
Photo 12 - Tanana River (Fairbanks Airport Dike)

If a solid mass armament is combined with a successful vegetative parameter such as a buffer bench zone **(Photo 12)**, vegetation exists at the toe and head of the riprapped bank where no riprap exists

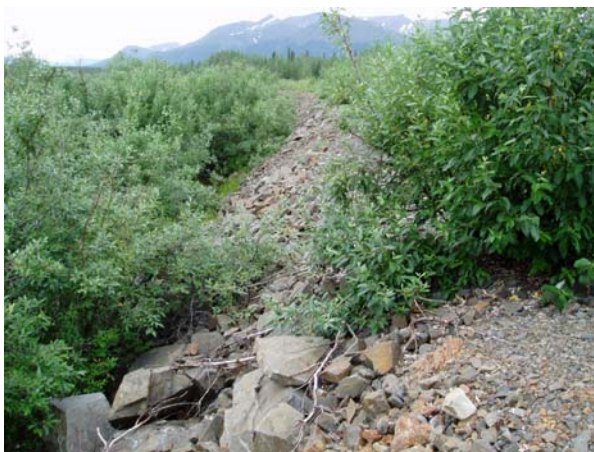
Photo 13 - Jack River (Parks Hwy)

Given time, vegetation at the base of a riprapped bank will grow enough to overhang an adjacent stream and cover the face of the bank. **(Photo 13)**

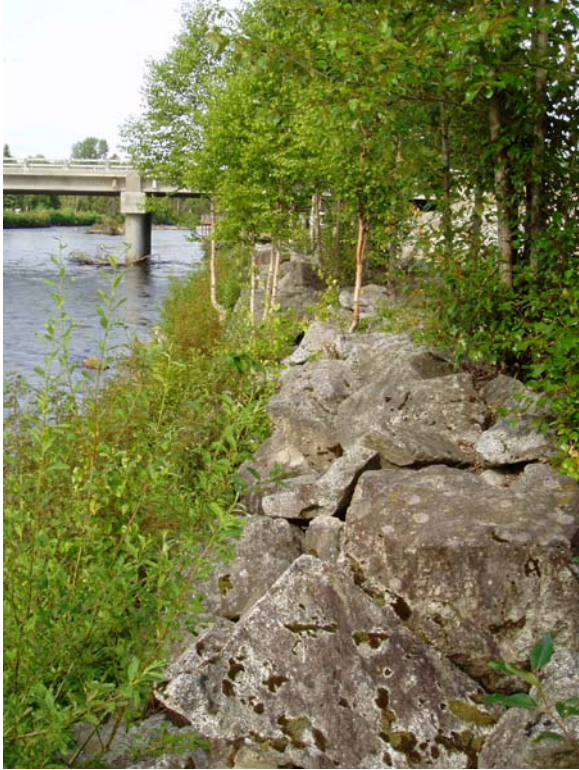
Photo 14 - Willow Creek (Parks Hwy)

---Note that some vegetation has propagated in the bank face, but primarily exists at OHW and bank head.

If the solid mass armament contains large diameter rocks and time allows, vegetative growth from the toe and head may find spots in the bank face that accumulated enough organic and fine material to sustain plant growth. **(Photos 14 and 15)**

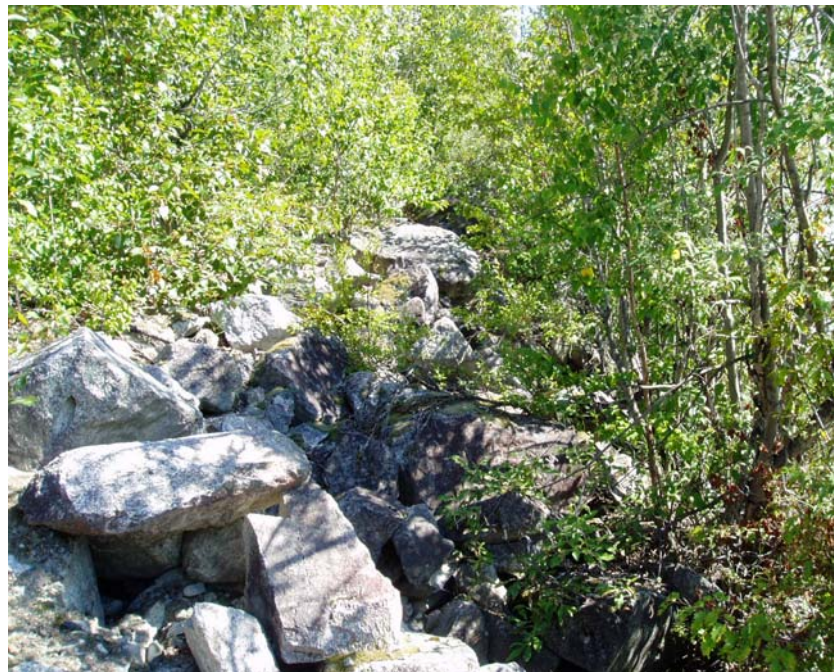
Photo 15 - Kashwitna River (Parks Hwy)

----Note: Vegetation at OHW level has grown to cover the bank face and some vegetation has propagated in the bank face.

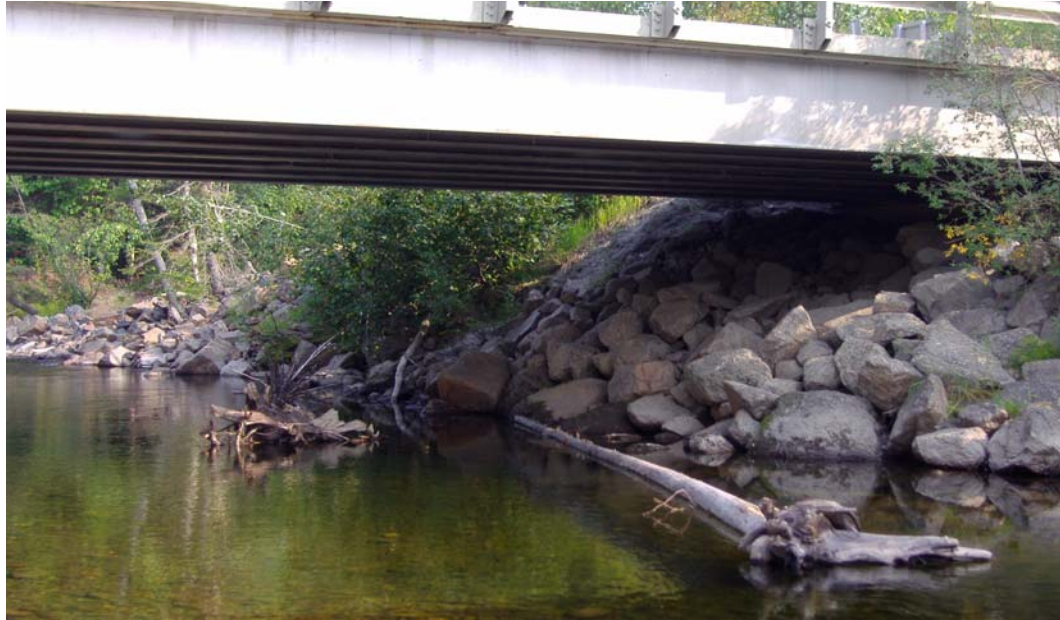
Photo 16 - Fish Creek (Dalton Hwy)

Most of the sites surveyed with riprapped areas directly underneath bridges had minimal plant cover. Many factors may play a role in this issue. The bridge may create a microclimate beneath it through shading and exclusion of precipitation. It also might reduce snow cover on establishing vegetation which would increase the plants susceptibility to winter kill. Increased water velocities and higher ice forces at a bridge crossing due to channel constriction may also contribute to the lack of vegetation.
