Alaska Department of Transportation & Public Facilities Research & Technology Transfer

High Friction Surface Treatment Experimental Feature Final Report and 3rd Year Monitoring Results

Publication Number: FHWA-AK-RD-000S(882)

December 2019

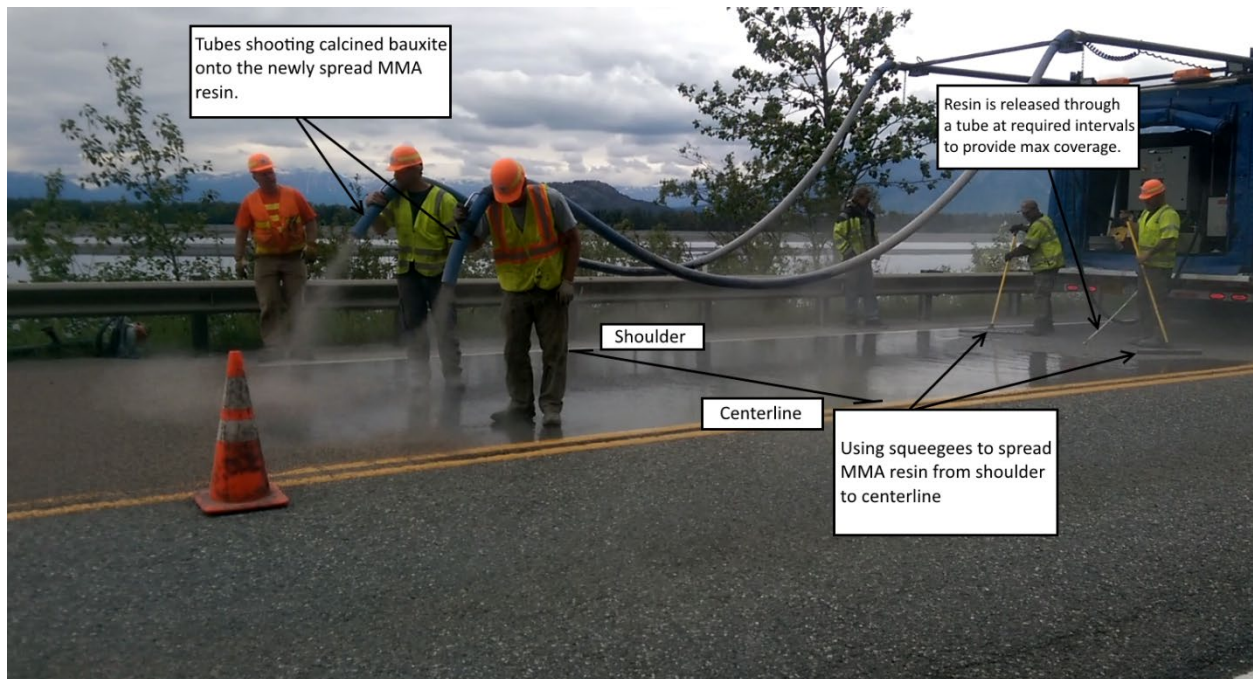
Photo 1: 2016 Application using Method 2 on Old Glenn Highway

If HFST is applied in the future it is recommended that method 1 be used, where machine mixing, measuring and automated, continuous application and thickness measurements are required. This would remove the possibility for squeegees to be used for resin distribution, which can provide varying levels, and no hoses would be present that can drag through the aggregate prior to hardening.

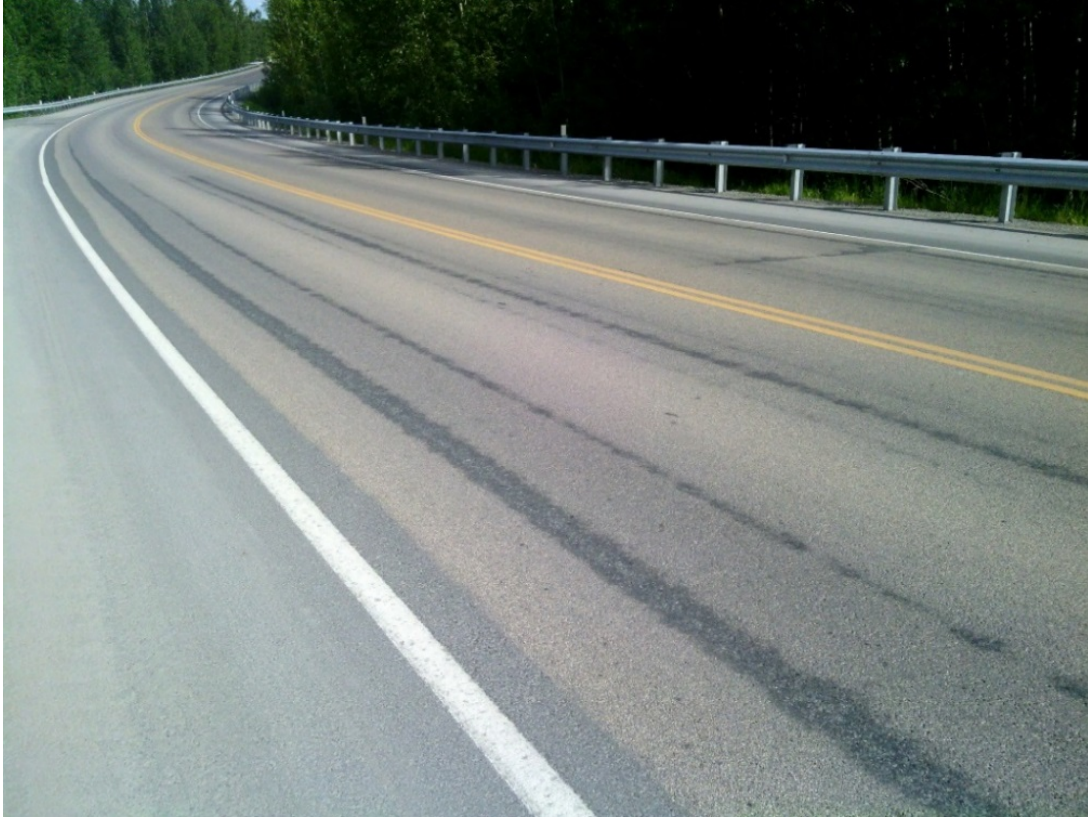
Site 30 (Eagle River Road Mile Point 0-5.3 Pavement Preservation) revealed there may have been an error with the resin application which resulted in strips of bare pavement a consistent distance from the fog line prior to the first winter (See Photo 2). This result, however, was noticeable in other areas as well with Method 2 though it has a distinctly different wear pattern (see Photo 3).

Photo 2: June 2016, Eagle River Road one year after Method 1 application.

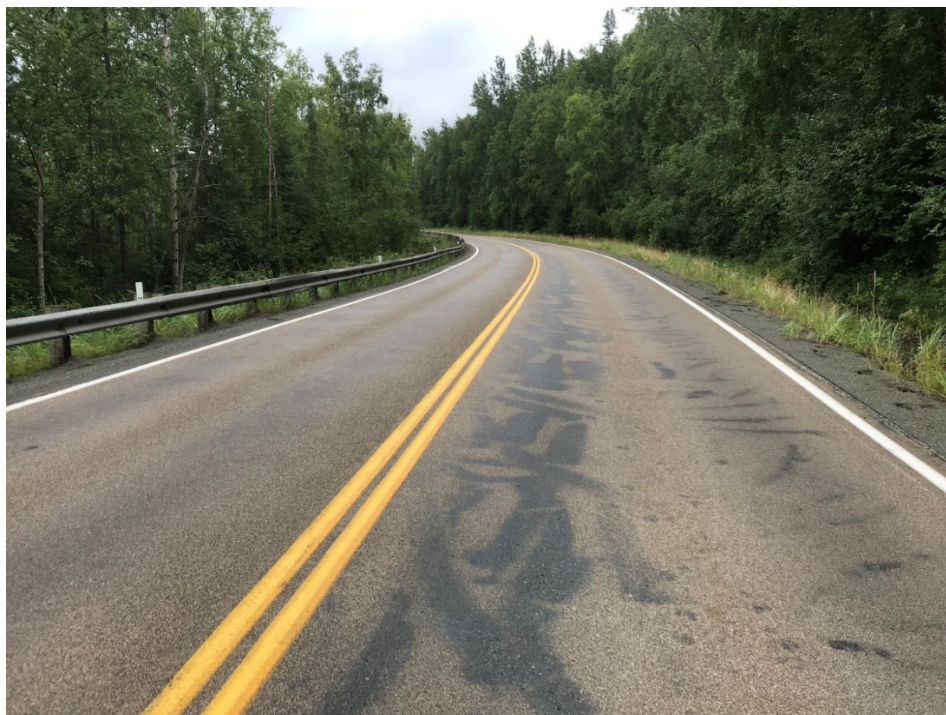
Unique Pattern of Material Loss In Wheelpaths

Photo 6: Old Glenn Highway at Milepost 2 – Site 17 (2018)

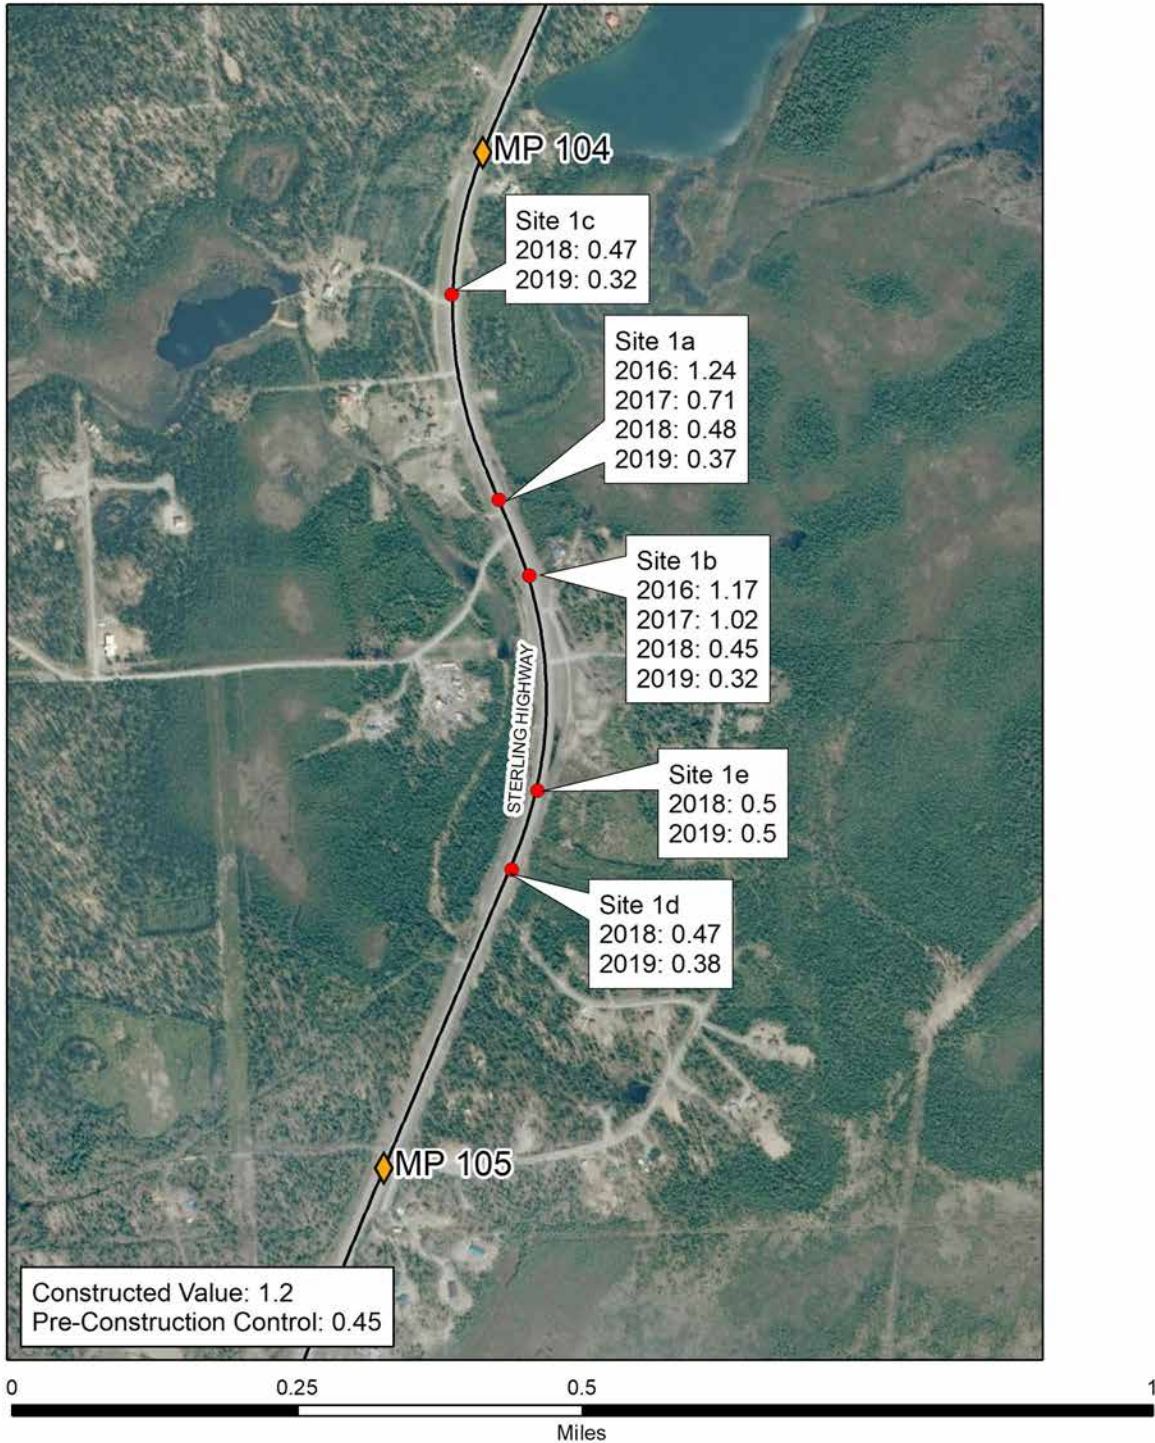
Site 1: Sterling Hwy MP 104-105

Site 1 – Sterling Highway MP 104 - Friction Overview

The site has lost significant friction. Four out of the five tests in 2019 were less than typical pavement value of 0.45, with an average value of 0.38. A zoomed in look at the surface texture in 2019 (below) shows visible pavement under the remaining HFST, and the HFST left in the wheelpaths shows signs of polish.

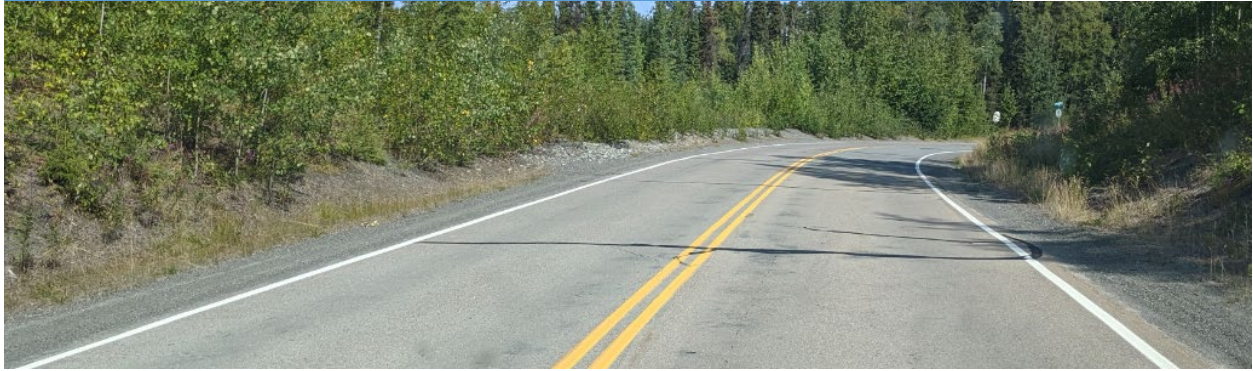
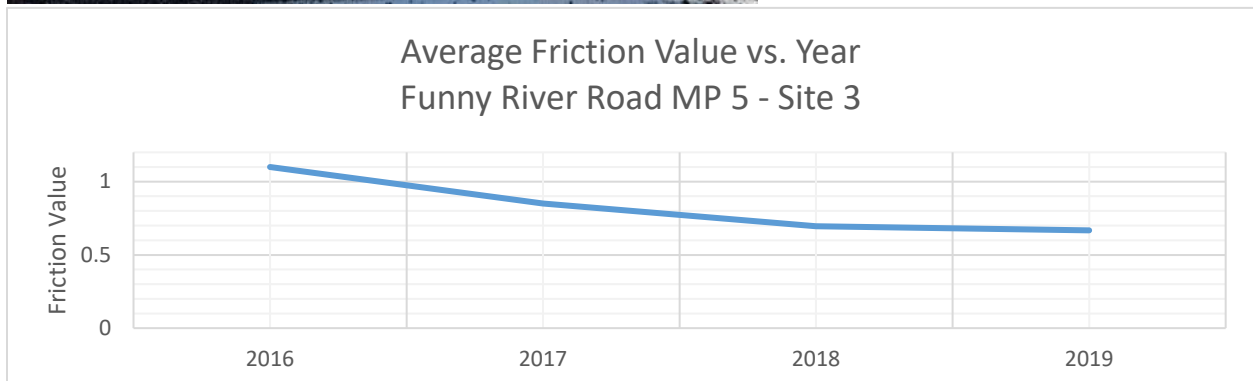
Site 3 – Photo Log

Funny River Road has lost moderate friction, but did not lose a large amount between testing in 2018 and 2019. None of the four tests in 2019 were less than typical pavement value of 0.48, with an average value of 0.67. The first picture below from 2019 does show visible wear in the wheelpaths into and out of curves. Areas in straightaways seemed to show less signs of visible wear, as shown in the second picture taken in 2019.

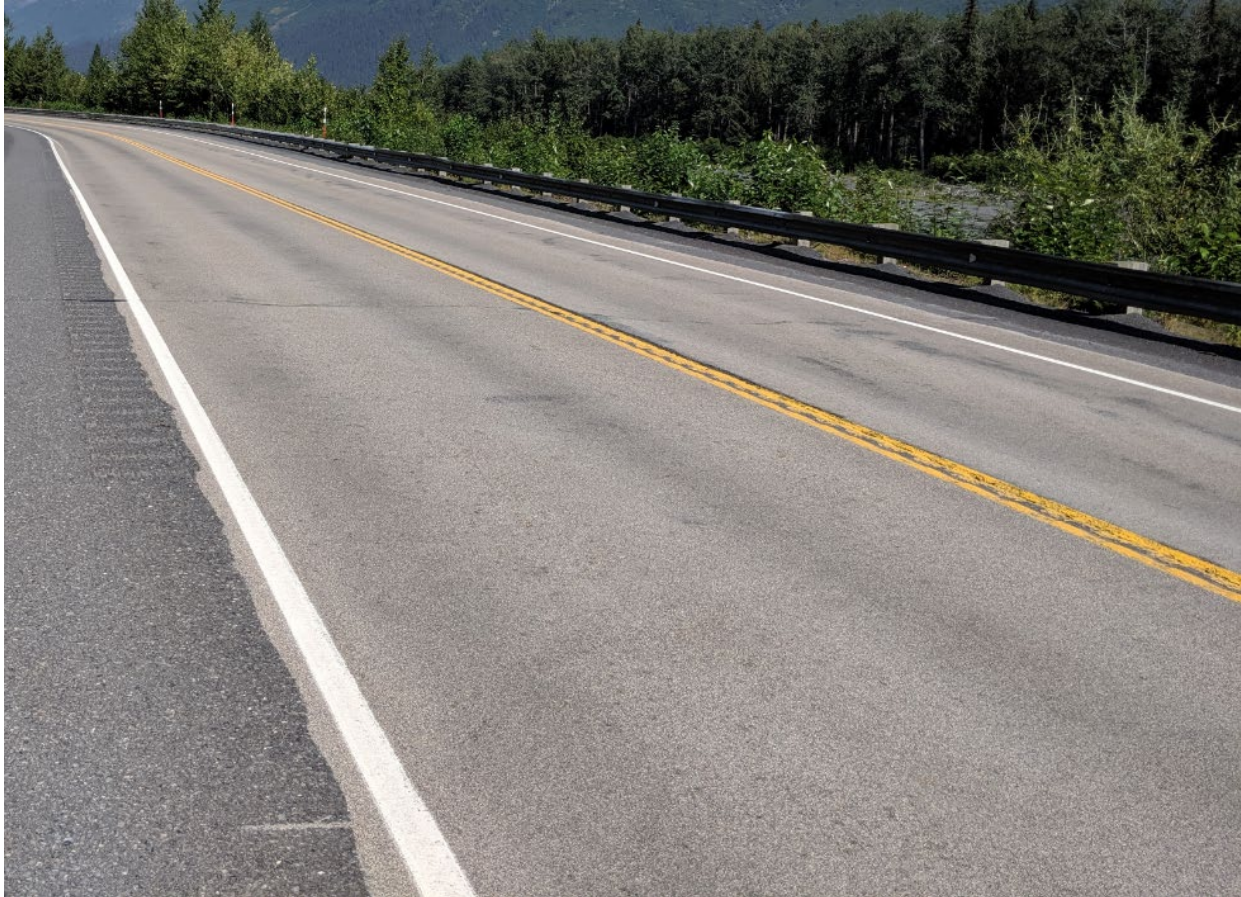
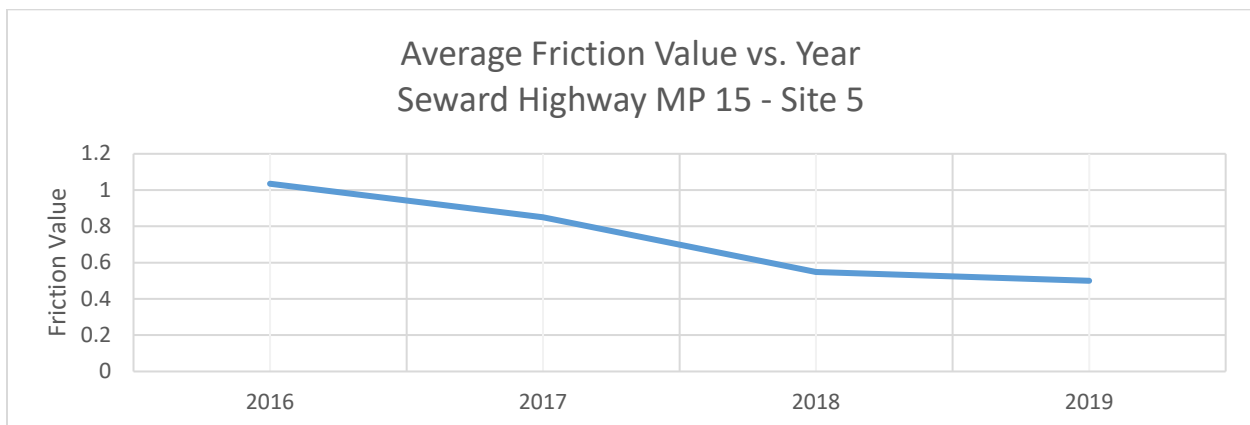
Site 5 – Photo Log

Seward Highway at milepost 15 has lost moderate friction overall, but significant friction at specific locations. Three of the six tests in 2019 were less than typical pavement value of 0.48, with an average value of 0.50. The picture from 2019 below shows wear in the wheelpaths going into and out of a curve.

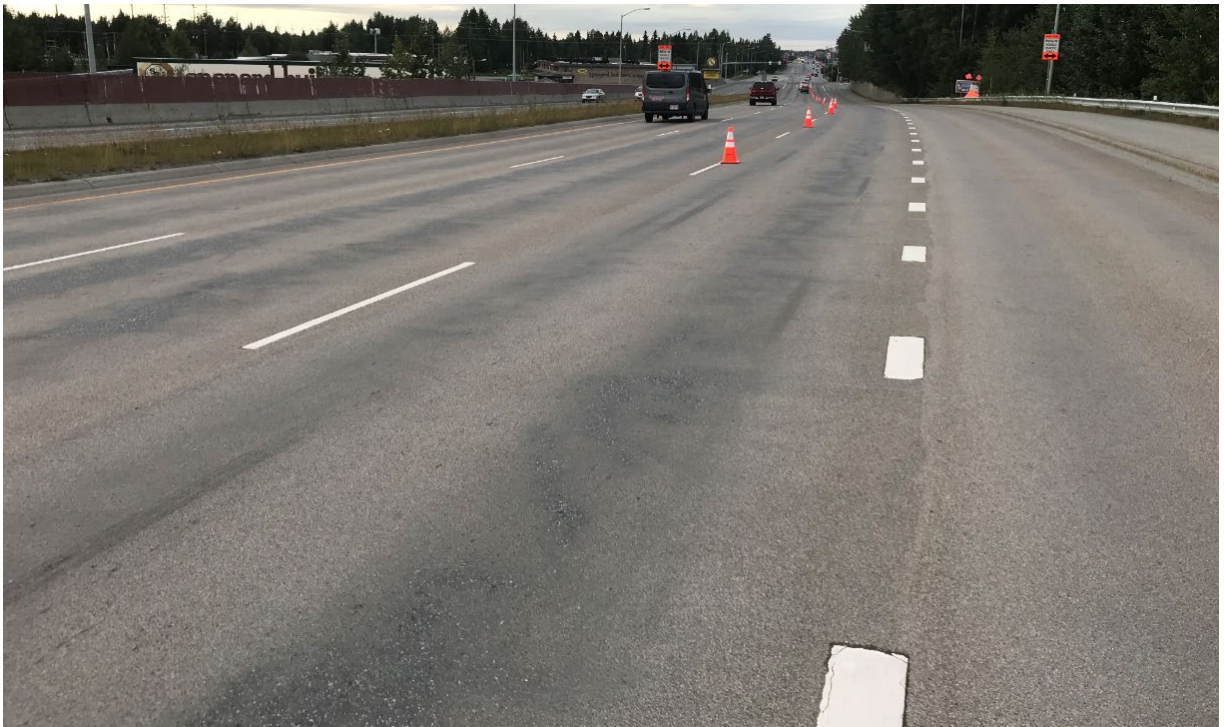
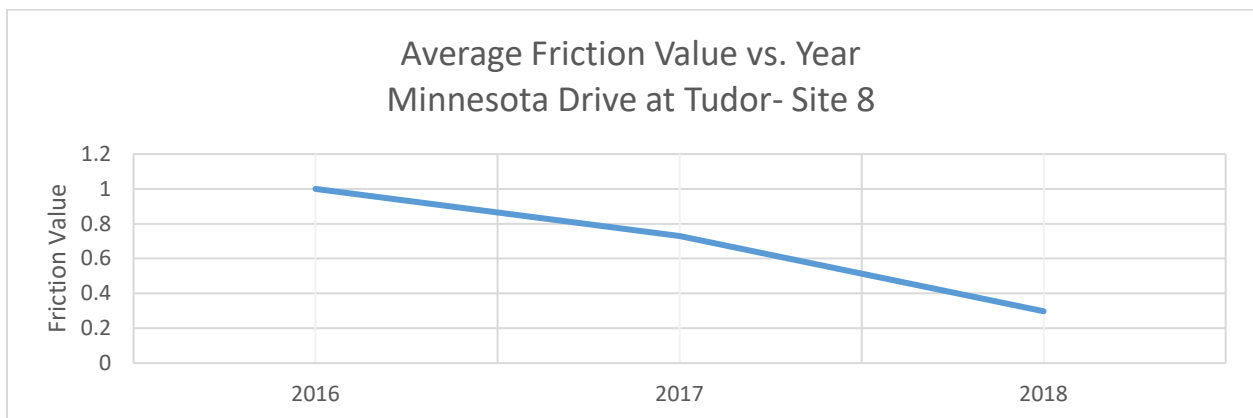
Site 8 – Photo Log

Minnesota Drive at Tudor lost significant friction. The friction drop between 2017 and 2018 was major and all four tests in 2018 were less than typical pavement value of 0.60, with an average value of 0.30. As can be seen in the 2018 photo, below, all wheelpaths show wear and show large amounts of bare pavement.

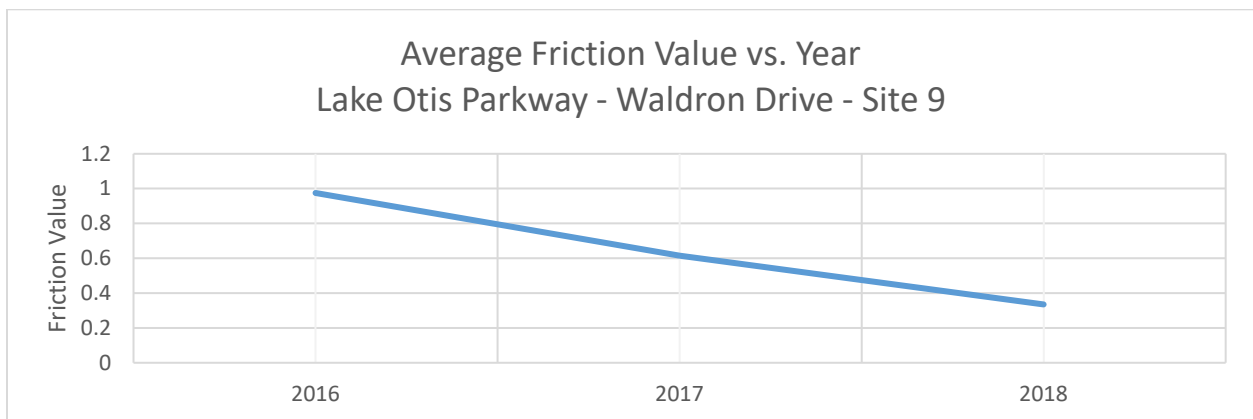
Site 9 – Photo Log

Lake Otis at Waldron lost significant friction. The friction drop between 2017 and 2018 was major and the two tests in the through lanes in 2018 were less than typical pavement value of 0.56, with an average value of 0.34. As can be seen in the 2018 photo, below, all wheelpaths show significant wear. The third test performed in 2018 was in the turn pocket, and that data can be seen at the end of the appendix summarized with other turn pocket data.

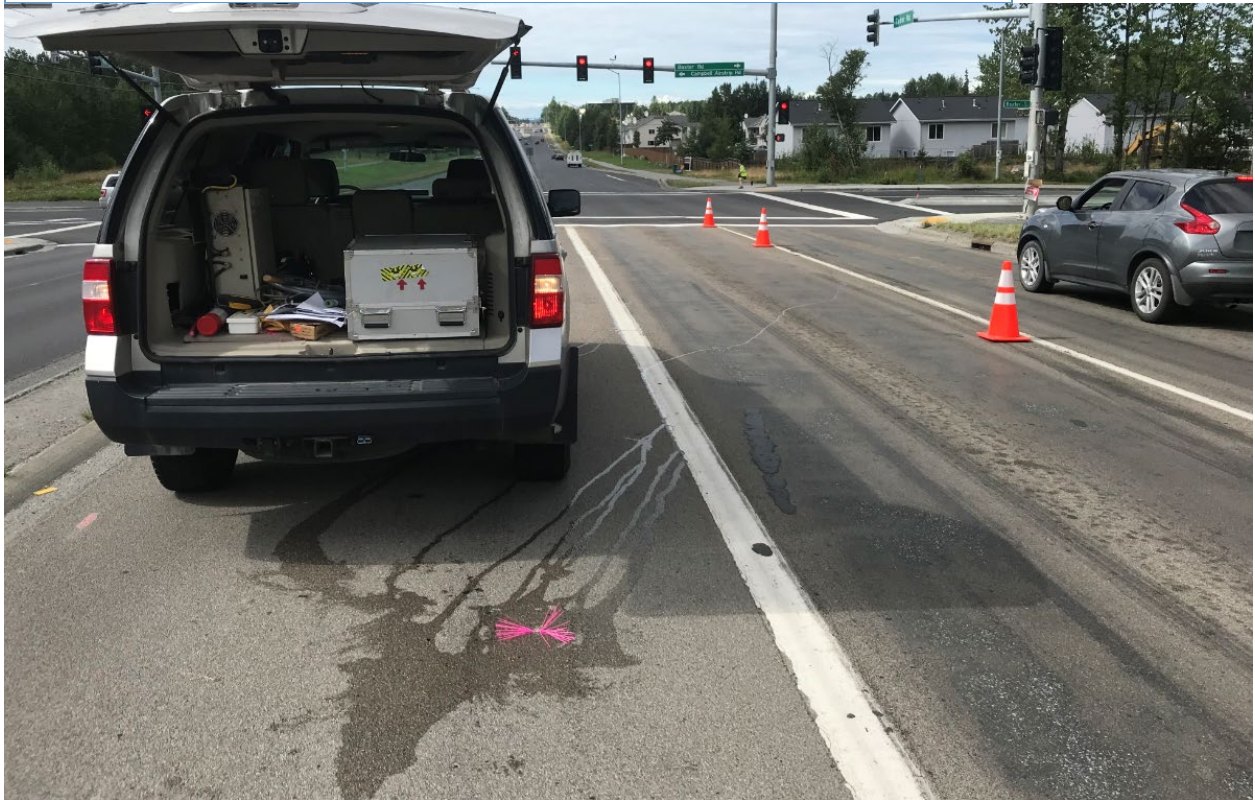
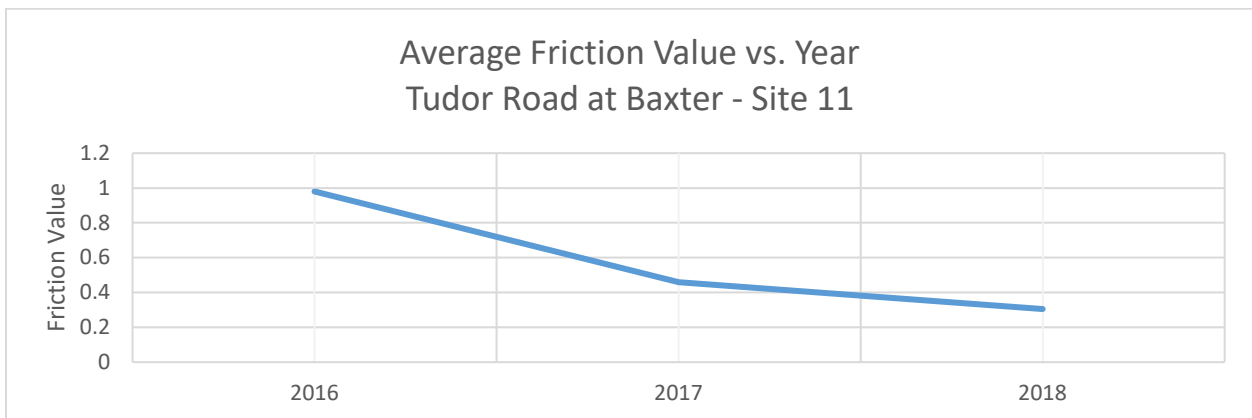
Site 11 – Photo Log

Tudor Road showed major friction loss in all tests. The friction drop between 2017 and 2018 was significant and both tests were less than typical pavement value of 0.58, with an average value of 0.31. As can be seen in the 2018 photo, below, the turn pocket shows minimal wear while the wheelpaths in the the through lanes show visible pavement and substantial wear. The third test performed in 2018 was in the turn pocket, and that data can be seen at the end of the appendix summarized with other turn pocket data.

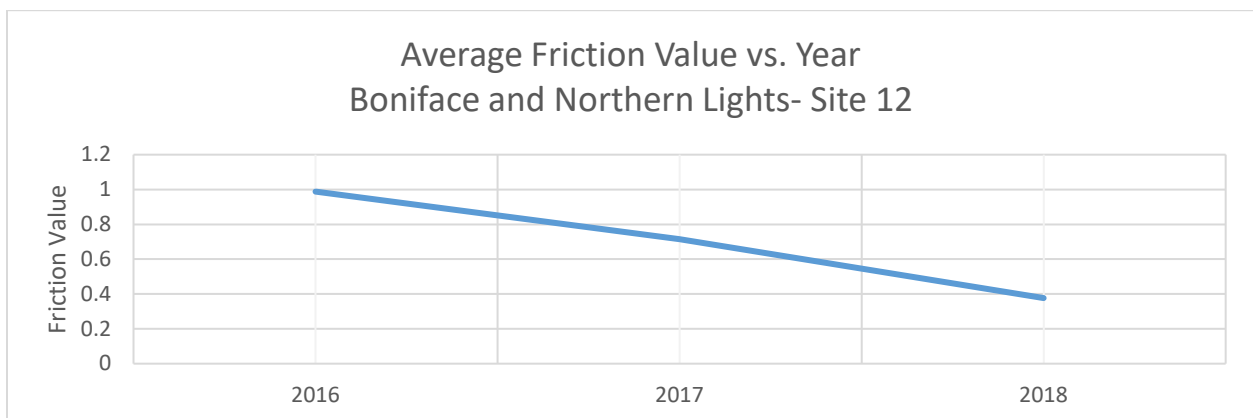
Site 12 – Photo Log

Boniface and Northern Lights showed major friction loss in all tests. The friction drop between 2017 and 2018 was significant and all six tests were less than typical pavement value of 0.60, with an average value of 0.38. Through lanes showed wear with visible pavement in areas. Turn pocket testing can be found at the end of the appendix summarized with other turn pocket data.

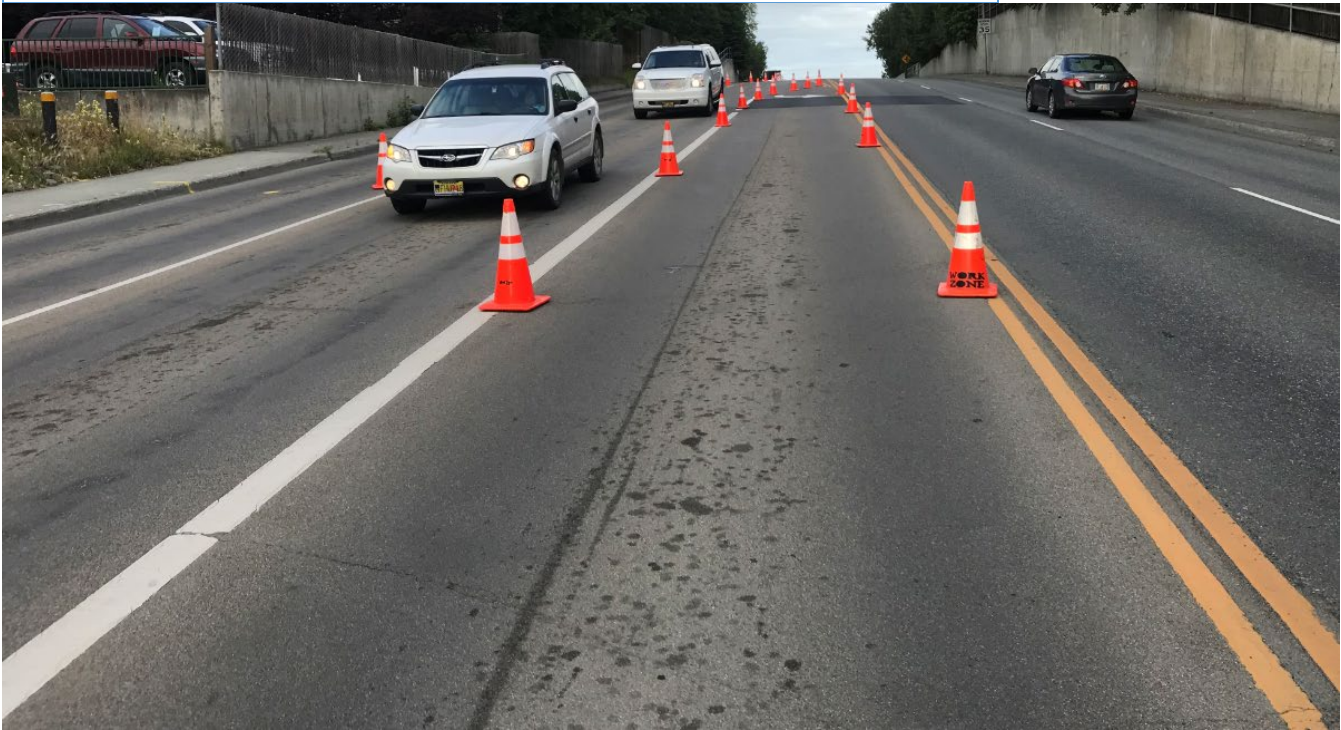
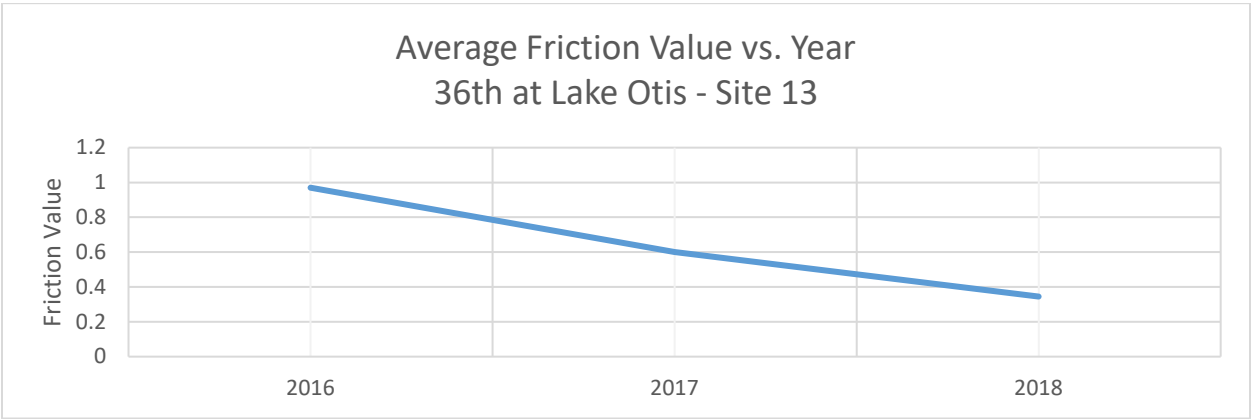
Site 13 – Photo Log

36th at Lake Otis showed major friction loss in all tests. The friction drop between 2017 and 2018 was significant and both tests in through lanes were less than the pavement control value of 0.57, with an average value of 0.35. Through lanes showed wear with visible pavement in areas. While the turn pocket showed major wear no pavement was visible. Turn pocket testing can be found at the end of the appendix summarized with other turn pocket data.

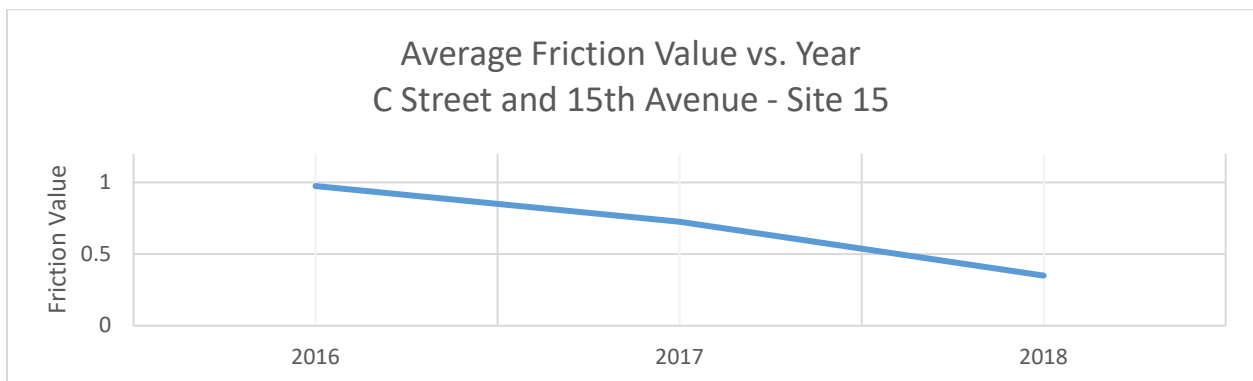
Section 15 – Photo Log

C Street at 15th showed major friction loss in all tests. The friction drop between 2017 and 2018 was significant and both tests in through lanes had less friction than the pavement control value of 0.57, with an average value of 0.35. Through lanes showed bare pavement as can be seen in the 2018 photo, below. Turn pocket testing can be found at the end of the appendix.

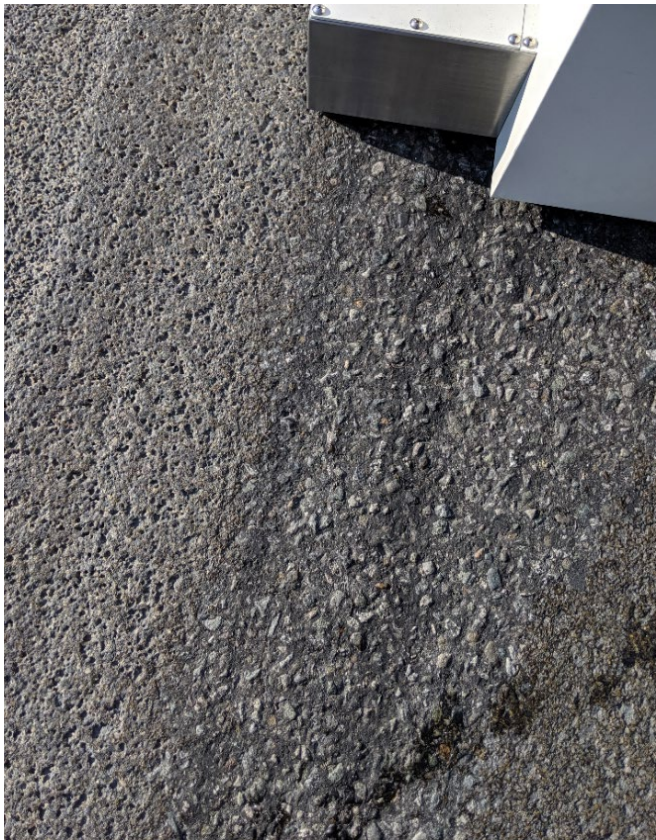
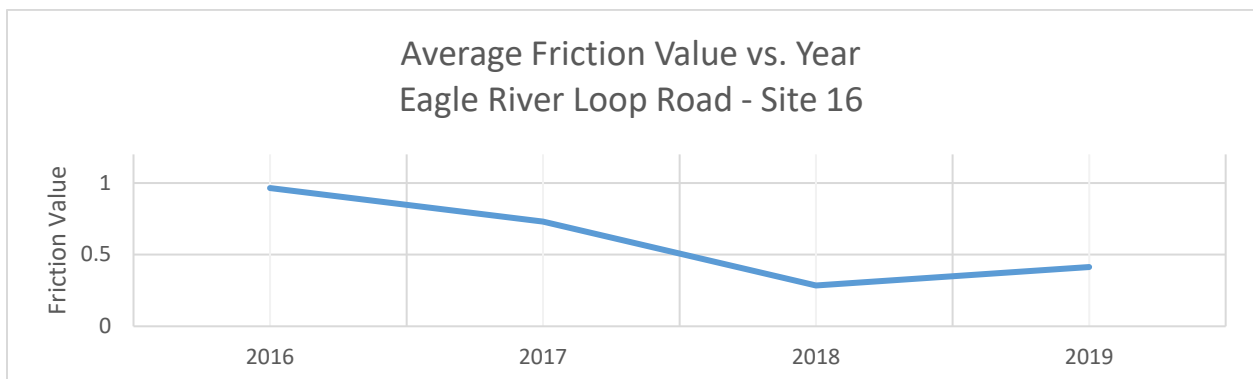
Site 16 – Photo Log

Eagle River Loop Road showed significant friction loss. A third test was performed in through lanes in 2019 with a value of 0.73. This value remained higher than the other two performed in the through lanes closer to the intersection with 2019 values of 0.31 and 0.20. This higher value raised the average value in 2019. Major polishing of the HFST and bare pavement can be seen in the 2019 photo, below. Turn pocket testing can be found at the end of the appendix.

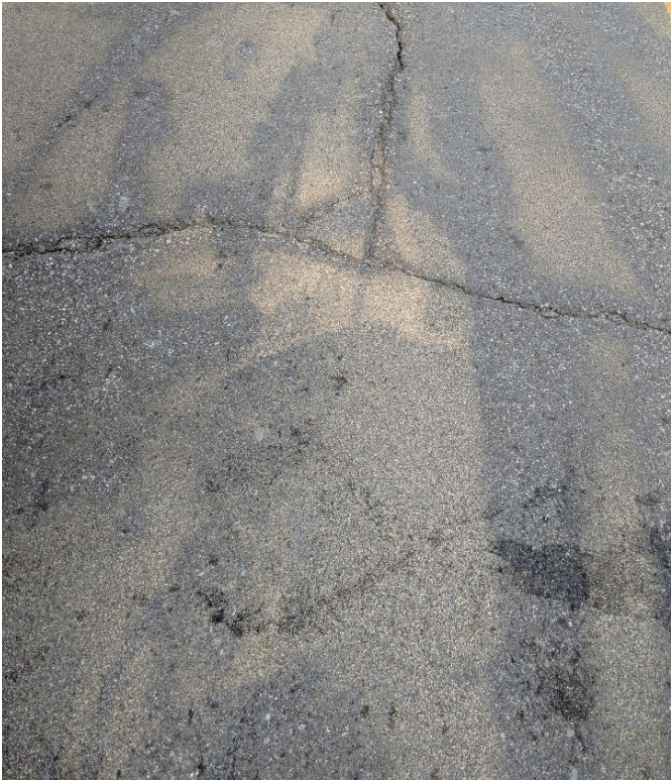
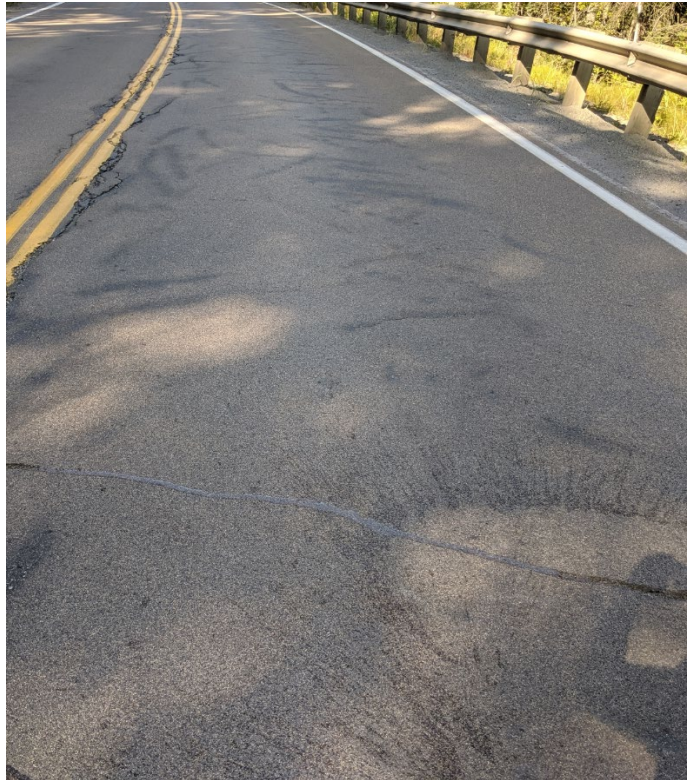
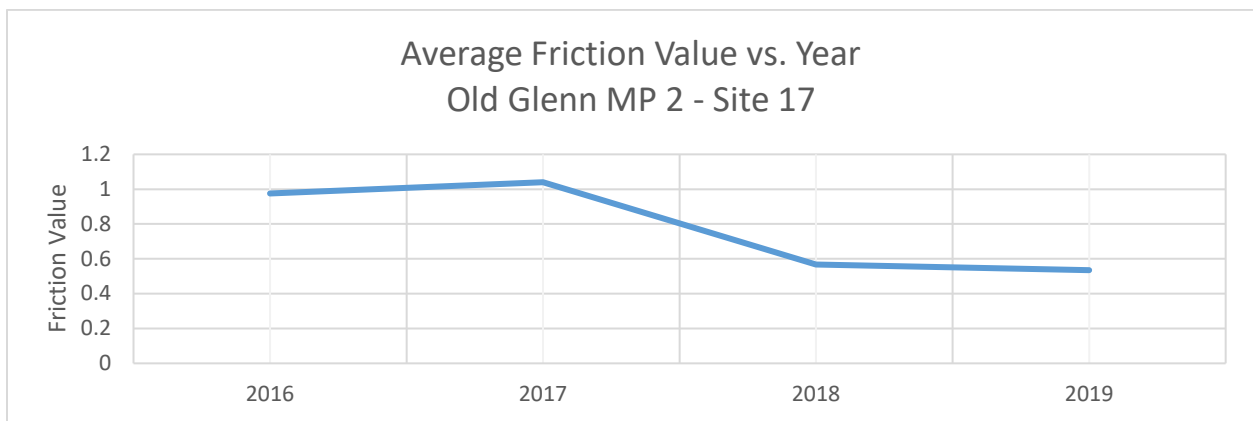
Site 17 – Photo Log

Old Glenn at MP 2 showed moderate friction loss, although not a major loss on average between 2018 and 2019. Two of the four tests had less friction than the original pavement control of 0.57, with an average of 0.54. Areas of bare pavement were visible from both studded tire wear in wheelpaths and areas where the pavement heaved in the winter and the HFST was bladed through, as can be seen in the 2019 photos, below.

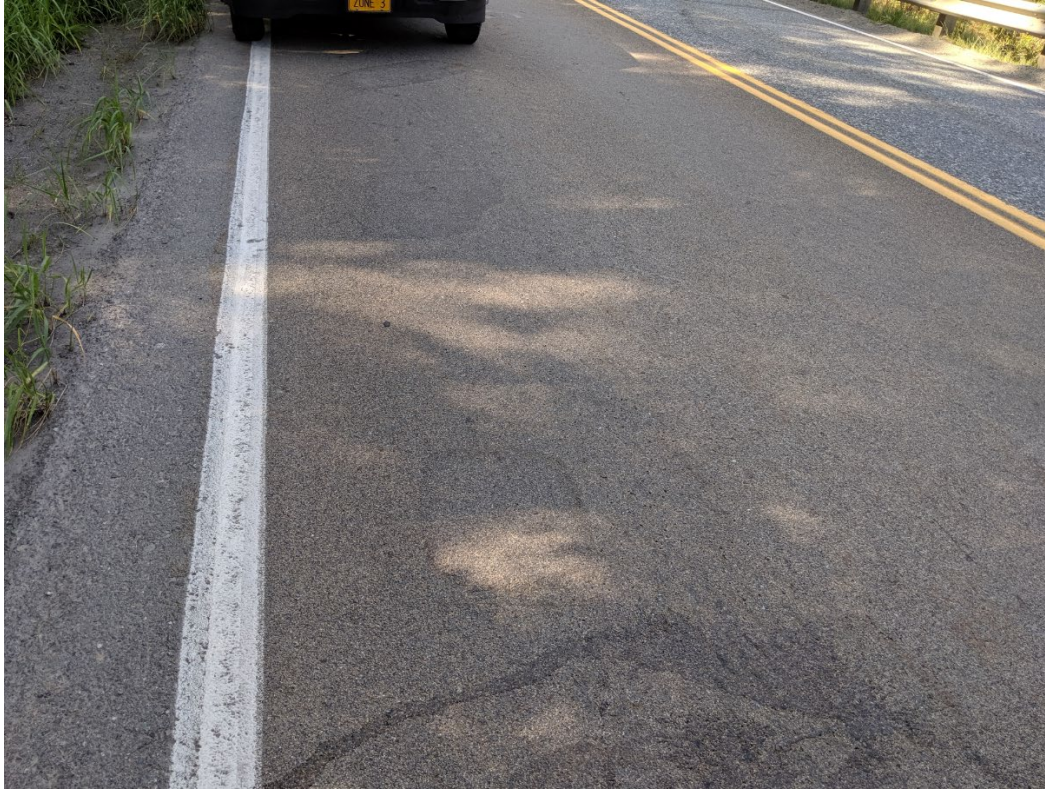
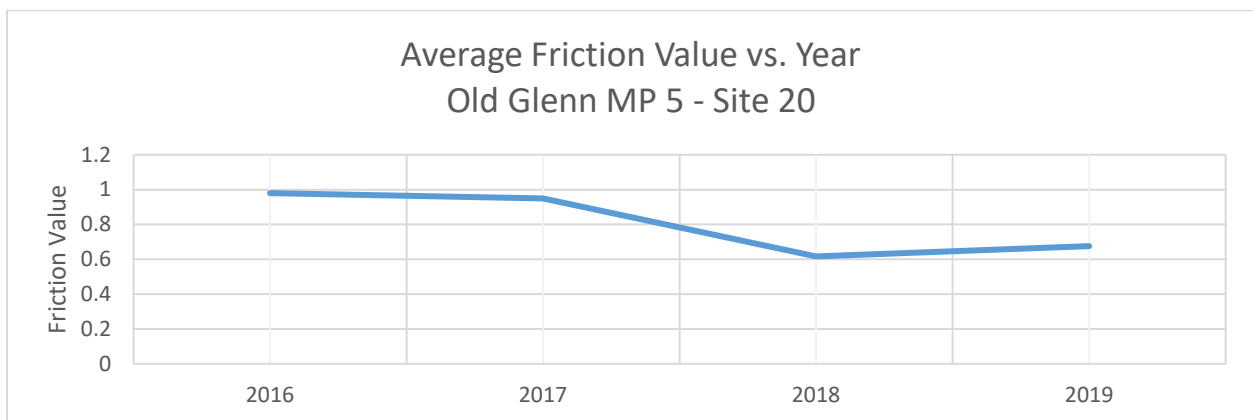
Site 20 – Photo Log

Old Glenn at milepost 5 showed moderate friction loss. None of the three tests had less friction than the original pavement control of 0.54, with an average of 0.68. The PK nails could not be located in 2019 so the testing was performed as close as the crew could manage to the original locations. This is likely the cause of the discrepancy of friction values between 2018 and 2019.

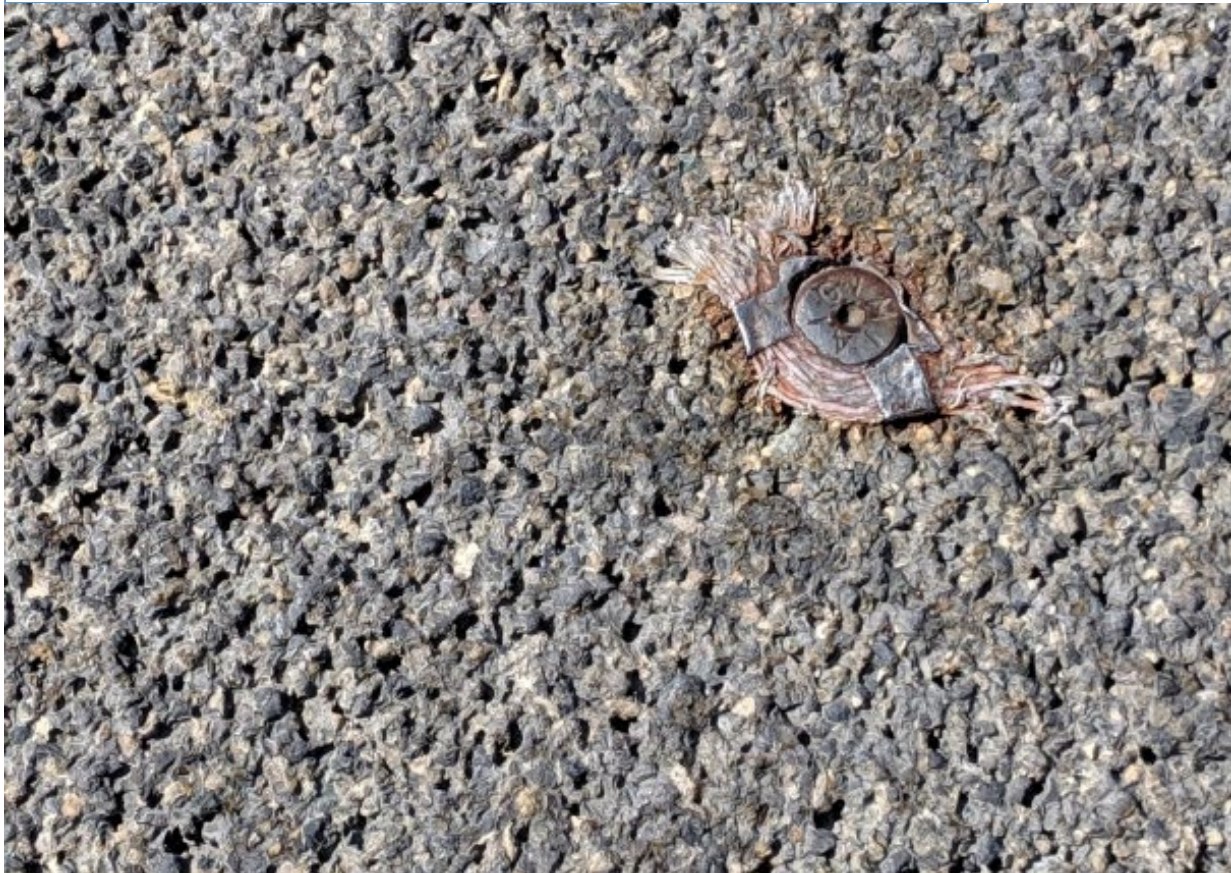
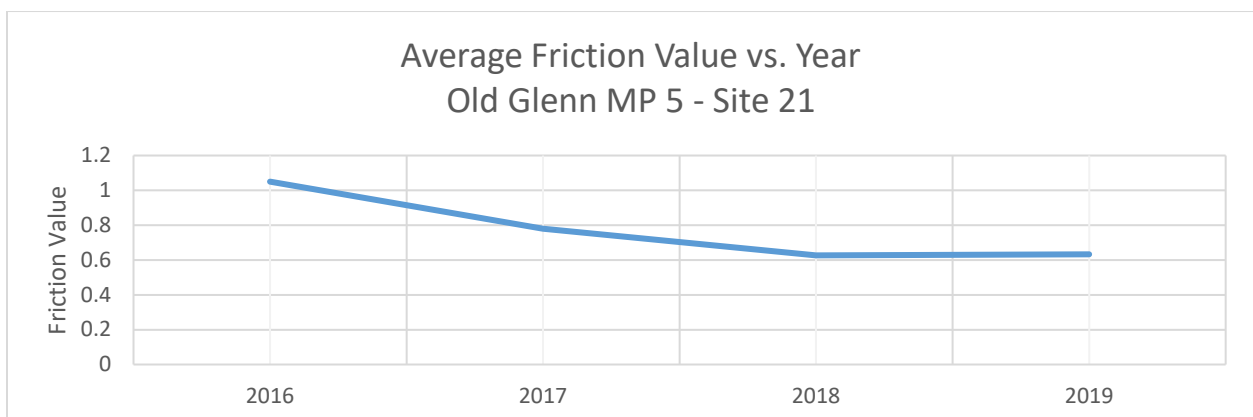
Site 21 – Photo Log

Old Glenn at at milepost 6 showed moderate friction loss, although no loss on average between 2018 and 2019. None of the three tests had less friction than the original pavement control of 0.54, with an average of 0.63. Small amounts of bare pavement was visible under the HFST, although this did not affect testing at this location. Typical wear of the HFST can be seen in the second 2019 picture adjacent to the PK nail, below.

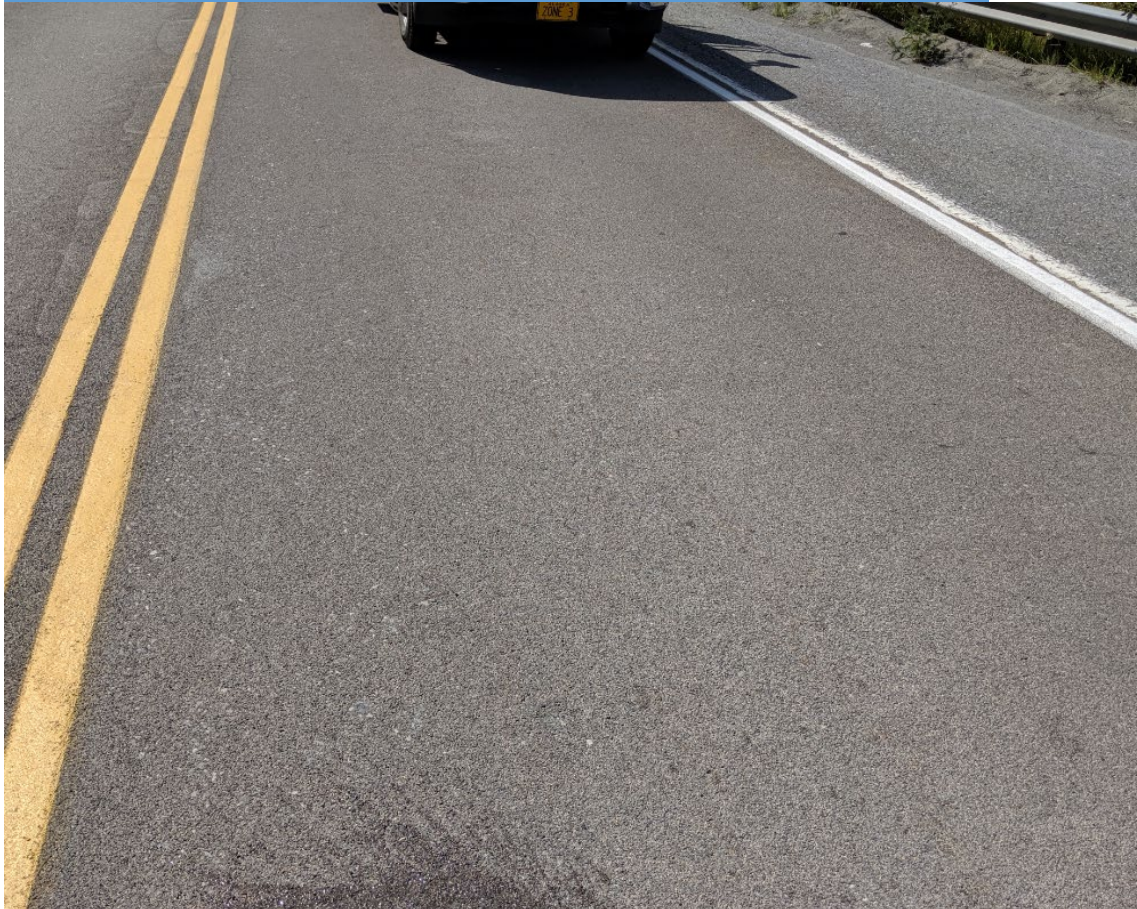
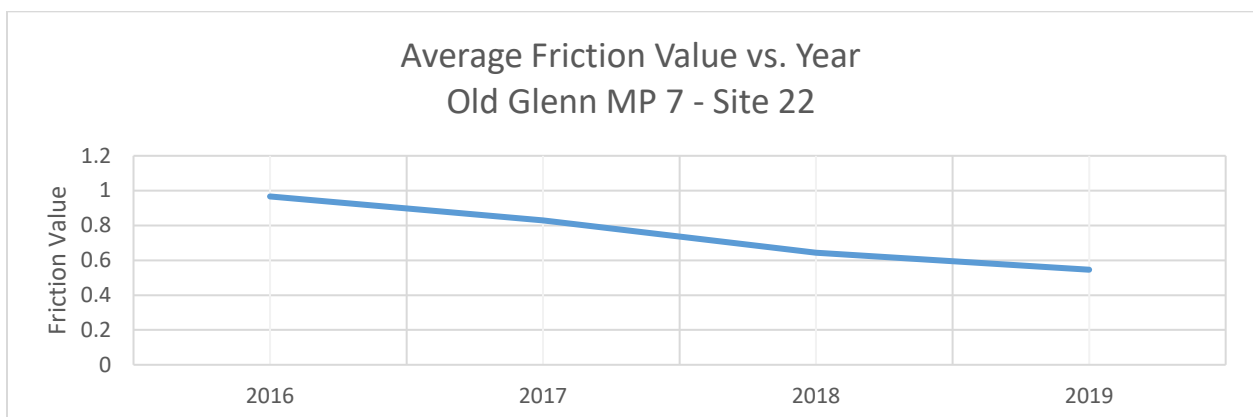
Site 22 – Photo Log

Old Glenn at at milepost 7 showed moderate friction loss. One of the five tests had less friction than the original pavement control of 0.49, while the average was 0.55. Small amounts of bare pavement was visible under the HFST, likely due to snowplowing as there typically wasn't major wear evident in the wheelpaths. See the 2019 picture, below.
