Alaska Department of Transportation & Public Facilities Research & Technology Transfer

High Friction Surface Treatment Experimental Feature Final Report and 3rd Year Monitoring Results

Publication Number: FHWA-AK-RD-000S(882)

December 2019

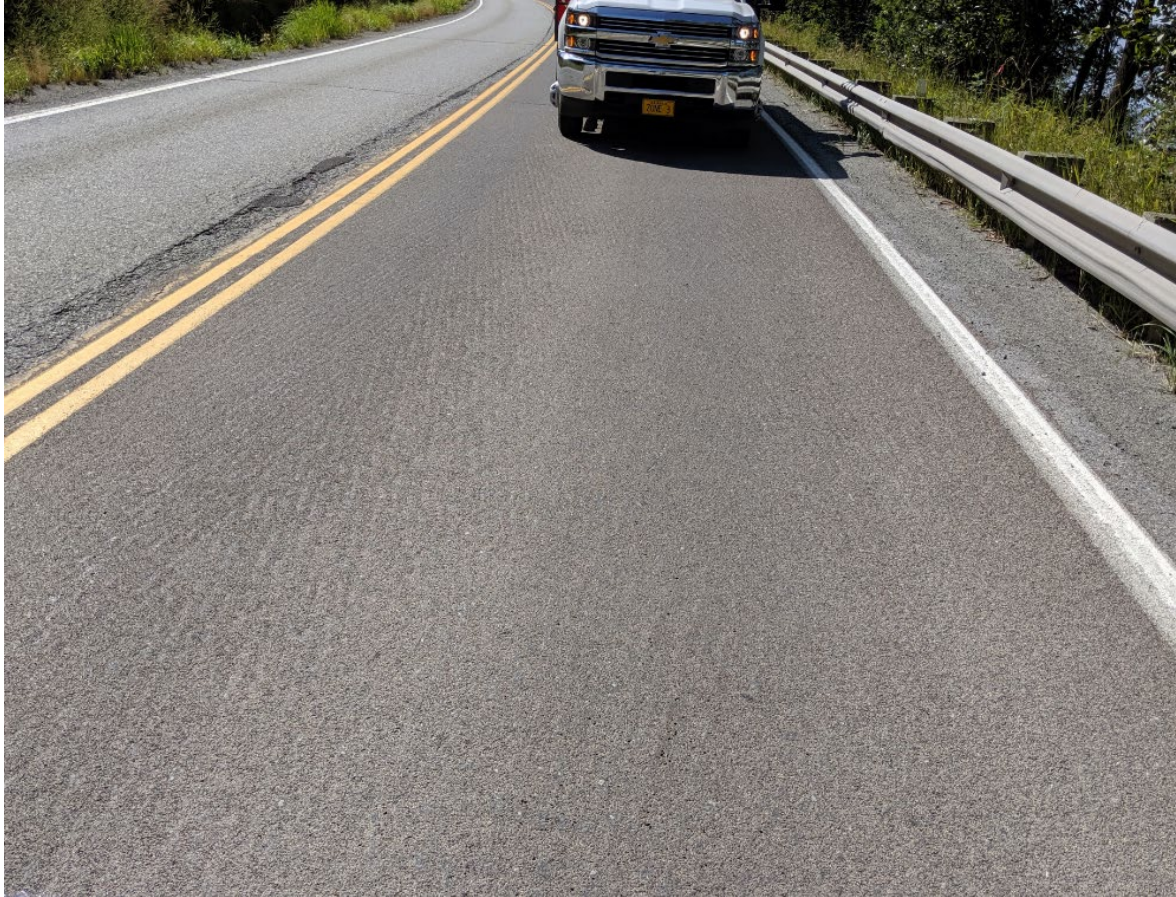
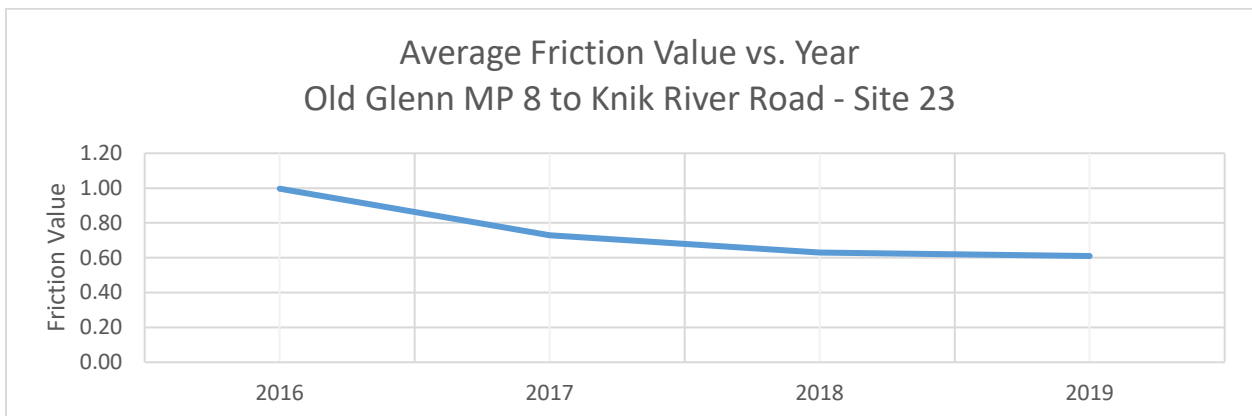
Site 23 – Photo Log

Old Glenn at milepost 8 showed moderate friction loss, although minimal loss on average between 2018 and 2019. One of the five tests had less friction than the original pavement control of 0.49, while the average was 0.61. Small amounts of bare pavement was visible under the HFST, likely due to snowplowing and studded tire wear. See the 2019 picture, below and on the next page.

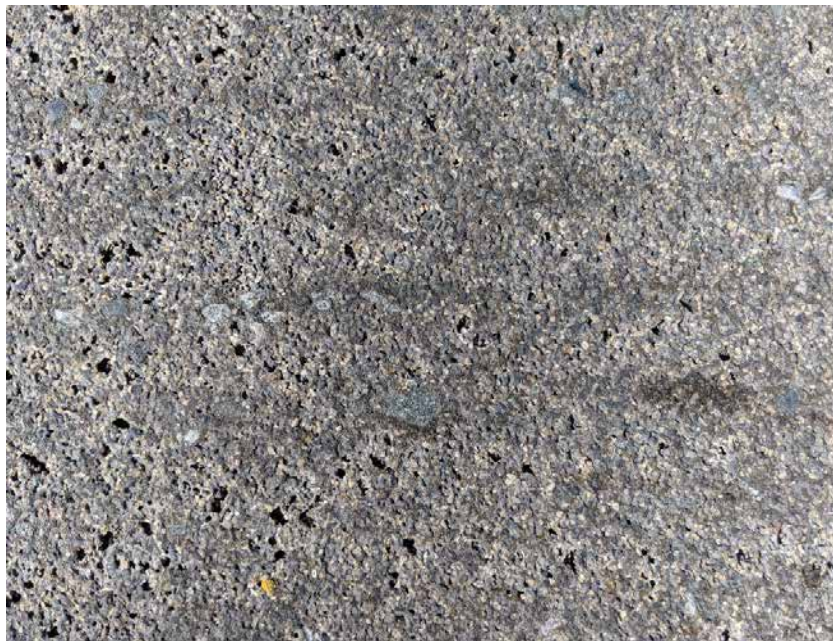
2019 – Bare Pavement and Significant Wear

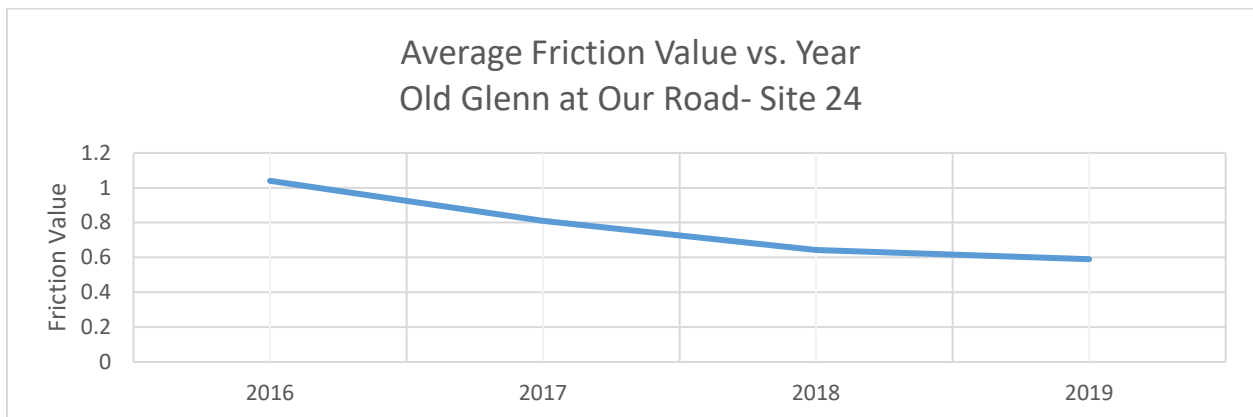
Site 24 – Photo Log

Old Glenn at Our Road showed moderate friction loss, although minimal loss on average between 2018 and 2019. One of the three tests had less friction than the original pavement control of 0.55, while the average was 0.59. Small amounts of bare pavement was visible under the HFST, likely due to snowplowing as some of the observed pavement is outside of wheelpaths. The surface texture observed in the 2019 photo, below, is due to the HFST application being located in the floodplain and the surface required milling to maintain elevation.

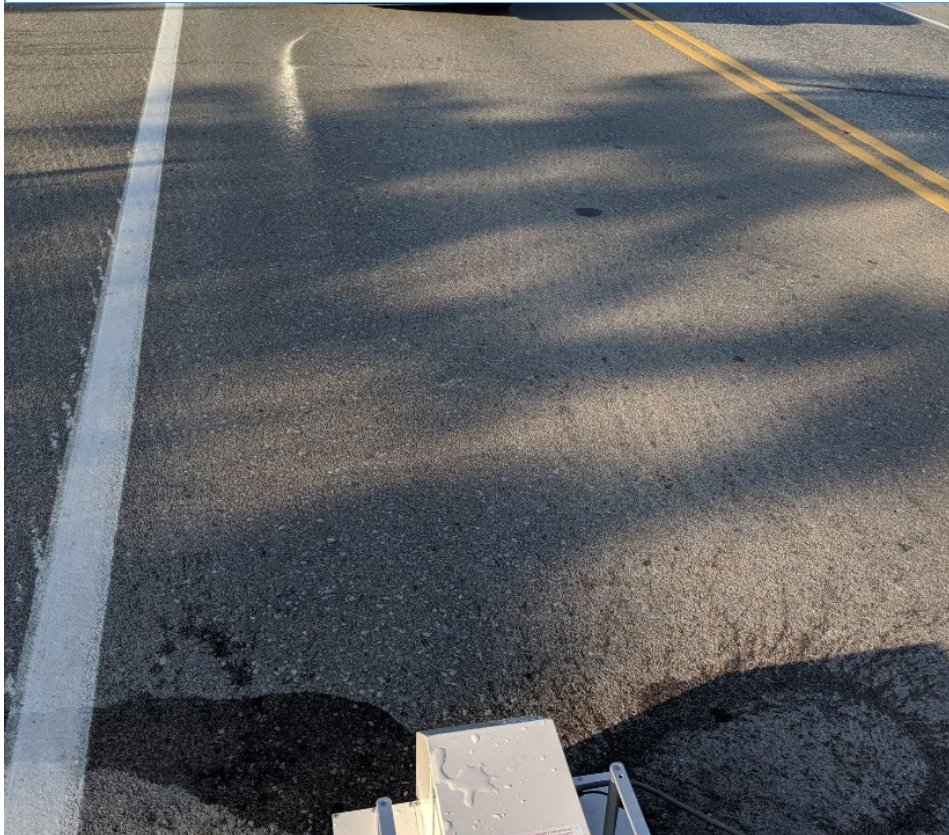
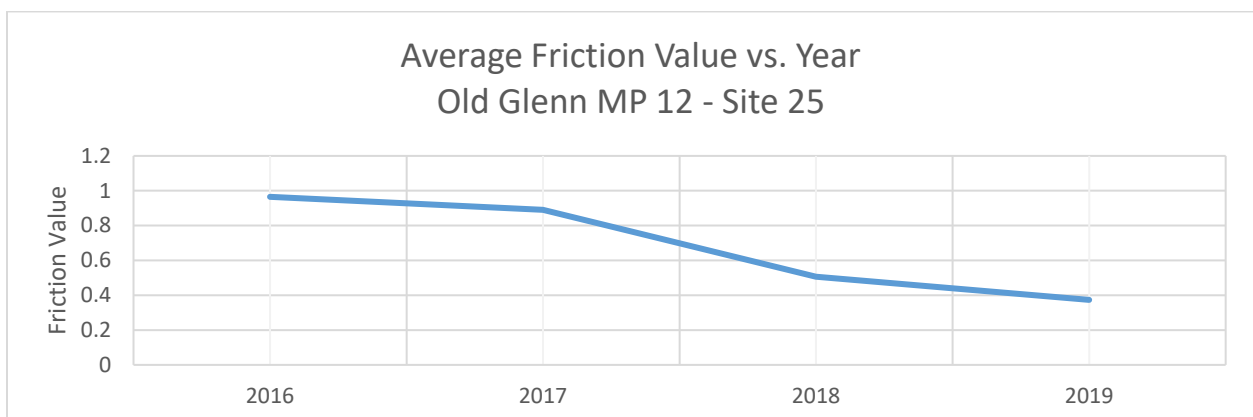
Site 25 – Photo Log

Old Glenn at milepost 12 lost significant friction. All three of the tests had less friction than the pavement control of 0.56. The average 2019 friction value was 0.37. Bare pavement was common at this site and in the 2019 photo, below, bare pavement can be observed in the wheelpath where the friction test is being performed. This site is closer to Palmer and contains higher traffic volumes than the rest of the sites on the Old Glenn Highway which is contributing to the wear compared to other Old Glenn Highway sites.

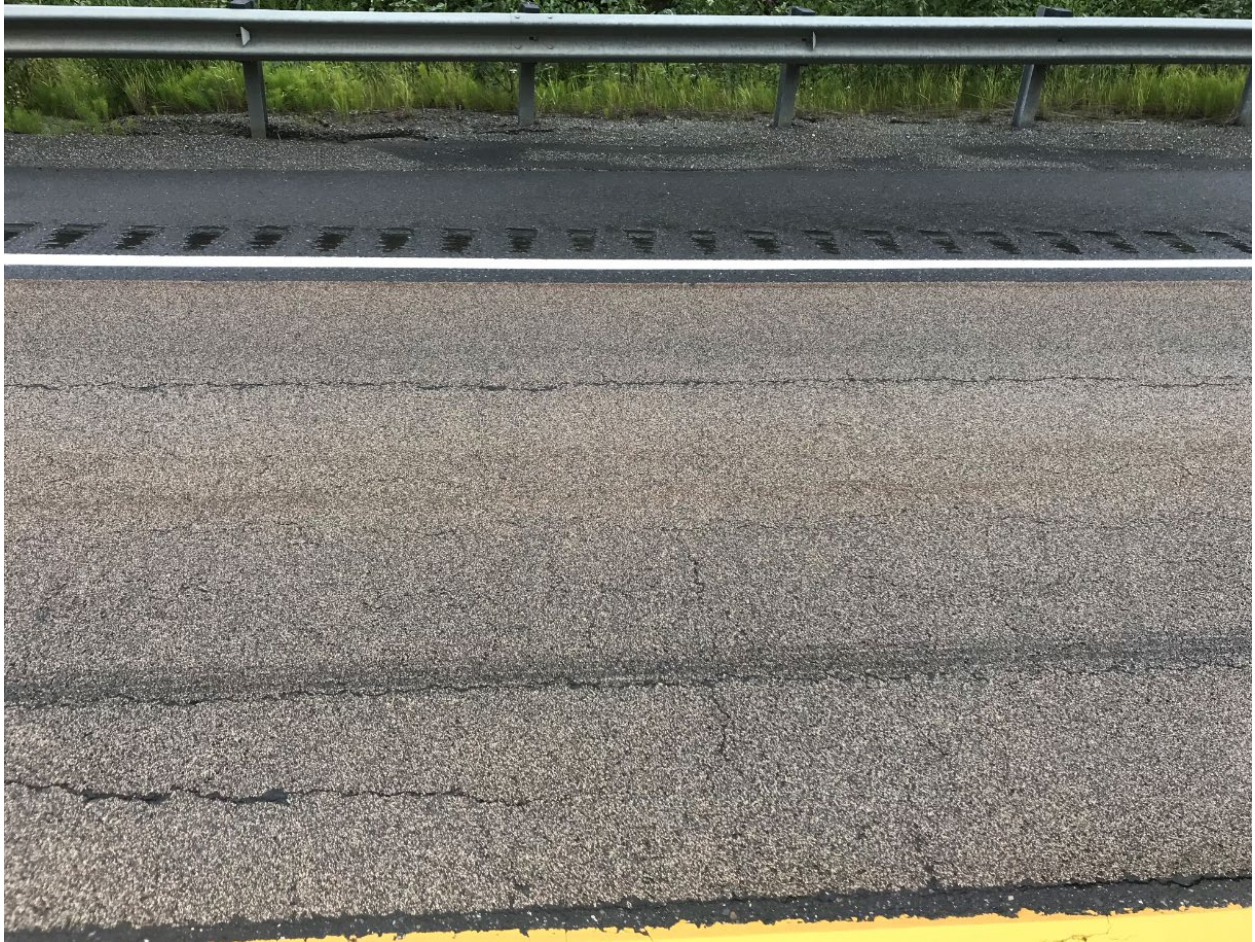
2018 Photo – osbserved cracking pattern

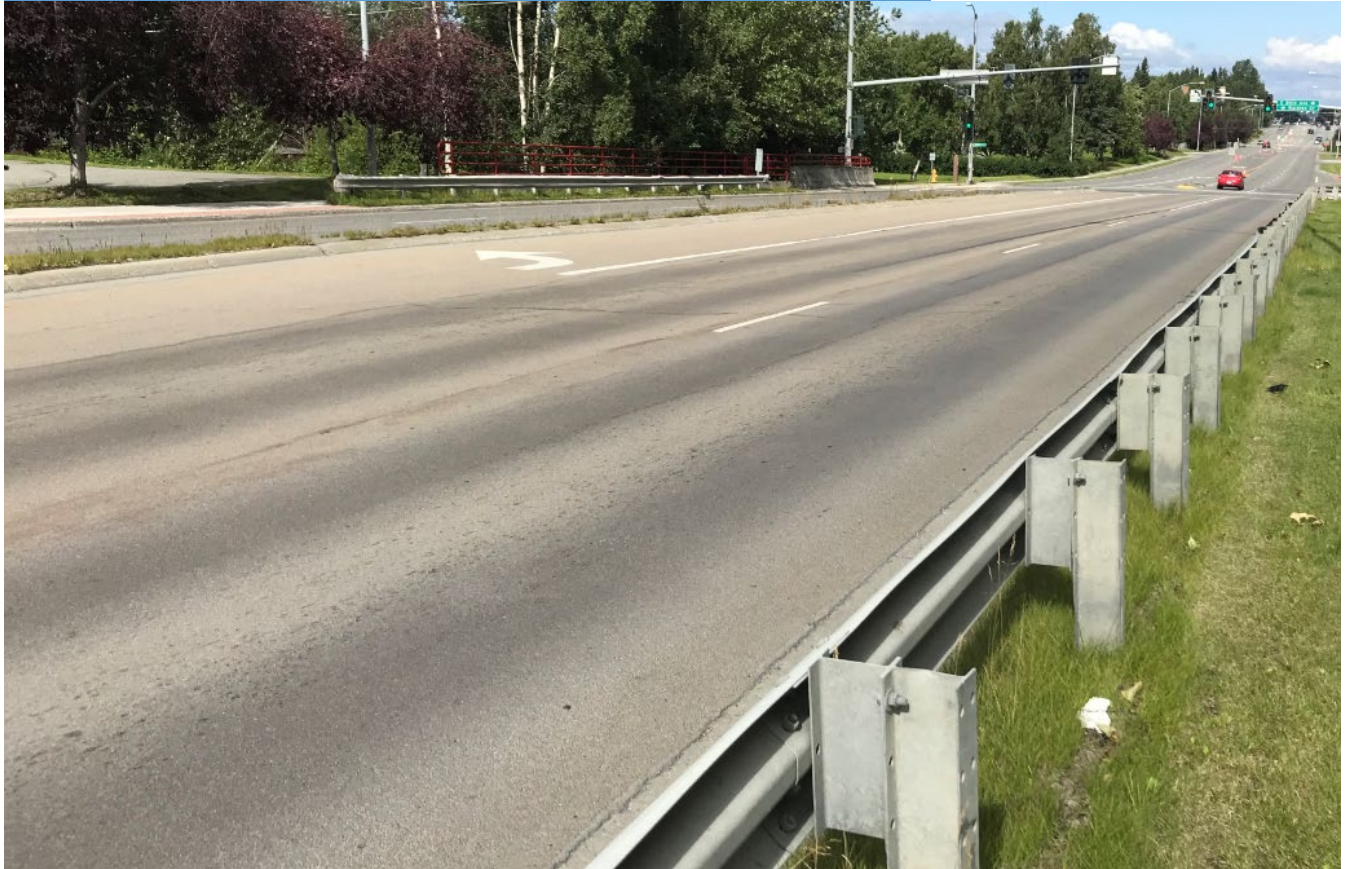
In the picture on the previous page, taken in 2018 just south of the intersection of Waldron and Lake Otis, extensive wheelpath wear is apparent in the through lanes while the turn pocket looks to have minimal wear. At this site the turn pocket retained a friction value of 0.70, while the two tests in the through lanes had values of 0.30 and 0.37.
