Aerial Infrared Scanning of Bridge Decks on Parks Highway to Map Delaminations

FINAL REPORT

Prepared by:
Infrasense, Inc.
Woburn, MA

Report # FHWA-AK-RD-000S(960)
March 2, 2023

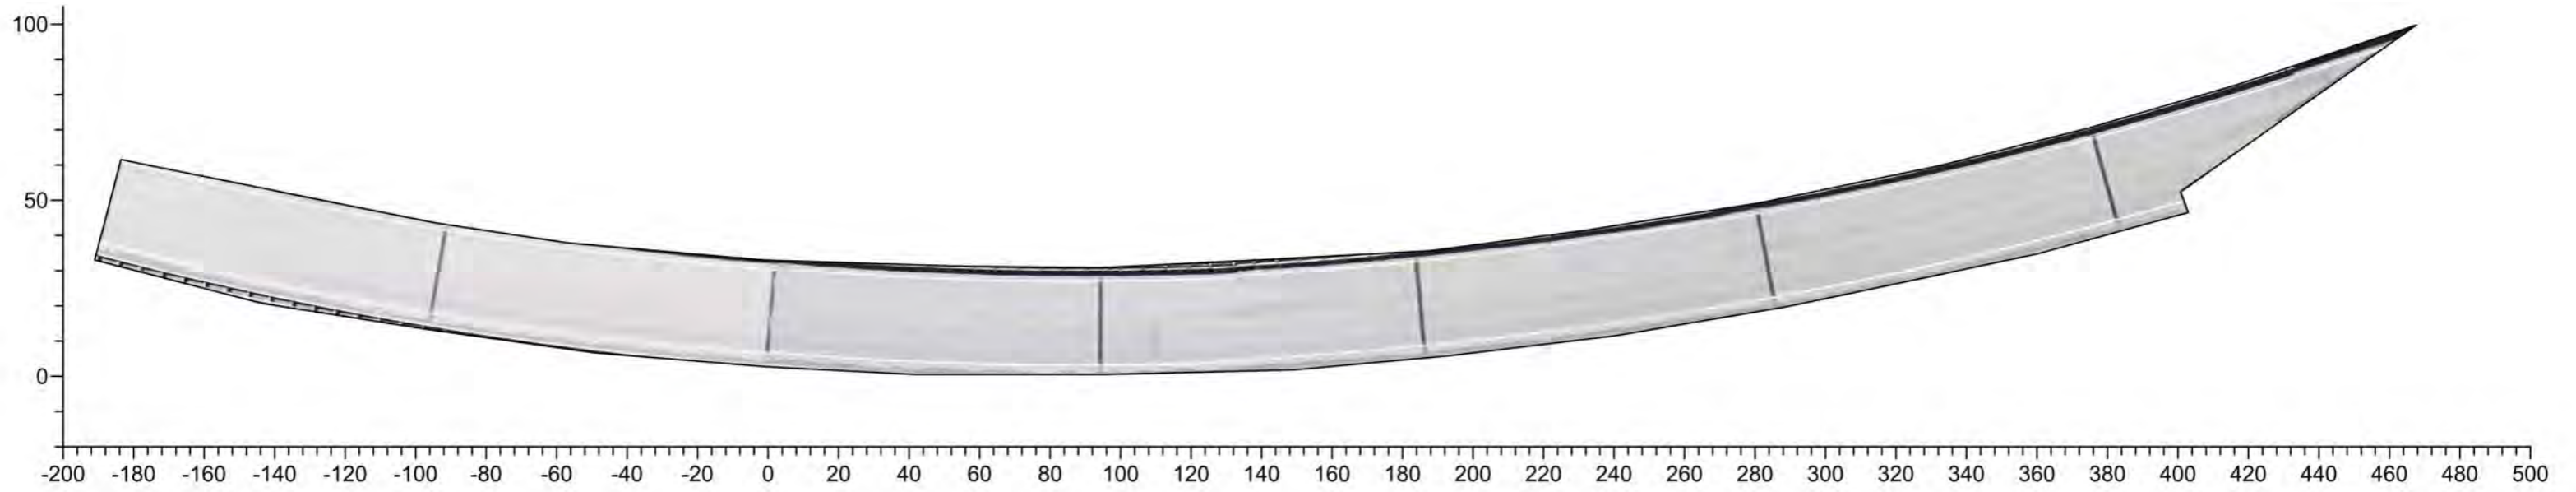
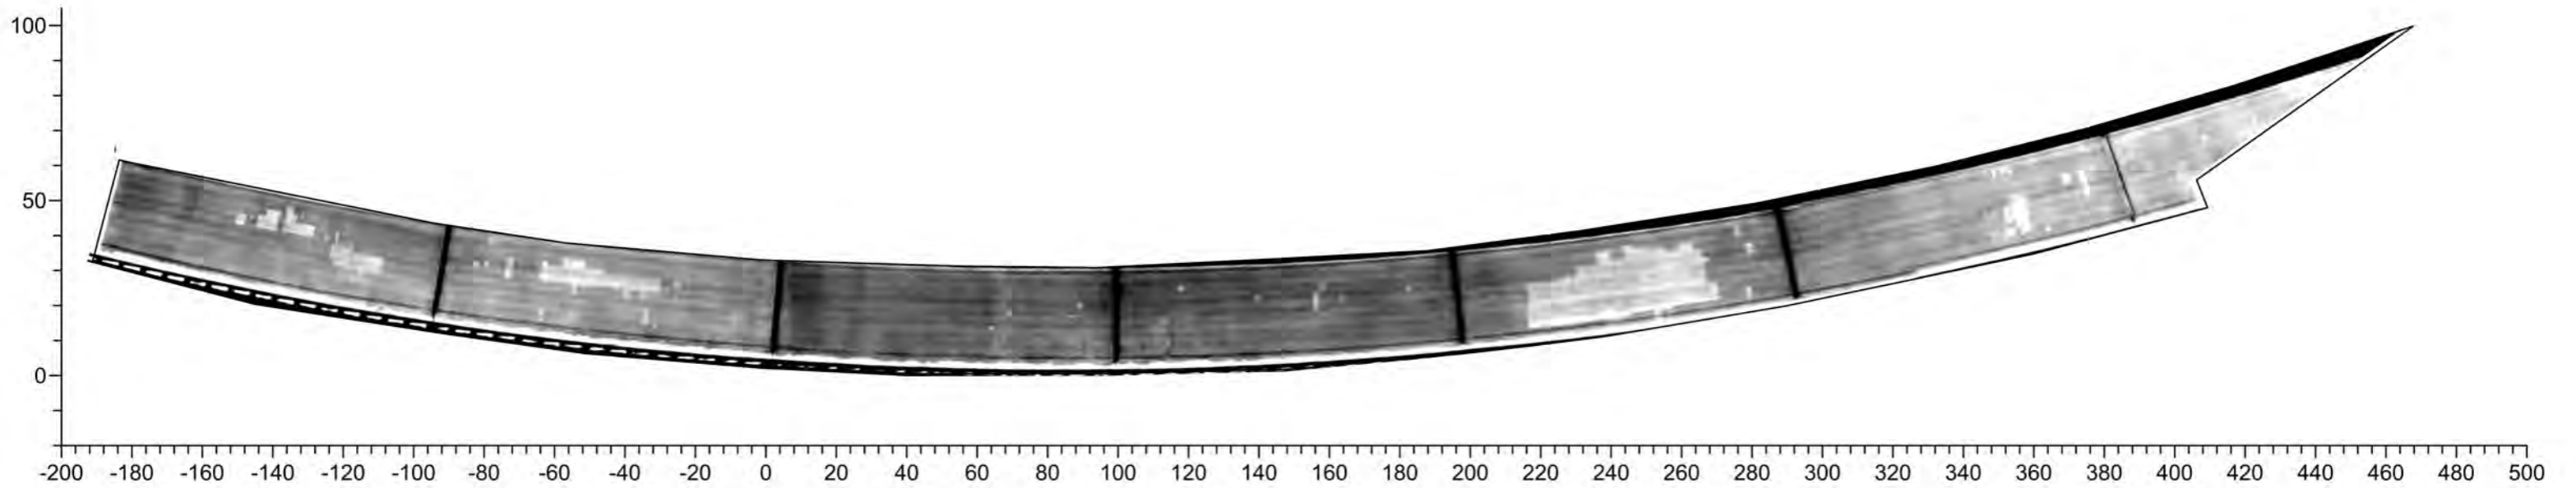
*Note: 1447 sq. ft. of thermal anomalies not mapped due to being rectilinear in shape and appearing more like subsurface patching or some other structural feature

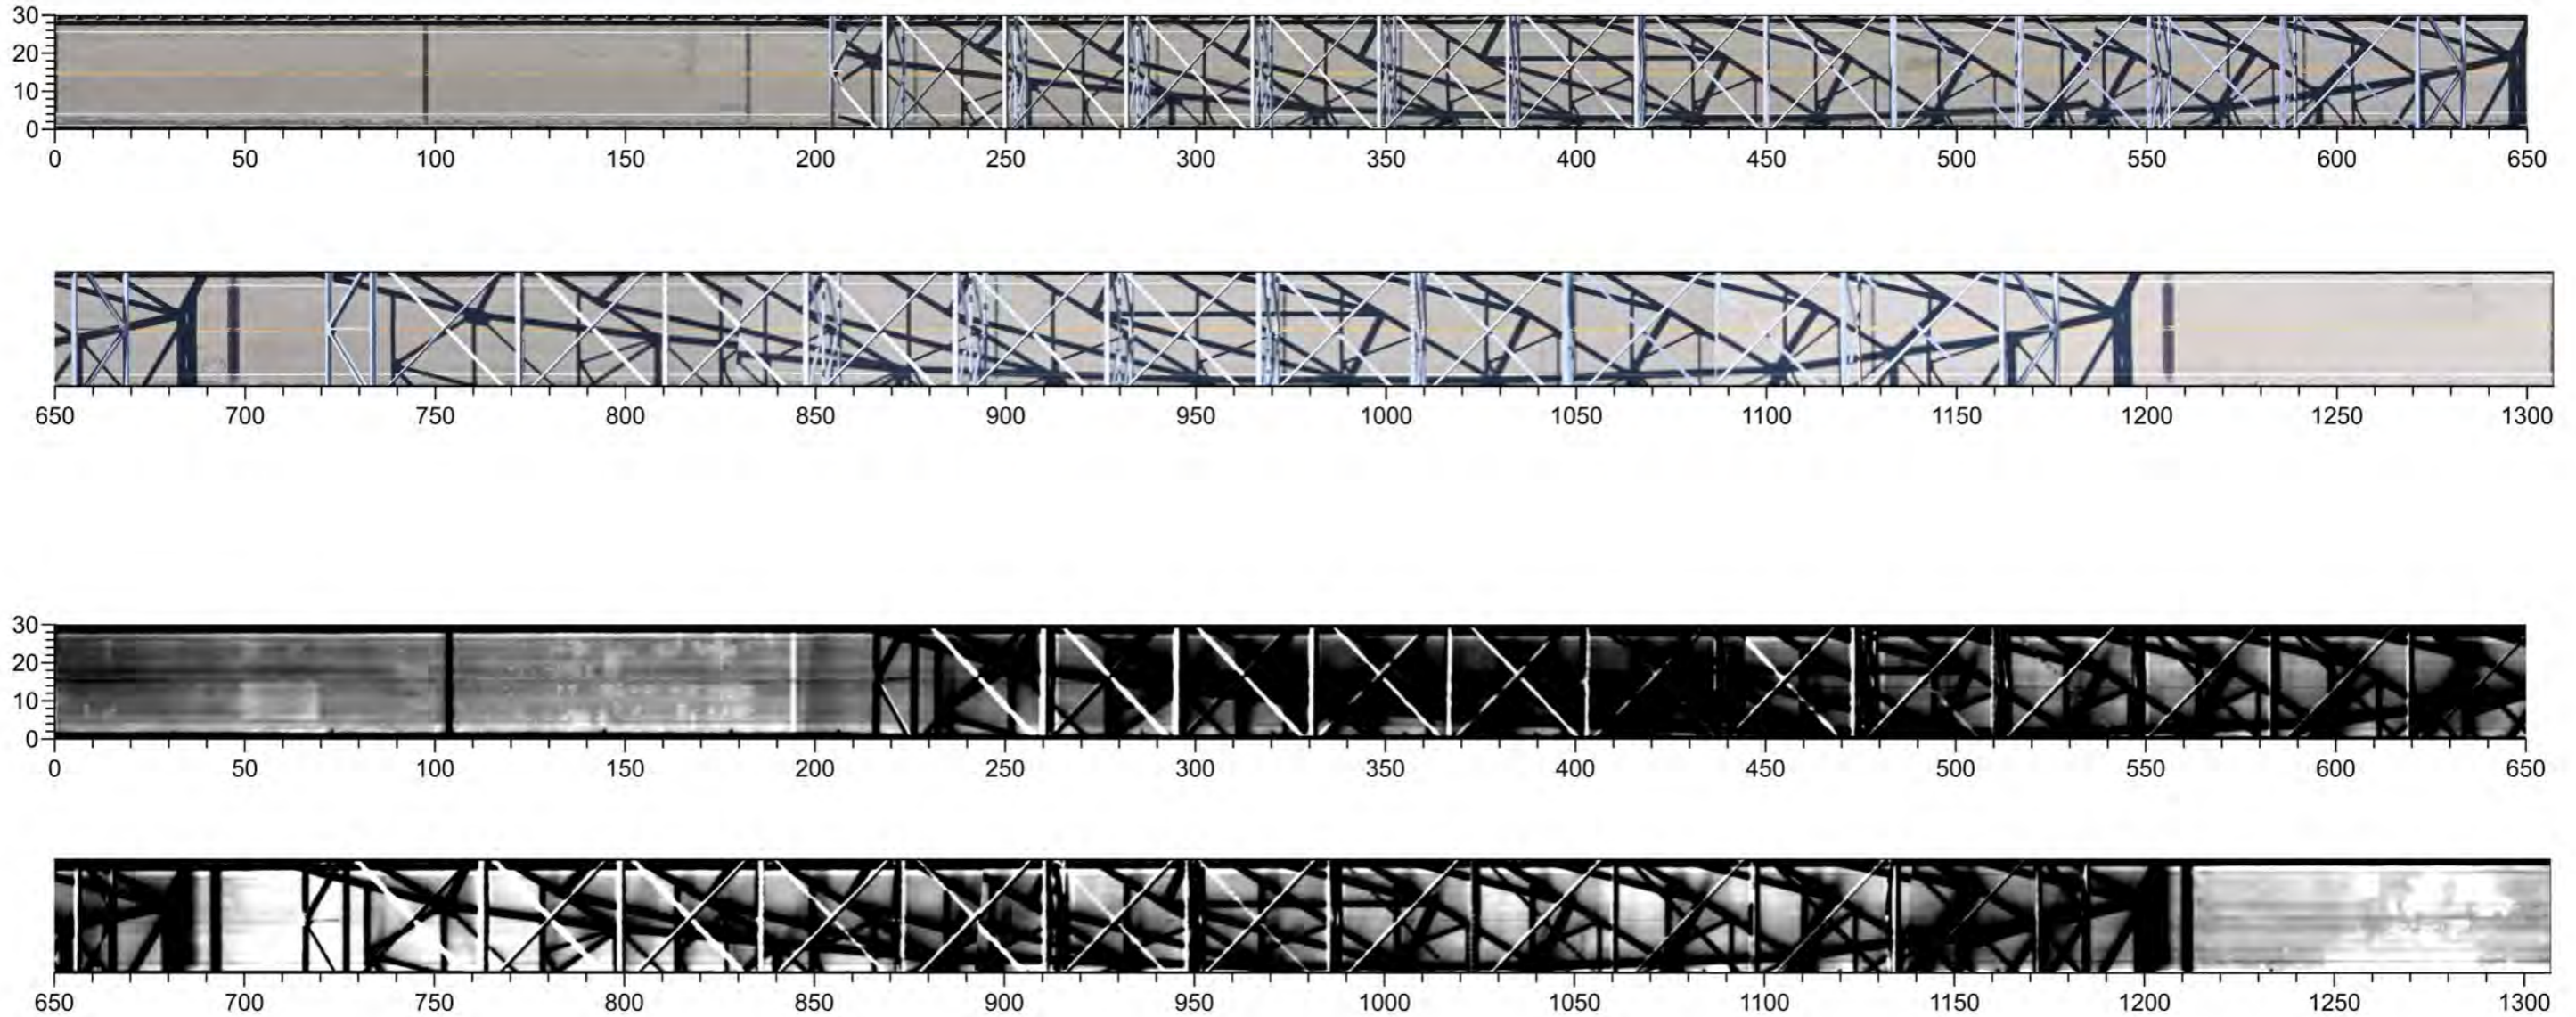
1304 sq. ft. of thermal anomalies not mapped due to being rectilinear in shape and appearing more like subsurface patching or some other structural feature

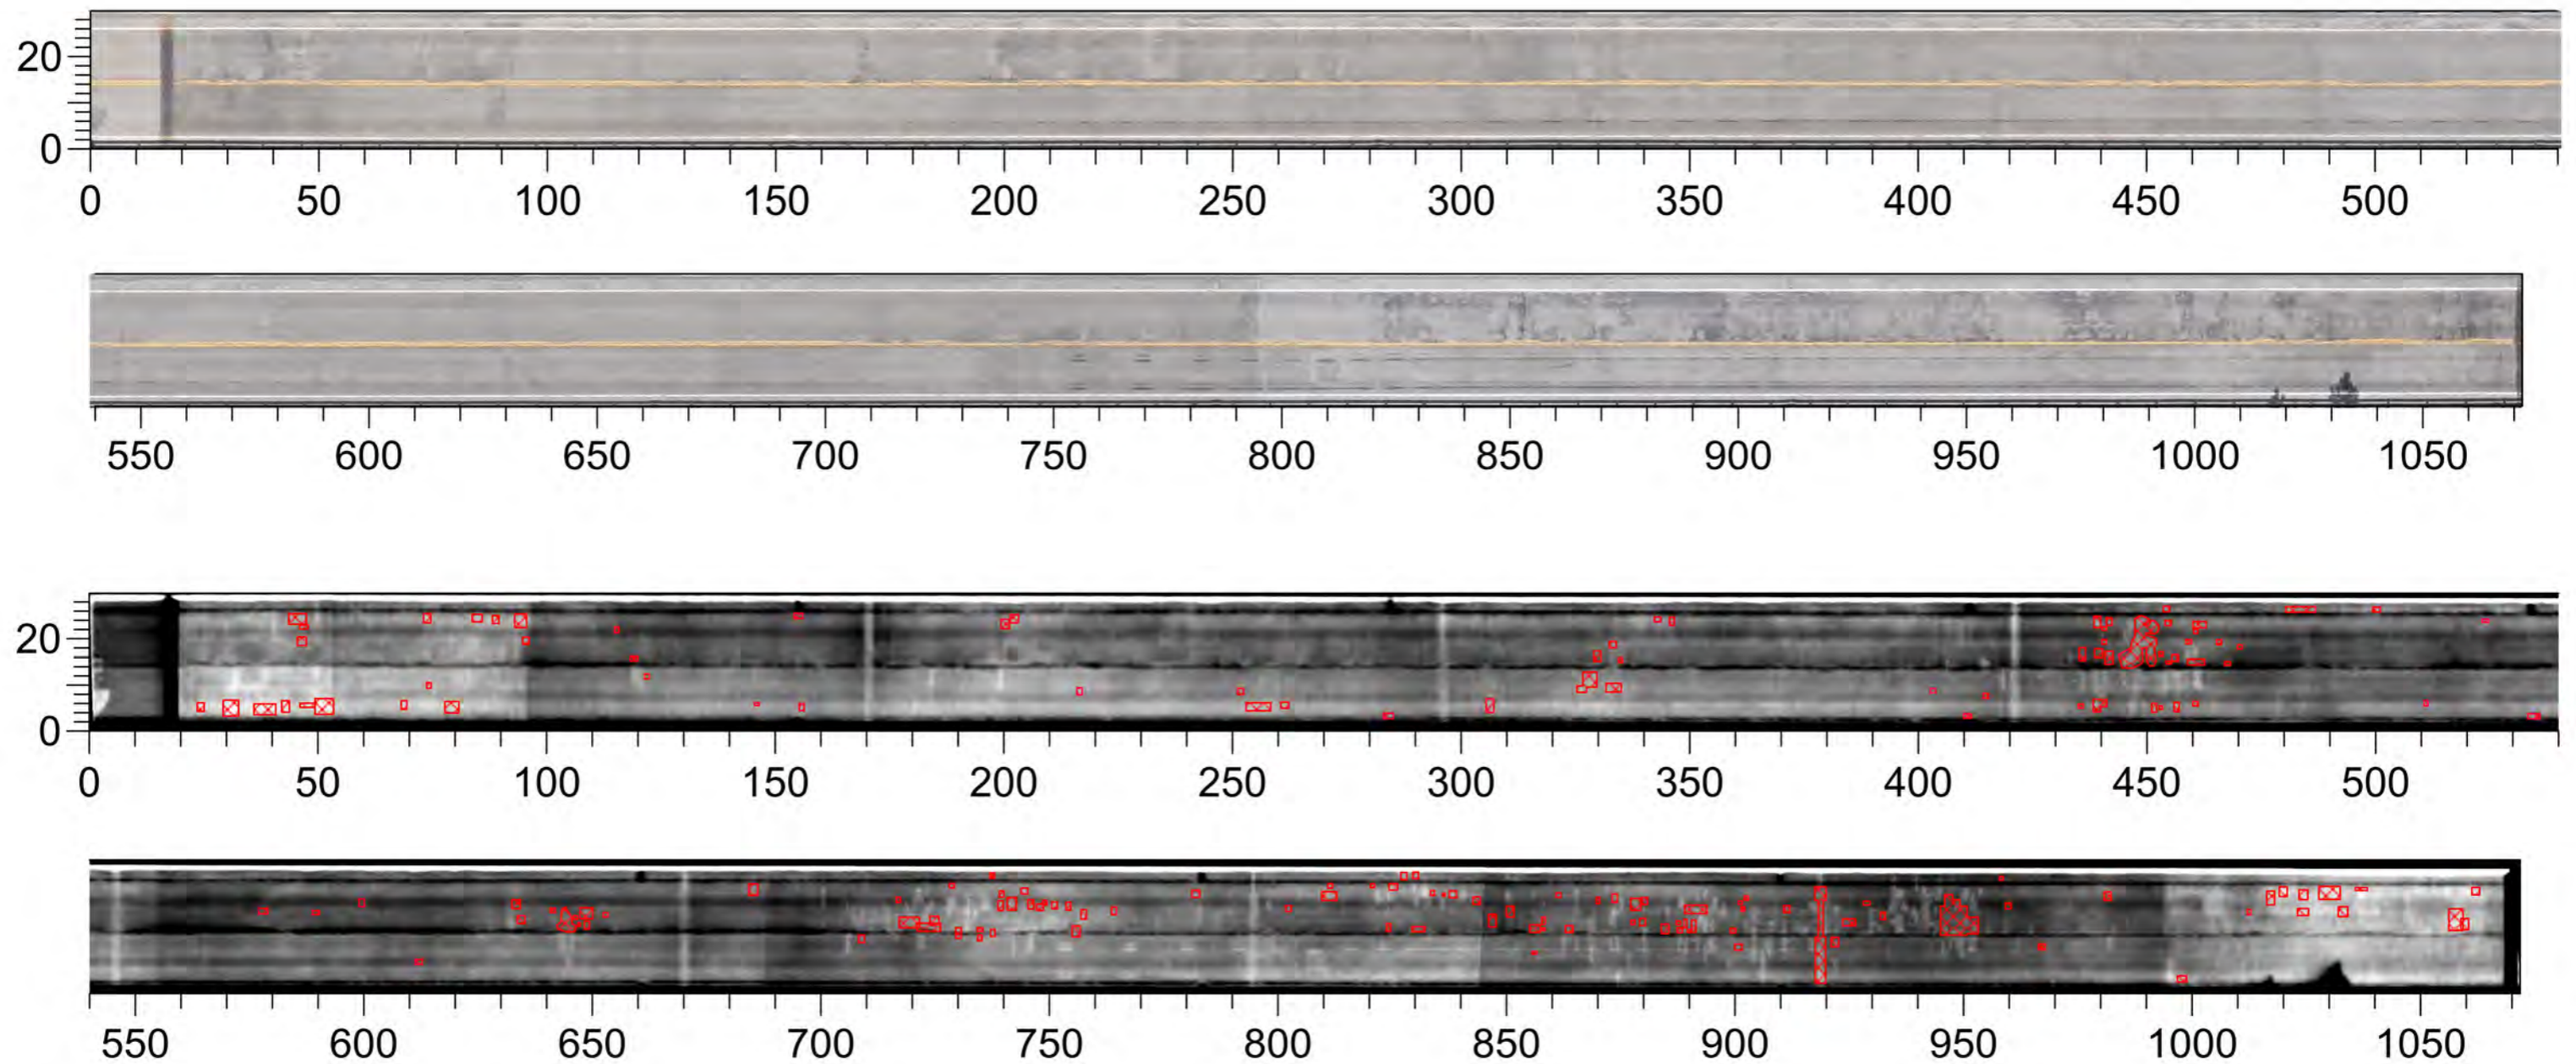
*Note: 948 sq. ft. of thermal anomalies not mapped due to being rectilinear in shape and appearing more like subsurface patching or some other structural feature

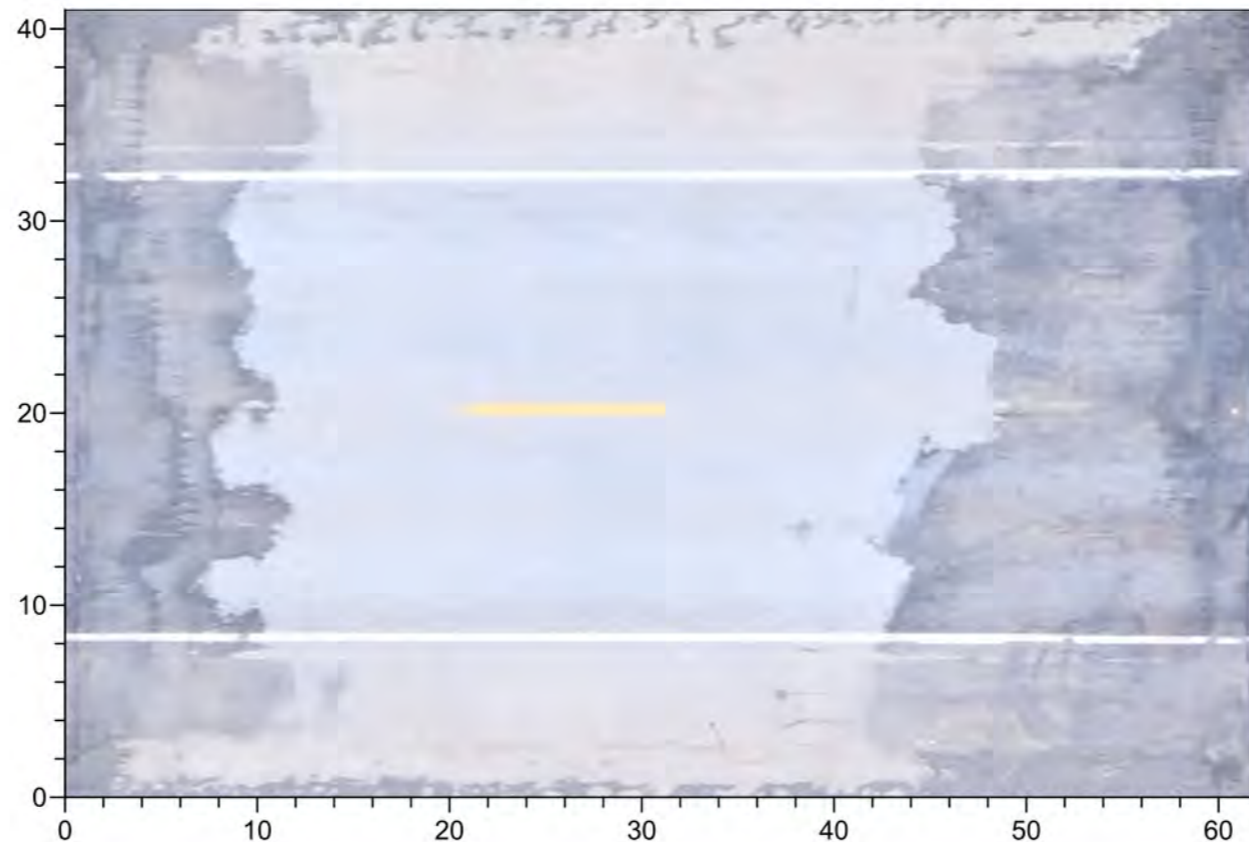
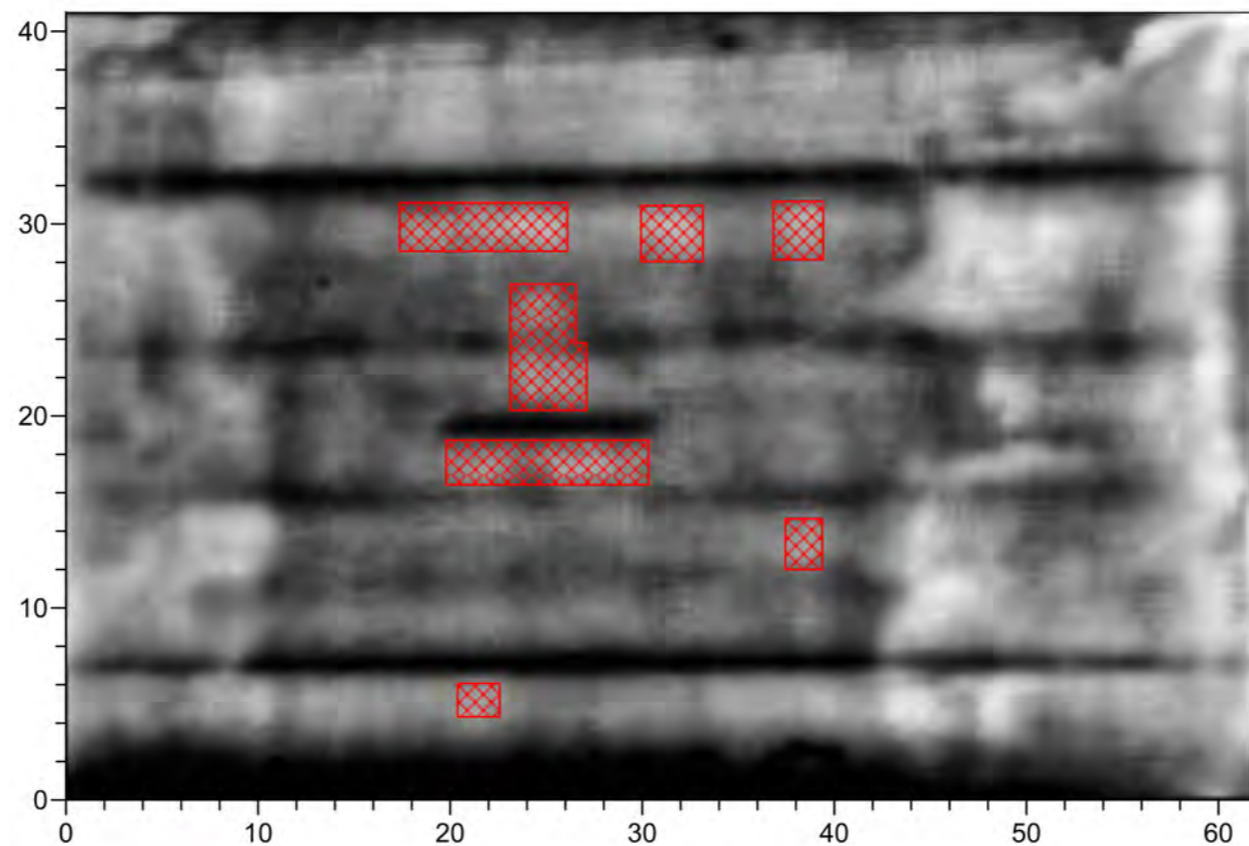
*Note: Irregular surface conditions at ends of bridge represent 1078 sq. ft.. If this area is removed from the analysis, then the results would show 6.6% of the deck area as delaminated.

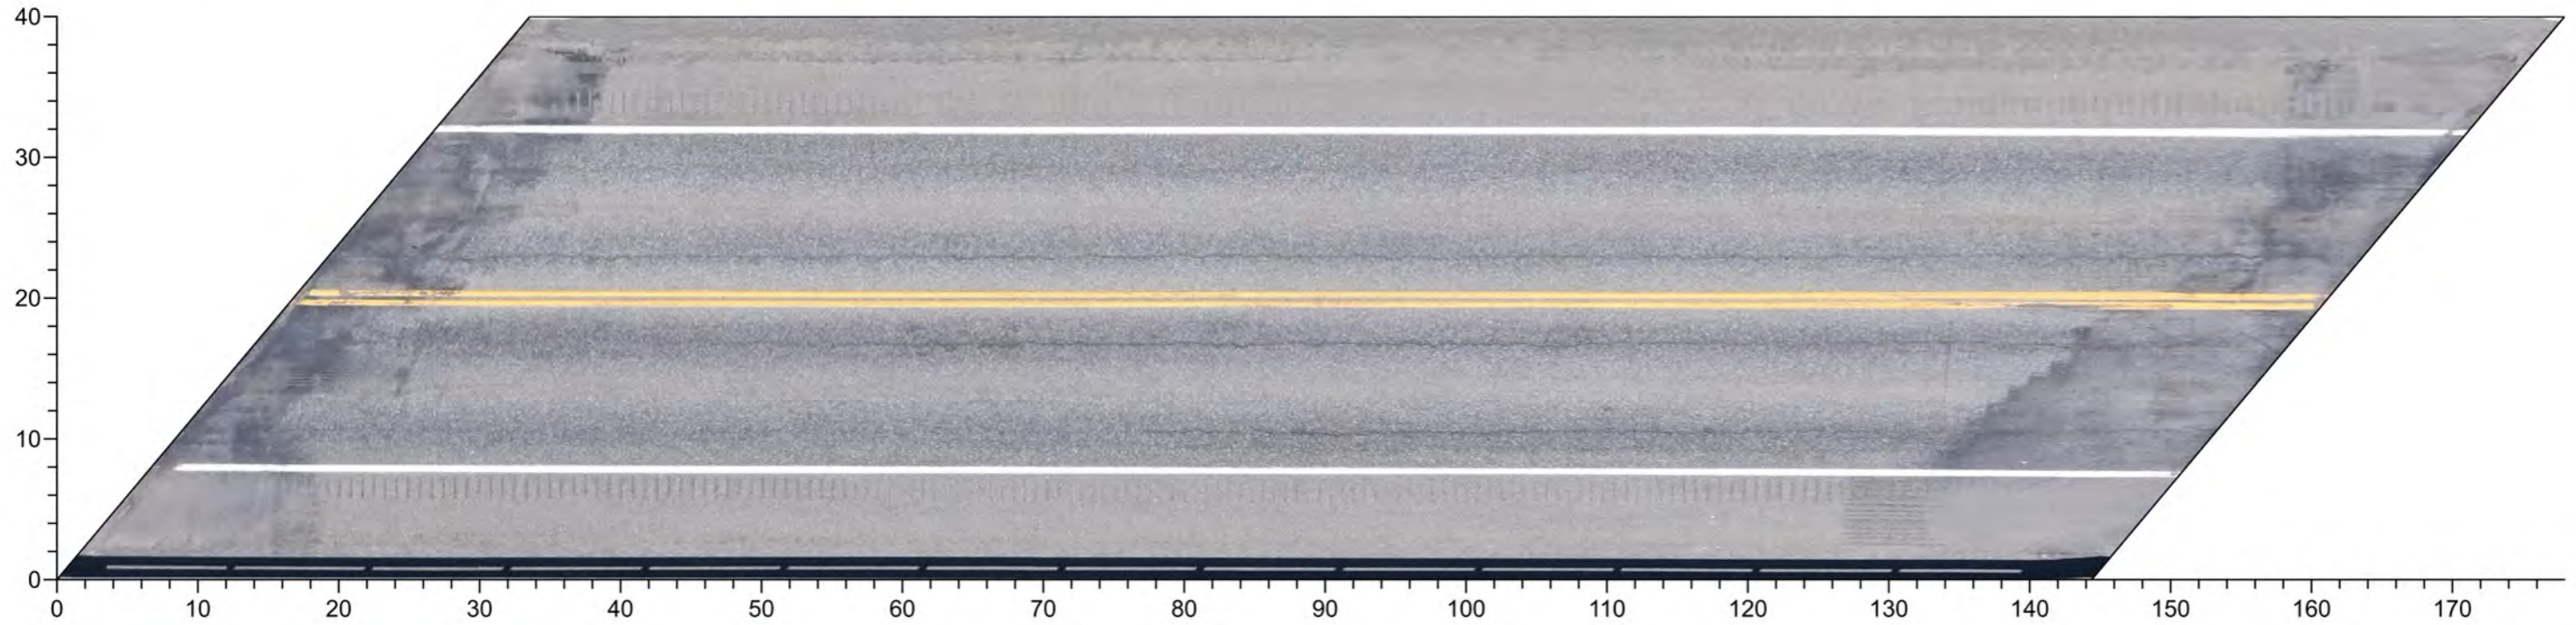
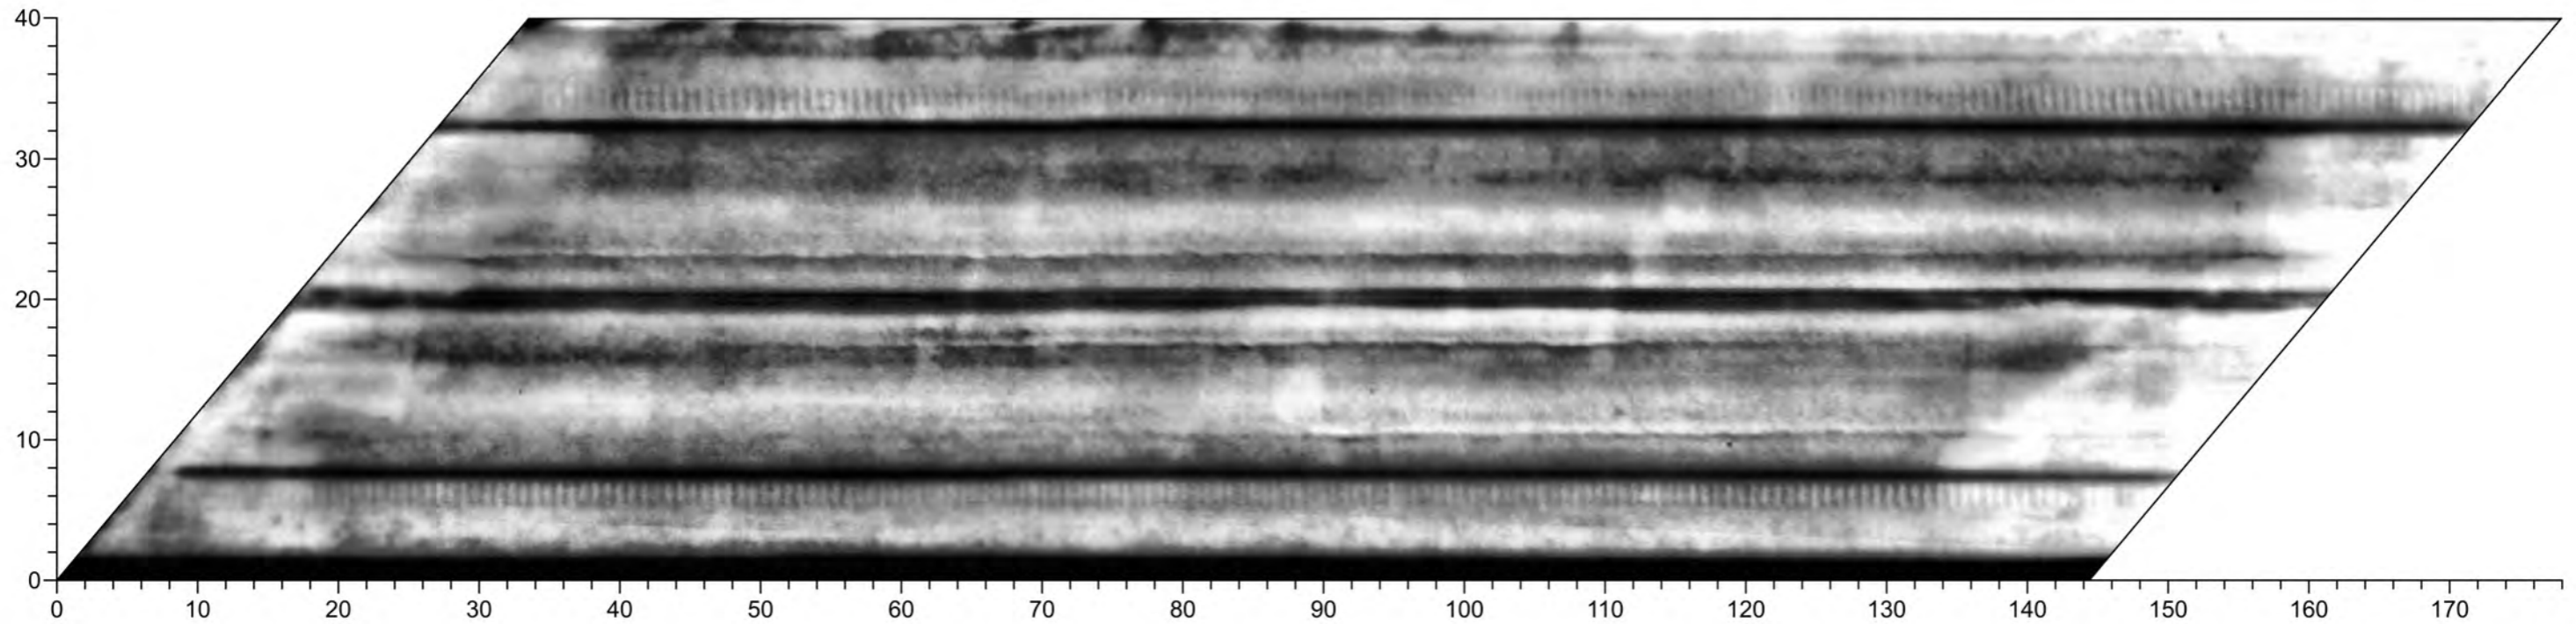
*Note: 59 sq. ft. of thermal anomalies not mapped due to being rectilinear in shape and appearing more like subsurface patching or some other structural feature

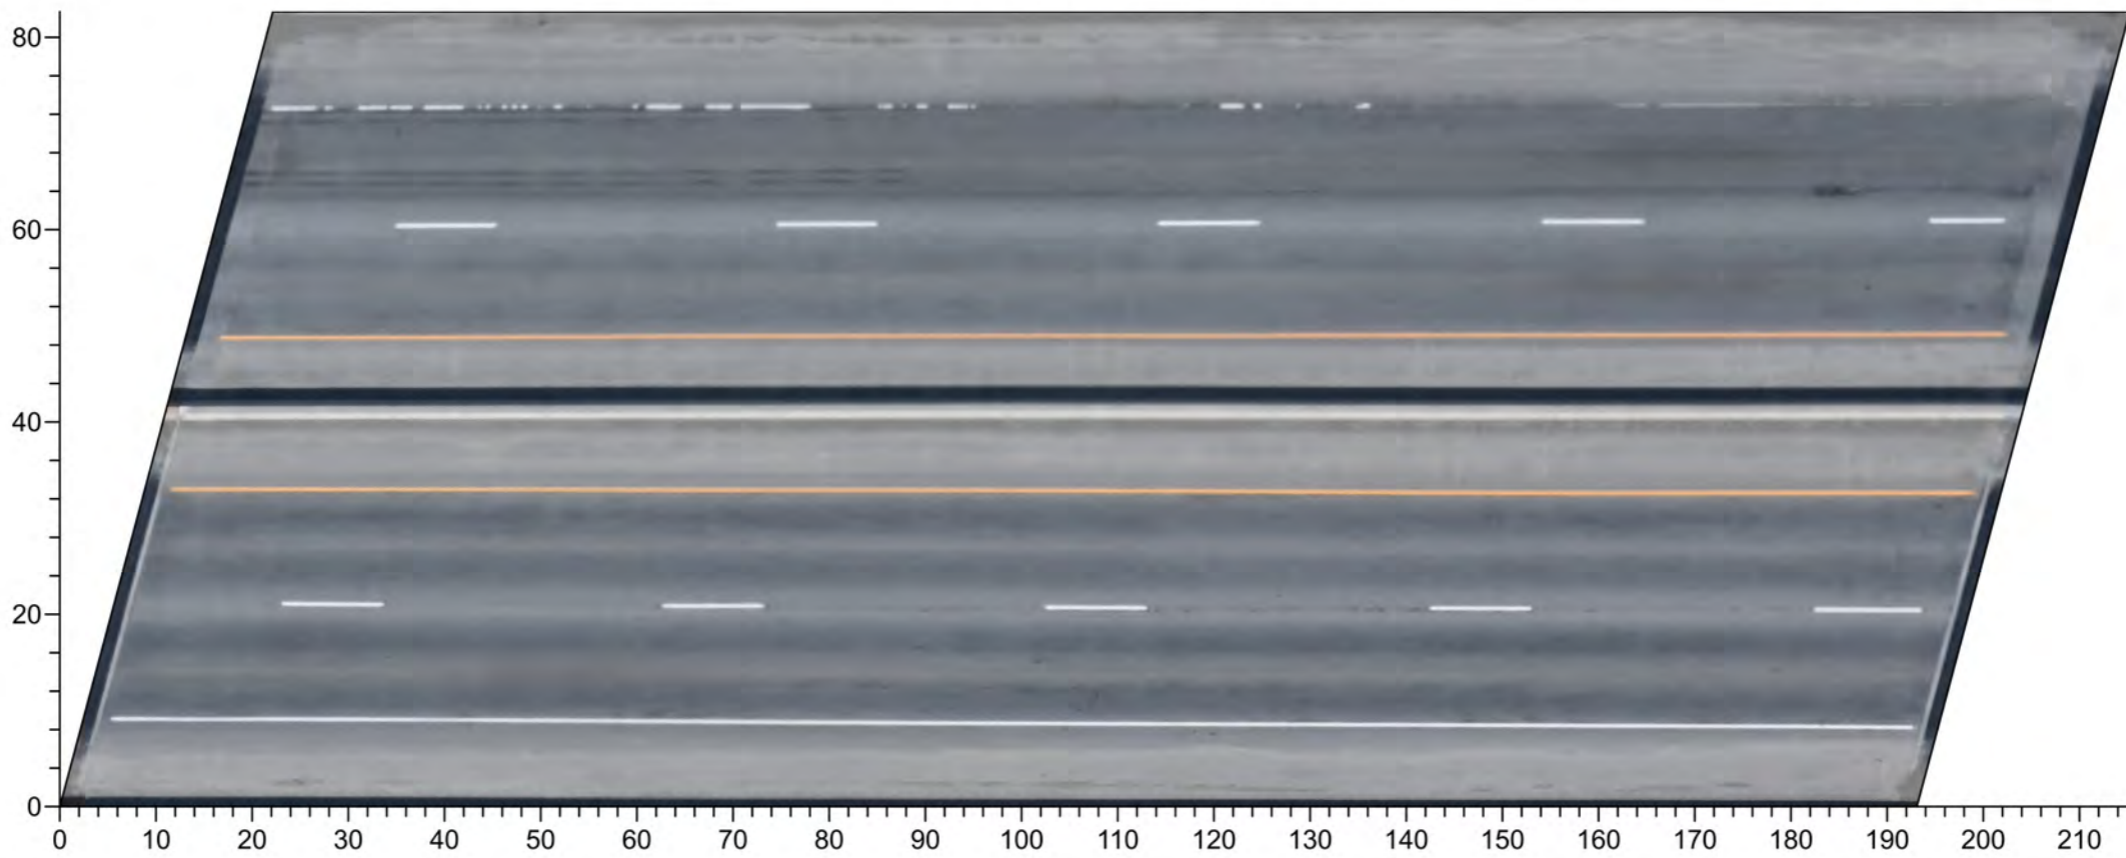
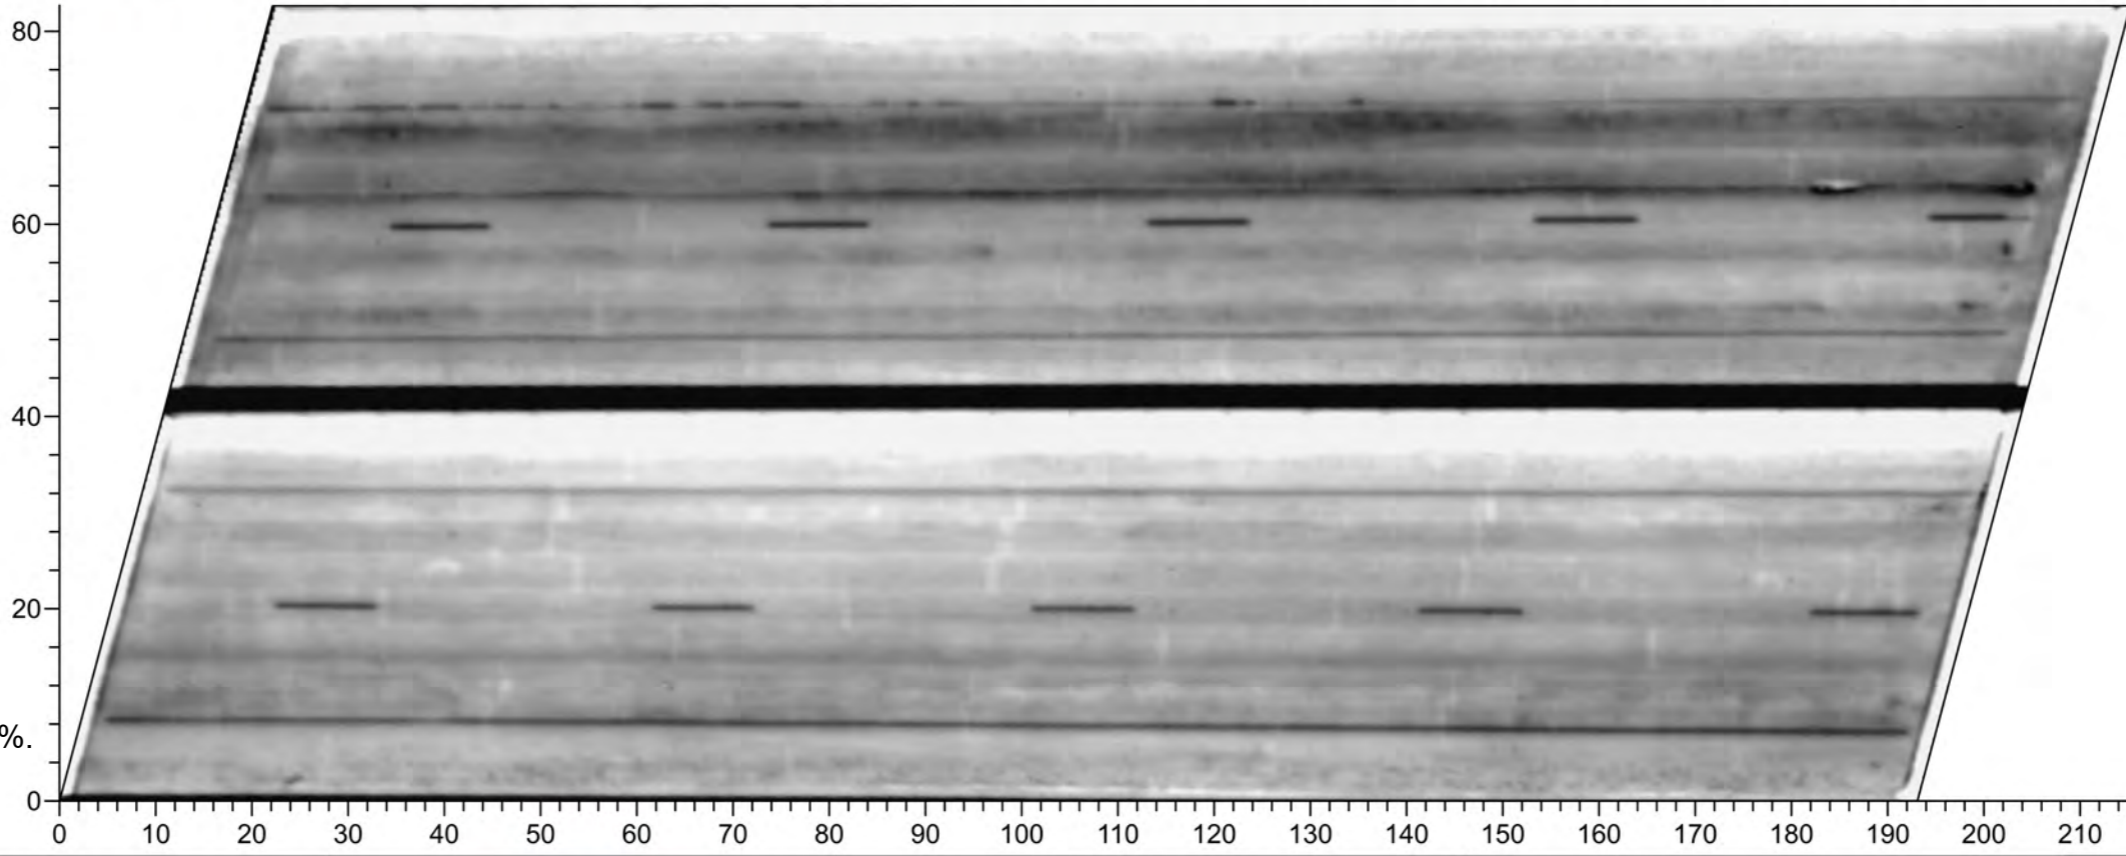
*Note: 184 sq. ft. of thermal anomalies not mapped due to being rectilinear in shape and appearing more like subsurface patching or some other structural feature

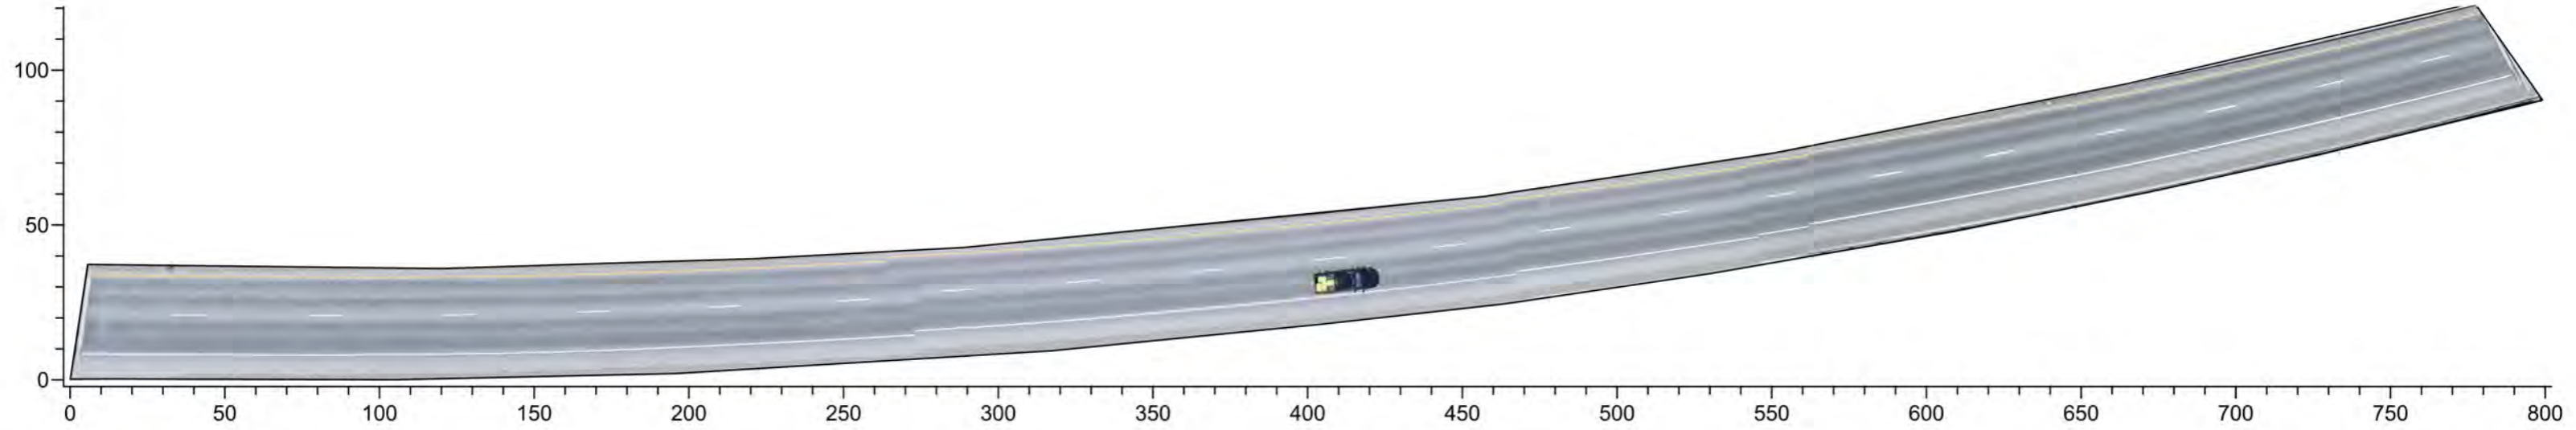
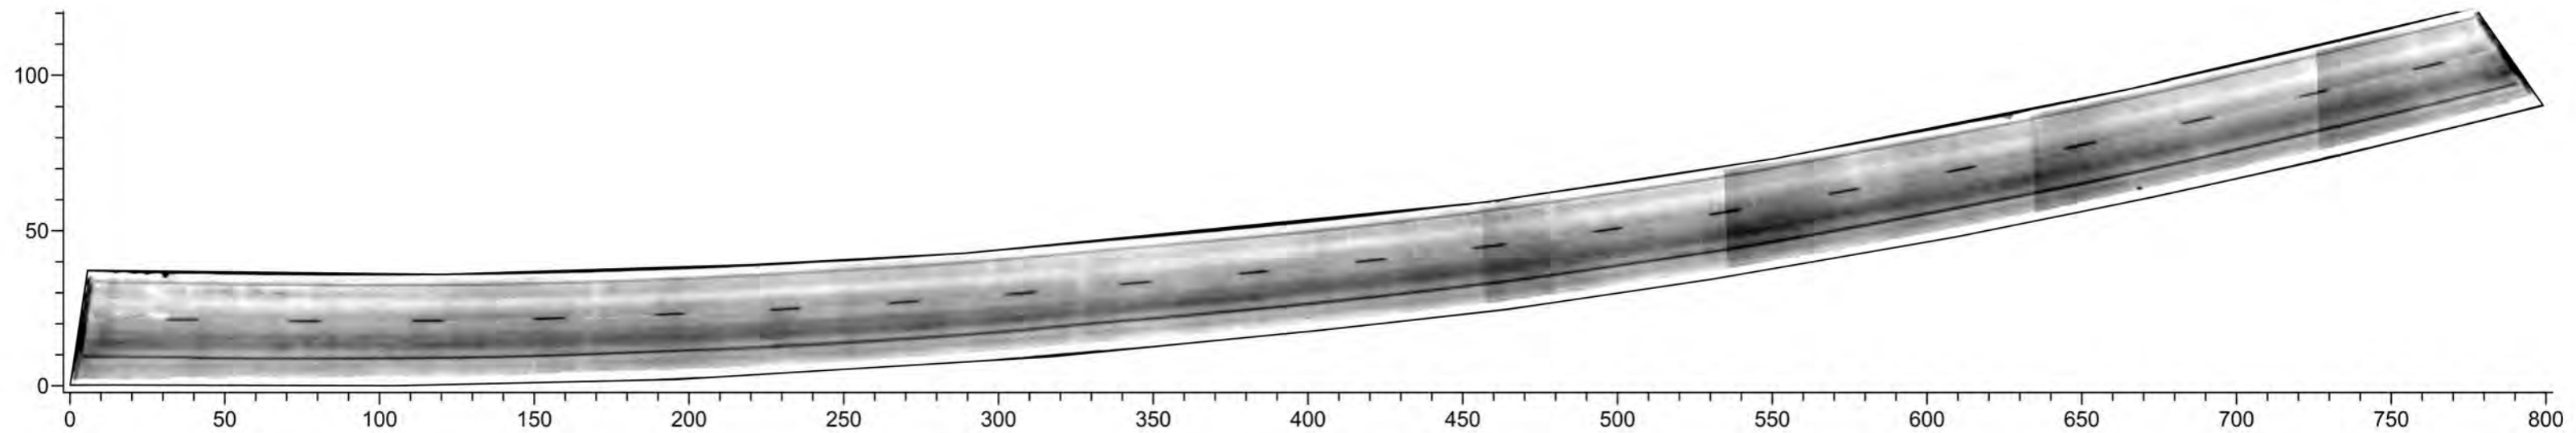
*Note: 155 sq. ft. of thermal anomalies not mapped due to being rectilinear in shape and appearing more like subsurface patching or some other structural feature

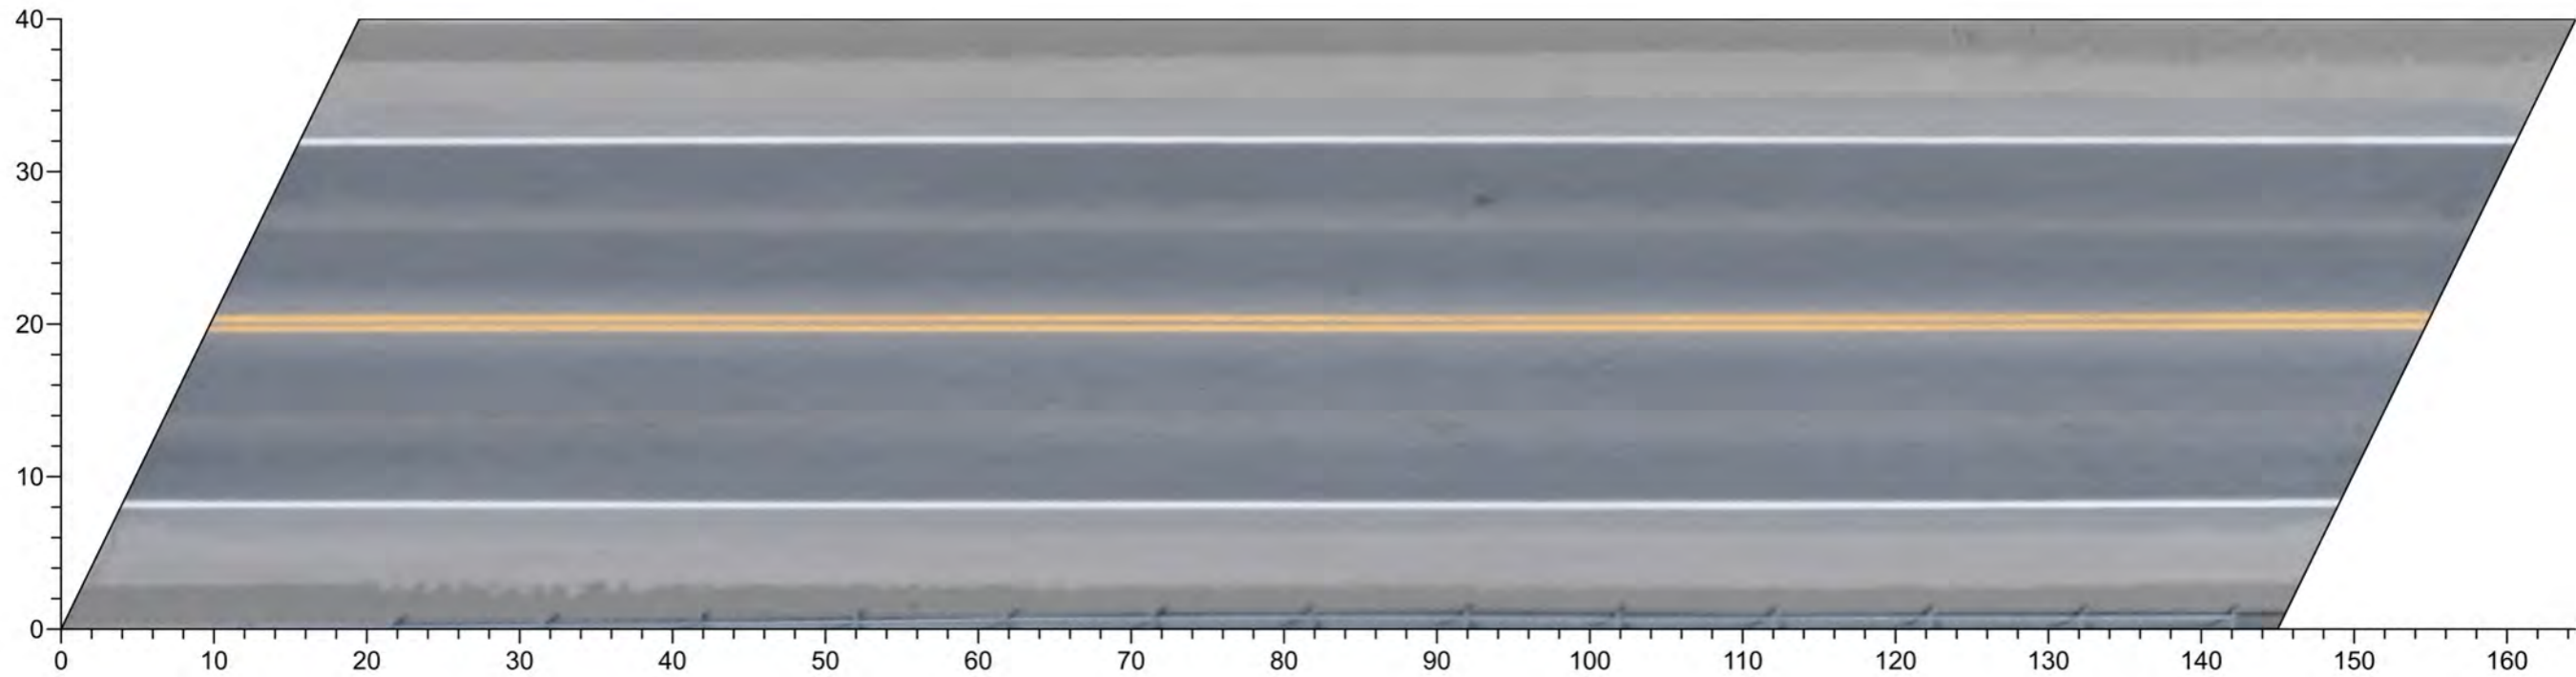
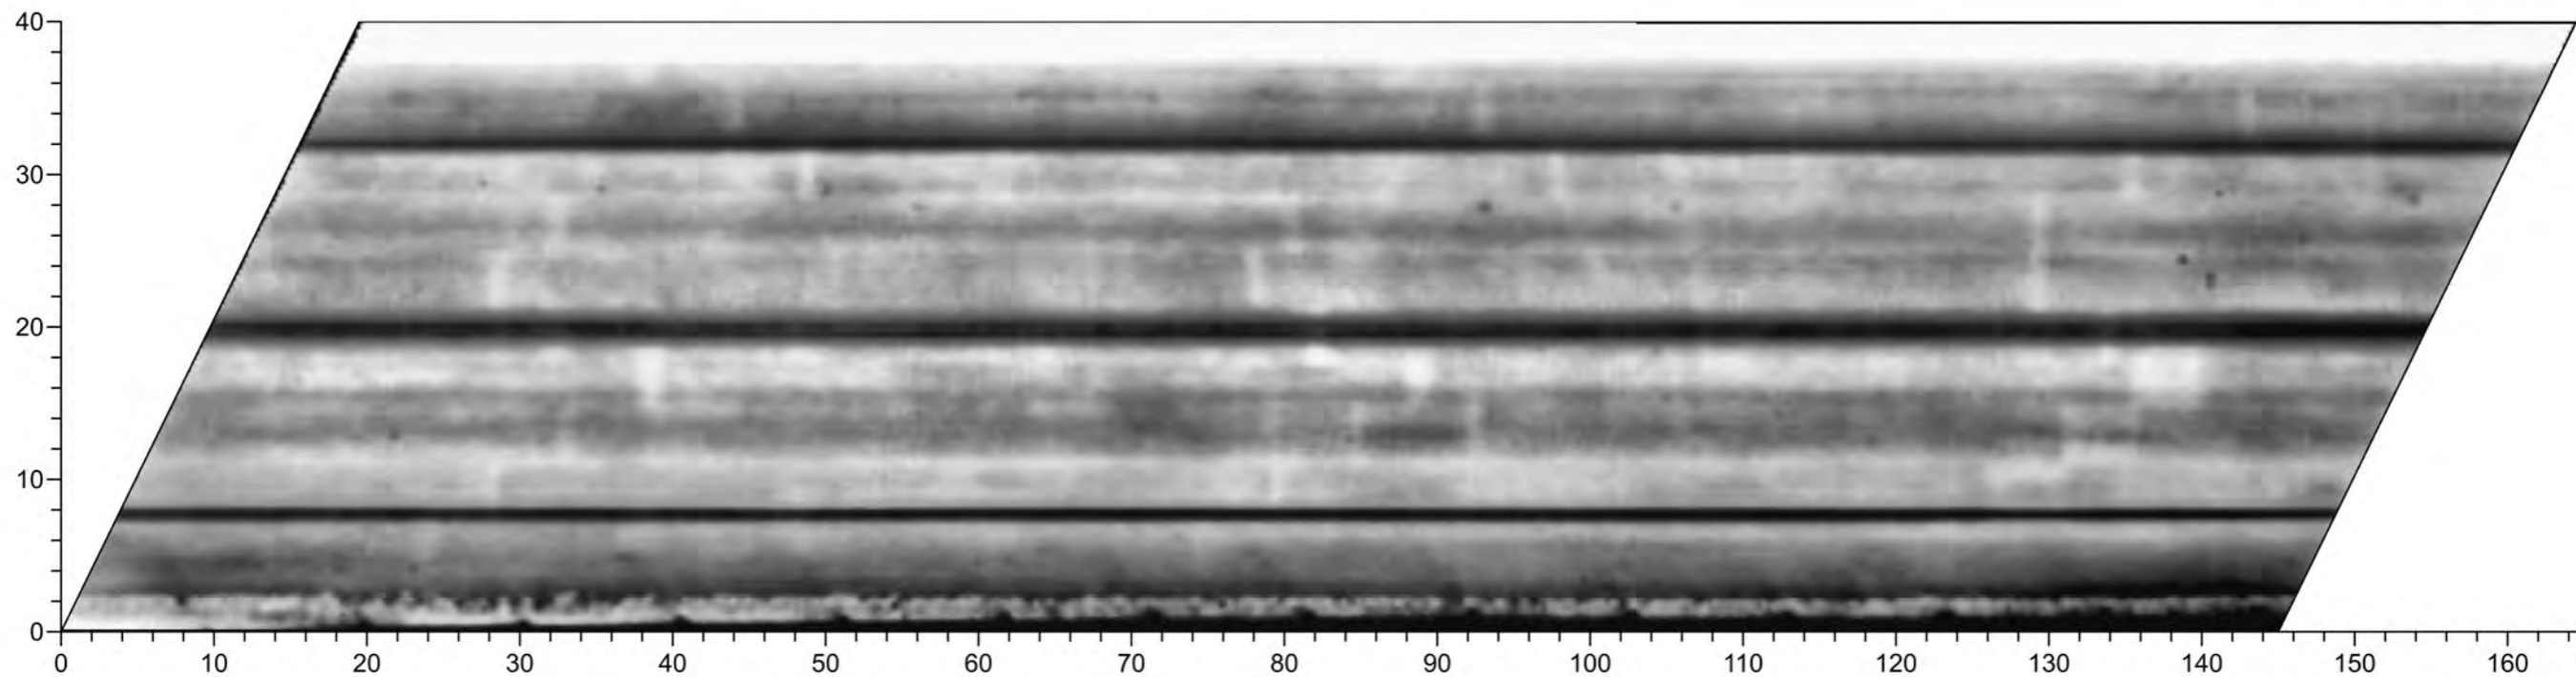
Delamination Quantity (%)	0.3	
			Delamination Quantity (ft ²)	21

*Note: 160 sq. ft. of thermal anomalies not mapped due to being rectilinear in shape and appearing more like subsurface patching or some other structural feature
