Aerial Infrared Scanning of Bridge Decks on Parks Highway to Map Delaminations

FINAL REPORT

Prepared by:
Infrasense, Inc.
Woburn, MA

Report # FHWA-AK-RD-000S(960)
March 2, 2023

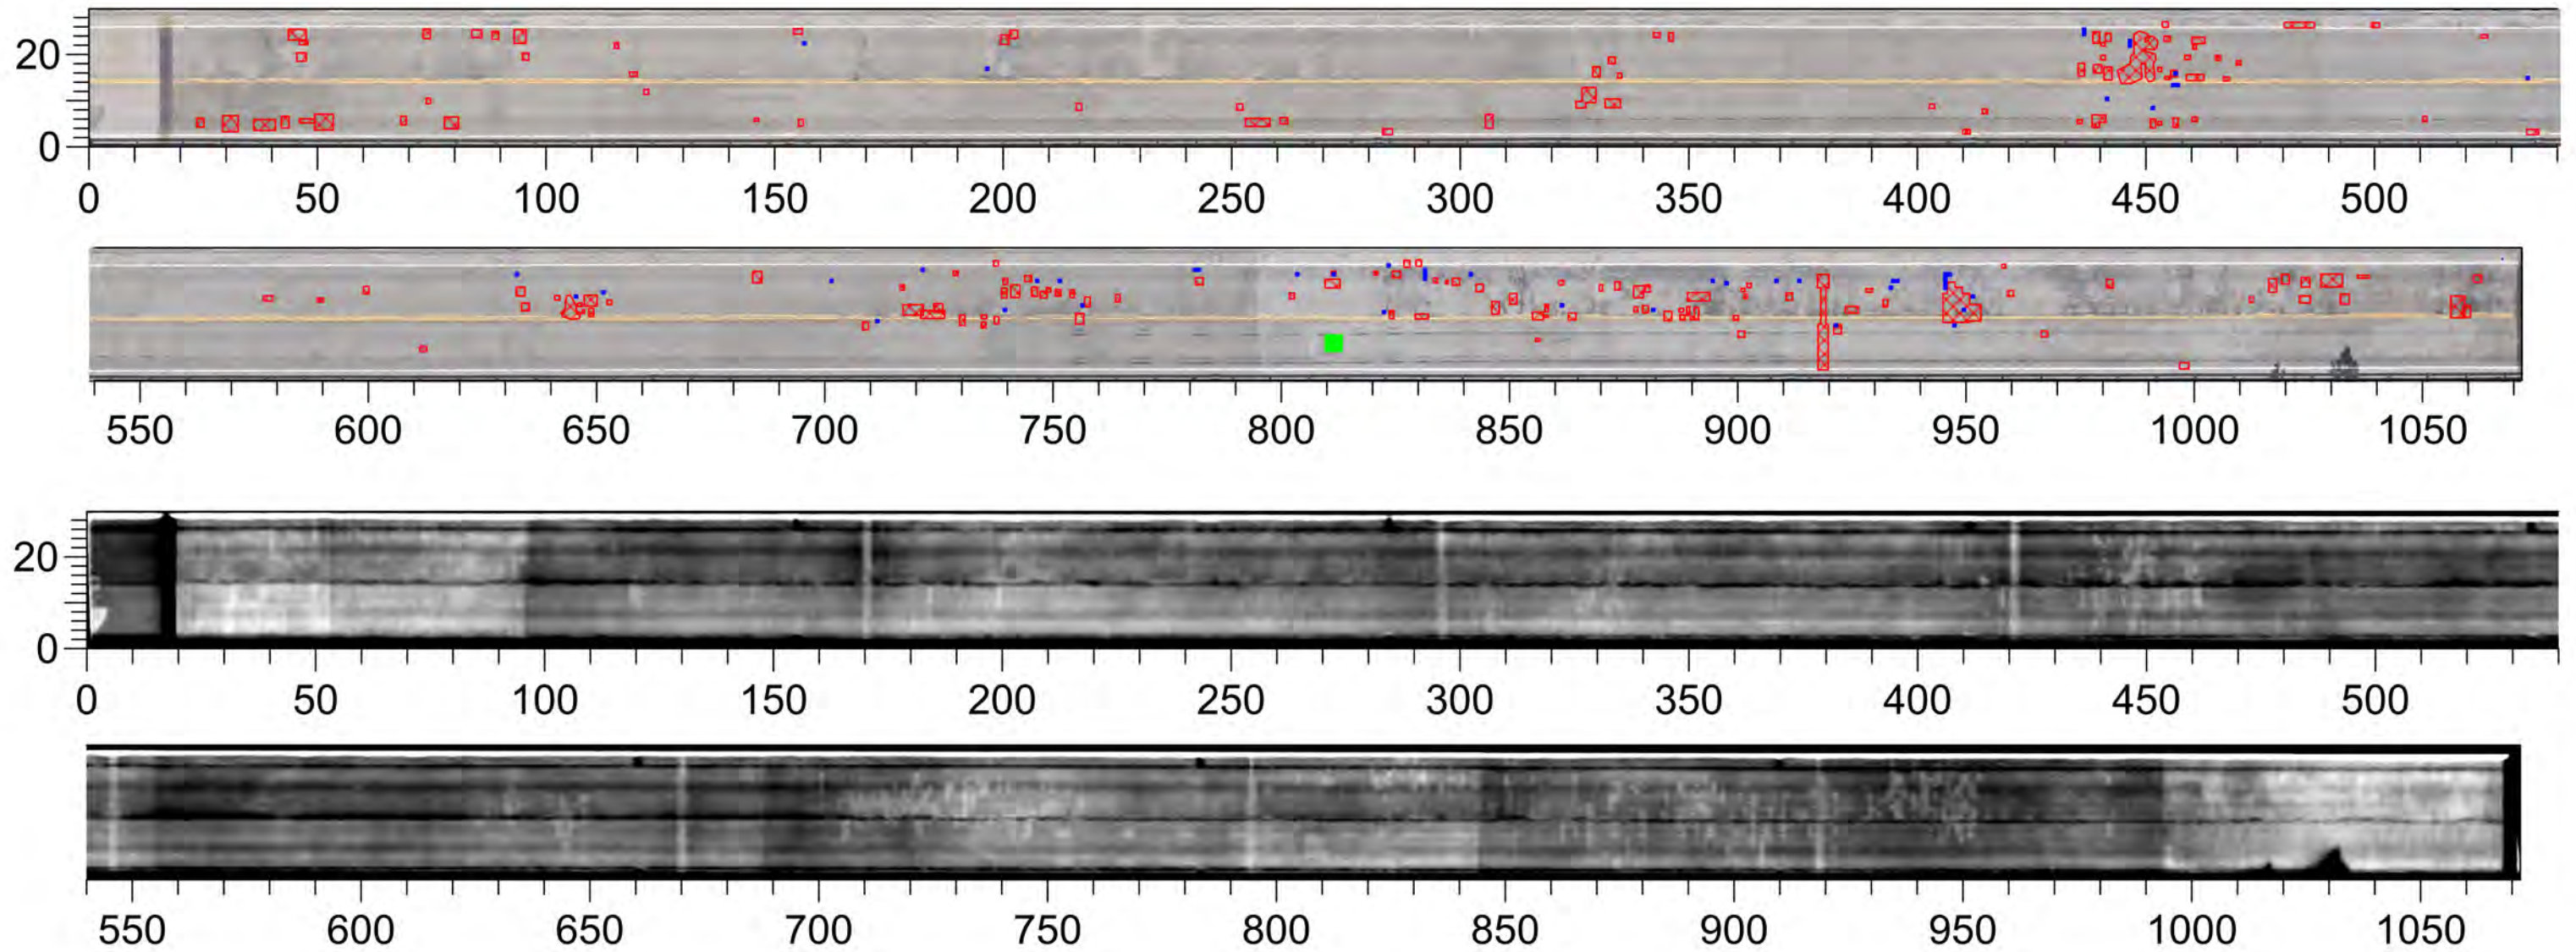
*Note: 948 sq. ft. of thermal anomalies not mapped due to being rectilinear in shape and appearing more like subsurface patching or some other structural feature

Chain Drag Delamination Quantity (%)	Chain Drag Delamination Quantity (ft ²)	Chain Drag Patching Quantity (%)	Chain Drag Patching Quantity (ft ²)
0.2	50	0.1	16
