Alaska Department of Transportation & Public Facilities  
**Research & Technology Transfer**

# Experimental Study of Various Techniques to Protect Ice-Rich Cut Slopes

August 2014

**Number:** 4000(113)B

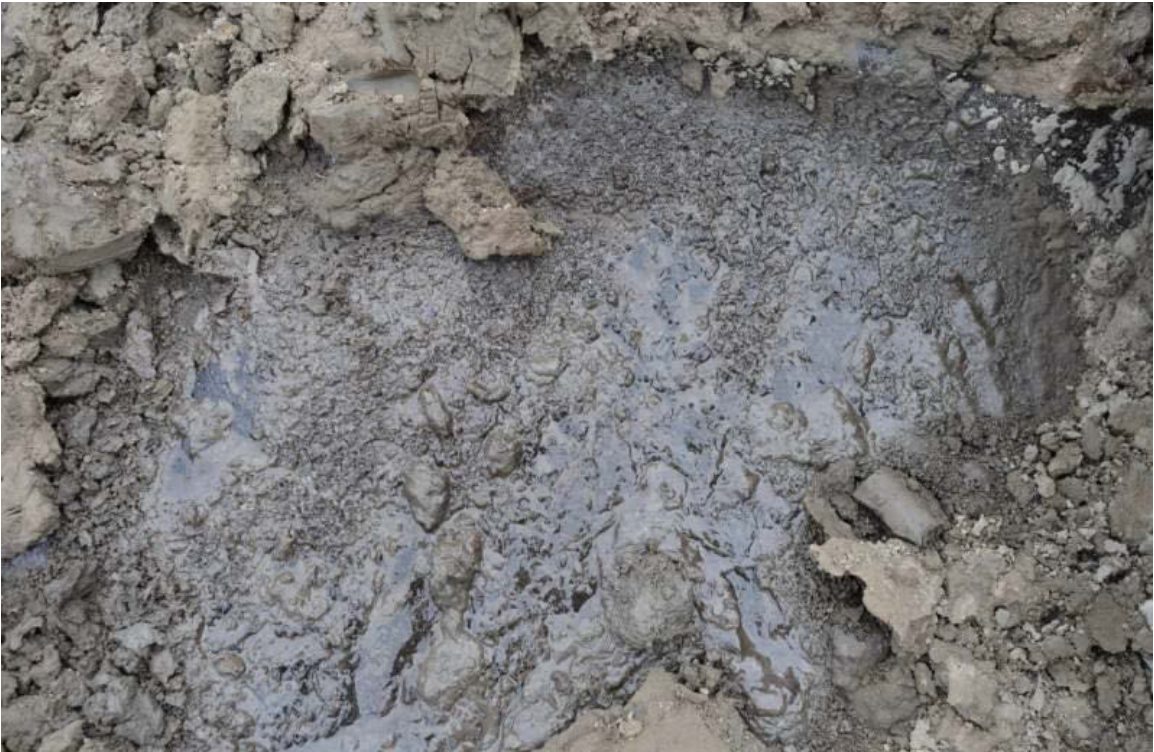
**Figure 4.9 Ice exposed in the cut slope**

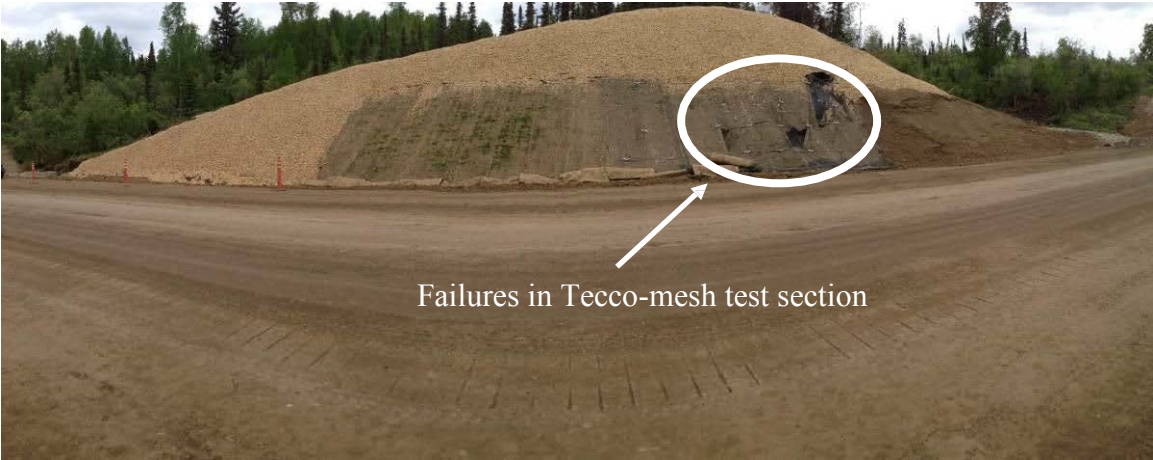
suspended one to several ft above the present soil/ice surface. At that time, none of the Tecco-mesh and only small areas of the coconut matting within Section C had failed.

**Figure 6.1 Panorama view of Experimental Feature showing failure in Tecco-mesh section**

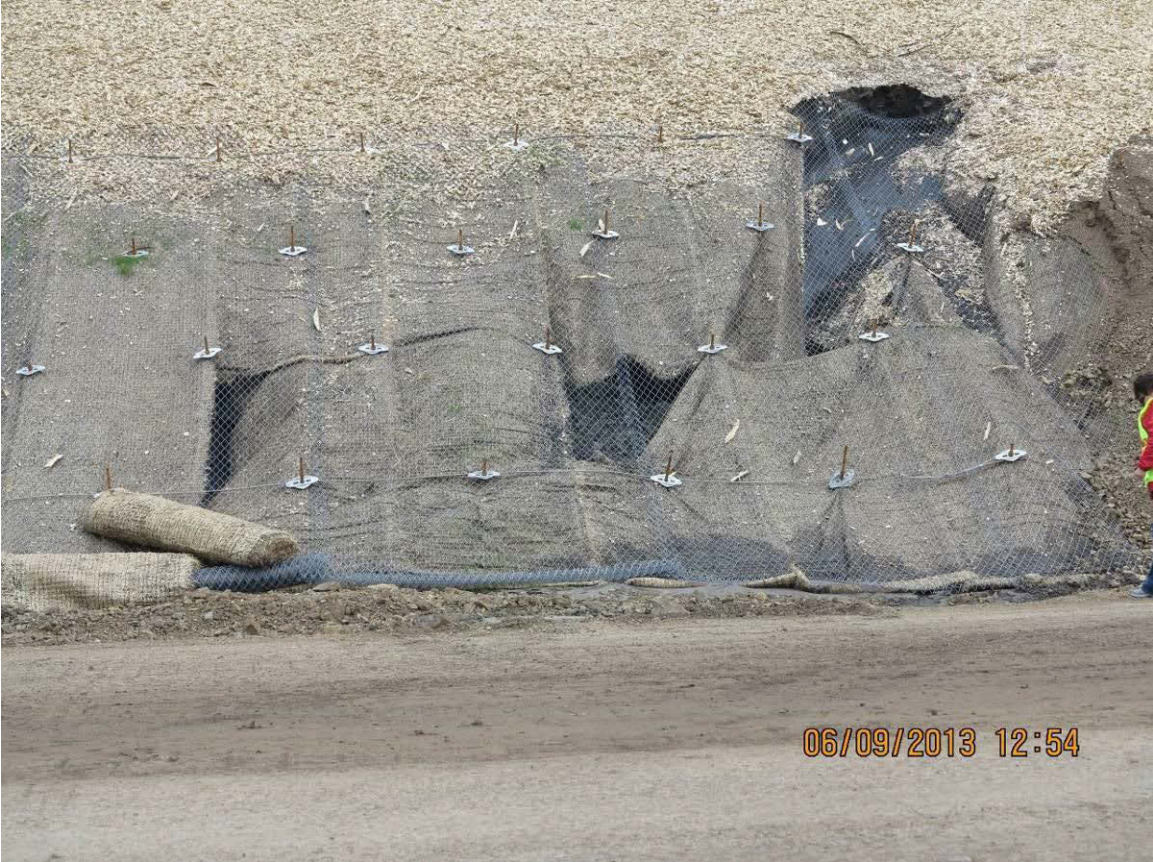
**Figure 6.2 Close view of failure within the Tecco-mesh section**

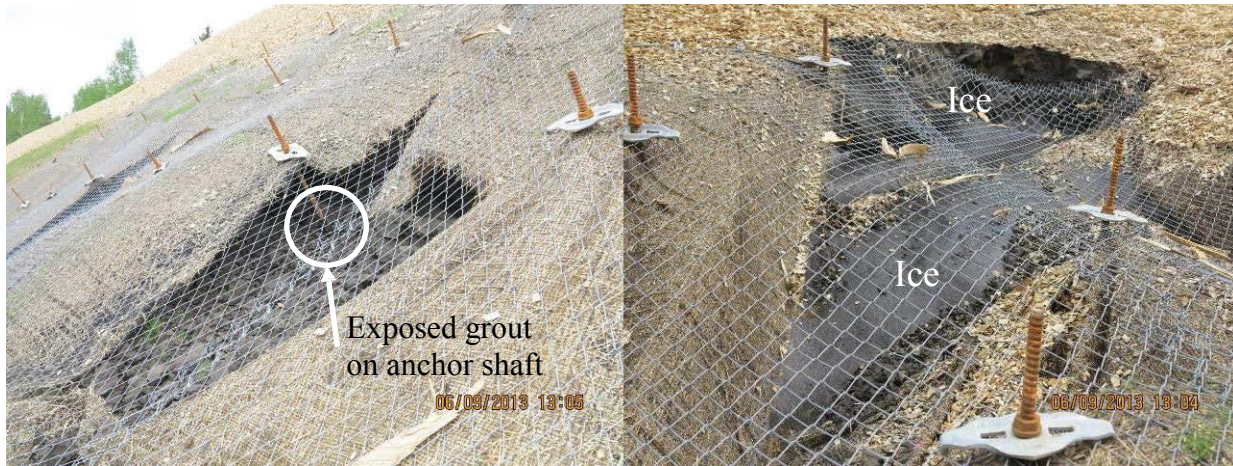
The significant loss of material from the original cut slope is evident in the left side of Figure 6.3, where the anchor grout is exposed. The depth from cut slope face to top-of-grout was 3 ft. The lighter gray material labeled in the right side of Figure 6.3 is some of the massive ground ice that caused serious problems with the Tecco-mesh experimental section.

**Figure 6.3 Close views showing exposure of soil anchor grout (left) and portion of massive ice feature under Tecco-mesh (right)**

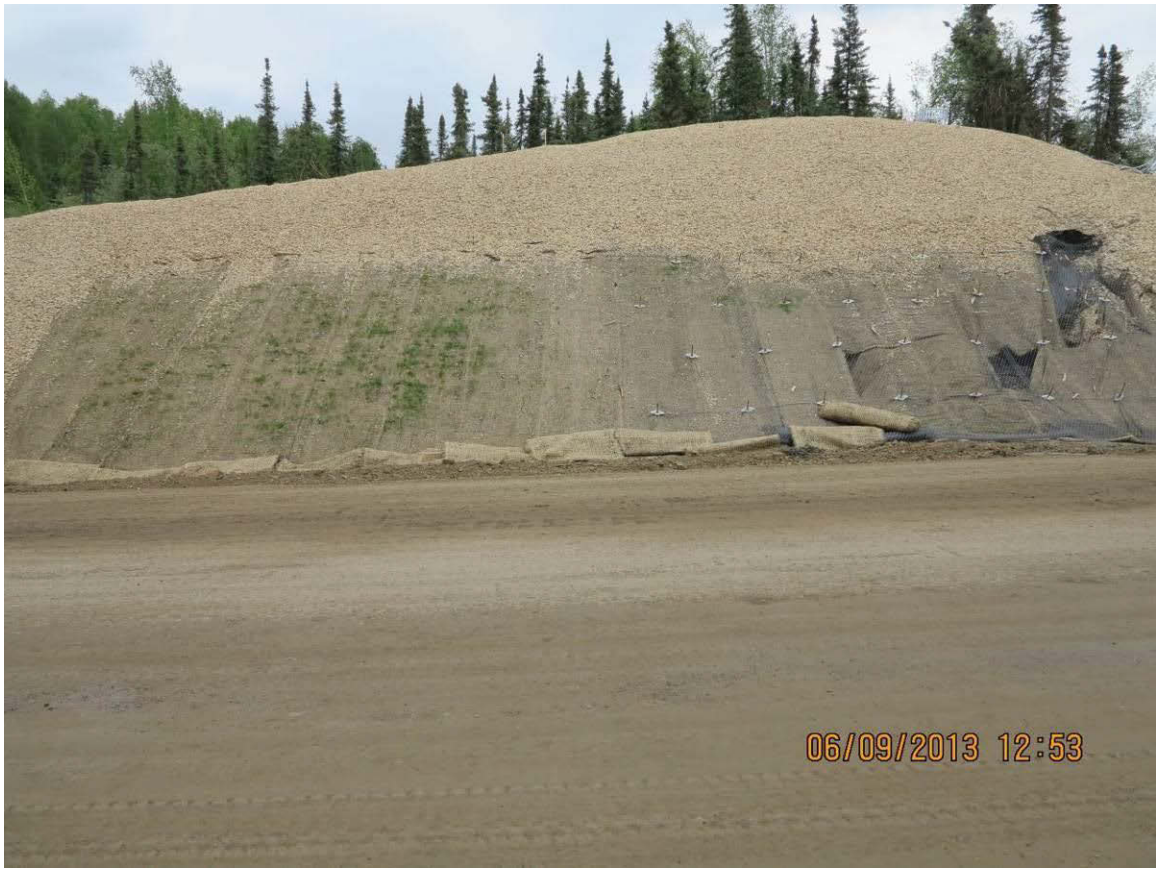
In Figure 6.4, the areas where the ground surface is *not* in contact with the Tecco-mesh or the adjoining coconut matting are those areas where no grass had yet appeared. As Figure 6.4 shows by the appearance of grass, only the very top portion of the Tecco-mesh section still has soil/Tecco-mesh contact.

**Figure 6.4 Surface protection matting in area showing no grass growth is not in direct contact with ground surface**

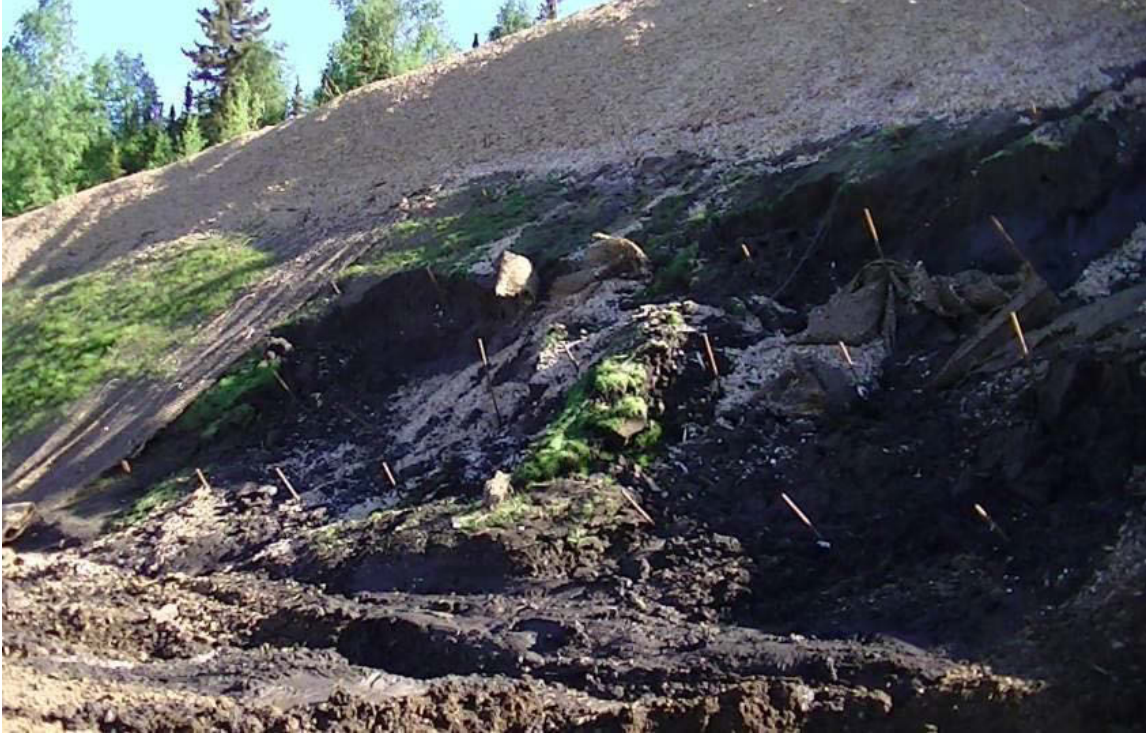
**Figure 6.5 Section C without Tecco-mesh and coconut blanket**

According to the recommendations listed above, on June 17, 2013, Tecco-mesh and the coconut erosion control blankets at Section C were removed (shown in Figure 6.5). The great loss of volume in cut slope soil at Section C can be seen in Figure 6.6, especially where massive ice is exposed. Crushed rock was hauled to the test site, and an excavator was used to cover Section C with crushed rock (see Figure 6.7). The hollow rebar anchors were left intact during these repairs to serve as survey and photogrammetric reference points. Figure 6.8 shows the cut slope after completion of repairs on June 17, 2013.

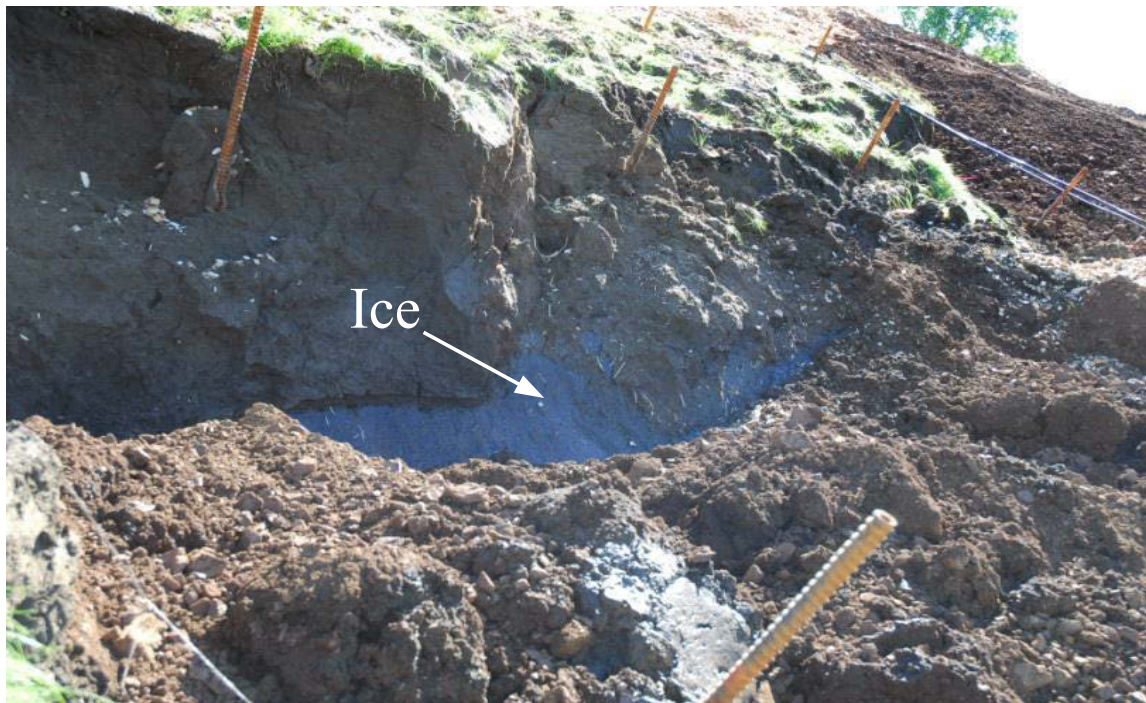
**Figure 6.6 Massive ice in Section C**

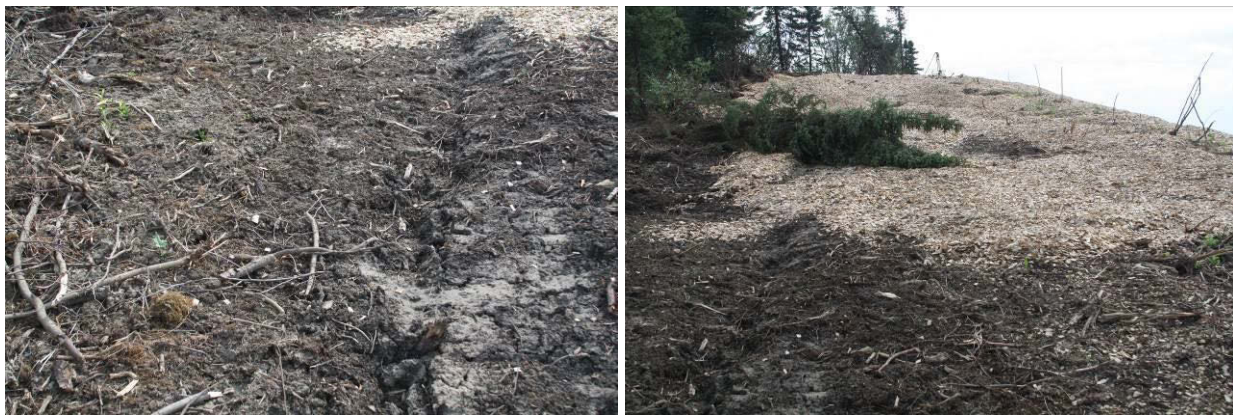
**Figure 6.9 Start of thaw related damage at top of Experimental Feature cut slope**
