Continued Field Evaluation of Precutting for Maintaining Asphalt Concrete Pavements with Thermal Cracking

August 2017

INE/AUTC 17.17

FHWA-AK-RD-4000(155)

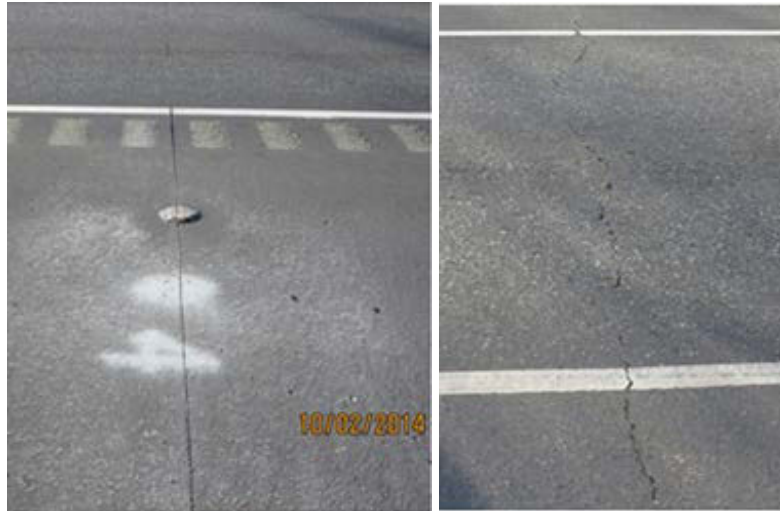
Figure 1.1 Cracks on the road

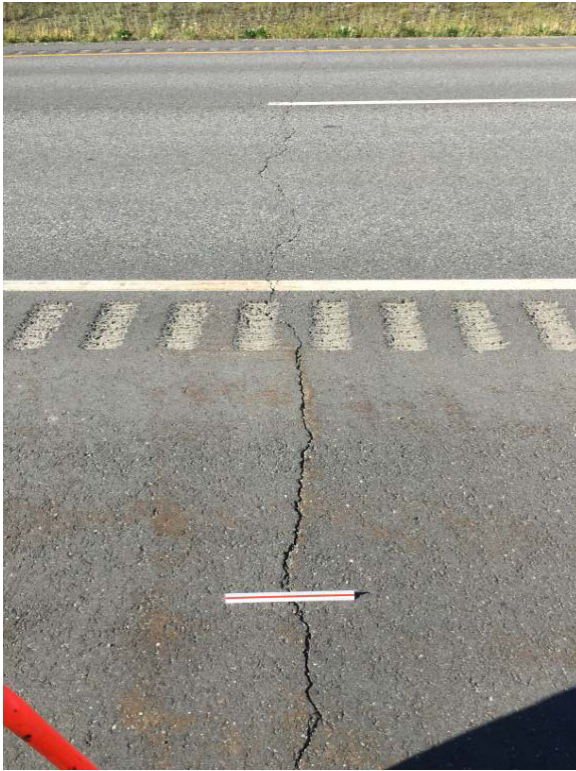
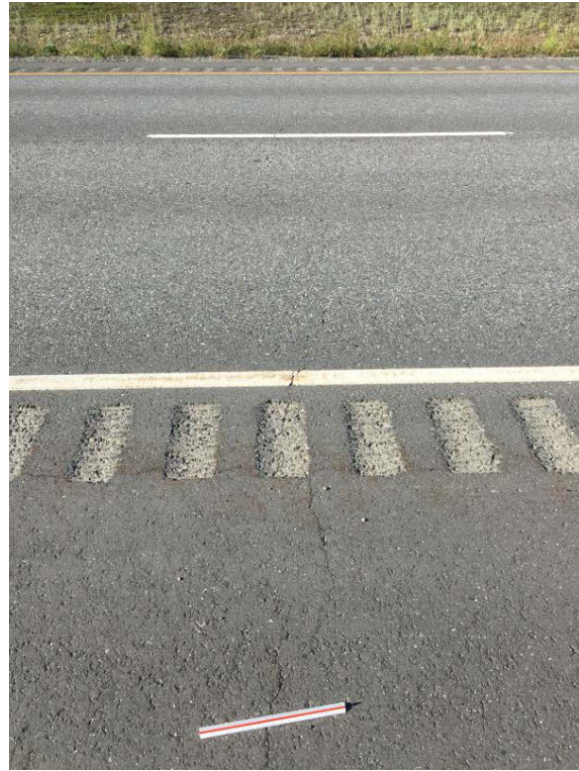
Figures 4.5 and 4.6 show observations on the control section (section No. 1 in Table 3.1). As expected, the most noticeable distress was the natural transverse cracks during the 3 years after construction. Figure 4.5 presents natural transverse cracks at different severity levels perpendicular to the road centerline. Natural transverse cracks skewed to the road centerline were also observed, as shown in Figure 4.6.

Figure 4.5 Transverse cracks perpendicular to the road centerline on the control section of the Moose Creek project: (a) high severity; (b) low severity

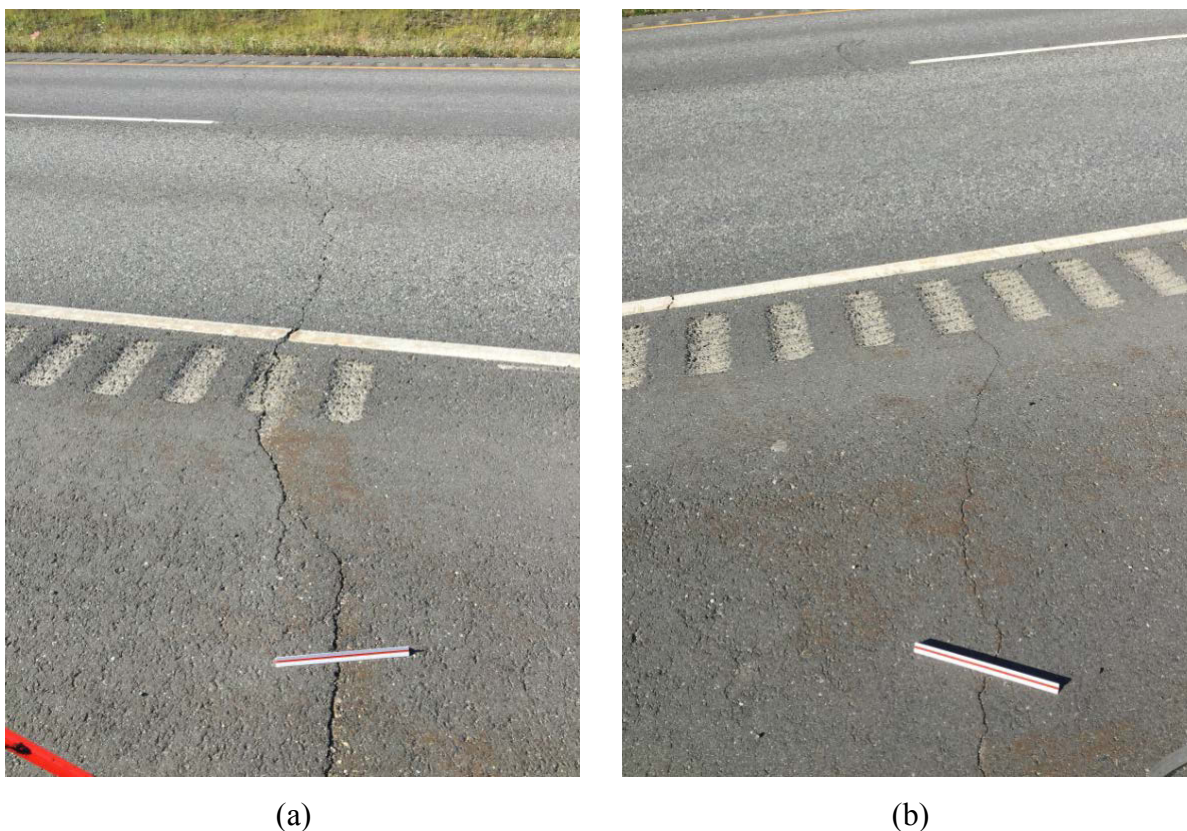
Figure 4.6 Transverse cracks skewed to the road centerline on the control section of the Moose Creek project: (a) high severity; (b) low severity

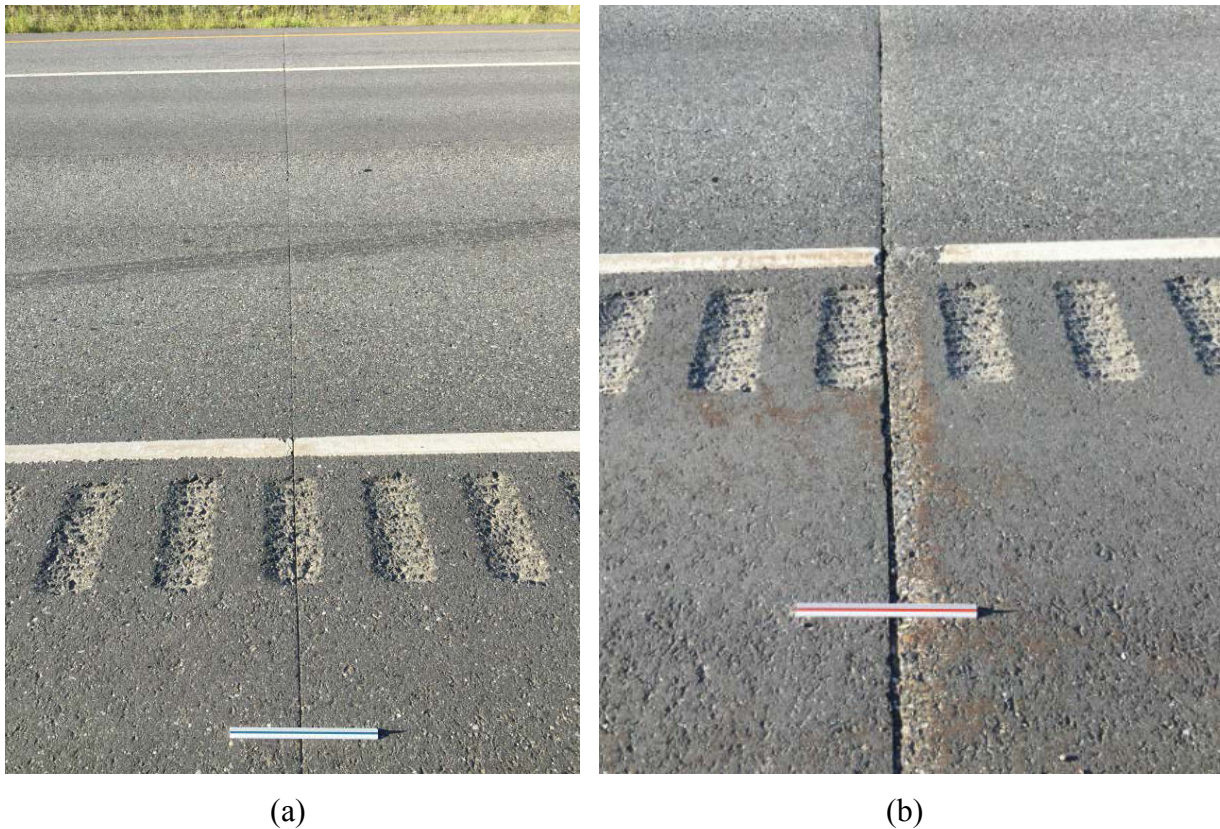
Figures 4.7 through 4.10 show observations of the precut sections with designed spacings (Moose Creek sections No. 2 to No. 7). Figure 4.7 presents the current conditions of precuts. Many precuts were non-active or closed, similar to the form of the one shown in Figure 4.7a. This means that stress concentrations sufficient to rupture the small amount of remaining pavement along the bottom of the precut slots and produce an active crack had not yet occurred. In contrast, a few active or open precuts were observed, as shown in Figure 4.7b. These open precuts are considered “nicely designed cracks,” and more are expected in a future survey. The existence of them might indicate that potential natural cracks were prevented by the precutting technique. In addition, it seems that most precuts did not require any maintenance, even if they were active.

Figure 4.7 Precuts observed on the precut sections with designed spacings on the Moose Creek project: (a) non-active (closed) (section No. 7); (b) active (open) (section No. 9)

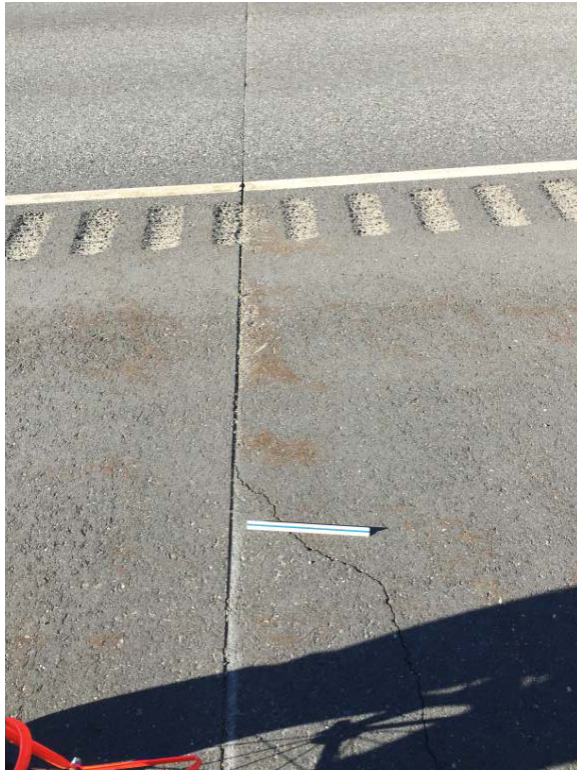
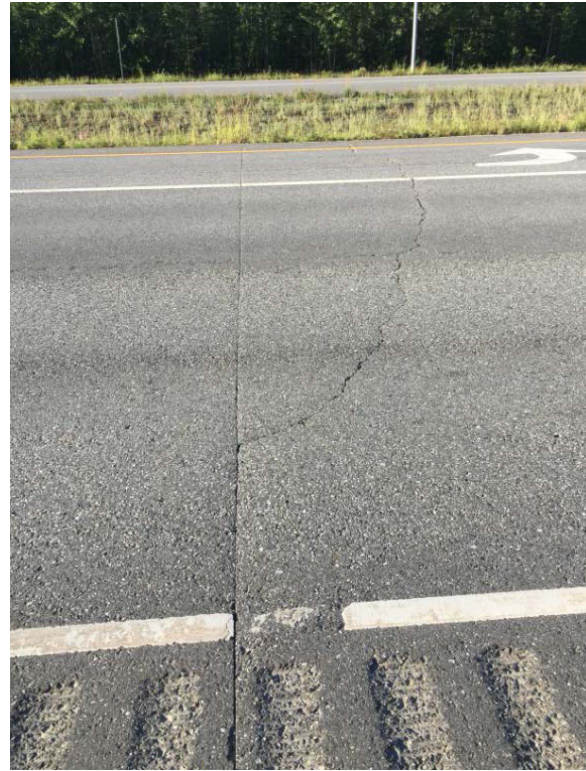
The locations of a few natural cracks were found to be at least partially controlled by precutting (Figure 4.8). Figures 4.8a and 4.8b show that the propagation of natural cracks was influenced by precutting. Both photos show natural cracks that were at least partially controlled (partially captured) by precutting. Several years of field observations during this study made it obvious that the effectiveness of precutting for controlling natural crack location can vary significantly from location to location. It is especially dependent on the thickness of the newly constructed section (the total thickness of pavement plus any other newly placed layers) that receives the precut treatment. The reader is reminded that the total thickness for new construction at the Moose Creek precut test site was only about 6 inches.

Figure 4.8 Transverse cracks partially controlled by precuts on the precut sections with designed spacings on the Moose Creek project: (a) section No. 3; (b) section No. 7

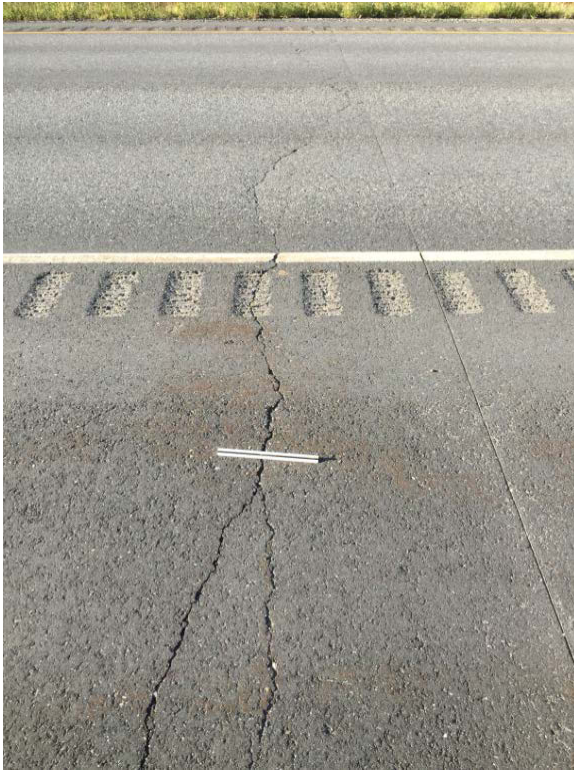
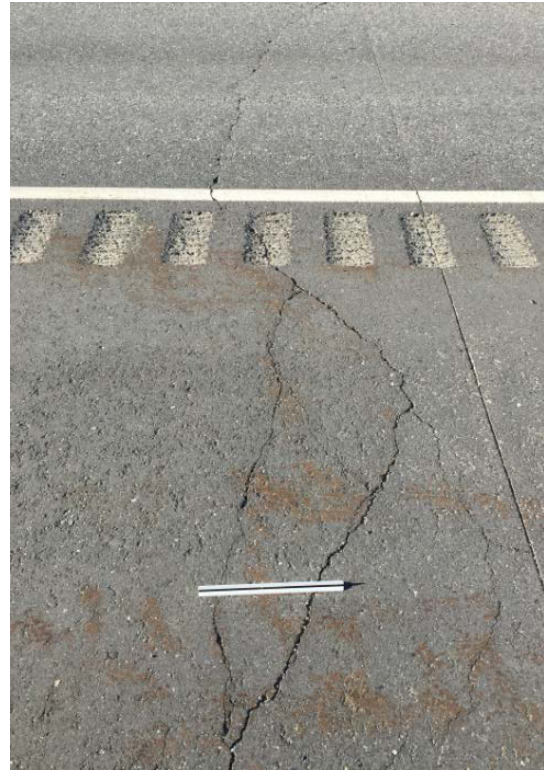
A few natural cracks were observed to develop near precuts that were not active at all (Figure 4.9). These natural cracks were generally of complicated shape, which might indicate that they were reflective thermal cracks rather than new natural thermal cracks. It seems that precuts installed with designed spacings may not necessarily even partially control the location of reflective cracks.

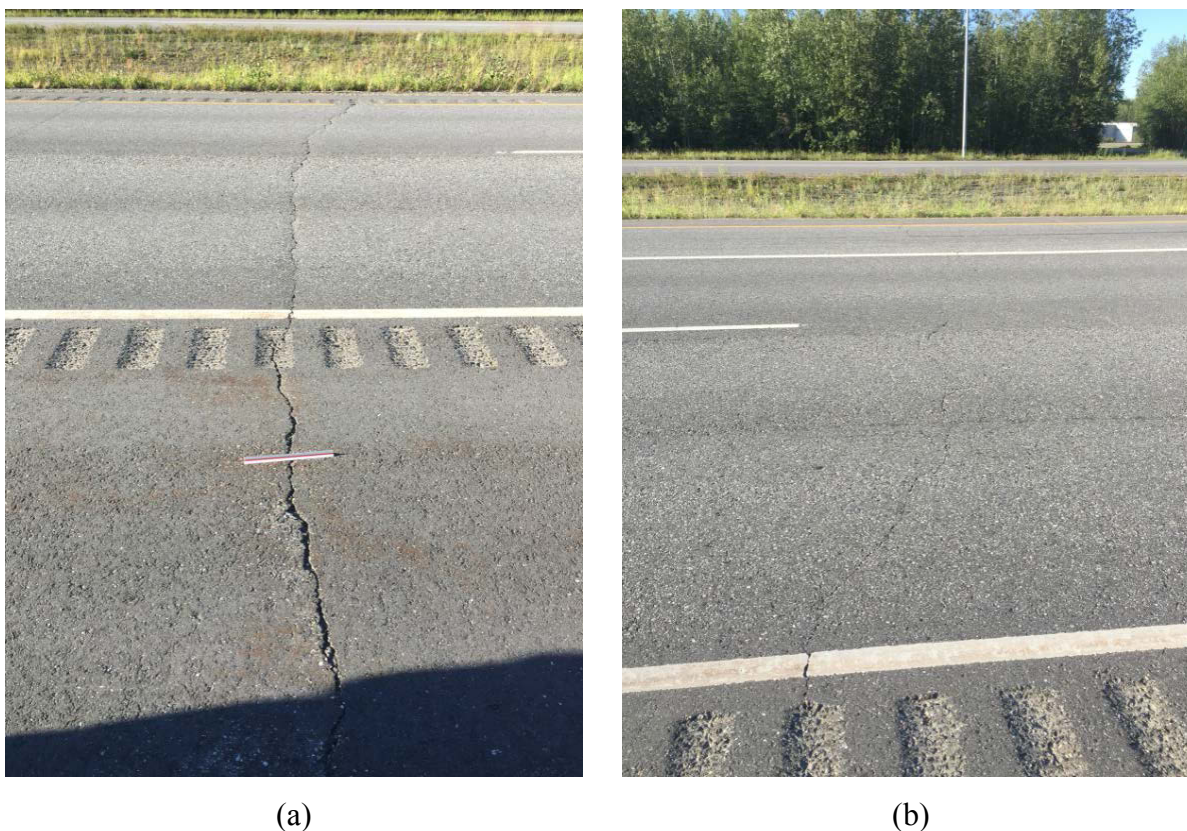
Figure 4.10 presents natural cracks of different severity level observed between the precuts. These cracks mean that a natural crack could still occur even with a short precut spacing of 40 feet.

Figure 4.10 Transverse cracks in between precuts on the precut sections with designed spacings on the Moose Creek project: (a) high severity (section No. 6); (b) low severity (section No. 7)

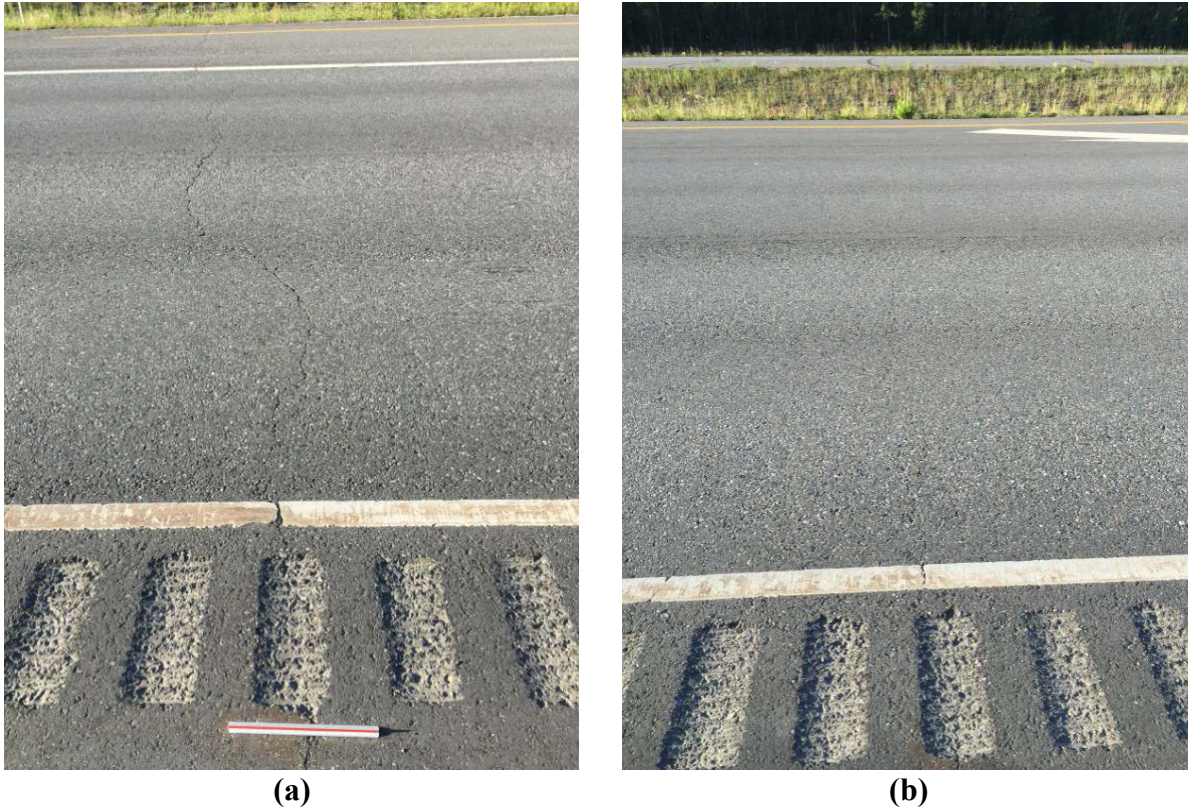
Transverse cracks that occurred between two precuts were mostly at low-severity level (Figure 4.12).

Figure 4.12 Natural transverse cracks between precuts—where precuts are at locations of old thermal cracks on the Moose Creek project: (a) high severity (section No. 8); (b) low severity (section No. 9)

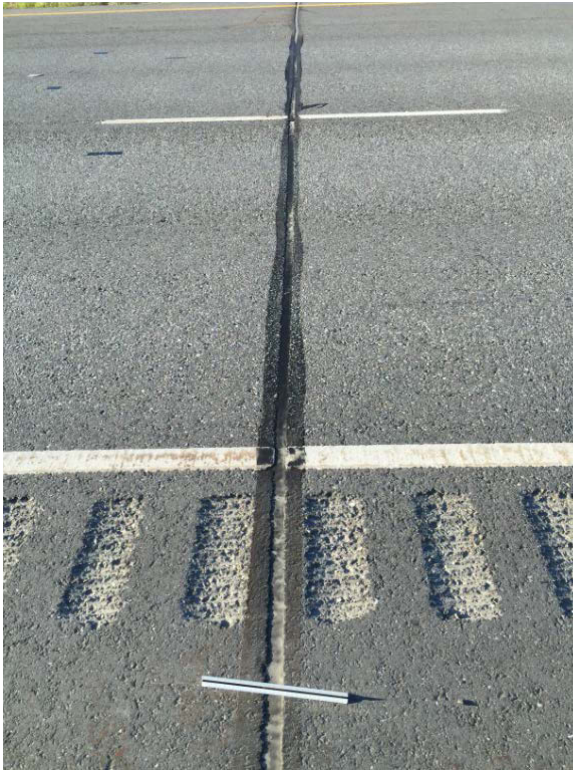
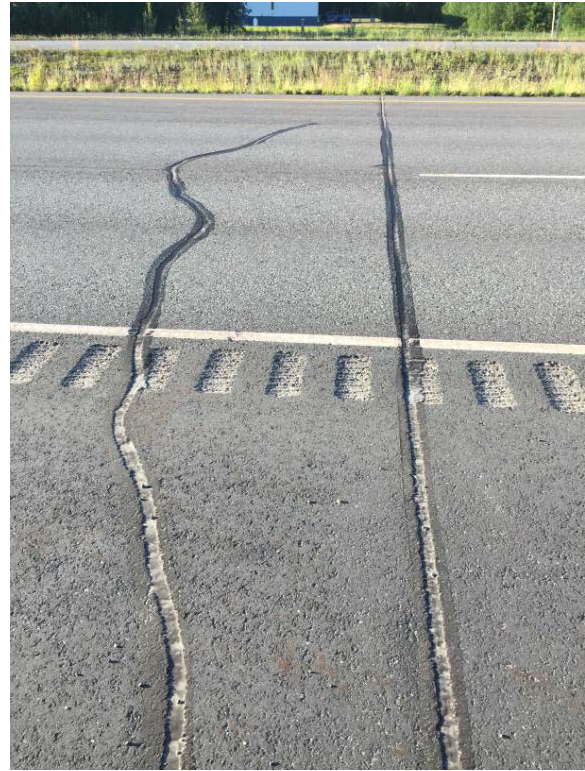
One special observation (Figure 4.13) was that the cut-on-existing-cracks section with a 1.5 inch cut depth (No. 10 in Table 3.1) was maintained with routing followed by crack sealing. It is not known why this type of expensive maintenance treatment was used at this and some nearby locations, but its effectiveness can become part of future field evaluations of the precut test sections.

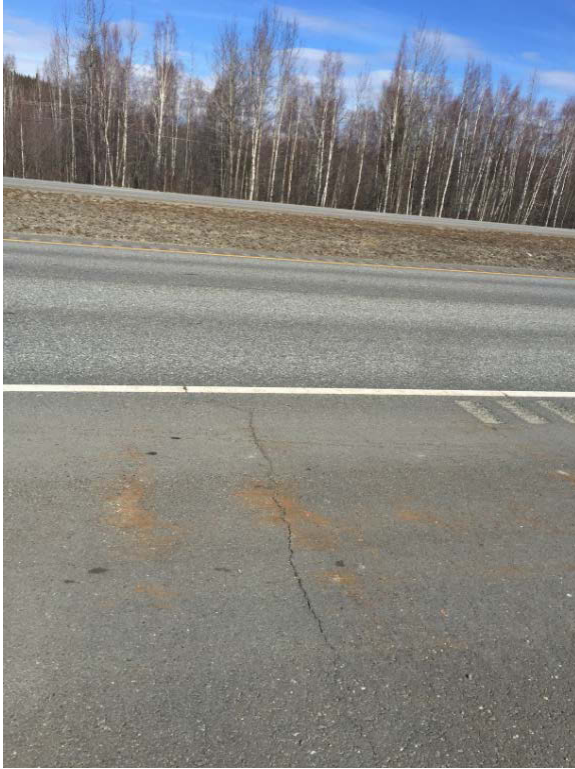
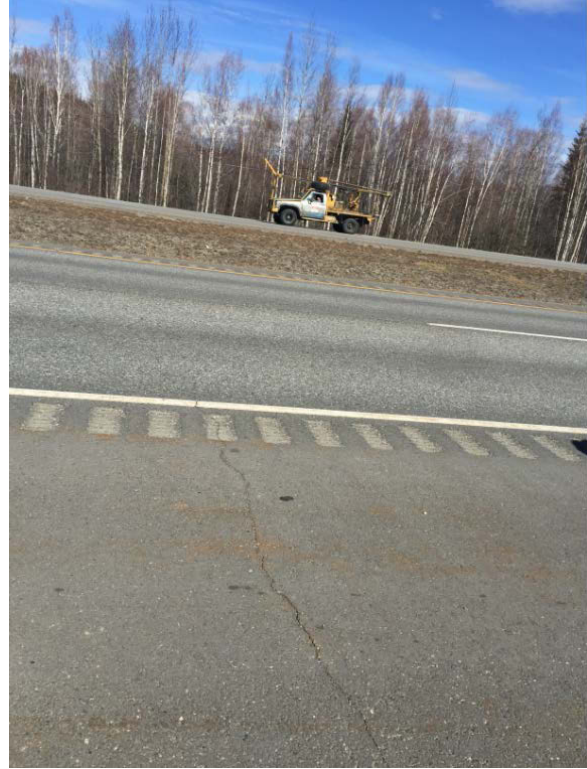
Figure 4.14 presents two new transverse cracks across the entire road on the control section. It can be seen that both cracks were at low- to medium-severity levels.

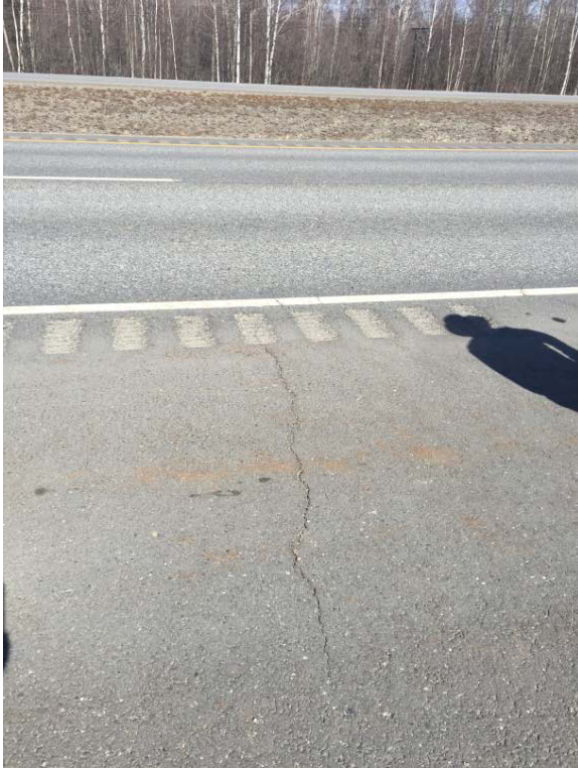
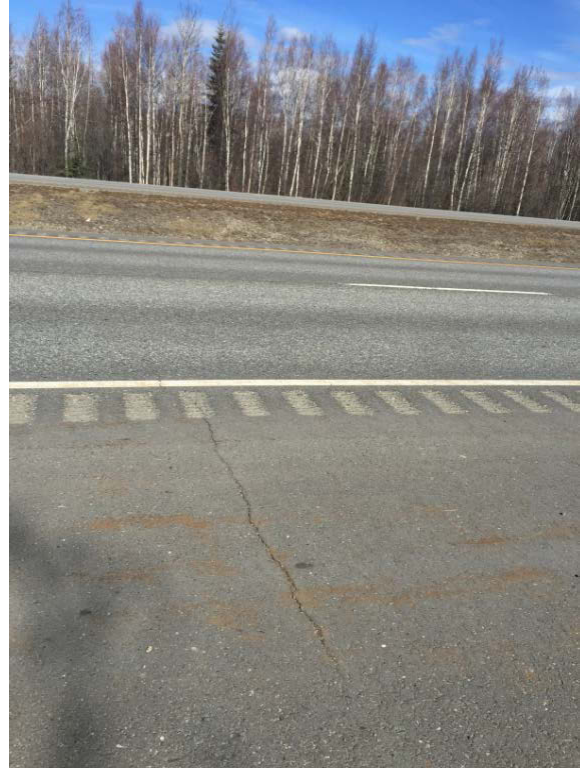
Figure 4.15 presents two new small cracks that were perpendicular to the road centerline. The cracks had not developed to cross the entire road, but may propagate to full width in future years. The types of cracks seen in 2016 and 2017 were similar, and the 2016 survey shown in Appendix B was supplemented with the 2017 survey to become Appendix D. Most cracks and interesting spots were documented with photos that can be seen in Appendix D. Several newly taken pictures are presented below.

Figure 4.15 New partial cracks observed on the control section of Moose Creek project:
(a) case 1; (b) case 2

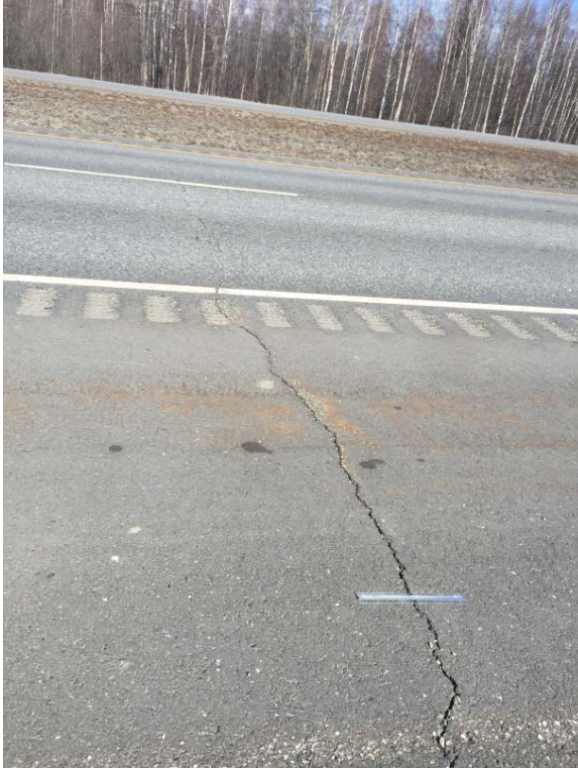
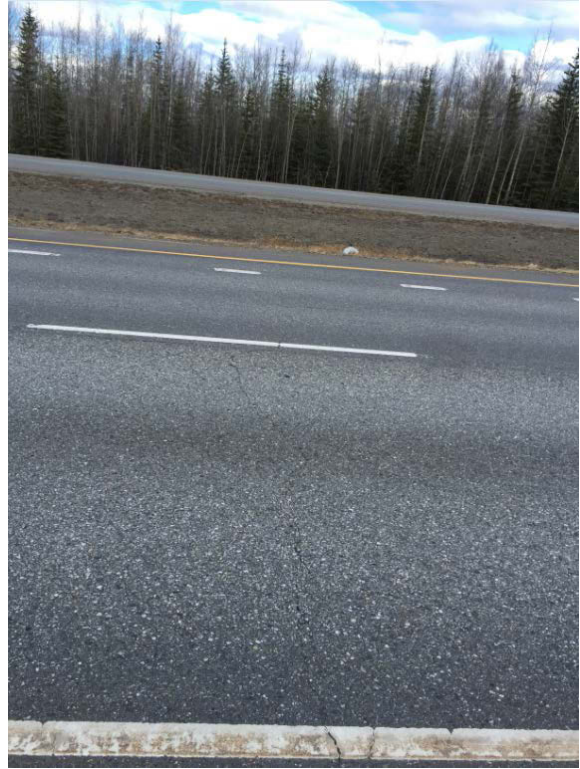
Figure 4.16 Newly documented natural cracks observed on sections of Moose Creek project in summer 2017: (a) the control section; (b) section No. 6

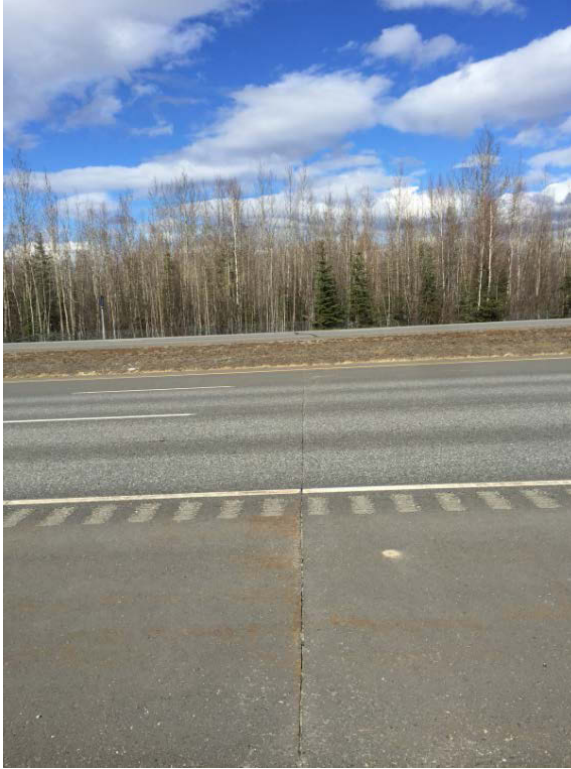
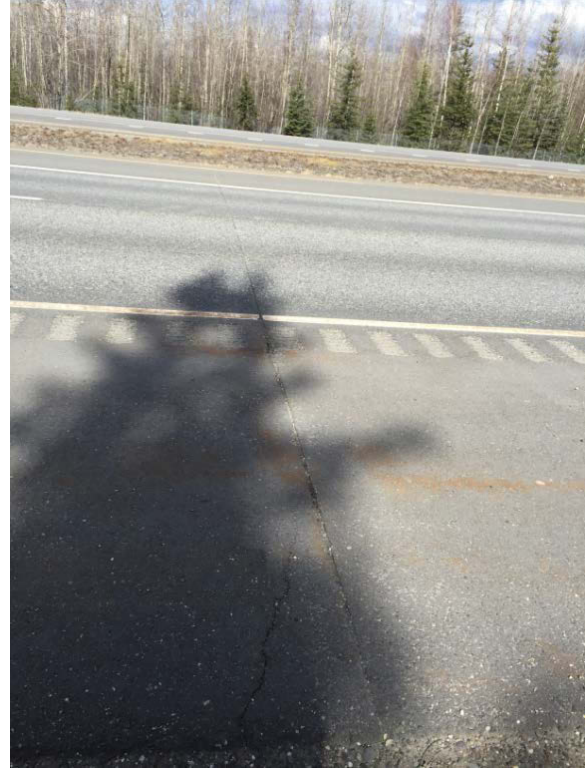
Figure 4.17 Newly documented precuts observed on sections of Moose Creek project in summer 2017: (a) section No. 9; (b) section No. 8

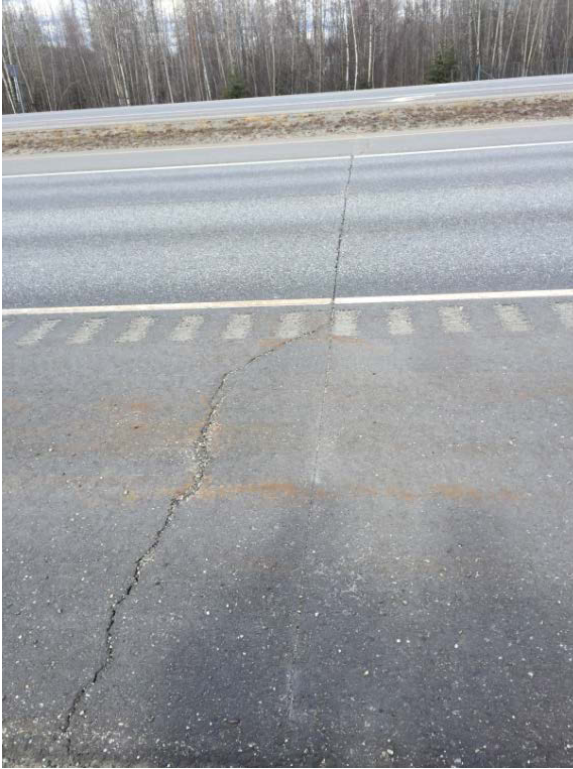
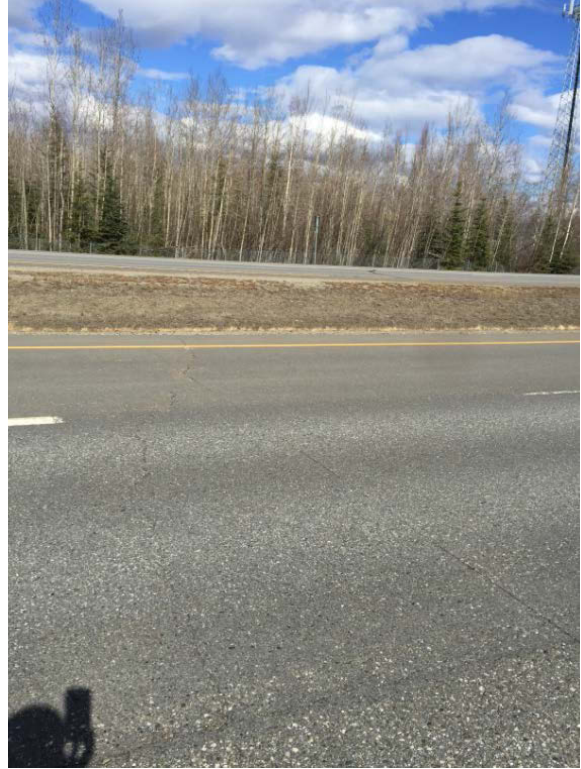
Figure 4.18 Newly documented cracks adjacent to precuts in sections of Moose Creek project in summer 2017: (a) section No. 8; (b) section No. 9

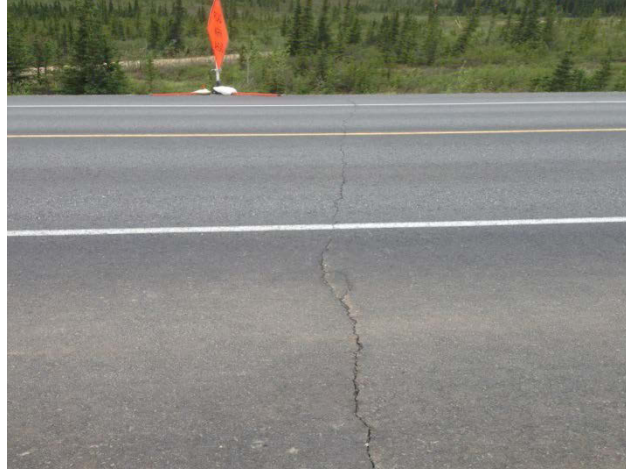
Figure 4.20 Natural transverse crack observed

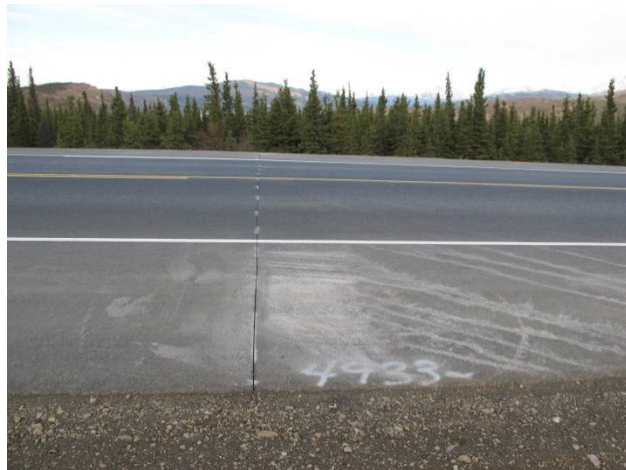
Figure 4.21 Precut observed

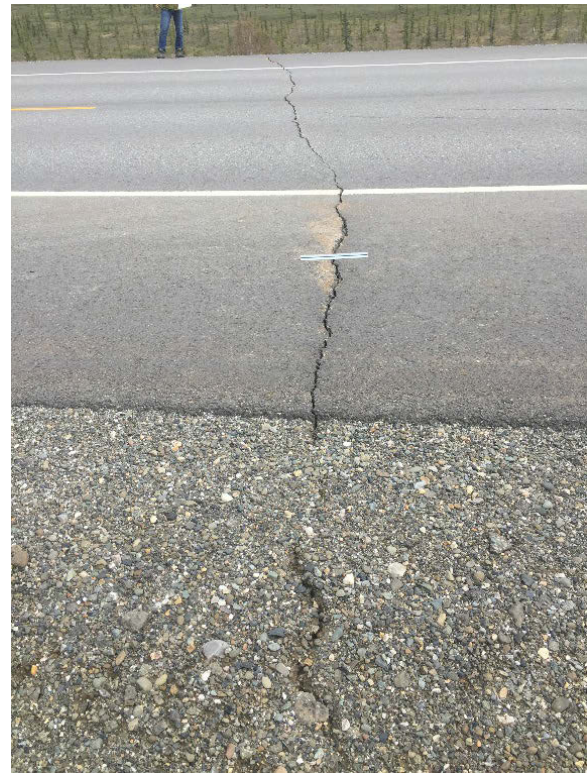
Figure 4.23 Transverse cracks observed: (a) low-severity crack (on precast section) (section No. 6); (b) high-severity crack (on control section) (section No. 2)

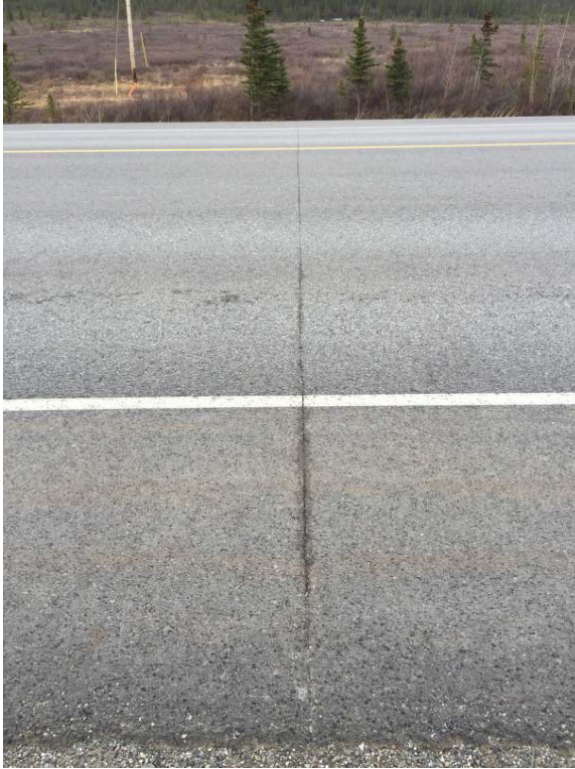
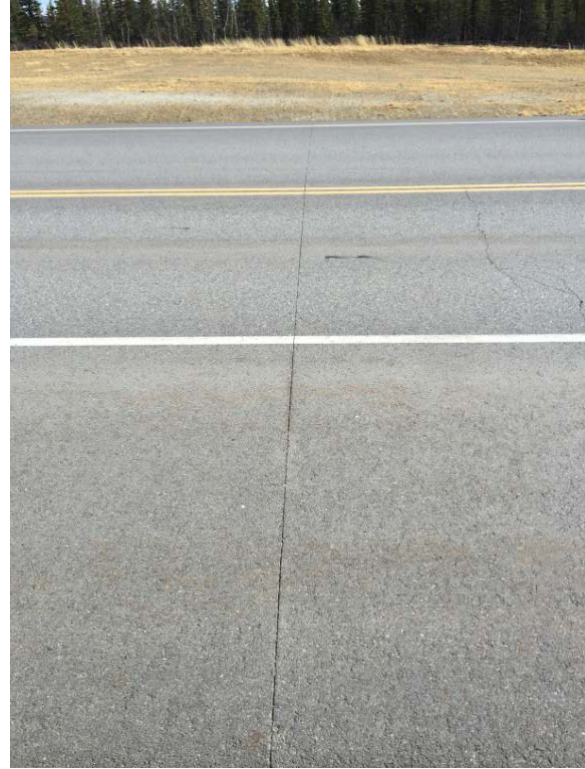
Figure 4.25 Completely closed precuts observed: (a) section No. 13; (b) section No. 7

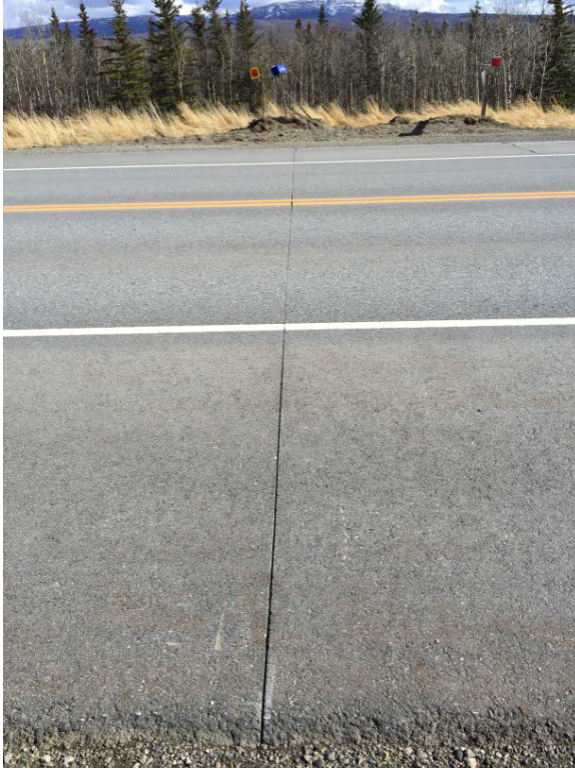
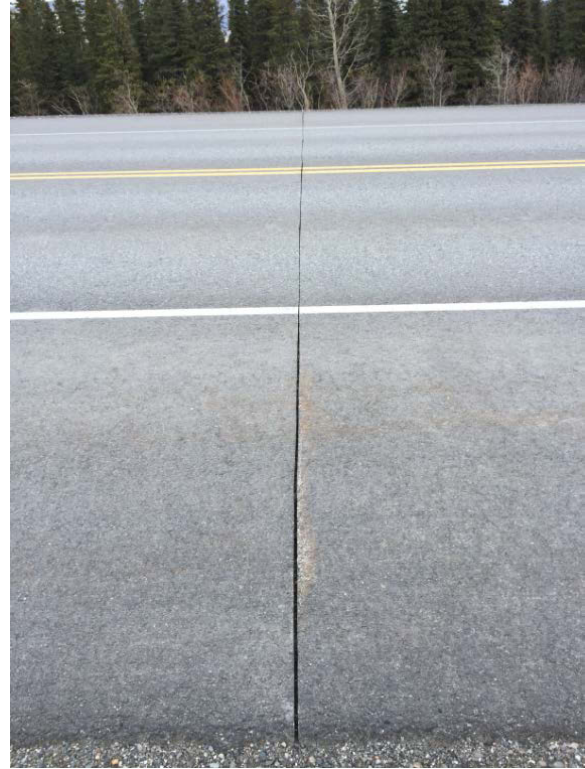
Figure 4.26 Partially open precuts observed: (a) section No. 6; (b) section No. 16

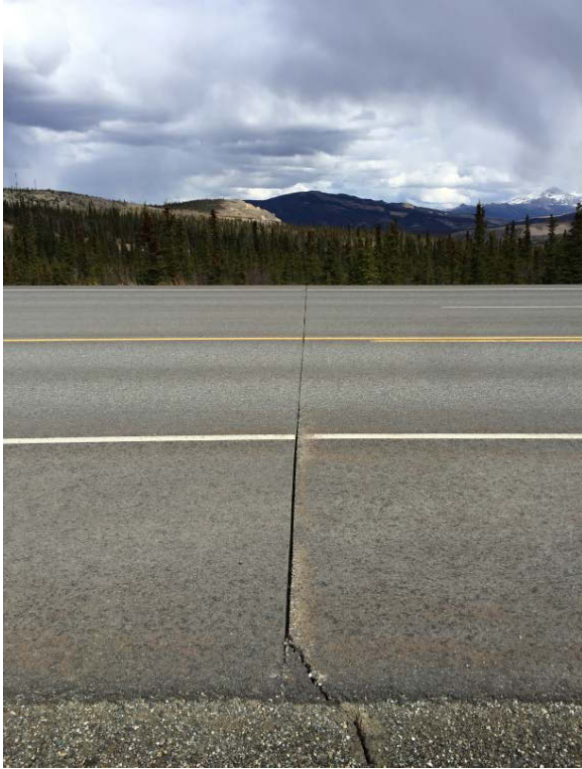
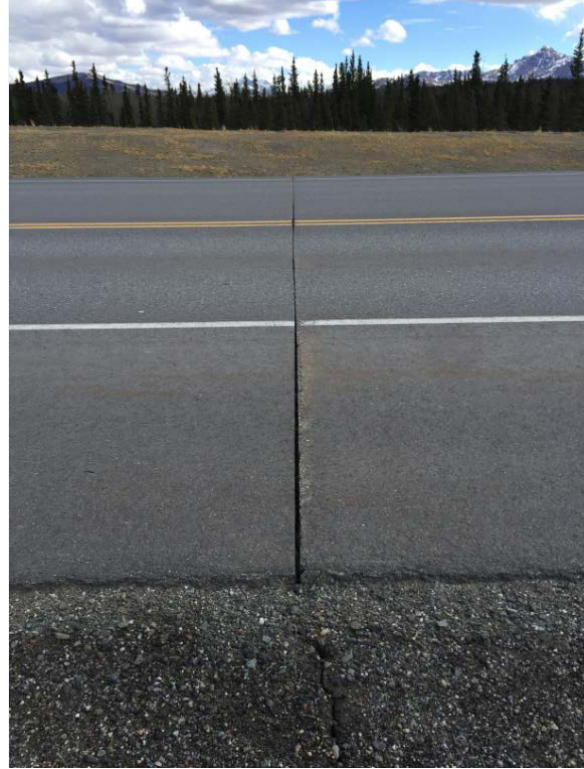
Figure 4.27 Very active (open) precuts observed: (a) section No. 14; (b) section No. 8

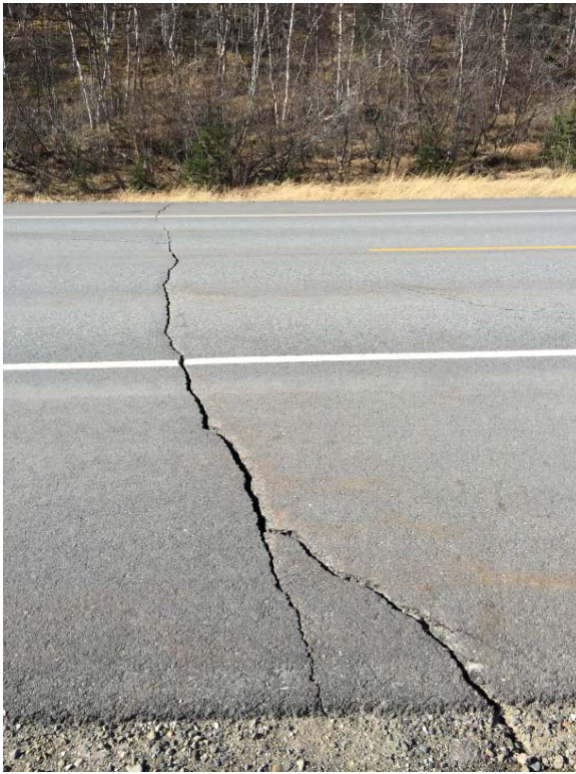
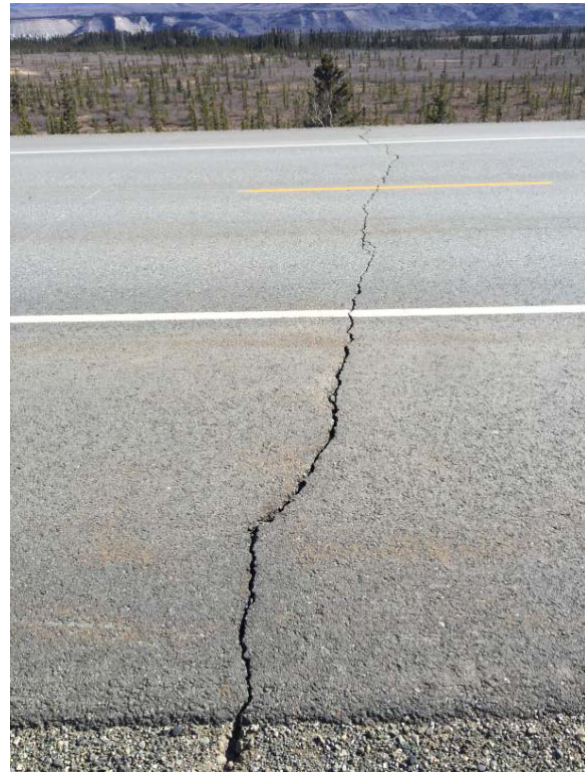
Figure 4.28 Natural transverse crack examples: (a) section No. 2; (b) section No. 1

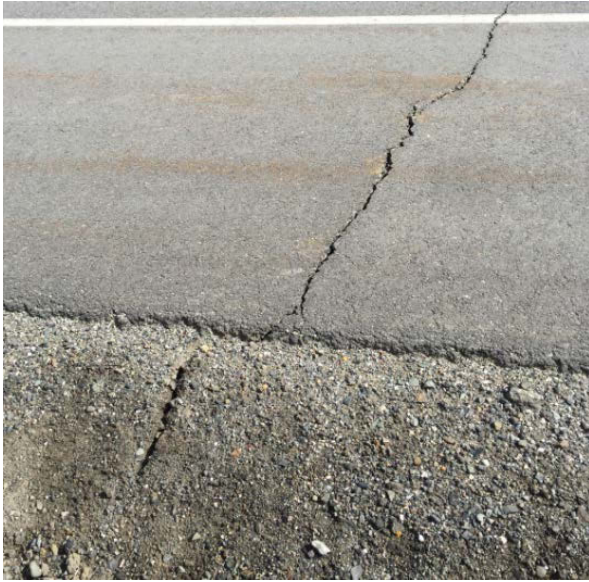
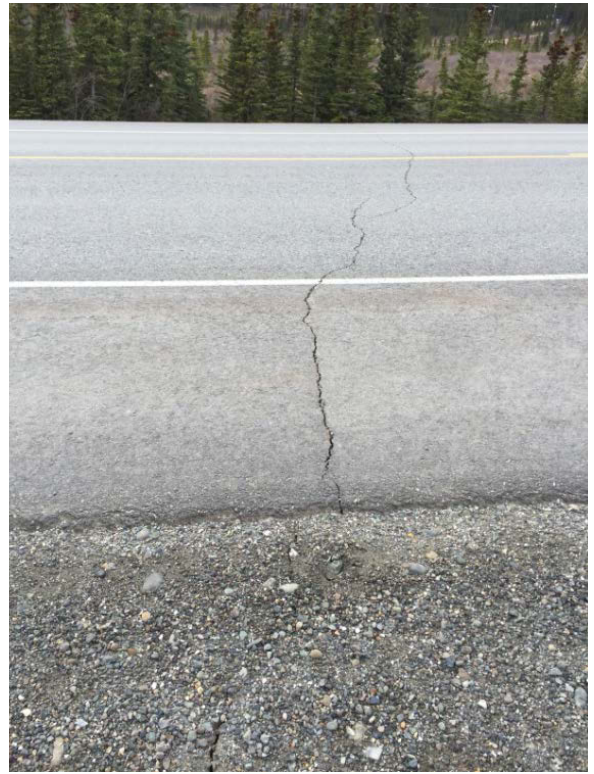
Figure 4.29 Cracks extending past the paved surface: (a) section No. 9; (b) section No. 15

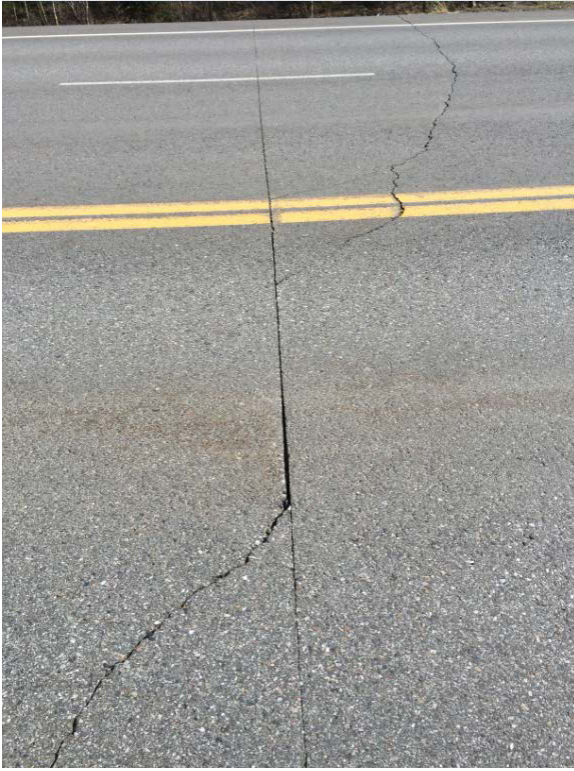
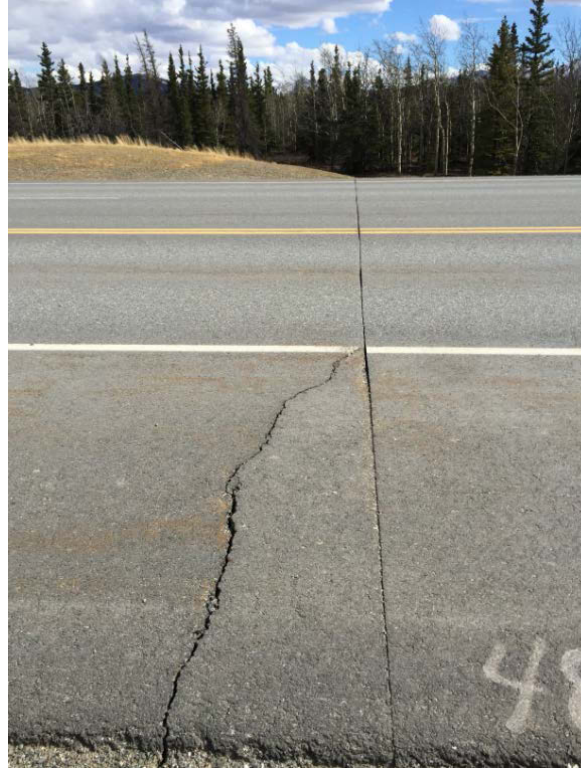
Figure 4.30 Cracks partially captured by the precuts: (a) section No. 9; (b) section No. 8

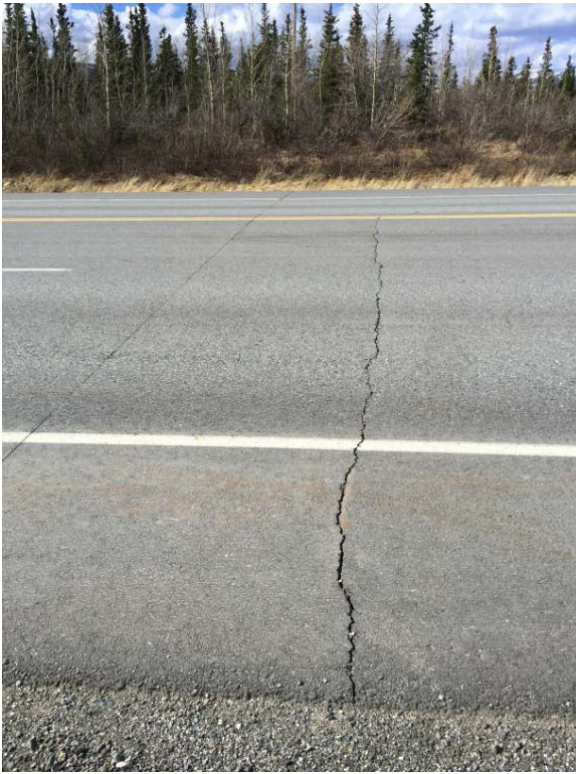
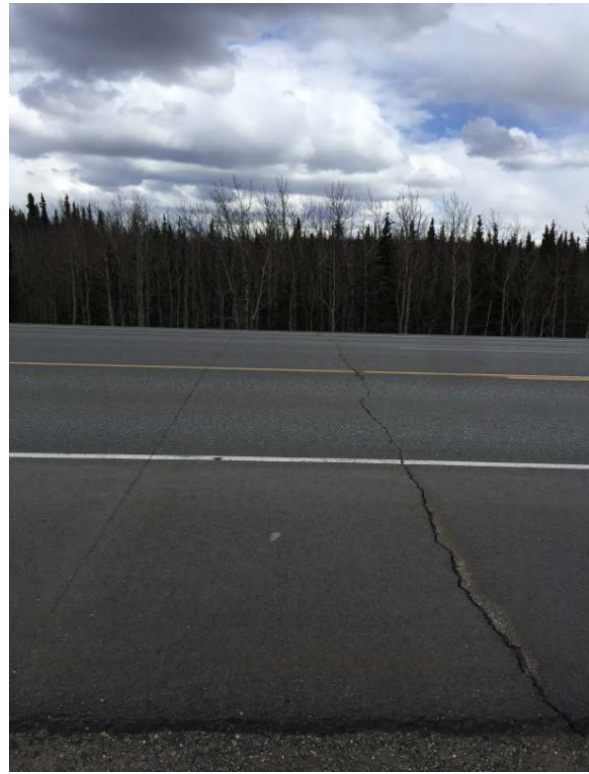
Figure 4.31 Cracks adjacent to precuts, without capture: (a) section No.9; (b) section No.12
