Minnesota Drive Ramps Microsurfacing Experimental Feature

Year 2 Monitoring Report

Alaska Department of Transportation and Public Facilities
Statewide Materials and Asset Management

January 2023

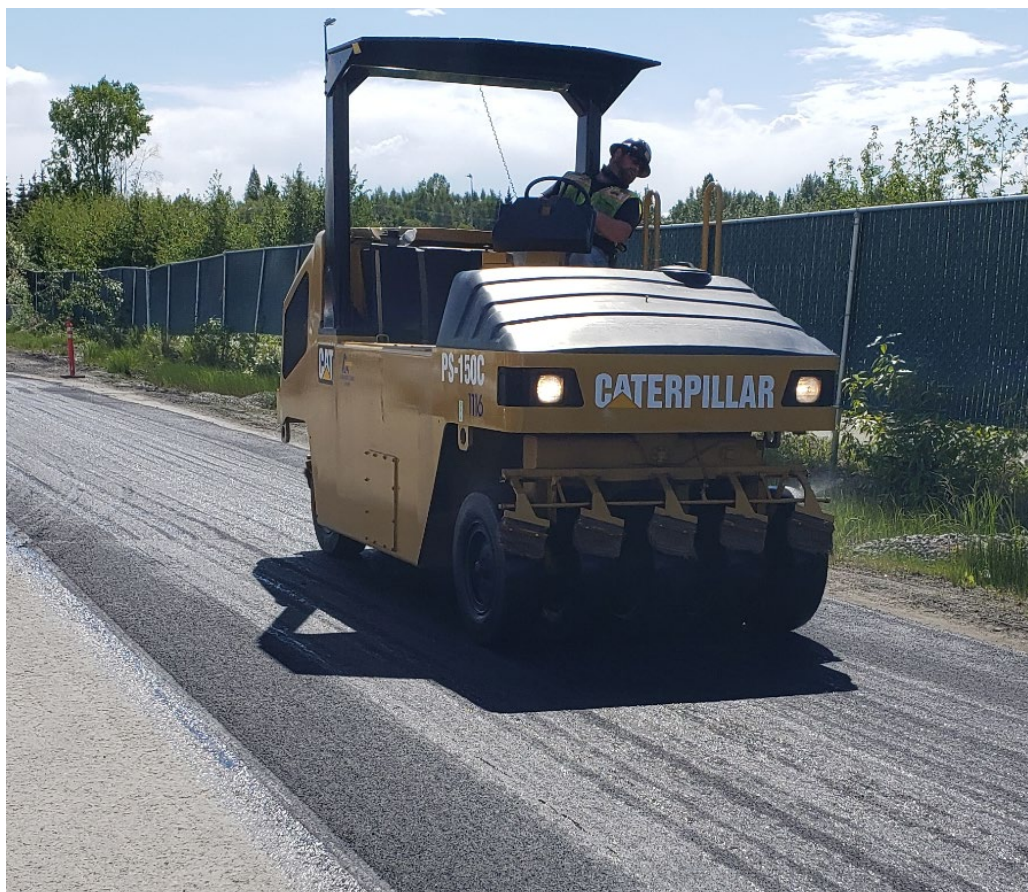
Photo 41 - Pneumatic Roller on Test Strip

It was intended for the pneumatic roller to finish rolling the mat within an hour of application so traffic would be able to return to the ramp shortly after. However, it took slightly over two hours for the pneumatic roller to begin rolling the test strip without damaging the fresh microsurfacing. The Department was informed this was due to the high emulsion temperature and the reduced lime content and that, with the full lime dosage and cooler emulsion, the pneumatic would be able to begin rolling the mat sooner.

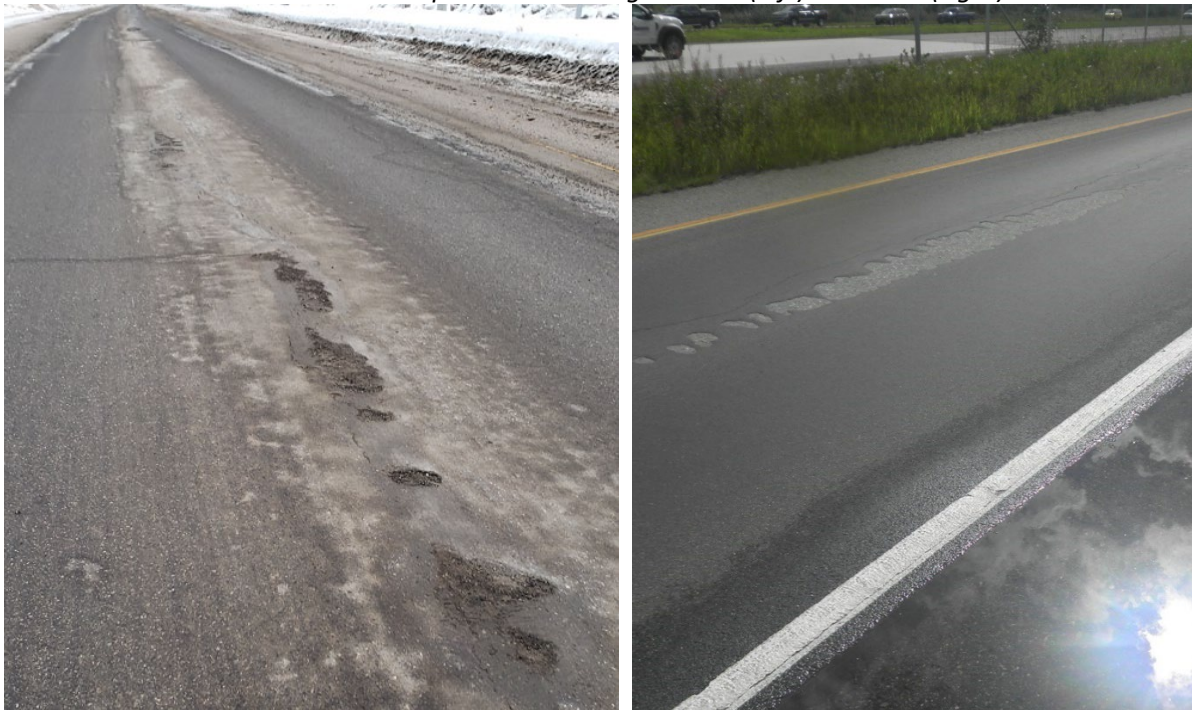
Photo 10 - Ramp 12 Plow Damage – 2021 (left) and 2022 (right)

In March of 2021, after a freezing rain, significant plow damage was noted along the centerline and edge of the lane on Ramp 12, the Strawberry Ramp. It is suspected there was significant down pressure on the snowplow to clear the ice off of the ramp that caught the microsurfacing along the longitudinal crack near the centerline that reflected through over the winter. This damage had increased when inspected in 2022.

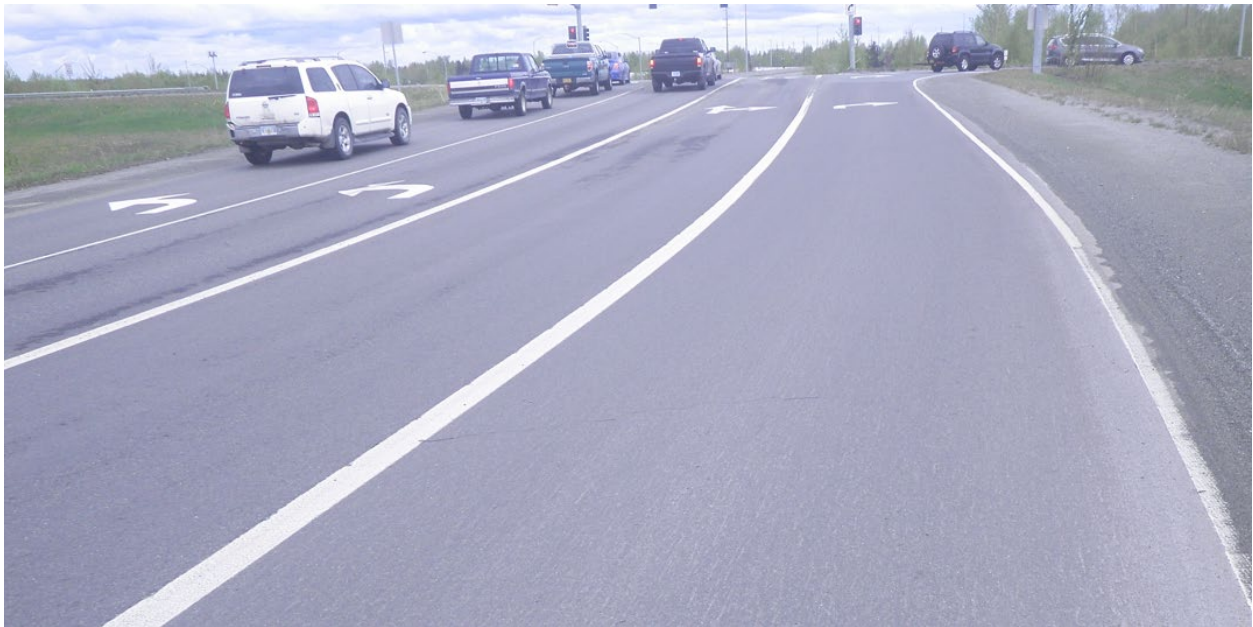
The right lane is microsurfacing in good condition while the other three turn lanes are hot mix asphalt. The ramp remained in similar condition in 2022.

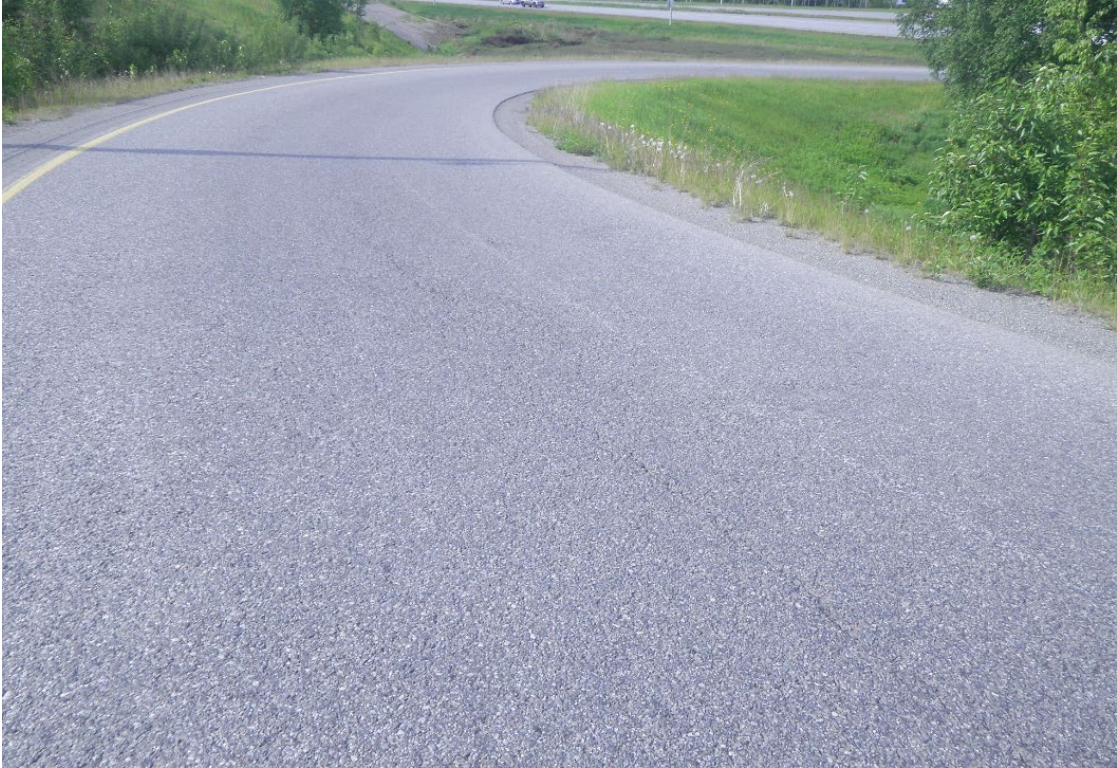
This ramp is a cloverleaf with minimal rutting, minor raveling and isolated moderate severity cracking.

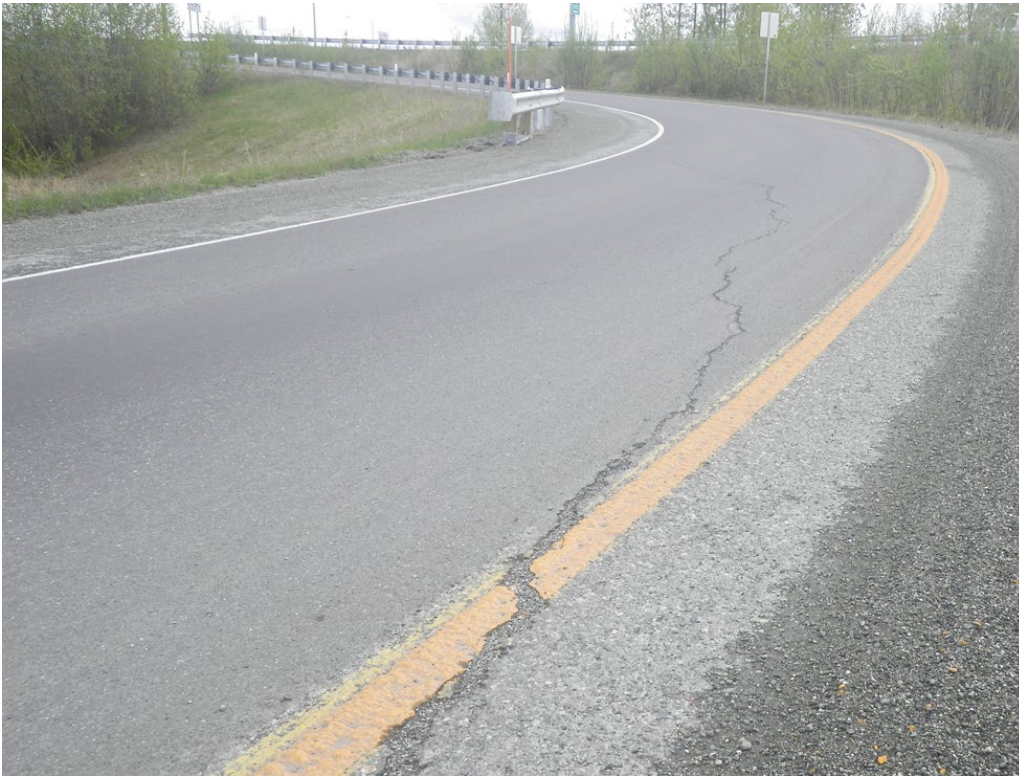
The ramp remained in good condition although cracks on the ramp did reflect through the micro.

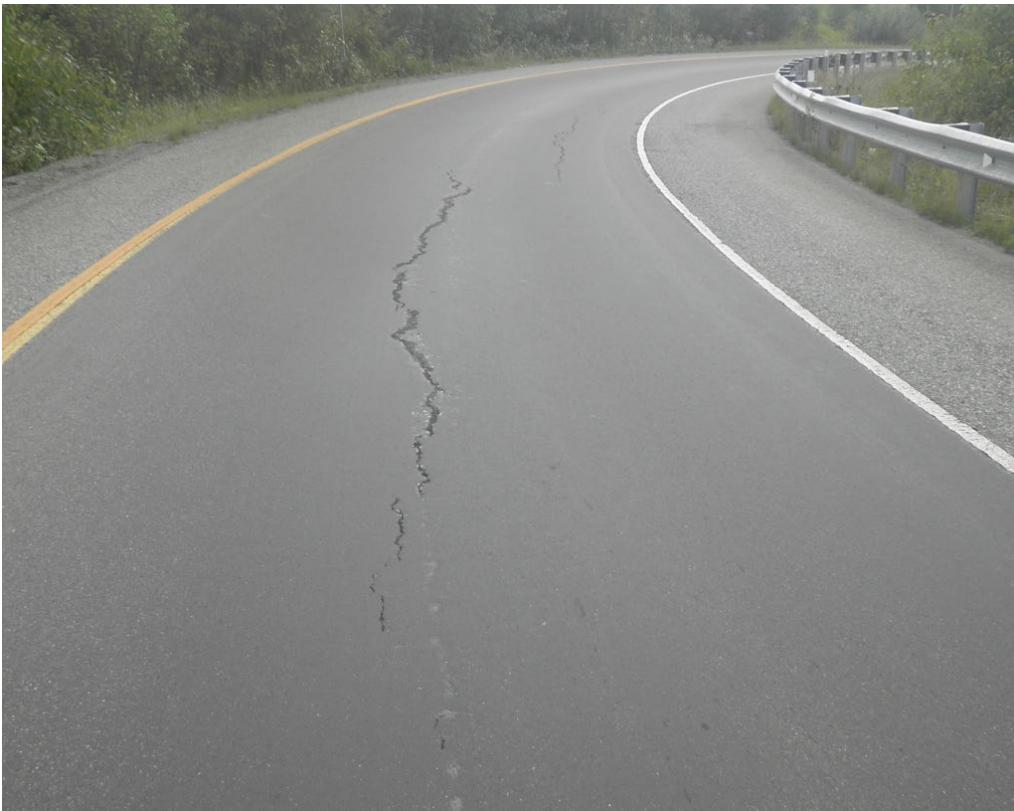
There is increased severity in reflective cracking and plow damage along the centerline.

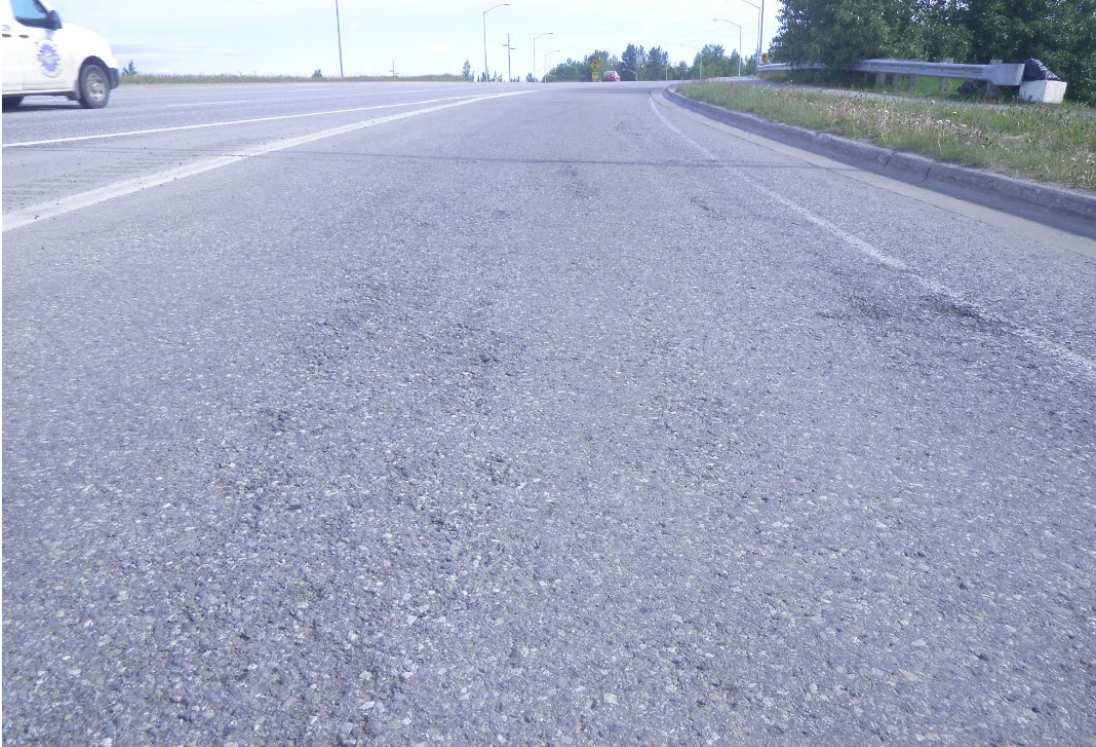
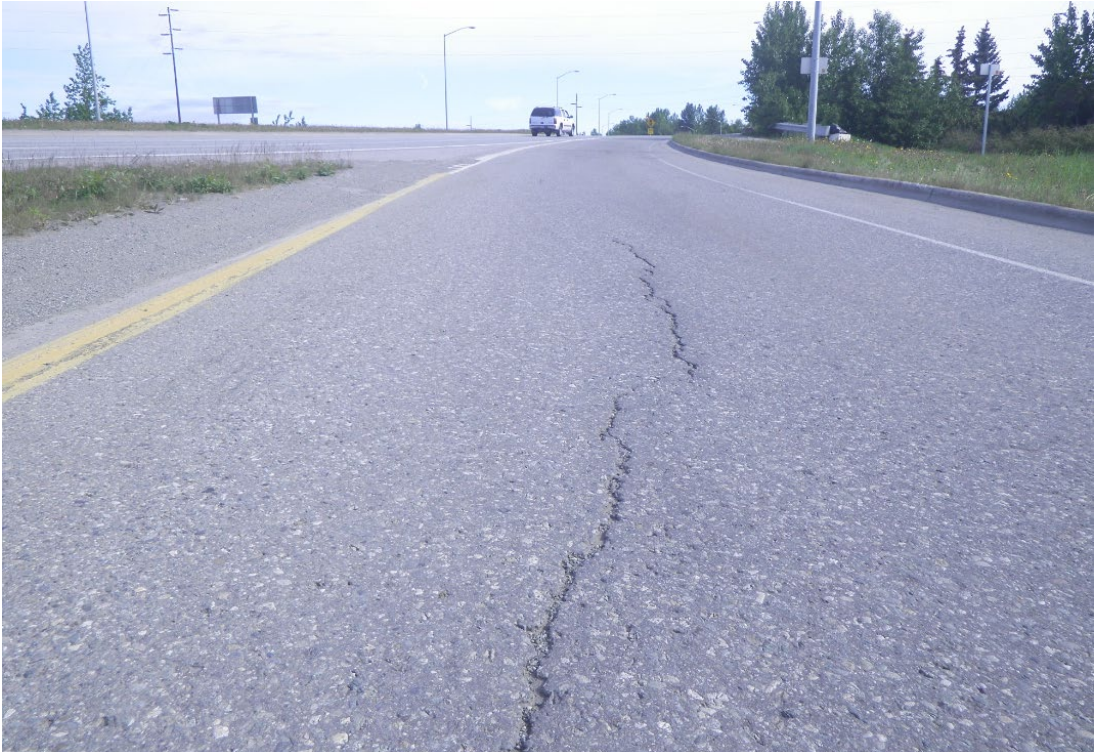
Microsurfacing was applied over a small portion of this ramp to cover an area of raveling and cracking.

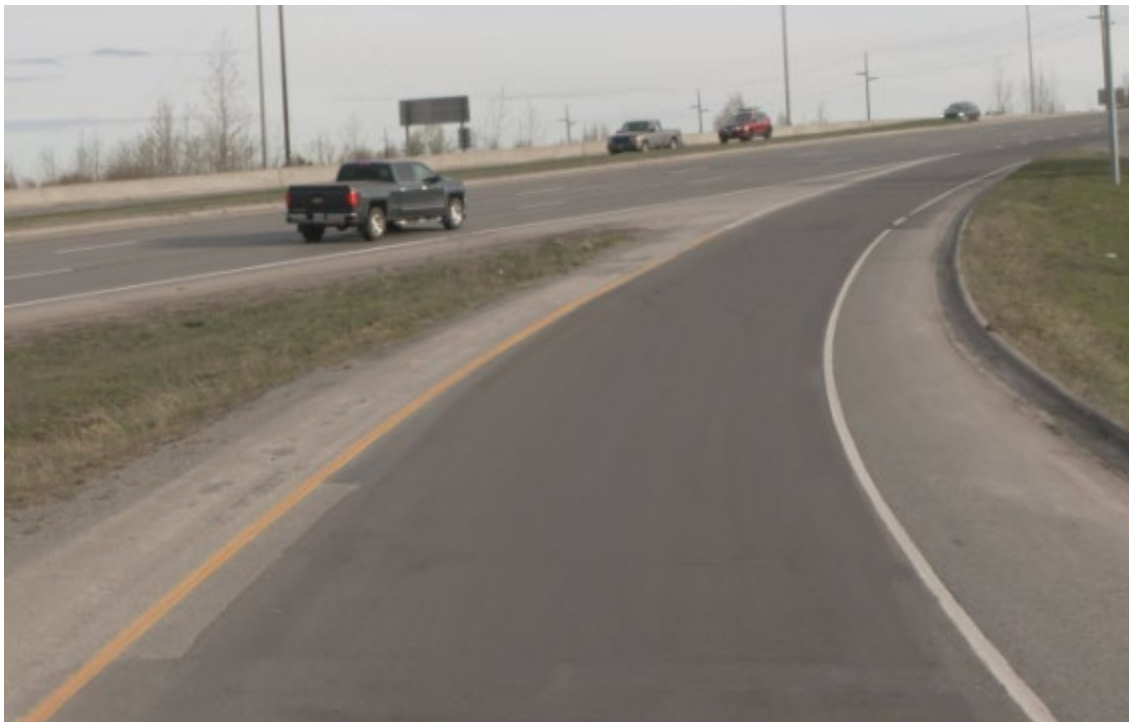
There is an increase in reflective cracking and plow damage along the right side of the lane.

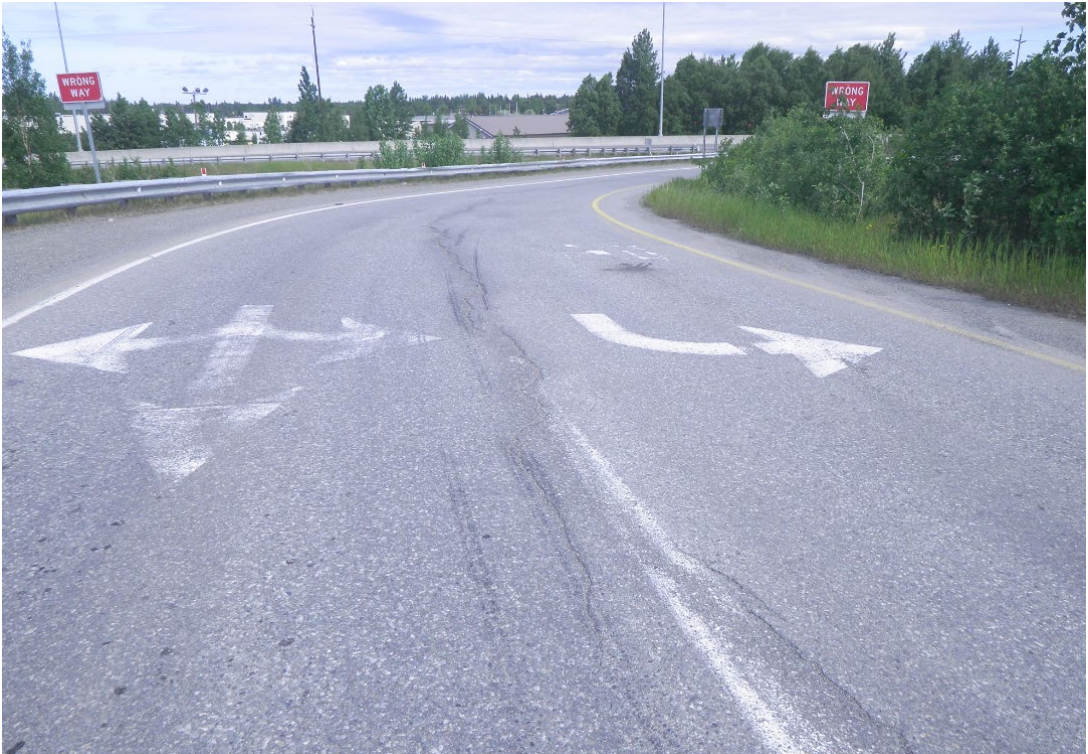
This ramp had minor rut depths but moderate to high severity longitudinal cracking.

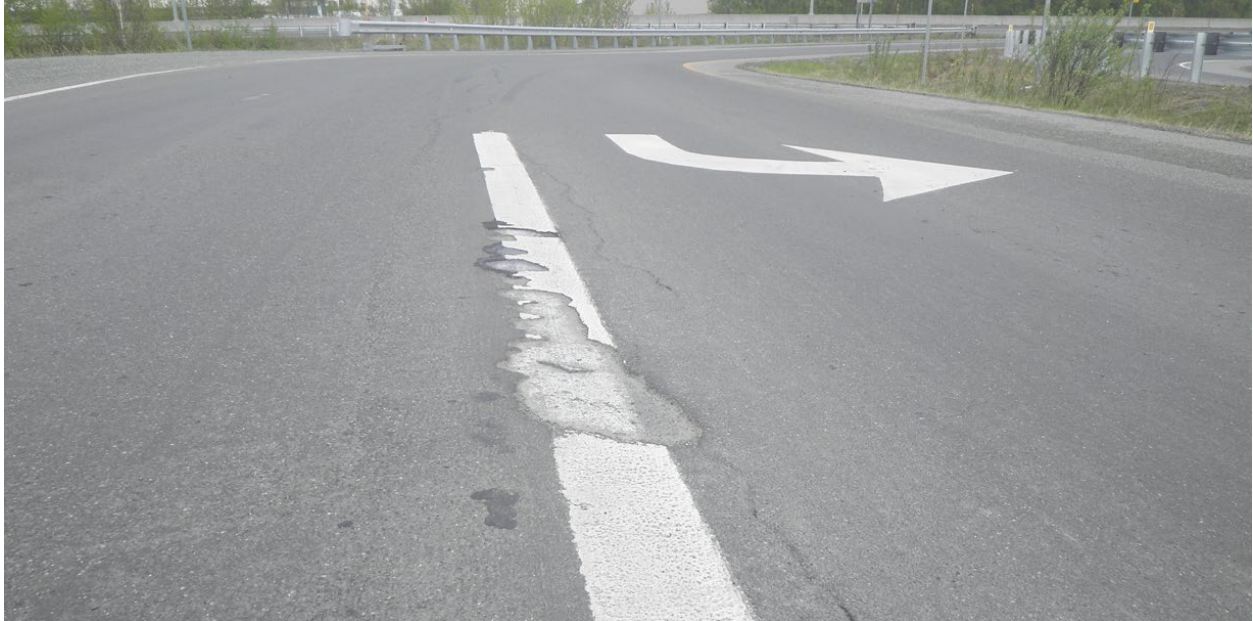
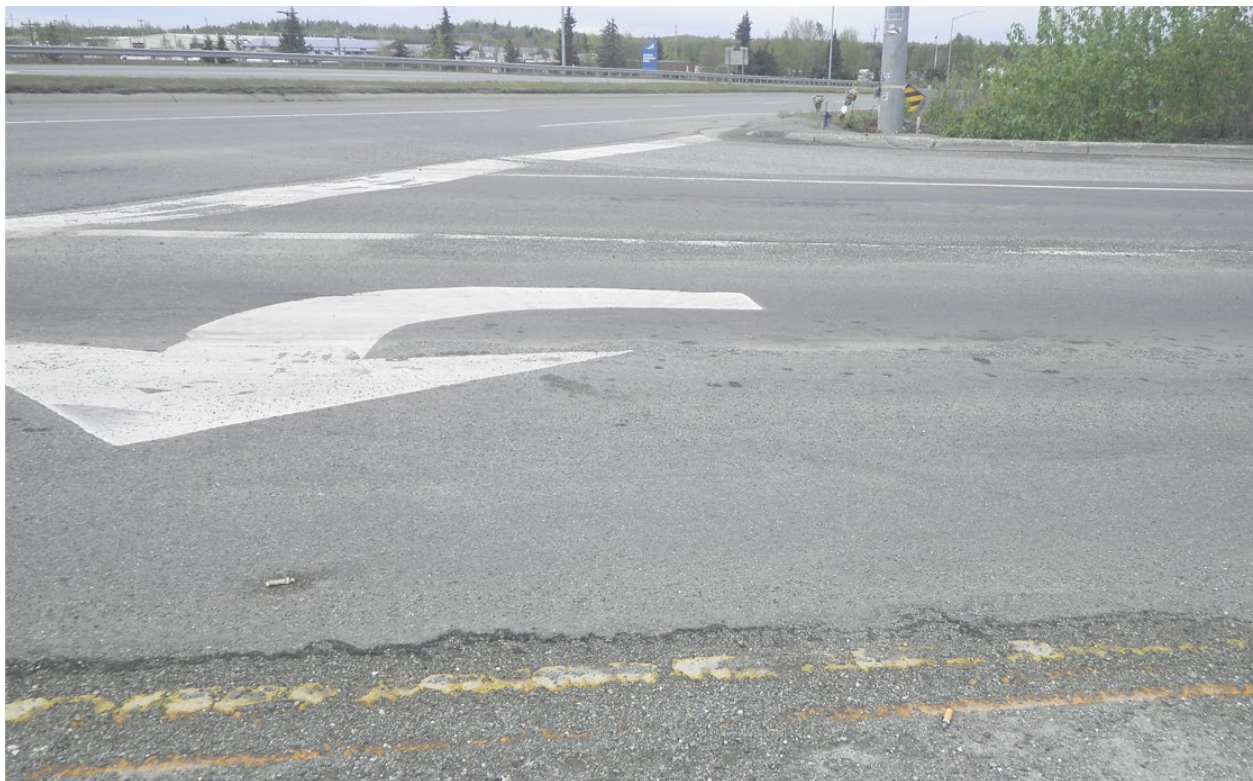
During year 1 of monitoring the cracks reflected through the microsurfacing, plow damage was present on the striping at the center of the lane and rutting from deformation was noted at the signalized intersection.

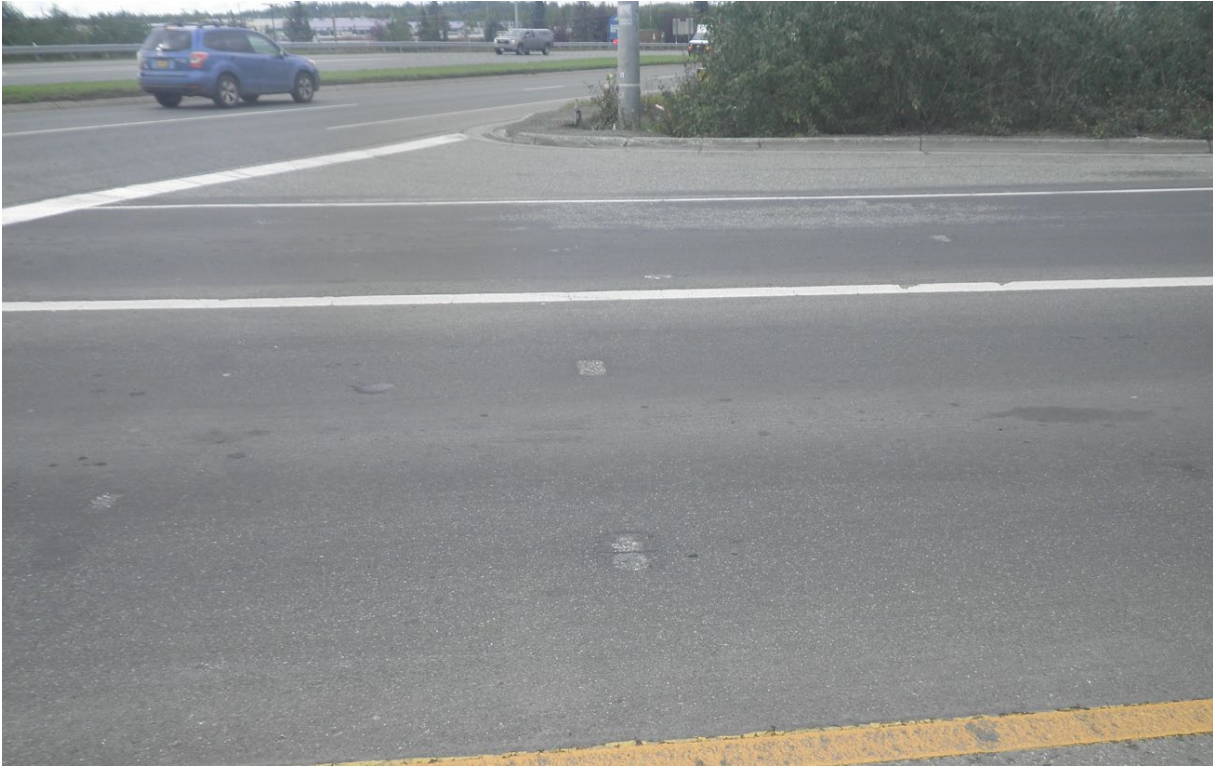
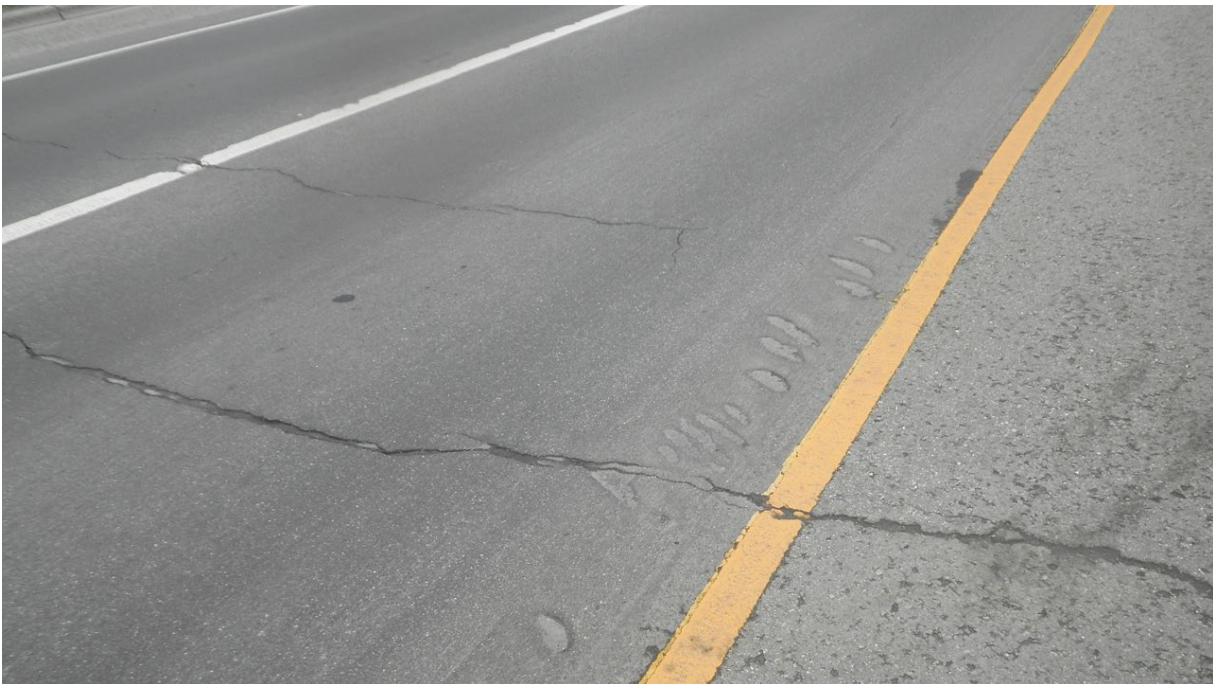
There is increased plow damage at the signalized intersection and cracks have reflected at higher severity than year 1.

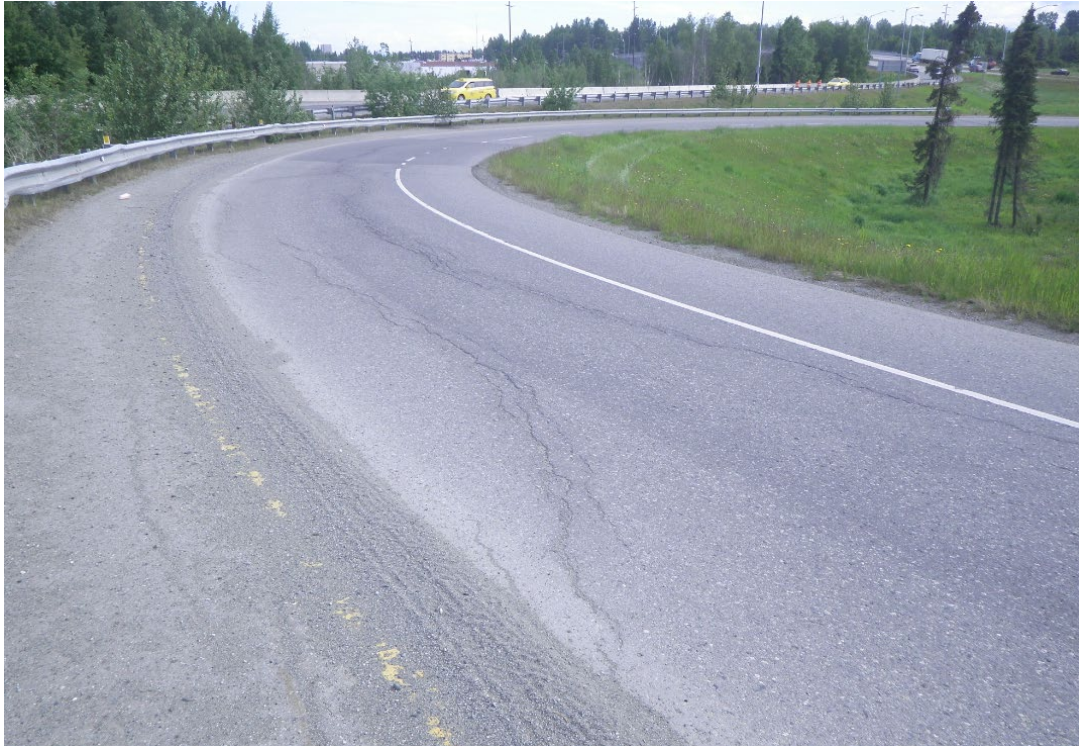
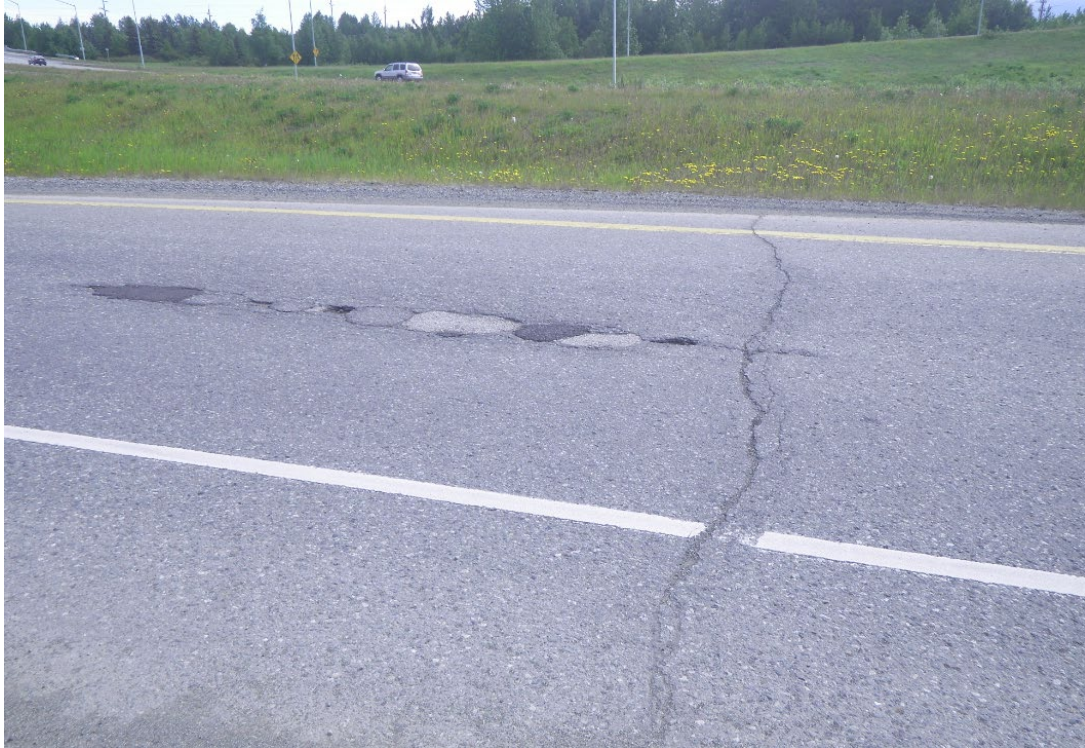
There were low rut depths, but high severity longitudinal cracking was present in the middle of the ramp that may have been related to embankment movement as well as underlying frost susceptible soils. At the base of the ramp there was transverse cracking with potholing.

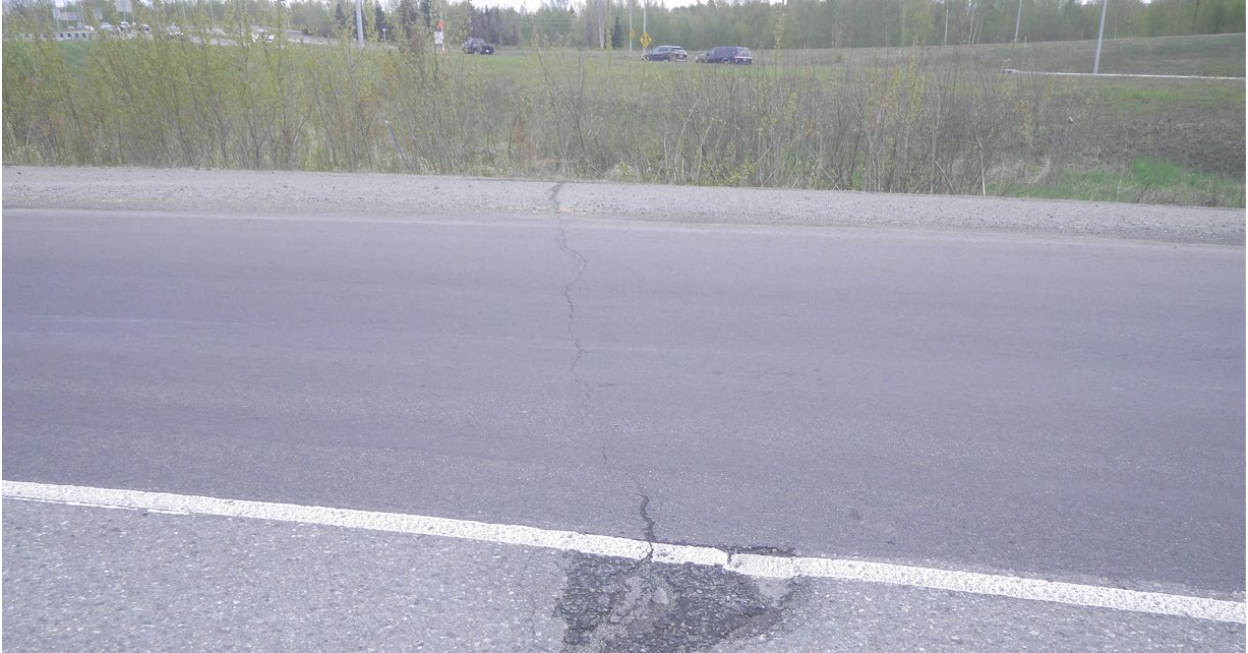
Cracks reflected through the microsurfacing but remained in low severity on this ramp, which is in good condition overall.

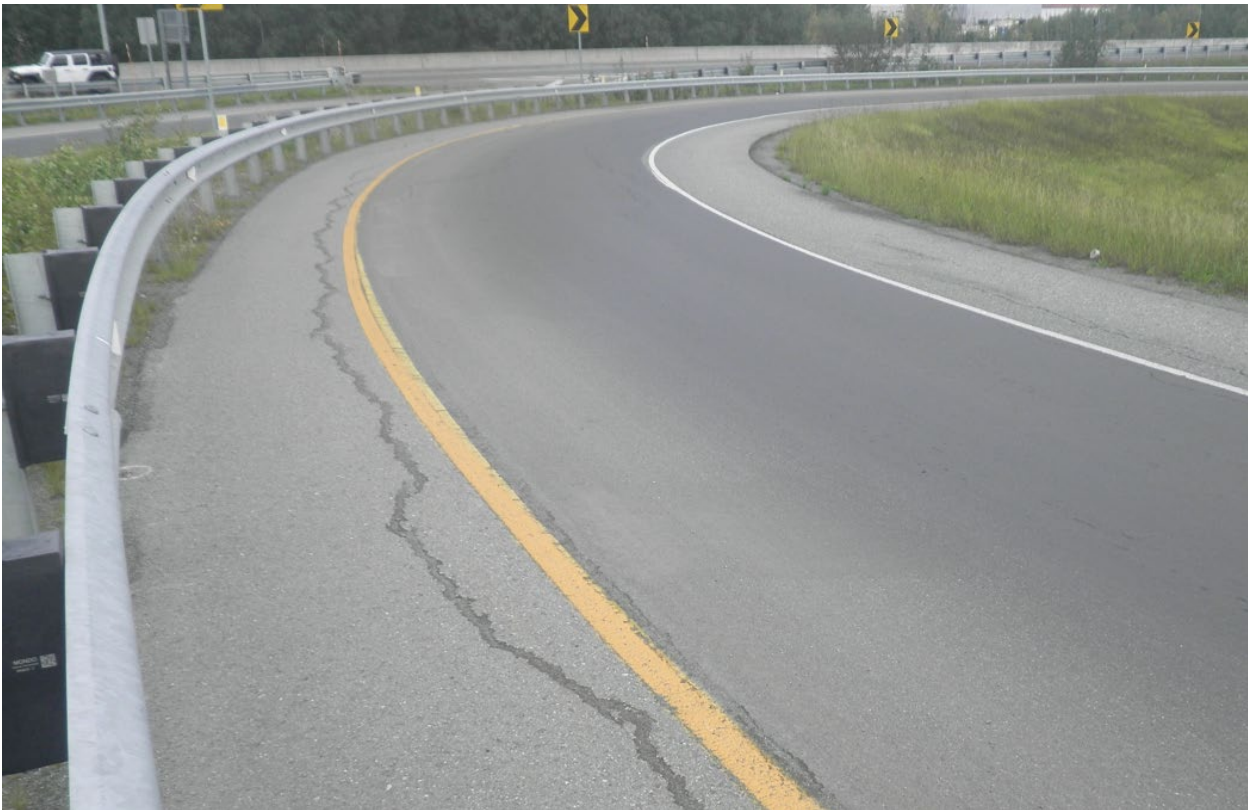
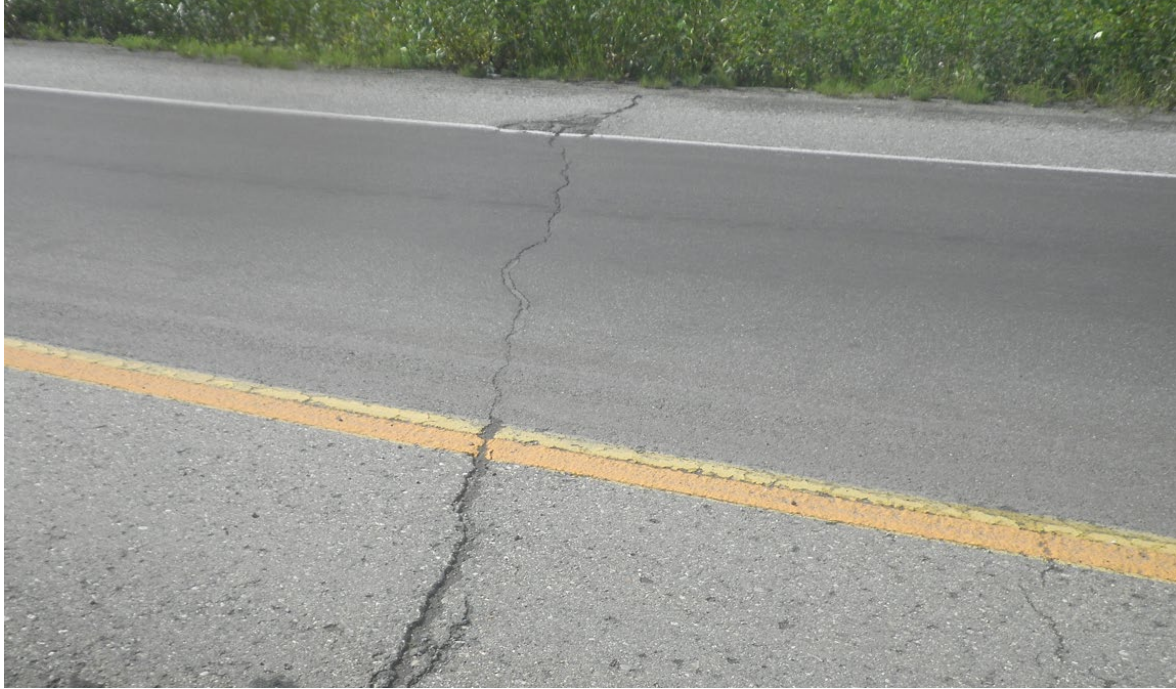
There is increased damage along longitudinal cracks where plows are catching and damaging the surfacing treatment.

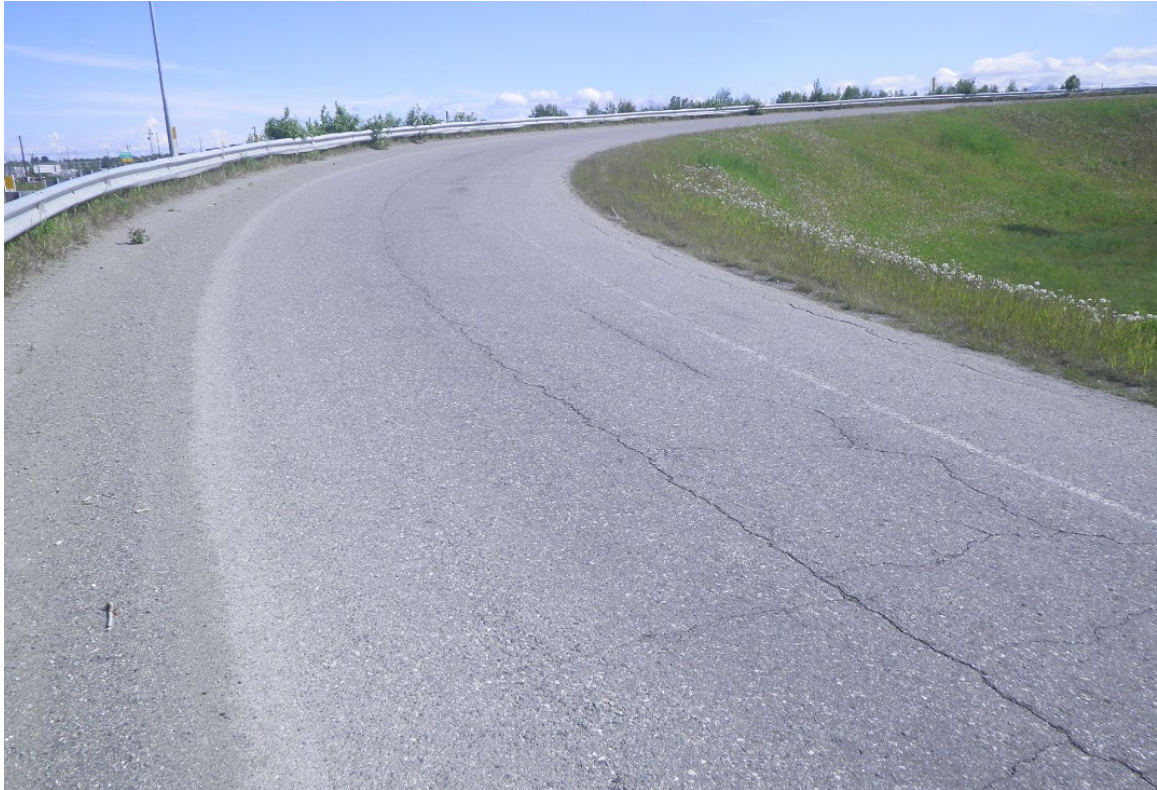
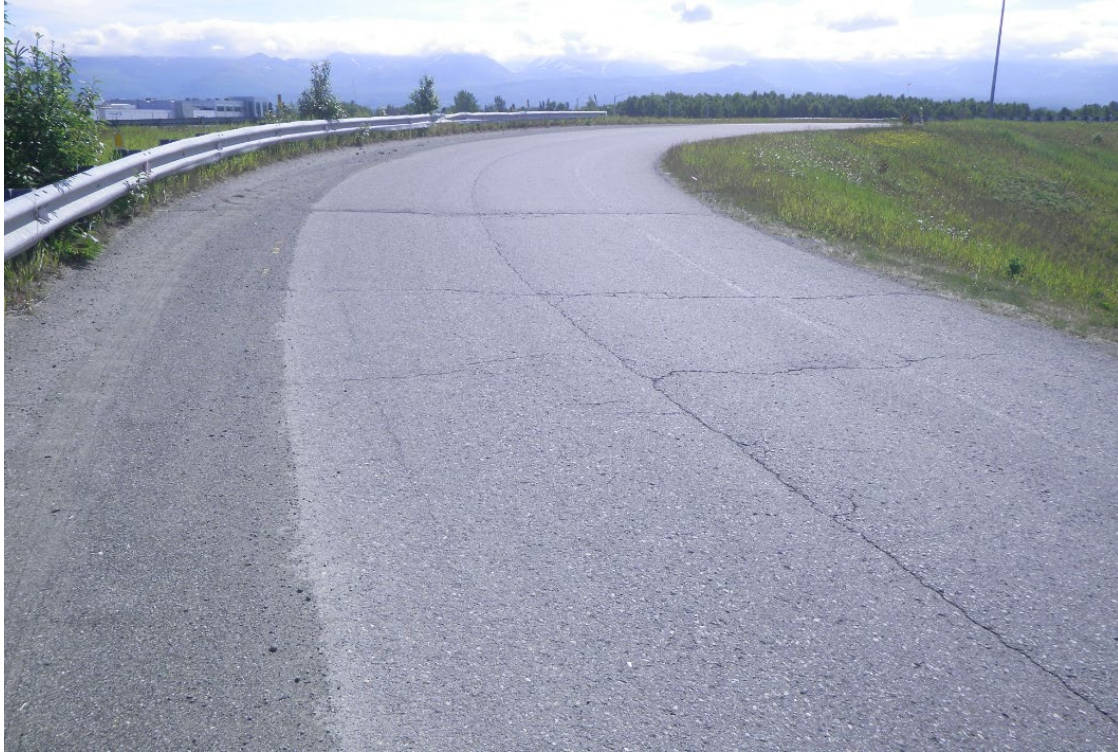
The entire ramp was blocked cracked with a centerline crack present for the entire length. Fatigue cracking was beginning to develop in the inside wheelpath.

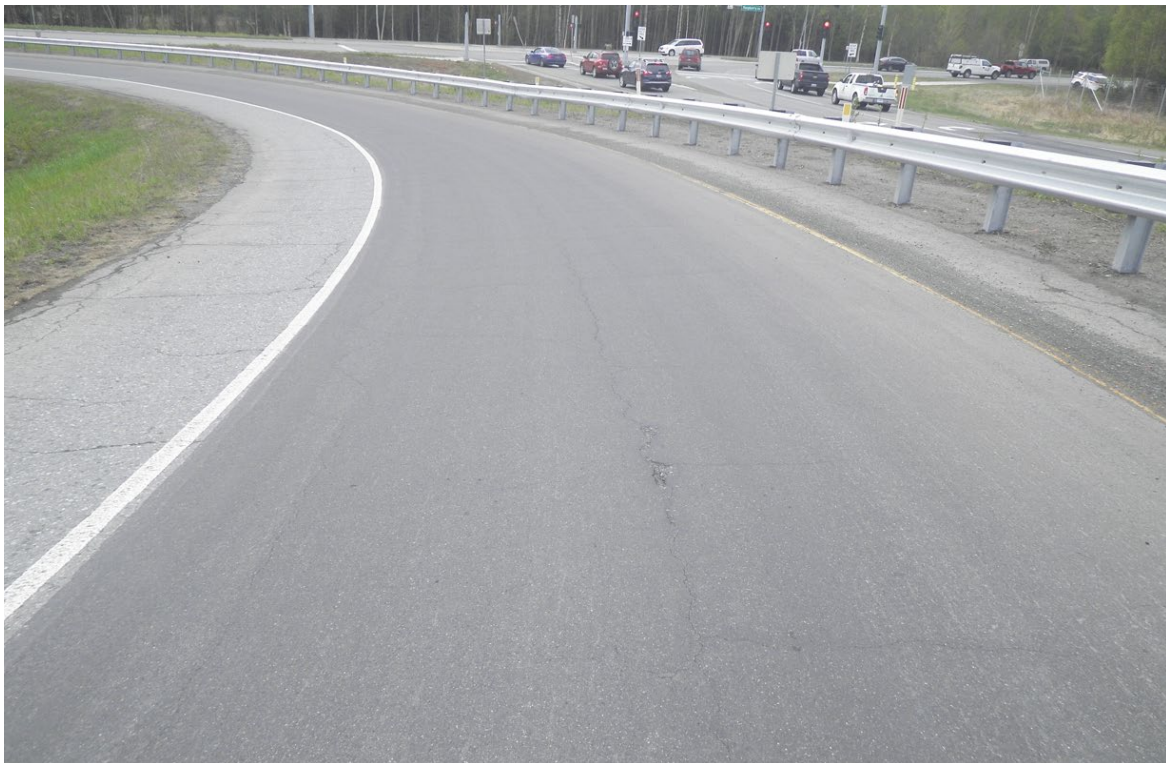
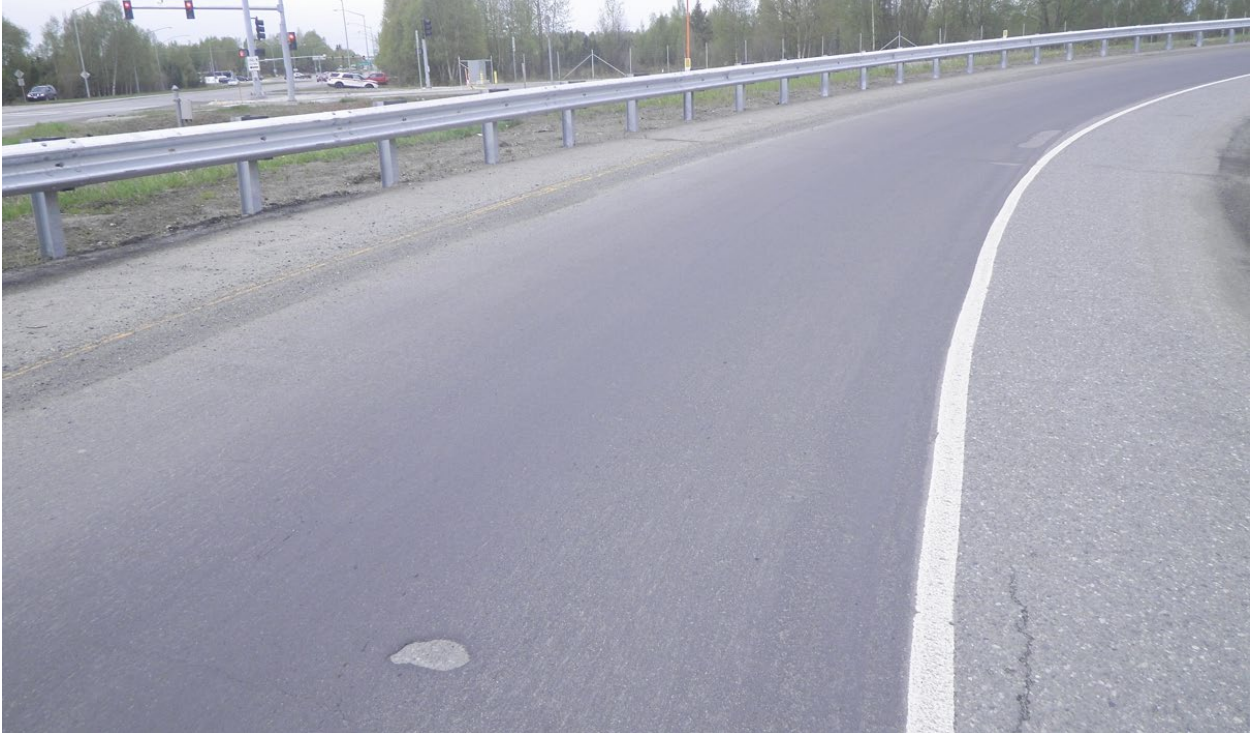
Cracks reflected through the ramp and plow damage was present having caused damage along the centerline and right side of the lane. The ramp is in moderate to poor condition.

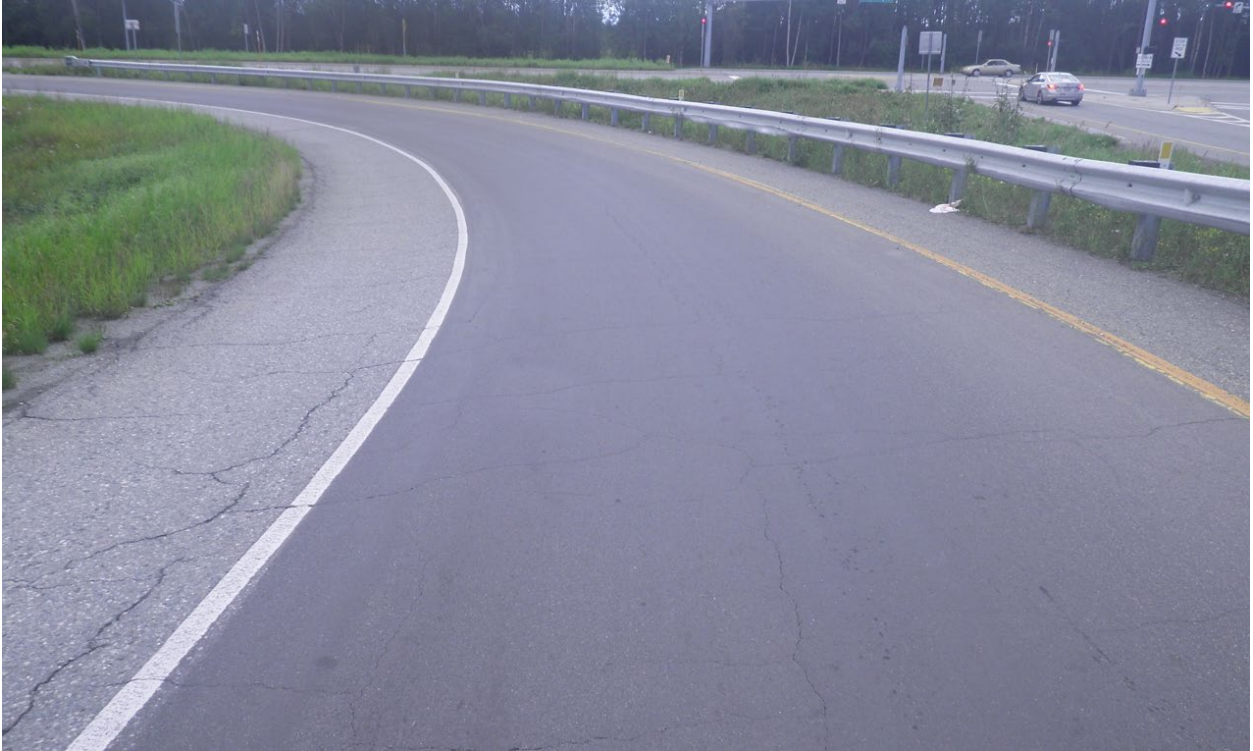
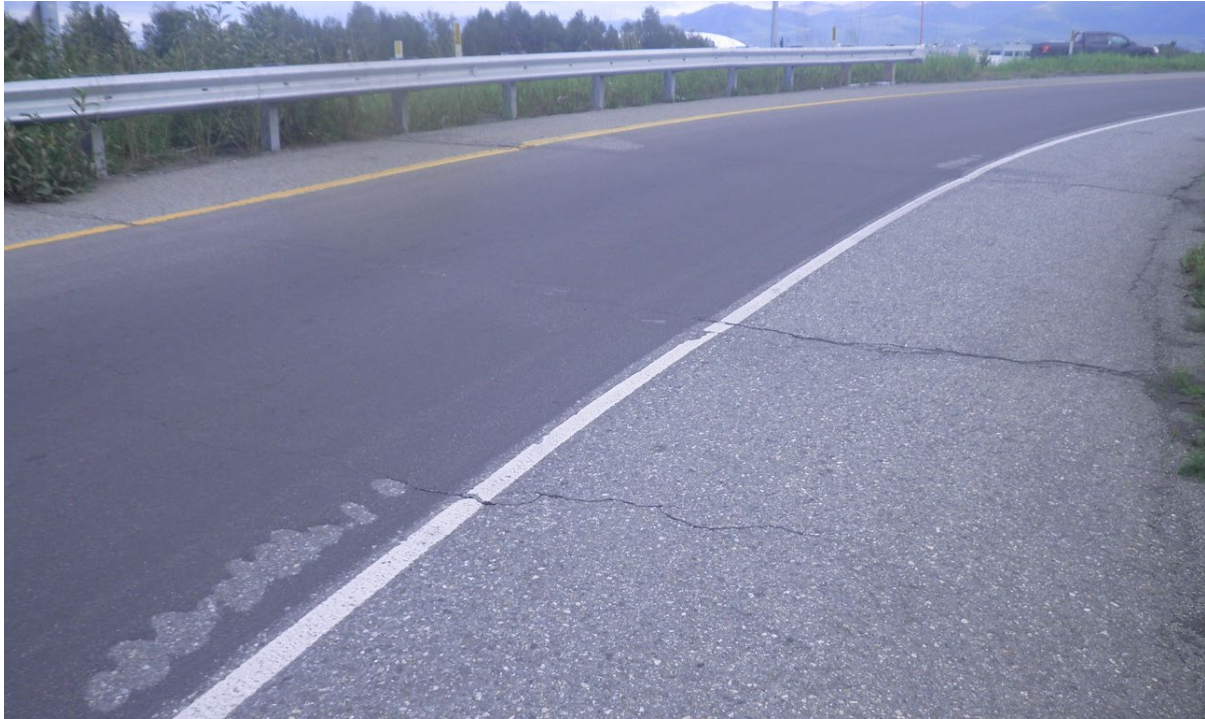
There is additional plow damage on the ramp in year 2 and increased damage over reflective cracking.

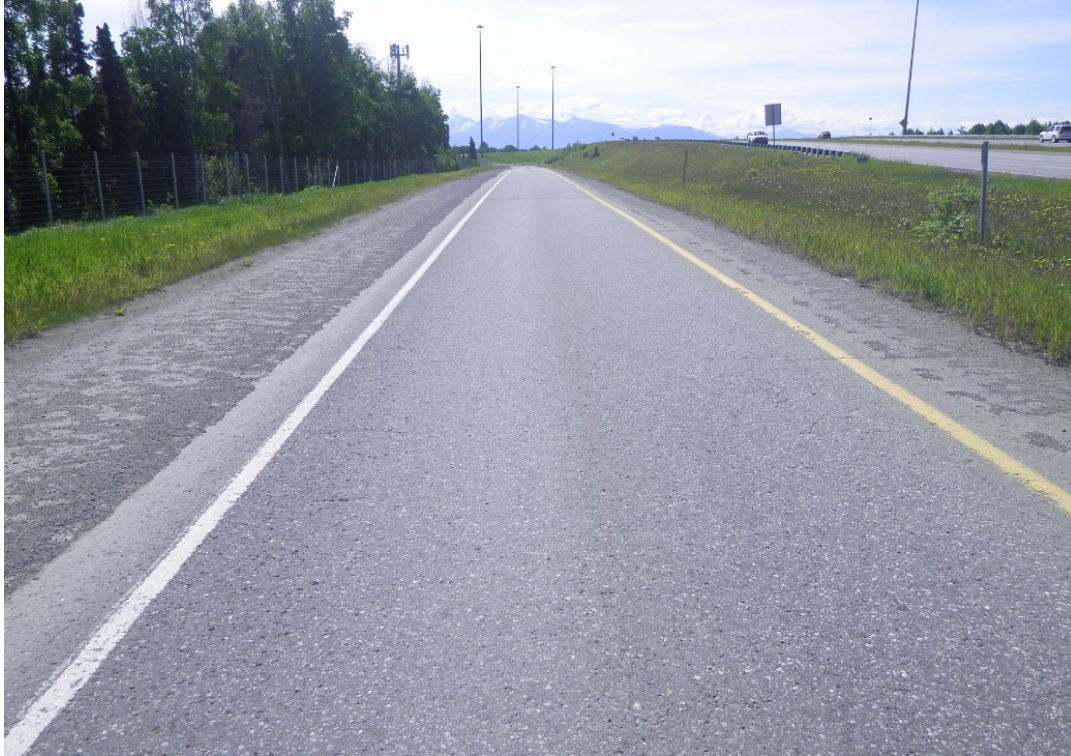
At the beginning of this ramp there was high severity center crack with fatigue cracking forming in the right wheelpath. The conditions improved at the International Airport sign, although faint wheelpath cracking was beginning to form in areas.
