Minnesota Drive Ramps Microsurfacing Experimental Feature

Year 2 Monitoring Report

Alaska Department of Transportation and Public Facilities
Statewide Materials and Asset Management

January 2023

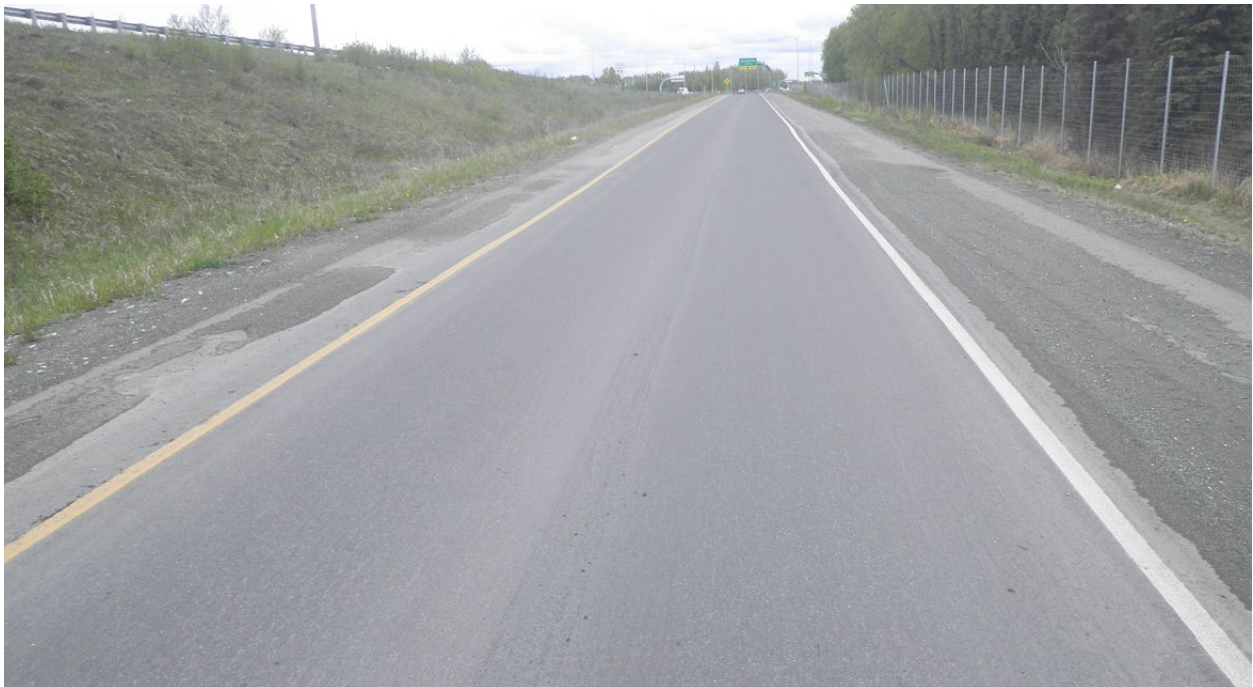
The block cracking and fatigue cracking reflected through the microsurfacing, but the largest cracks to reflect and experience damage were the transverse cracks on the ramp. The ramp remains in moderate condition.

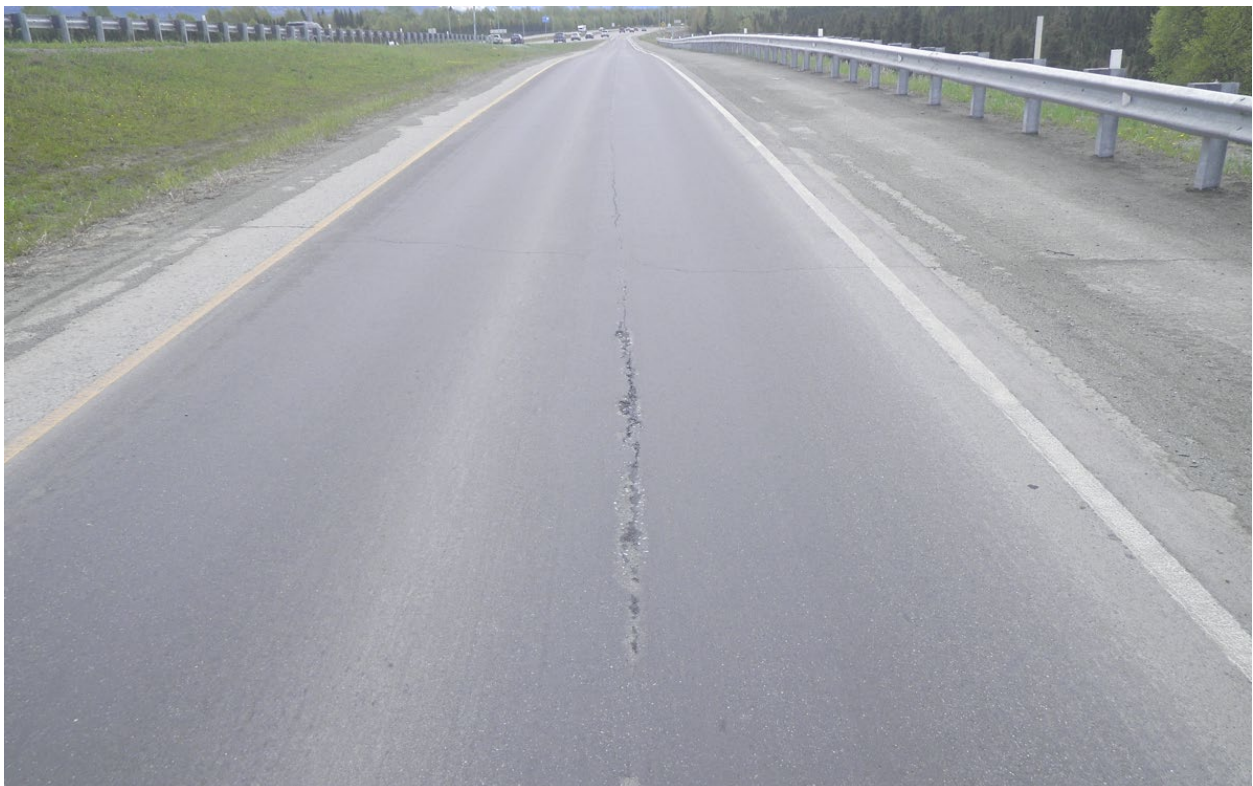
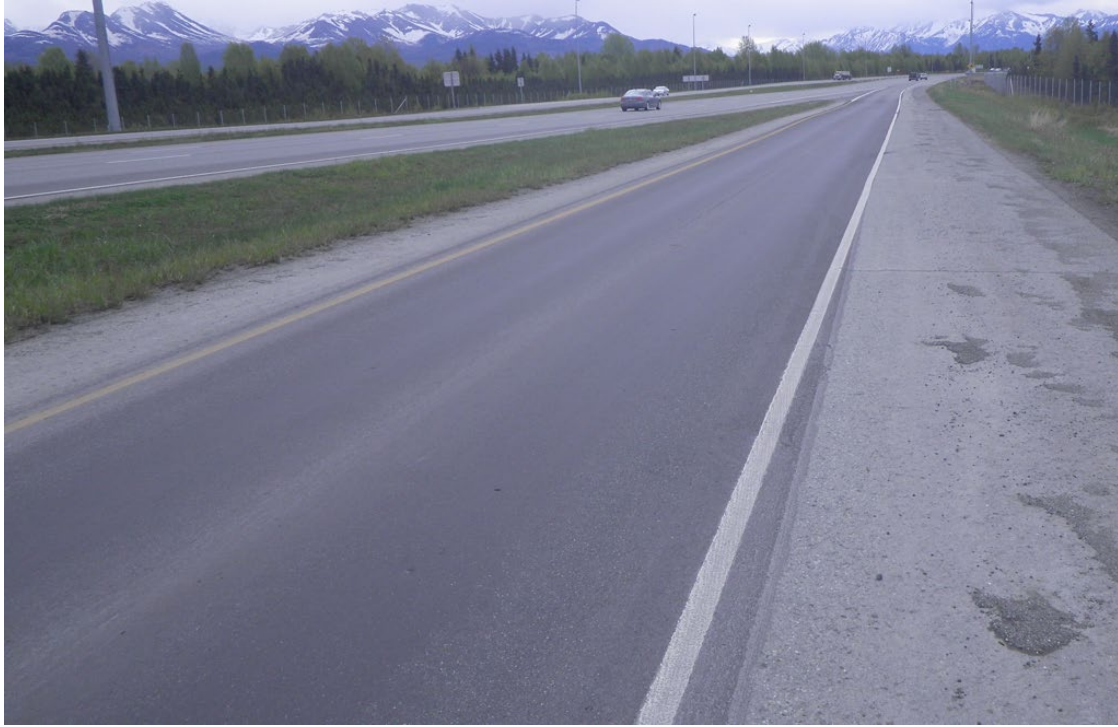
There was moderate flushing present on this ramp in the curve at Raspberry and near the end of the ramp. There was also damage along the centerline joint from plows.

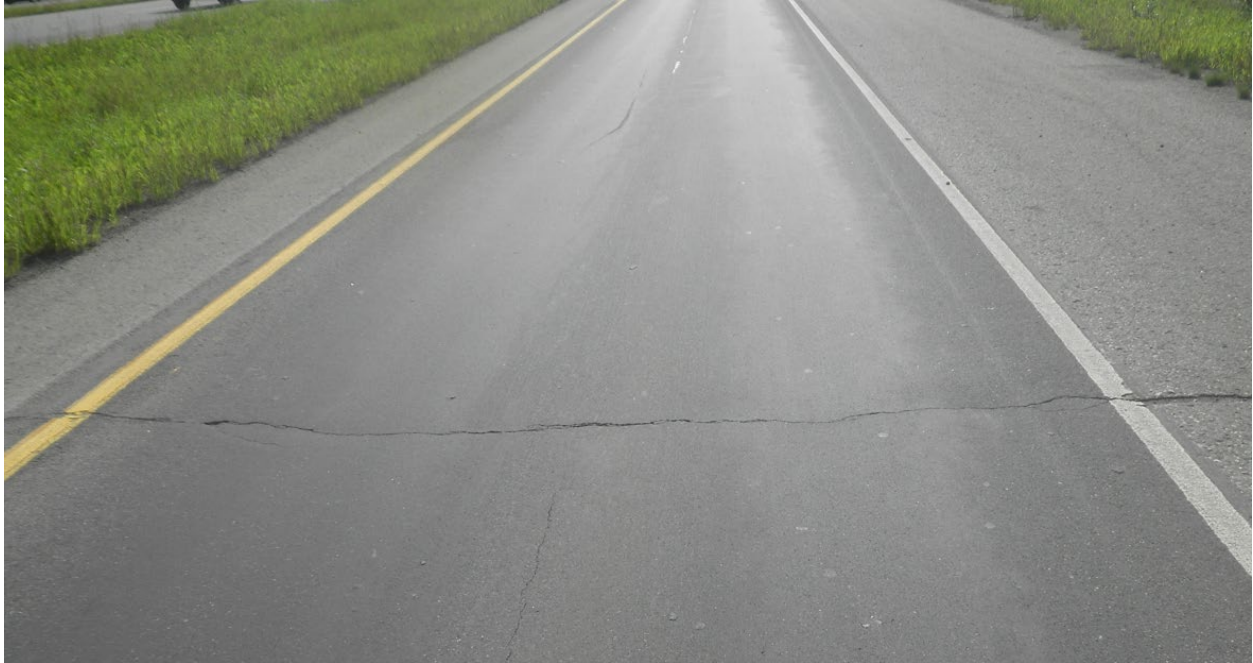
There is significant flushing on this ramp, especially at the beginning of the ramp in the curve and at the end where the deepest ruts were. The reflective transverse cracks are still significantly less severe than they were originally, but the joint raveling along the centerline is opening up since 2021.

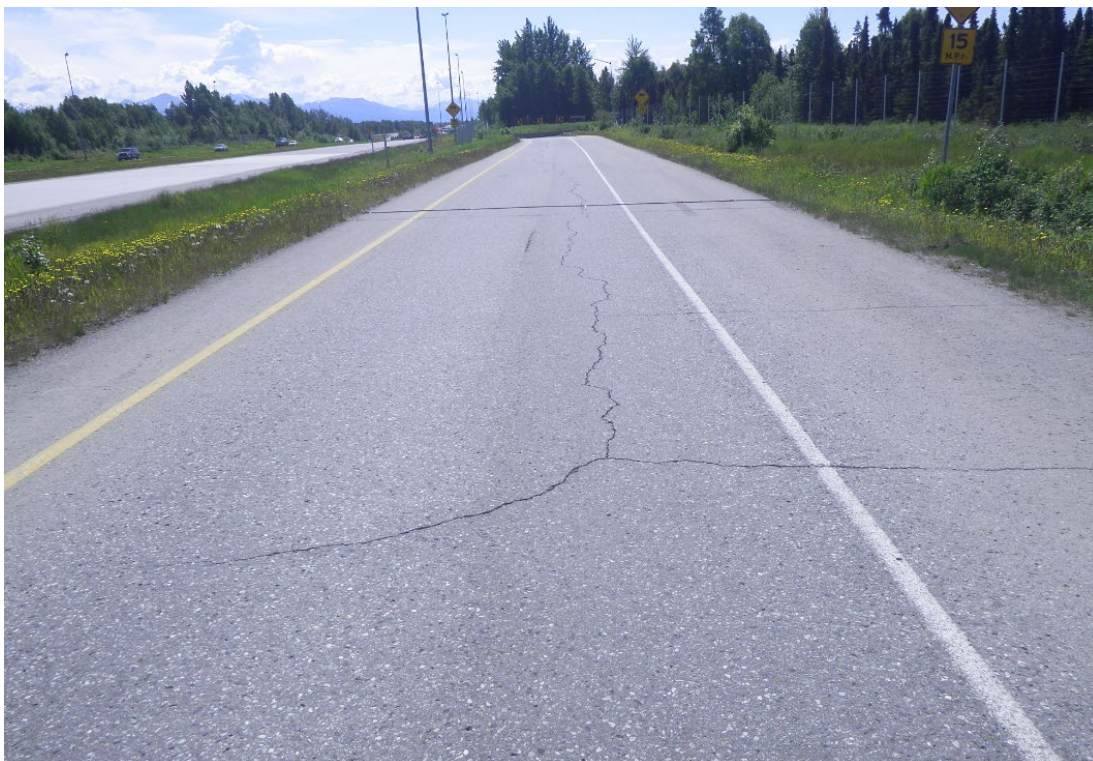
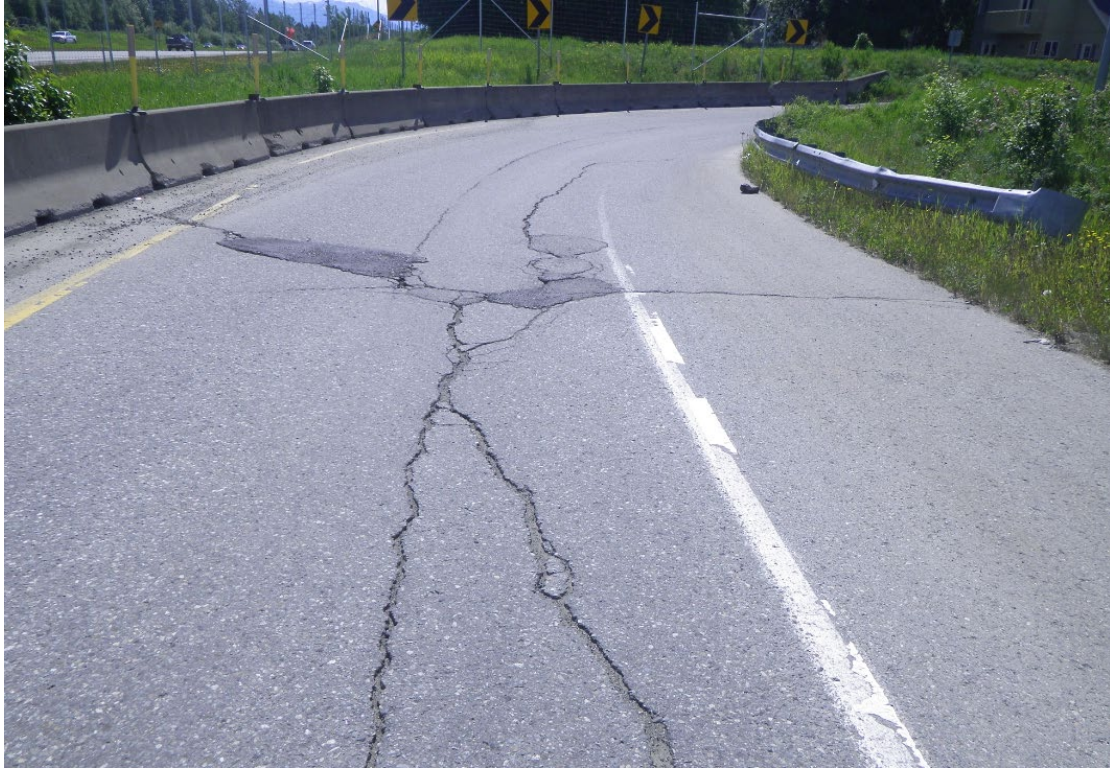
There were low rut depths on this ramp, but it did have high severity longitudinal cracking, transverse cracking and potholing that worsen towards the end of the ramp.

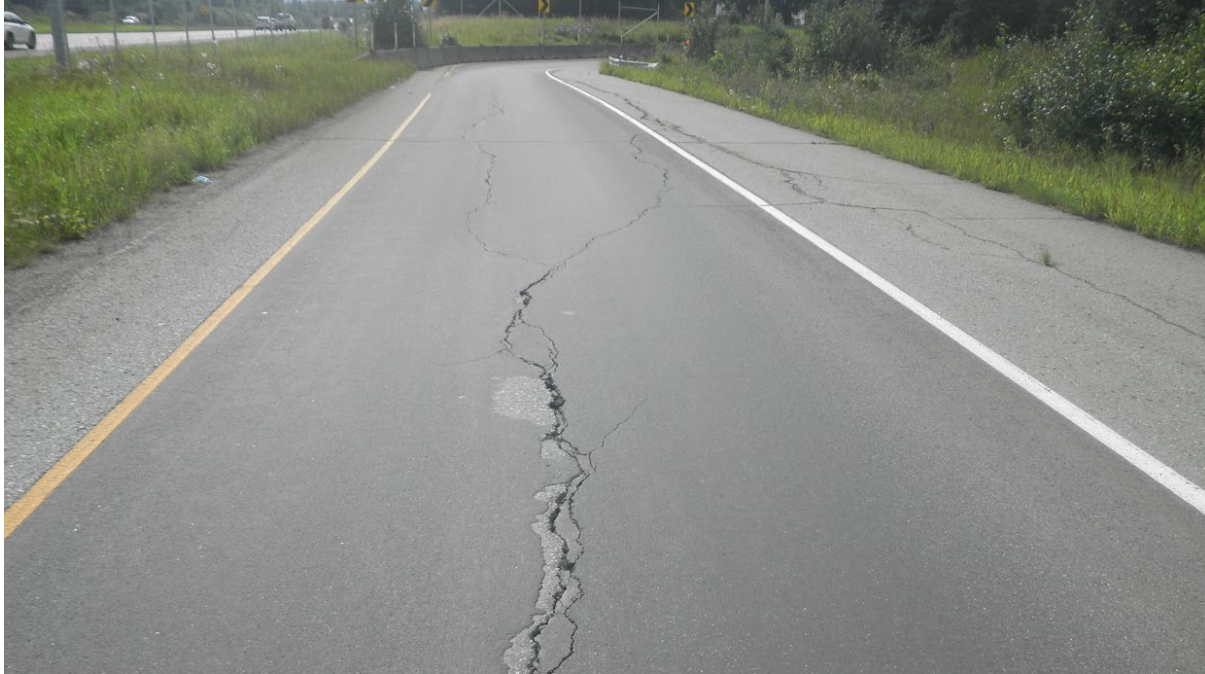
This ramp is in poor condition from plow damage along the centerline and edges of the ramp. The damage was noted after a night of freezing rain when there was likely a large amount of down pressure put on the snowplow to remove ice.

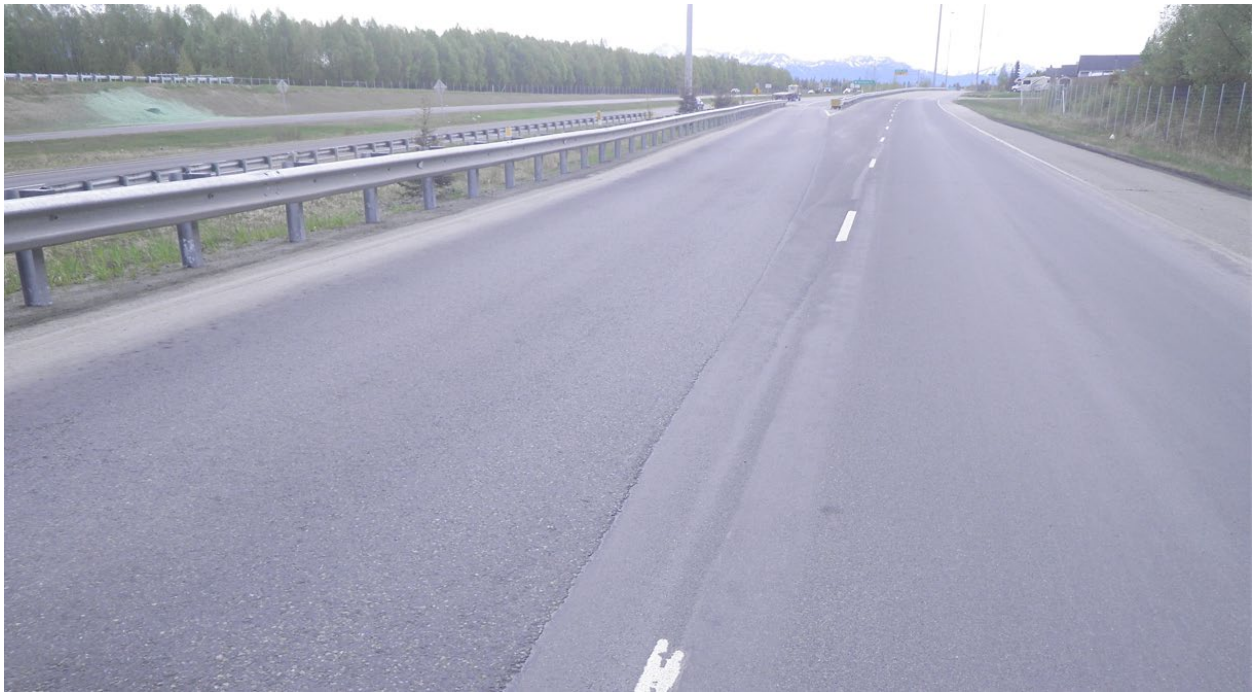
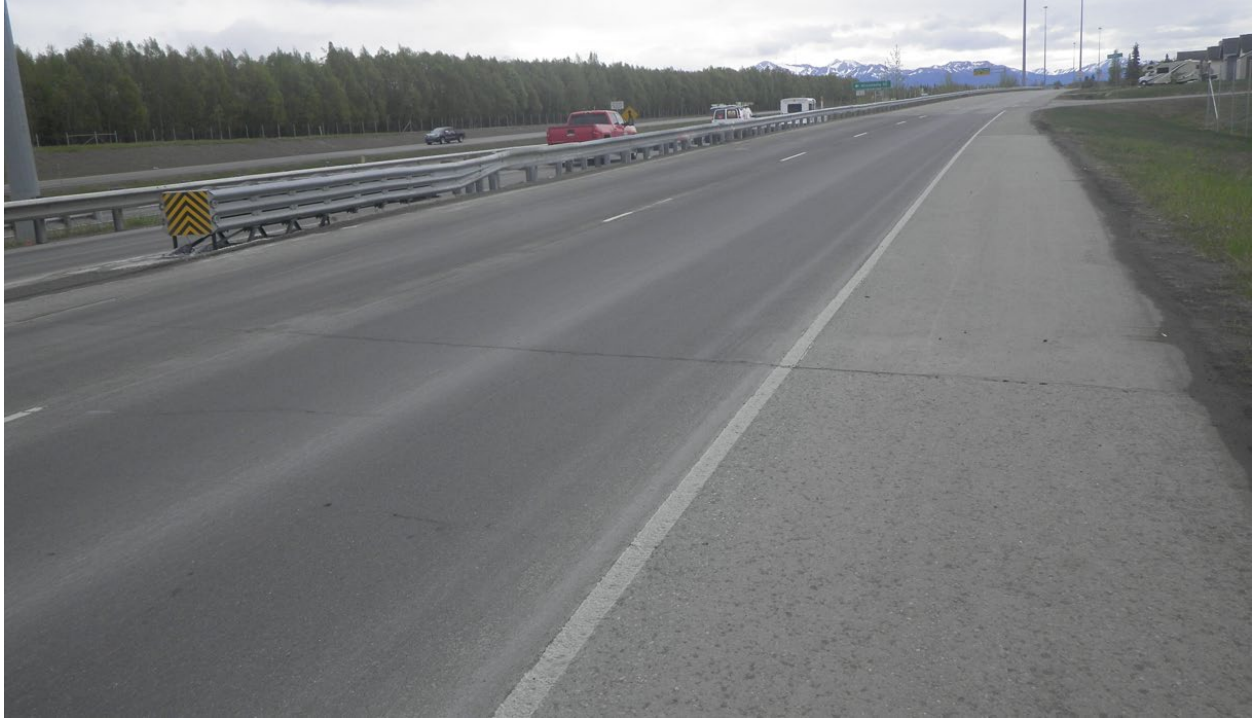
The photo below provides a comparison of the removal area (left) with hot mix, while the microsurfacing remains on the right. The ramp remains in overall good condition with some plow damage on transverse cracks that have reflected through the microsurfacing.

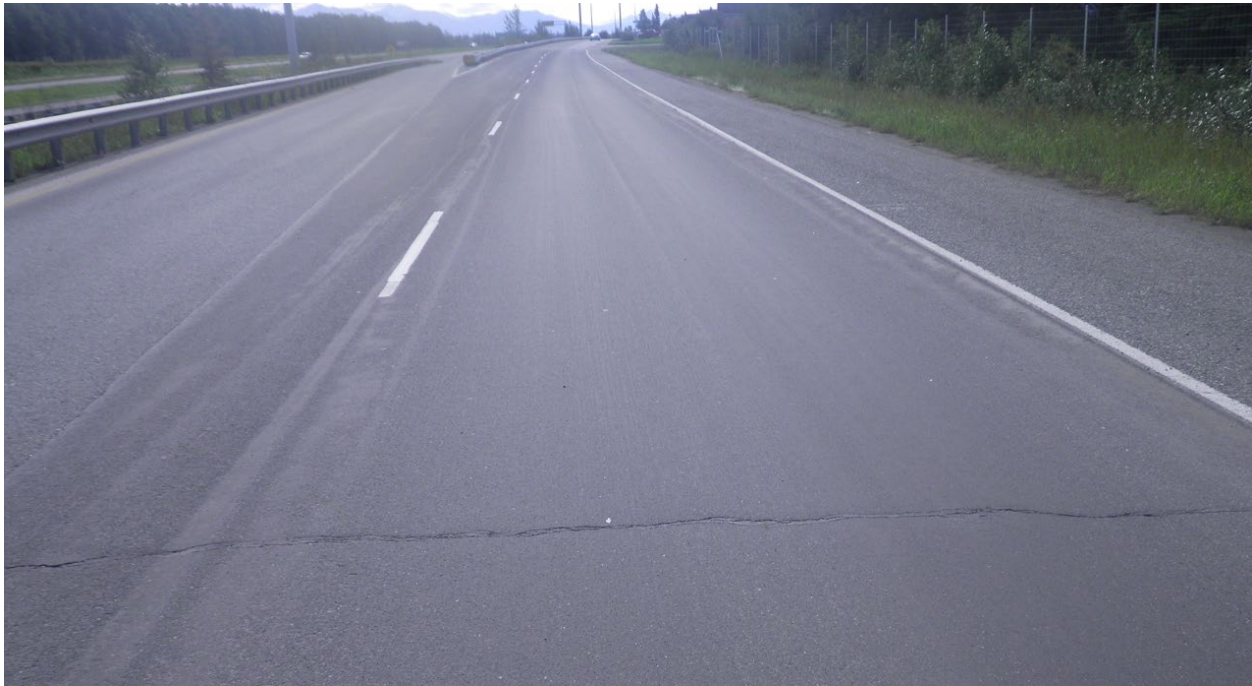
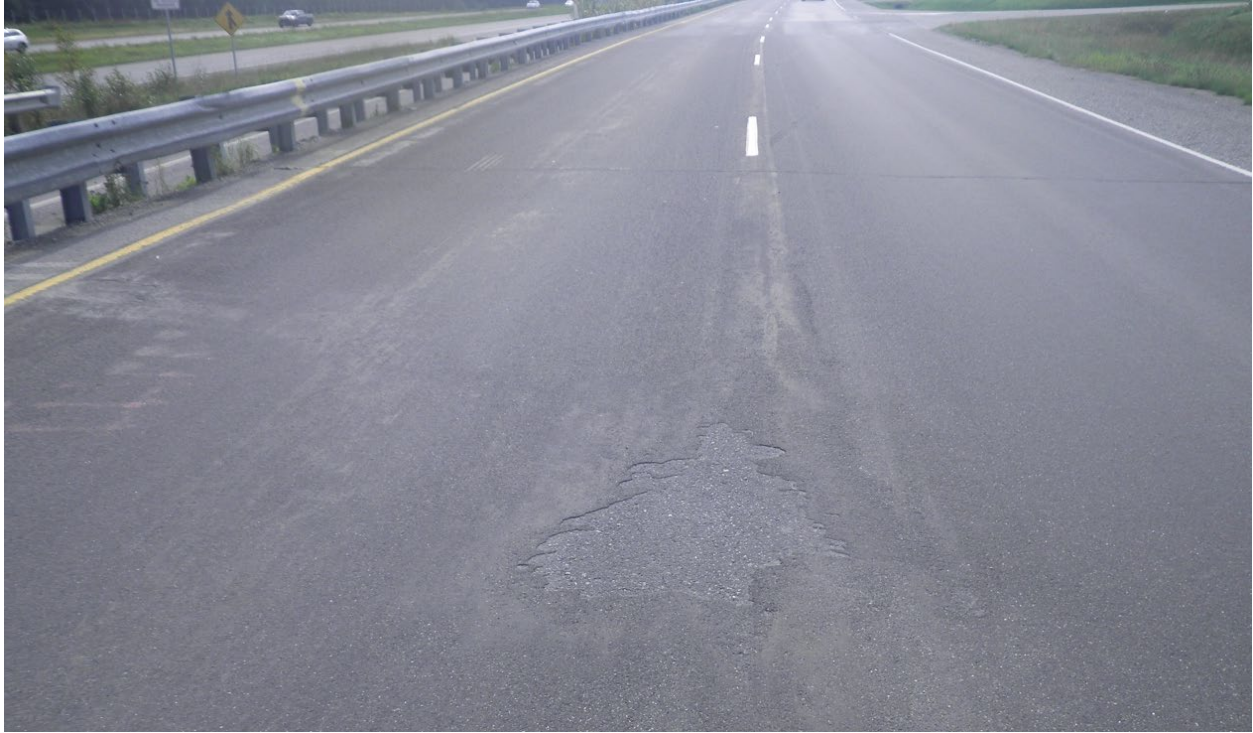
The ramp remains in good condition outside of one location near the end of the application where the plowed removed a portion along the centerline.

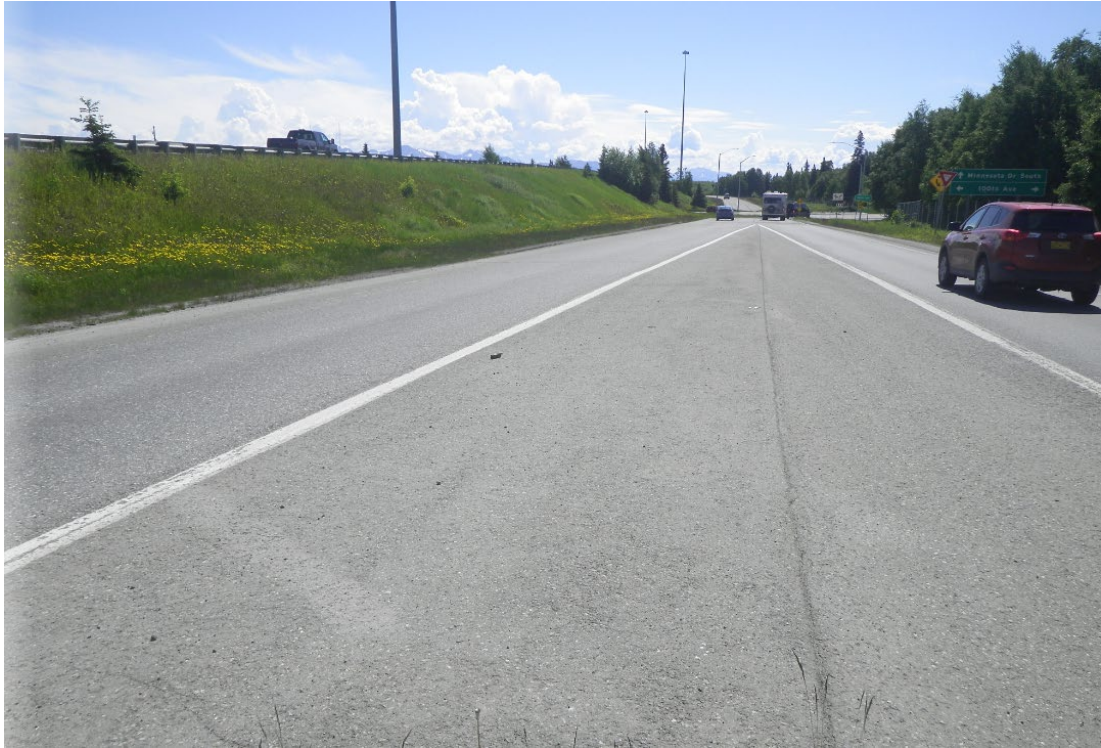
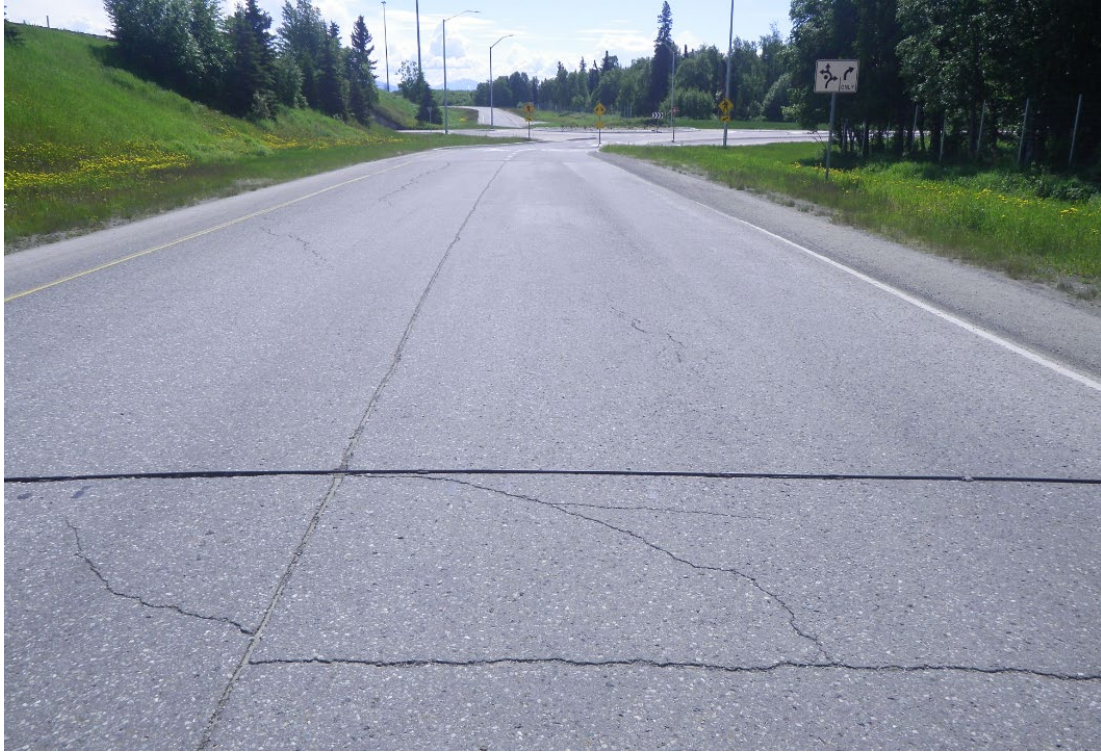
The ramp had isolated potholes, low rut depths but higher severity longitudinal and transverse cracking near 100th Avenue.

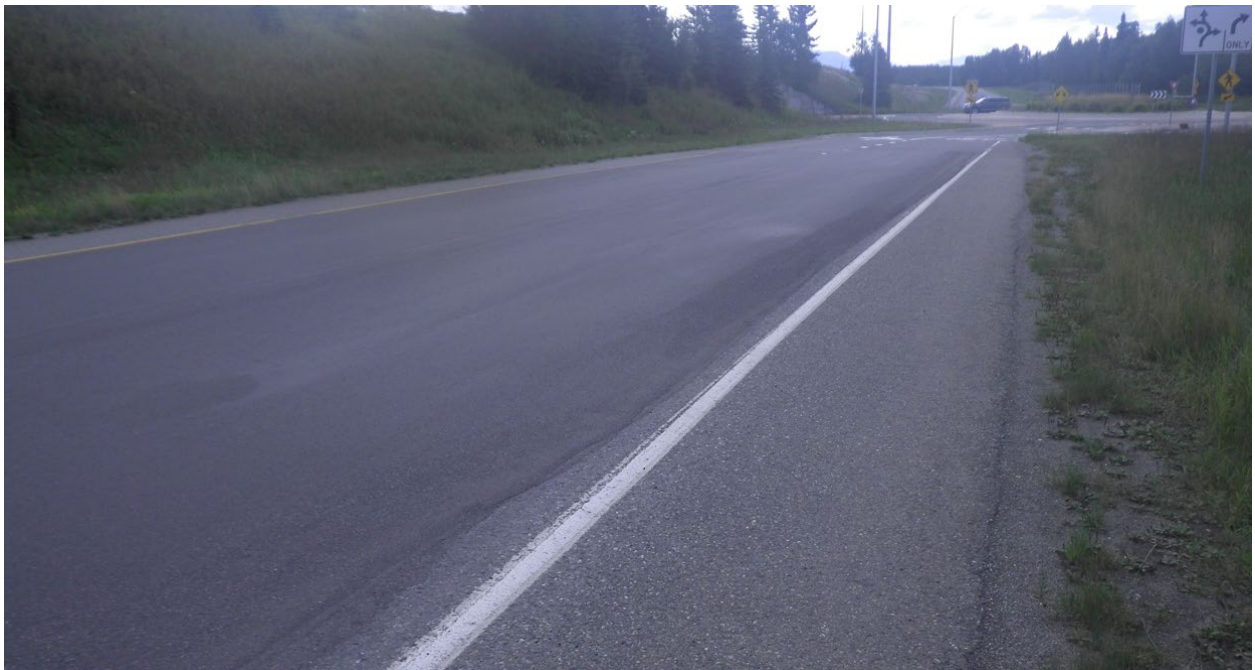
The ramp remains in moderate condition with some isolated plow damage and reflective cracking.

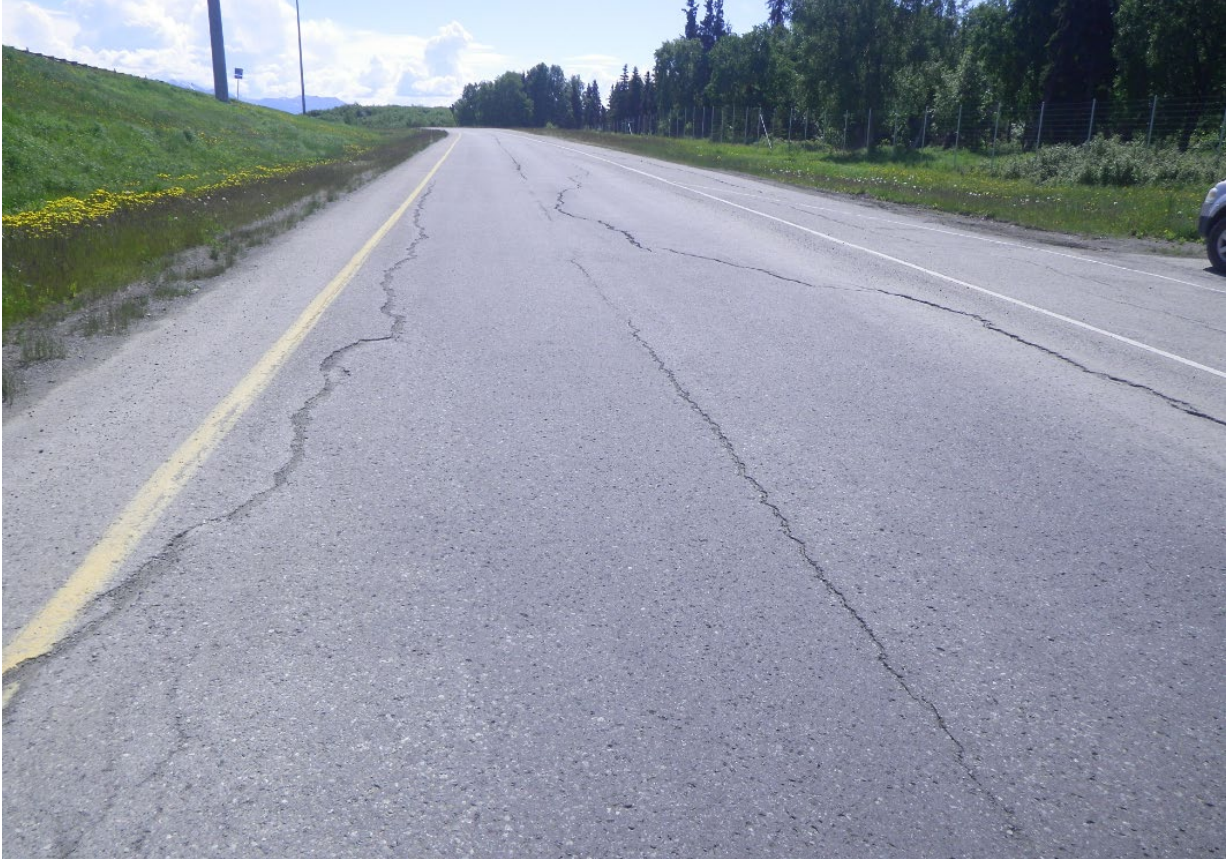
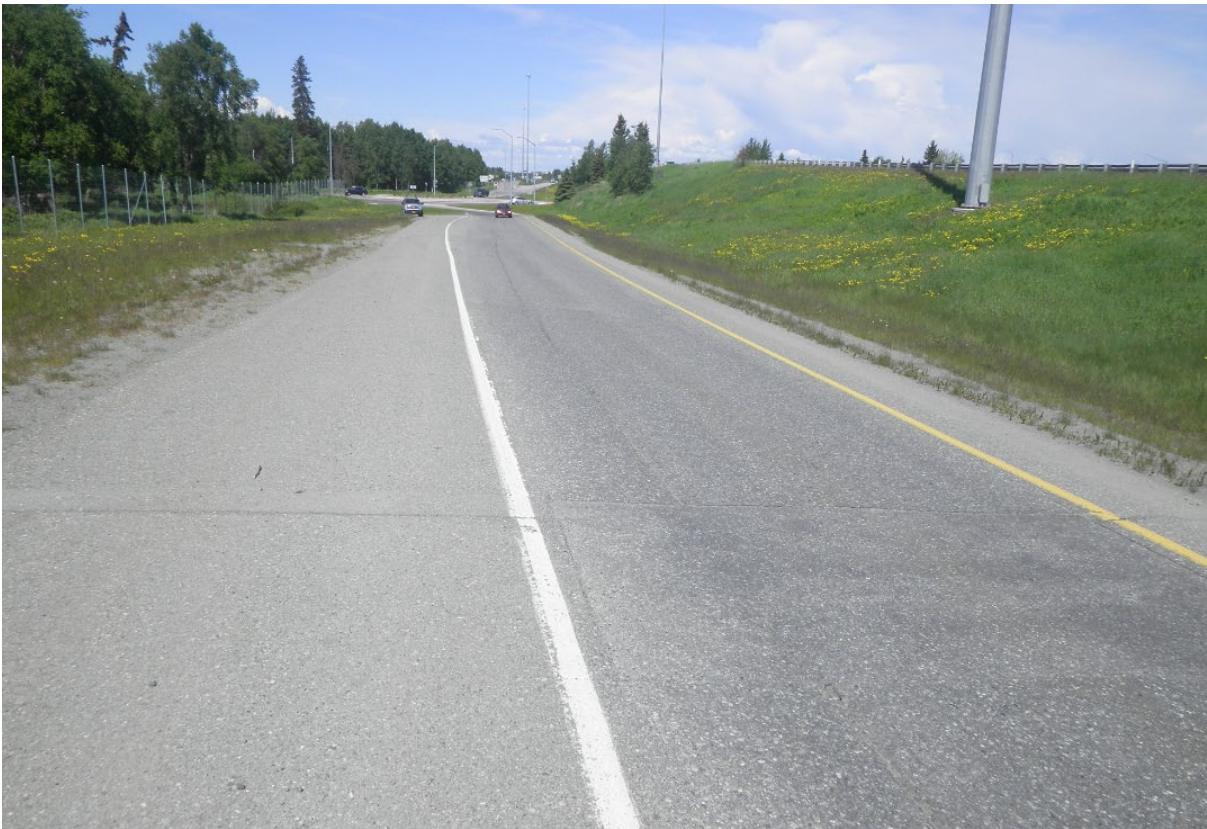
There was high severity longitudinal cracking and joint cracking near 100th Avenue that improved farther down the ramp.

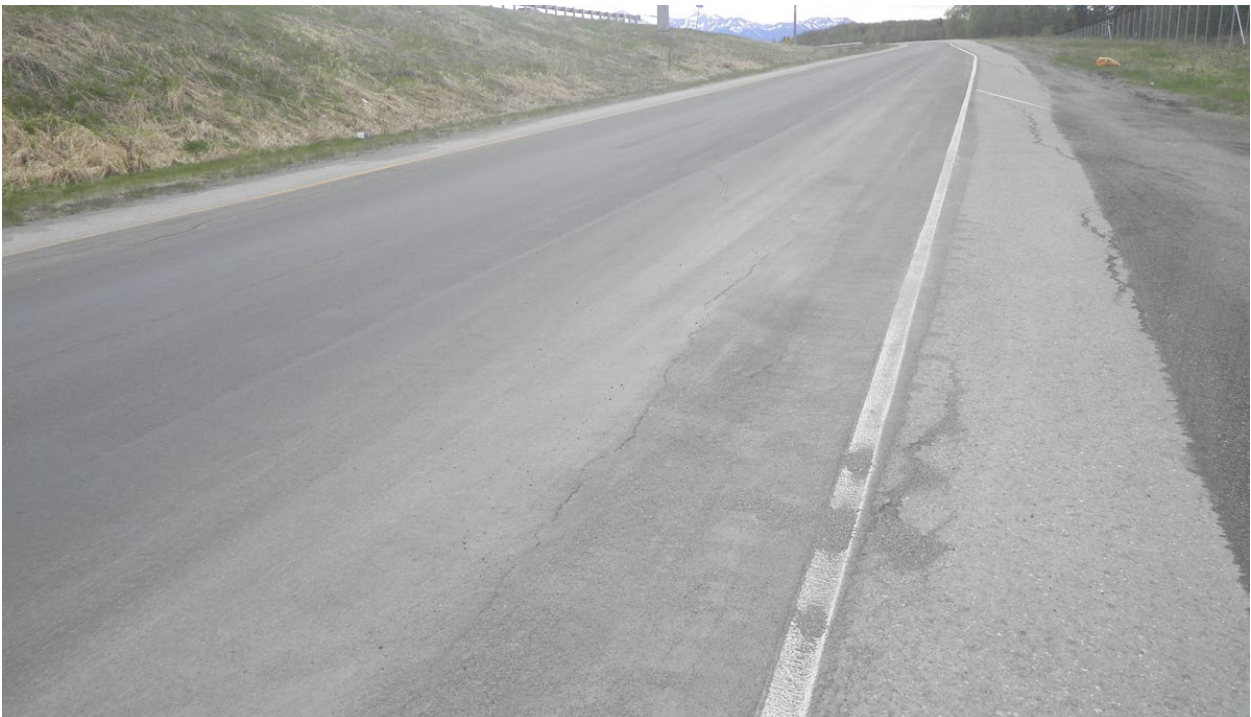
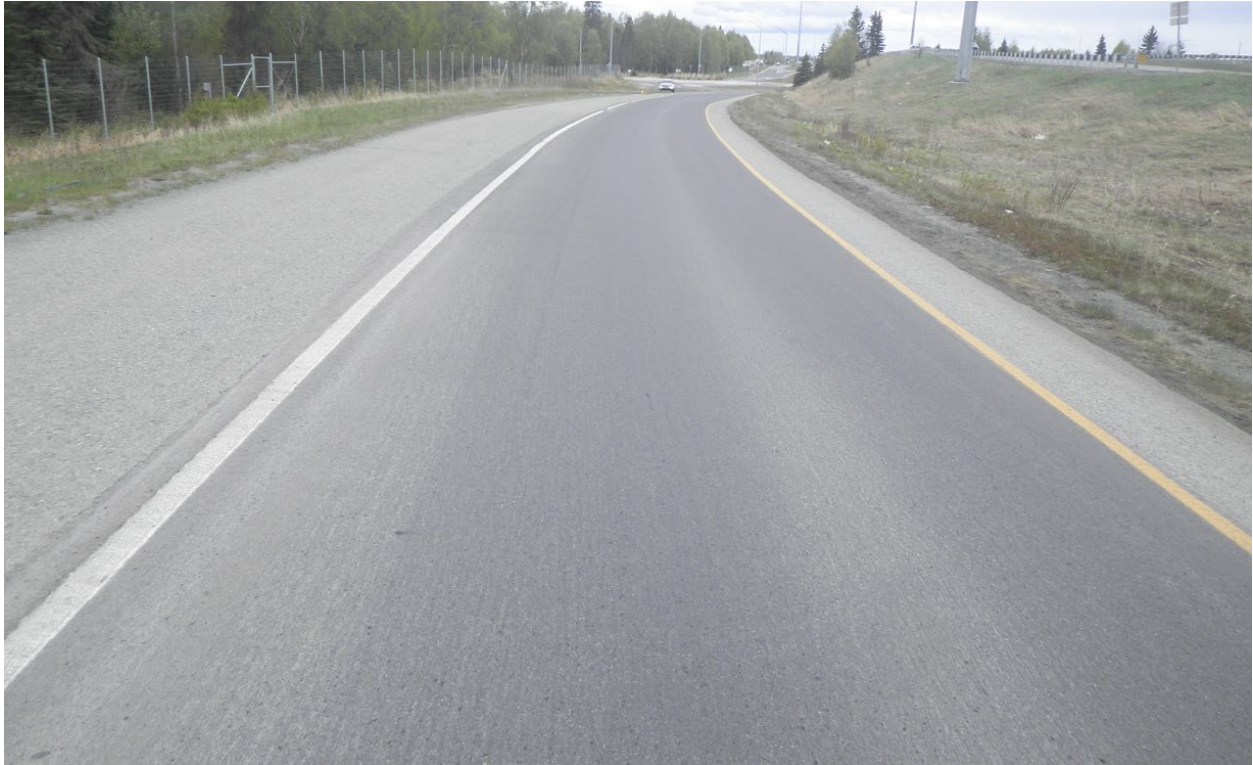
The high severity longitudinal cracking reflected through the microsurfacing near 100th Avenue, but it remained at low severity. Transverse cracks reflected, but overall the ramp remains in good condition outside of the distress near 100th Avenue.

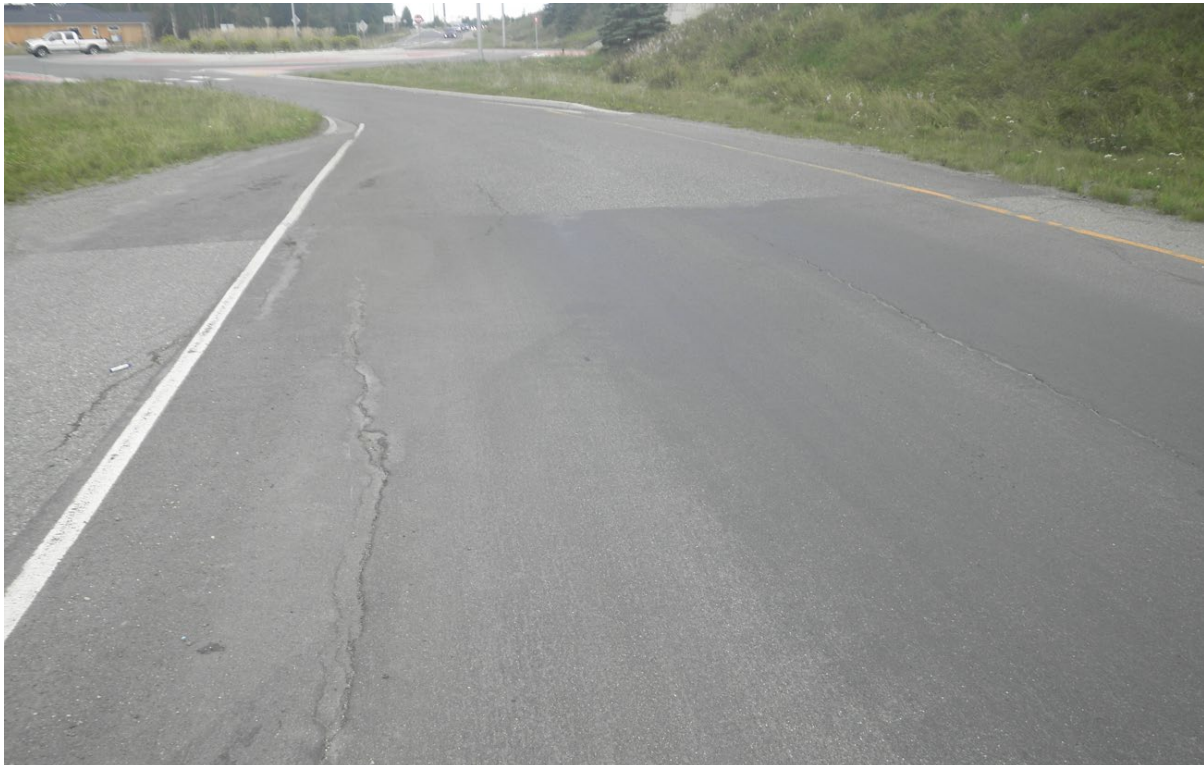
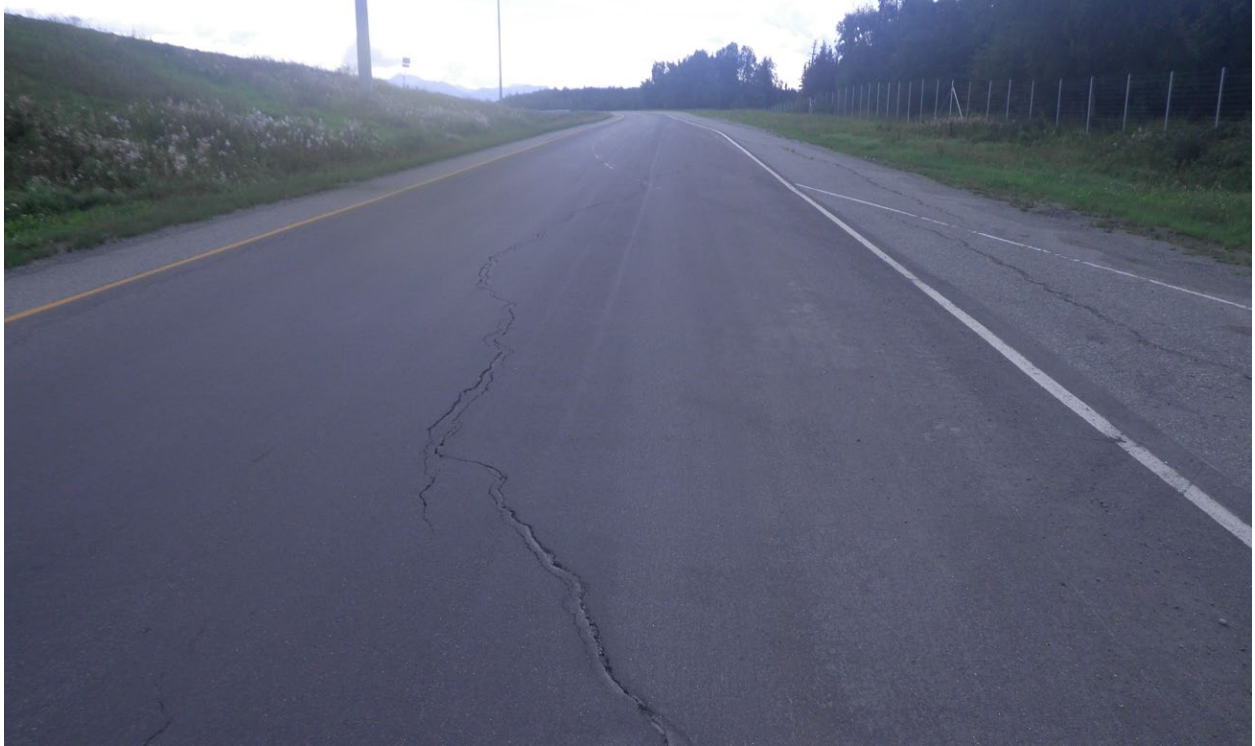
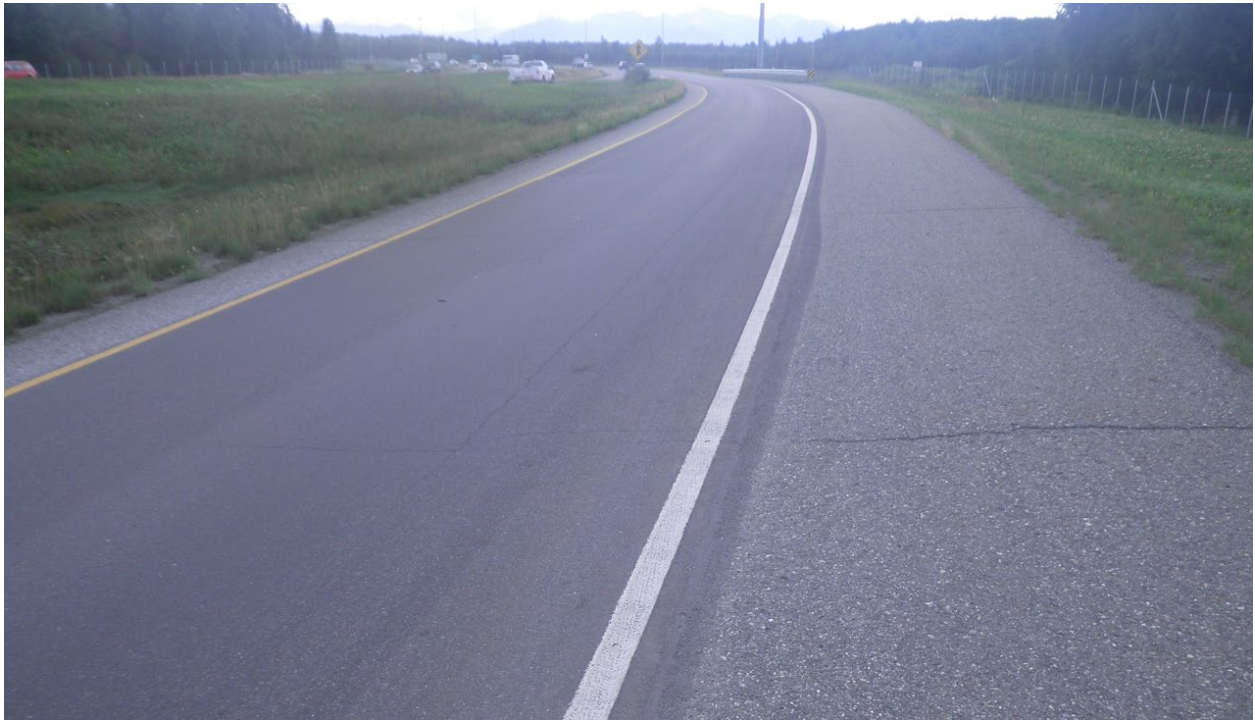
There are significant cracks at 100th Avenue, but the ramp remains in good condition outside of that and isolated plow damage.

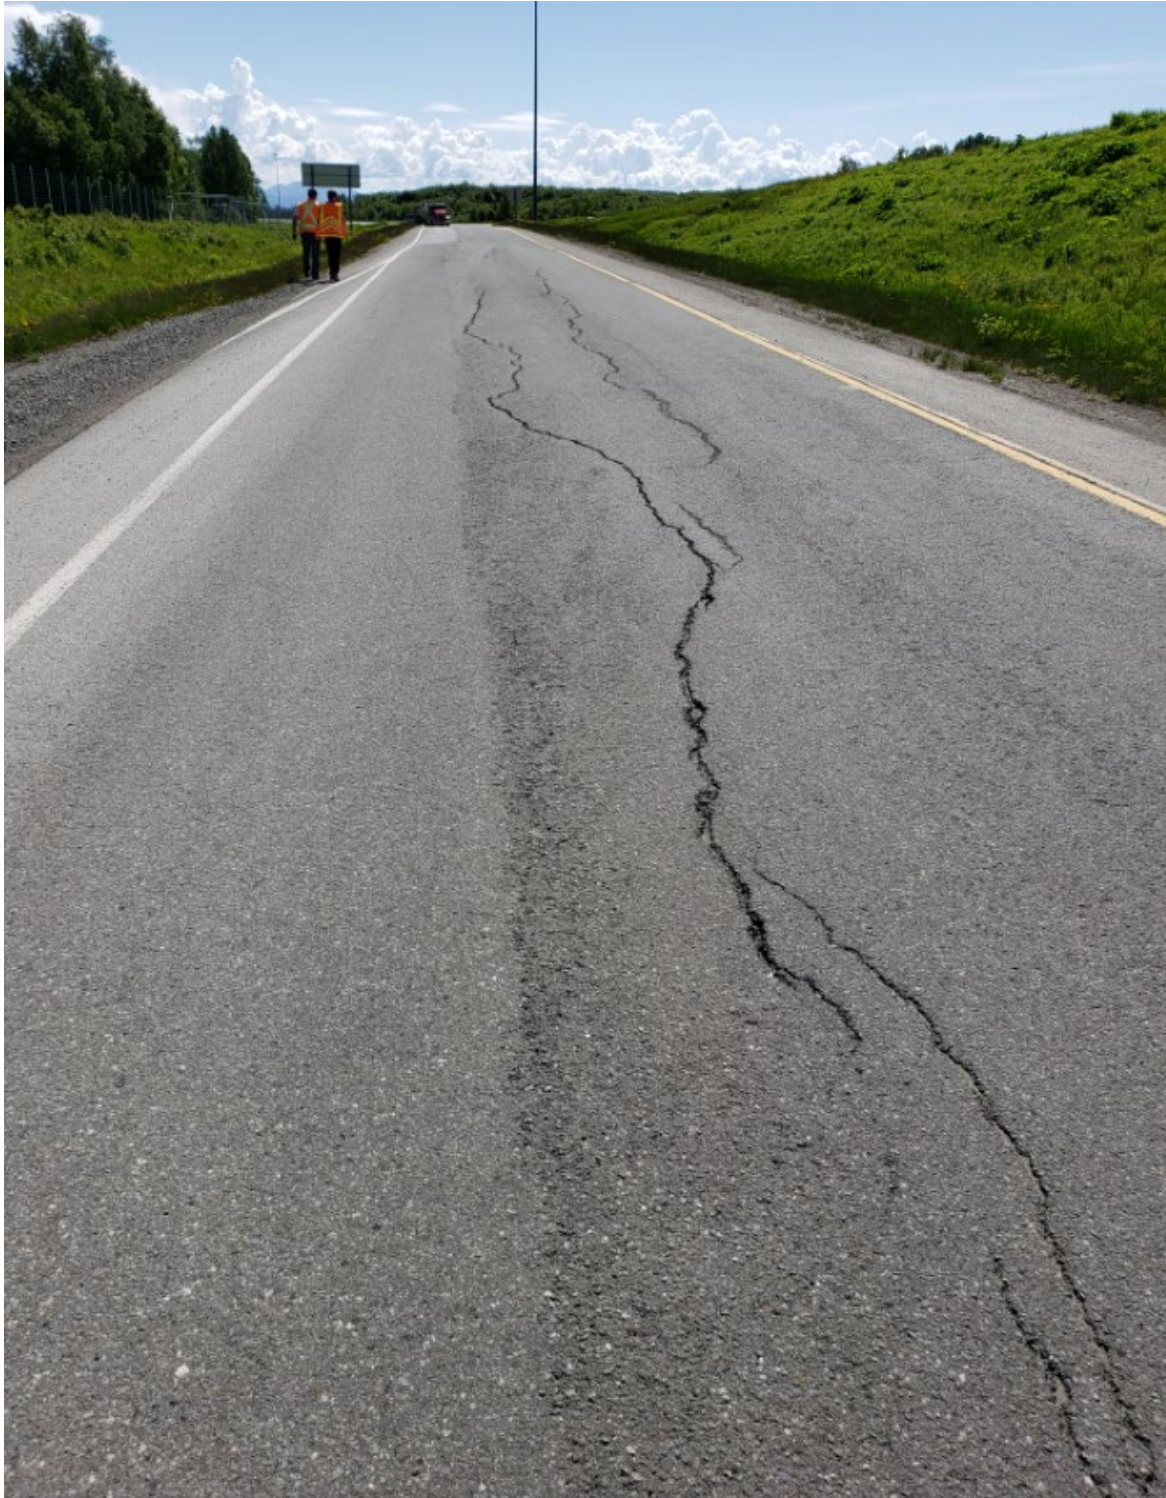
Near the beginning of the ramp there was low severity transverse cracking and raveling, but closer to 100th Avenue there was high severity longitudinal cracking.

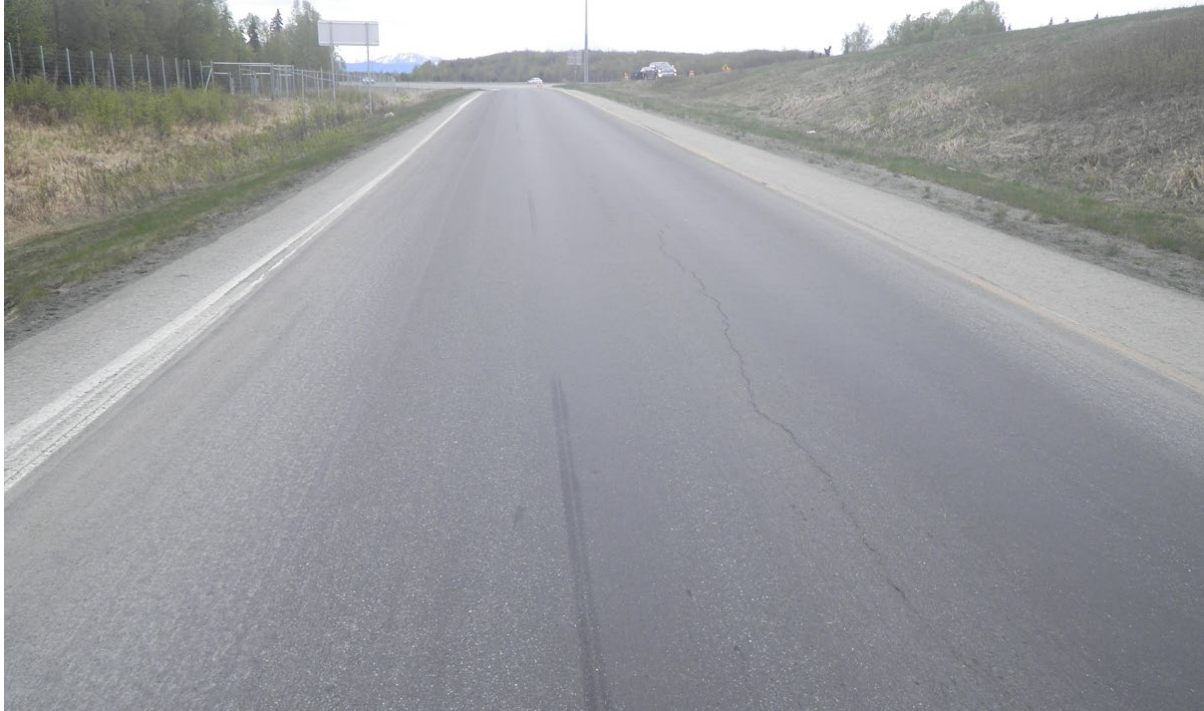
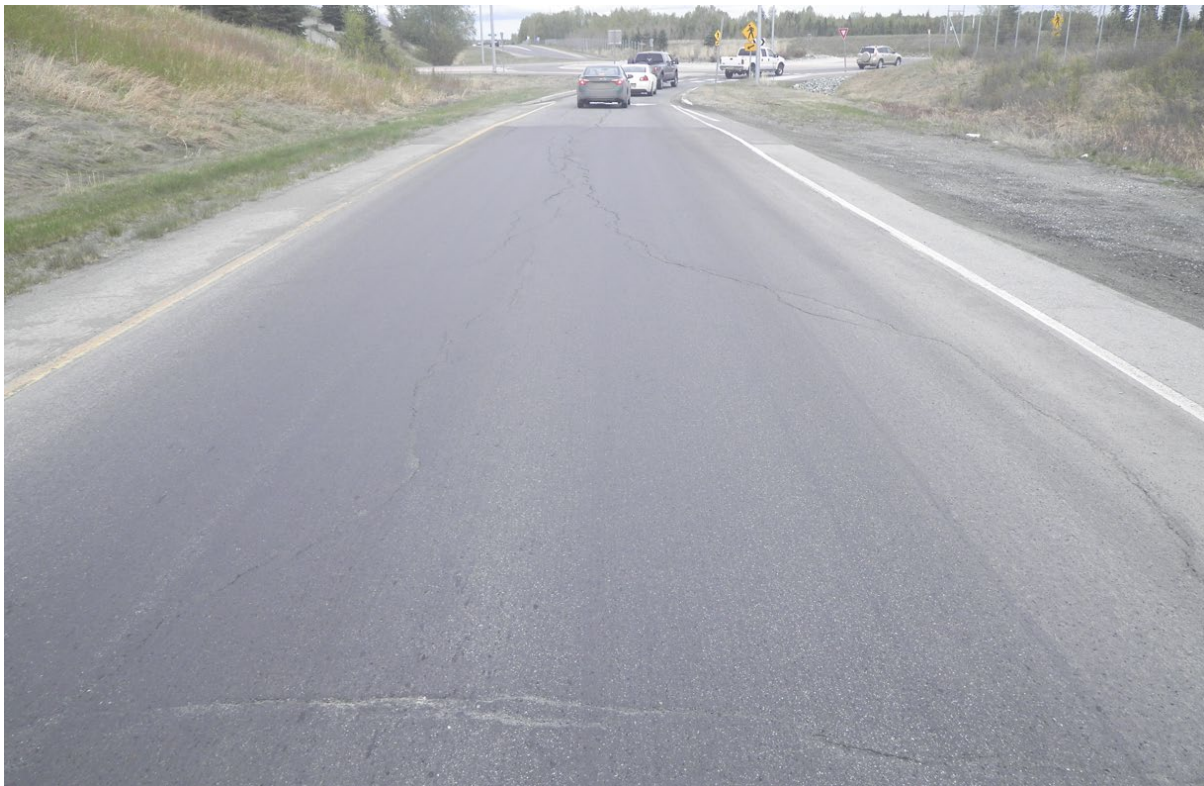
The beginning of the ramp remains in good condition with some low severity reflective cracking, but near 100th Avenue the major cracking reflected and is in poor condition at the cracks. Some flushing was present on the ramp with a loss of friction.
