Minnesota Drive Ramps Microsurfacing Experimental Feature

Year 2 Monitoring Report

Alaska Department of Transportation and Public Facilities
Statewide Materials and Asset Management

January 2023

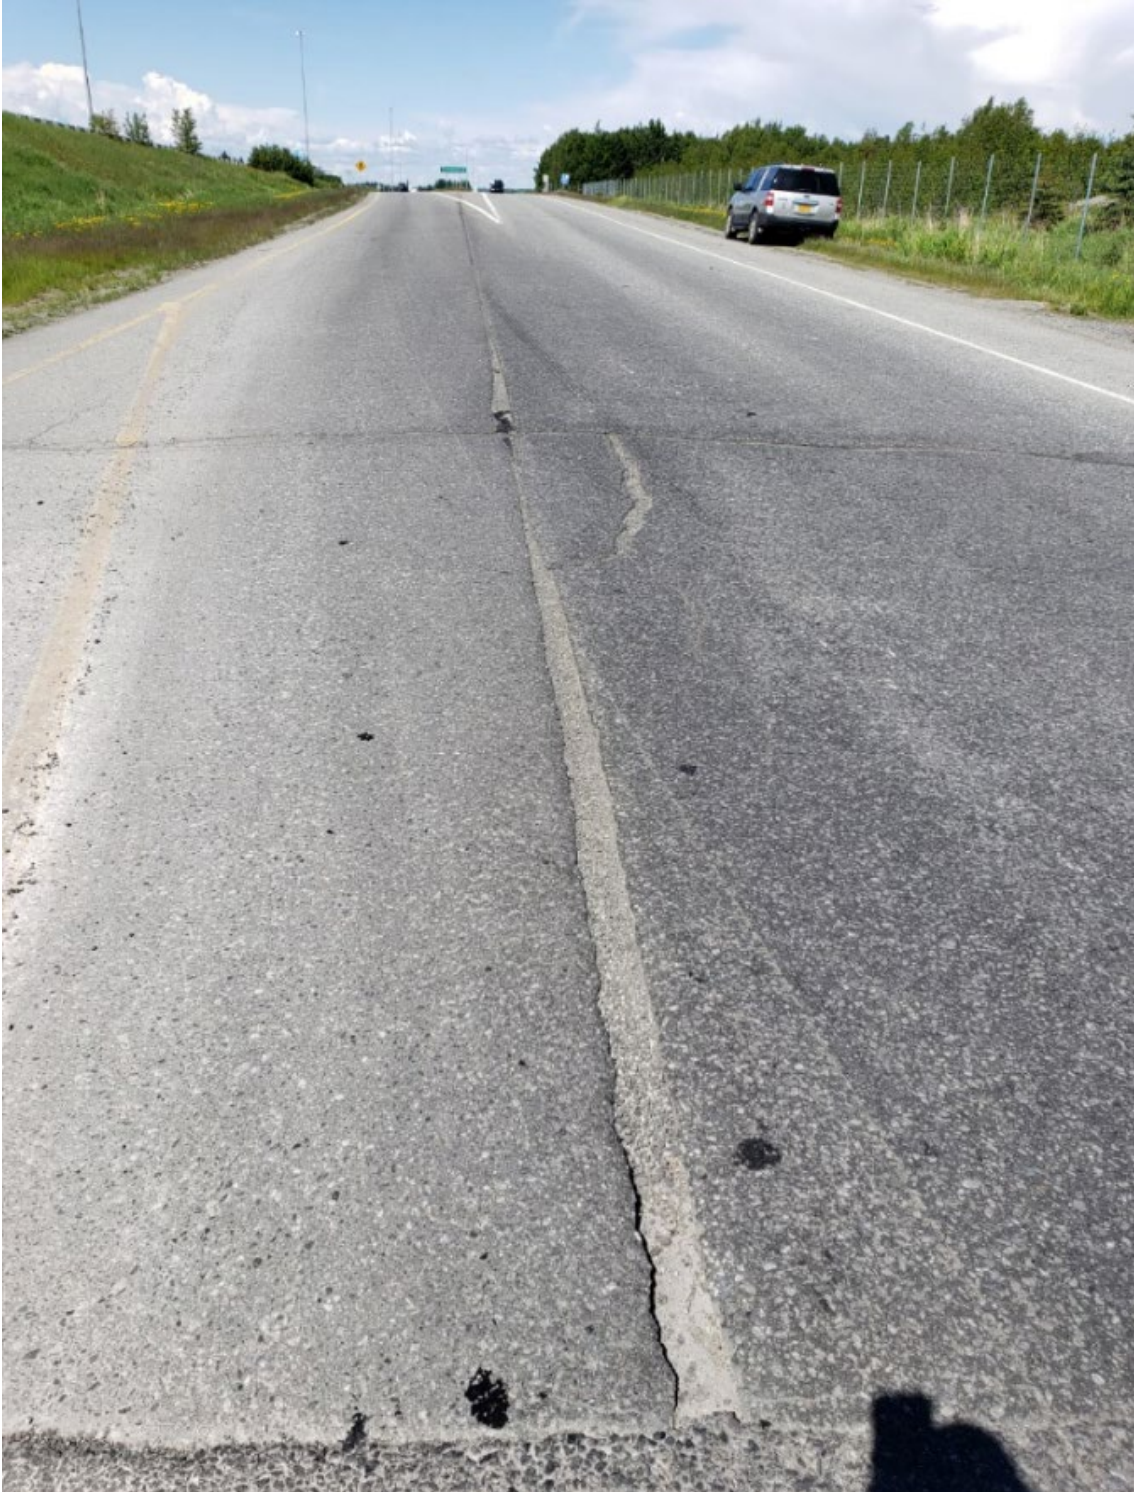
There is moderate longitudinal and transverse cracking near 100th Avenue with isolated potholes and some high severity transverse cracking where the ramp merges into Minnesota Drive.

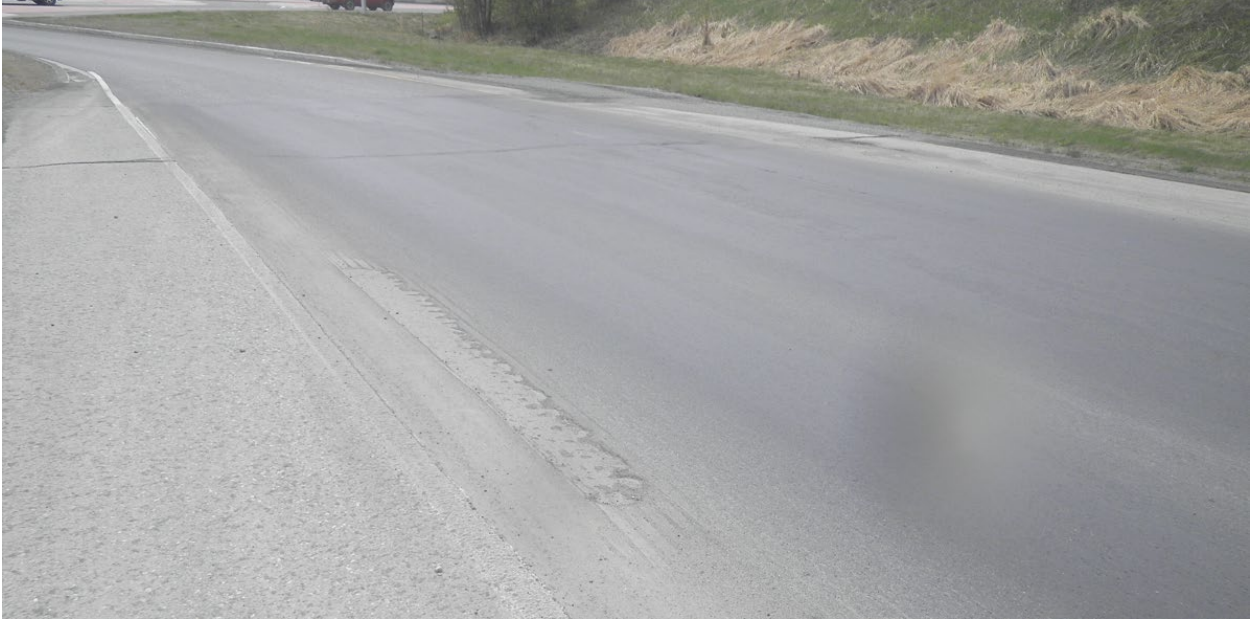
This ramp is in moderate condition from some plow damage at the end of the lanes and reflective transverse cracking.

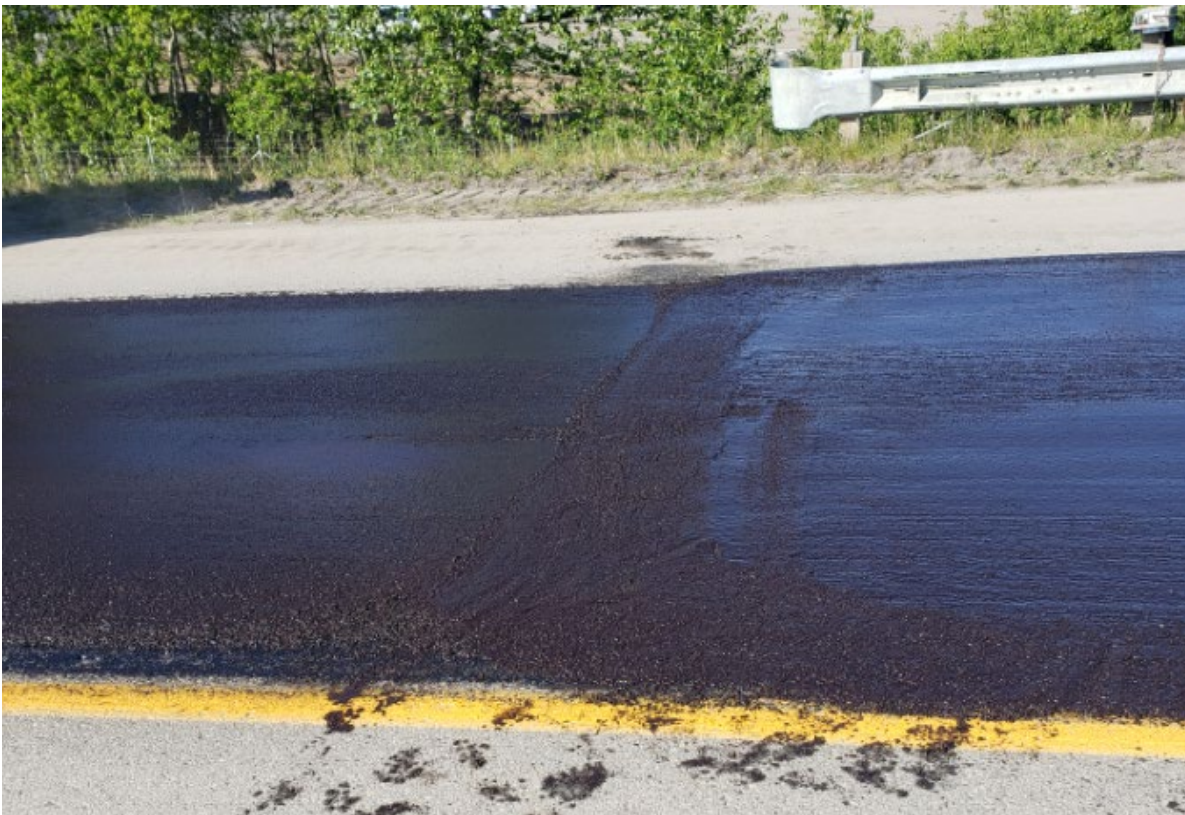
Ramp 1 – Hand worked portion at the joint where the aggregate bin ran out on the first Macropaver and the second Macropaver took over application while it was refilling.

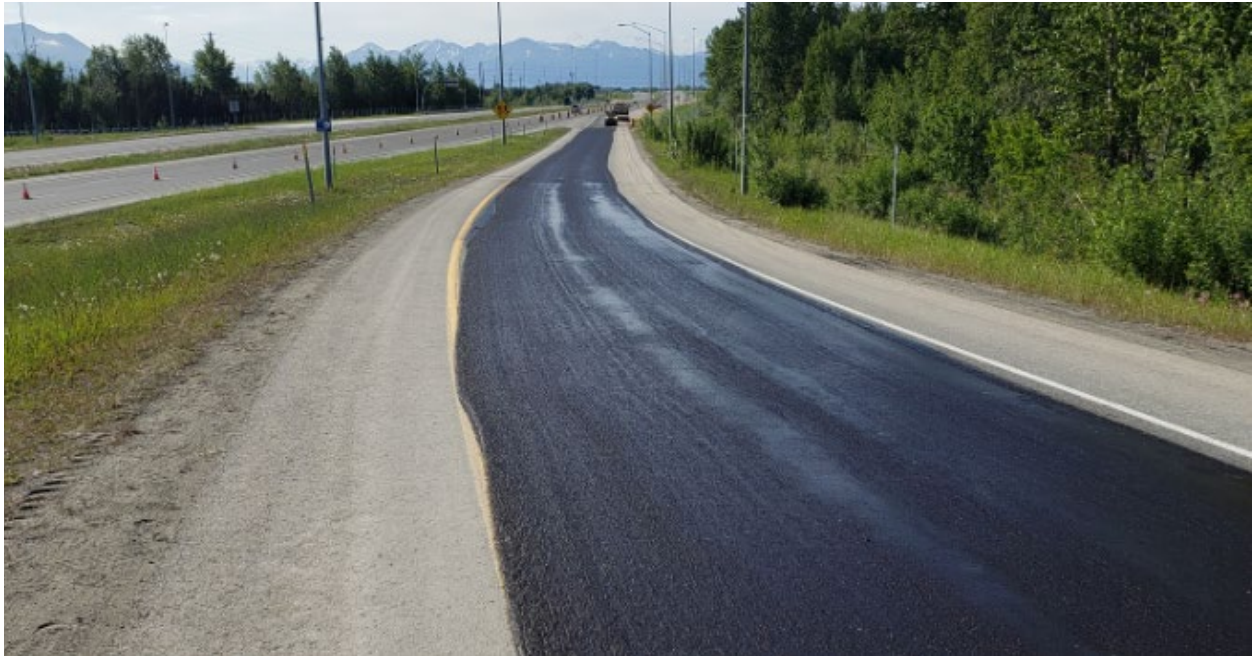
Scratch course on Ramp 1 prior to rolling. It can be observed where the water escaping is shiny in the ruts. The shininess ends where the ruts were filled by hot mix at the base of the ramp.

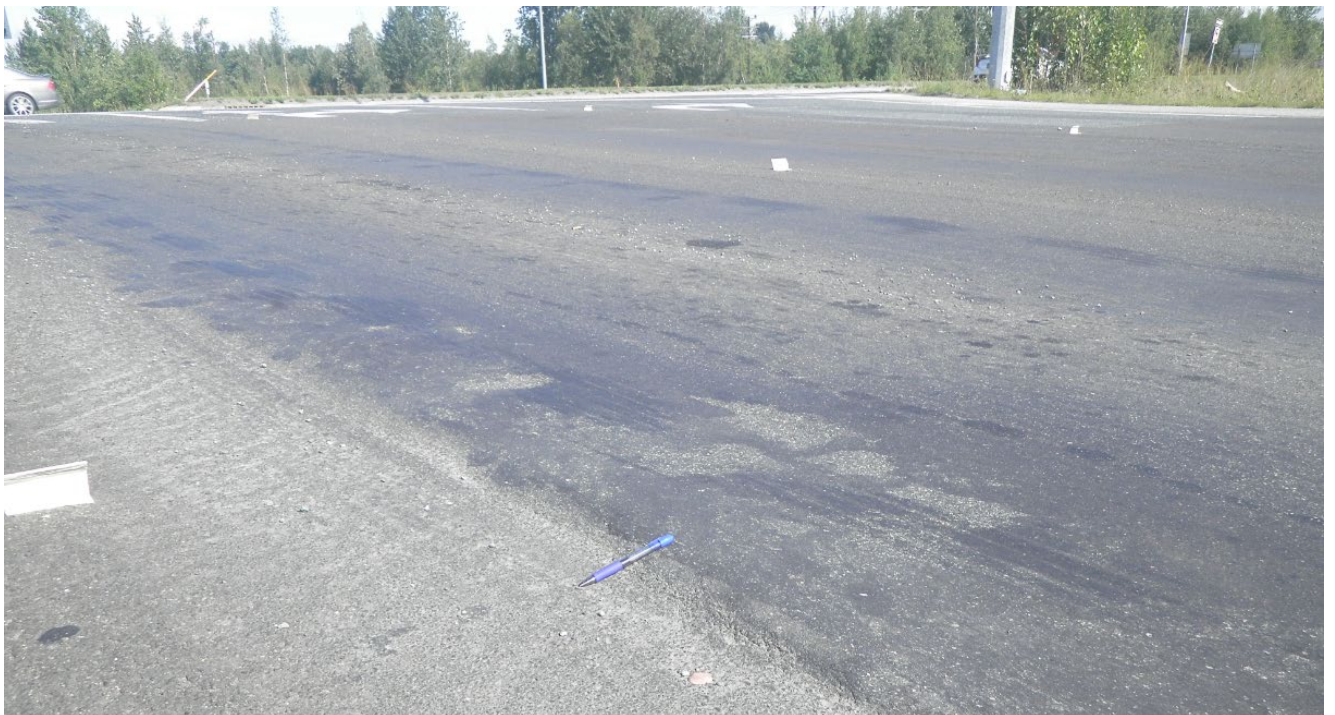
The deformation of the micorsurfacing created a hump where the pen is placed in the photo below. This deformation was not observed on any other ramps where flushing was present, likely because Ramp 2 is the only ramp that has static loading on the micorsurfacing.
