## ALASKA DEPARTMENT OF TRANSPORTATION

# Evaluation of Wearing Surfaces for the Yukon River Bridge

July 2009

FHWA-AK-RD-09-07

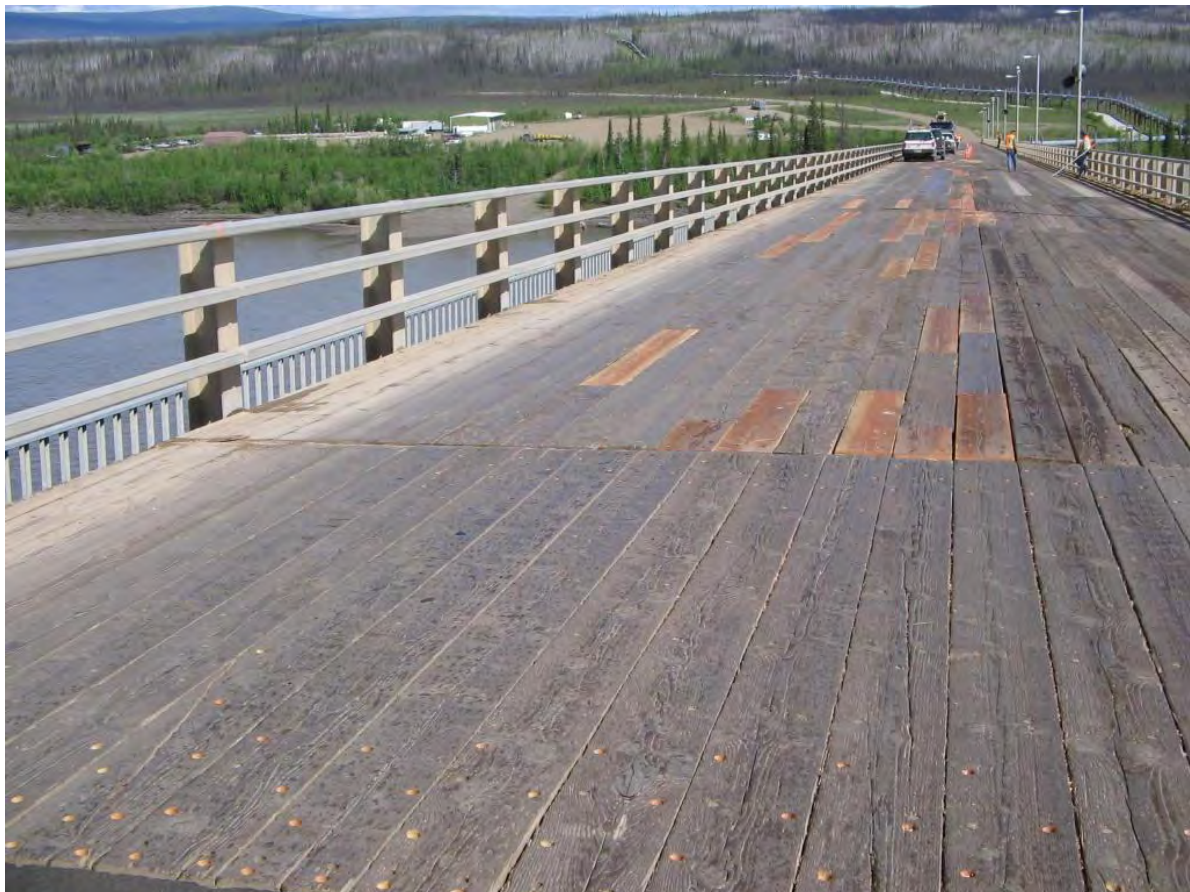
The problem is that timber wearing surfaces are damaged by both traffic and weather, and these surfaces do not last beyond five to six years before extensive maintenance or replacement is needed (see Figures 1.1 and 1.2).

Figure 1.1 Timber deck repair, a maintenance activity.

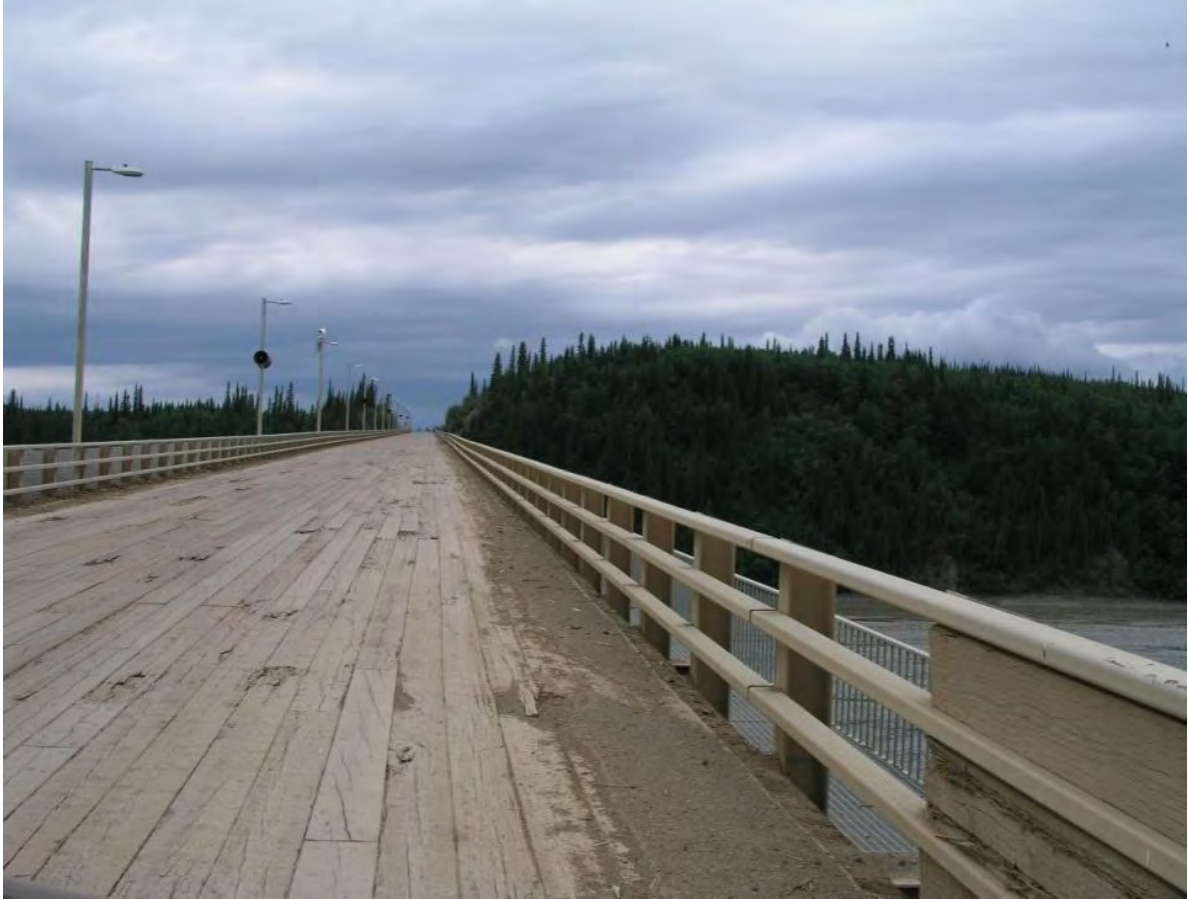
Figure 1.2 Timber deck at the end of its service life.

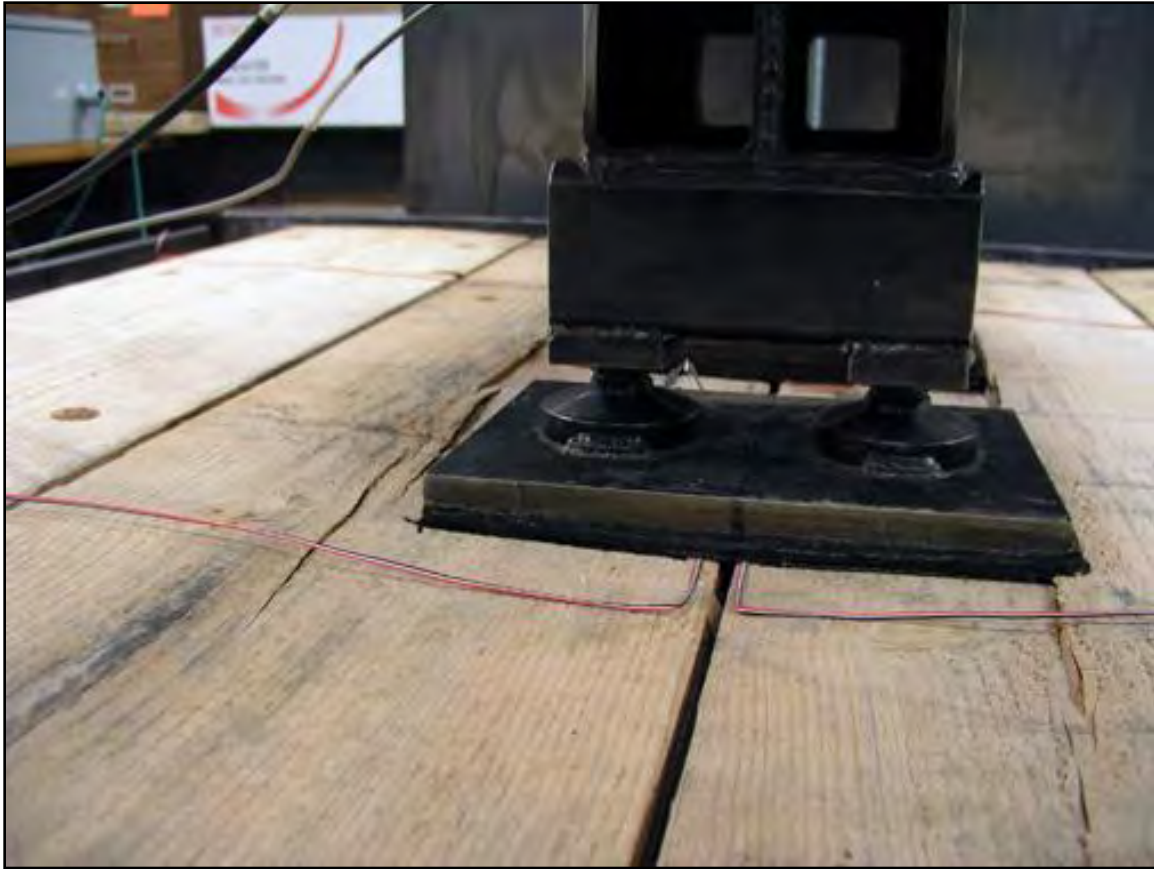
This abrupt change in strain indicates that the majority of the load was being taken by timber running planks for the panels constructed of UHMW and timber. Material tests discussed later in this section show that timber running planks had a flexural modulus of elasticity thirteen times that of the UHMW polyethylene. Creating a system with these two materials, with equal thicknesses, allows the neutral axis of bending to shift from the center of the section into the timber running planks. With the section no longer symmetric about the neutral axis, the bending curvature of the section creates greater strain values in the UHMW polyethylene layer. Laboratory tests confirmed that the timber running planks were taking the majority of the load as the planks began to crack. Figure 6.19 shows cracked running planks for the timber on M-shaped UHMW panel during the room-temperature tests.

Figure 6.19 Timber on M-shaped panel with running planks cracking.

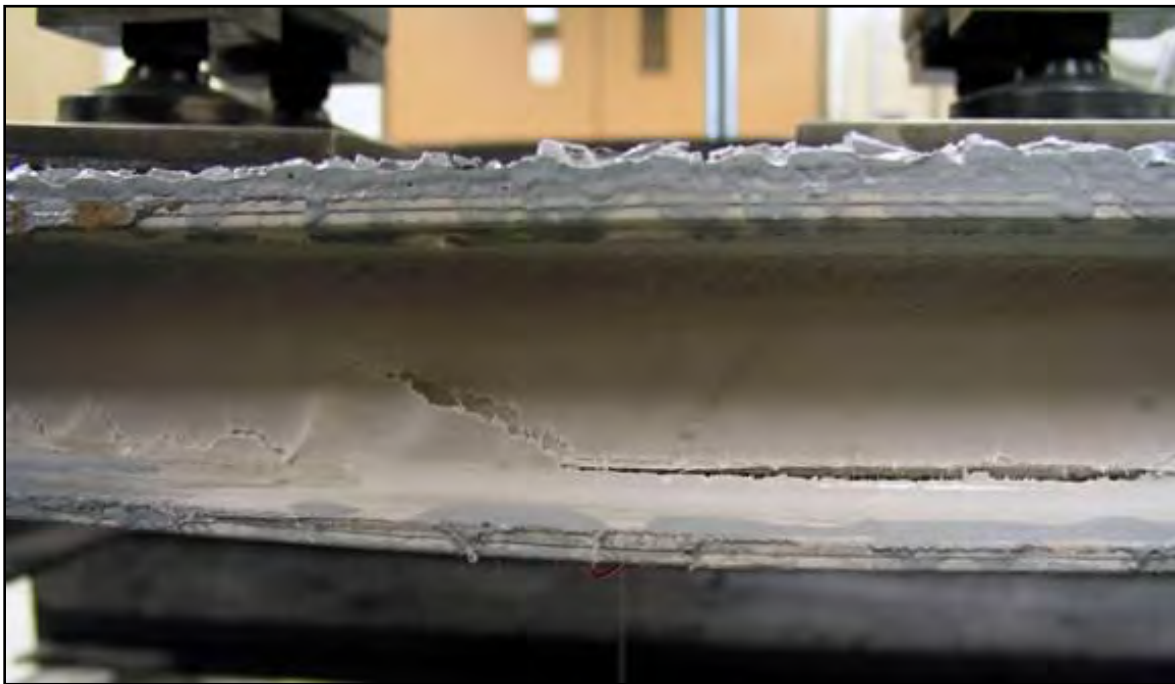
shape panel began to buckle. Post failure inspection of the panel revealed that several webs had buckled directly under the loading foot. We observed another mode of failure as the flanges sheared from the webs on the edges of the panel. Both of these modes of failure were seen during the material tests. Figure 6.21 shows the initial signs of failure observed during the Super Panel failure test.

Figure 6.21 Super Panel at ultimate load-carrying capacity.

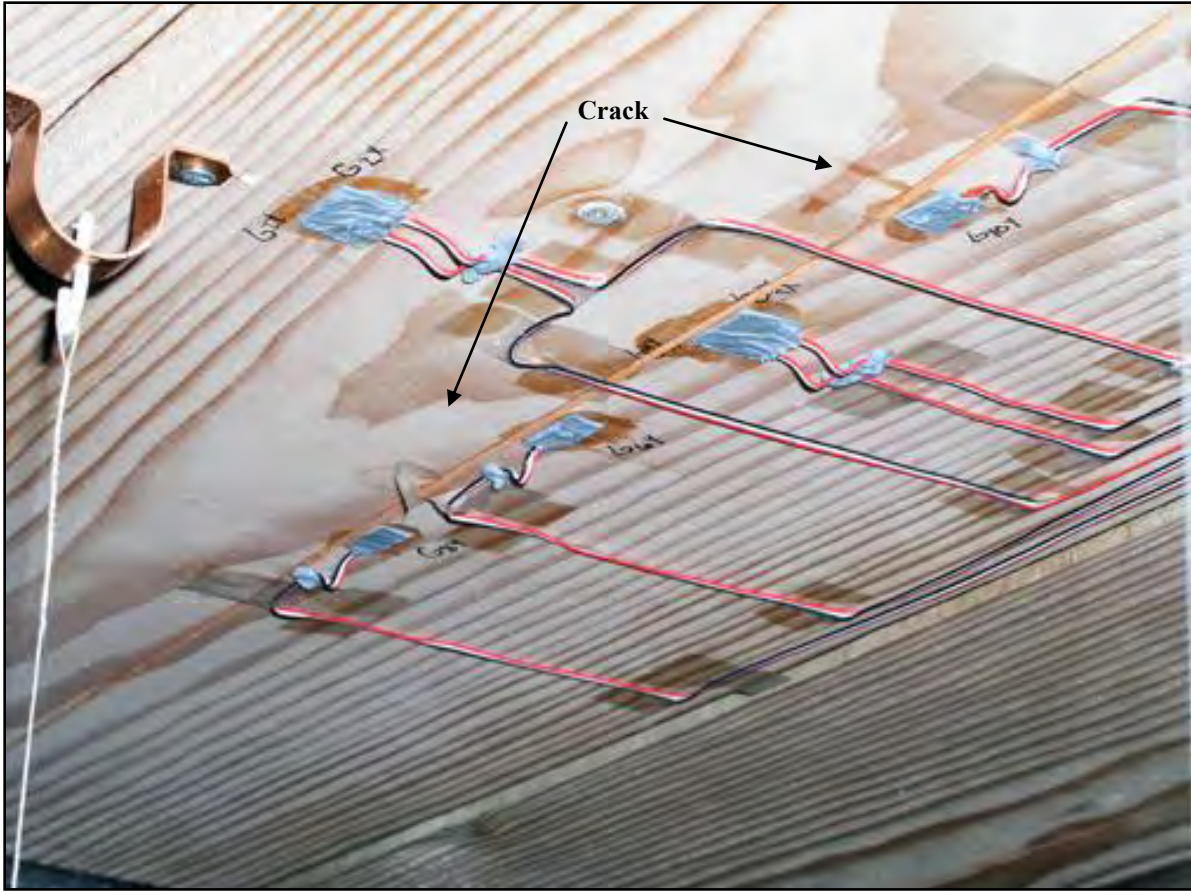
On the timber/timber panel, large cracks developed in the bottom layer of the panel, as shown in Figure 6.23.

Figure 6.23 Timber/timber panel failure cracks.

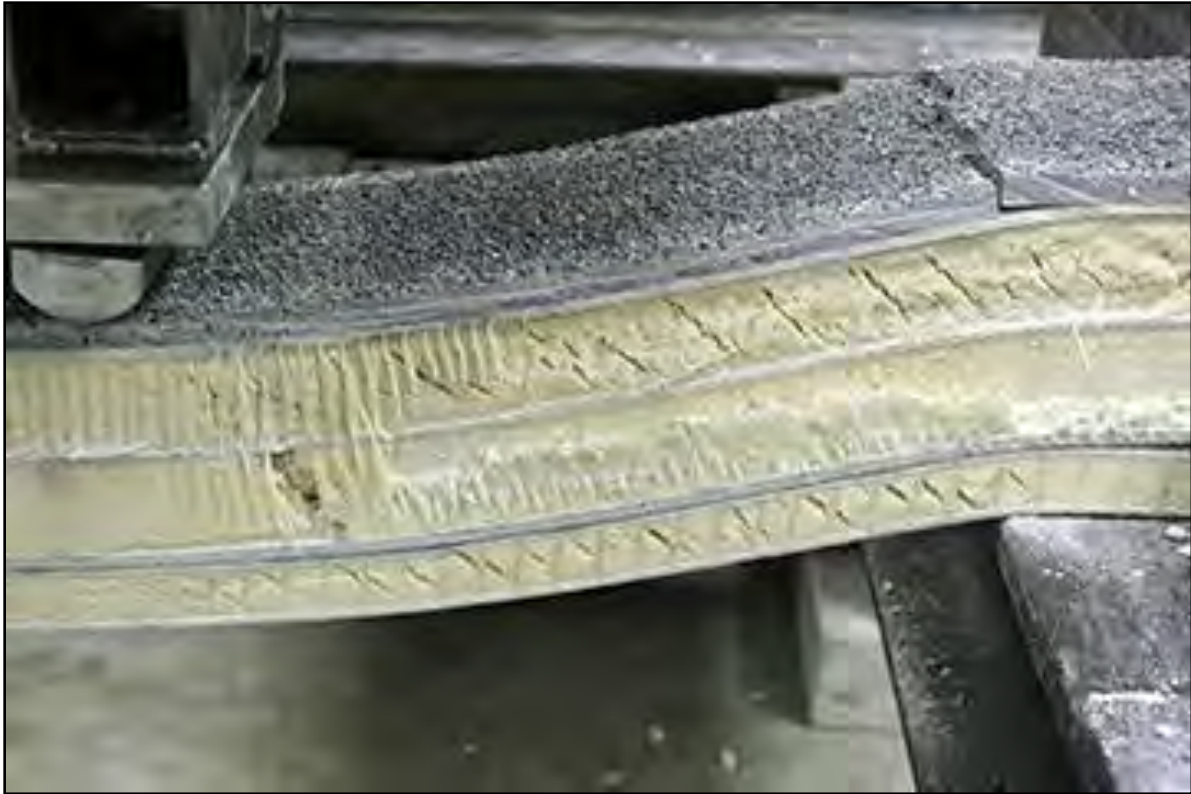
During the test, all beams displayed an area of zero shear and pure bending. Forty-five degree shear cracks began to develop in the foam, as shown in Figure 7.4. Shear cracks became distinguishable in all five beams when the applied load was between 1000 lb and 1500 lb.

Figure 7.4 Transonite 45° shear cracks.

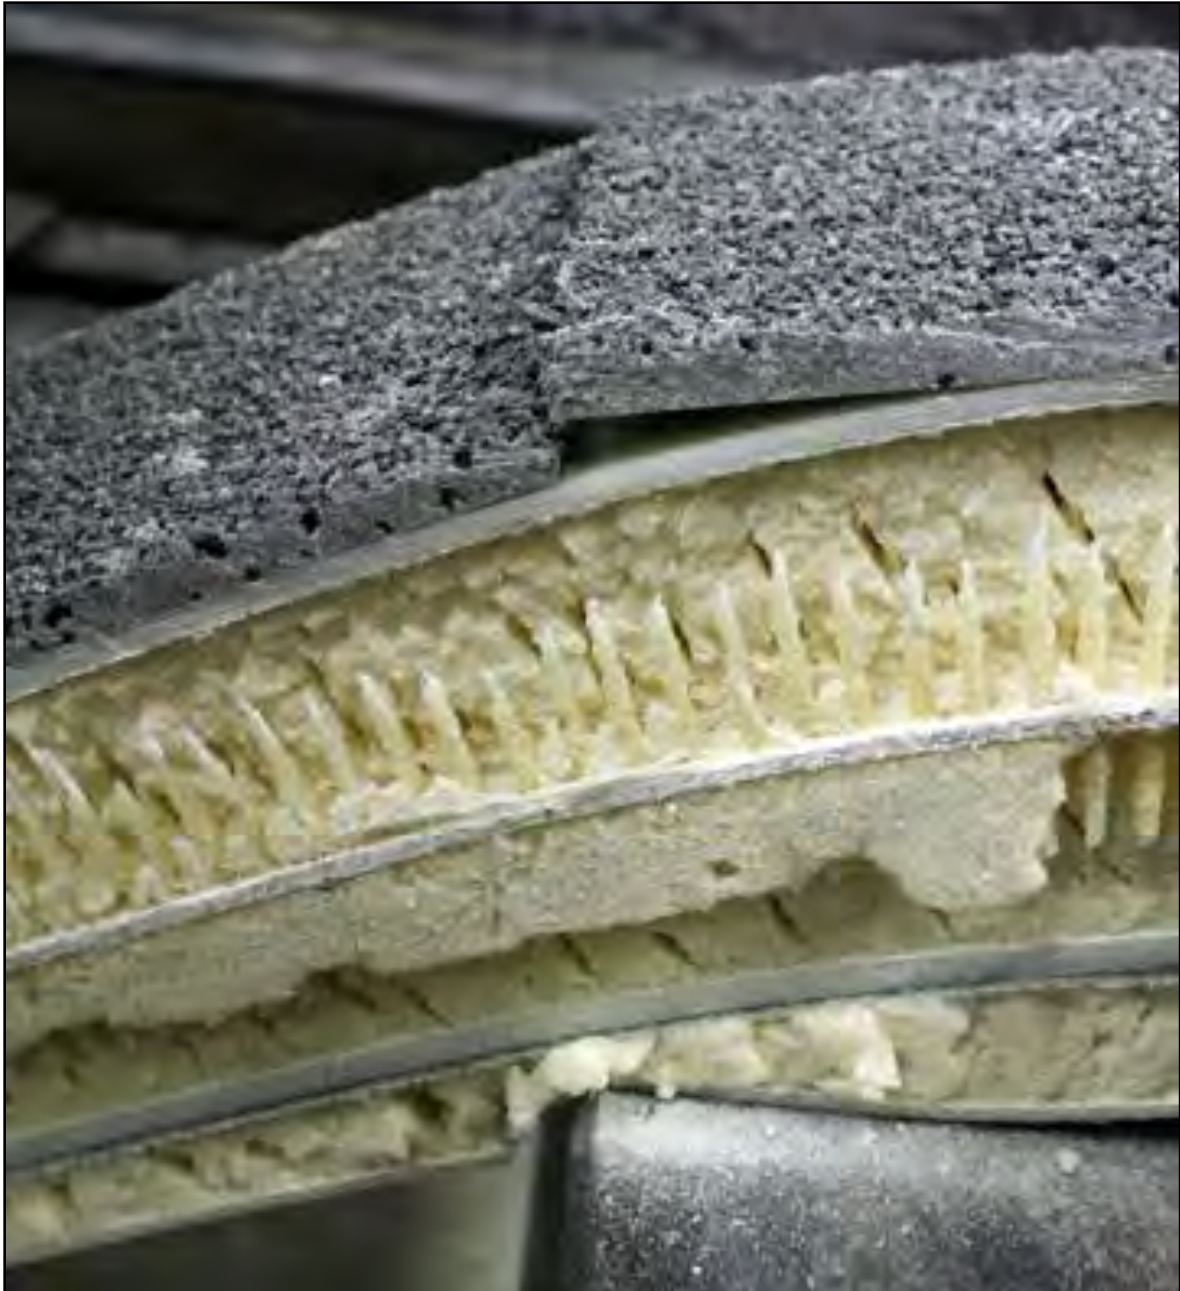
Based on the visual signs of shear, we speculated that the beam would have failed in shear if the bottom layer of the panel had not crushed at the supporting edges. All beams failed due to the bottom layer crushing at the supports; this failure potentially could have been avoided if the beam was placed on rollers. It is important to note that as the upper surface of the beam began to undergo large deflections, the traction surface cracked and could be peeled from the upper layer of Transonite with a small amount of pressure. Cracks in the traction surfaces formed immediately above the crushing of the lower layer, as illustrated in Figure 7.5.

Figure 7.5 Transonite four-point bending failures.

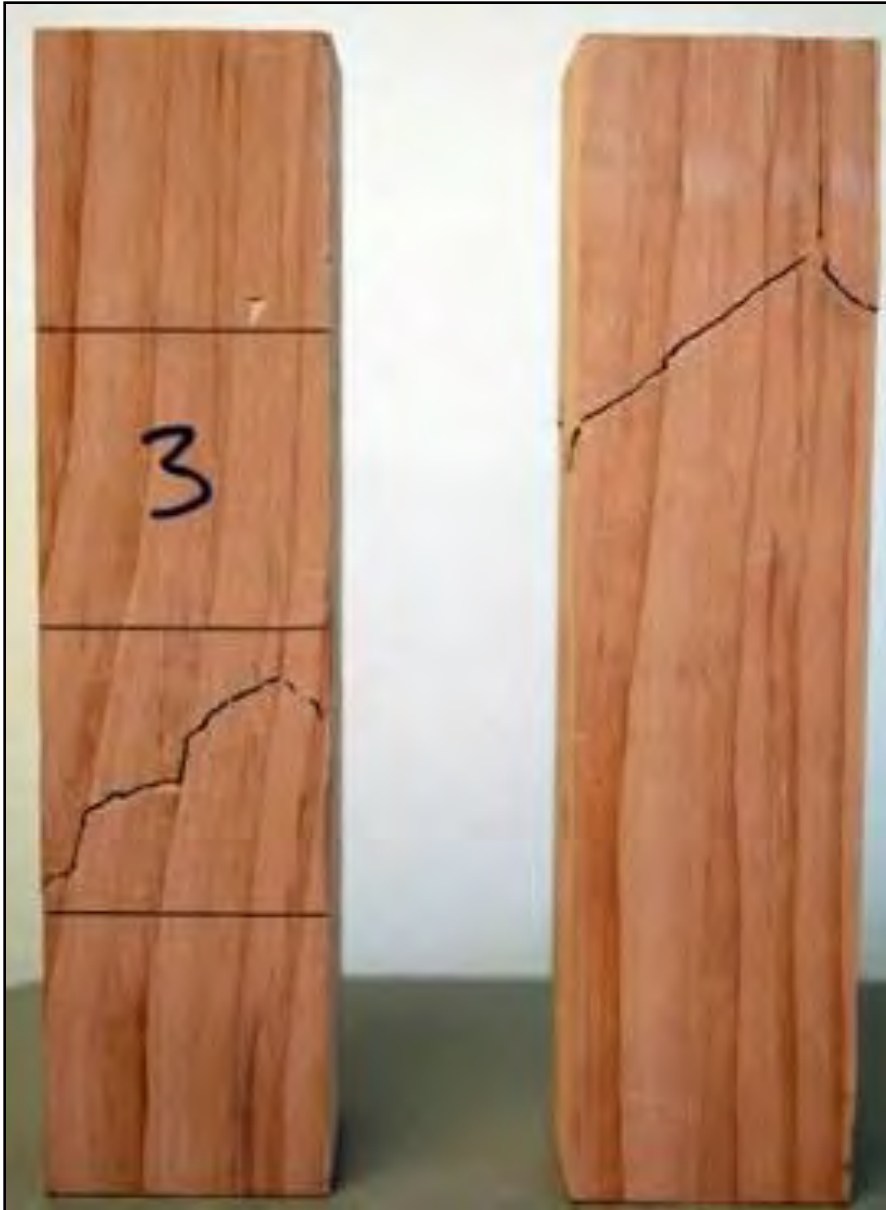
The cause of failure for all ten specimens was a combination of shearing or compression and shearing parallel to the grain. Specimen 3 (see Figure 7.7) showed signs of compression and shearing as horizontal cracks started to form parallel to the grain in conjunction with the shearing cracks. The second specimen in Figure 7.7 experienced a shear failure. The plane of rupture made an angle of roughly  $45^\circ$  with the top of the specimen. The cracks are outlined in the photograph to provide clarity.

Figure 7.7 Compression parallel-to-grain failure.

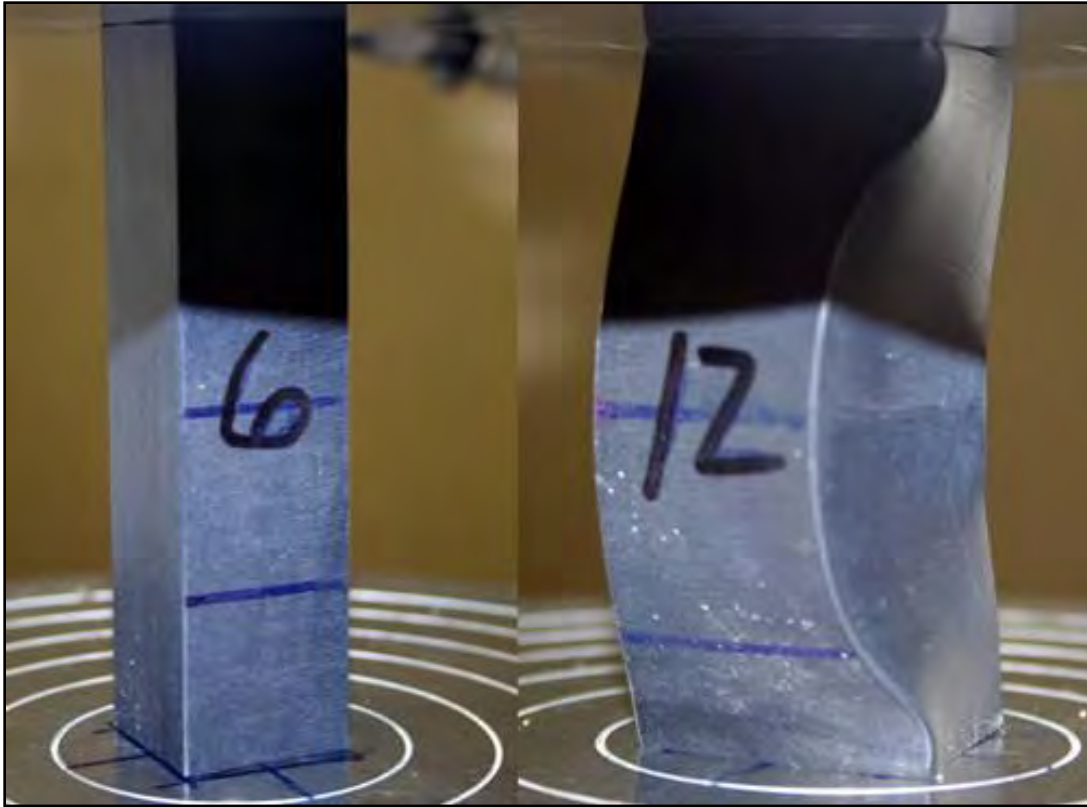
As with tension, a secant calculation was used to determine the modulus. Failure of the compression specimens was not observed during testing. Instead, the specimen developed excessive deformation. Figure 7.14 shows a specimen prior to testing (Specimen 6) and another specimen after testing (Specimen 12).

Figure 7.14 UHMW polyethylene compression failure.

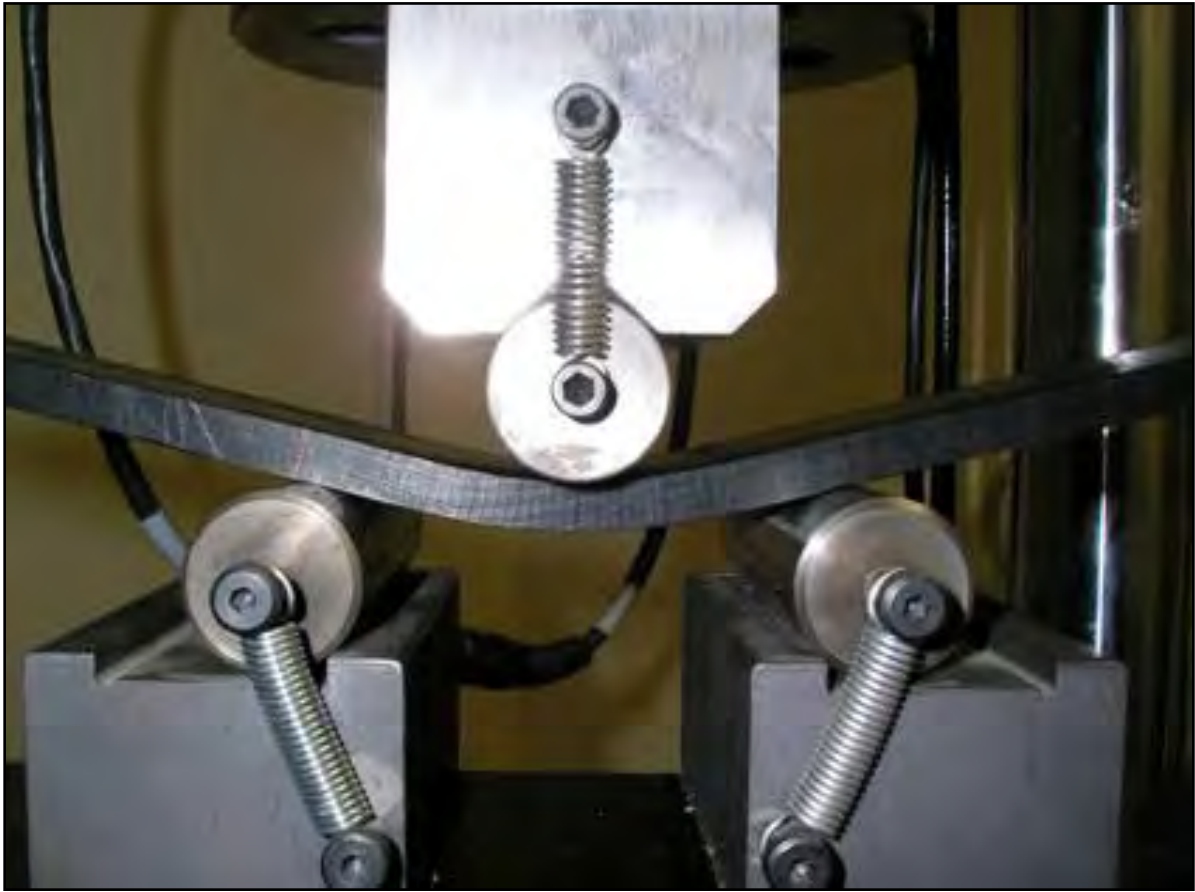
to deform with increased load. This ductility, illustrated in Figure 7.16, shows a specimen near its maximum flexural stress.

Figure 7.16 UHWM polyethylene three-point bending failure.

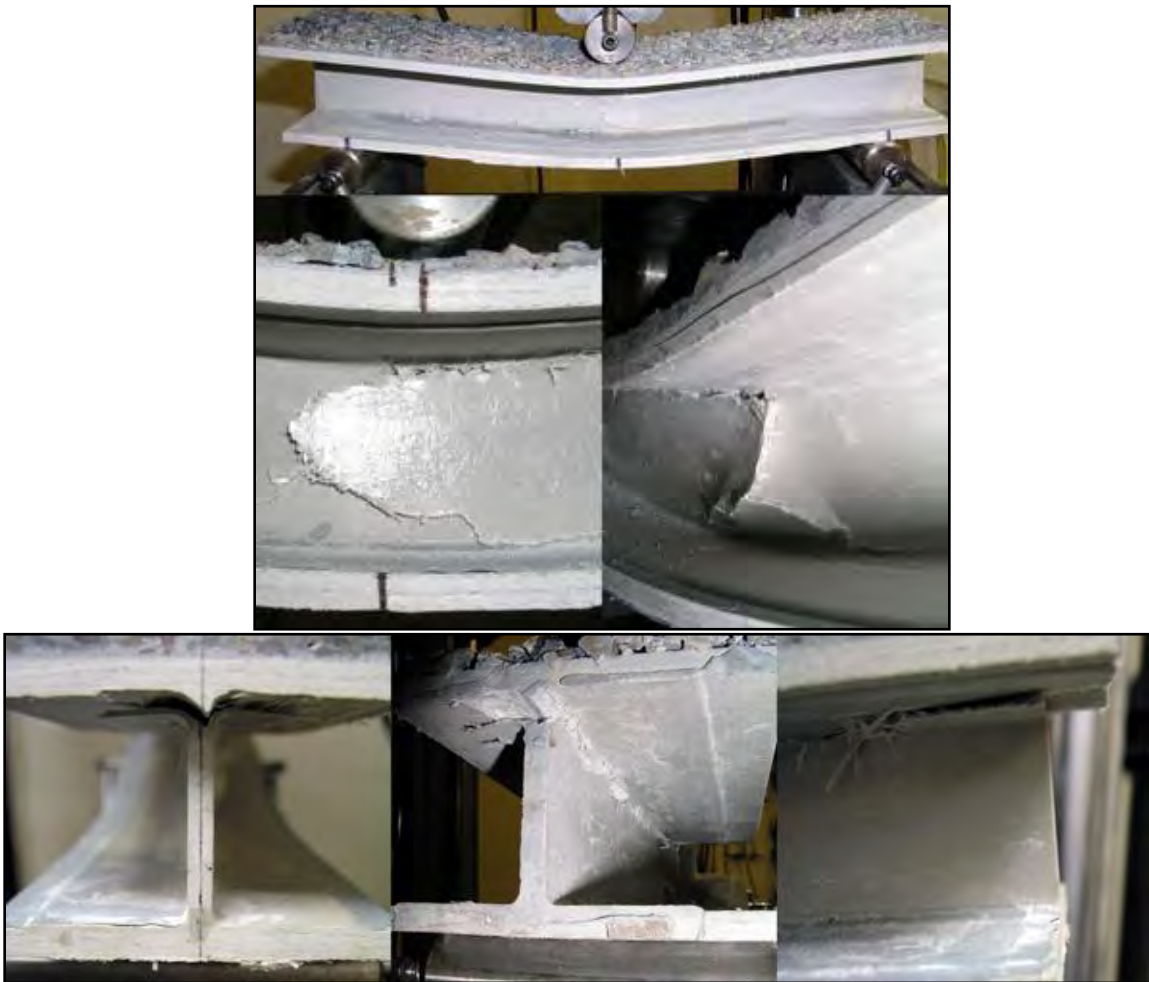
A clear failure point in the load-deflection curve was observed in all three beams; this was similar to the compression specimens. Sudden failures in the beams indicate how the low-ductile material behaves under load. The stress-strain curve remained linear until failure, and the flexural modulus of elasticity was computed as the slope of the tangent line. Although the beam stress-strain curves are similar, there were two different modes of failure. In Beams 1 and 3, failure started by the upper flange, shearing from the web. Shortly thereafter, the web buckled directly under the loading point. Figure 7.20 depicts shear failure at the ends of the beams and the buckling of the web that occurred after the shear failure.

Figure 7.20 Super Panel web buckling and flange shear in Beams 1 and 3.

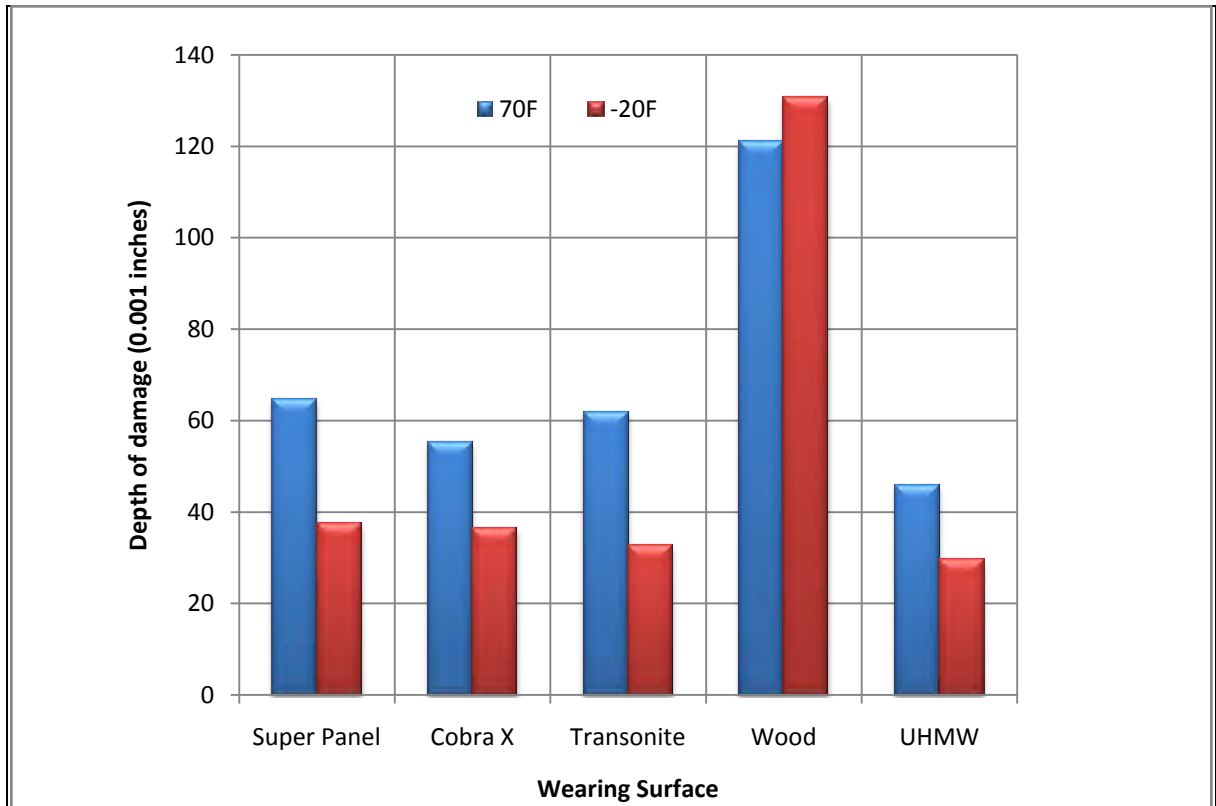
Figure 8.12 Rolling damage after 32 to 36 passes.

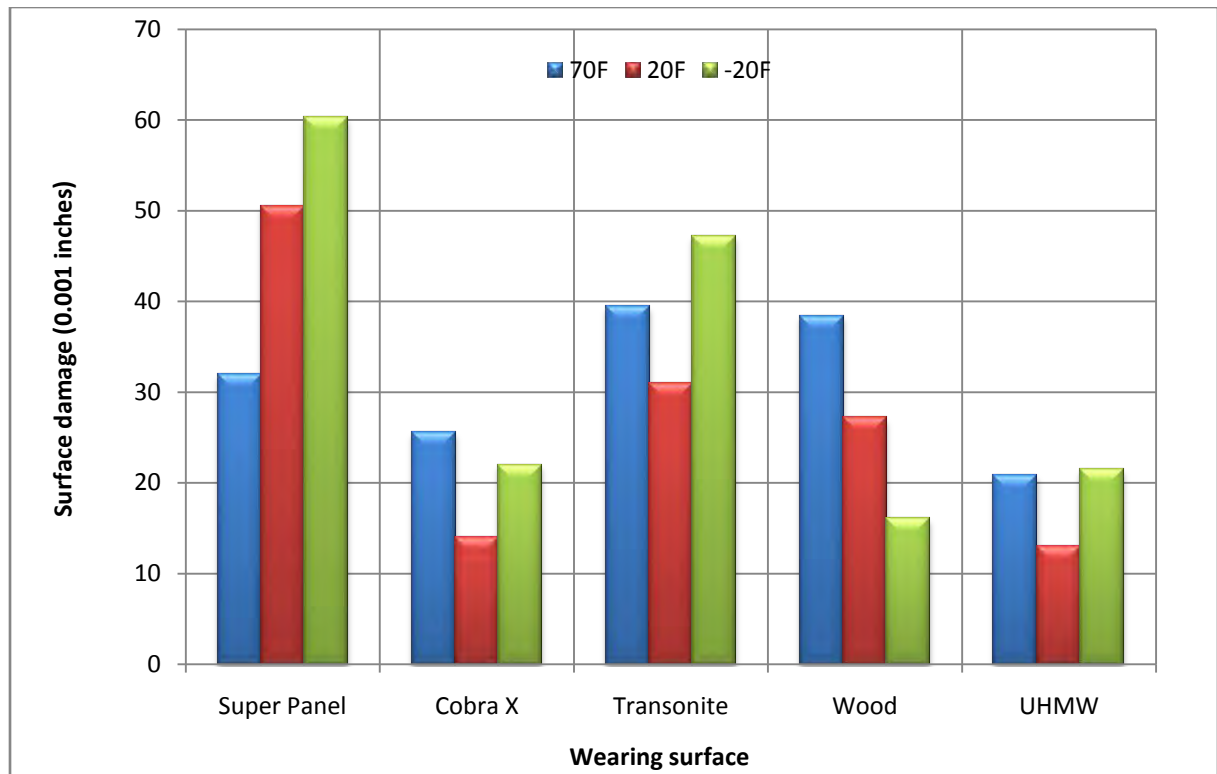
Figure 8.13 Lashing damage.

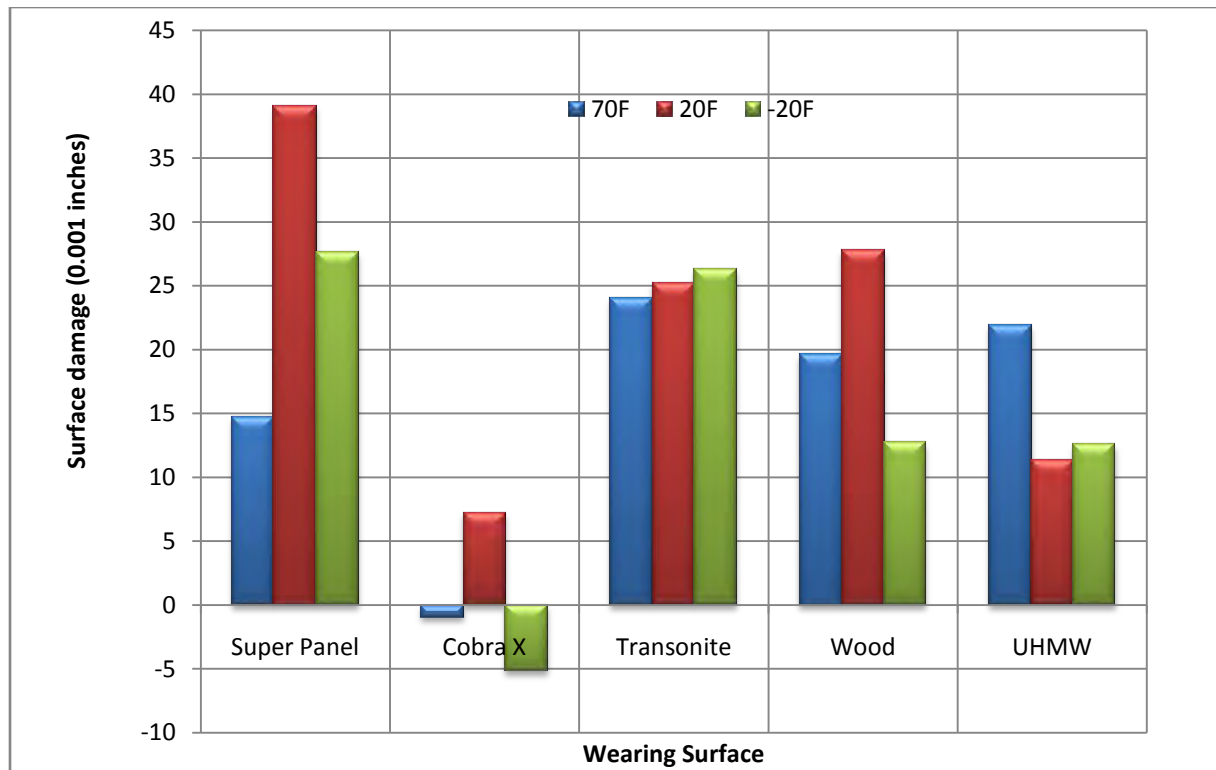
Figure 8.14 Dragging damage after 11 cycles.

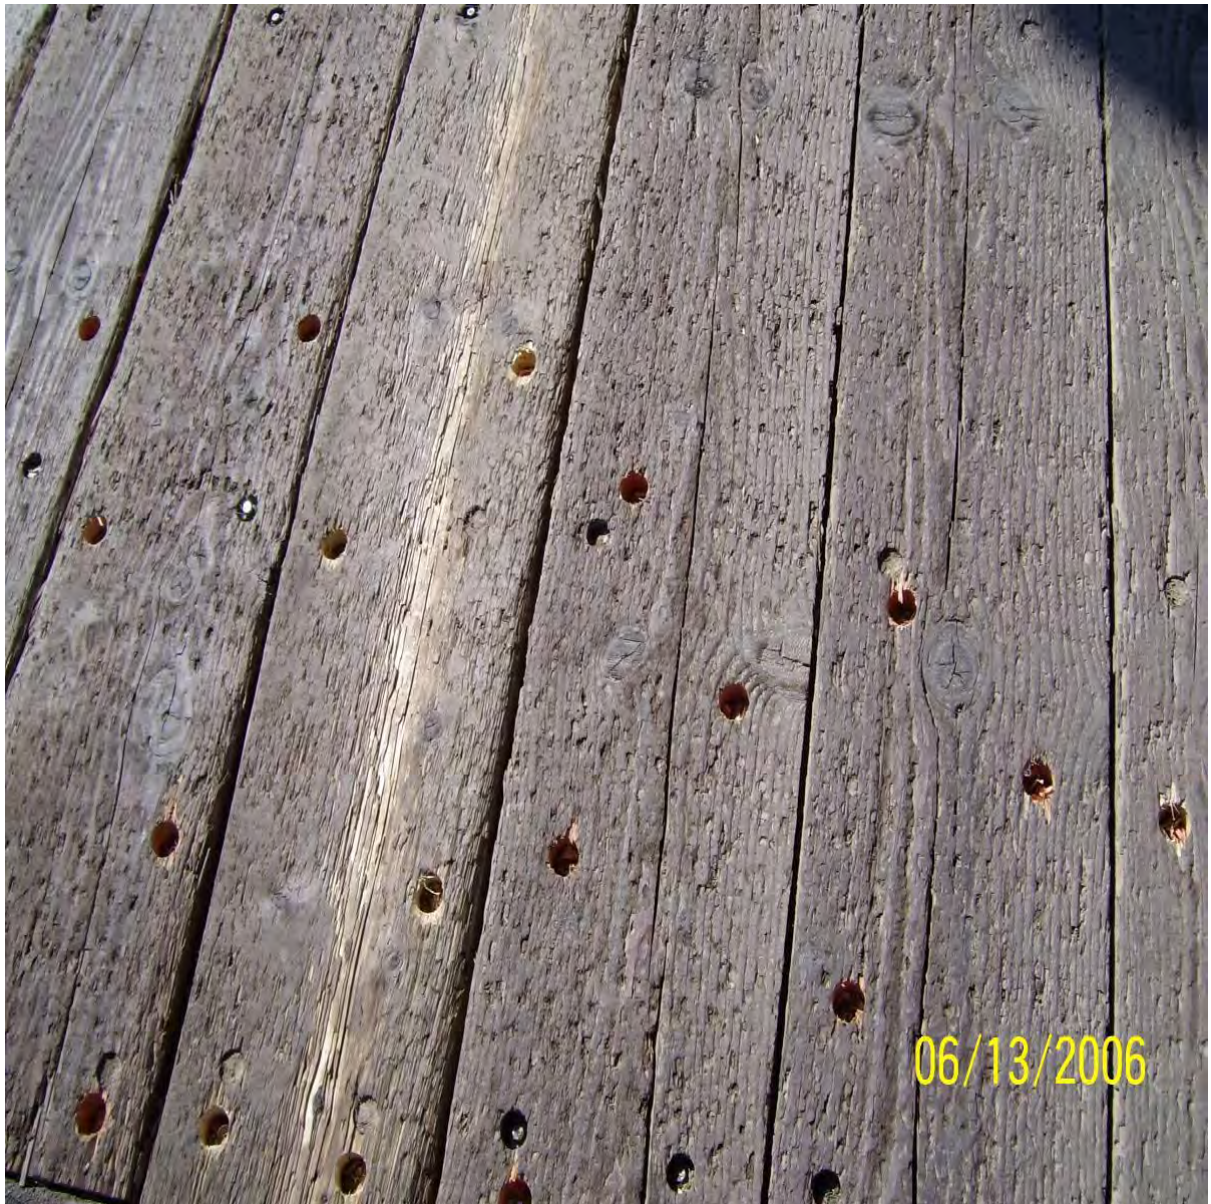
Figure B.2 Surface wear damage caused by tire chains.

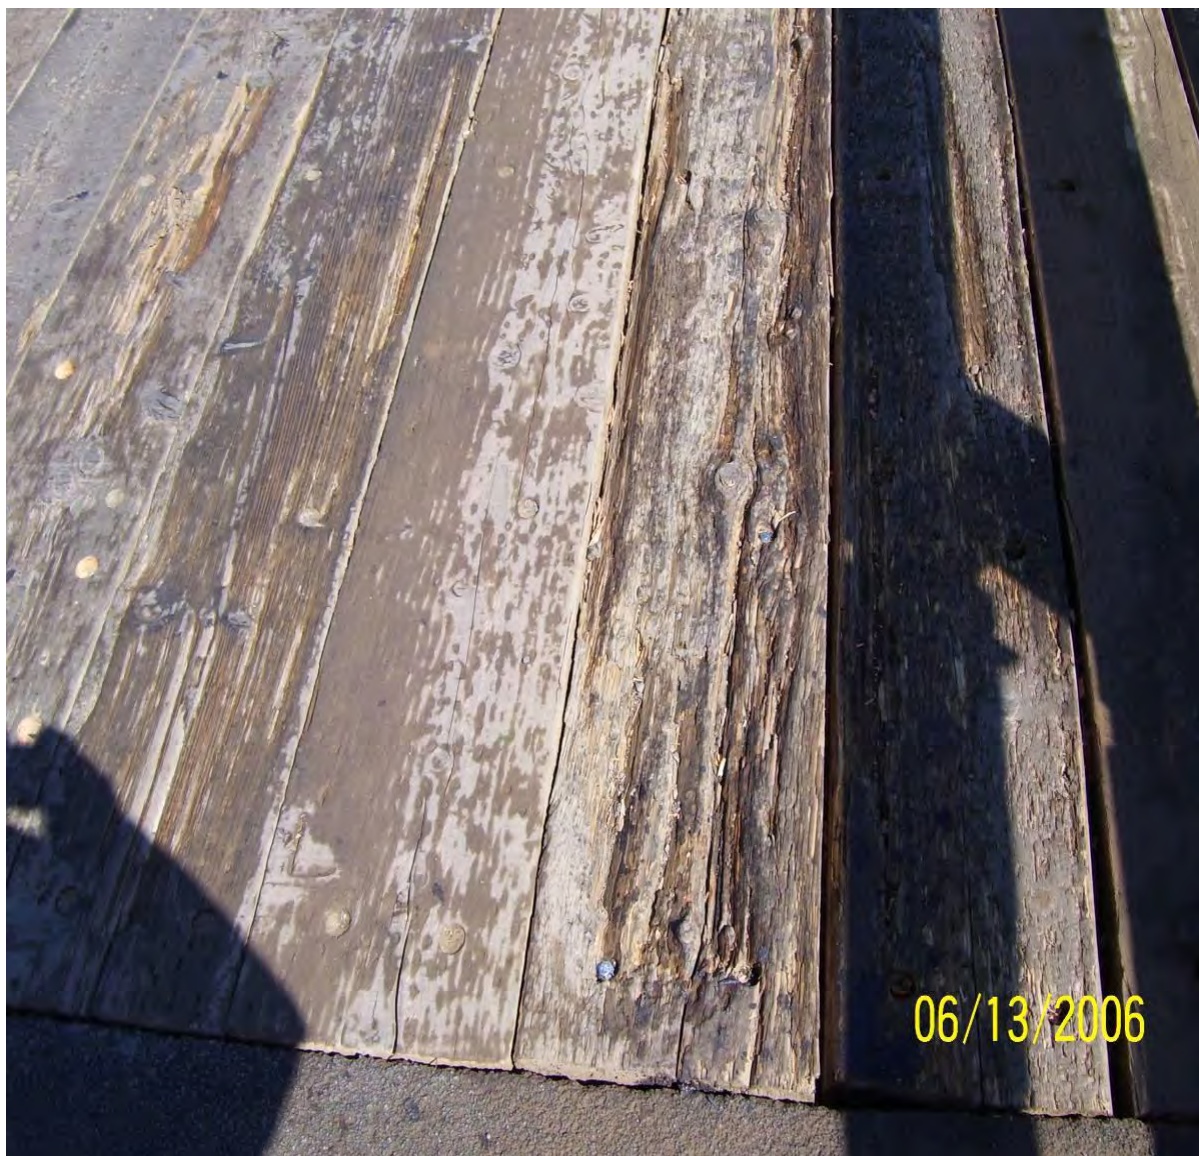
Figure B.3 Decay in the top of the wearing surface.

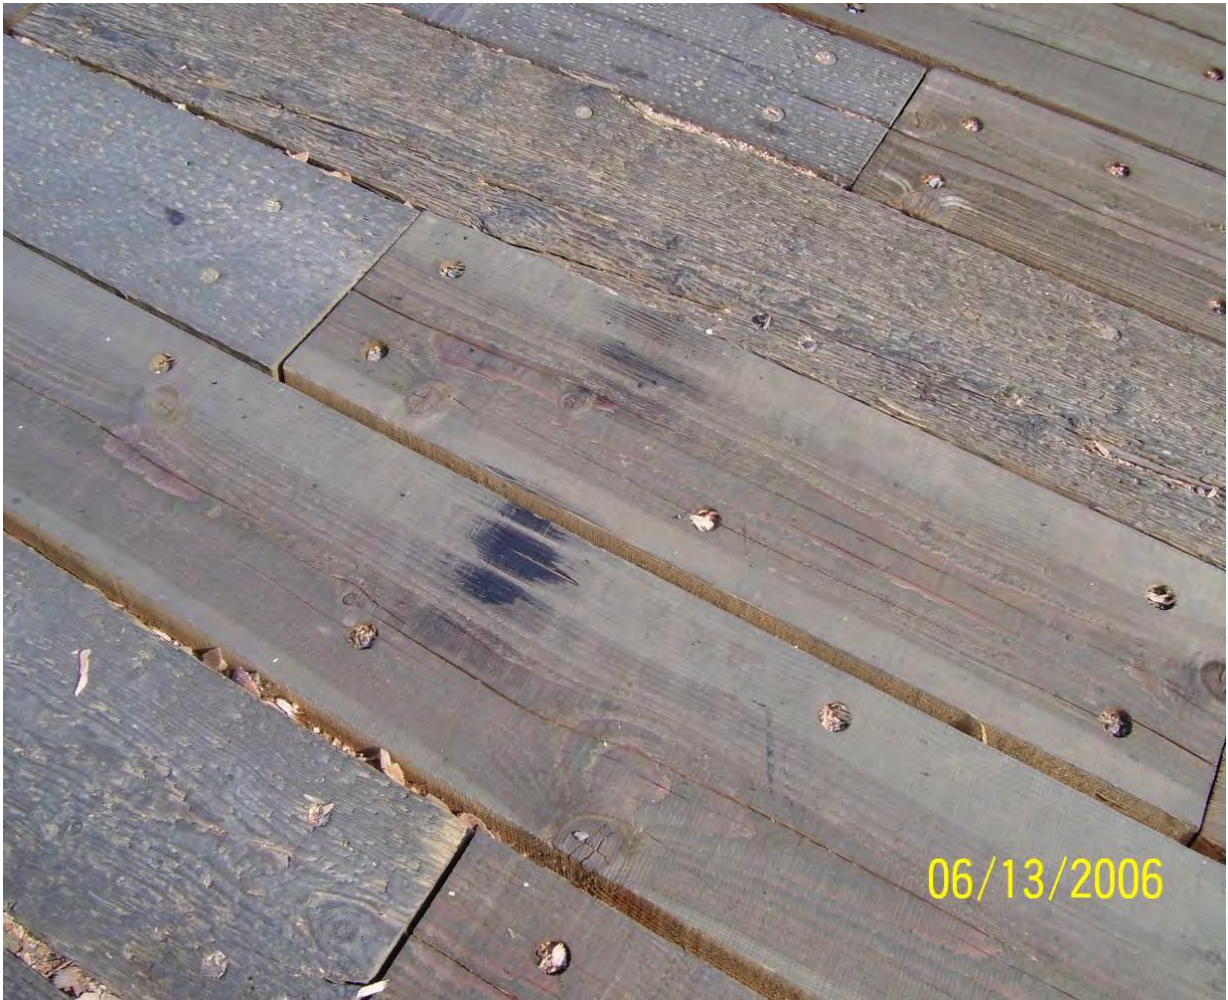
Figure B.4 Rubber tire marks caused by loss of traction.

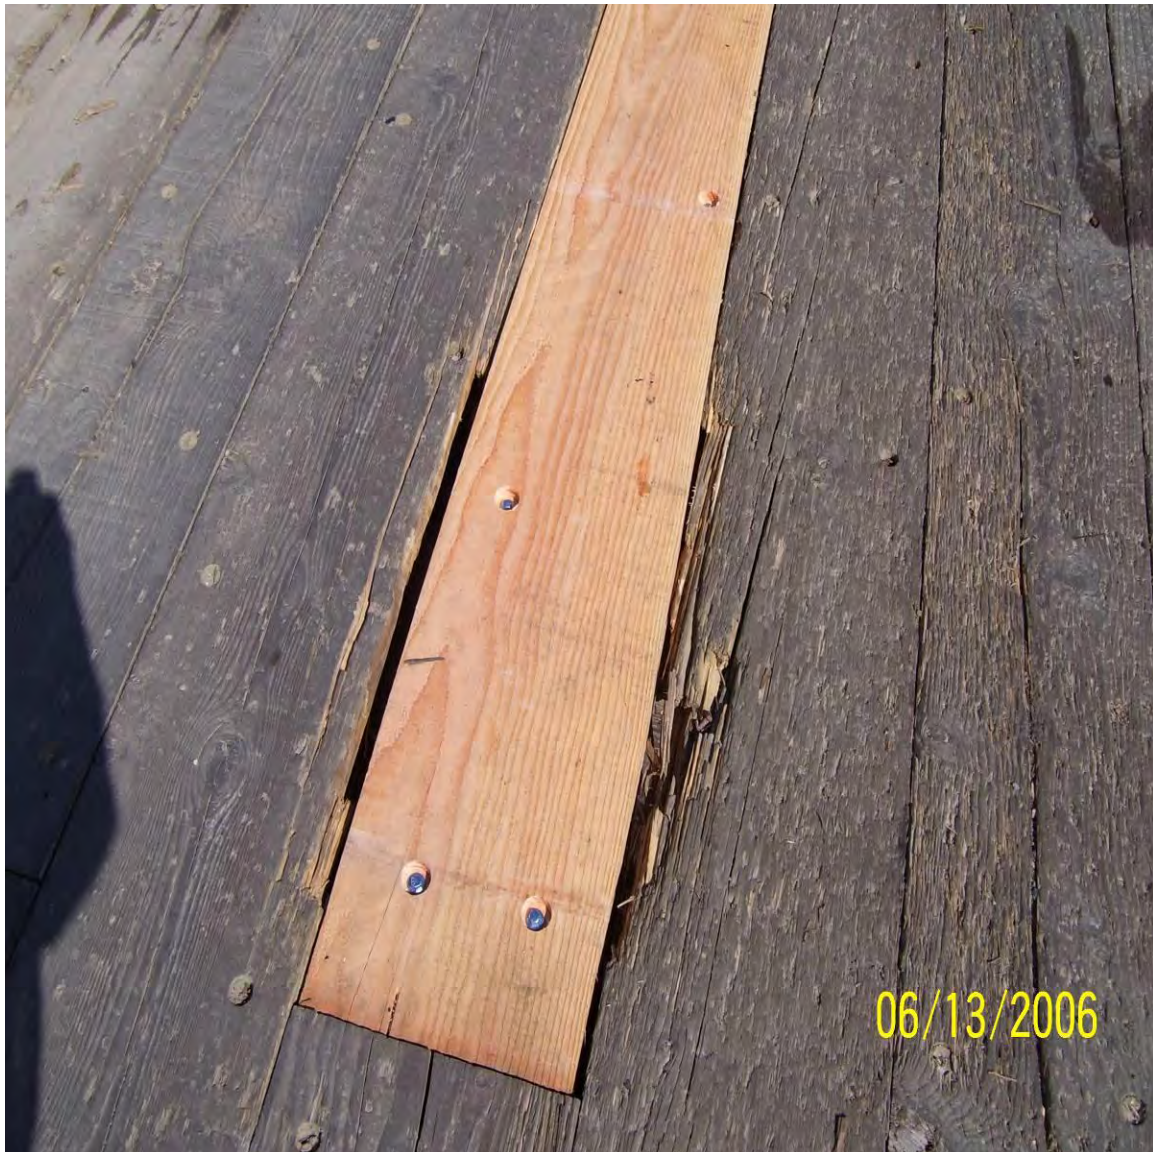
Figure B.5 Wood wearing surface: A typical replacement by Maintenance.

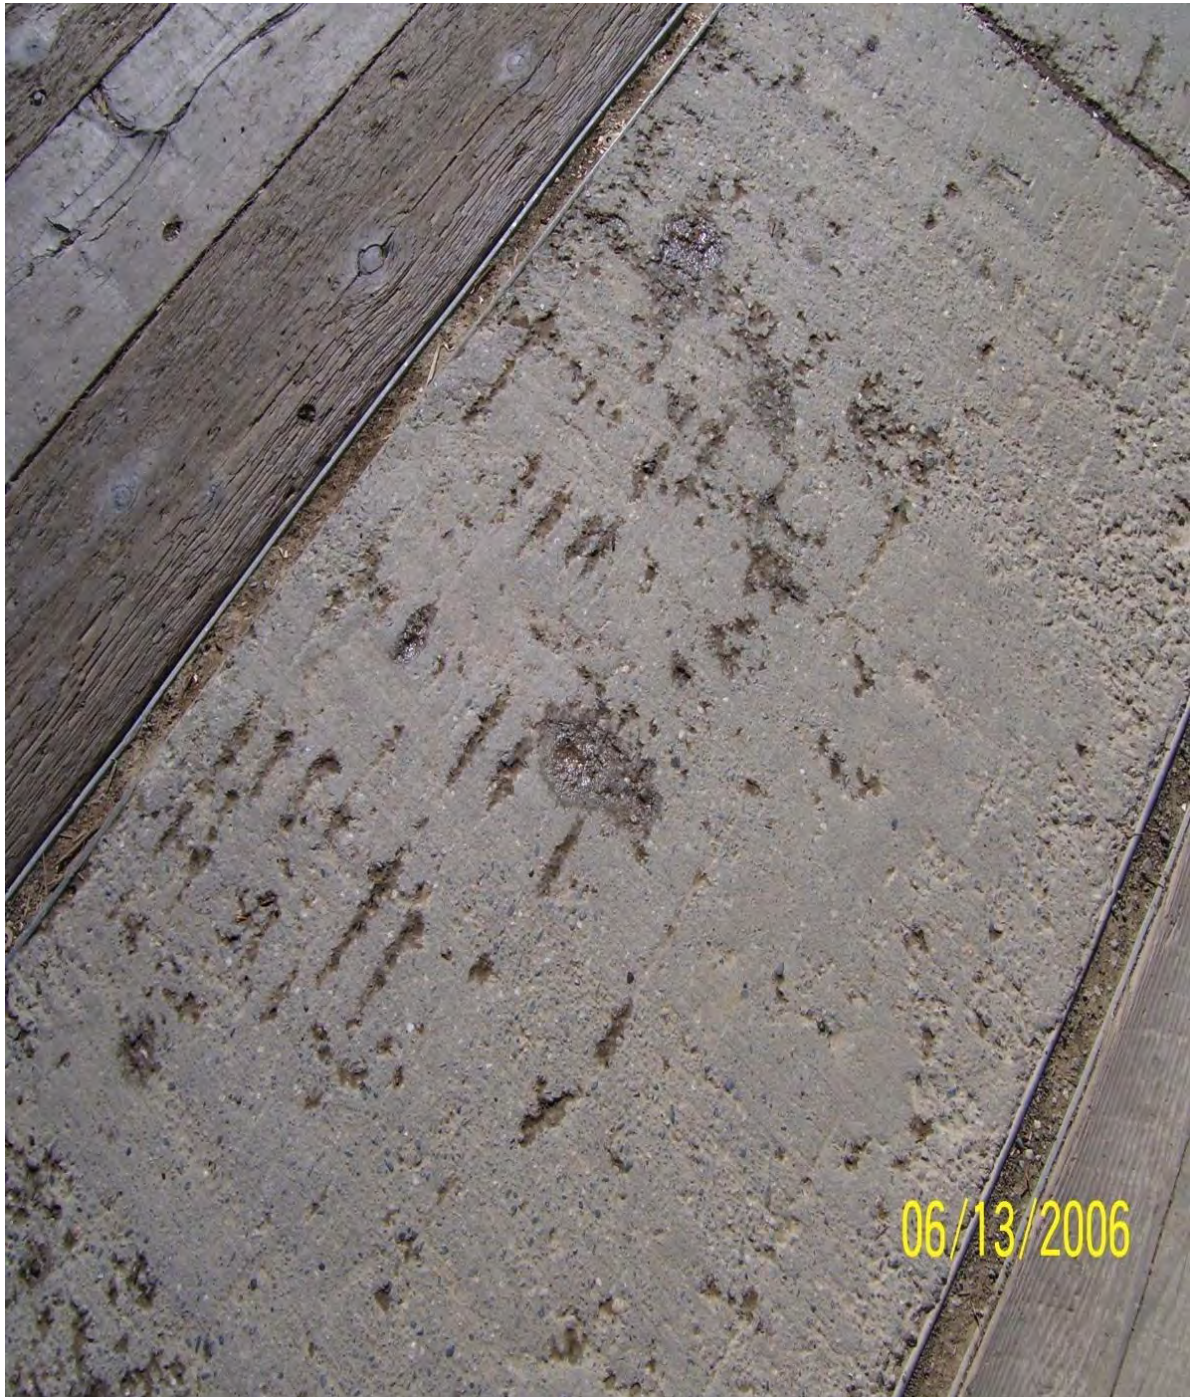
Figure B.8 Concrete-filled metal grid: Possible chain damage (age is 7 years).
