## ALASKA DEPARTMENT OF TRANSPORTATION

# Evaluation of Wearing Surfaces for the Yukon River Bridge

July 2009

FHWA-AK-RD-09-07

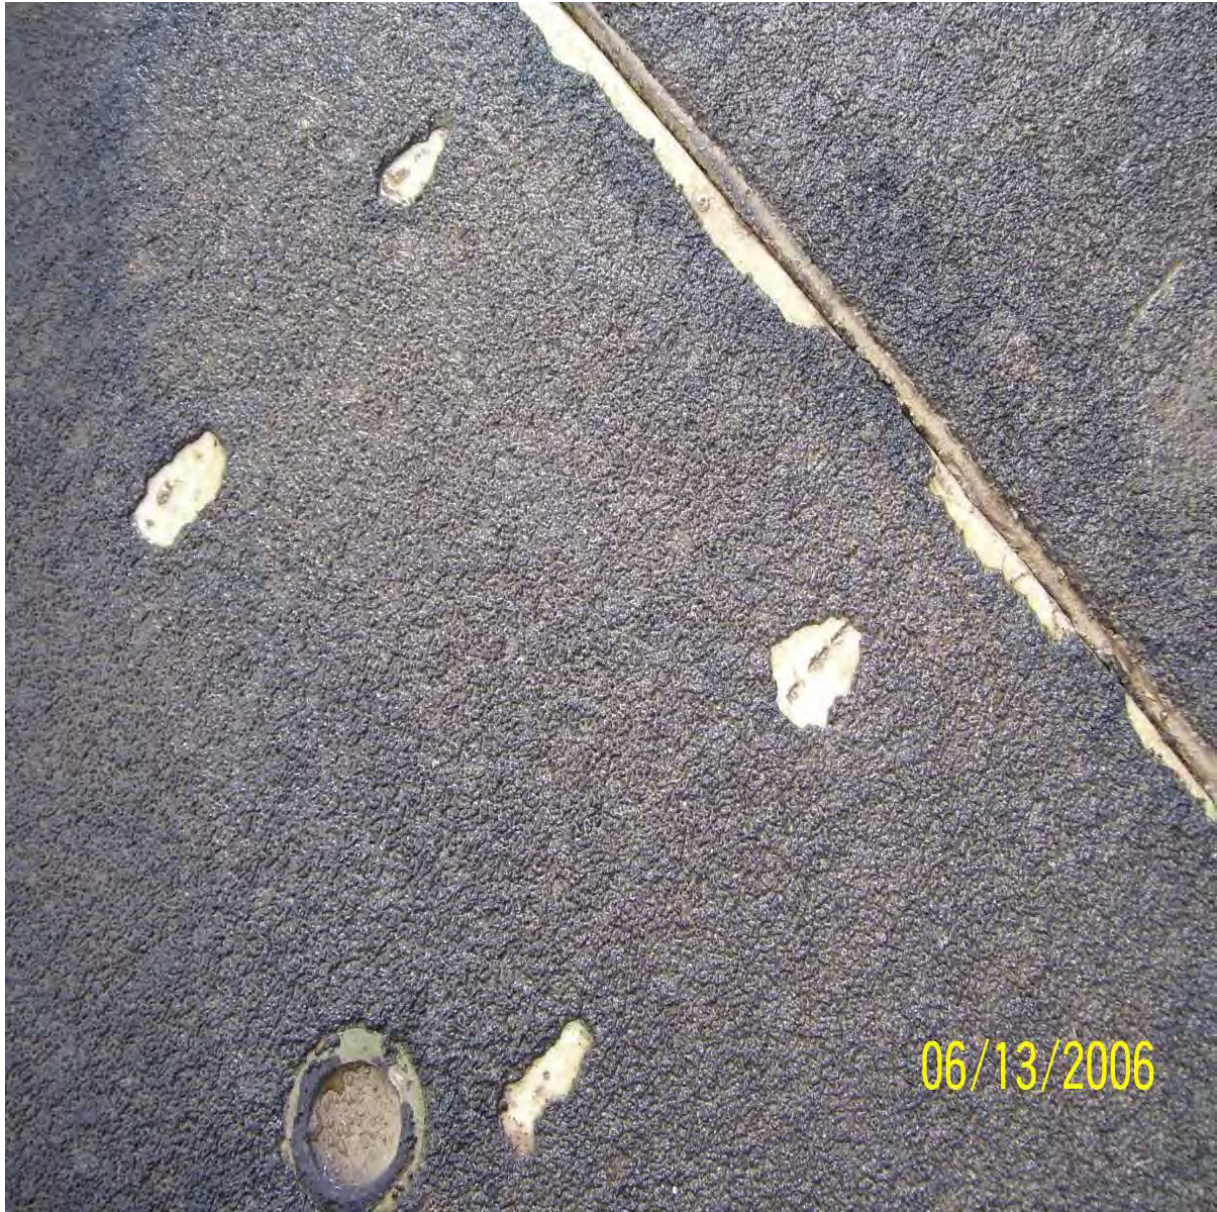
Figure B.10 Early delamination of the Transonite wearing surface (1 year old).

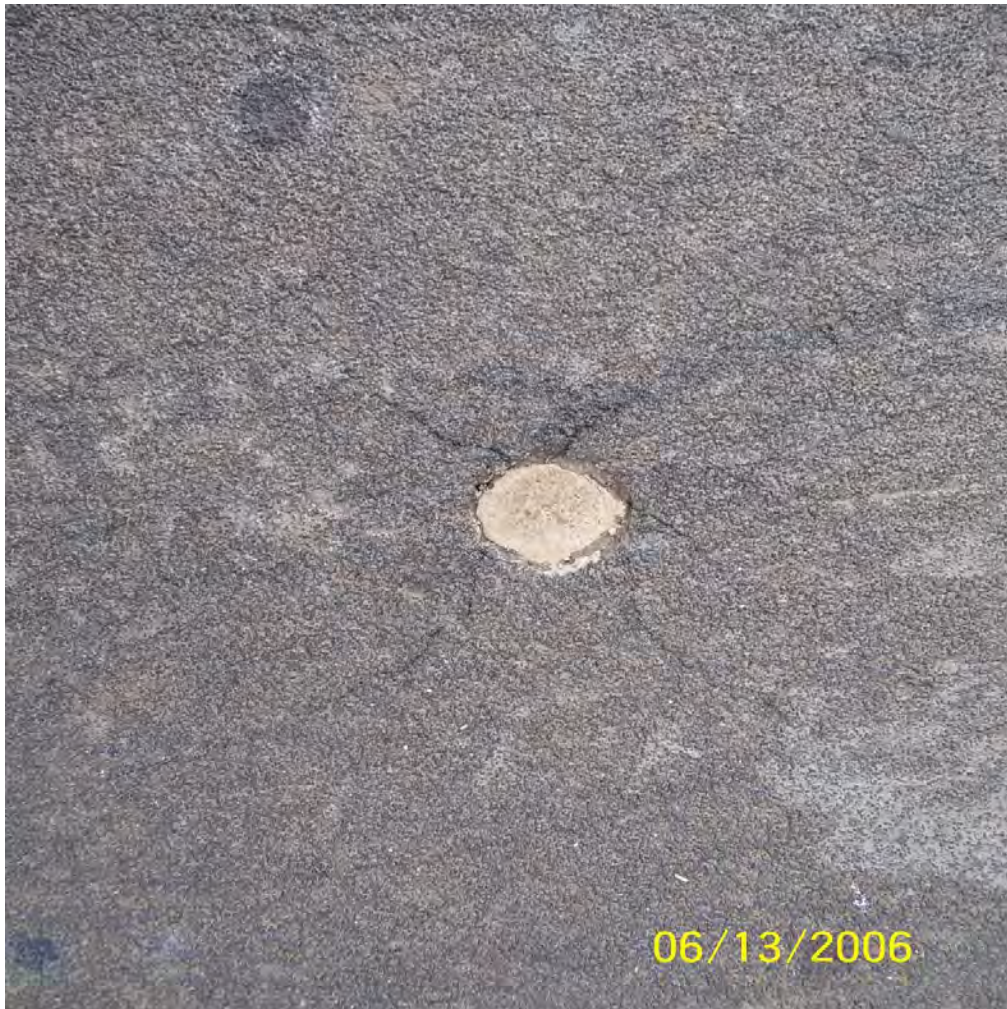
Figure B.11 Cracks around attachment hole: Transonite wearing surface.

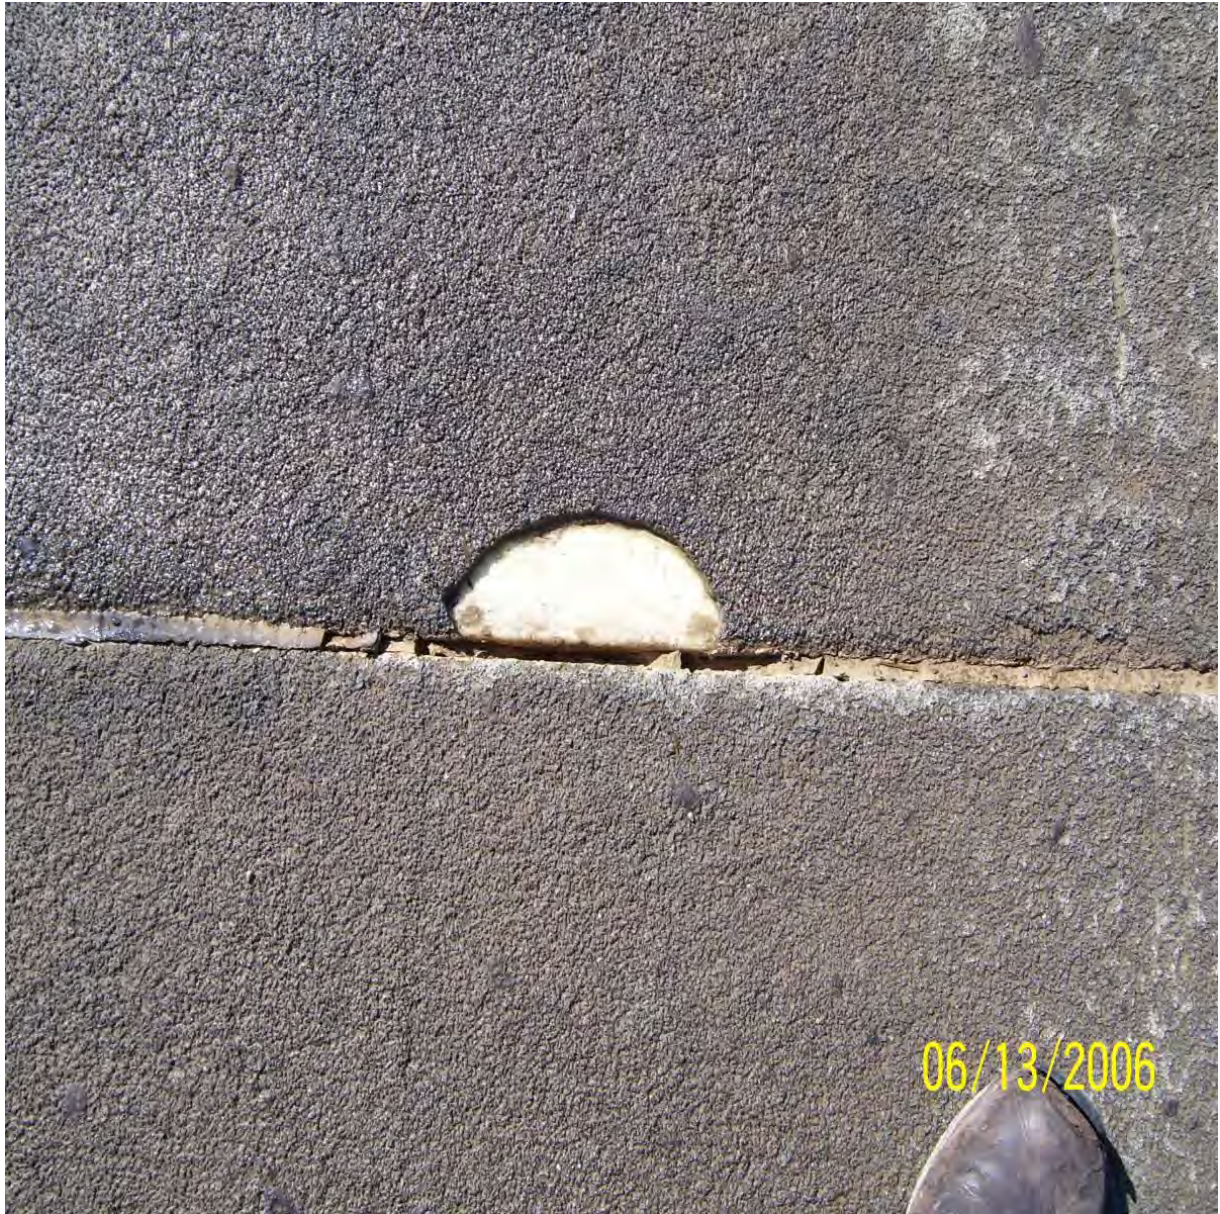
Figure B.12 Possible delamination caused by a bolt in the splice plate.

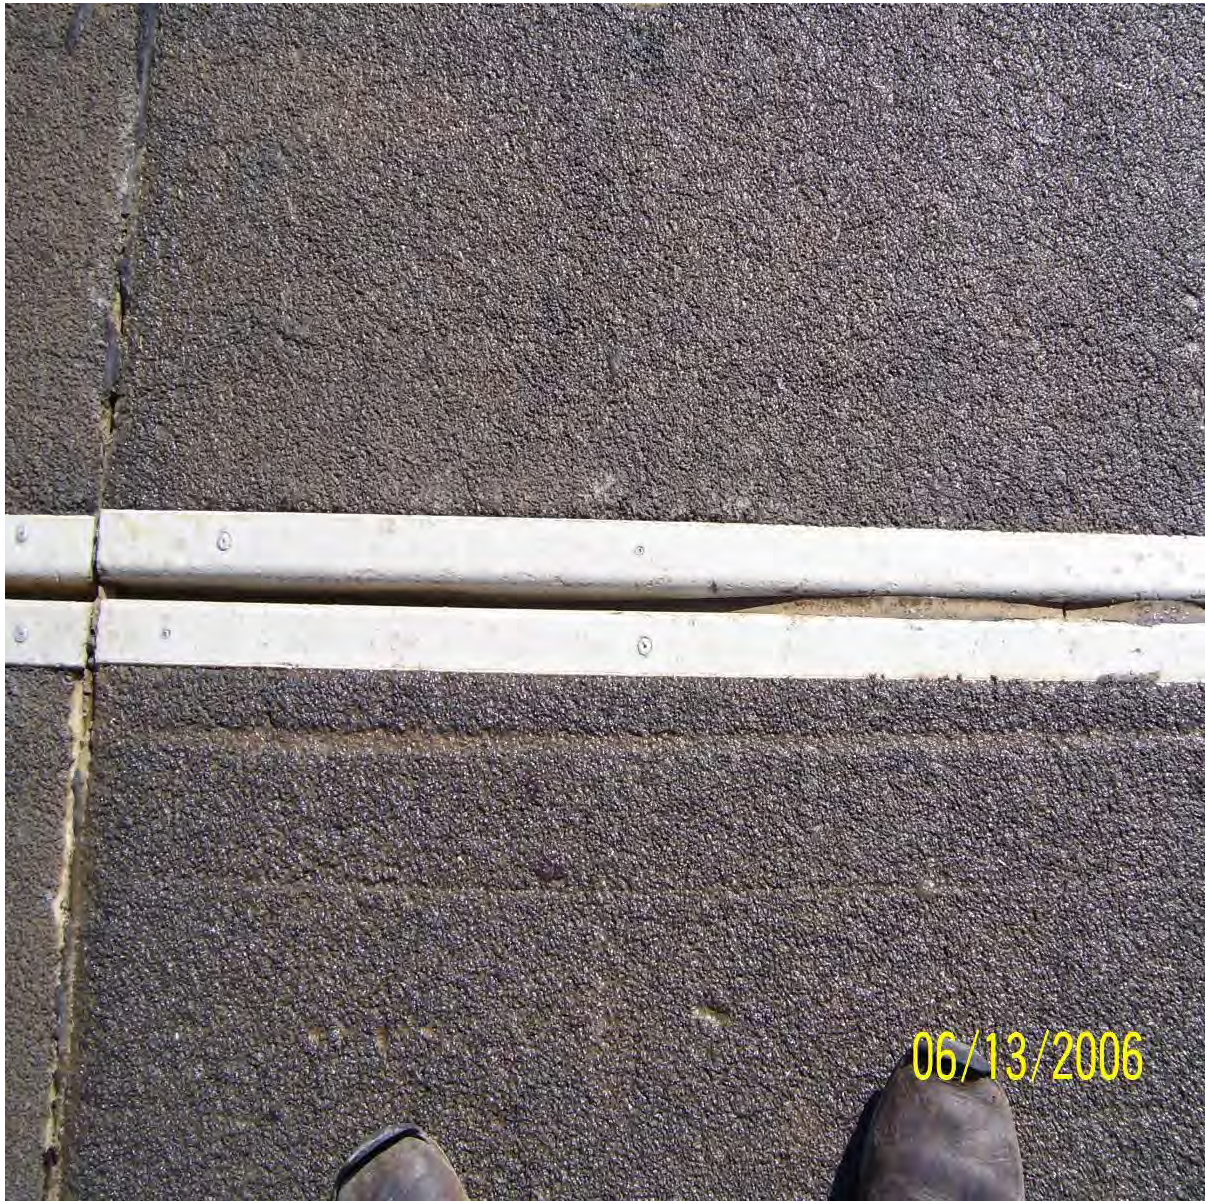
Figure B.13 Transonite edge strip with missing pop rivets.

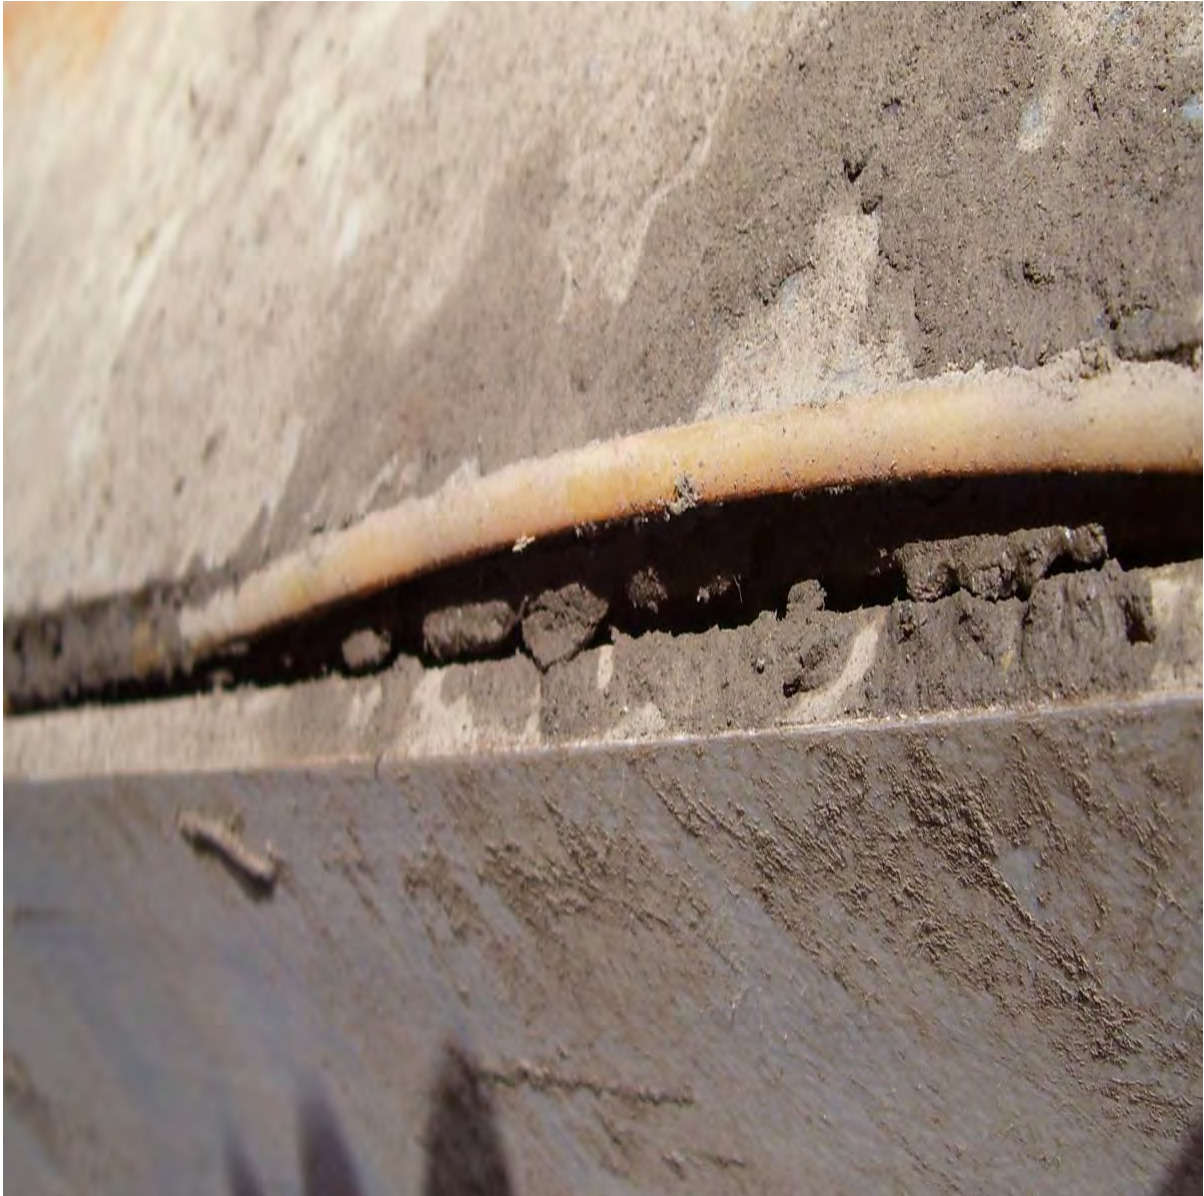
Figure B.14 Leaky seal under the Transonite panel.

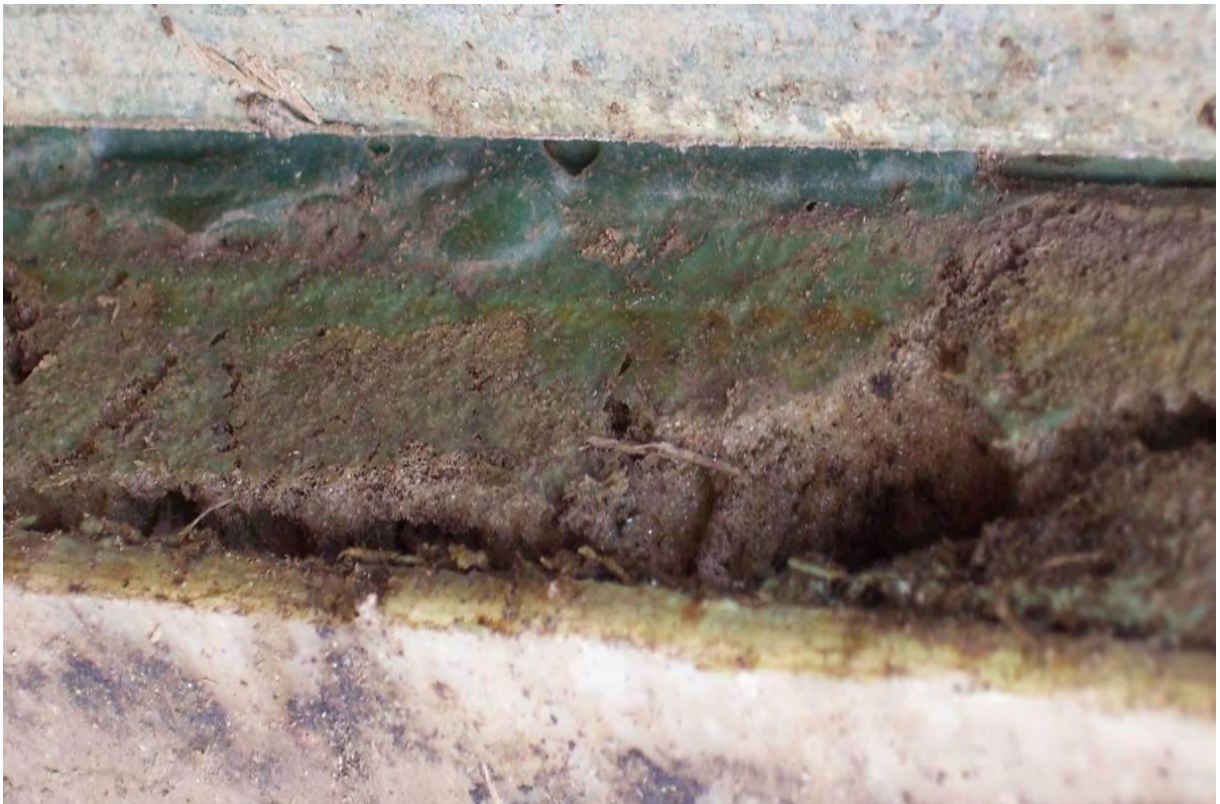
Figure B.15 Cracked sealer and foam on the Transonite panel.

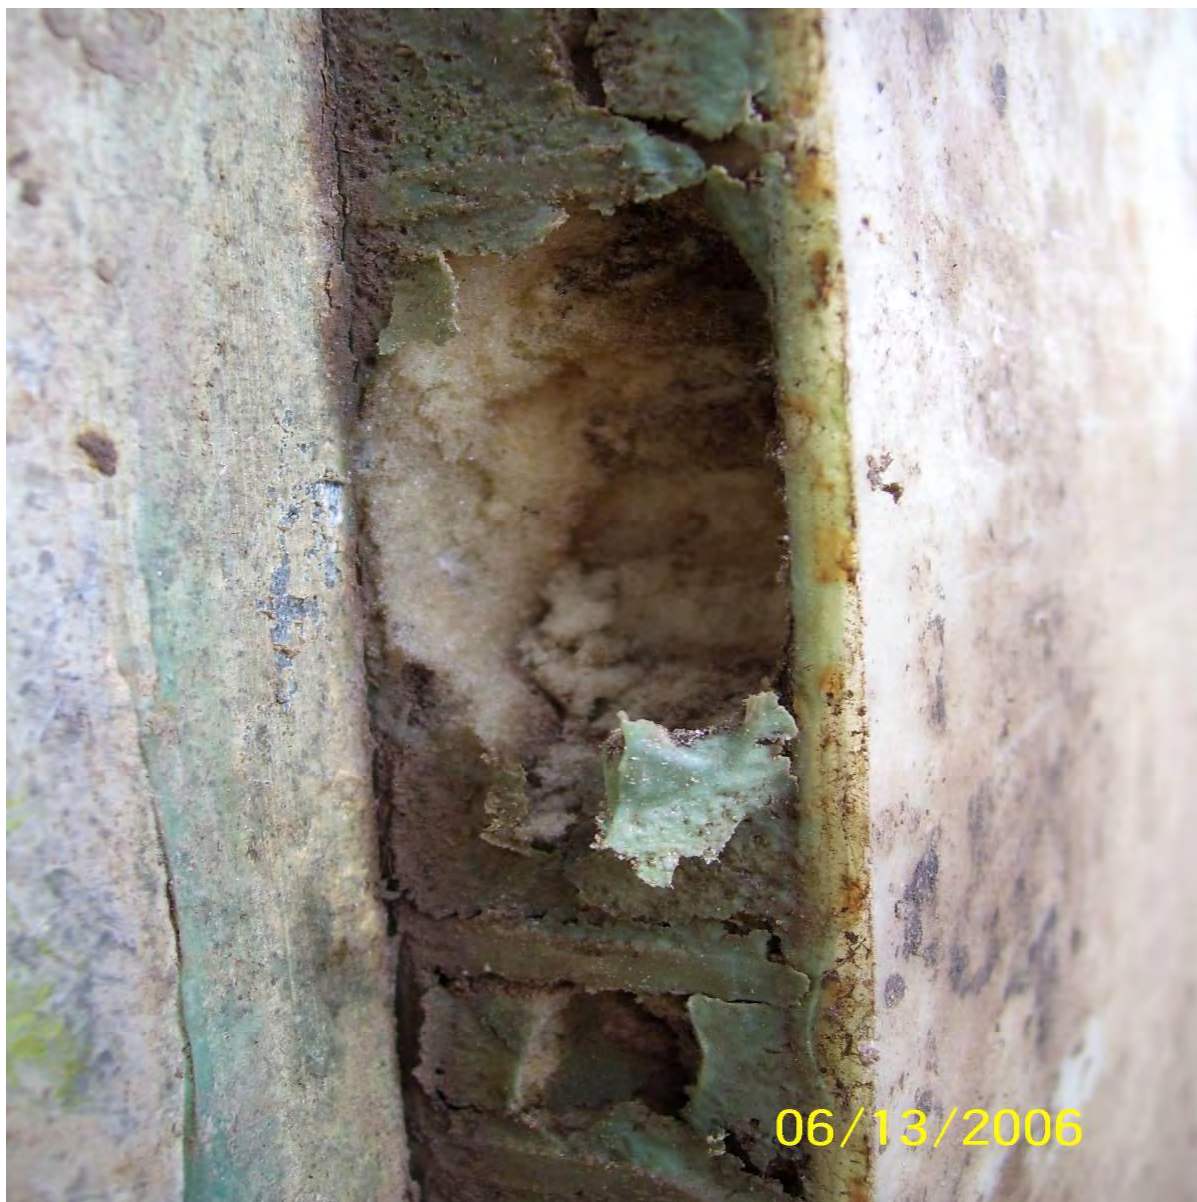
Figure B.16 Damaged fiberglass pillars and foam in the Transonite panel.

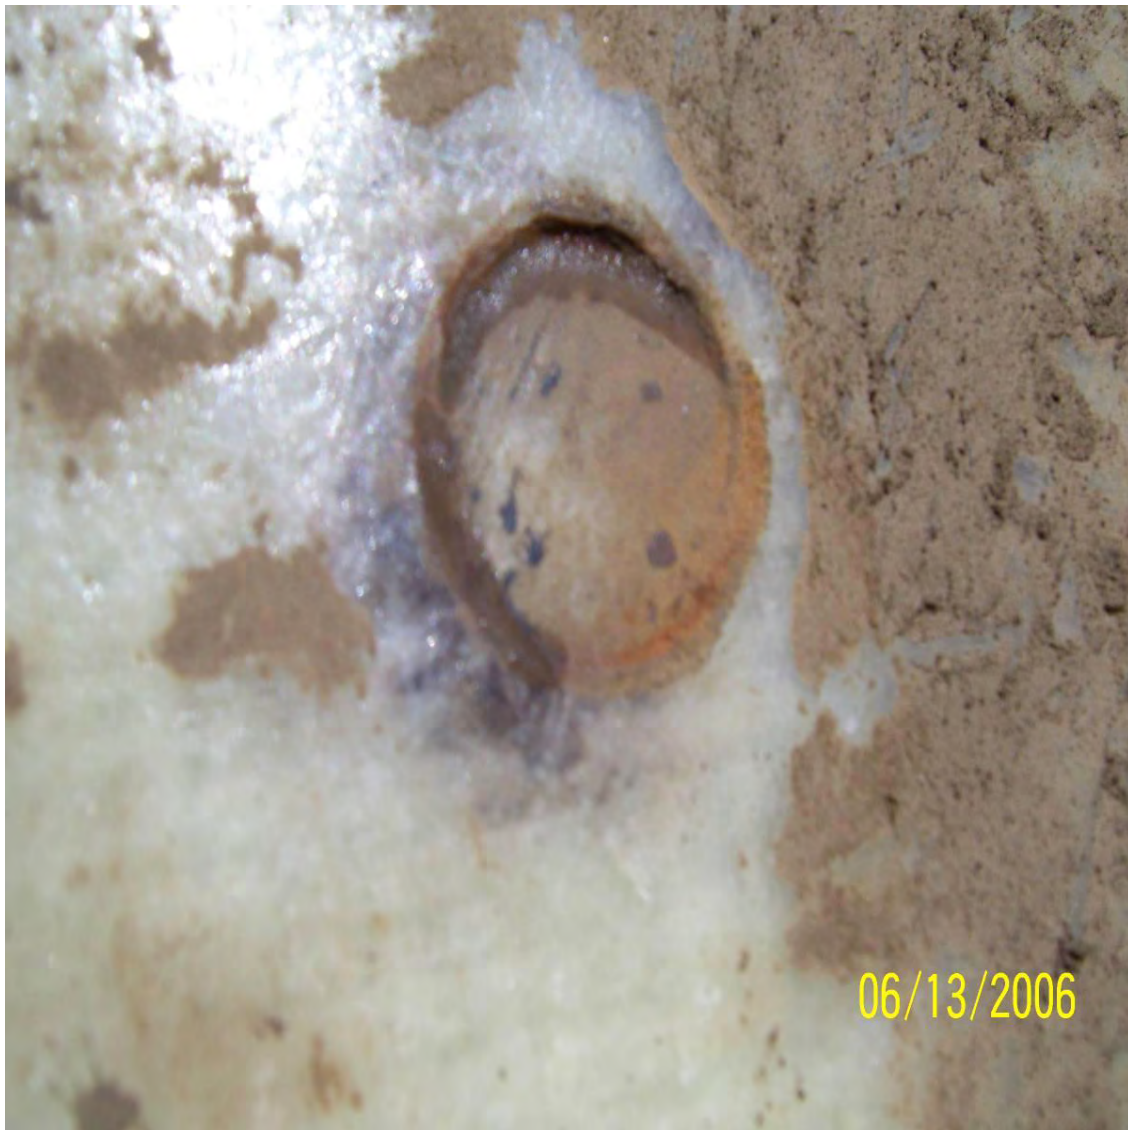
Figure B.20 Punctured bottom surface of the Transonite test panel.

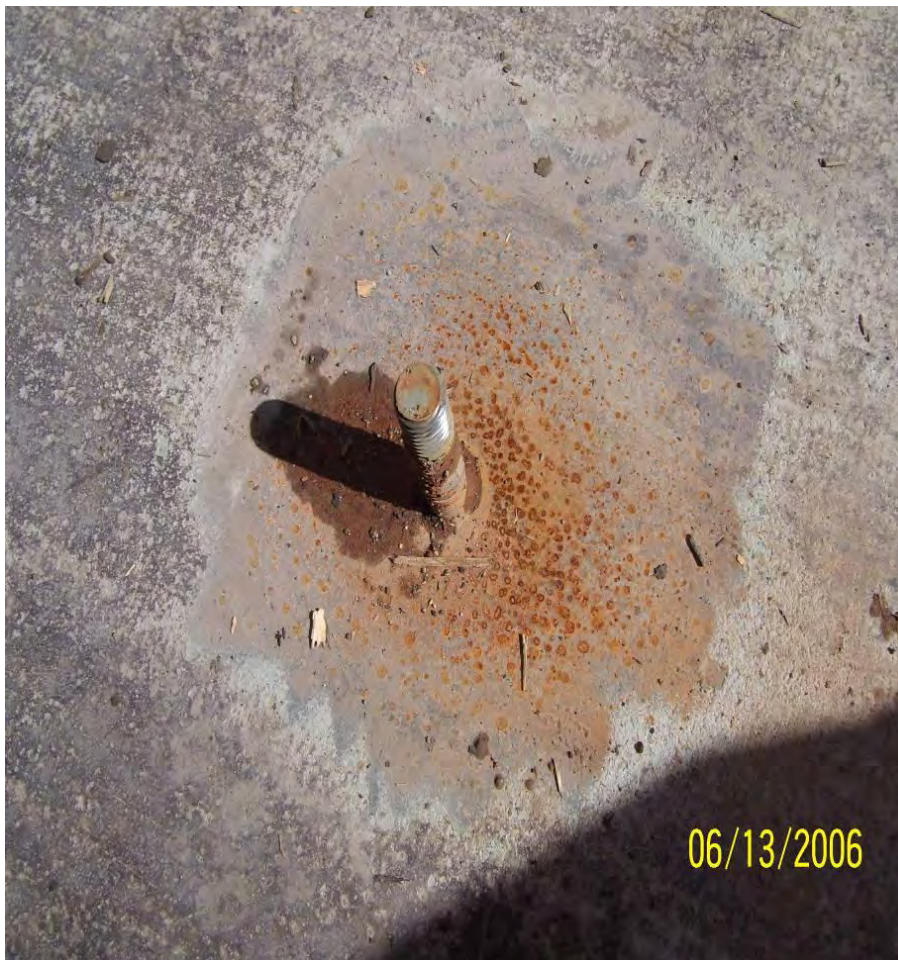
Figure B.21 Deck rust at a welded stud; loss of anticorrosion coating.

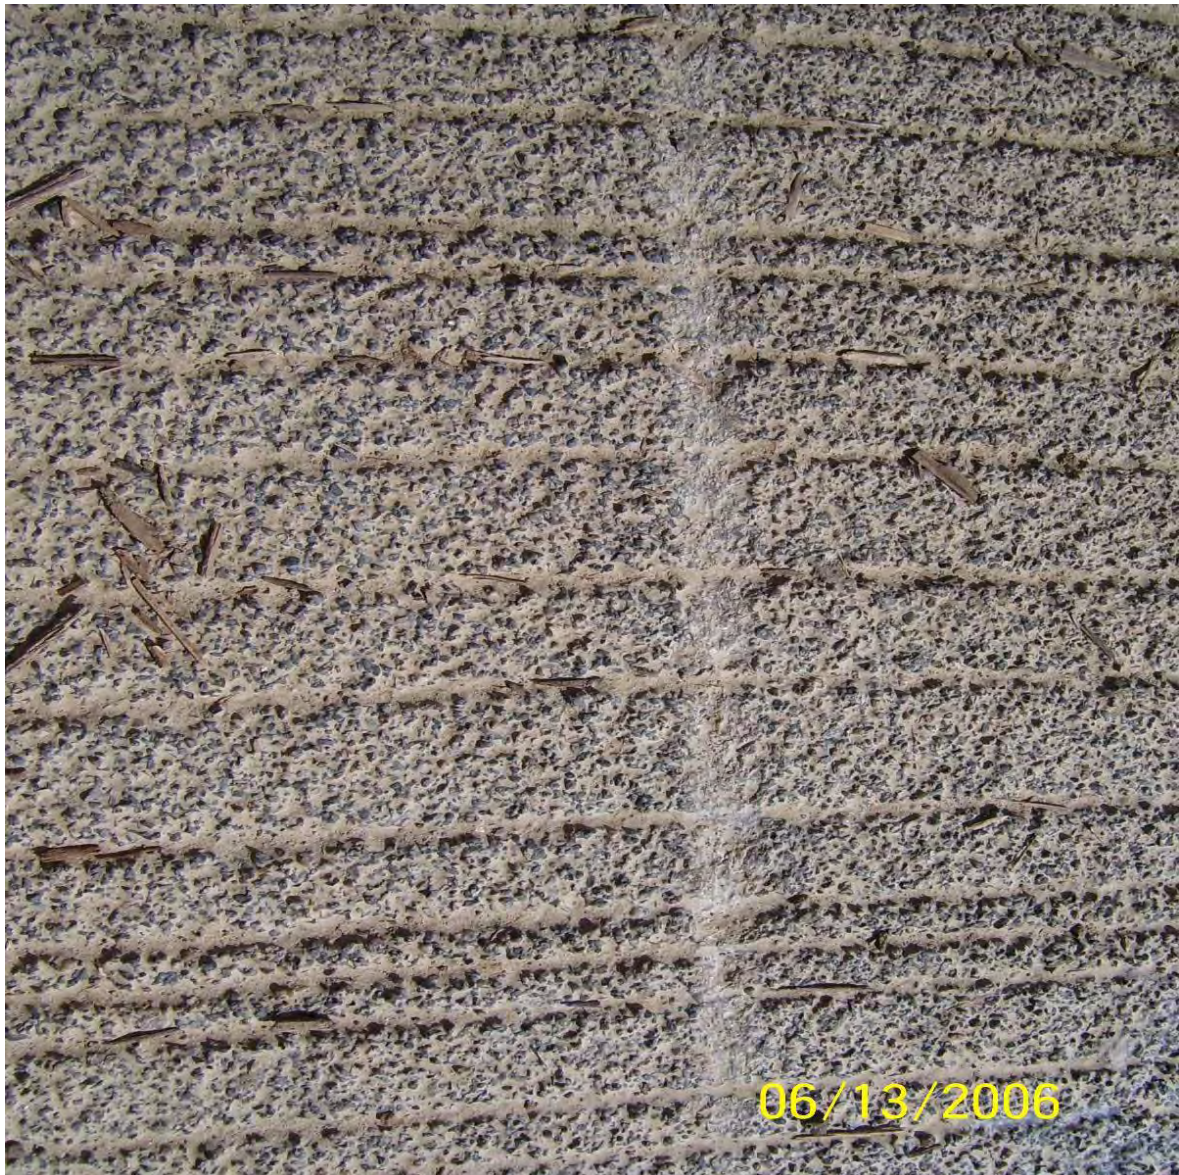
Figure B.22 Grader scratch to the wearing surface on the Prodeck test panel.

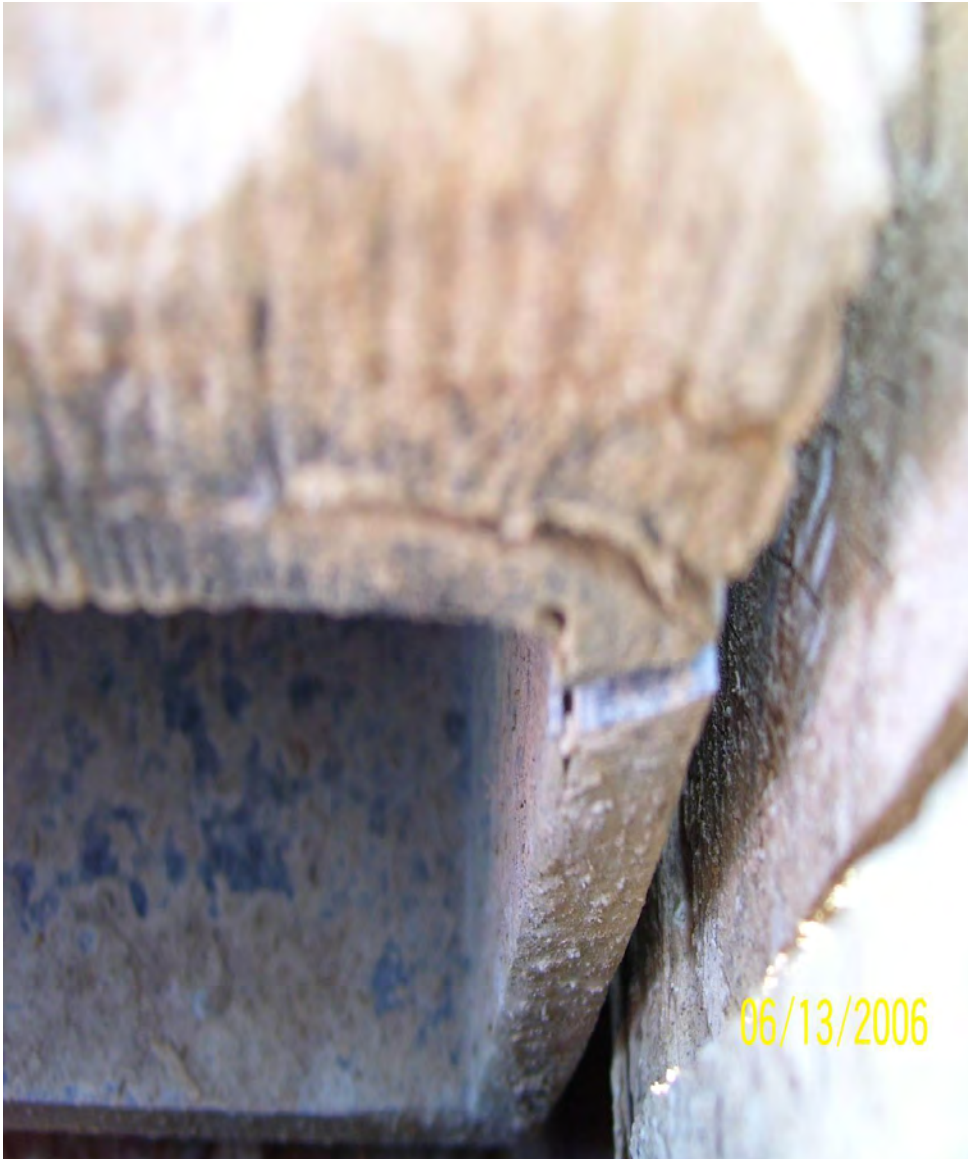
Figure B.24 Prodeck 4 test panel: Cracked fiberglass end.

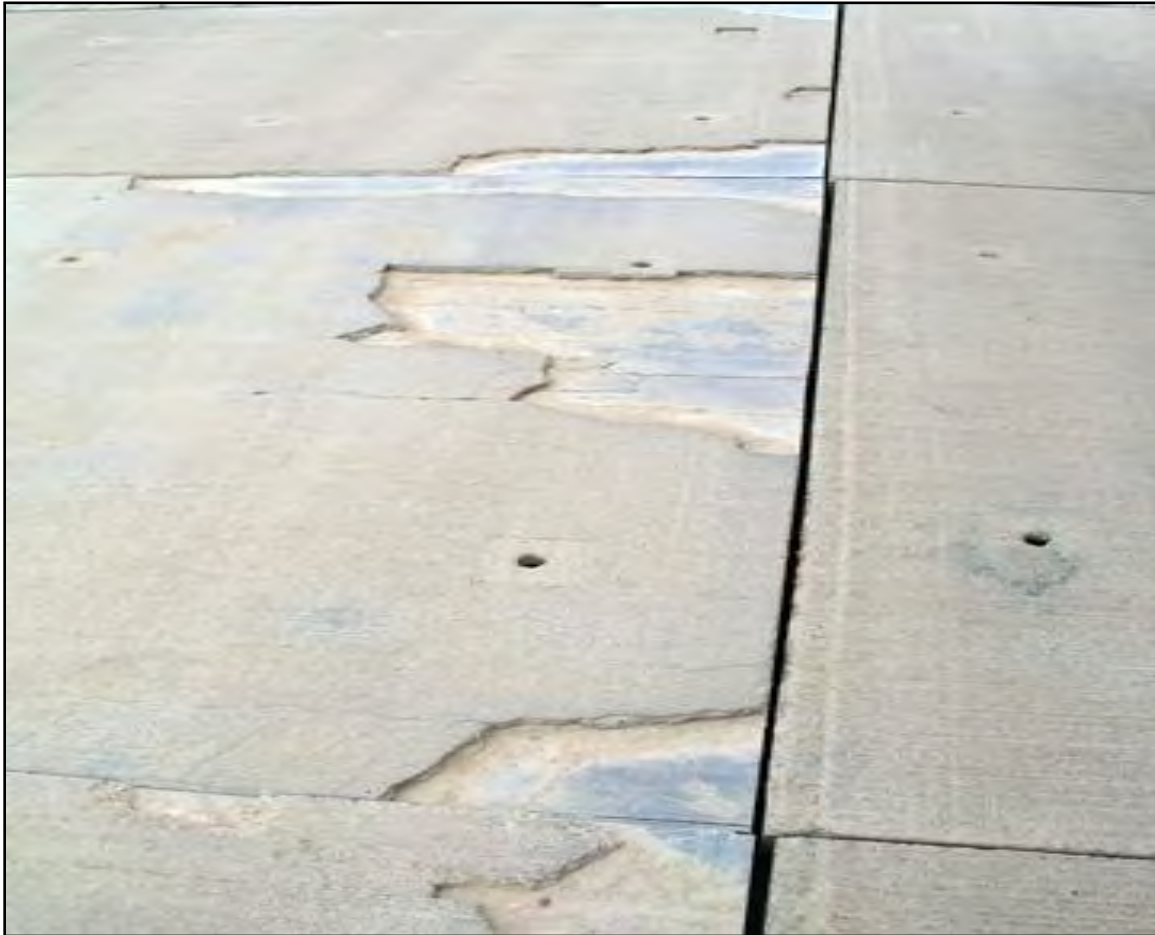
Figure C.4 Prodeck 4, surface delaminating.
