# Landslide Collides with Highway: Measuring Its Impact to Inform Future Mitigation – FINAL REPORT

Margaret M. Darrow, University of Alaska Fairbanks  
Ronald P. Daanen (posthumously), Alaska Division of  
Geological & Geophysical Surveys  
December 31, 2023

Alaska Department of Transportation & Public Facilities  
Statewide Research Office  
3132 Channel Drive  
Juneau, AK 99801-7898

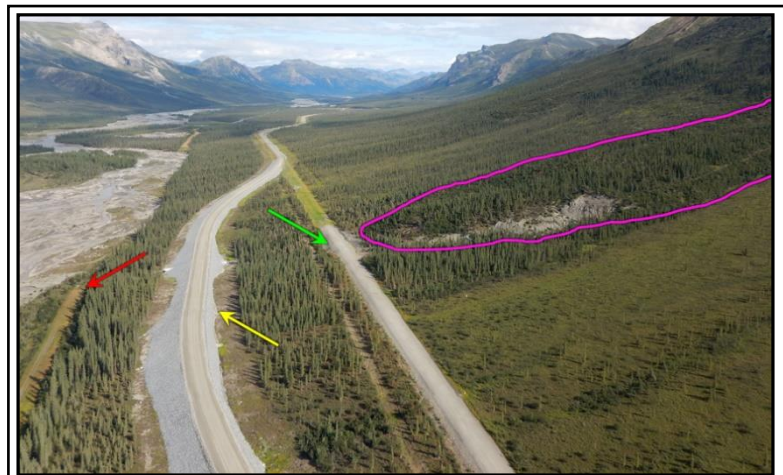
Figure 1. Oblique view of FDL-A (outlined in pink), the old (green arrow) and new Dalton Highway (yellow arrow) alignments, and the location of the buried Trans Alaska Pipeline System (red arrow), as seen in August 2019.

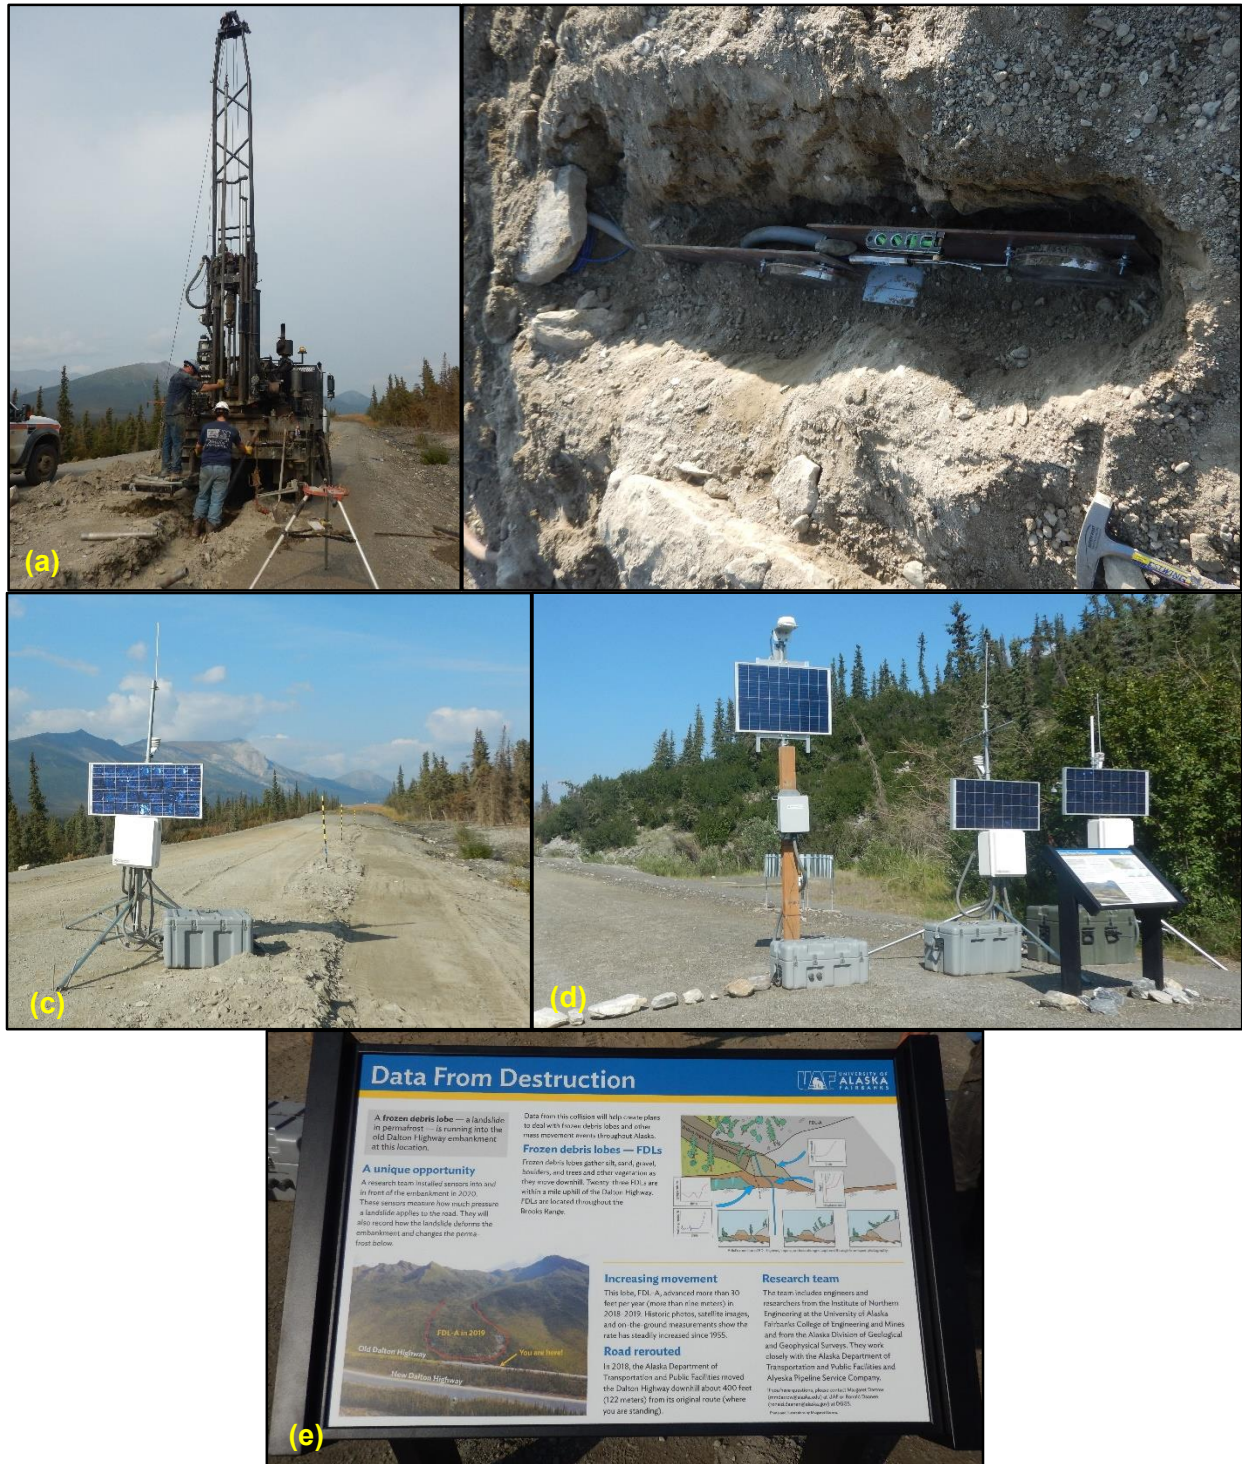
Figure 2. Images from the 2020 drilling program: a) drill truck centered on trench to drill TH20-03; b) looking down at the pressure plates and tilt meter embedded into the uphill side slope of the embankment near TH20-02; c) looking to the north at the 2020 location of the secondary ADAS moved to accommodate the short cables; d) all ADAS at the southern end of the project location in 2022; e) interpretative display installed as an outreach component.

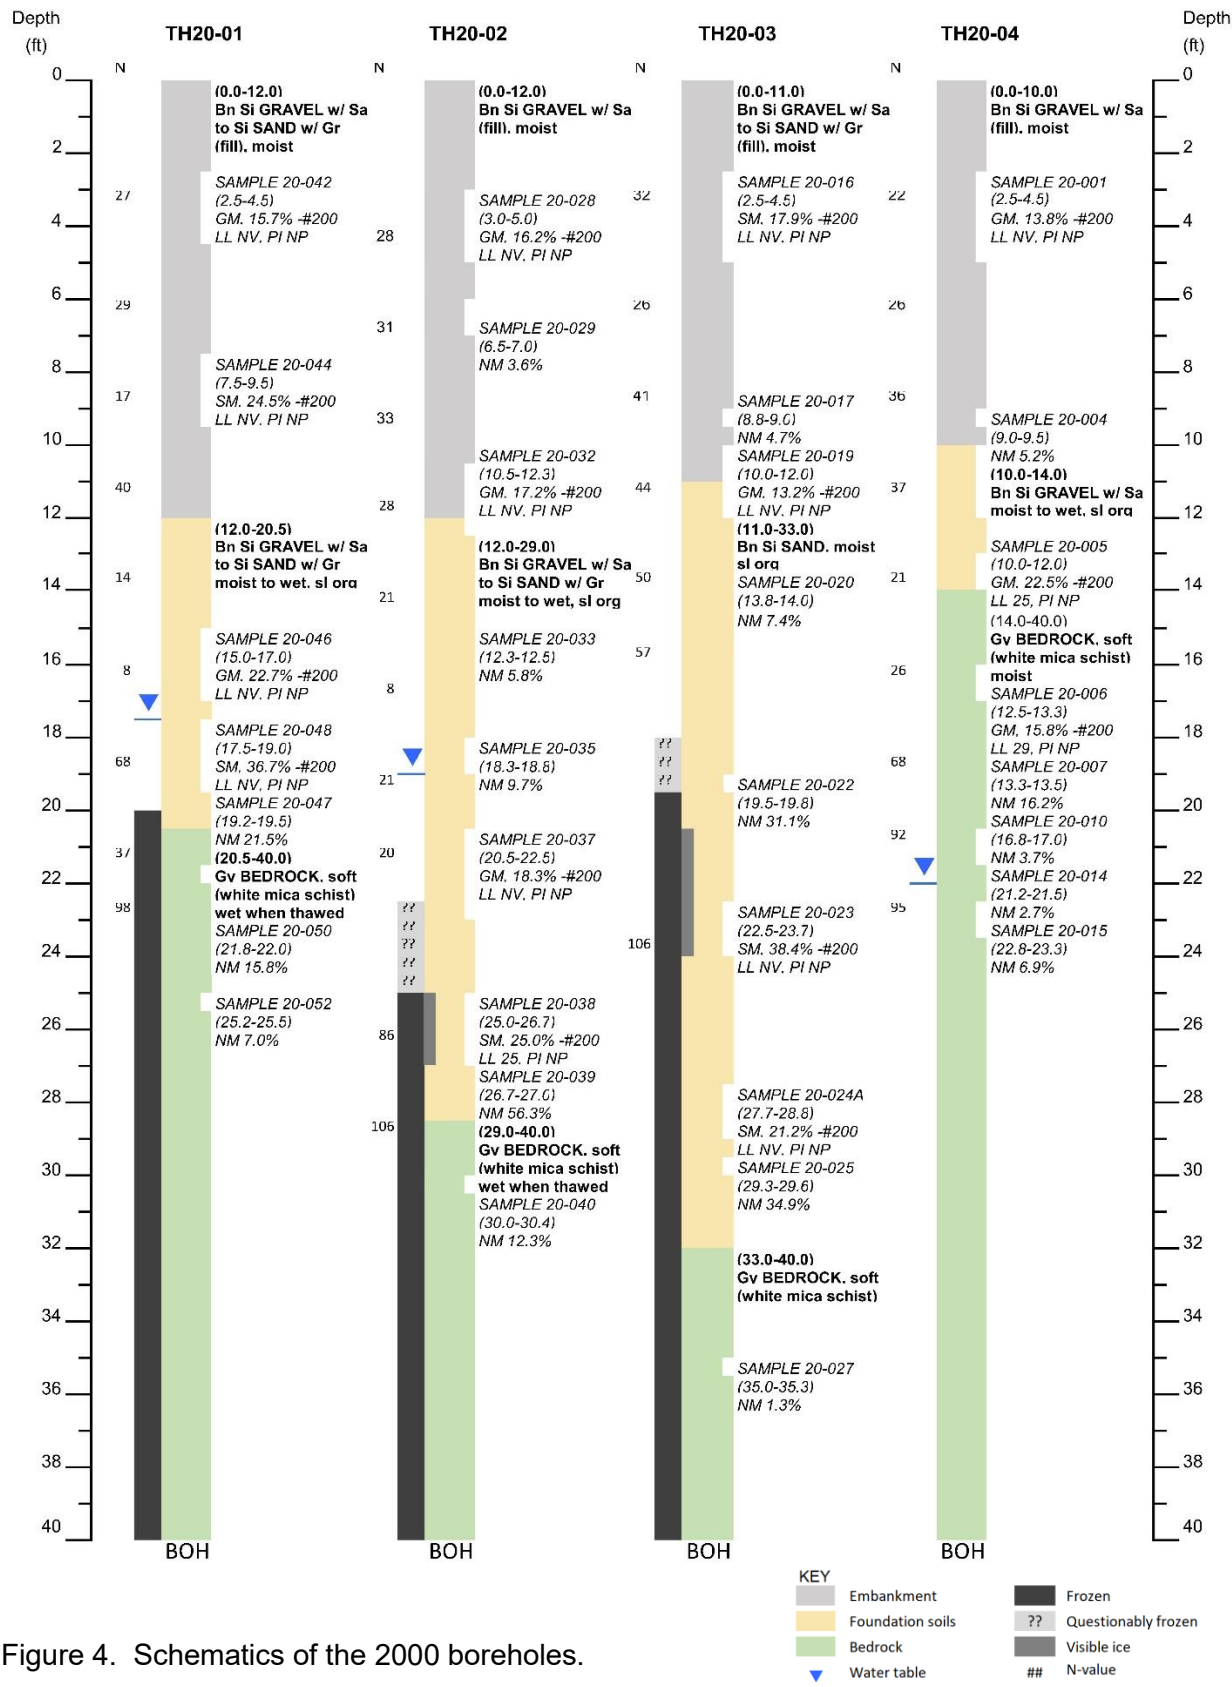
Figure 4 contains schematics of the four boreholes. Where drilled, the embankment ranged from 10 to 12-ft thick, consisting of moist, brown, non-plastic silty gravel with sand to silty sand with gravel. The foundation soils typically consisted of brown, non-plastic slightly organic silty sand with gravel to silty gravel with sand. These soils were moist to wet where unfrozen. We intercepted gray, white mica schist bedrock in all boreholes, varying between 14.0 and 32.0 ft below the embankment surface. The highly weathered bedrock was moist to wet where unfrozen. We intercepted the permafrost table 19.8 to 25.0 ft below the ground surface in TH20-01 through TH20-03. A water table was perched on the permafrost table in TH20-01 and TH20-02. We also intercepted a water table in TH20-04.

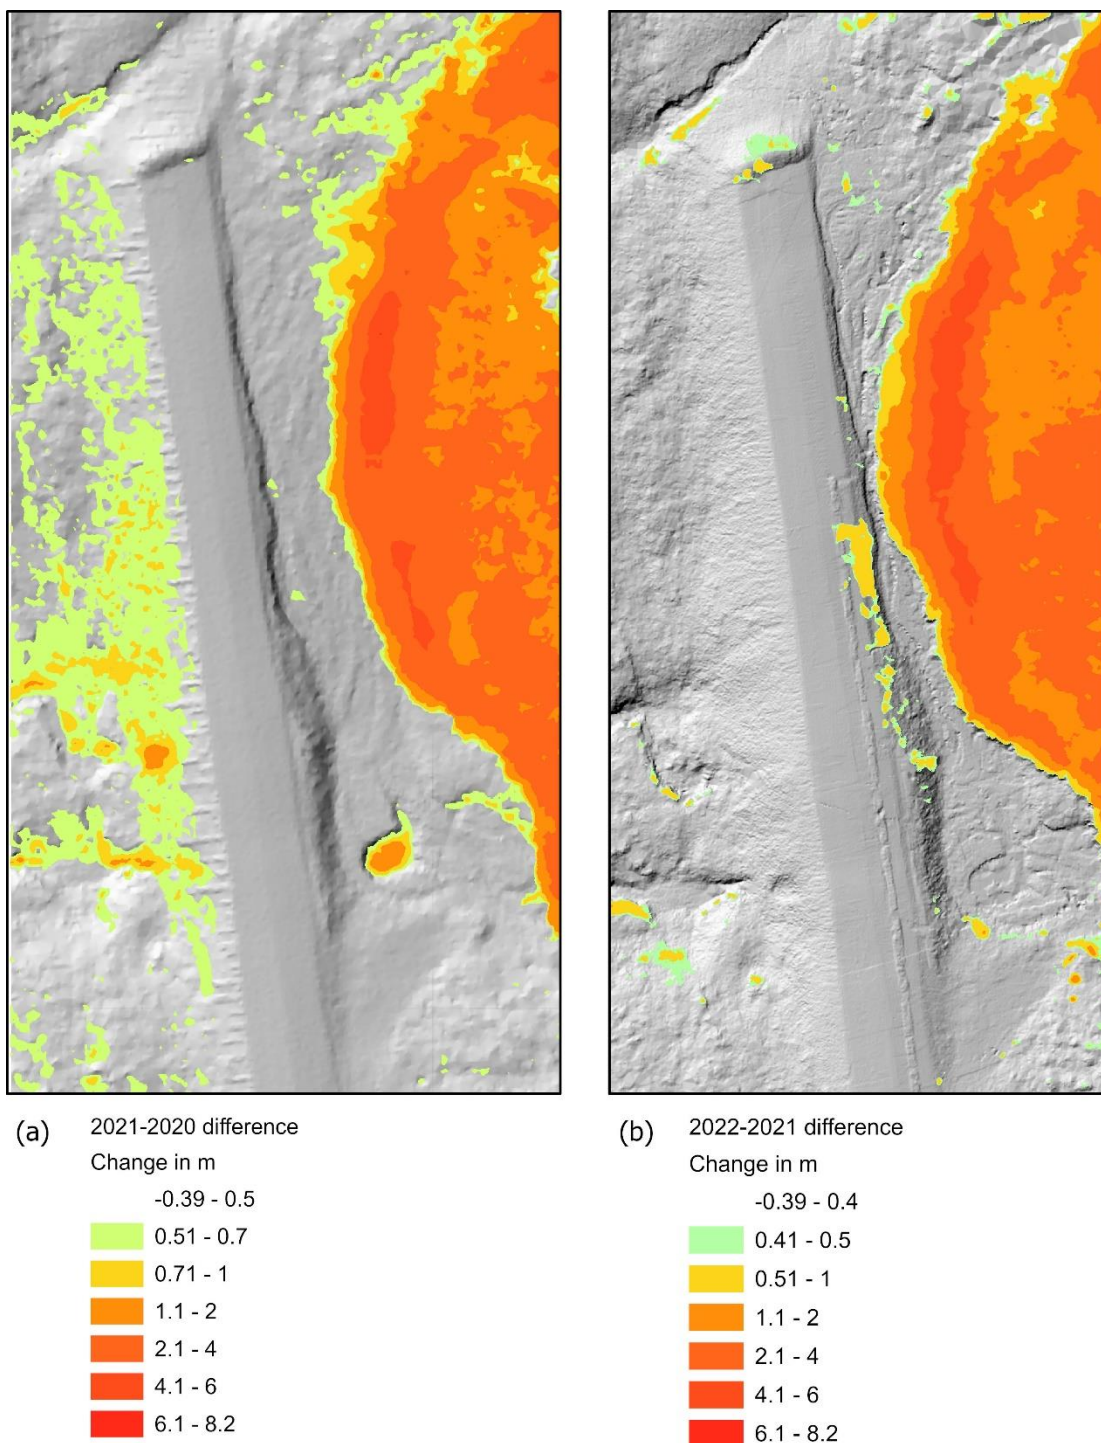
collected for this project and the 2020 lidar indicated movement in areas for which there should be none (e.g., areas of light green color west of the embankment in Figure 7a). We attribute this to lidar collected after leaf out in 2020. There was better agreement between the 2021 and 2022 data sets, resulting in error of less than 0.43 m (Figure 7b); however, the 2021 dataset demonstrated pixelated areas that produced artifacts along the eastern part of the embankment (i.e., light orange area in Figure 7b). Field observations indicated that there is no bulging within the abandoned Dalton Highway embankment in this area. Despite these discrepancies, these datasets illustrate dramatic changes in the position of the toe of FDL-A, with vertical changes up to 8.2 m.

Figure 7. DEMs of difference for the toe area of FDL-A: (a) between 2020 and 2021; (b) between 2021 and 2022. Base map data are 2020 and 2022 lidar, respectively, both unpublished.

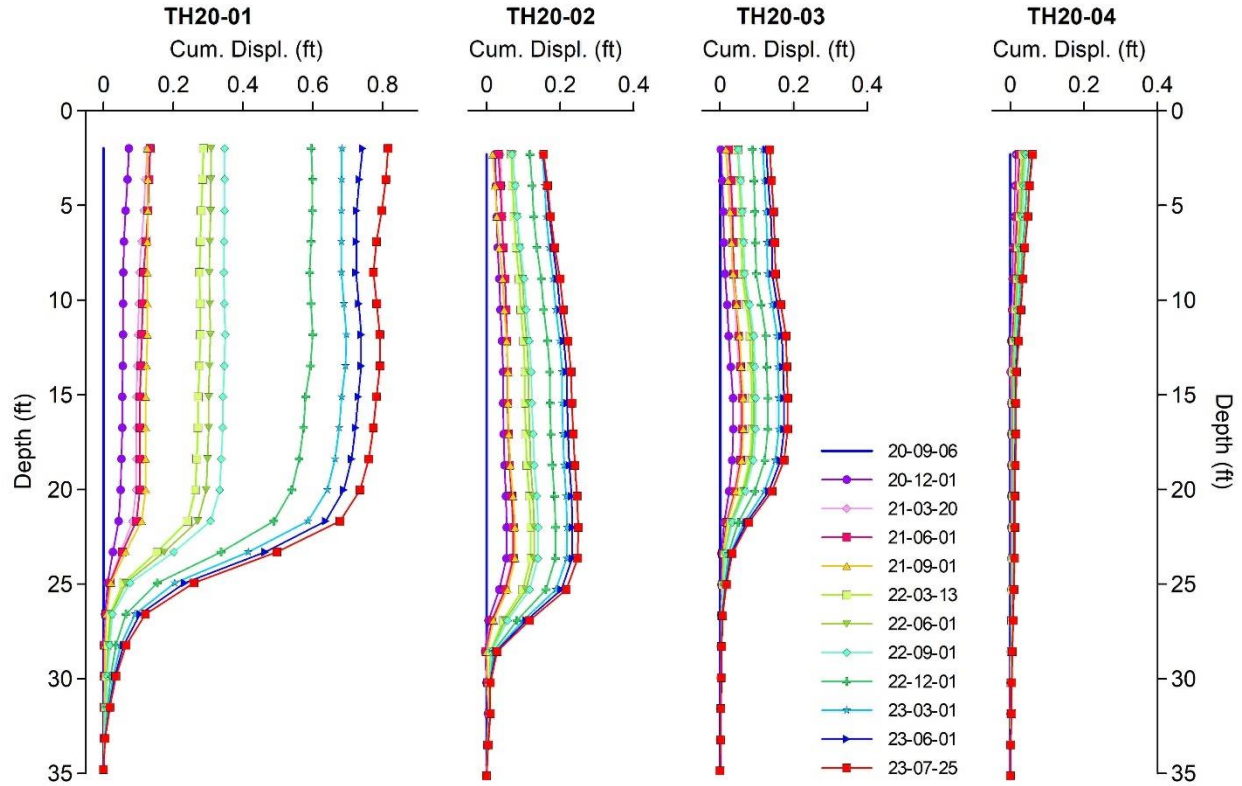
Figure 11 contains plots of the M-IPI measurements for the four test holes shown in Figures 3b and 4. We detected movement in TH20-01, -02, and -03 immediately upon installation in 2020 while the toe of FDL-A was still more than 30 ft away. These data indicate that the base of FDL-A is shearing into the weathered bedrock (TH20-01) and below the permafrost table (TH20-01 through TH20-03). These data also indicate that FDL-A has displaced TH20-01 approximately 9 inches horizontally. This amount of deformation is not discernable in the lidar (see Section 3.2), in careful viewing of the timelapse movie (see Section 3.3), or through field observations;

Figure 11. M-IPI measurements from selected months over the project measurement period.

Based on the M-IPI data, FDL-A was shearing approximately 13 ft below the bottom of the Dalton Highway embankment before this project started in 2020 and while the lobe was still tens of feet away. Based on field observations, and comparison of RTK-GPS measurements of FDL-A's toe and previously-developed shapefiles of the toe of the embankment, FDL-A started to overlap the side slope of the highway embankment in July 2022. During a trip to the site to download data and collect toe measurements in October 2021, we observed a mound of uplifted soil between FDL-A and the highway embankment in the vicinity of TH20-01 (Figure 13a). Analysis of the daily photographs taken of the toe indicates that this mound first appeared on September 19, 2021 (Figure 13b), becoming more prevalent by November 30, 2021 (Figure 13c). We interpret this mound to be soil trapped between FDL-A and the embankment forced upwards due to rotational shearing and buckling as FDL-A approached the embankment.

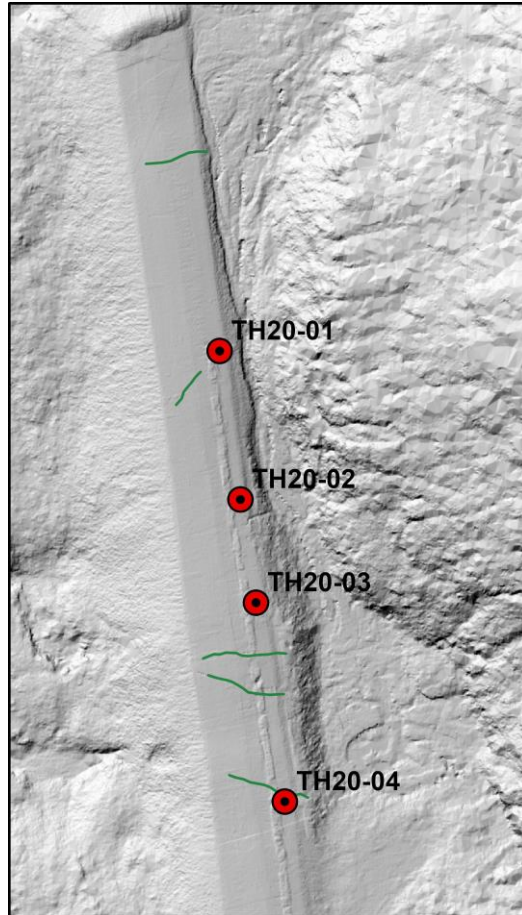
however, the horizontal displacement may be manifesting in cracks within the embankment surface. In 2022, we noticed persistent cracks in the embankment surface, and mapped their positions using the RTK-GPS device in May 2023 (see Figure 12). It is possible that these cracks formed through thaw settlement, as this portion of the embankment is no longer maintained; however, their locations and orientations also suggest that they could be due to horizontal shearing from FDL-A. We recommend on-going monitoring to determine the cause of the cracking.

Figure 12. Persistent cracks (in green) in the embankment surface mapped in May 2023. Background data is 2022 lidar (unpublished).

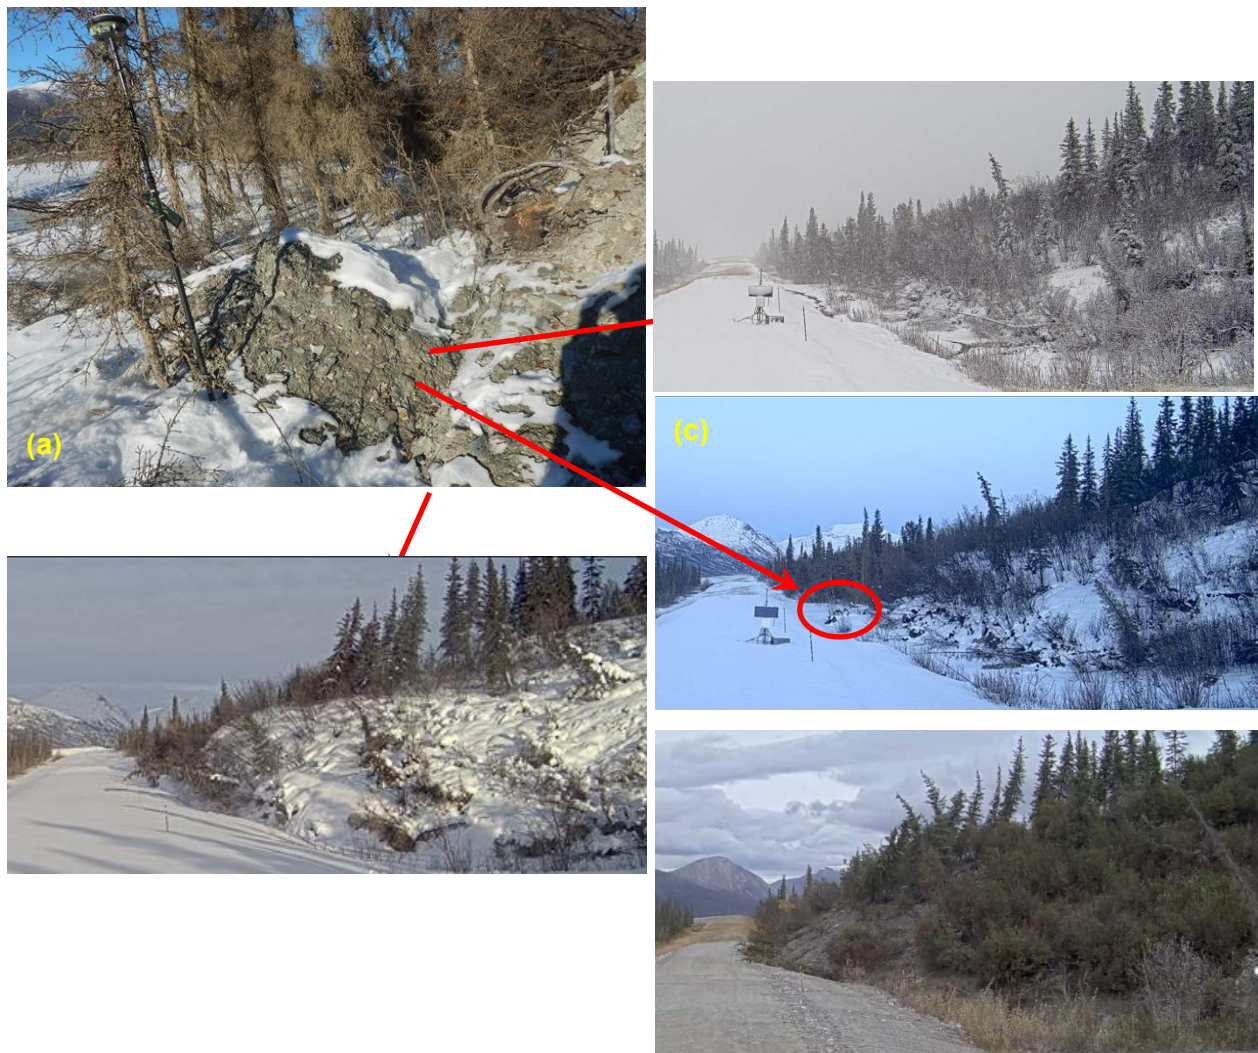
Figure 13. Sequence of deformation at the toe of FDL-A: (a) soil mound noted during a field visit on October 2, 2021; location (red ellipses) of the soil mound in (a) on (b) September 19, 2021 and (c) November 30, 2021; (d) back-tilted trees (red arrow) along toe on March 1, 2023; (e) slumping of previous back-tilted trees (red arrow) on September 9, 2023.

During the fall of 2021, there was no change in the M-IPI data at TH20-01, which continued to demonstrate steady horizontal displacement within the upper few feet of the bedrock.

The next noteworthy change in the westward progression of FDL-A was the back-tilting of trees that became visible in the daily images on March 1, 2023 (Figure 13d). This suggests a shallow rotational failure of the toe, possibly along the shear surface developed during the fall of 2021. During a field visit in June 2023, we noted the presence of scarps and down-dropped blocks in the vicinity of the trees shown in Figure 13d, supplying more evidence of rotational failure. By September 2023, there were several pulses of soil slumping down the toe, causing the trees to rotate forward towards the embankment (Figure 13e). We last downloaded data from the site on July 25, 2023. The last reading of the M-IPI in TH20-01 indicates an outward leaning of the device beginning at about 7 ft below the embankment surface; previous readings suggest this leaning began around June 1, 2023 (Figure 11). We interpret this as the actual mass of FDL-A impacting the embankment at and above the original ground surface, and suspect that the pressure plate and tilt meter at TH20-01 also will indicate this impact through a significant increase in earth pressure and change in tilt in the future. So far during this collision, there have been no unusual changes in water pressure or temperature measured within the embankment. As previously mentioned, the progression of FDL-A's approach and collision with the abandoned Dalton Highway embankment can be viewed through time-lapse videos available on the webpage for FDL research ([fdlalaska.org](http://fdlalaska.org)).
