**HOOPER BAY AIRPORT
IMPROVEMENTS**

PROJECT No. 57419

RECONNAISSANCE STUDY, 2005

RECONNAISSANCE Study Report

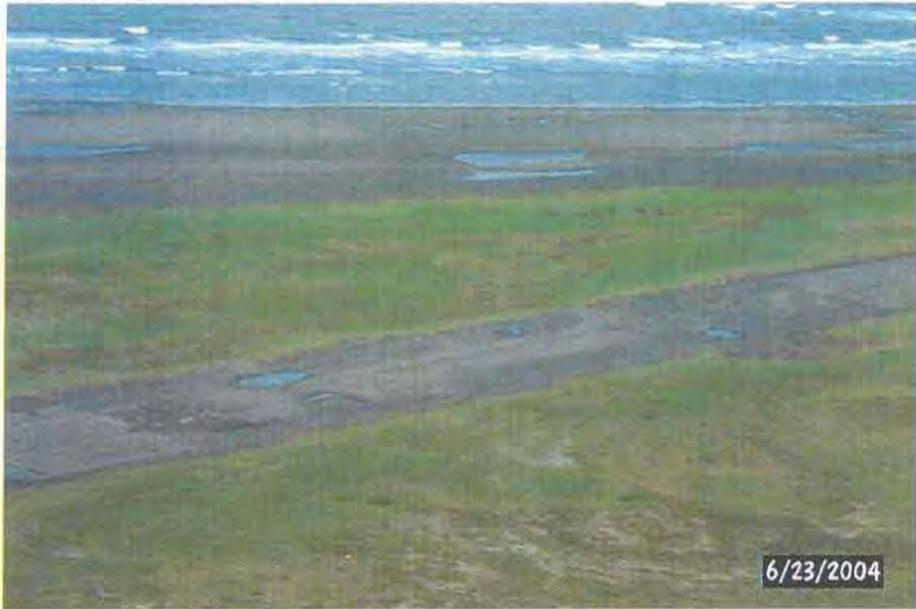
The existing airport facilities have a limited life expectancy due to beach erosion, inland flooding and other mitigating factors. Because of these immediate concerns, an interim project is required before a long-term solution can be implemented. It is recommended that an interim project include a surface treatment for approximately 570' of asphalt pavement missing from the center section of the runway (as shown right).

Approximately 560' of asphalt is currently missing from the center of the runway. The exposed subgrade has been degraded and a number of large potholes exist. Air carriers were questioned about the condition of the runway during the June 2004 field trip and most stated that the potholes were a source of concern. After consultation with the DOT/PF Central Region Materials Section, it was recommended that the subgrade be treated with an emulsion treated base course with a single high float application as a surface course. This repair will create a maintainable working surface and extend the life of the runway until a more permanent solution can be constructed.

Interim projects are required in order to keep the existing facilities operational until a future airport improvement project can be constructed. The center section of the existing runway is in emergency need of repair and the airport access road requires a stabilized base to provide a maintainable year round driving surface.

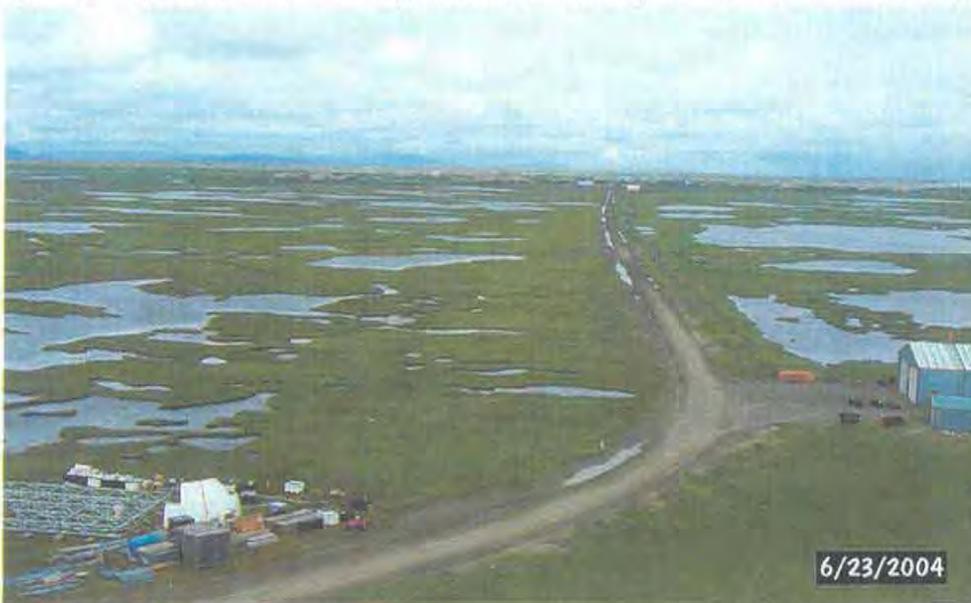
In addition to the runway surfacing, an interim project should also include a stabilized base for the airport access road (as shown below) to withstand recurring flood events. The

airport access road is presently in poor condition and is subject to recurring flood events. The road elevation is approximately 1.5' to 3.5' above mean sea level, while the airport is located on coastal dunes adjacent to the Bering Sea at a higher elevation of approximately

9'. According to locals, the area can be inundated with up to four feet of standing water. In addition to the flooding, the access road also experiences significant wear from

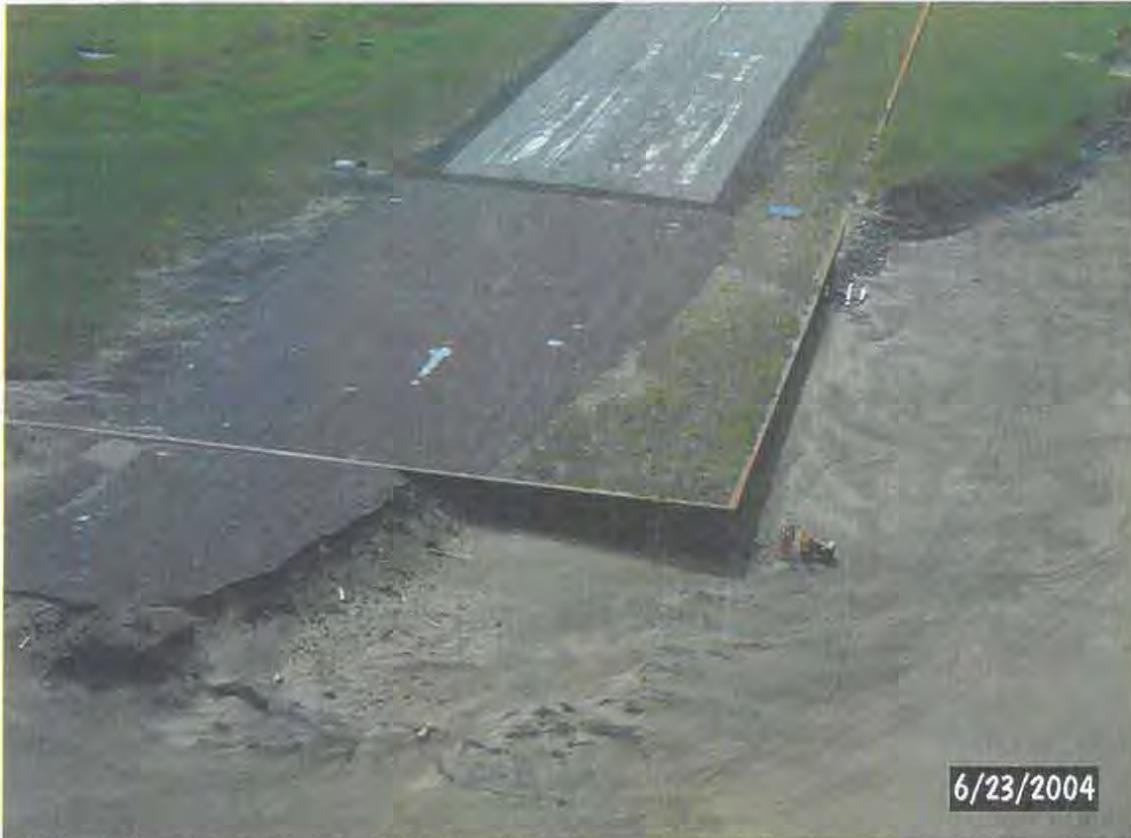
Runway erosion is not as much of an immediate concern as the runway surfacing or the stabilization of the access road, but it is a major factor when considering the remaining useful life of the existing facility. The picture shown below depicts the end of the existing

runway (13). Prior to 1996, the pavement was eroding at an accelerated rate so sheet piling was installed in an attempt to maintain the existing embankment. This photo also shows the ongoing undermining of the surface course located outside the piling. At the apparent erosion rate of 8-feet per year, it is estimated that the erosion will breach the ends of the sheet pile wall in another 7 to 10 years. This timeline limits the design life of the existing facilities and warrants a long-term solution. A cost estimate has been prepared for an interim project as described and is located in Appendix V.

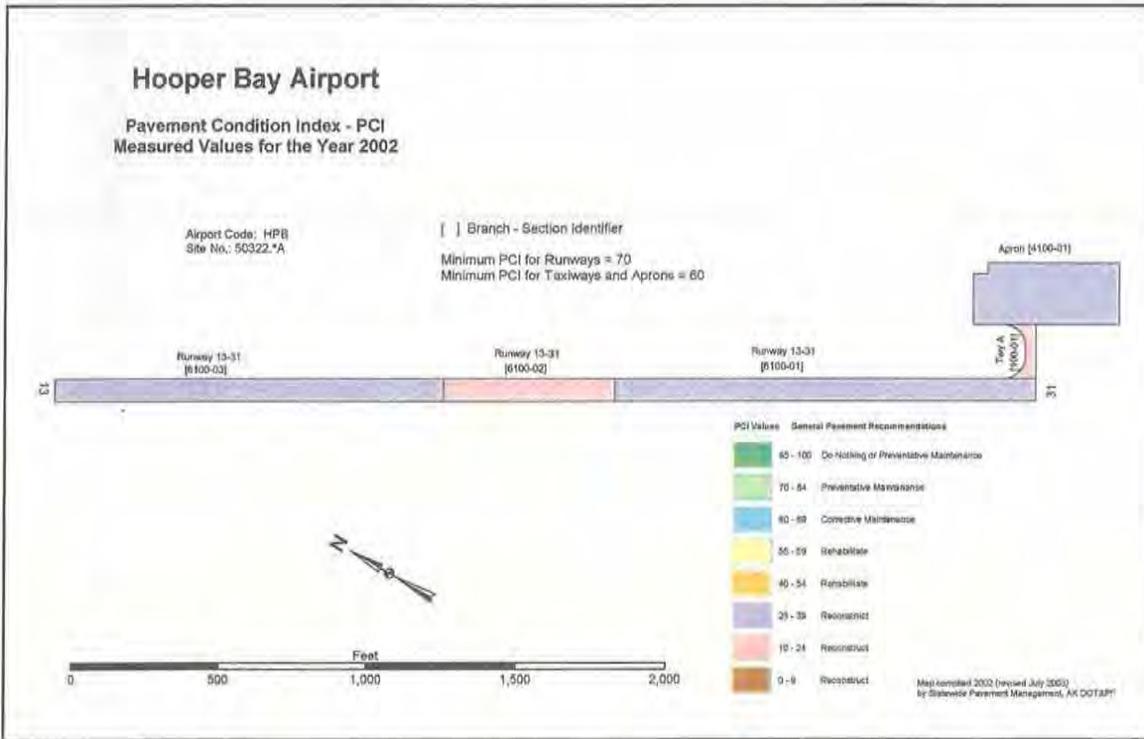
The runway, taxiway and apron were evaluated in 2002 using the Corps of Engineers Pavement Condition Index (PCI). The graphic shown on the next page summarizes the evaluation.

A perfect, new pavement has a PCI value of 100. Deductions are made for measured pavement distresses so that a completely failed pavement would have a PCI of 0. As indicated in the 2003 PCI report, the average weighted runway PCI for Hooper Bay was 31, while the taxiway and apron scored a 28. As previously shown, all existing pavement falls under the “reconstruct” category.

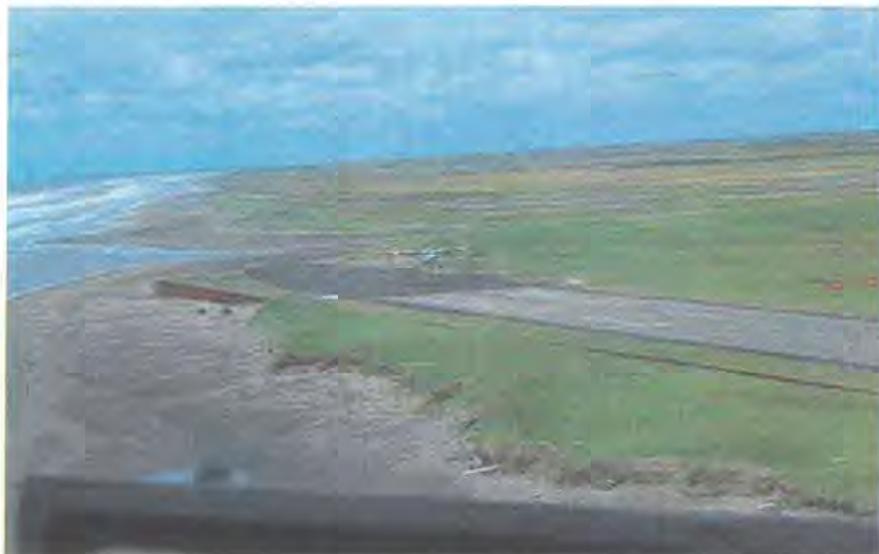
In 1996, the department installed 1000 feet of sheet pile along the north end of the runway (as shown right). Originally designed as a "last defense" to erosion, modifications to the original sheet pile plan moved the wall into a more active wave environment. Because of the design change, the ArmorFlex anchor system was cut after the installation of the

sheet pile and the blocks were left in place to provide scour protection at the toe of the wall. At the time it was thought that these erosion measures would extend the life of the runway as much as 20 years. However, erosion rates at that time were approximated at 3 feet per year. With current approximations at 8 feet per year, it may be necessary to relocate the runway in the near term.

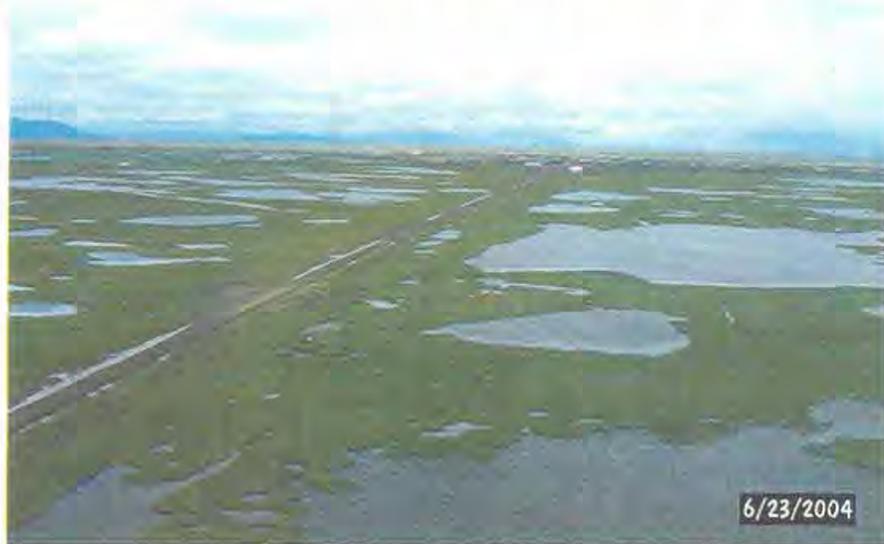
Another immediate concern is the airport access road. The existing road is in use, but is in major need of repair. As shown below, flooding and storm surge events have eroded nearly all of the useable

material from the road, which currently exists as a footprint, with sections falling below the surrounding terrain. Because of these high water events, the interim design prohibits the possibility of building up the road without major erosion protection. For an interim project, this would prove quite costly to construct and difficult to maintain. Because of these concerns it is

recommended that the interim project place 1.5' of medium sized aggregate (3" – 8") to provide a shallow solid base that will be resistant to flooding erosion. The low profile will still allow high water events to pass over the road, but will remain in place after the event.

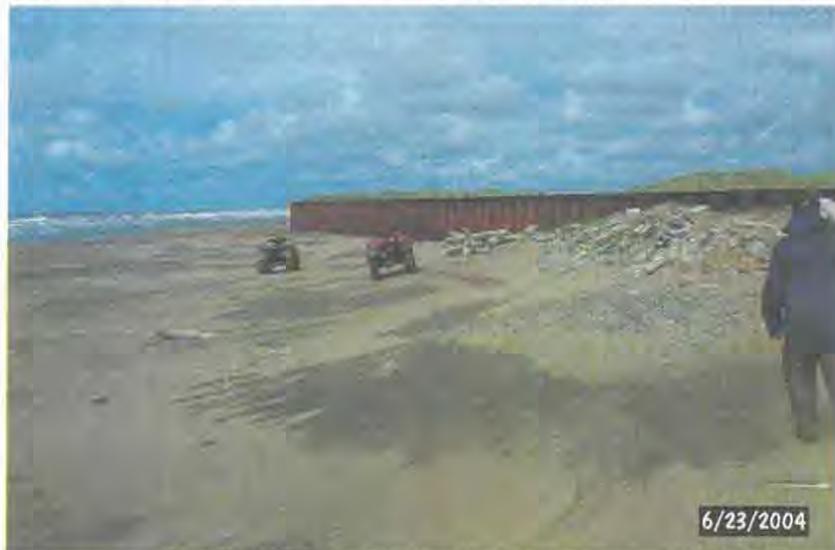
Beach erosion is another drawback to reconstructing the existing facilities. The existing runway embankment is currently held in place at its north end by sheet pile. The sheet pile wall was constructed to protect the embankment from erosion caused by tidal influence and storm surge events. The Department's Coastal Engineering Section was consulted and with the apparent erosion rate of 8-feet per year, erosion will have breached the ends of the sheet pile wall in another 7 to 10 years. The picture to the right depicts the sheet pile wall and some of the concrete matting installed during a 1996 project to prevent or slow down the rate of erosion.

If erosion slows to the rate of 3 feet per year (historical rate observed from 1951 to 1994), the design life could possibly be extended to 30 years. Using either rate, erosion will prohibit a 50-year design life if the existing airport is reconstructed.

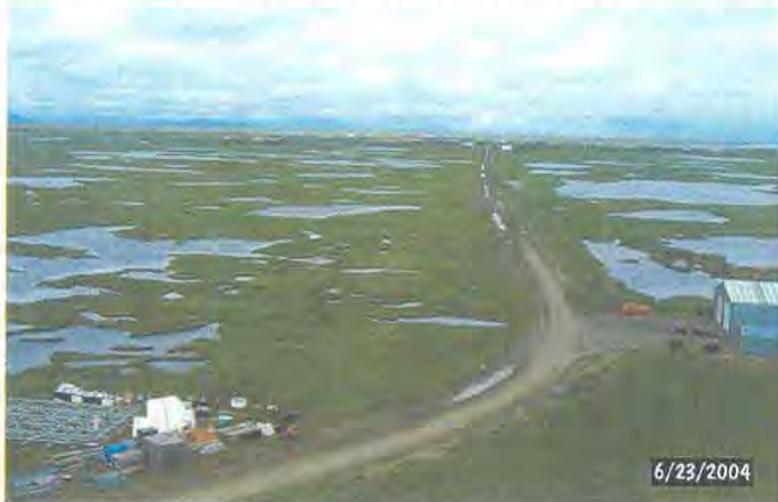
An obvious debris line composed of logs and abandoned vessels is visible at the toe of the numerous small hills north of Hooper Bay. This indicates the extent of flooding from storm surge events. During a field trip conducted on June 23, 2004, locals commented that the existing airport access road (as shown right) is subject to flooding from these events, which inundate the area with up to four feet of standing water. It was also learned that flooding occurs at least every two years to the extent that the road is impassible from the edge of the city to the airport. However, there is no evidence indicating that the village or airport has ever flooded. (Note: the elevation of Hooper Bay City is 35' on a USGS quad map, datum WGS84/NAD83.)

The existing airport access road presently remains as a footprint of previous construction attempts, with standing water on both sides. It is currently at or below the adjacent terrain, which is flat, wet and soft. The previous road embankment was constructed higher but was eroded by waves and scouring stemming from storm surge events. These events caused the road to fail in one season after employing traditional construction methods, with the absence of an active drainage system.

As previously mentioned, it is recommended that an interim project be constructed until a more permanent solution can be implemented. Under an interim project, a relatively inexpensive design for the access road would include 1.5' of rock of various gradations up to 8". This would allow water to flow freely through the embankment in addition to allowing overtopping during storm events. Allowing overtopping for an interim project would reduce the cost of a temporary fix. Another benefit is that the road surface would remain intact and firm after flood events have subsided. Material may need to be bladed to the center periodically since the material will tend to move outward under traffic loading.

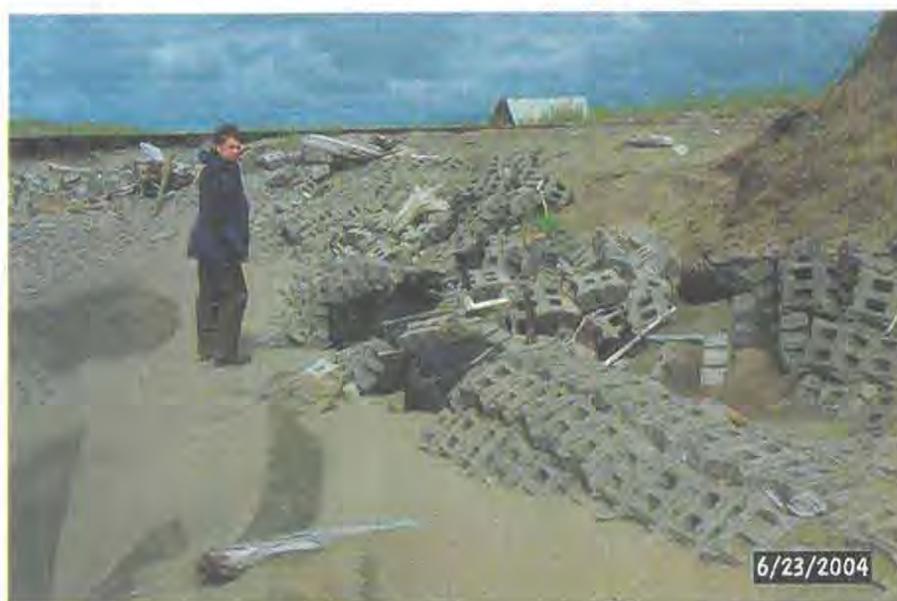
In addition to storm surge events and its related flooding, the existing airport is subject to beach erosion as shown right. The airport is located on coastal dunes adjacent to the Bering Sea, which has fetches hundreds of miles in length. Waves on the Bering Sea shelf exceed 30-feet. As the waves near the coast, they shoal and break

on the offshore bars. Generally, by the time they reach the beach, the waves are parallel to the shoreline and offshore bars. These waves impact the beach causing sedimentary transport. Although the sedimentary transport is bi-directional, the dominant direction is to the south. This means that the northern end of the runway will be subject to continued erosion. Presently, the northern end of the runway acts somewhat like a groin. The natural tendency of the beach would be to smooth the north end of the runway to conform to a more natural beach line.

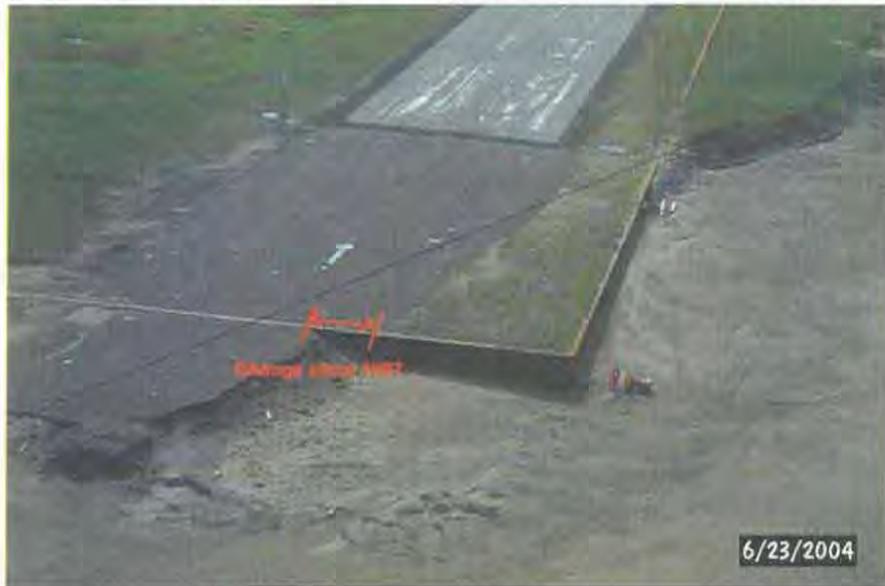
However, looking at a more recent 1997 photograph (shown right) and comparing it with a print from 1968, the beach has receded over 200-feet or about 8 feet per year. Changes in the rate of erosion can be due a number of issues such as the reduced sea ice, influence of the sheet pile wall acting as a groin, additional beach mining, larger storms, melting permafrost, global warming and sea level rise.

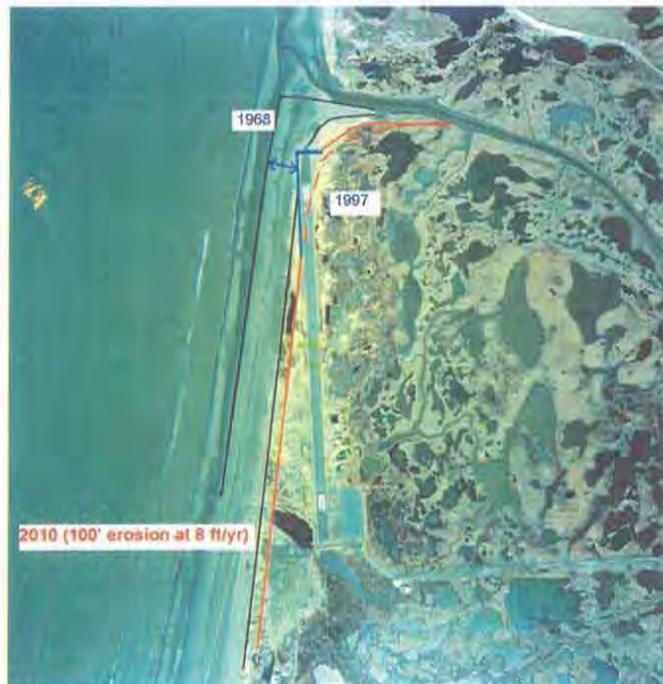
At the apparent erosion rate of 8-feet per year, erosion will have breached the ends of the sheet pile wall in another 7 to 10 years. This is depicted in the graphic shown right. The red line depicts what the beach line would be at the erosion rate of 8 feet/year. If erosion slows to the previous rate of 3 feet per year, we are looking at about 30 years. Either way, this does not provide a 50-year life.

In the event that the airport is reconstructed at its present location, erosion would affect the northwest corner of the safety area within 10 years (if the sheet pile were not in place). To

provide a 50-year design life at its present location, a 400-foot buffer measured perpendicular to the beach and between the edge of the vegetated berm and the northwest corner of the proposed reconstructed runway section would be needed, assuming 8 feet of erosion per year. This would place the northwest corner of the safety area about 2,400 feet south of the sheet pile corner along the current alignment.

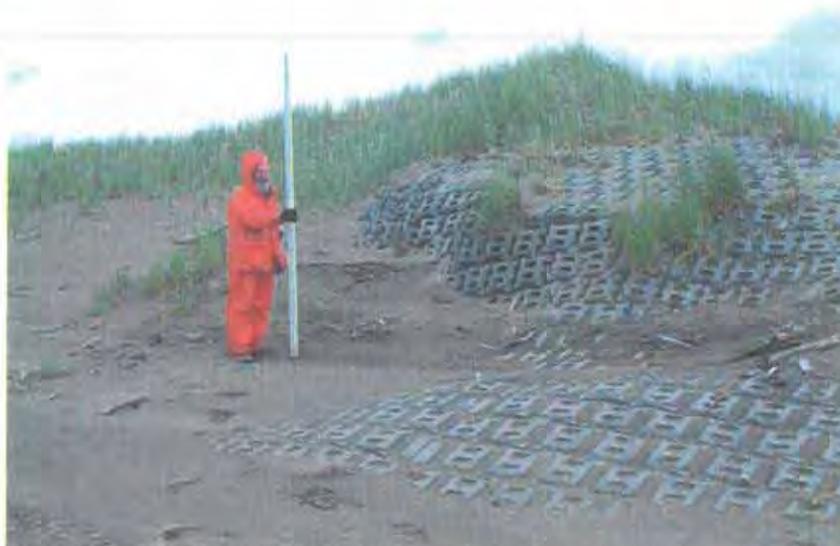
As mentioned in the Airport Project History section, an ArmorFlex concrete block system was constructed in 1981 to protect the bank from erosion. The ArmorFlex placed at Station 22+00 (as shown right) is stable and remains in good condition on a 3 to 1 slope. There is wild beach rye growing around the concrete armor units, which helps promote stability. However, areas with steep, non-vegetated bluffs between sections with ArmorFlex are actively eroding.

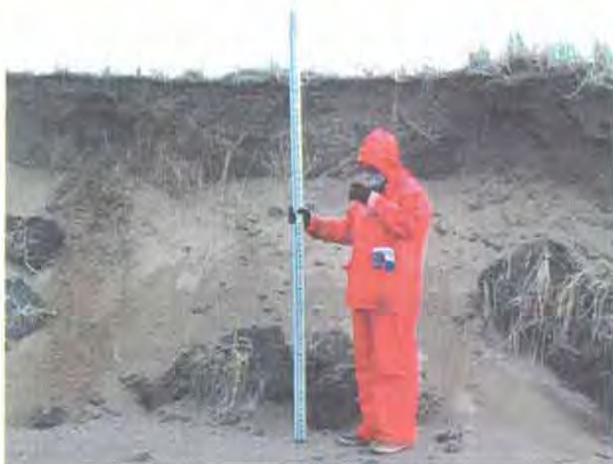
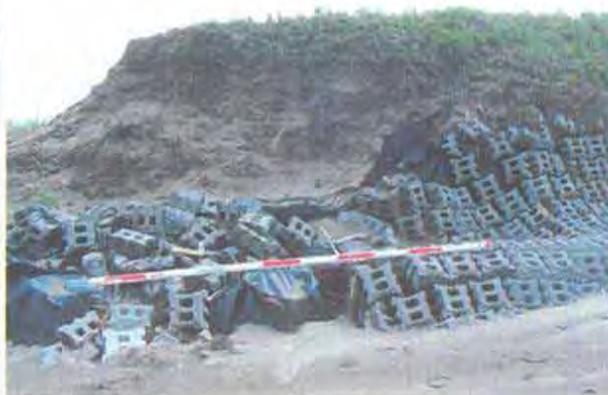
As you approach the north end of the runway, the beach slopes are less stable and erosion is evident (depicted below). The ArmorFlex mat on the north end of the runway is in a failed condition, but is still effective in stabilizing the shoreline. Barrels from the earlier project are visible under the debris as shown in the picture below.

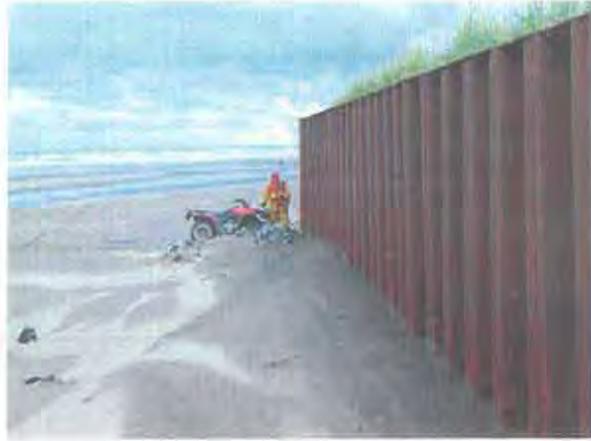
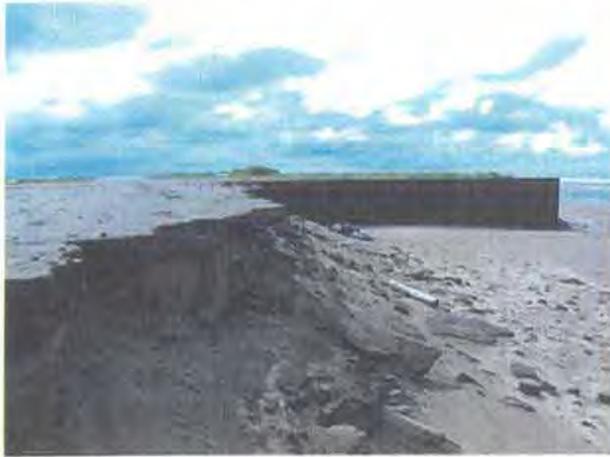
The sheet pile wall (shown right) at the north end of the runway is in relatively good condition, with little rust present. The east-west portion of the wall appears to adequately protect the runway from the stream located just beyond the north end. However, active erosion from the Bering Sea is occurring on the beach side of the wall. Fifty percent of the wall height (about 10 feet) is visible on the north end of the runway. There is some evidence of toe scour, but no evidence of overtopping.

The remaining pavement, which extends beyond the sheet pile onto the beach, is overhanging (as shown left). The more densely packed sand beneath this asphalt is eroding more slowly than the surrounding bluff.

If the existing airport is reconstructed, it is recommended that either: (a) add slope stabilization to protect the sheet pile wall, or (b) ensure the sheet pile wall will be stable during the design scour event without slope stabilization.

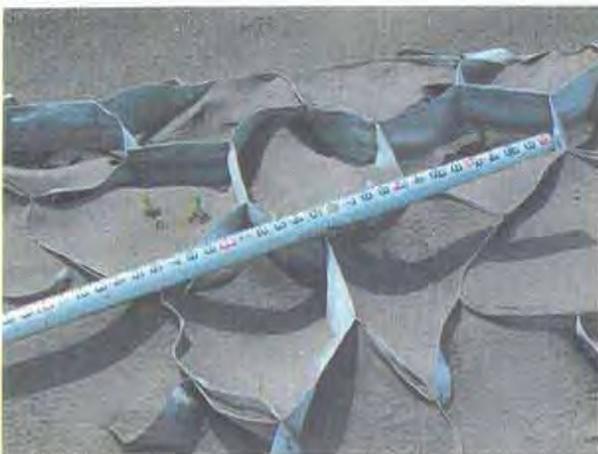
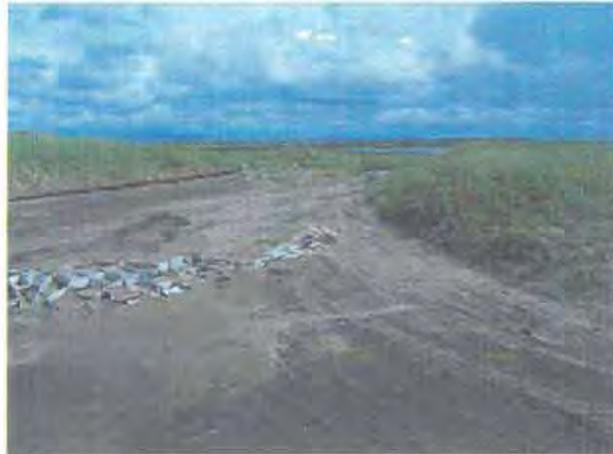
Seeding has proved to be an effective method of controlling erosion on flat ground. Most areas replanted with wild beach rye in 1996 are doing well. A geotextile grid was used to help stabilize the sand while the rye took hold (as shown below). The only unvegetated area is on the northeast end of the runway where four wheelers access the runway. In the photo below, it can be seen how the grasses have provided a solid vegetative cover in undisturbed areas.

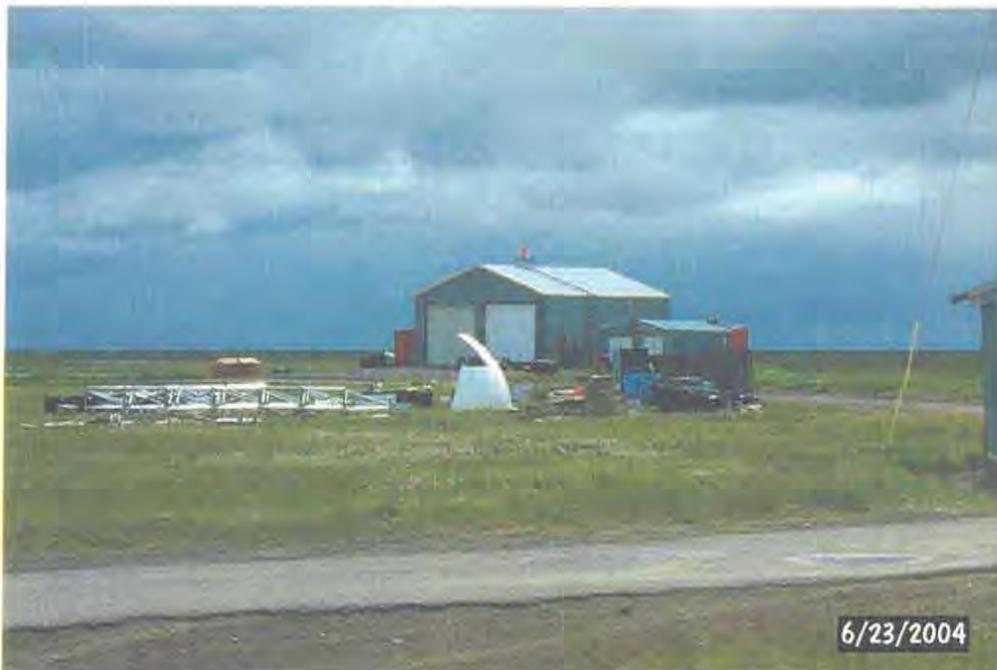
Hooper Bay currently has a 40' x 60' two-bay unheated snow removal equipment building, which is shown in the picture below. The building was built in 1964 and is currently included in the AIP spending plan for replacement. The plan includes a new heated 3-bay building with metal floor, which shall be located on the proposed apron.
