## Cantwell to Healy – Parks Highway Milepost 203-259 Planning & Environmental Linkages Study

Project No. NFHWY00492

## **Needs and Opportunities Assessment Report**

> > > > October 2020

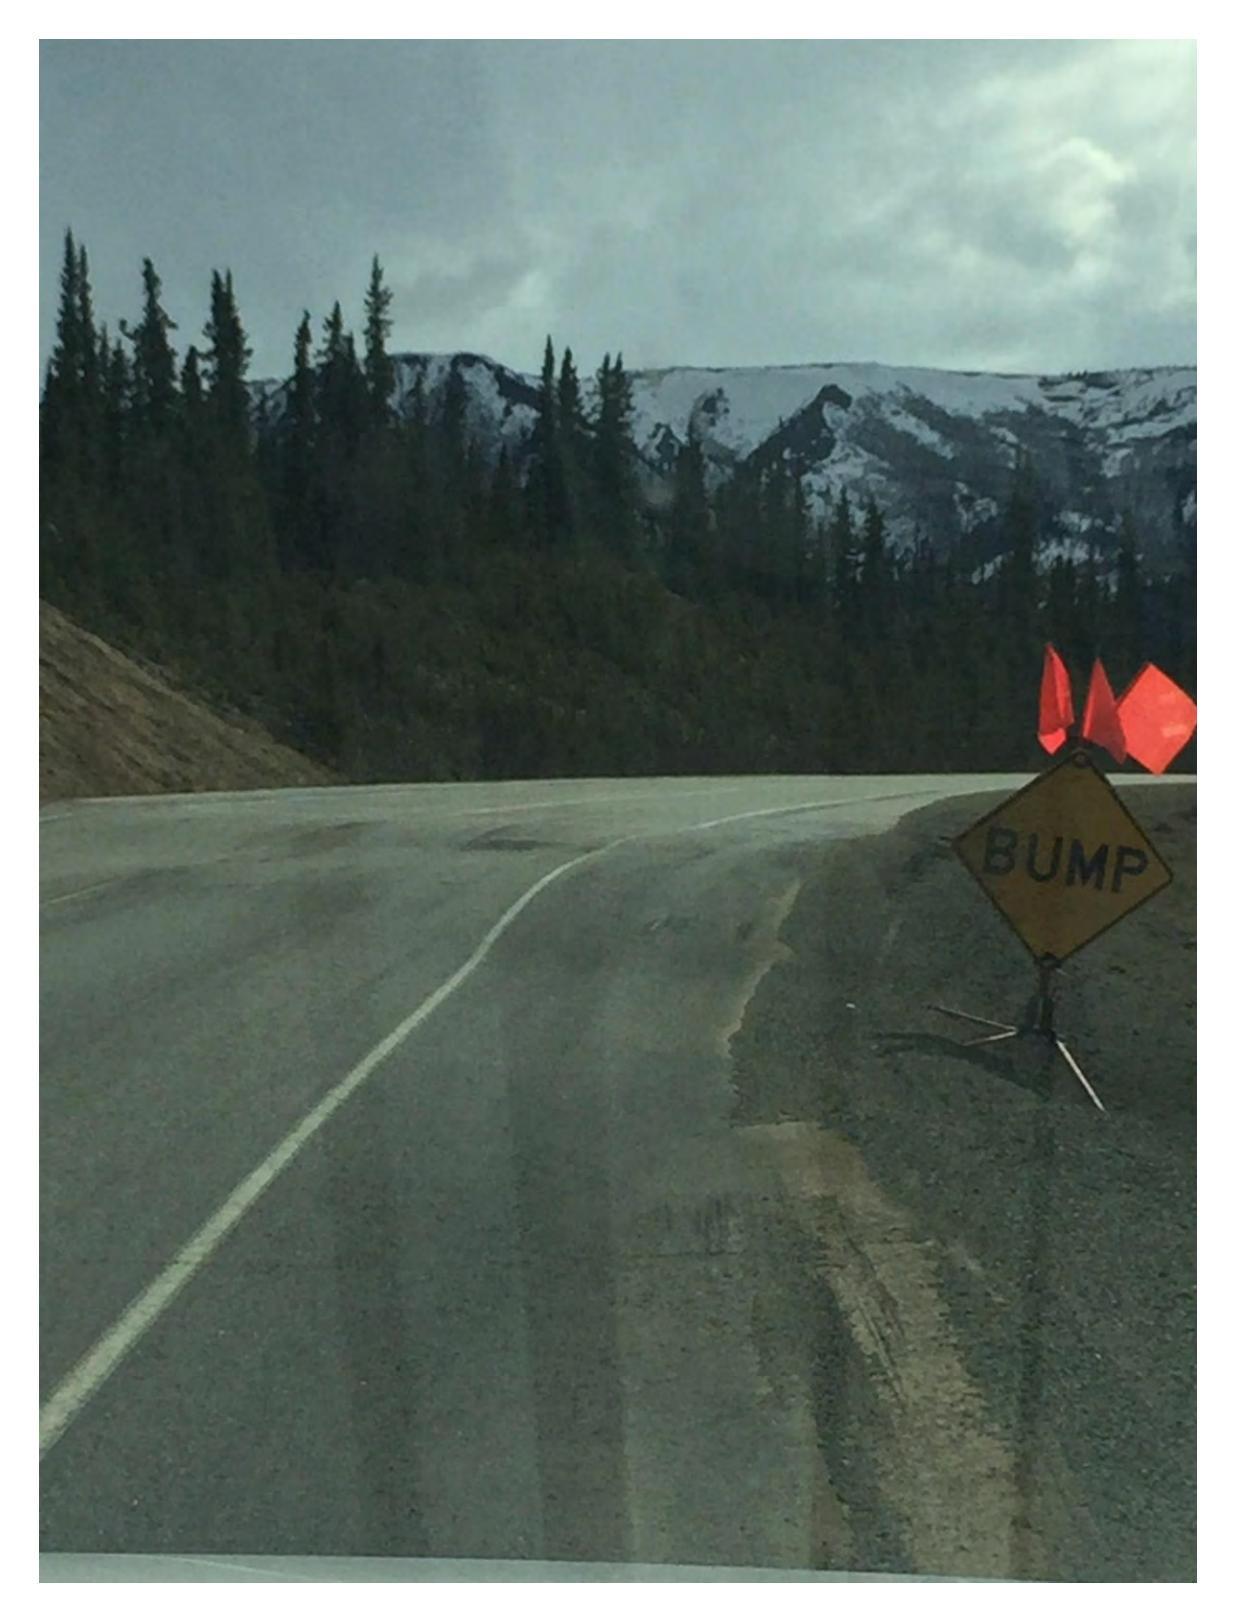
Figure 6 – Annually reoccurring bumps around MP 232.5, likely caused by an ice lens

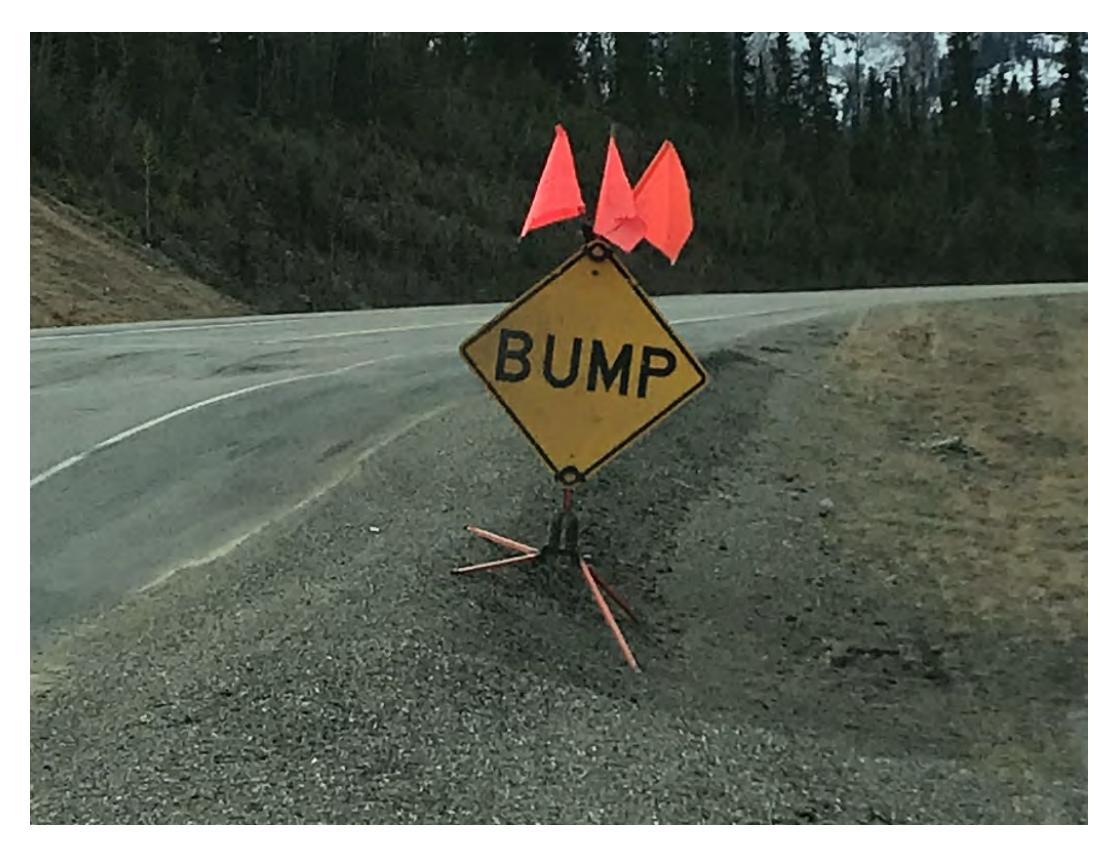
Figure 7 - Additional photo of bumpy section near MP 232.5

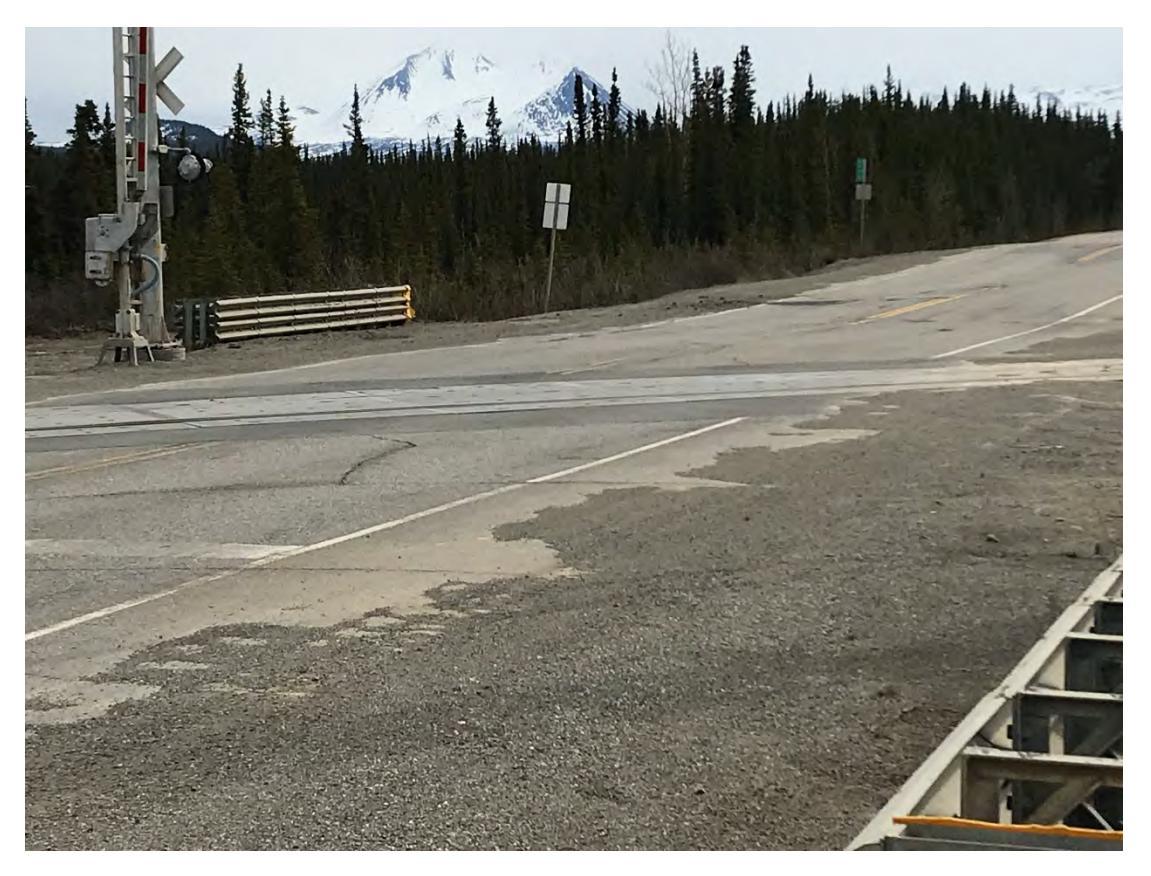
Figure 11 - Additional photo of roadway damage at railroad crossing

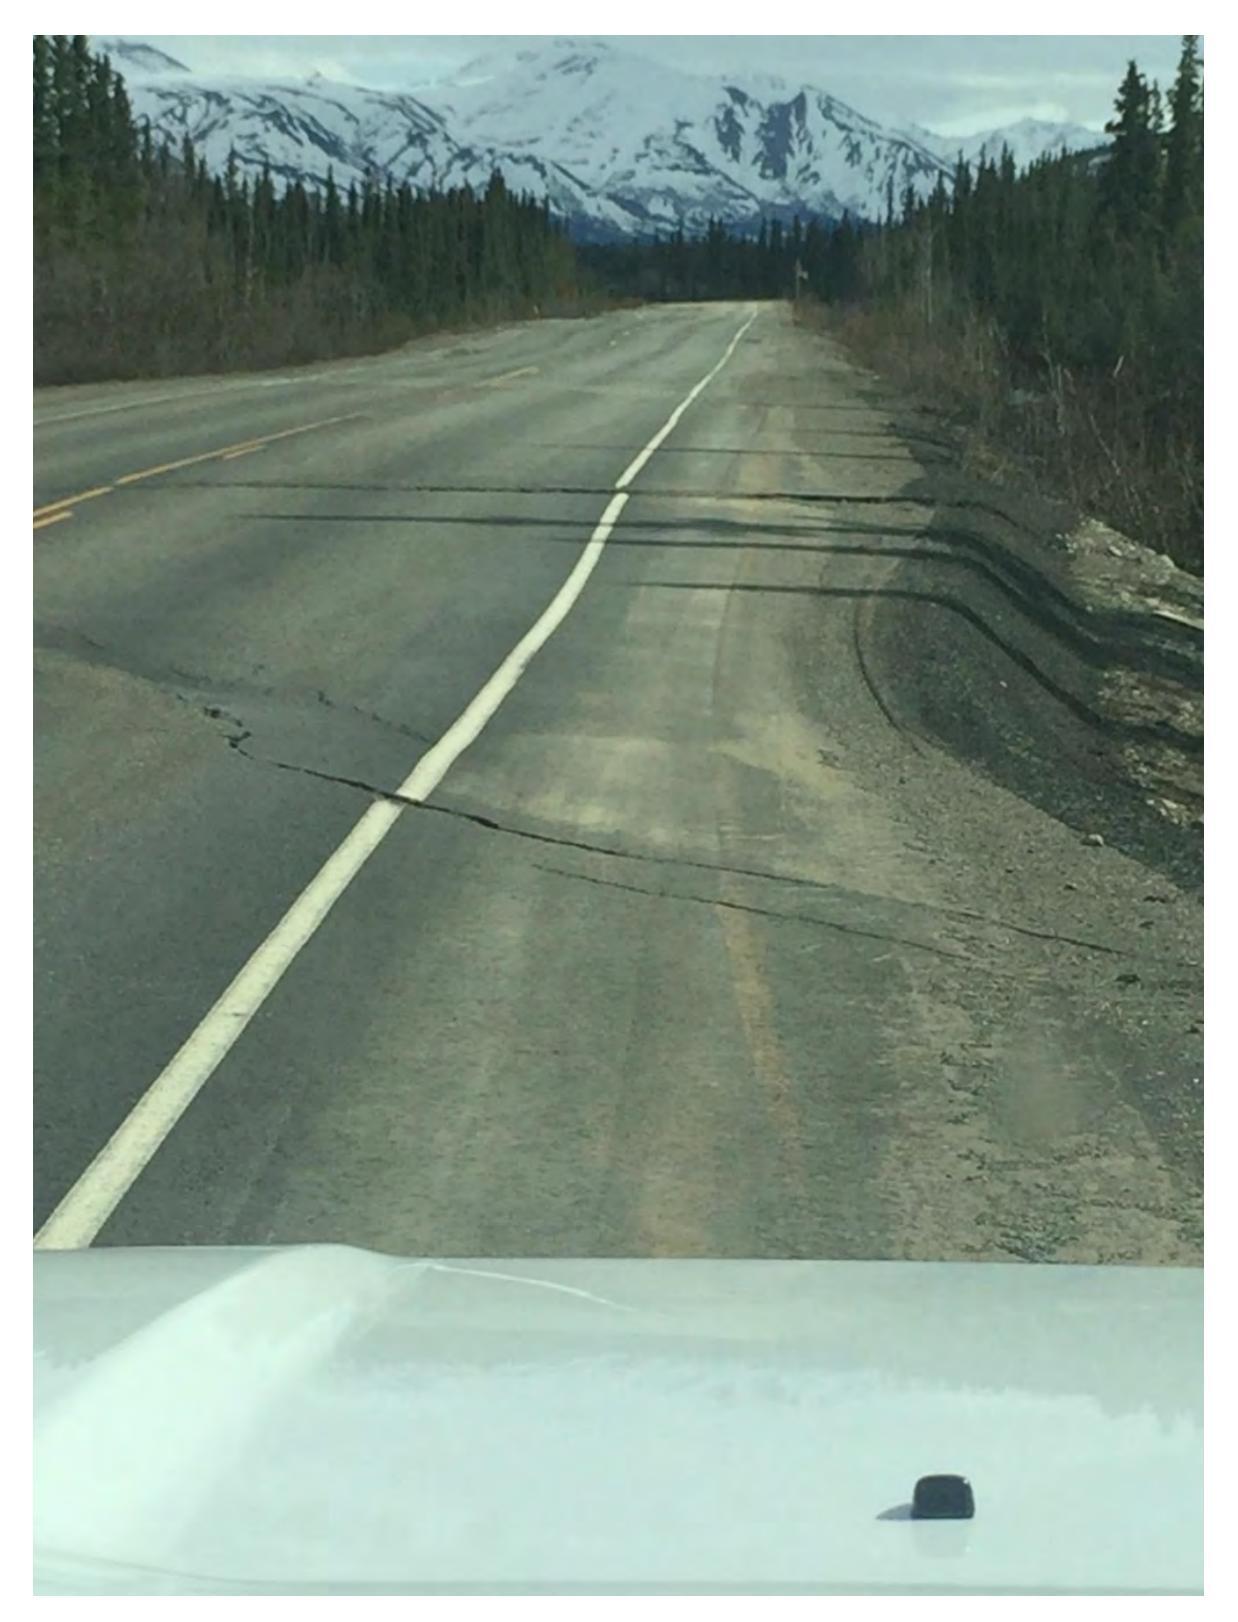
Figure 12 – Drainage issues and damaged pavement around MP 235.5

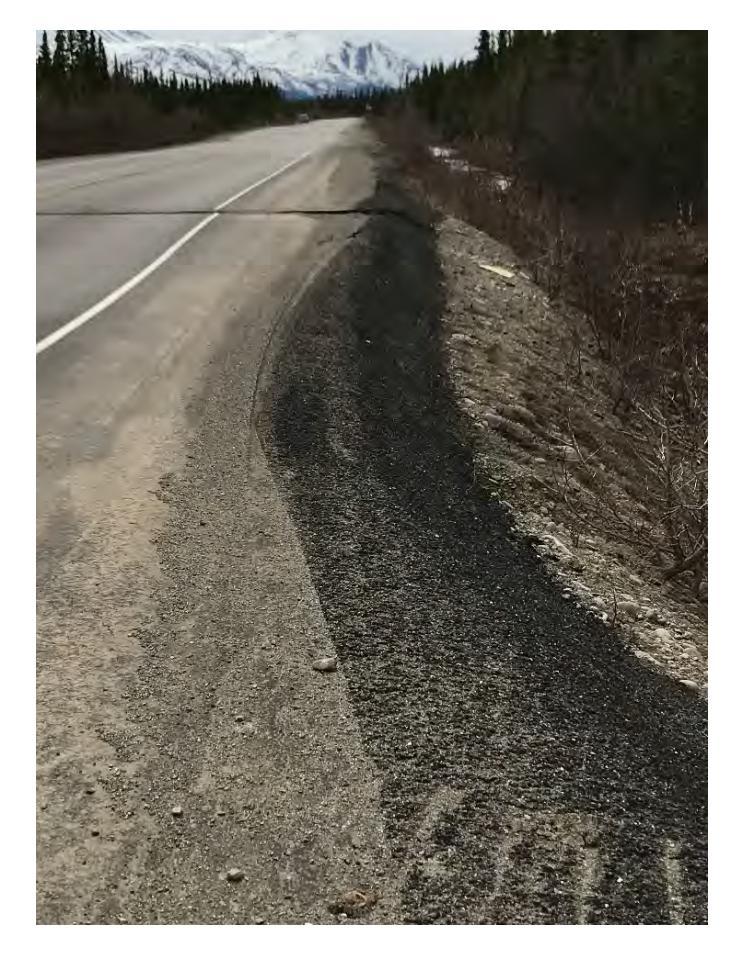
Figure 13 – Section of highway that requires annual repairs around MP 235.5

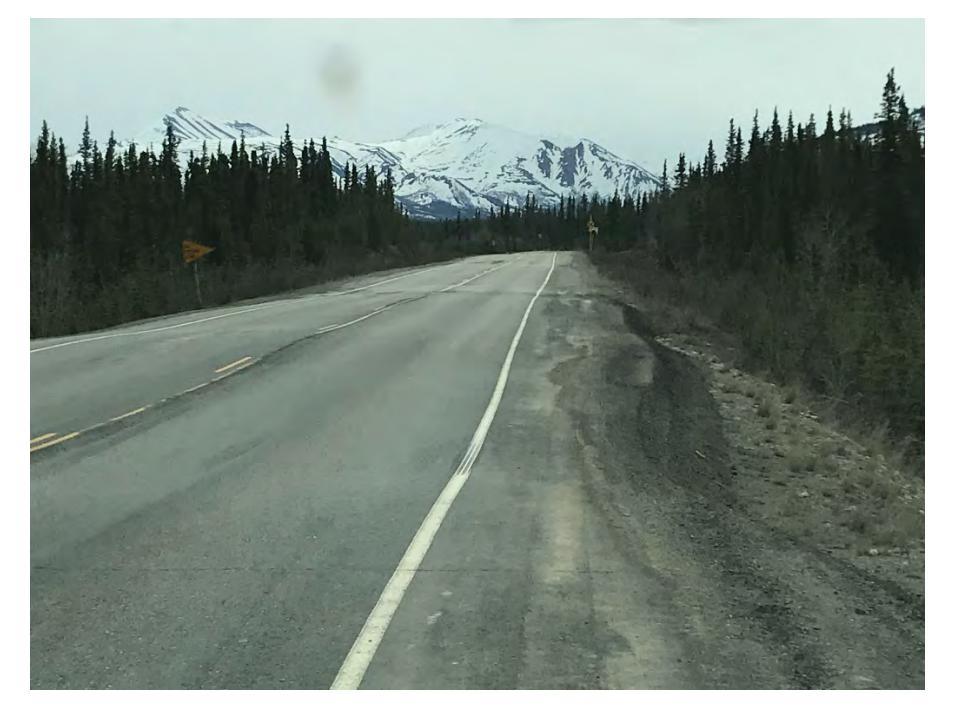
Figure 14 – Additional photo of section requiring annual maintenance due to drainage issues

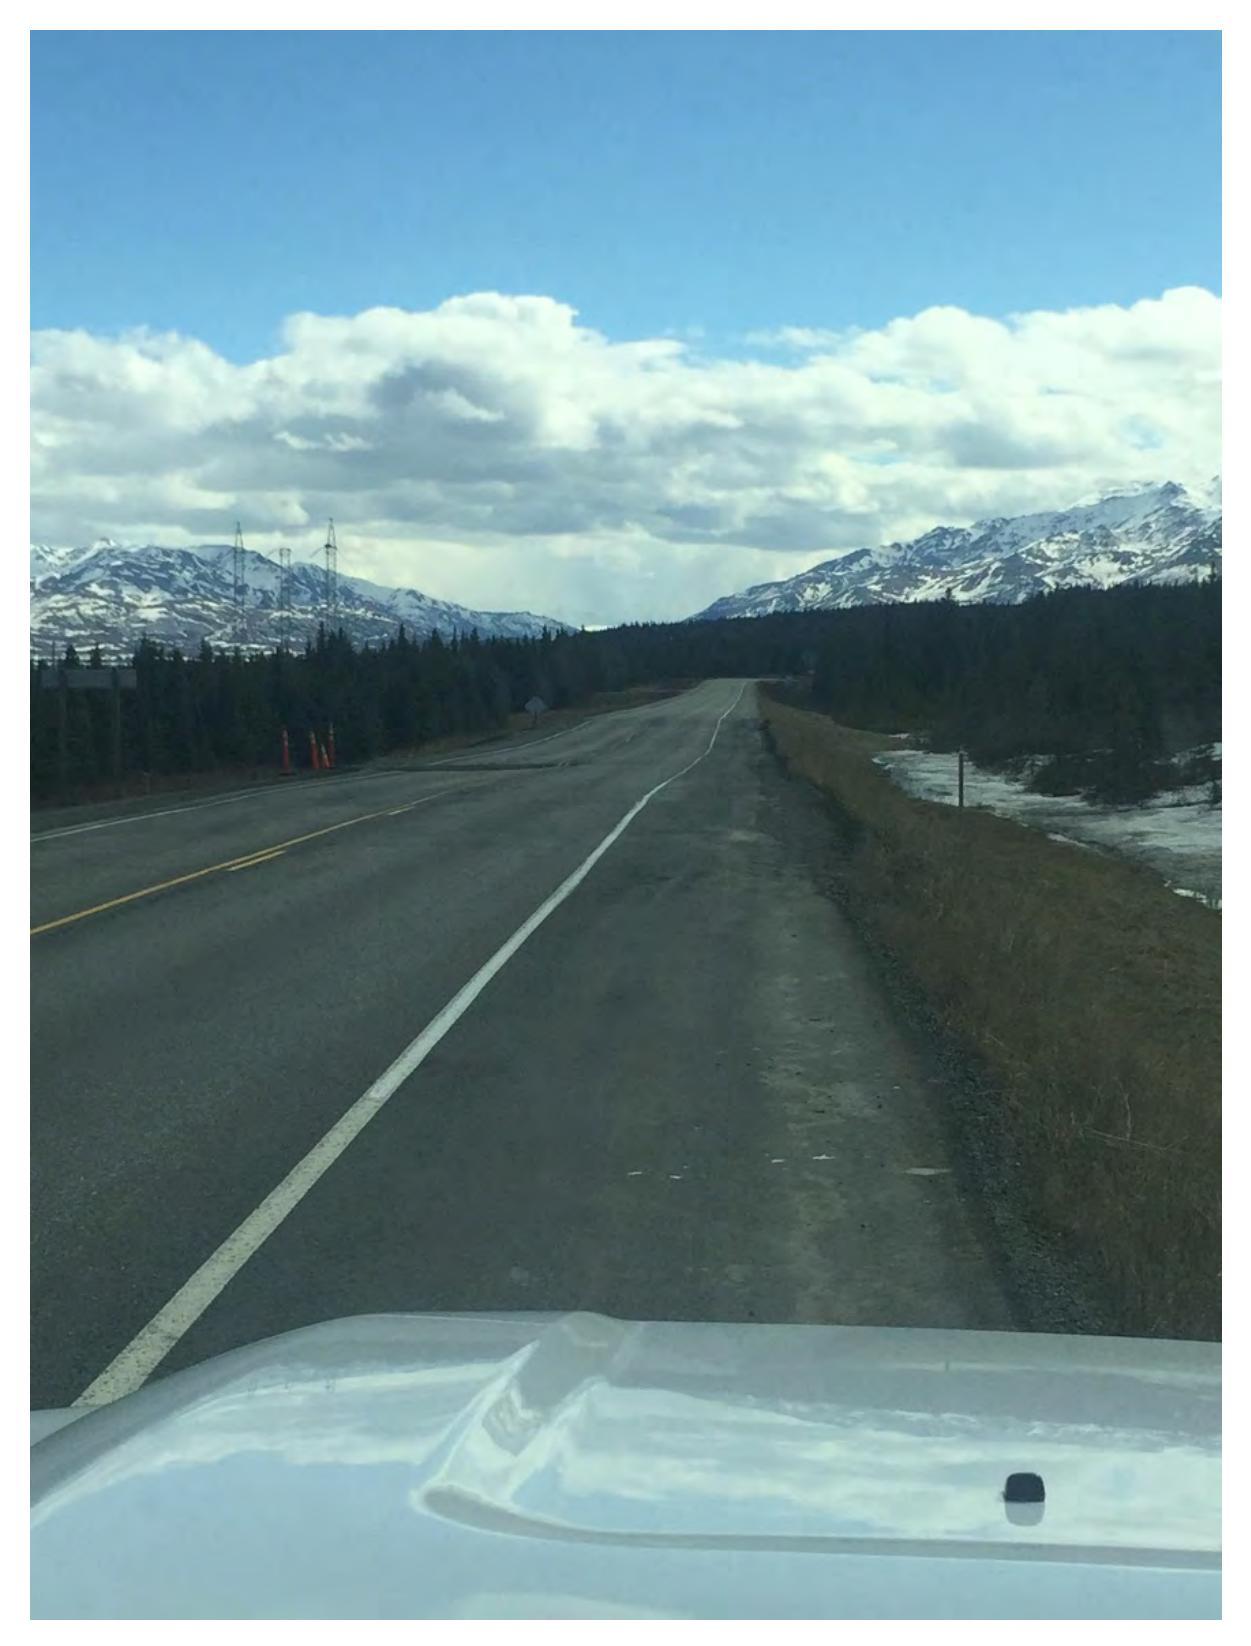
Figure 20 – Damage to road caused by drainage issues north of MP 253

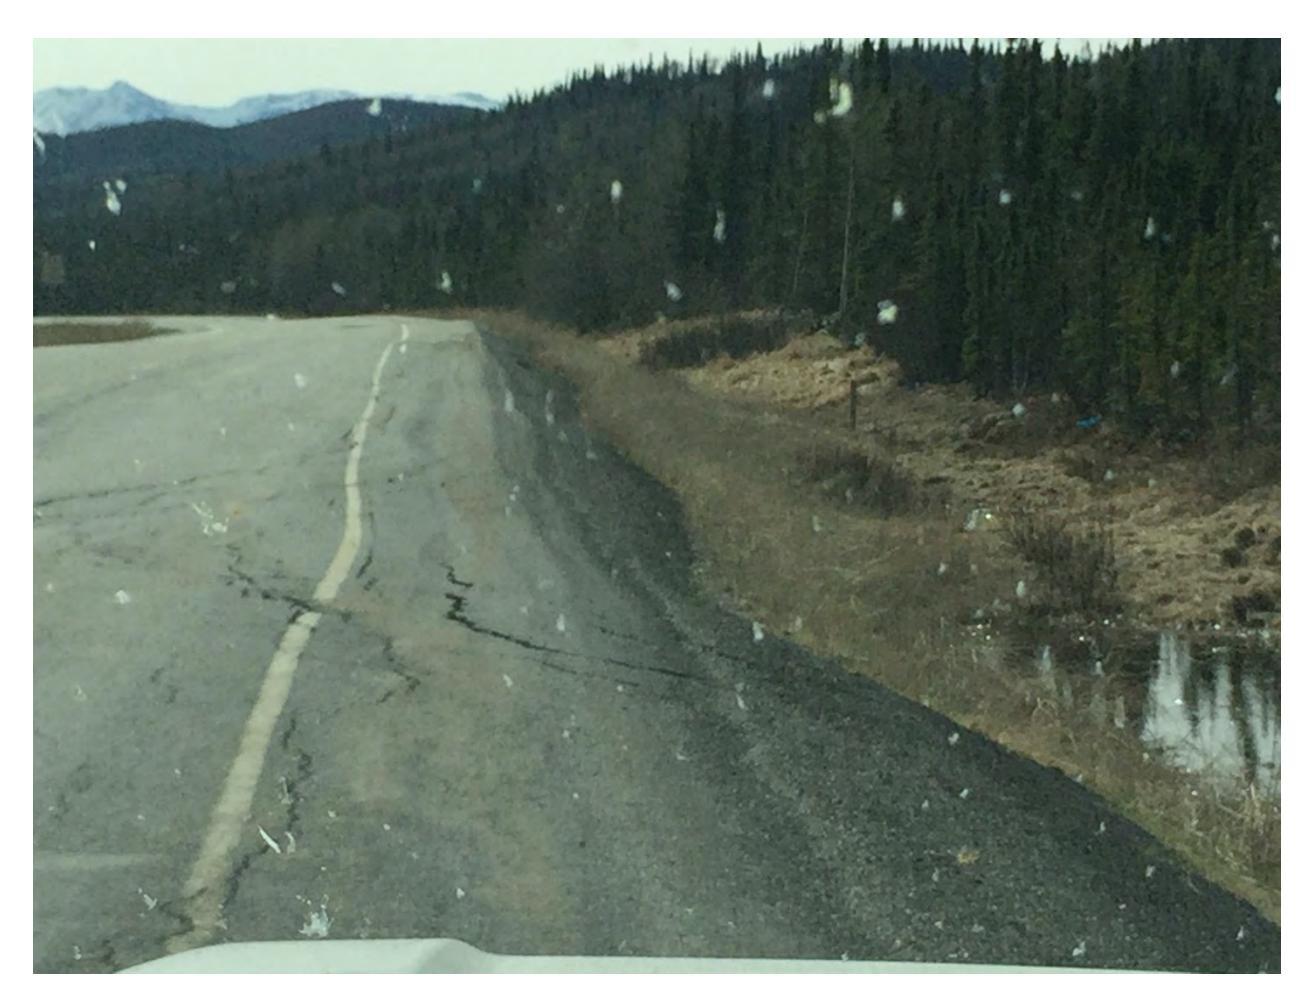
Figure 21 - Road shoulder failing due to drainage issues around MP 256.5

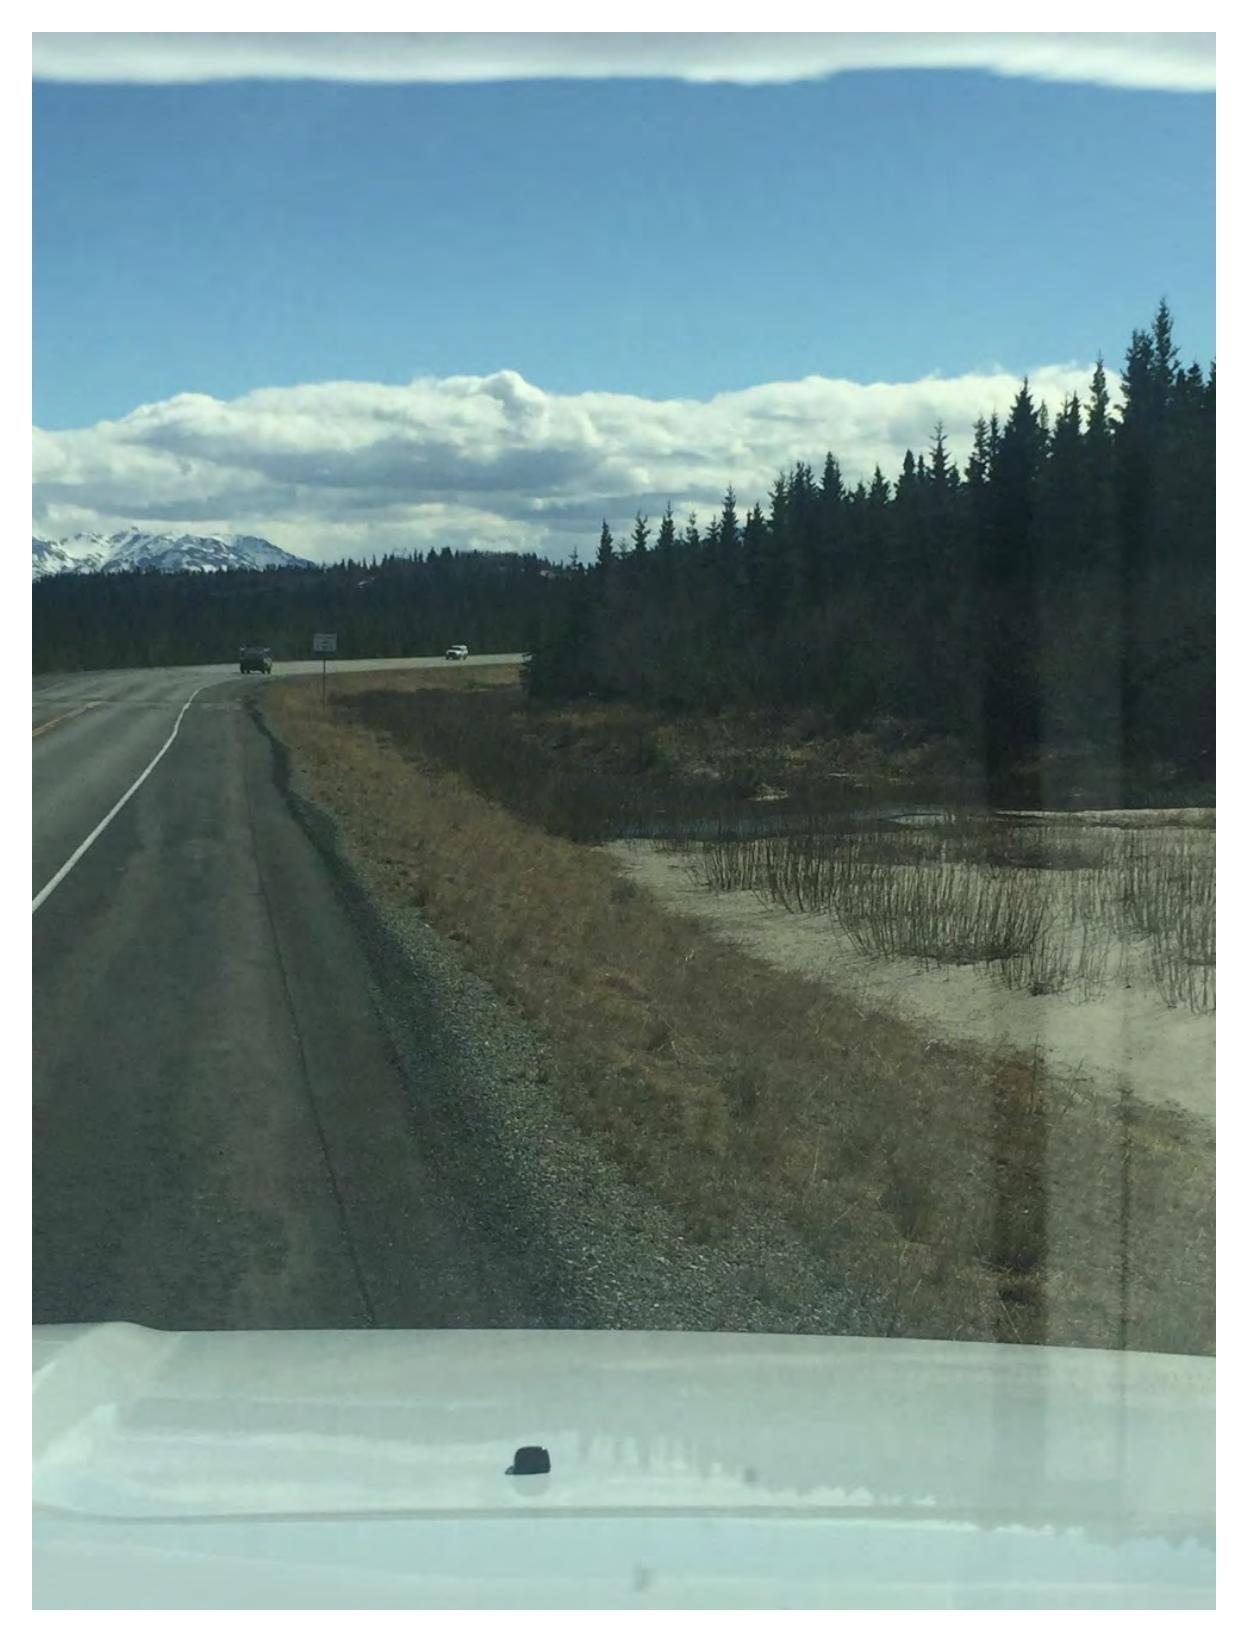
Figure 22 – Drainage issues effecting the road base near MP 258.5

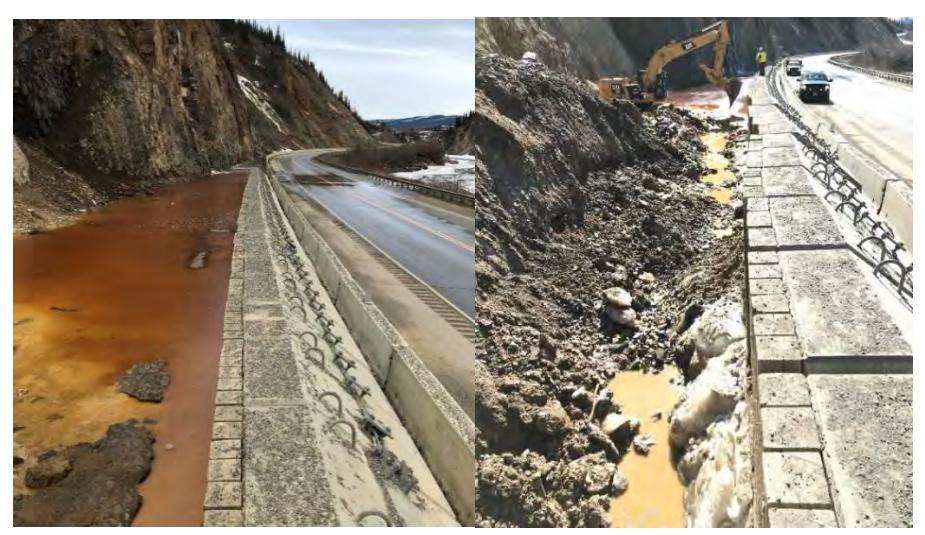
Figure 48. Drainage issues from slide debris behind concrete barriers Source: DOT&PF 2020

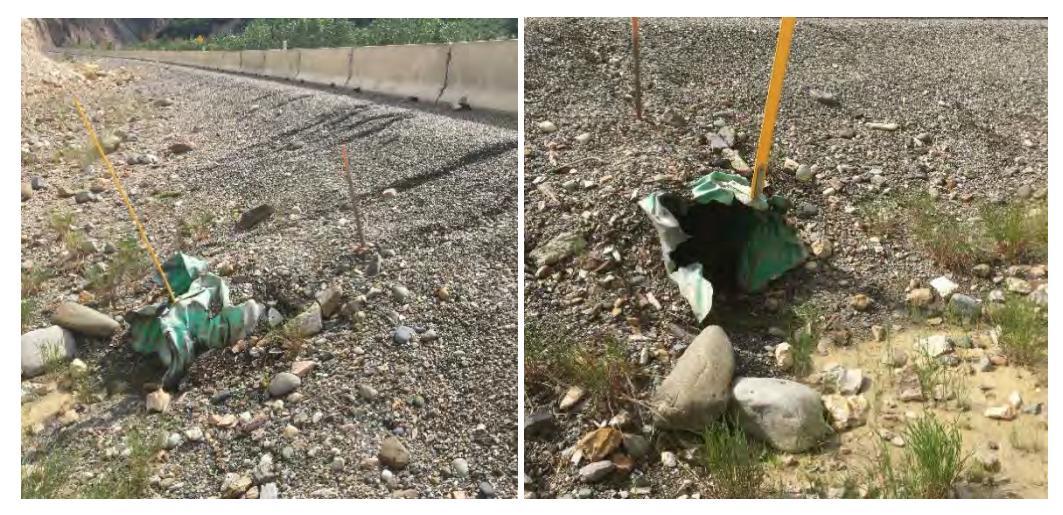
Figure 49. Damaged Culvert End Condition near MP 239.5 on the East Side

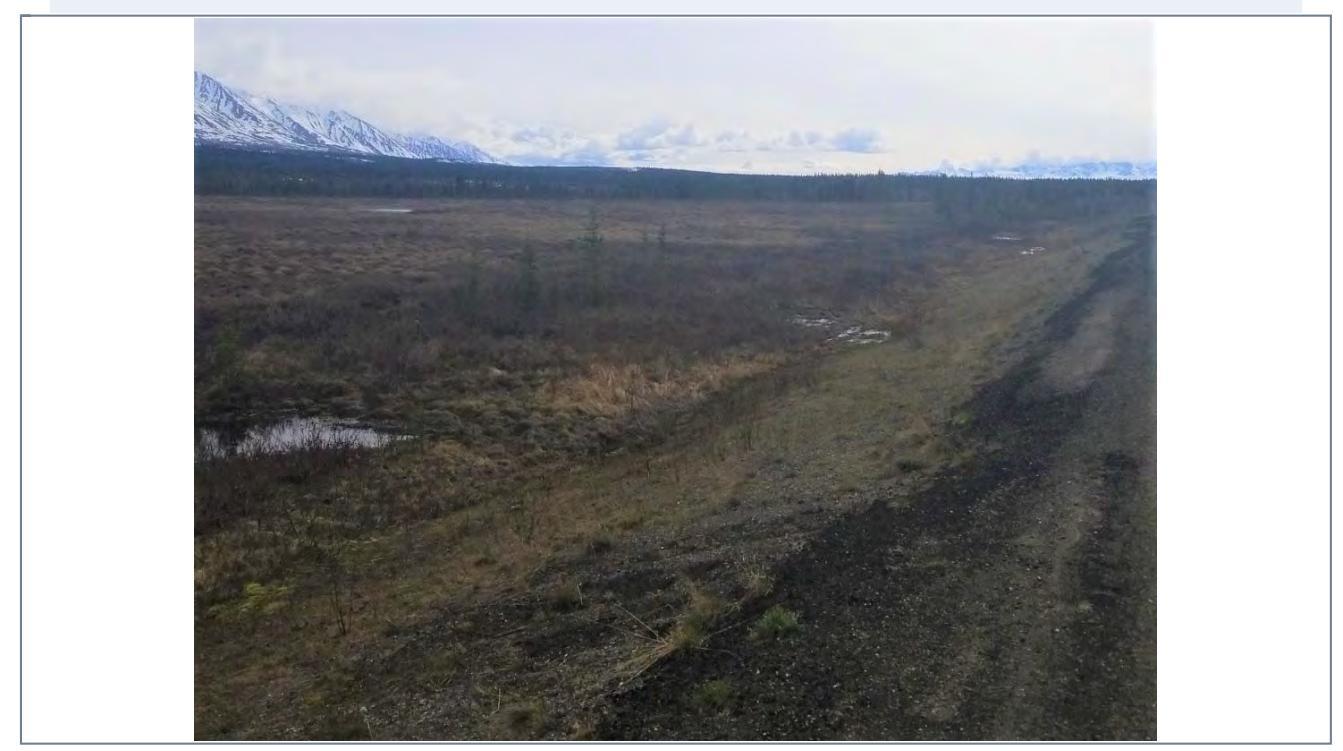
#### Photo 2: MP 208.2 to 209.3 Thaw ponds at toe of embankment slope. Thickened asphalt due to repeated patching.

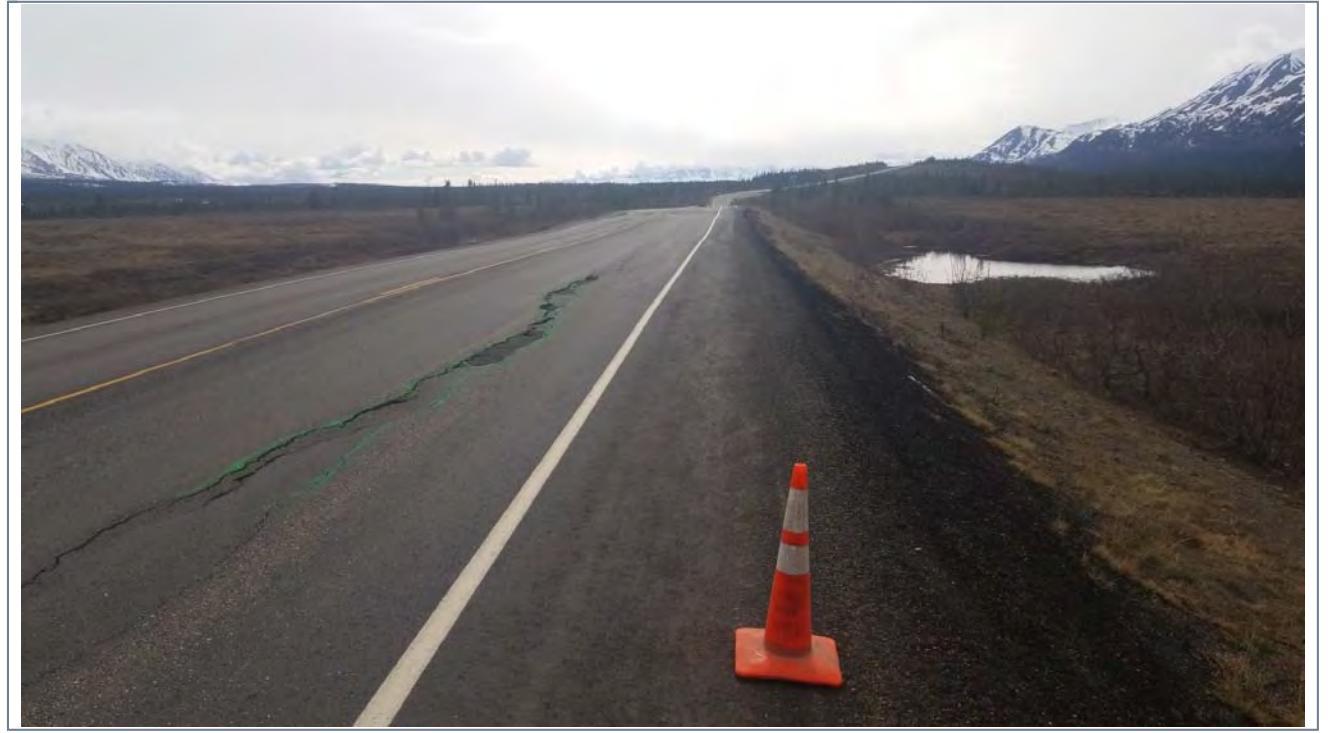
Photo 3: MP 208.2 to 209.3 Longitudinal crack down roadway due to embankment shoulder rotation. Thaw pond at toe of embankment.

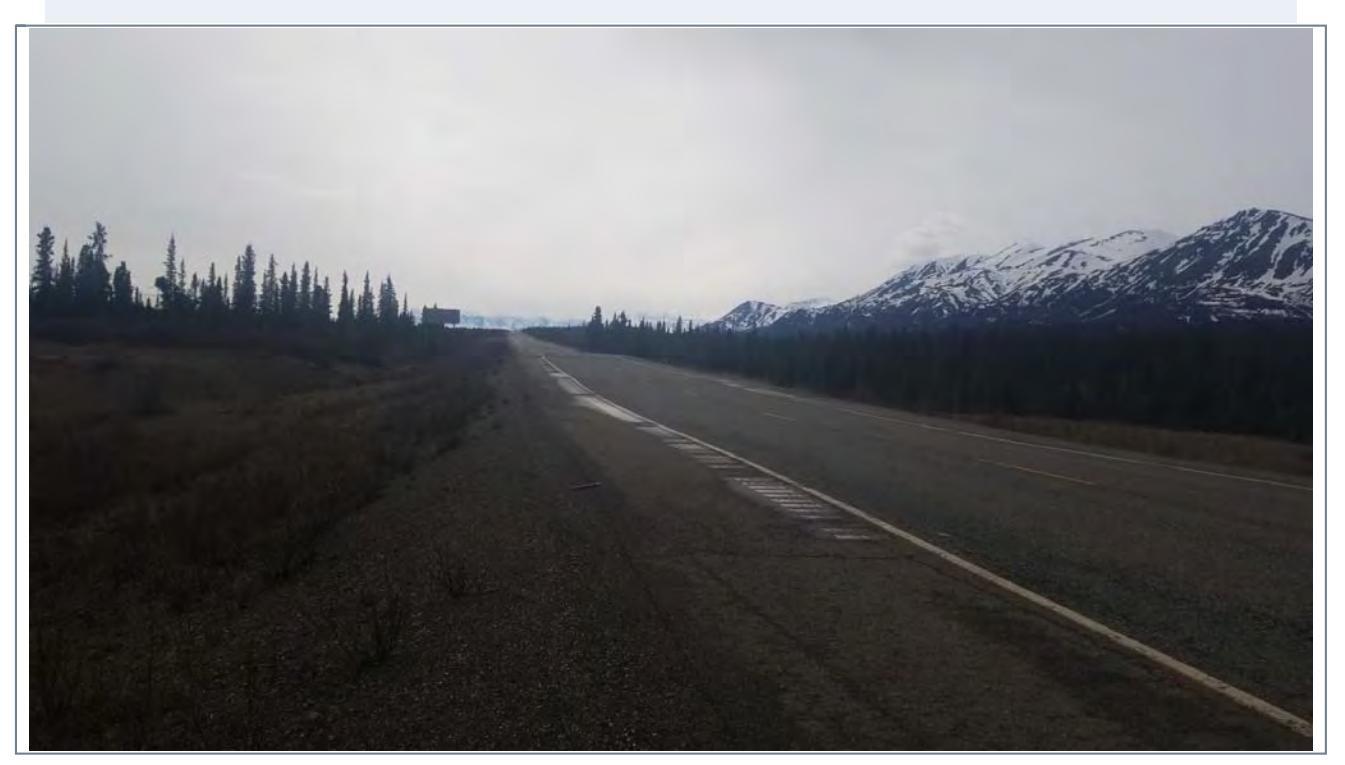
Photo 4: MP 208.2 to 209.3 Reoccurring frost heaves. (M&O) Bumps likely due to thaw settlement and/or heaving. Peat ground cover may suggest areas of possible shallow permafrost. (SW2020)

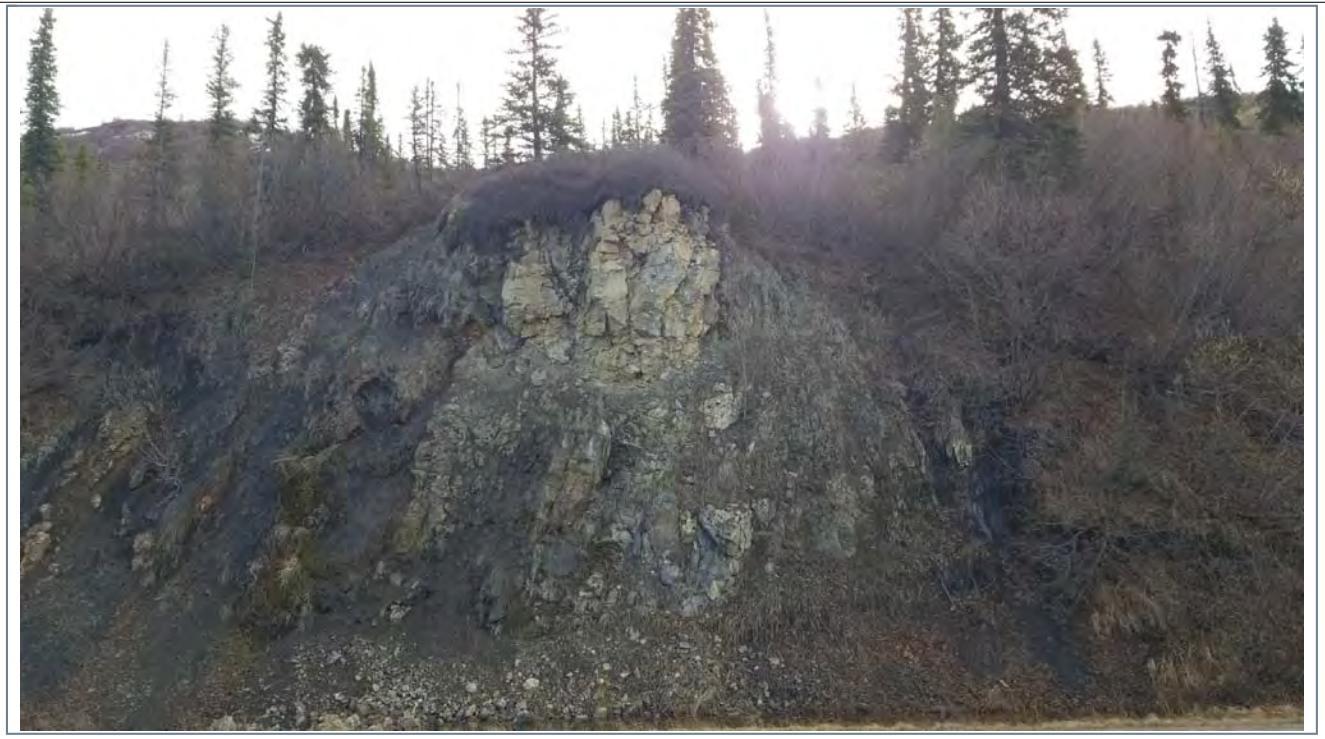
Photo 5: MP 212.3 Potential rockfall hazard.

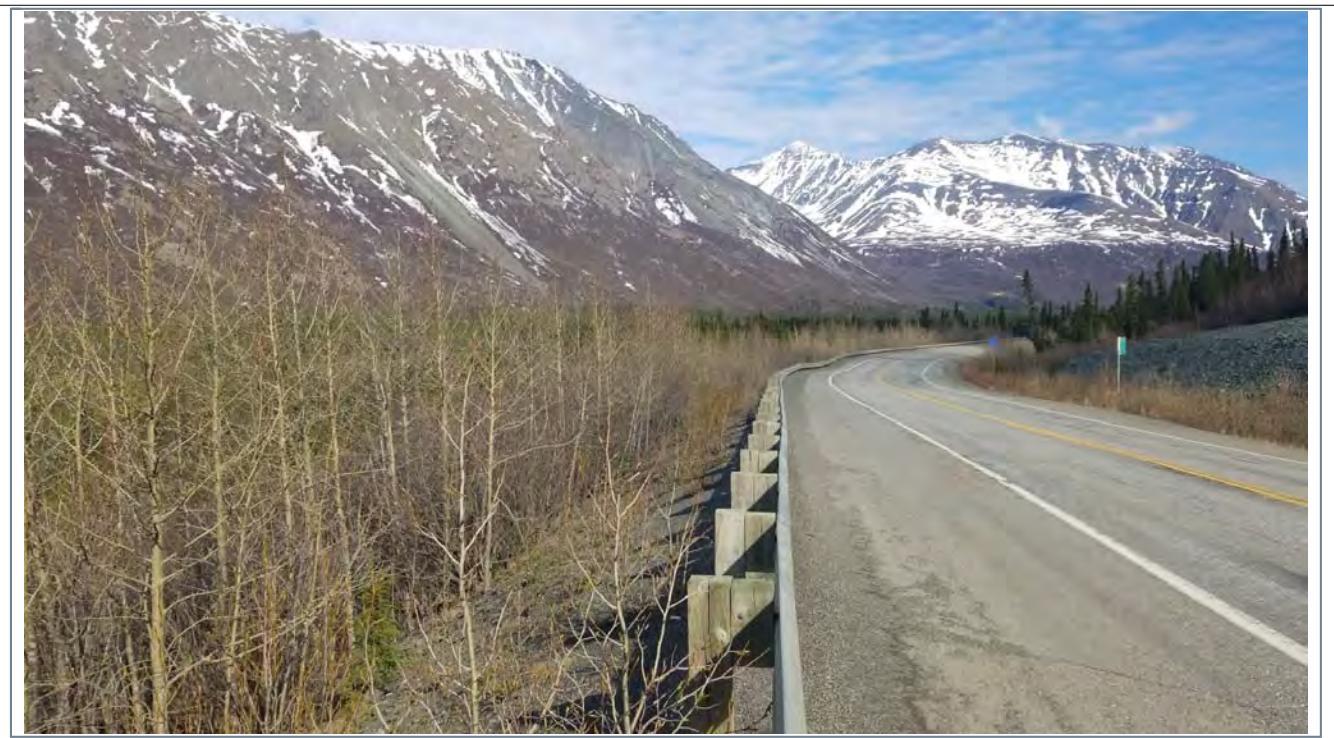
Photo 7: MP 217 Waviness and patching in the roadway. Large dip at MP 217. (SW2020)

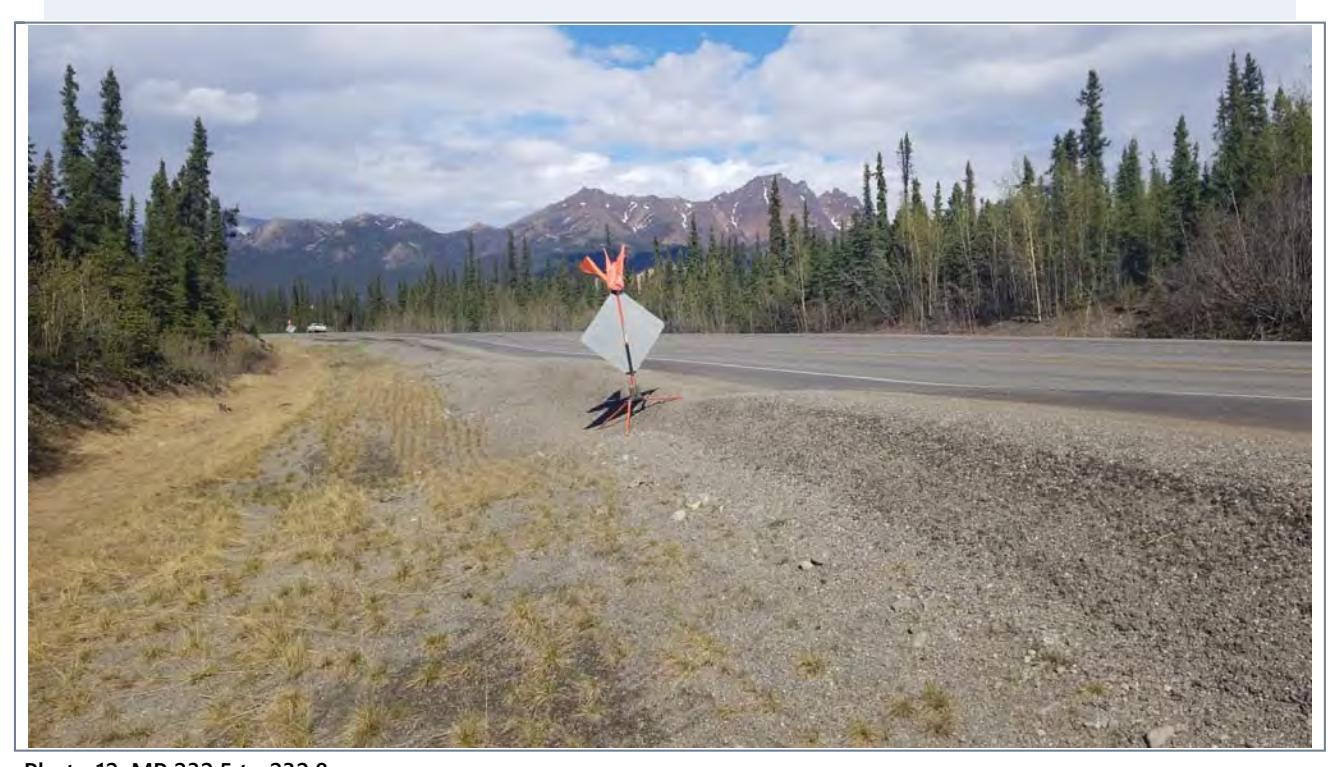
Photo 12: MP 232.5 to 232.8
Annually recurring bumpy section. Permafrost at approximately 32 feet based on prior drilling.
Poor pavement performance. Requires annual maintenance. (M&O)
Extreme area of thaw settlement and slumping of backslopes at the north end of the damage zone. (SW2020)

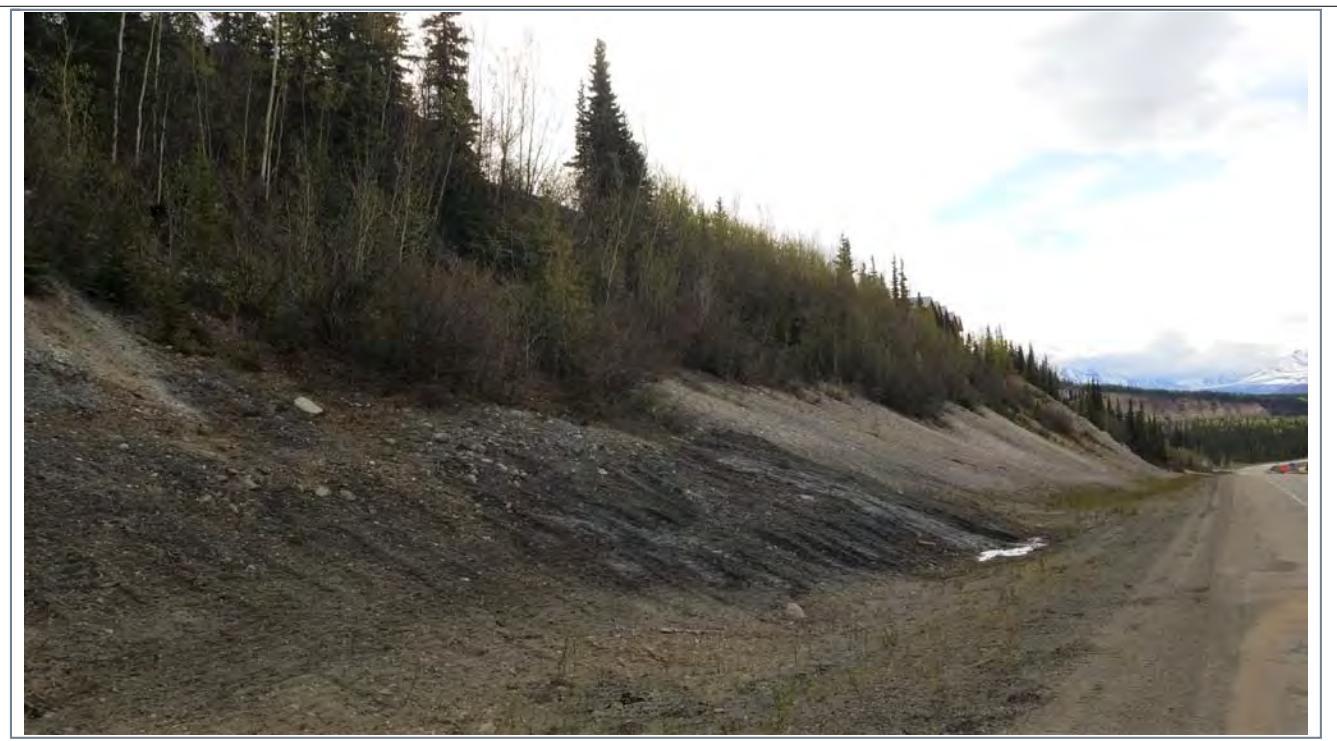
Photo 15: MP 238.3 Unstable cut slope likley related to thawing permafrost.

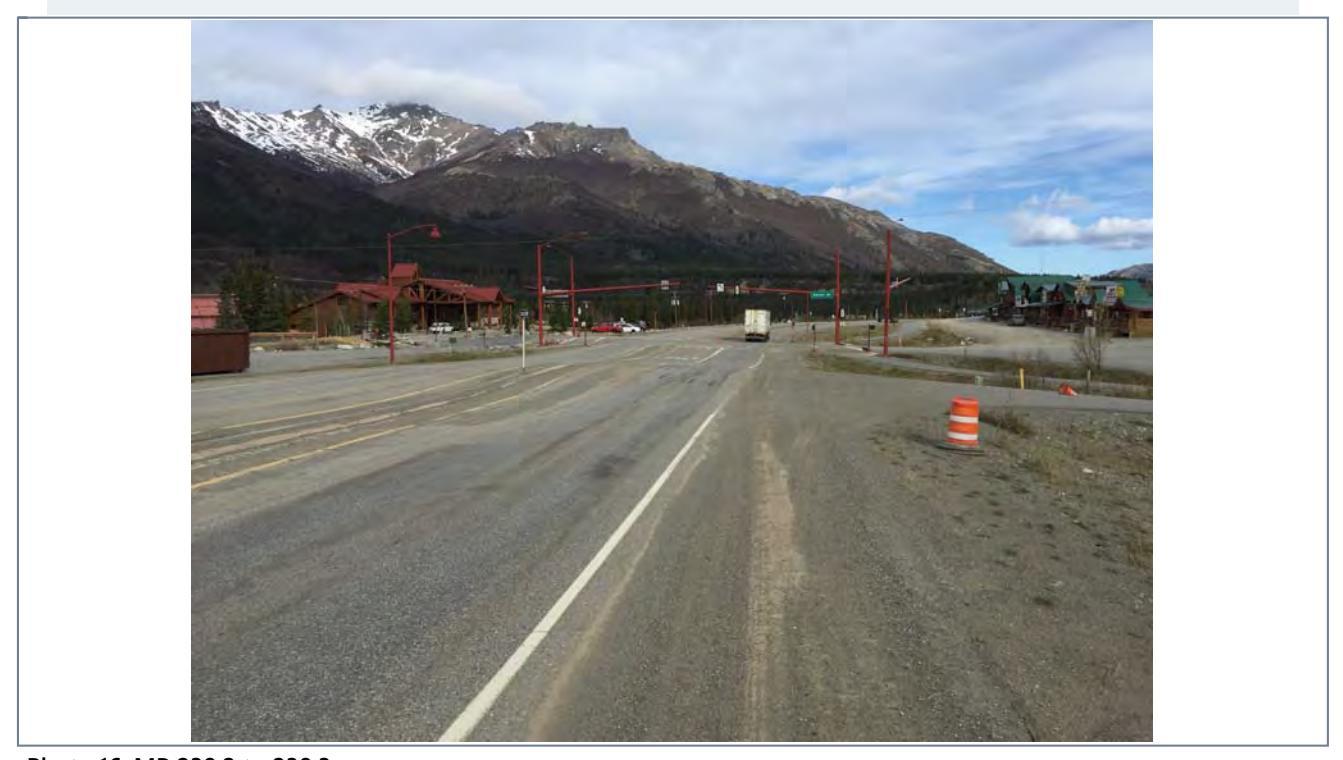
Photo 16: MP 238.2 to 238.3 Bumps and heaves. Previously documented area with underlying thaw unstable soils/massive ice, and potential larger scale landslide mechanism. (SW2020)
