## Cantwell to Healy – Parks Highway Milepost 203-259 Planning & Environmental Linkages Study

Project No. NFHWY00492

## **Needs and Opportunities Assessment Report**

> > > > October 2020

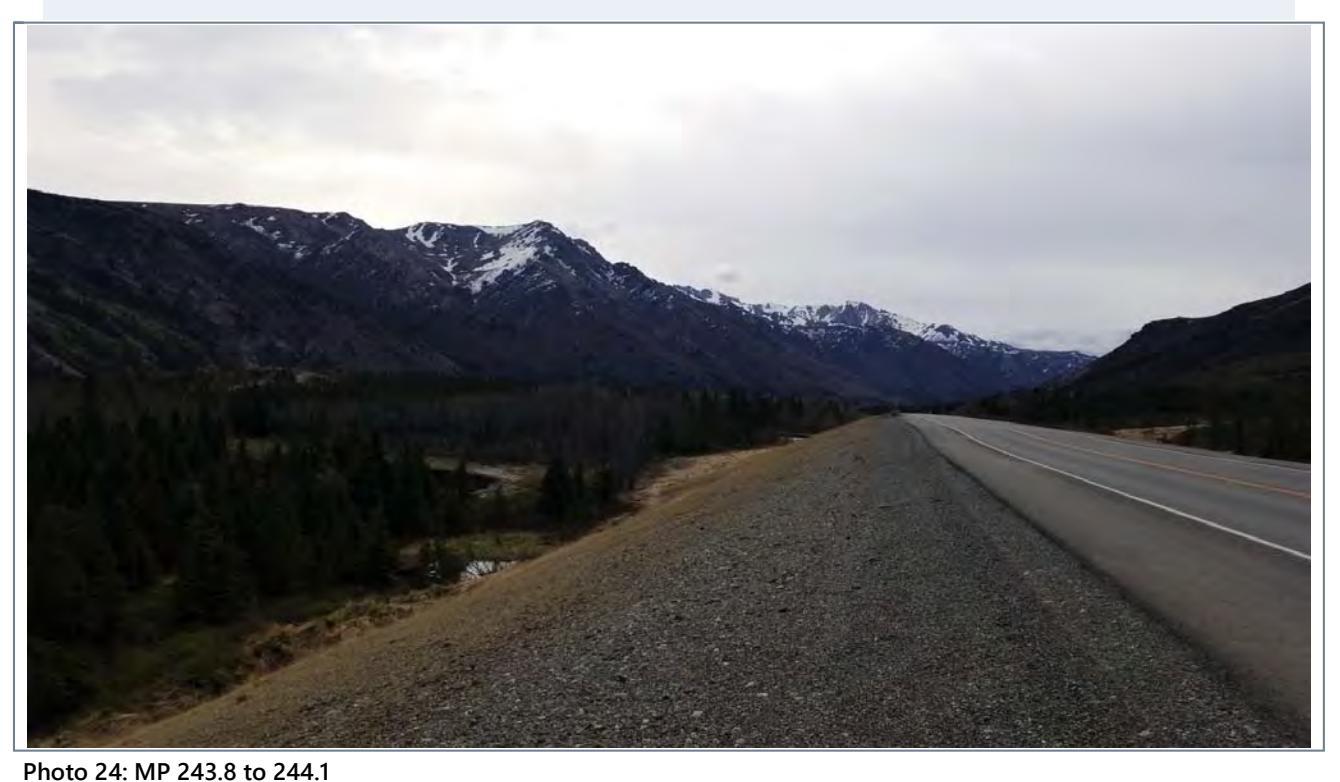
Thaw unstable embankment section exhibits up to 6 inches of differential settlement. M&O stated section requires maintenance every 2 to 3 years. Several thaw ponds visible at toe of slope and beyond. Condition = fair. (GAM)

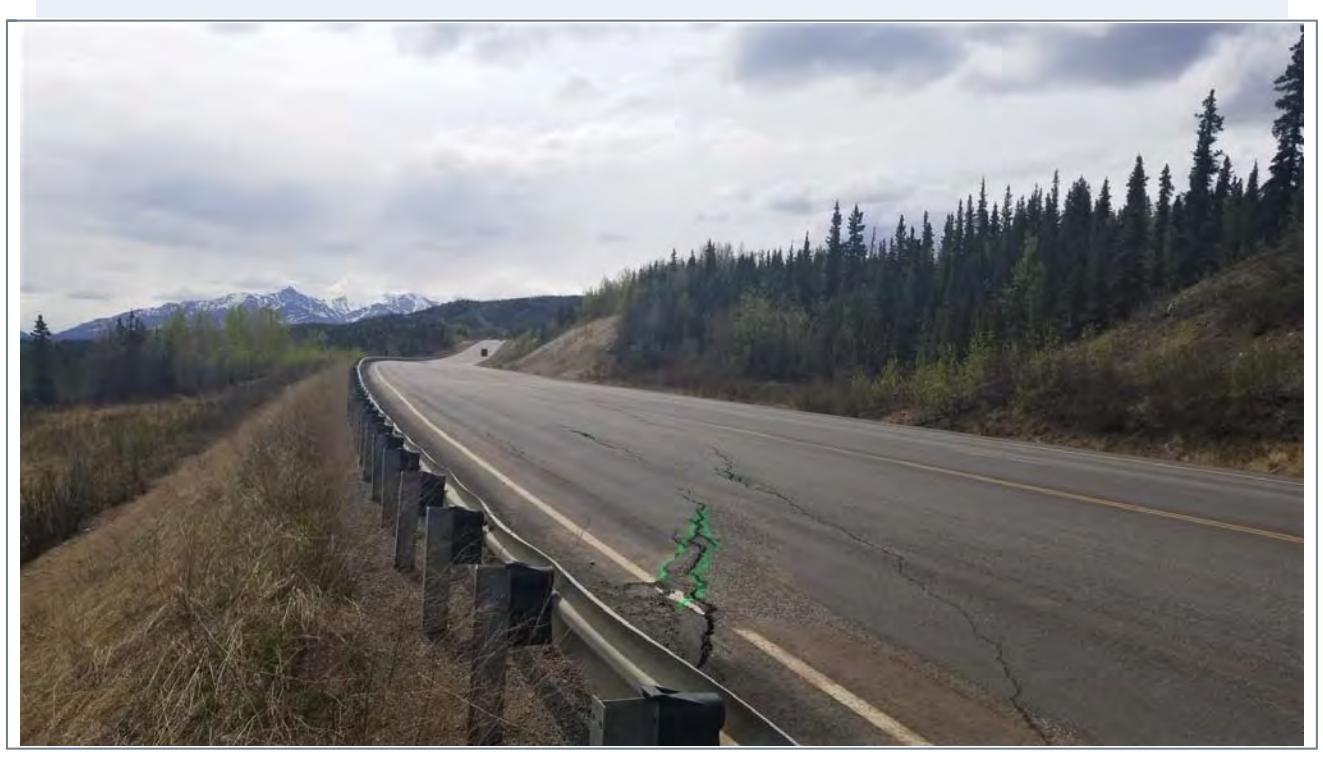
#### Photo 26: MP 255.3 to 255.5 A few bumps. Large circular failure propagating through northbound lane near 255.4. Toe pond and poor drainage at culverts. (SW2020)

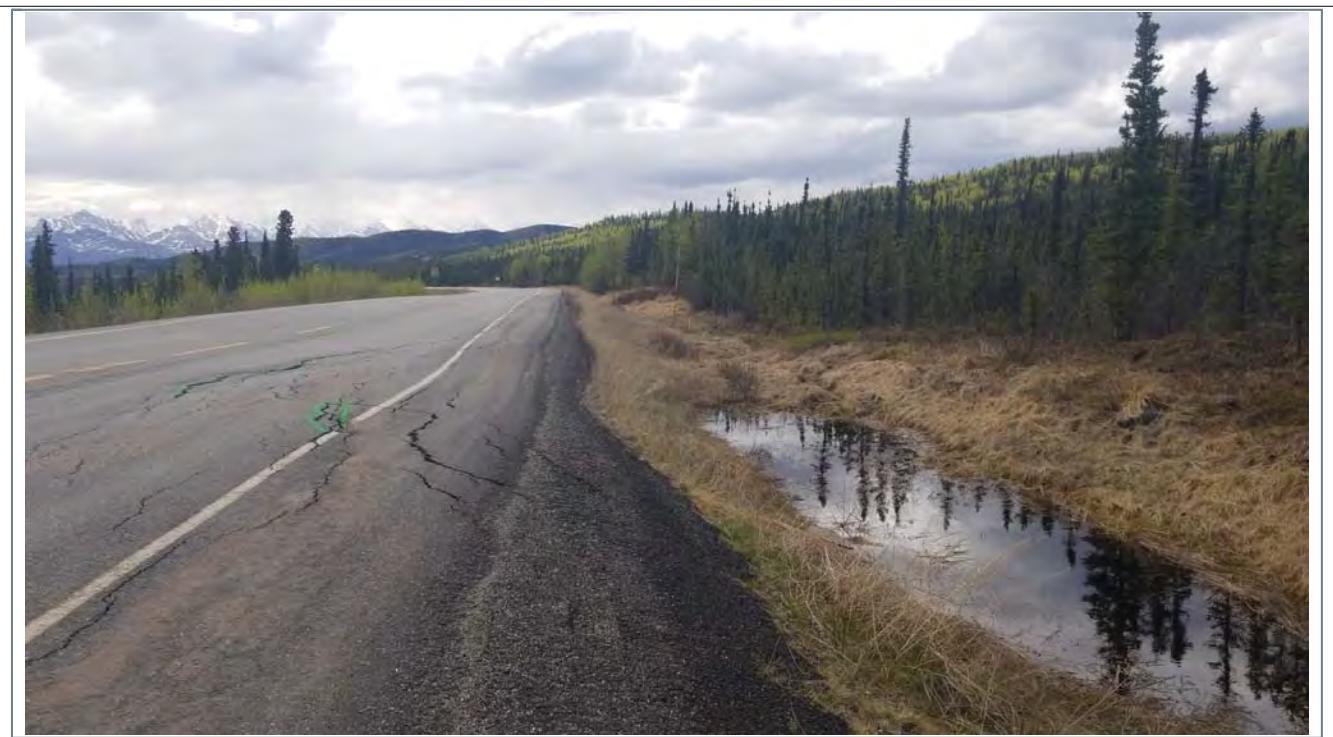
Photo 27: MP 256.3 to 256.5 Drainage issues are causing road damage. (M&O) Severe bumps and waves. Thaw settlement resulting in drainage issues. (SW2020)
