GENERAL LAYOUT YAKUTAT

Yakutat City Dock

Owner: City of Yakutat

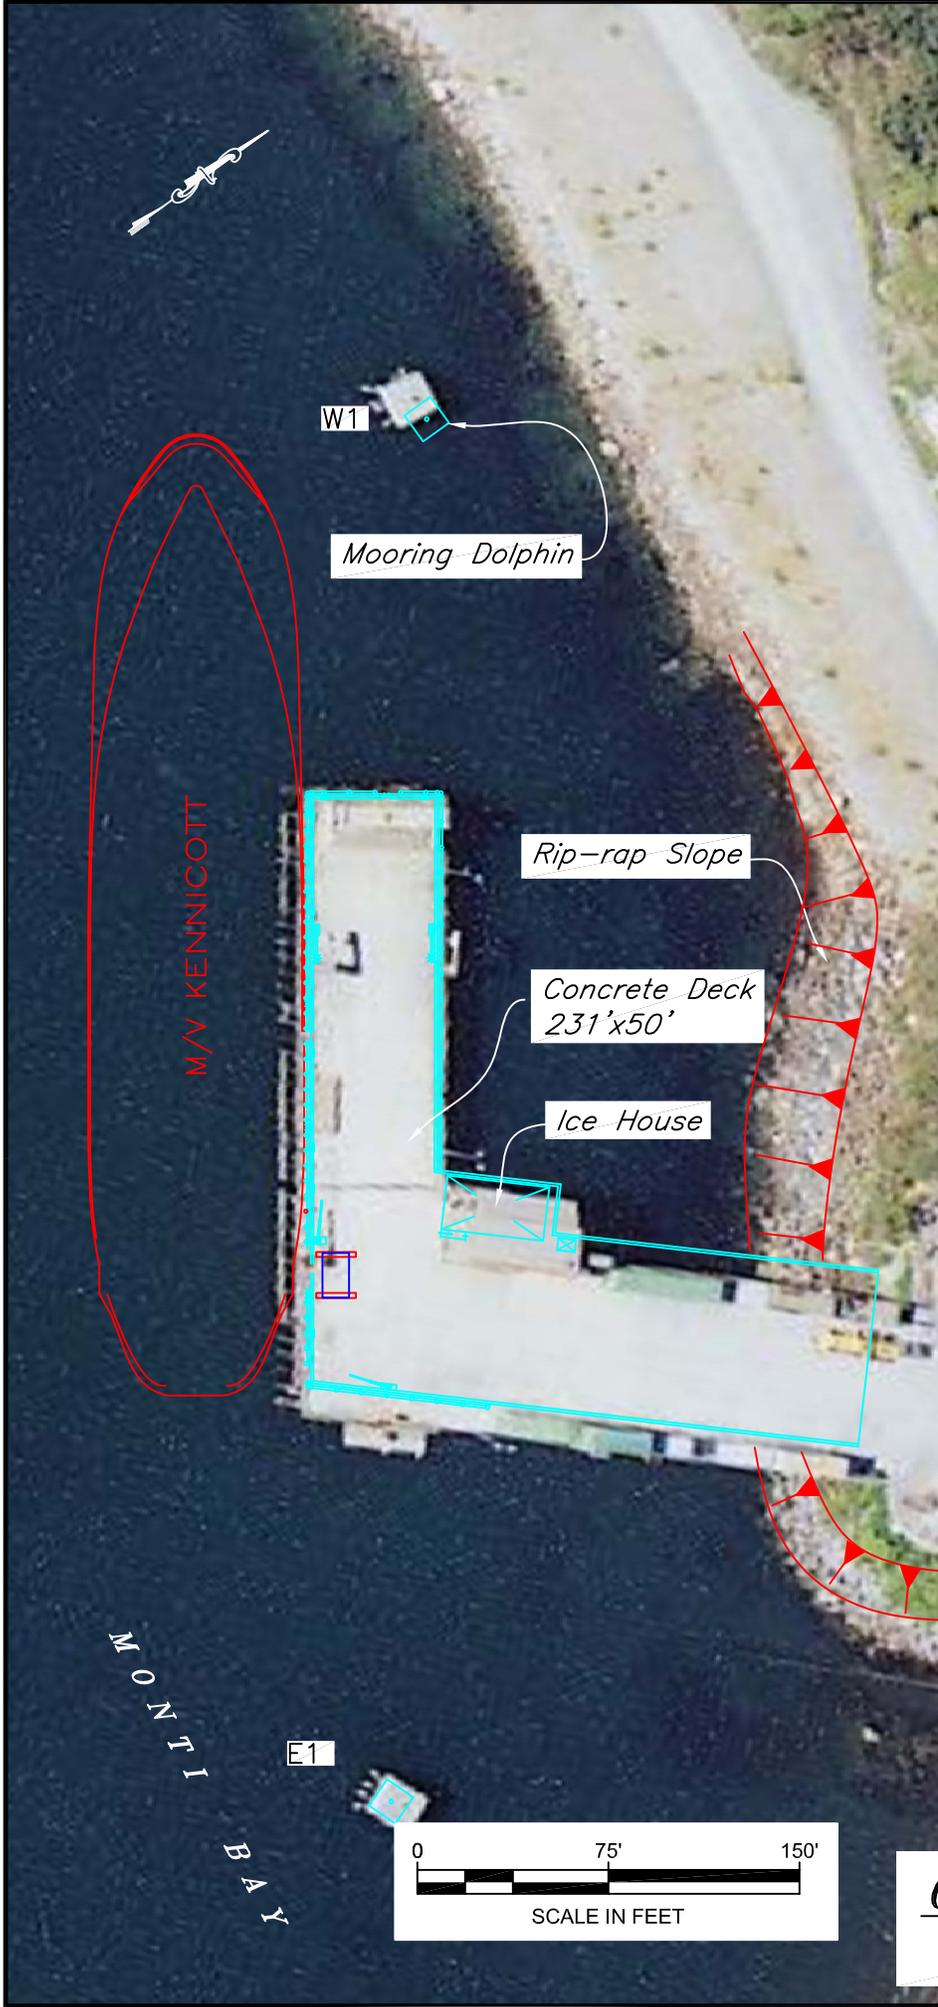
1. The dock is used for fish processing and the transfer of freight. There is an icehouse on the inside corner of the dock, a fish processing plant at the head of the approach, and the office of Alaska Marine Lines is nearby. The KENNICOTT ties up starboard-to, with bow and stern lines to the dolphins and spring line to the dock. This mooring configuration is marginal for the M/V KENNICOTT. There are no catwalks from the dock to the dolphins; a contract agent runs the bow & stern lines to each dolphin by skiff one at a time. In the winter, when the wind blows off the dock and snow/ice builds on the dolphin caps, the situation becomes dangerous when the KENNICOTT drifts while the linehandler is motoring over to disconnect the bow/stern line.

2. The steel support piling are epoxy-coated. The shoreward piling exhibit 75% coating loss with some laminating corrosion. Section loss is not known. Seaward piling are in fair condition, with 10-15% coating loss. Cathodic protection readings indicate the piles are not adequately protected. Visual inspection of the anode hangers found that more than 50% of the anode cables have broken off at the support angles.

3. Kennicott ship personnel are required to block the ship's vehicle transfer ramp up with wood in order to clear a cleat on the southern dock face. This results in excessively steep grades between the ship and the dock and requires additional work by ship's personnel.
There are several cranes fixed to the dock that are original vintage & all are not operational. One of the cranes on the north dock is in the way of the preferred landing for the Kennicott's vehicle ramp.

4. There was a vessel collision with the west corner of the timber fender system that caused significant damage. Approximately 6 timber piles were fractured below the waterline, the timber waler is missing (disconnected, sunk) and the steel waler attached to the rubber energy absorbing donuts at the top of the fender system is hanging by the donut brackets, unsupported by timber piles. No source of the collision was determined at the time of printing this document.
There are two (2) broken timber fender piles at the east corner of the dock. These are not connected to the timber waler below.

| Inspection Summary | | |
|---|---|---|
| Dock Fenders | 1 | The timber pile fenders are inadequate for the Kennicott. Program a project to replace with steel fender units to provide a higher berthing capacity. Meanwhile, repair the damaged timber piles and walers. |
| Mooring Arrangement | 2 | Install catwalks between the mooring dolphins & shore, to provide linehandler access. Consider installing a breasting dolphin in-line and west of the dock fenderline. |
| Dock support piling | 3 | Sandblast and repair the coating on steel pile surfaces above the tidal splash zone. |
| Mooring Cleats | 4 | Determine alternative location for conflicting mooring cleat and if one of the cranes along the south face of the dock could be removed for better accessibility by the Cross-Gulf ferry; replace missing grout beneath existing mooring cleats. |
| Anodes | 5 | Abandon existing angle hanger brackets in place. Weld a stud to the pile and hang a cable with anode, according to our standard drawing. |
