SURVEYOR'S CERTIFICATE

| Prepared By:<br>DOWL HKM | | <b>STATE OF ALASKA</b><br>DEPARTMENT OF TRANSPORTATION<br>& PUBLIC FACILITIES<br>SURVEY CONTROL DIAGRAM - RECORD OF SURVEY<br>AKSAS 58547<br><b>QUARTZ CREEK BRIDGE REPLACEMENT</b><br>LOCATED WITHIN SECTIONS 30 & 31, T5N R2W<br>& SECTION 36, T5N R3W<br>SEWARD MERIDIAN, ALASKA | |

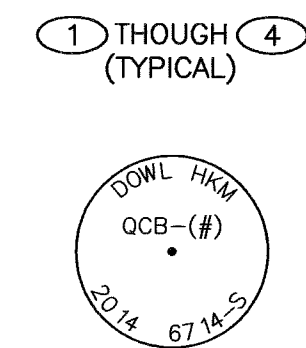
- SET -  
2" ALUMINUM CAP ON  
5/8"x30" REBAR

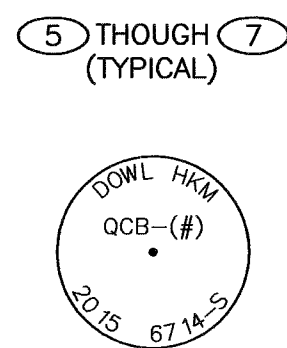
- SET -  
2" ALUMINUM CAP ON  
5/8"x30" REBAR

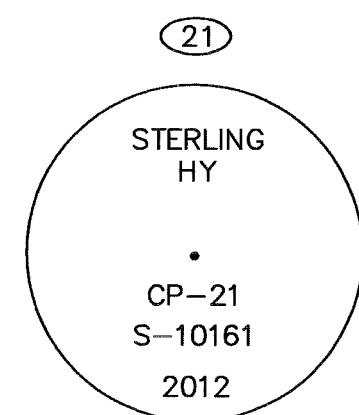
- FOUND -  
3-1/4" ALUMINUM MON.  
FLUSH WITH GRADE,  
GOOD CONDITION

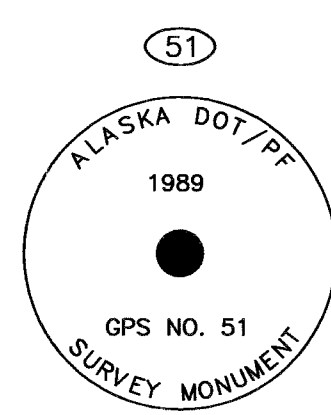
- FOUND -  
2-1/2" BRASS DONUT  
WITH COPPER WELD,  
IN PVC PIPE FLUSH  
WITH GRADE,  
GOOD CONDITION

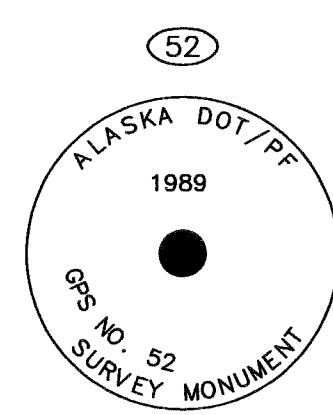
- FOUND -  
2-1/2" BRASS DONUT  
WITH COPPER WELD,  
0.2' BELOW GRADE,  
GOOD CONDITION

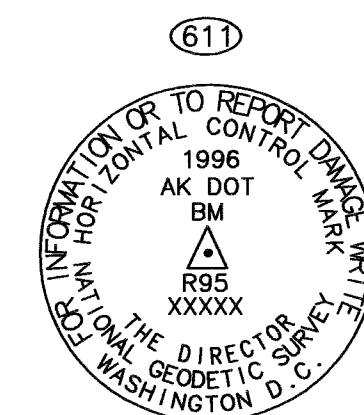
- FOUND -  
3-1/4" BRASS CAP MON.  
FLUSH W/GRADE,  
GOOD CONDITION

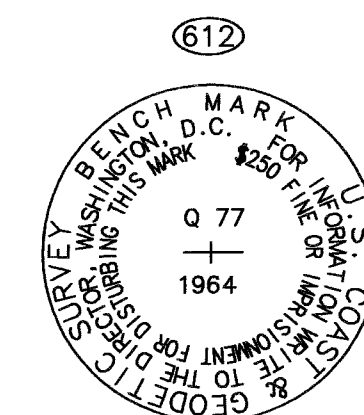
- FOUND -  
3-1/2" BRASS CAP MON.  
0.4' BELOW GRADE,  
GOOD CONDITION

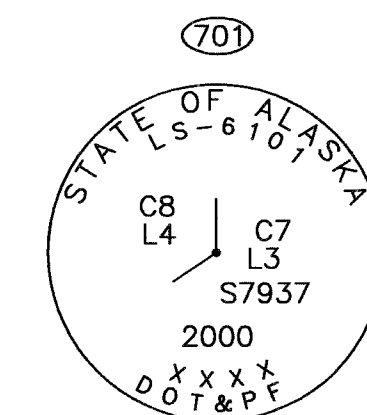
- FOUND -  
3-1/4" ALUMINUM MON.  
0.2' BELOW LIP OF  
MON. CASE  
GOOD CONDITION

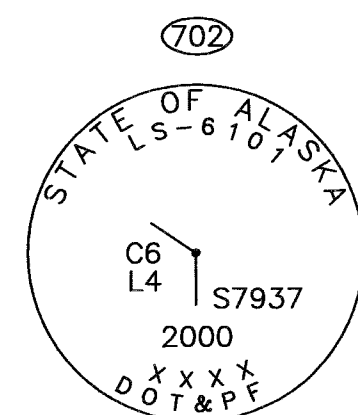
- FOUND -  
3-1/4" ALUMINUM MON.  
0.2' BELOW LIP OF  
MON. CASE  
GOOD CONDITION

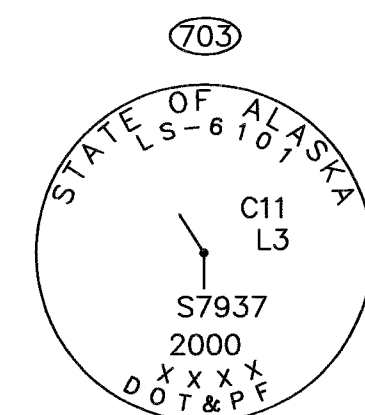
- FOUND -  
3-1/4" ALUMINUM MON.  
0.2' BELOW LIP OF  
MON. CASE  
GOOD CONDITION

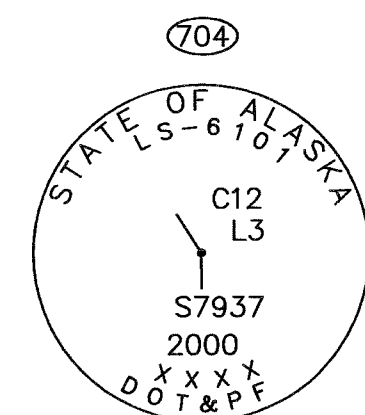
- FOUND -  
3-1/4" ALUMINUM MON.  
0.3' BELOW LIP OF  
MON. CASE  
GOOD CONDITION

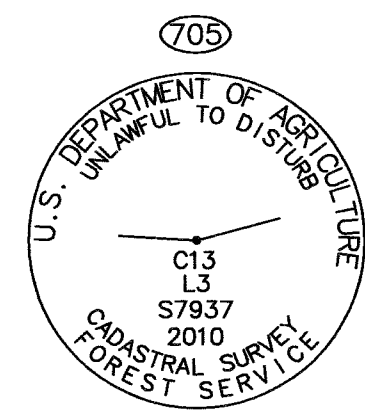
- FOUND -  
3-1/4" ALUMINUM MON.  
0.3' BELOW LIP OF ACCESS  
COVER, 0.8' BELOW GRADE,  
GOOD CONDITION

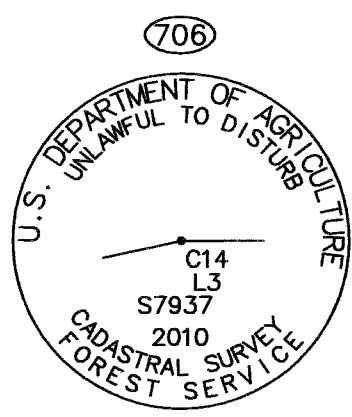
- FOUND -  
3-1/4" ALUMINUM MON.  
0.3' BELOW LIP OF ACCESS  
COVER, 1.1' BELOW GRADE,  
GOOD CONDITION

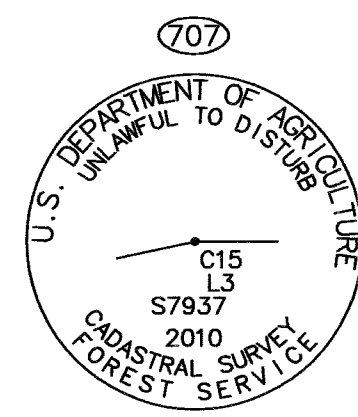
- FOUND -  
3-1/4" ALUMINUM MON.  
0.4' BELOW LIP OF ACCESS  
COVER, 1.6' BELOW GRADE,  
GOOD CONDITION

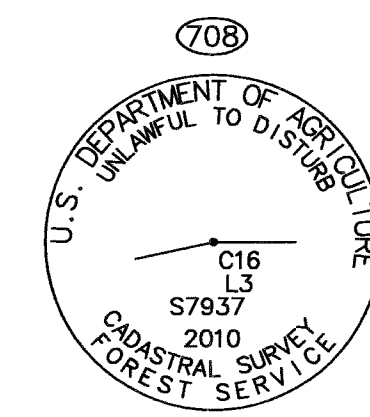
- FOUND -  
3-1/4" ALUMINUM MON.  
0.1' BELOW LIP OF ACCESS  
COVER, 2.2' BELOW GRADE,  
GOOD CONDITION

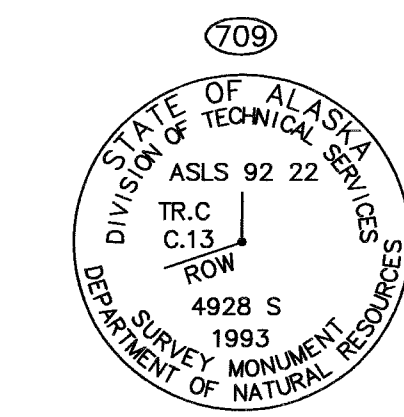
- FOUND -  
3-1/4" ALUMINUM MON.  
0.6' ABOVE GRADE,  
GOOD CONDITION

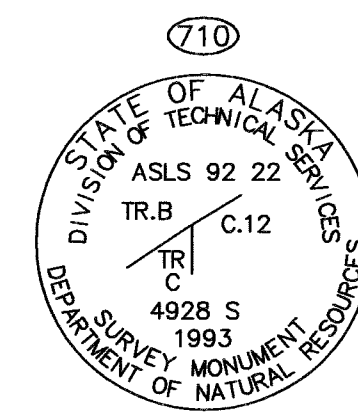
- FOUND -  
3-1/4" ALUMINUM MON.  
0.2' ABOVE GRADE,  
GOOD CONDITION

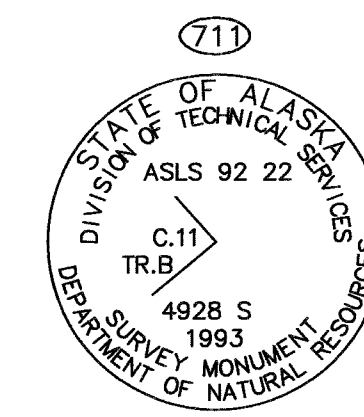
- FOUND -  
3-1/4" ALUMINUM MON.  
0.4' ABOVE GRADE,  
GOOD CONDITION

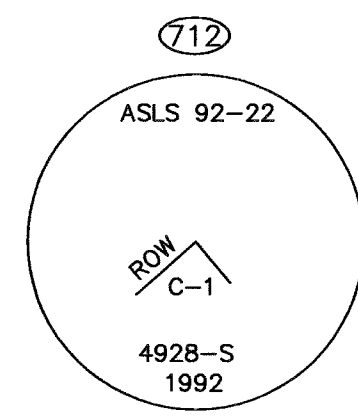
- FOUND -  
3-1/4" ALUMINUM MON.  
0.3' ABOVE GRADE,  
GOOD CONDITION

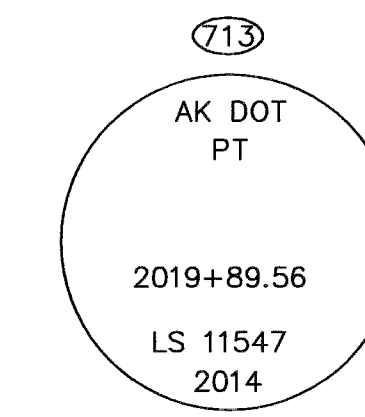
- FOUND -  
2" ALUMINUM CAP  
0.2' BELOW GRADE,  
GOOD CONDITION

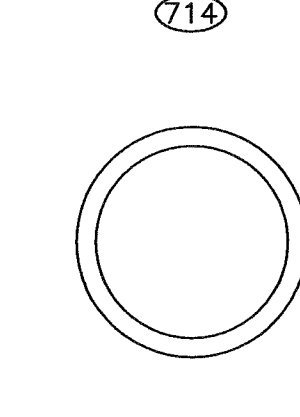
- FOUND -  
2" PIPE 0.2' BELOW LIP  
OF MON CASE-NO CAP,  
SOLID CONDITION

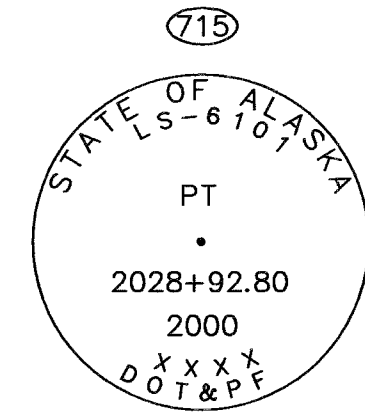
- FOUND -  
3-1/4" ALUMINUM MON.  
0.2' BELOW LIP OF  
MON. CASE GOOD CONDITION

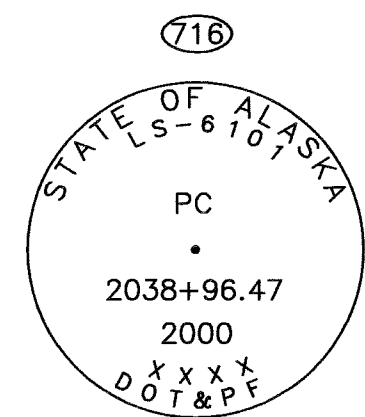
- FOUND -  
3-1/4" ALUMINUM MON.  
0.2' BELOW LIP OF MON.  
CASE GOOD CONDITION

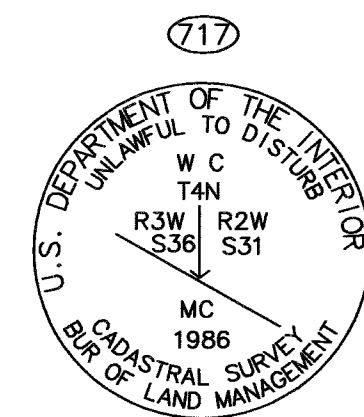
- FOUND -  
3-1/4" ALUMINUM MON.  
0.2' ABOVE GRADE,  
GOOD CONDITION

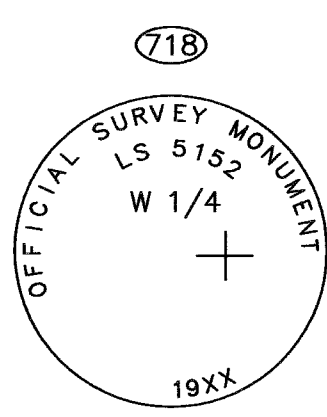
- FOUND -  
2-1/2" ALUMINUM MON,  
0.2' ABOVE GRADE  
GOOD CONDITION
