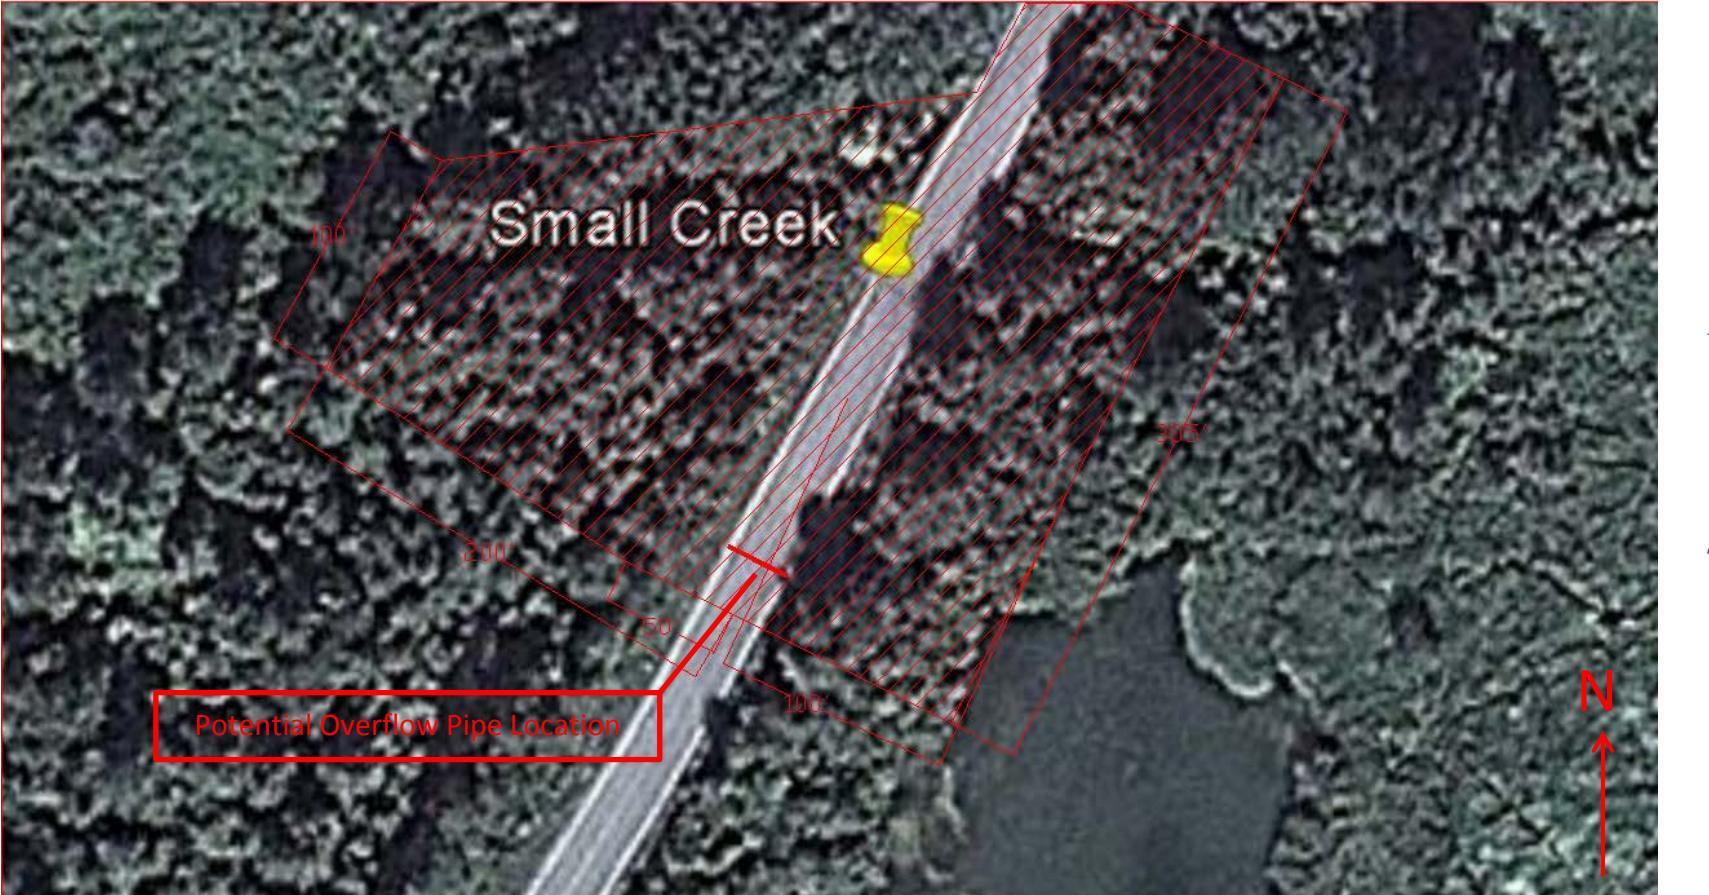
Site 1: Small Creek (MP 19.25)

- Approximate CDS Milepoint 9.2-9.3
- Sediment loads caused rerouting of stream away from existing bridge
- ٠ embankment
- flow
- Outlet area assumed to be fresh water, not sea water

Rerouted water is overwhelming adjacent lowland and pond against highway

• Overflow outlet for water is small diameter pipe, not adequate for current

- Immediate solution to rebuild stream bank to return flow under bridge (M&O doing this in 2014, but this project may need additional work)
- Design of overflow culvert may require berm to collect/guide water into culvert on inlet side

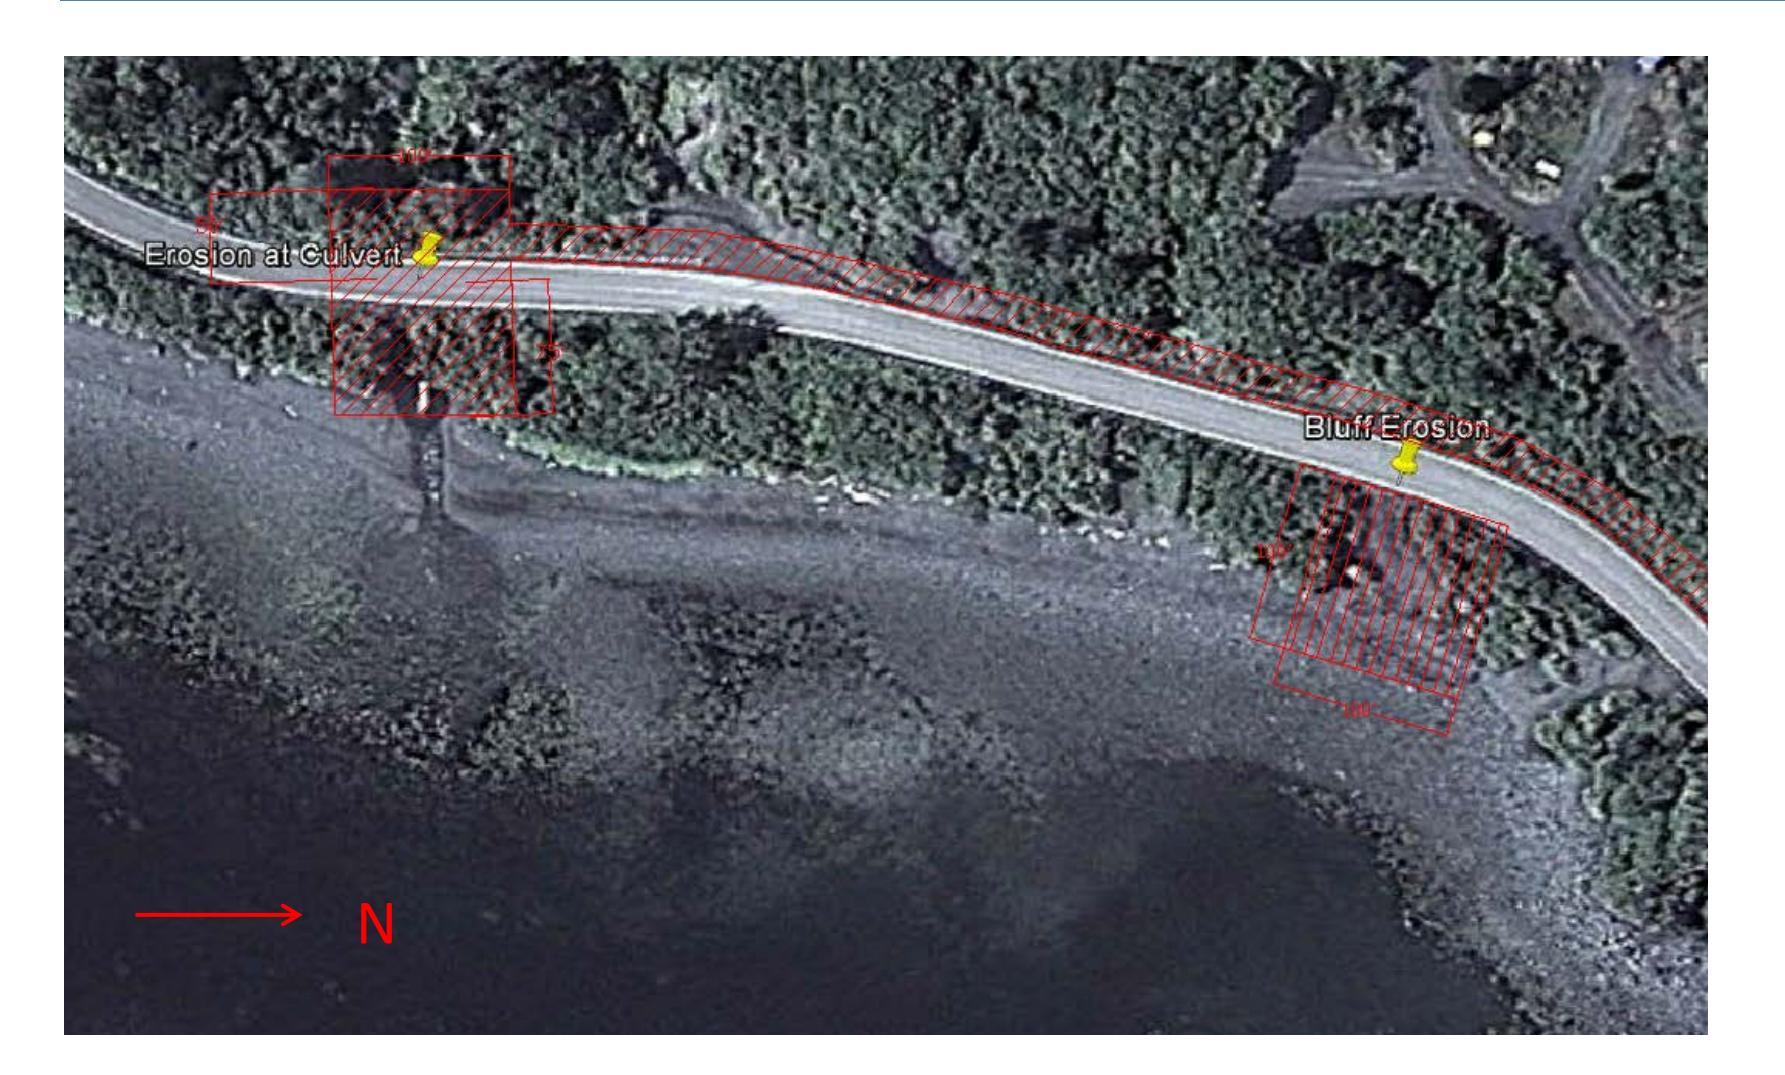
Site 2&3: MP 25.5(Erosion)-25.75(Culvert at Sag)

- Approximate CDS Milepoint 15.6-15.8 & 15.8-15.9
- Bluff erosion has undermined existing guardrail •
- Threatening to undermine paved surface •
- •
- ٠
- •
- ٠ roadway embankment
- There is a large plunge pool at the outlet ٠

Jersey barriers placed in front of undermined guardrail Roofing tar used at base of barriers to prevent more erosion Existing ditches on North side of road have minimal depth

At the sag curve there is erosion at the inlet and the outlet affecting the

- To repair bluff, riprap and fill section provided by materials

• Consider shifting roadway ½ lane width (research ROW and impacts to do so)

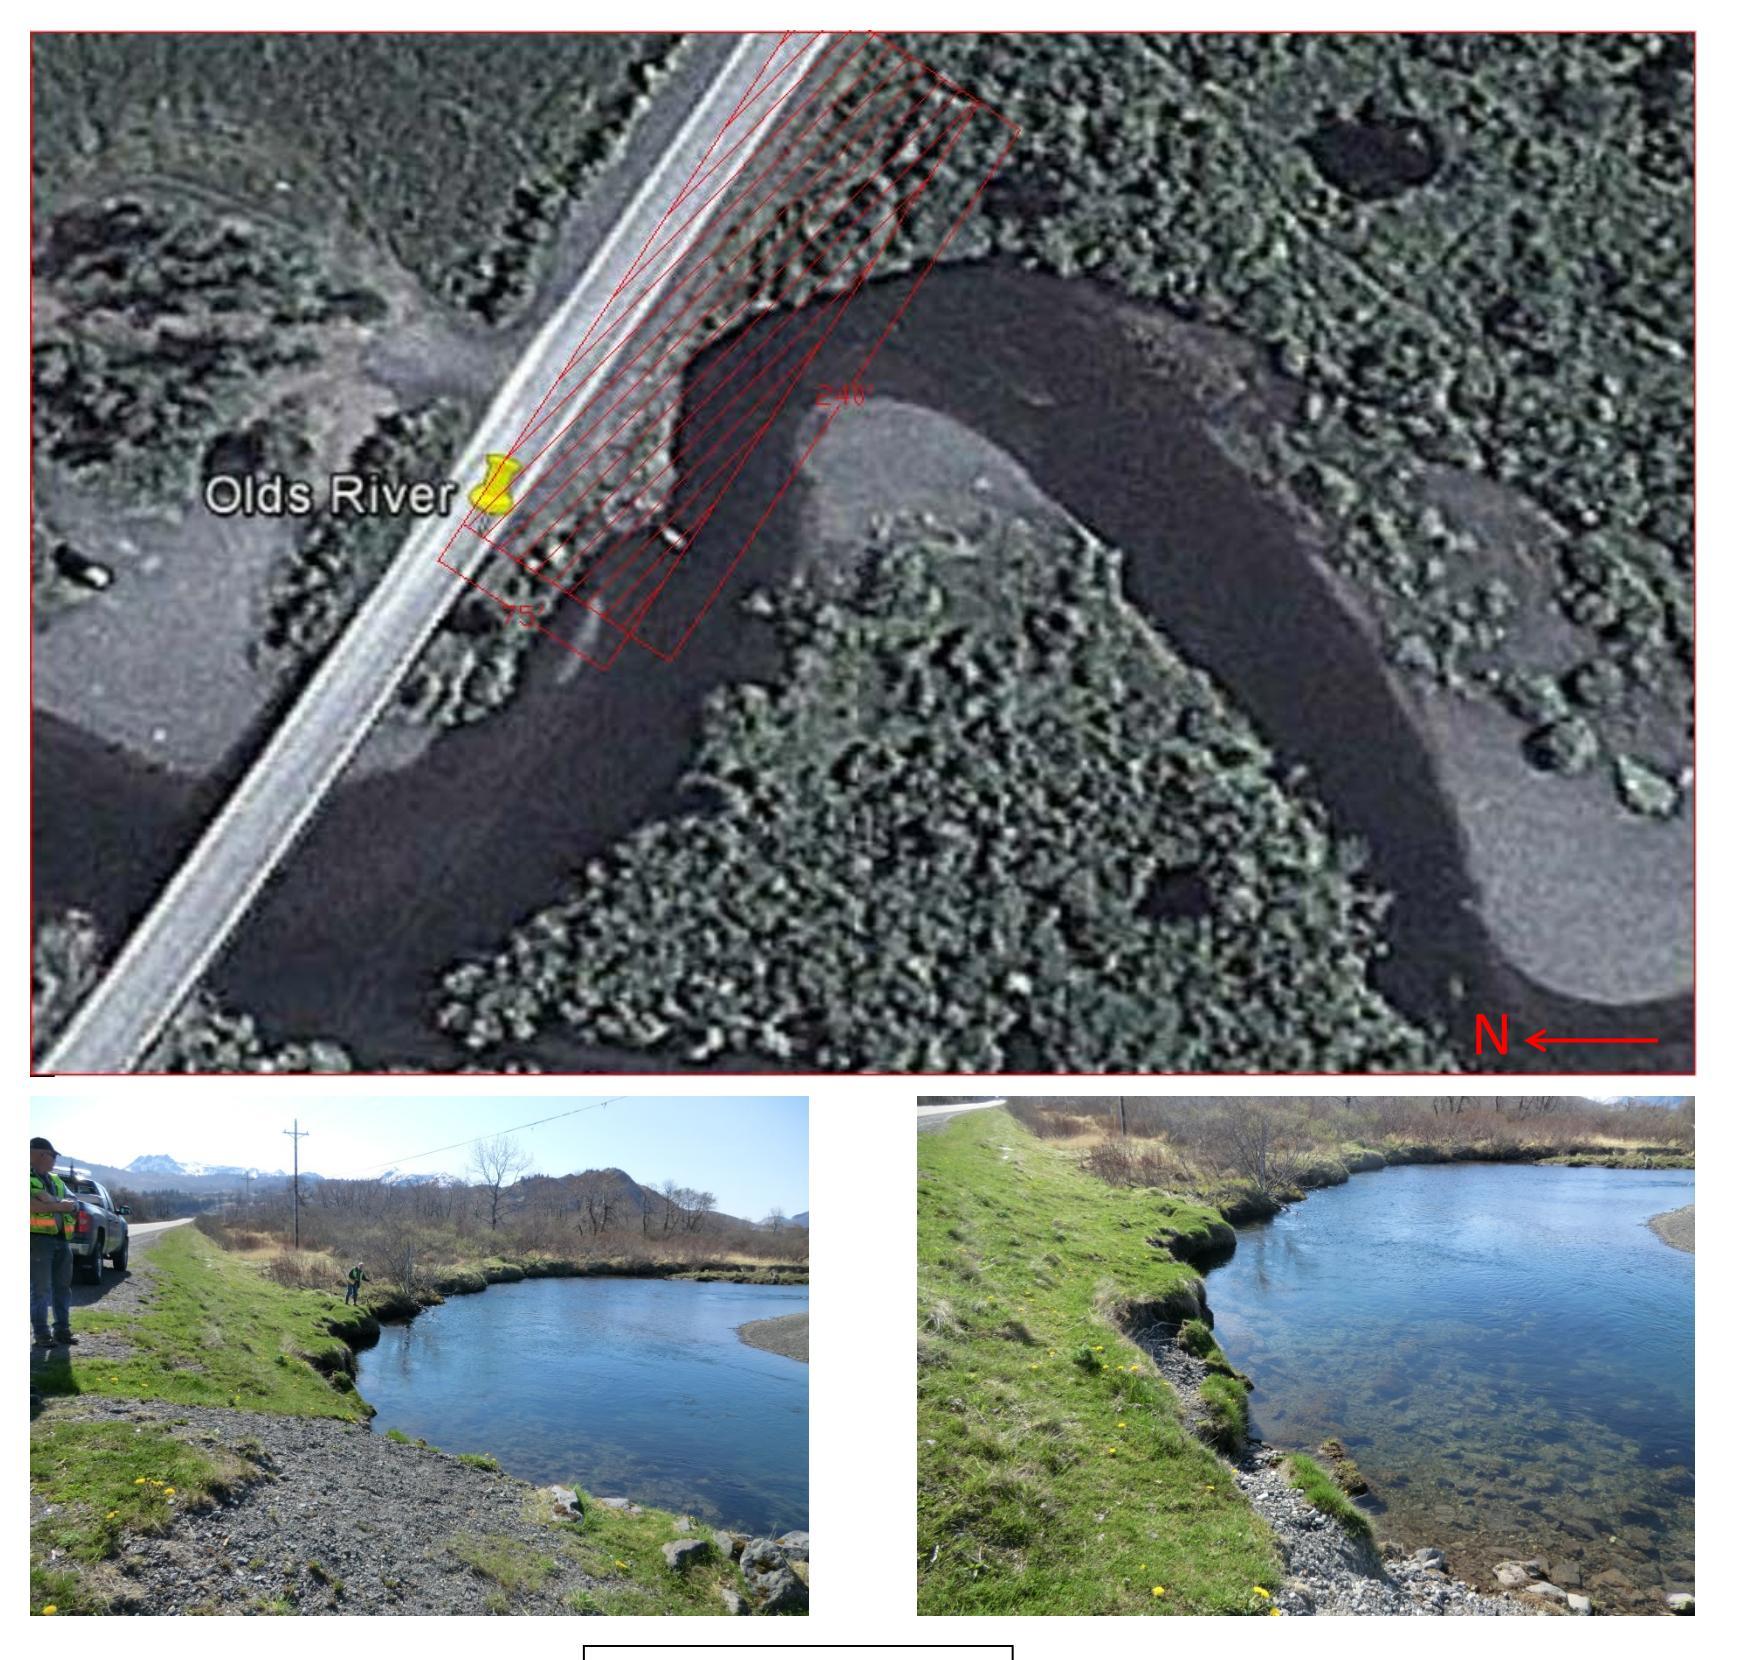
Site 4A: Olds River Bend

- Approximate CDS Milepoint 19.5-19.6
- Bend in river occurs against roadway embankment
- Shown significant movement over past few years

• Water velocity and direction has produced deep scour hole

• Fill bank with riprap and cutting in riprap on eastern bank near overhead

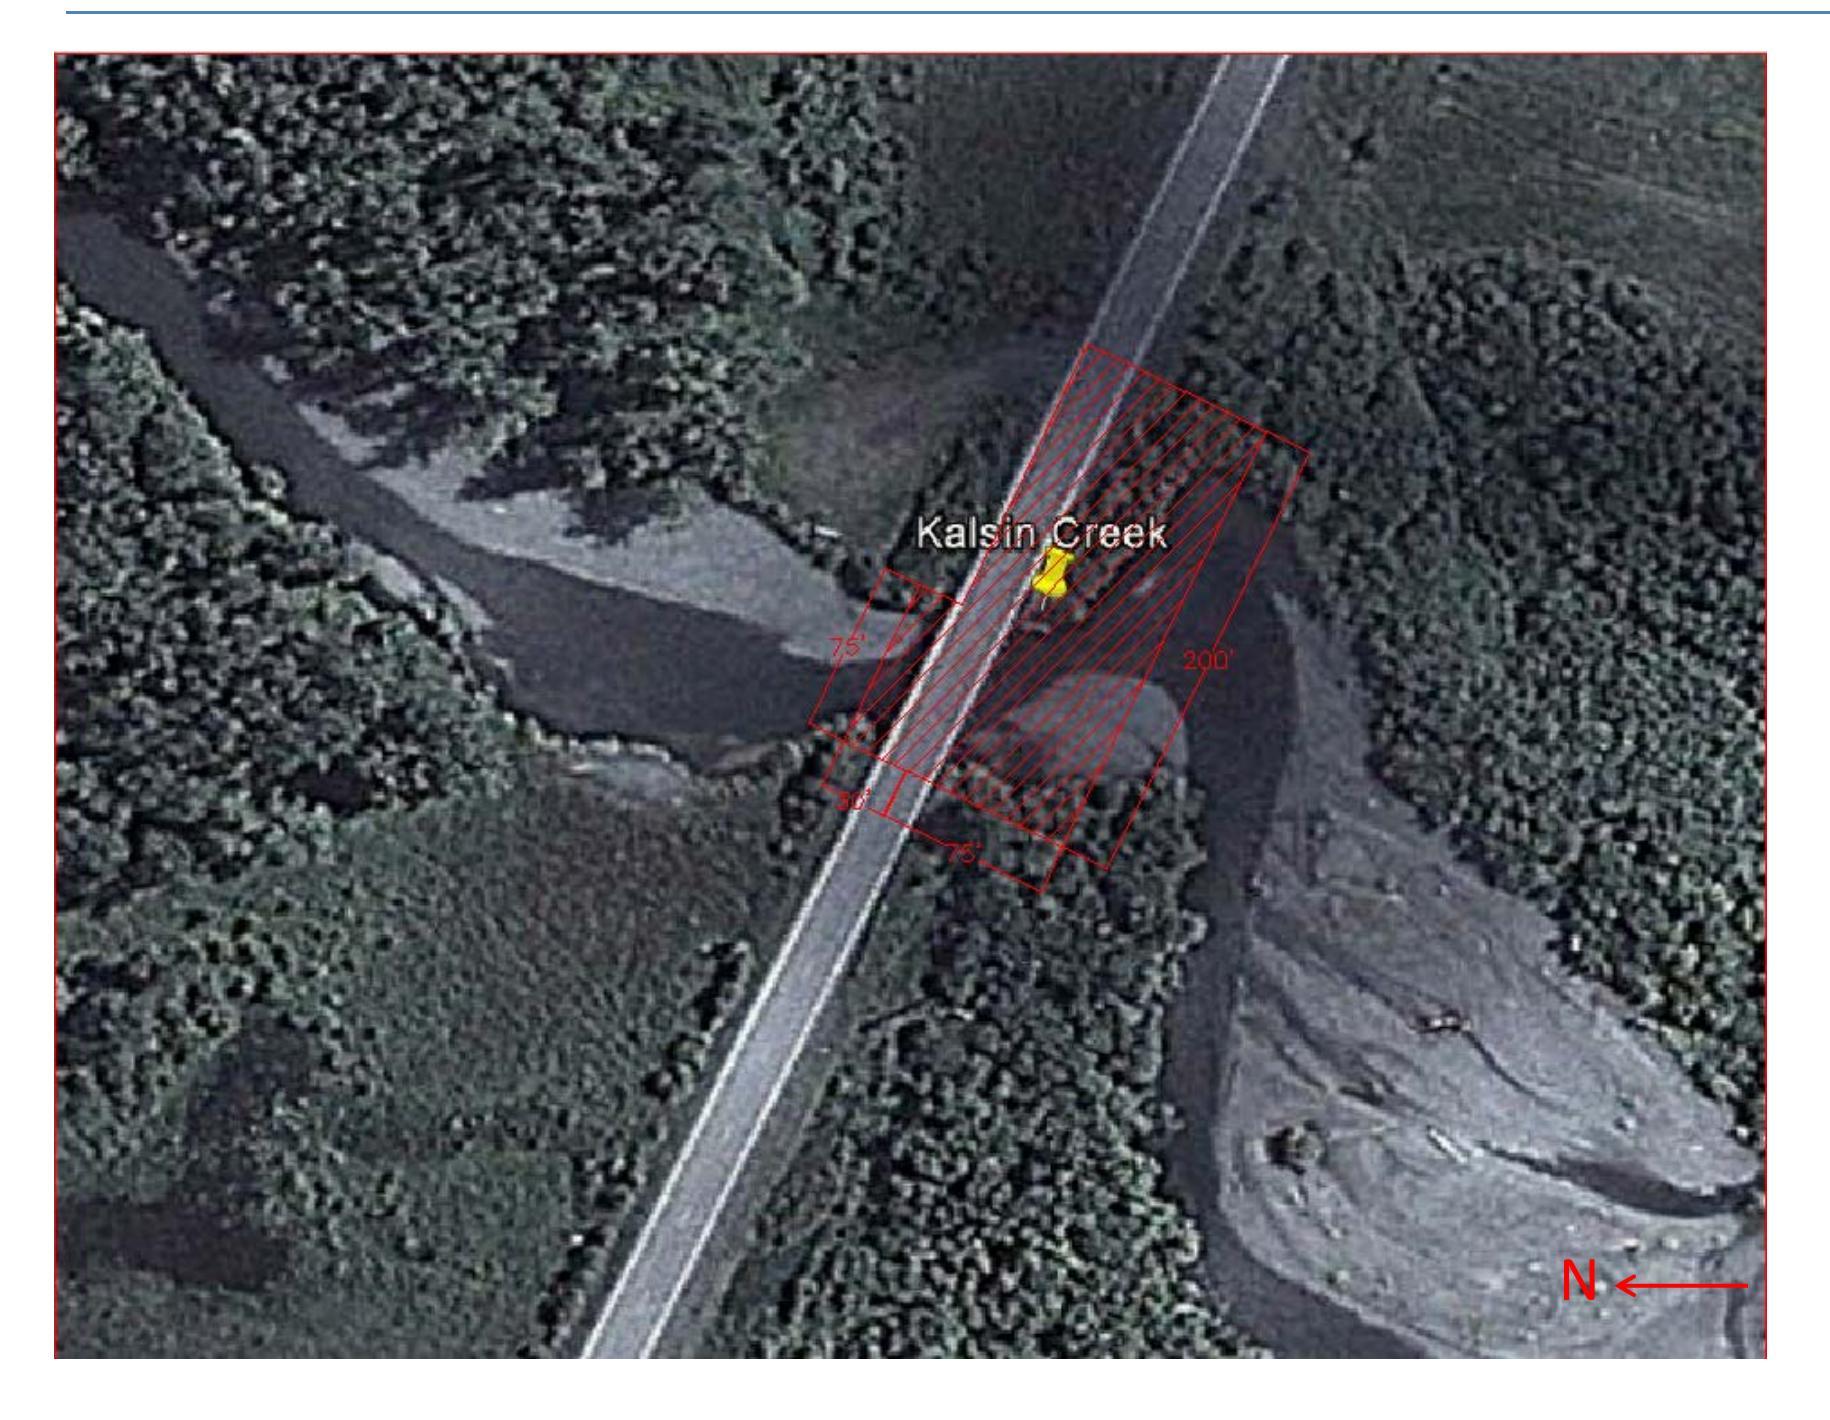
Site 4B: Kalsin Creek

- Approximate CDS Milepoint 19.9-20.0
- Bend in river occurs against roadway embankment

• Fill bank with riprap and cutting in riprap on eastern bank

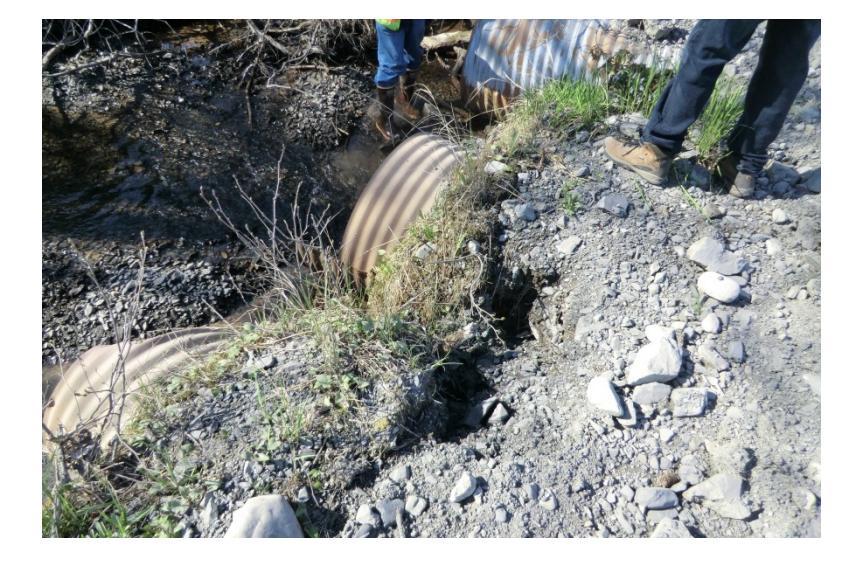
Site 5: 3 culvert inlets

- Approximate CDS Milepoint 22.9-23.1
- fish passage criteria and 2 of 3 have failed
- Ditch on inlet side is shallow

• 3 culverts are hydraulically inadequate, less than minimum cover, do not meet

- Ditch on inlet side will require ditch linear grading
- Replace culverts with one culvert and raise road 1.5'

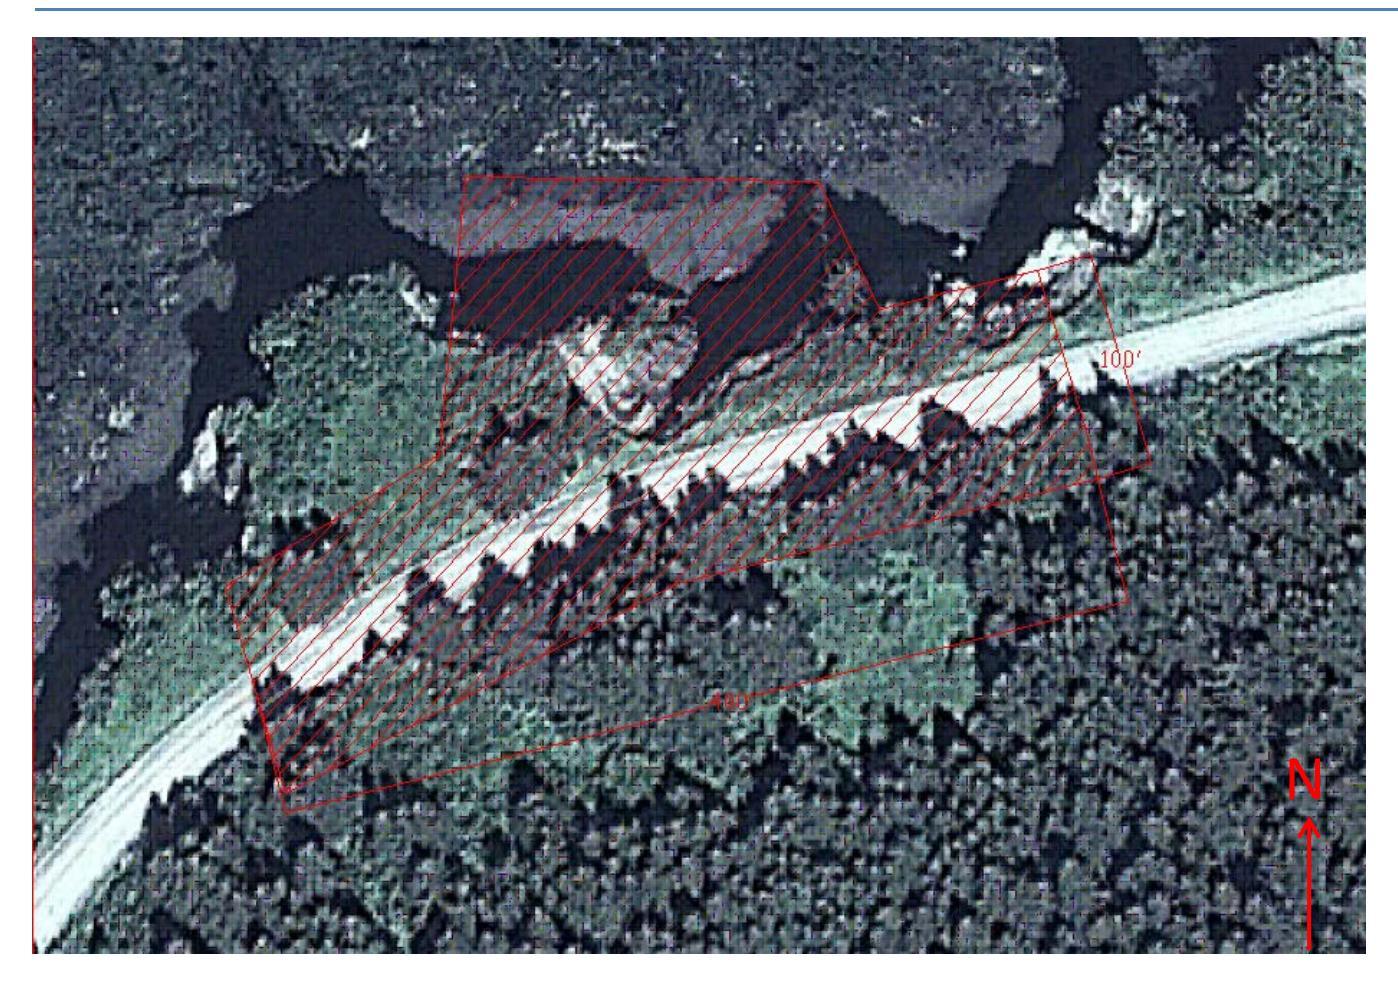
Site 6A: MP 38 Bluff Erosion

- Approximate CDS Milepoint 28.0-28.3
- Bluff erosion ٠
- Guardrail failing

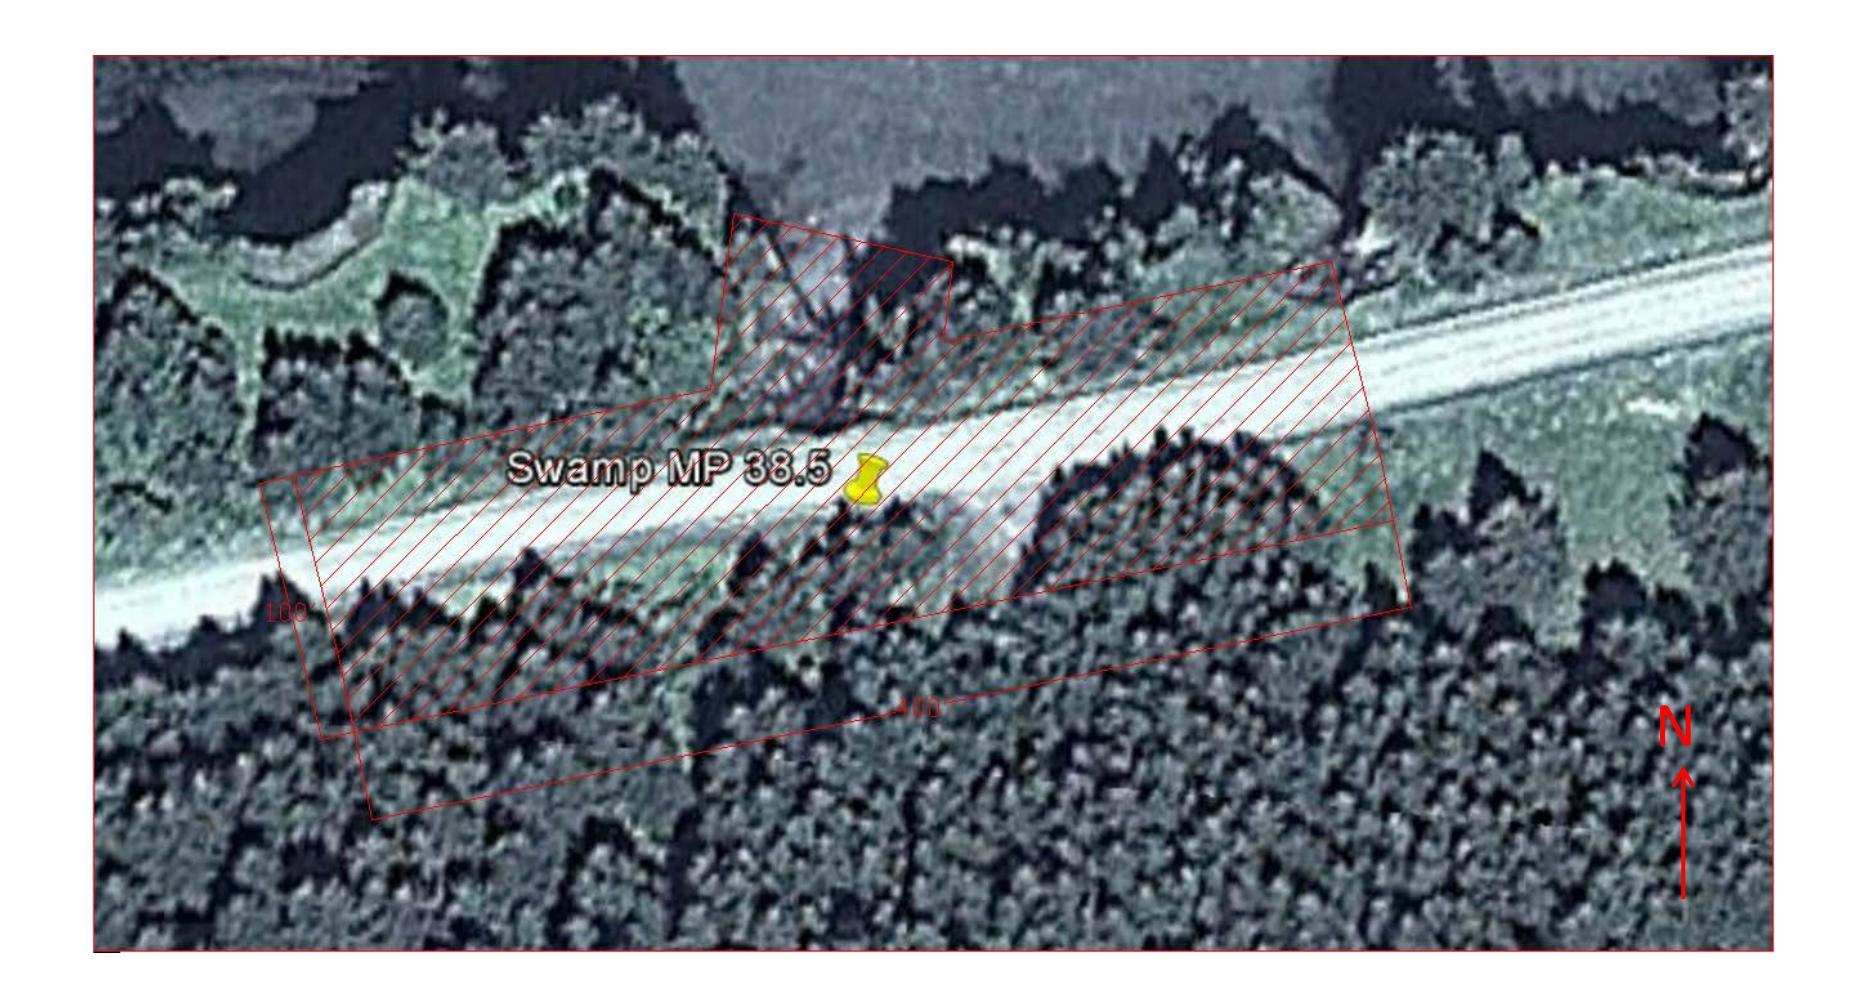
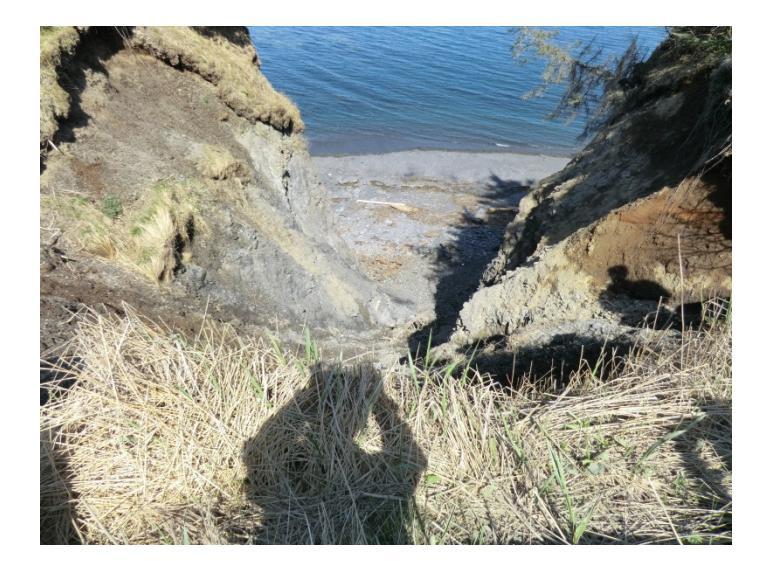
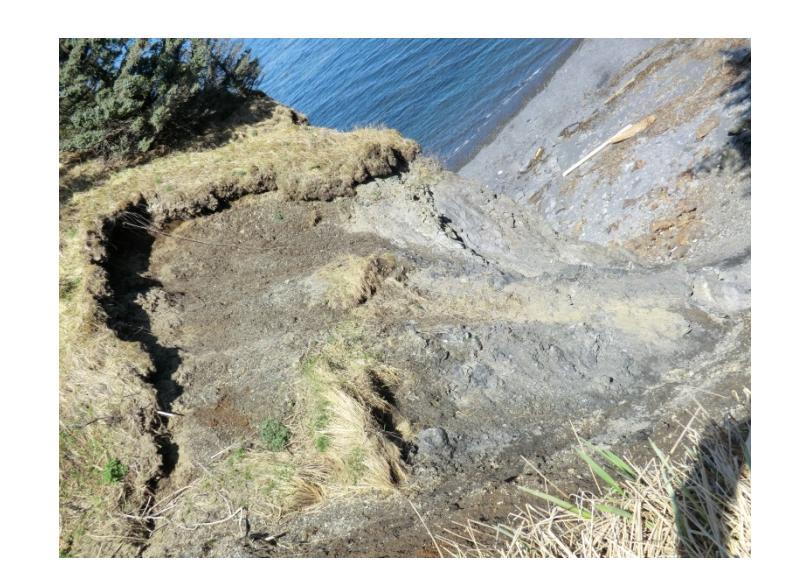
Site 6B: Erosion at MP 38.5

- Approximate CDS Milepoint 28.3-28.5
- No pipes observed
- Evidence of erosion at the sag in vertical curve
- Bluff erosion is 5-10' from guardrail

• Erosion partly caused by ditch discharging onto bluff

• Install 2 culverts and ditch blocks to remove drainage • Ensure improvements prohibit water flowing down existing unstable slope

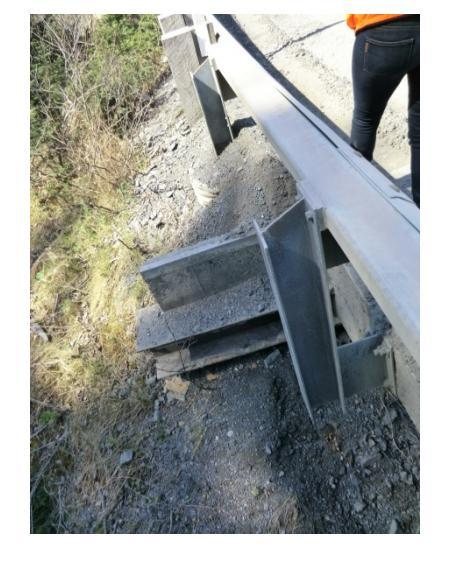
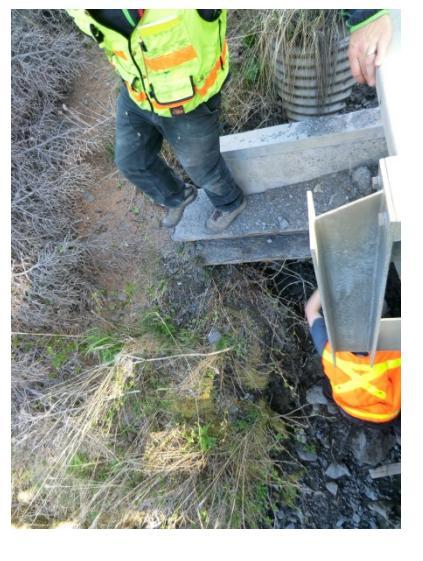
Site 7: Erosion at Twin Creeks (MP 40)

- Bridge abutments appear fine

• Erosion mostly occurring on East side of bridge, but erosion on both sides • Appears water runoff parallels road and eroding embankment near back wall

• No recommendations

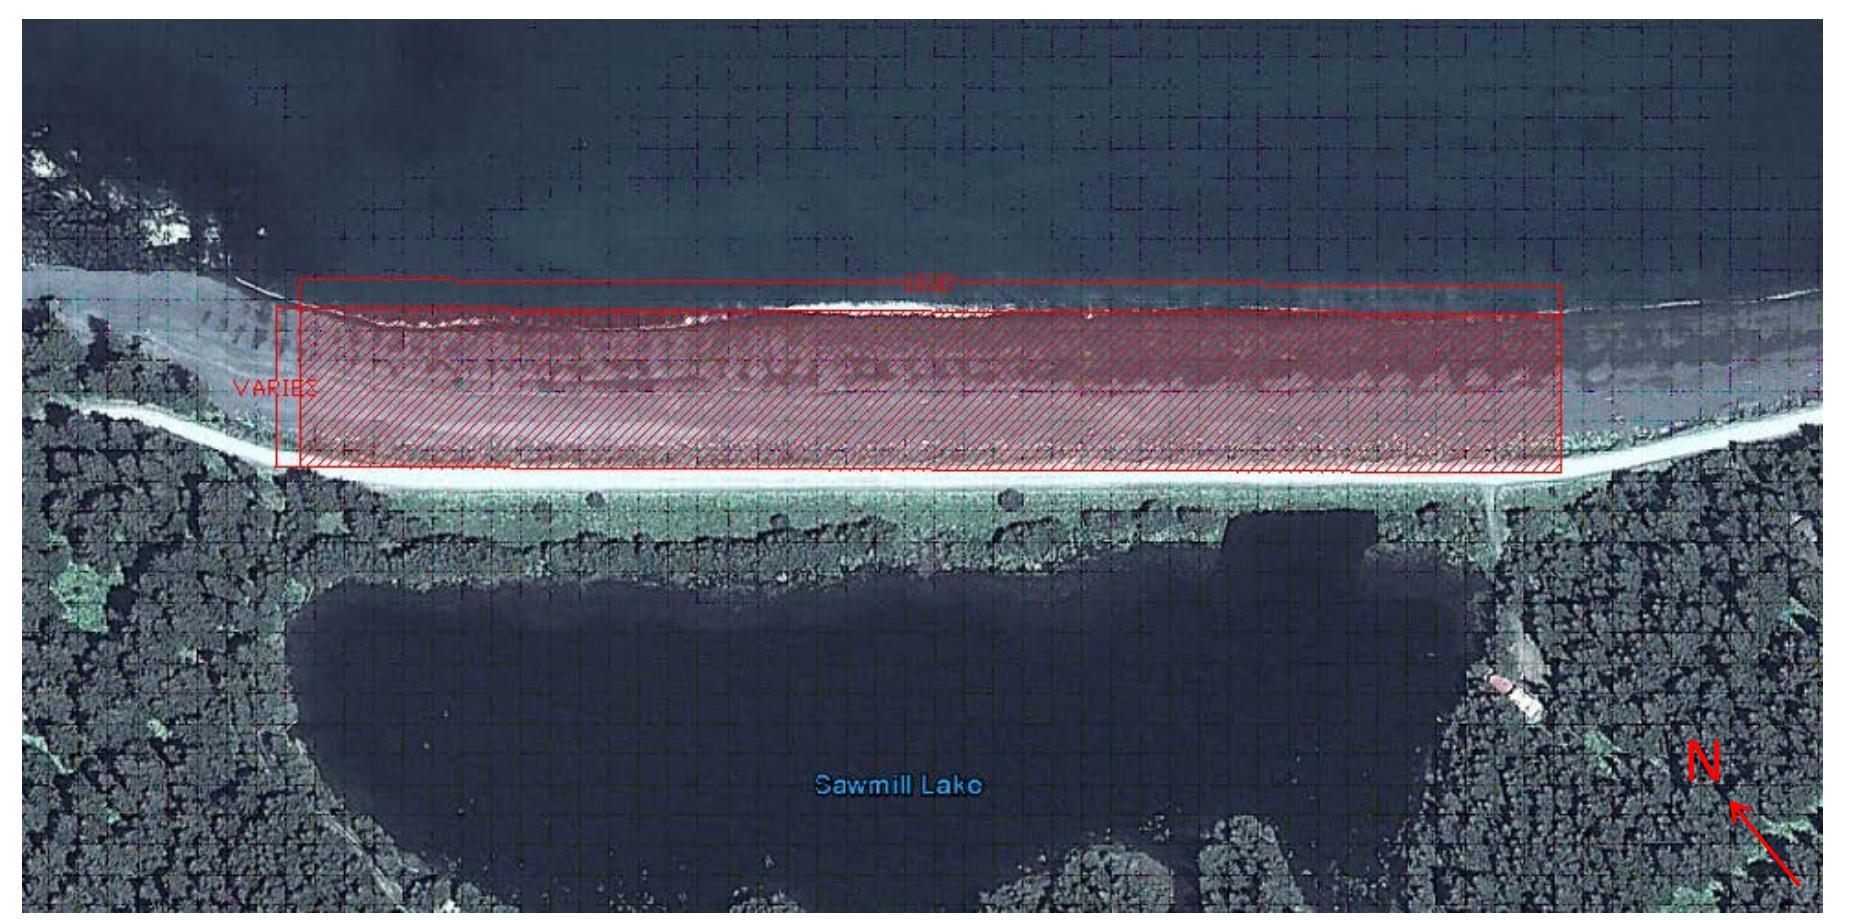
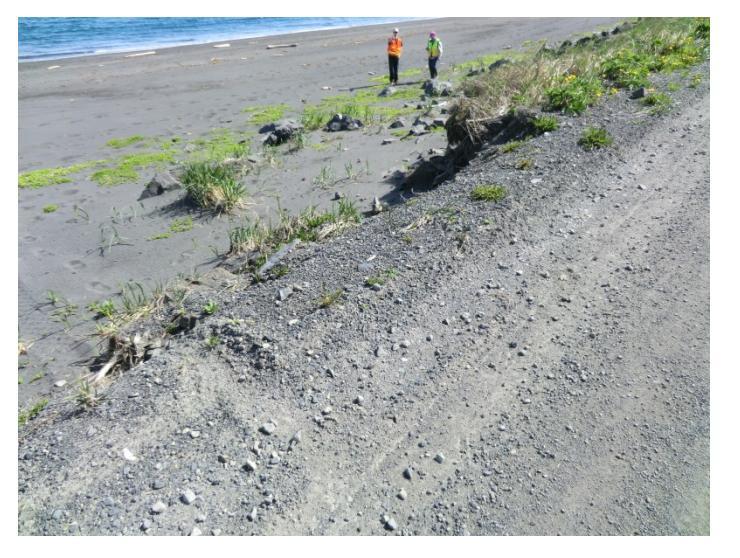
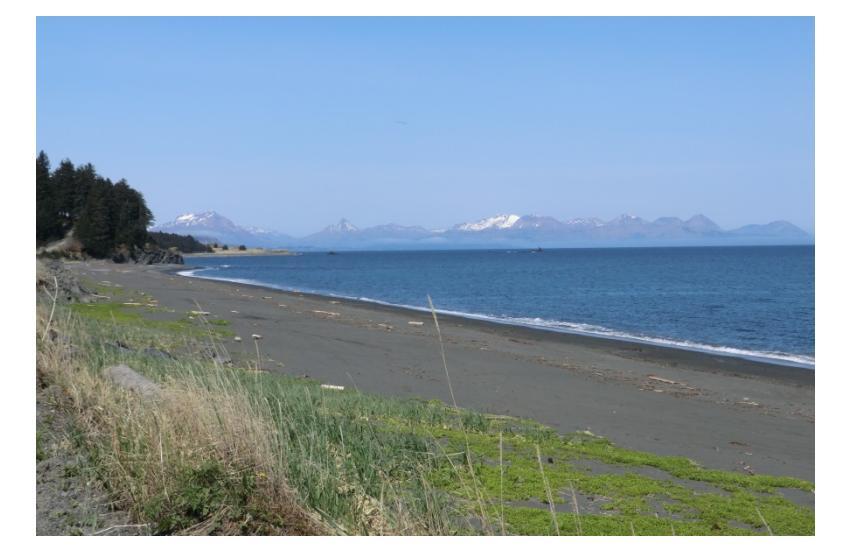
Site 8: Erosion at Silver Beach/Sawmill Lake

• Multiple spots along stretch where tidal erosion is a problem

- Most advanced spot is at end of guardrail section

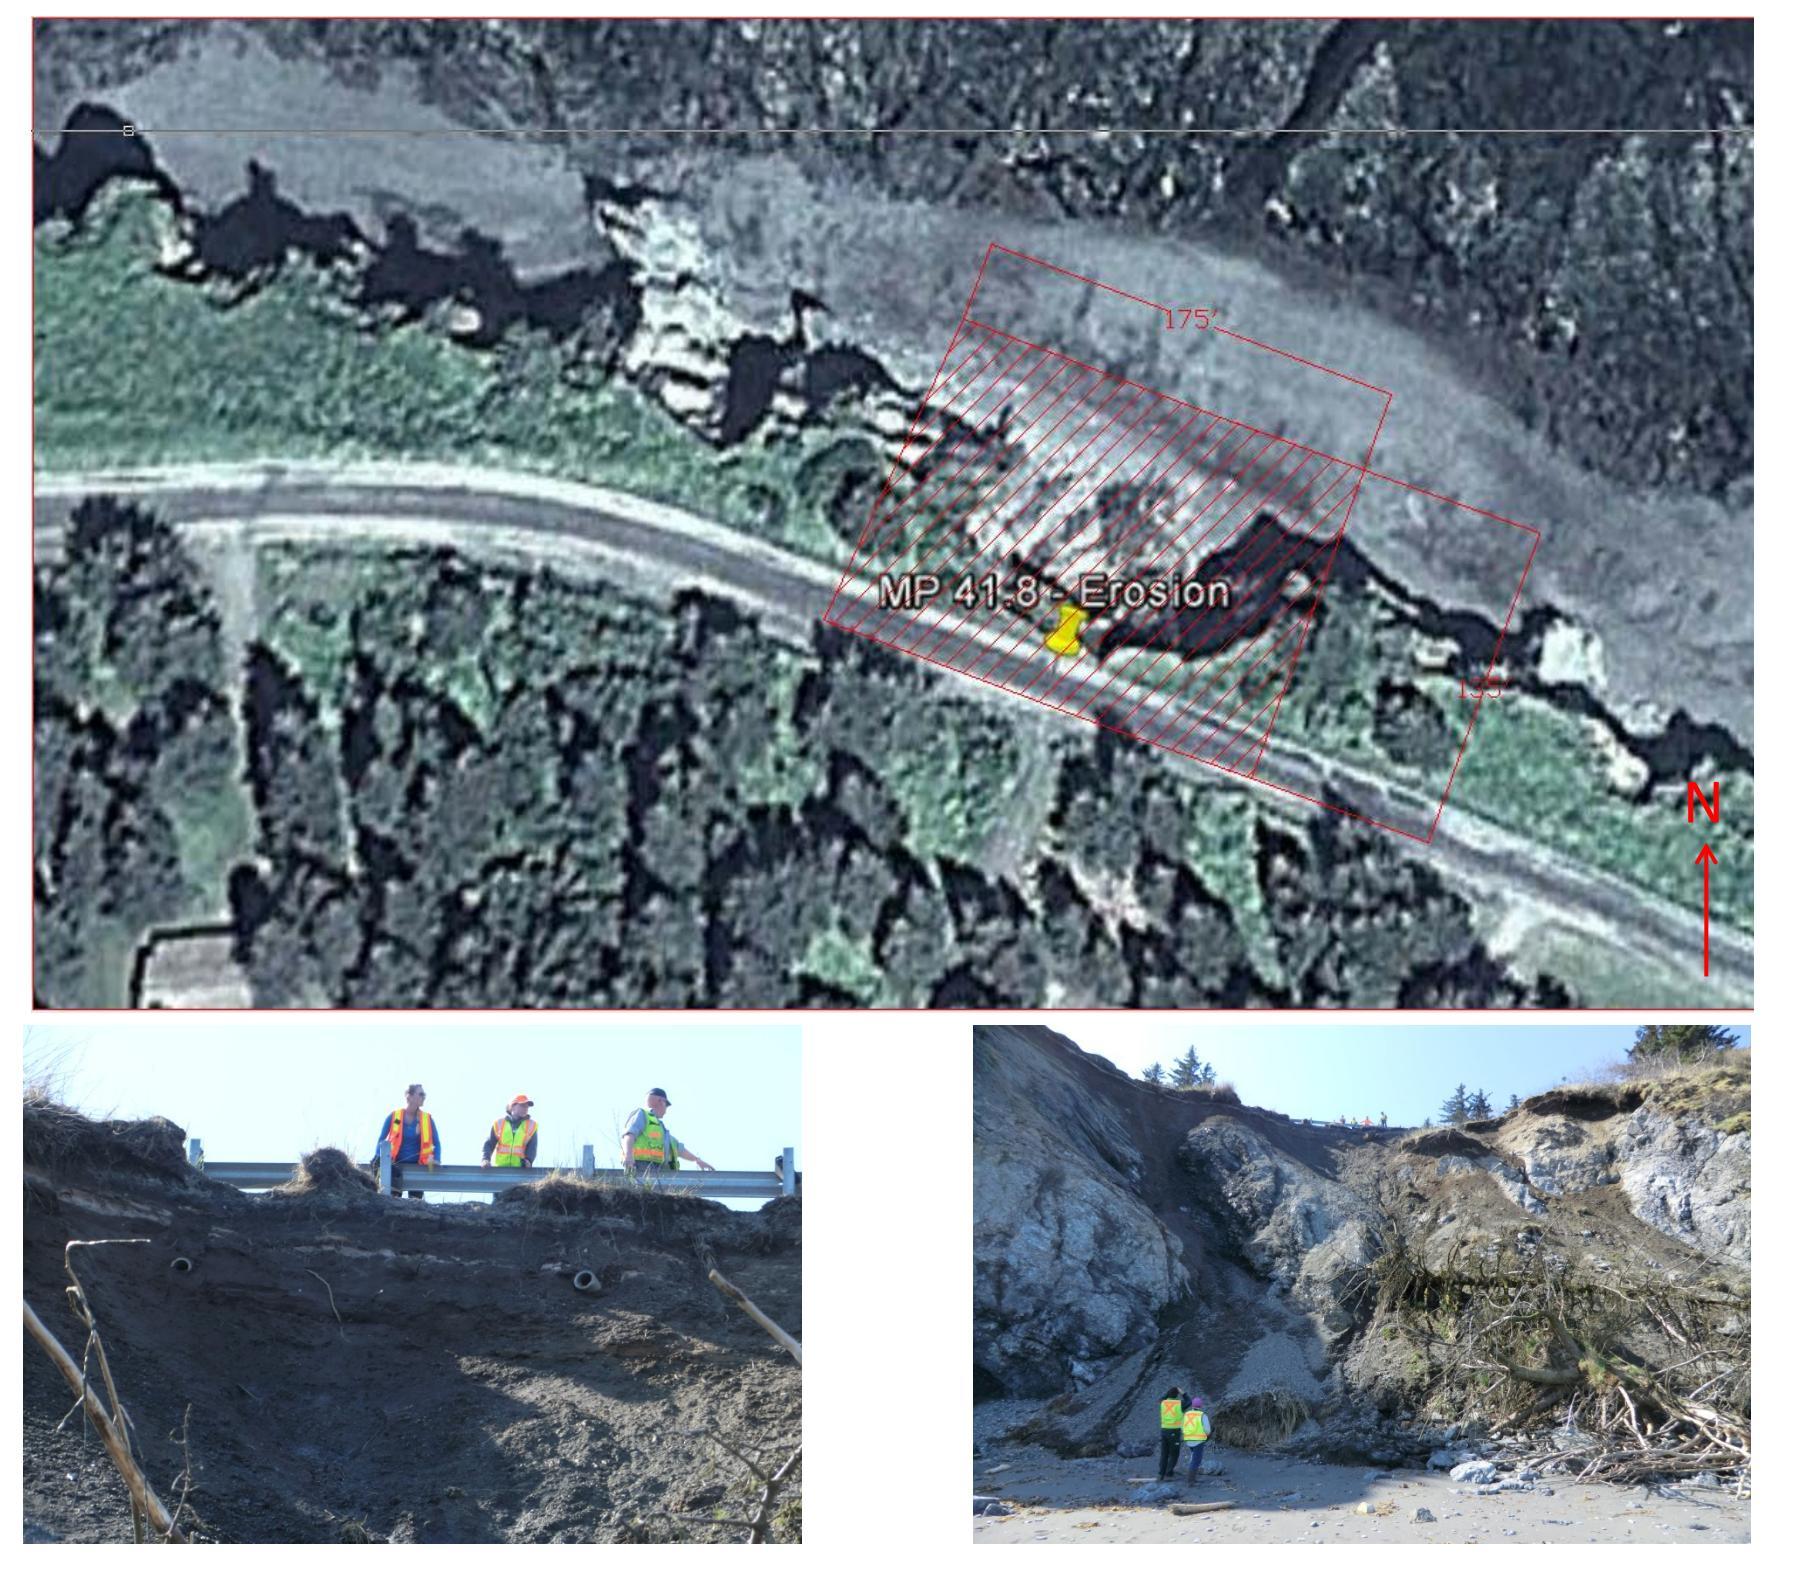
Site 9A: MP 41.8

- Approximate CDS Milepoint 31.8-31.9
- About 50' wide at top
- Pipes protruding from the side of embankment
- Purpose and origin of pipes is unknown • May be from two turrets on land side near site, could not locate

- Grout and abandon existing pipes to prevent additional erosion
- Fill saddle with riprap
- Ditch linear grade on road to help direct roadway water

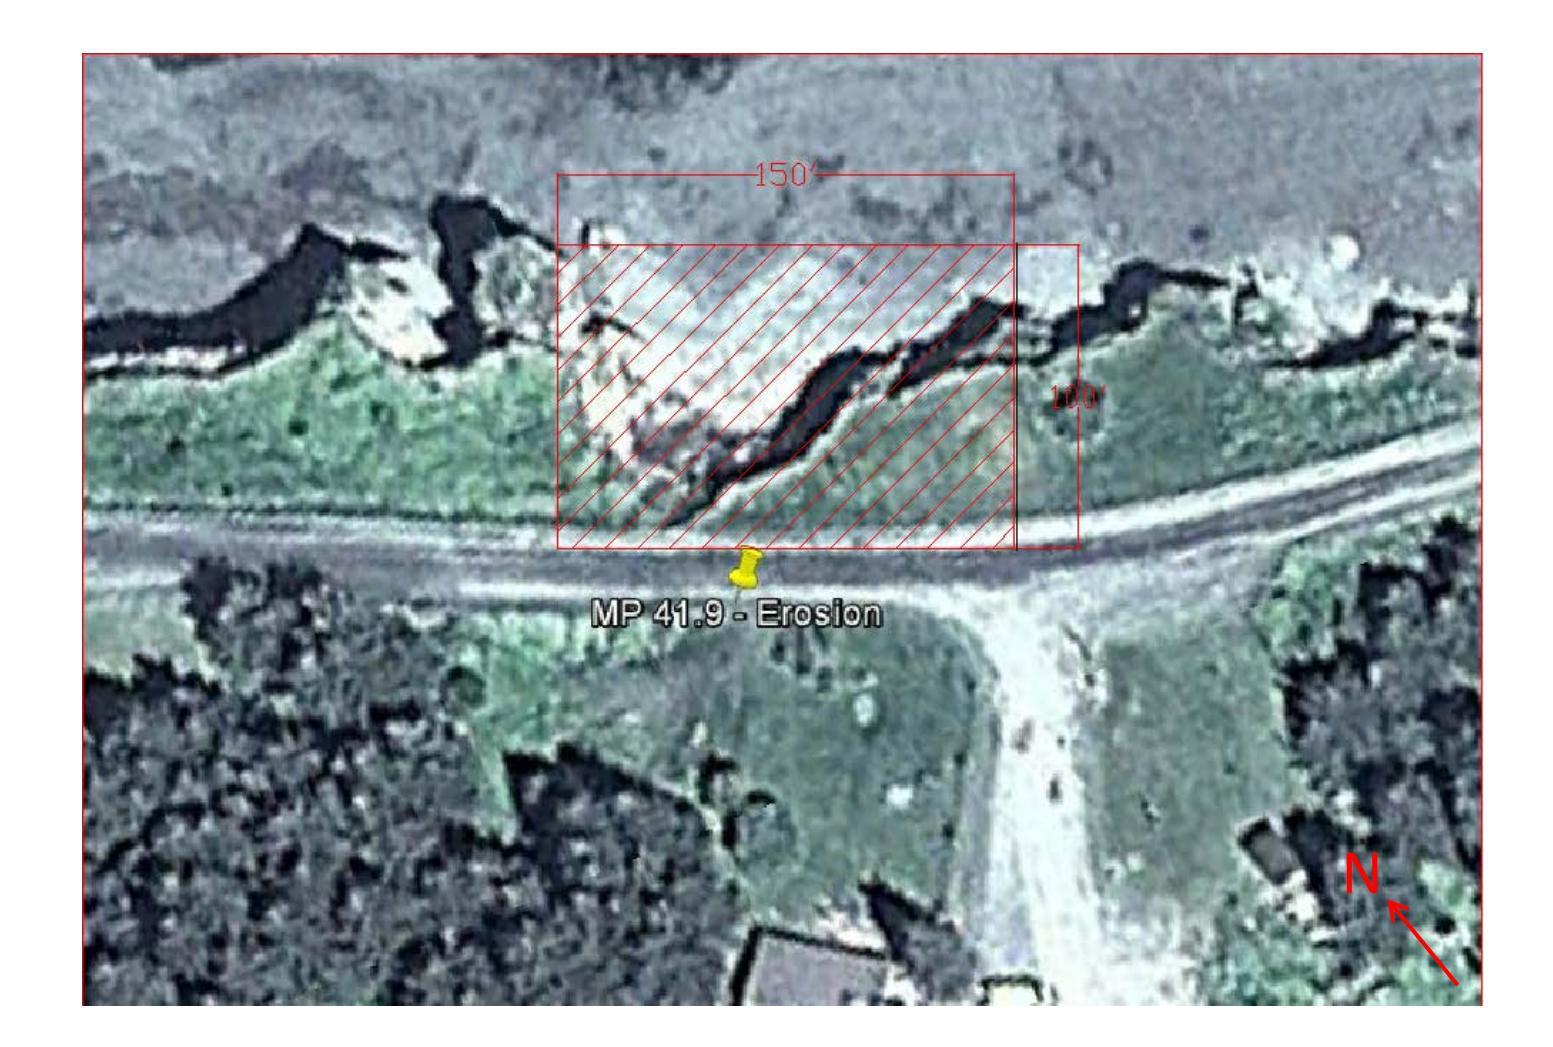
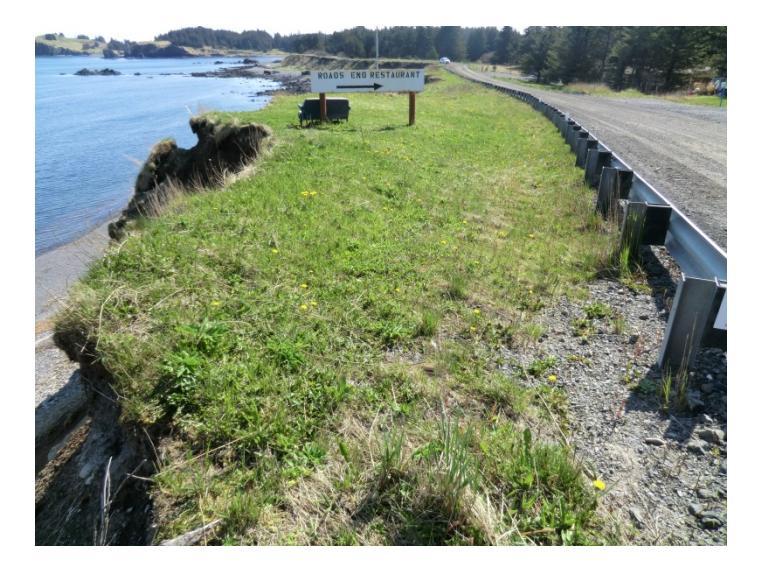
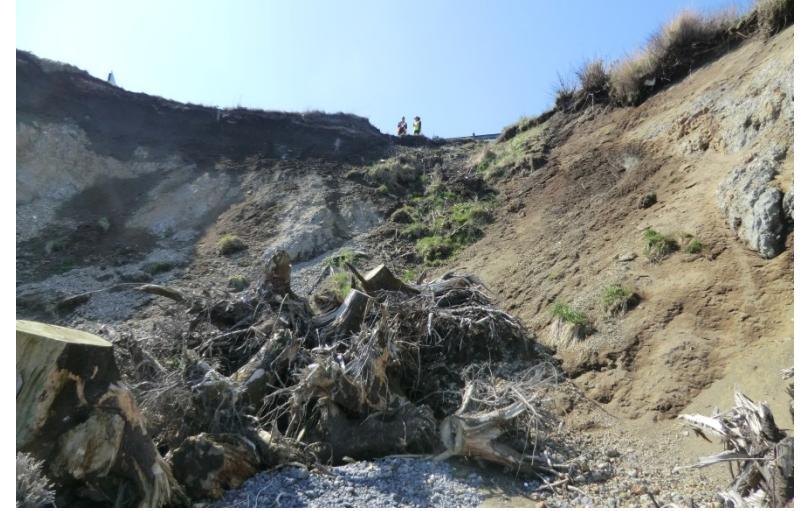
Site 9B: MP 41.9 Erosion

- Approximate CDS Milepoint 31.9-32.0
- Near sign and bench at the back end of guardrail

- Fill between rock knobs
- Bottom is tidally influenced
