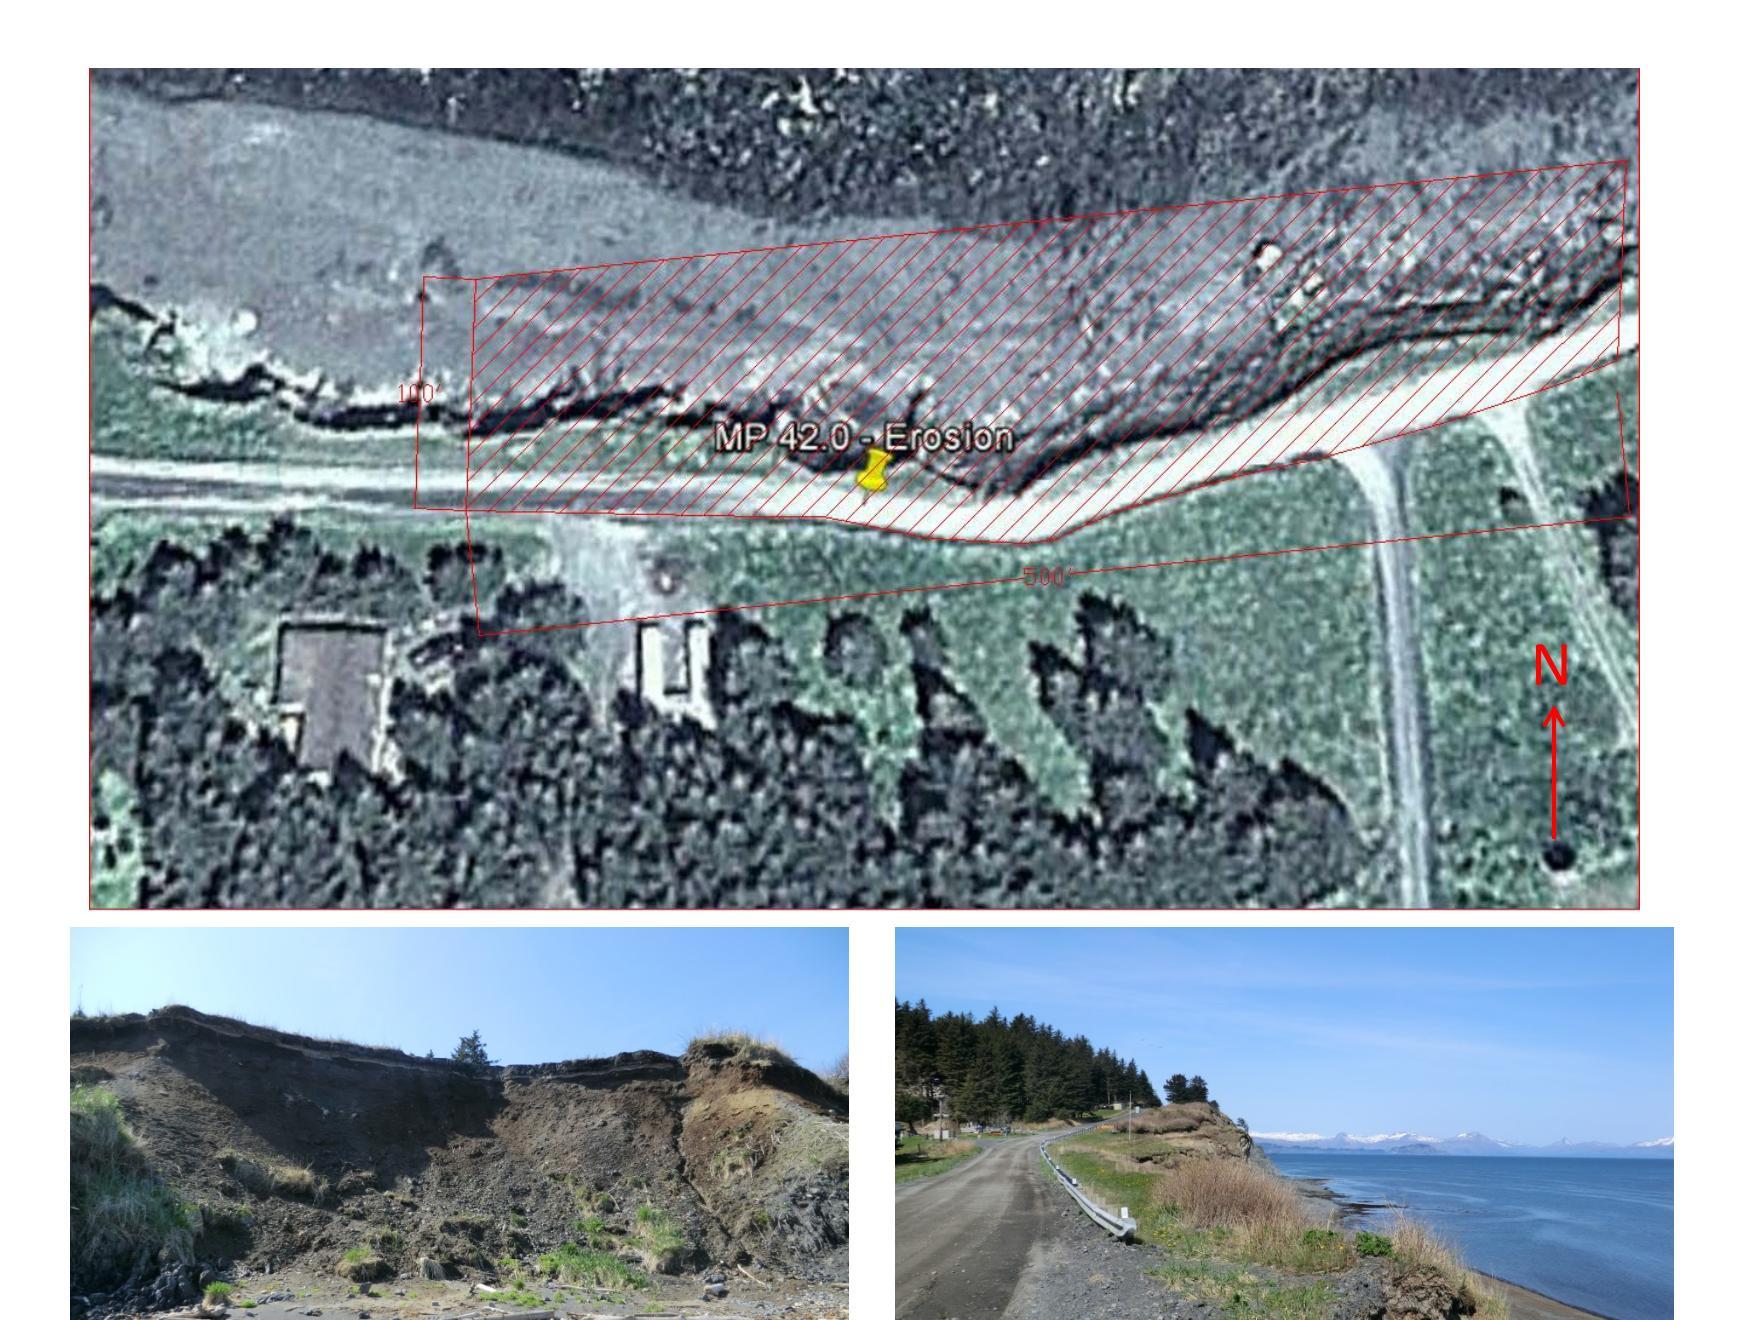
Site 9C: MP 42 Erosion

- Approximate CDS Milepoint 32.0-32.1
- Warning cones for erosion sites on roadway
- Road has been relocated once to current location
- Underground utilities are on land side
- Toe is not tidally influenced here

- Fill in area with riprap to stabilize
- Extend guardrail
